FIGURE 3-1
SITES, ZONES, AND OUs
CURRENTLY UNDER INVESTIGATION

MCAS EL TORO BCP

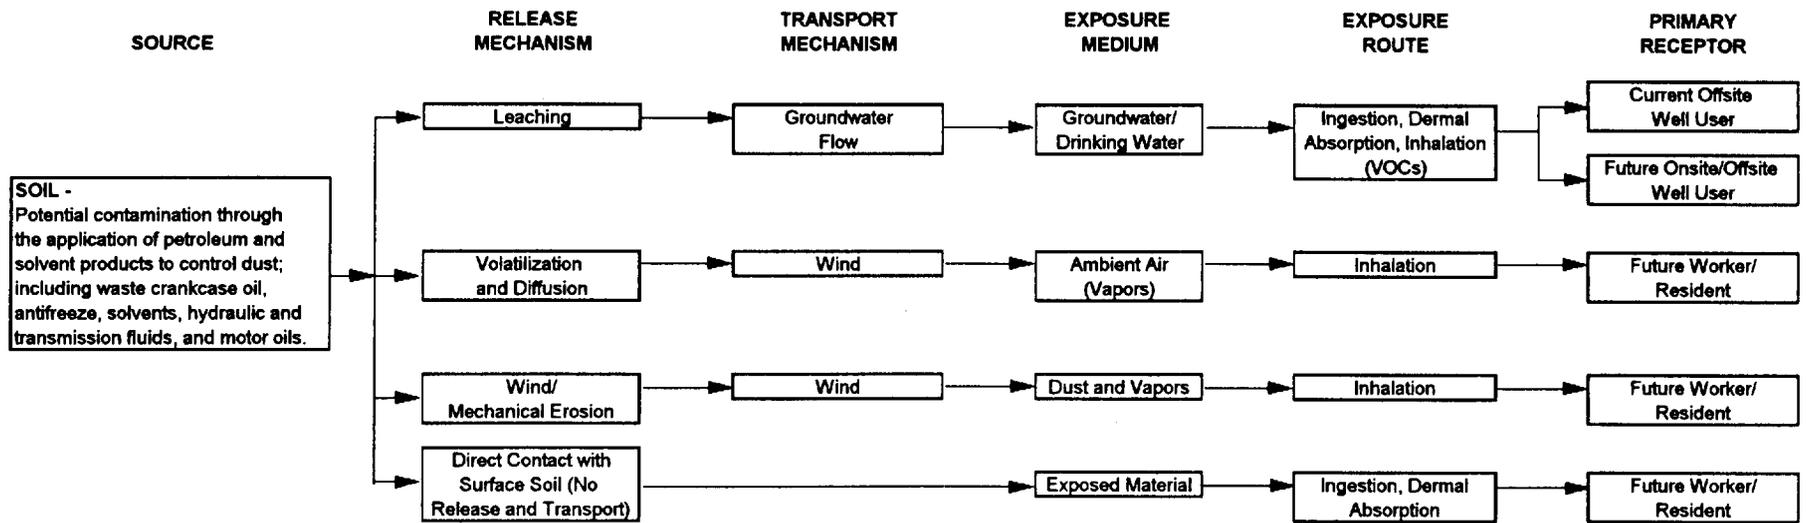
Figure E-10b
Site 10 (Petroleum Disposal Area):
Conceptual Site Model

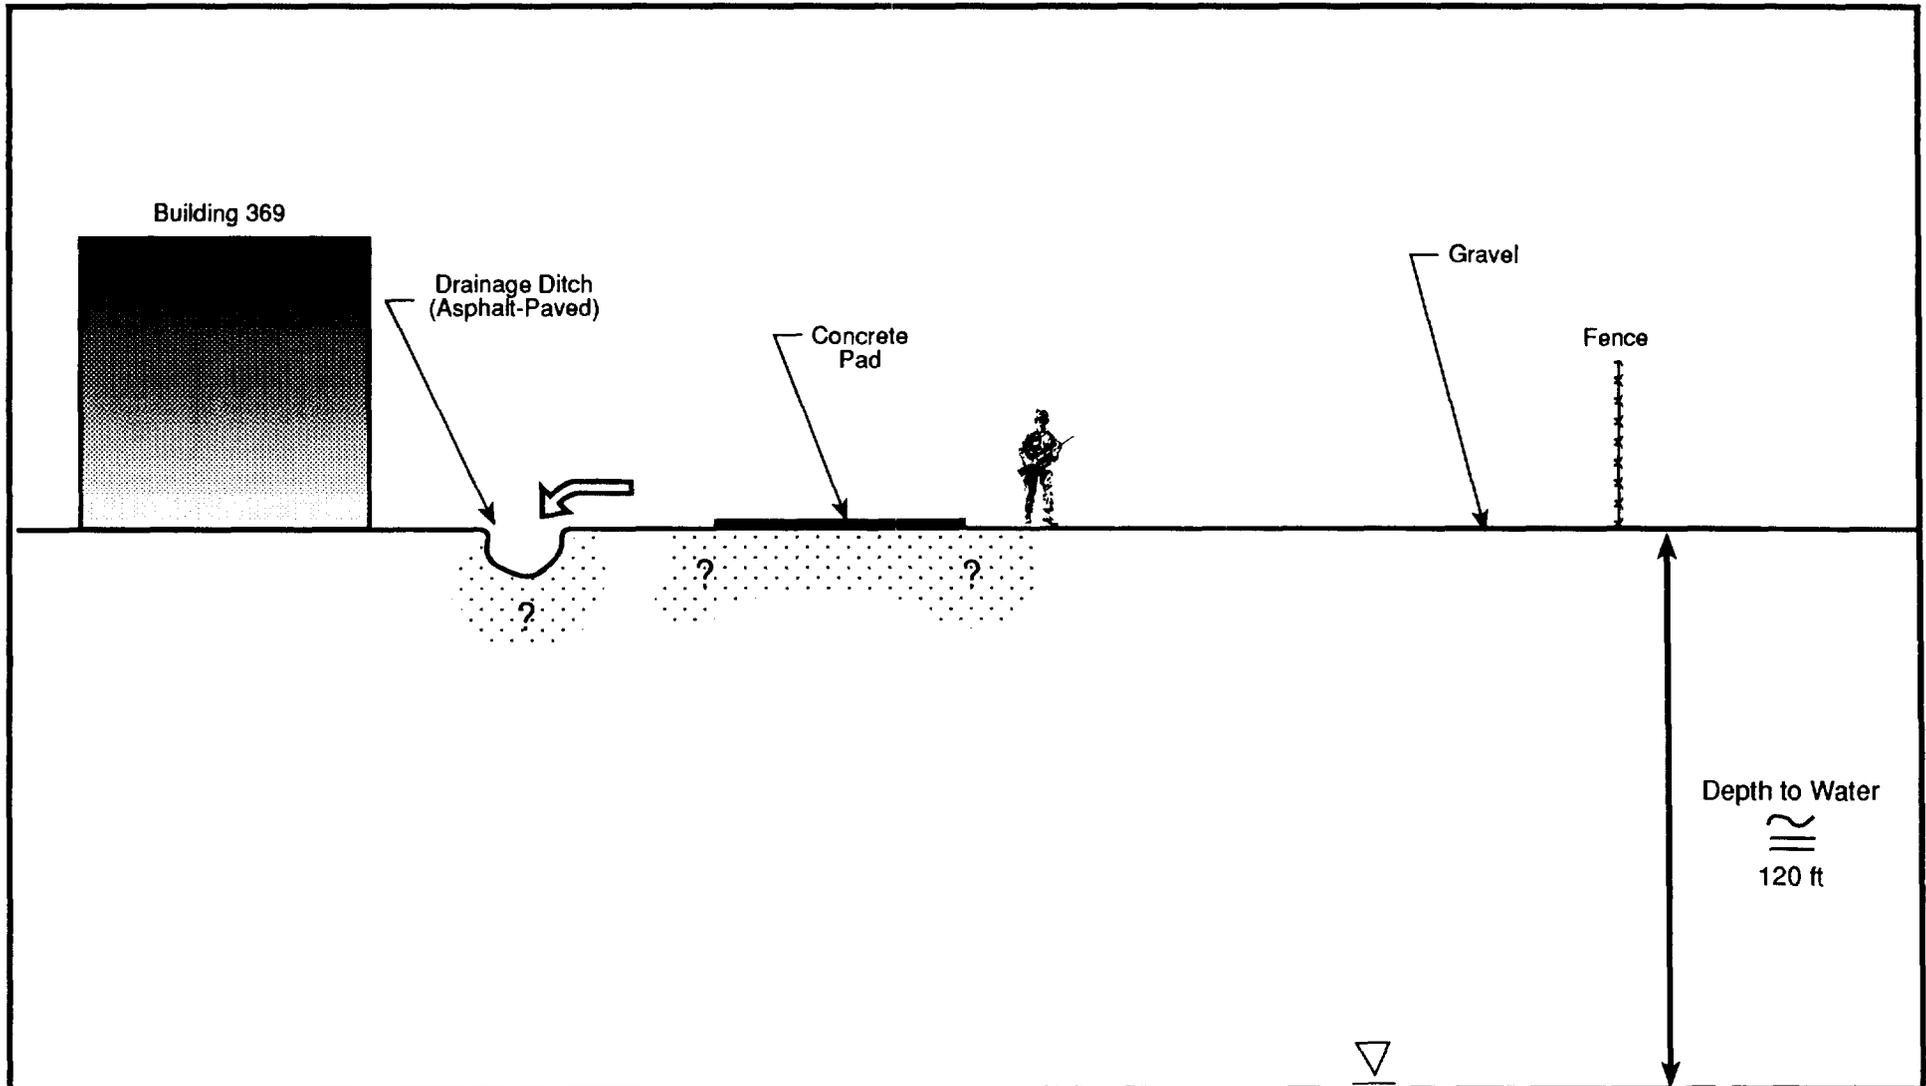
FIGURE E-11a
SITE 11 (TRANSFORMER
STORAGE AREA):
SITE LAYOUT

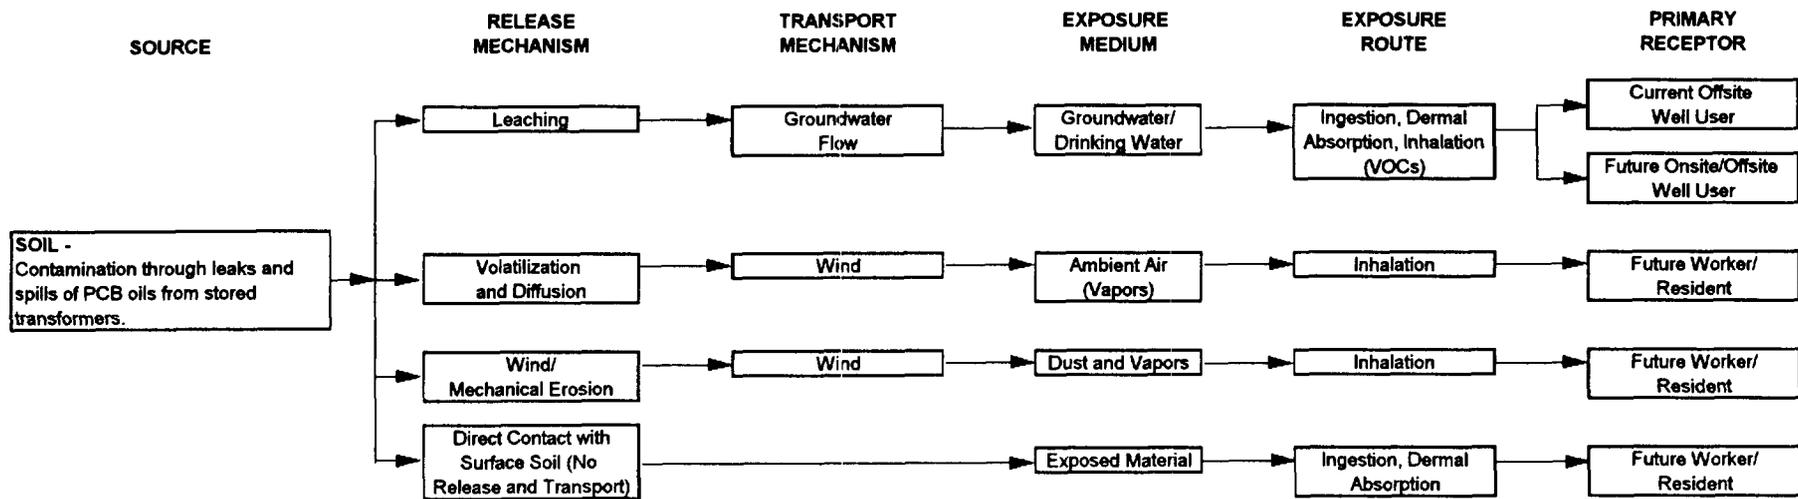
Figure E-11b
Site 11 (Transformer Storage Area):
Conceptual Site Model

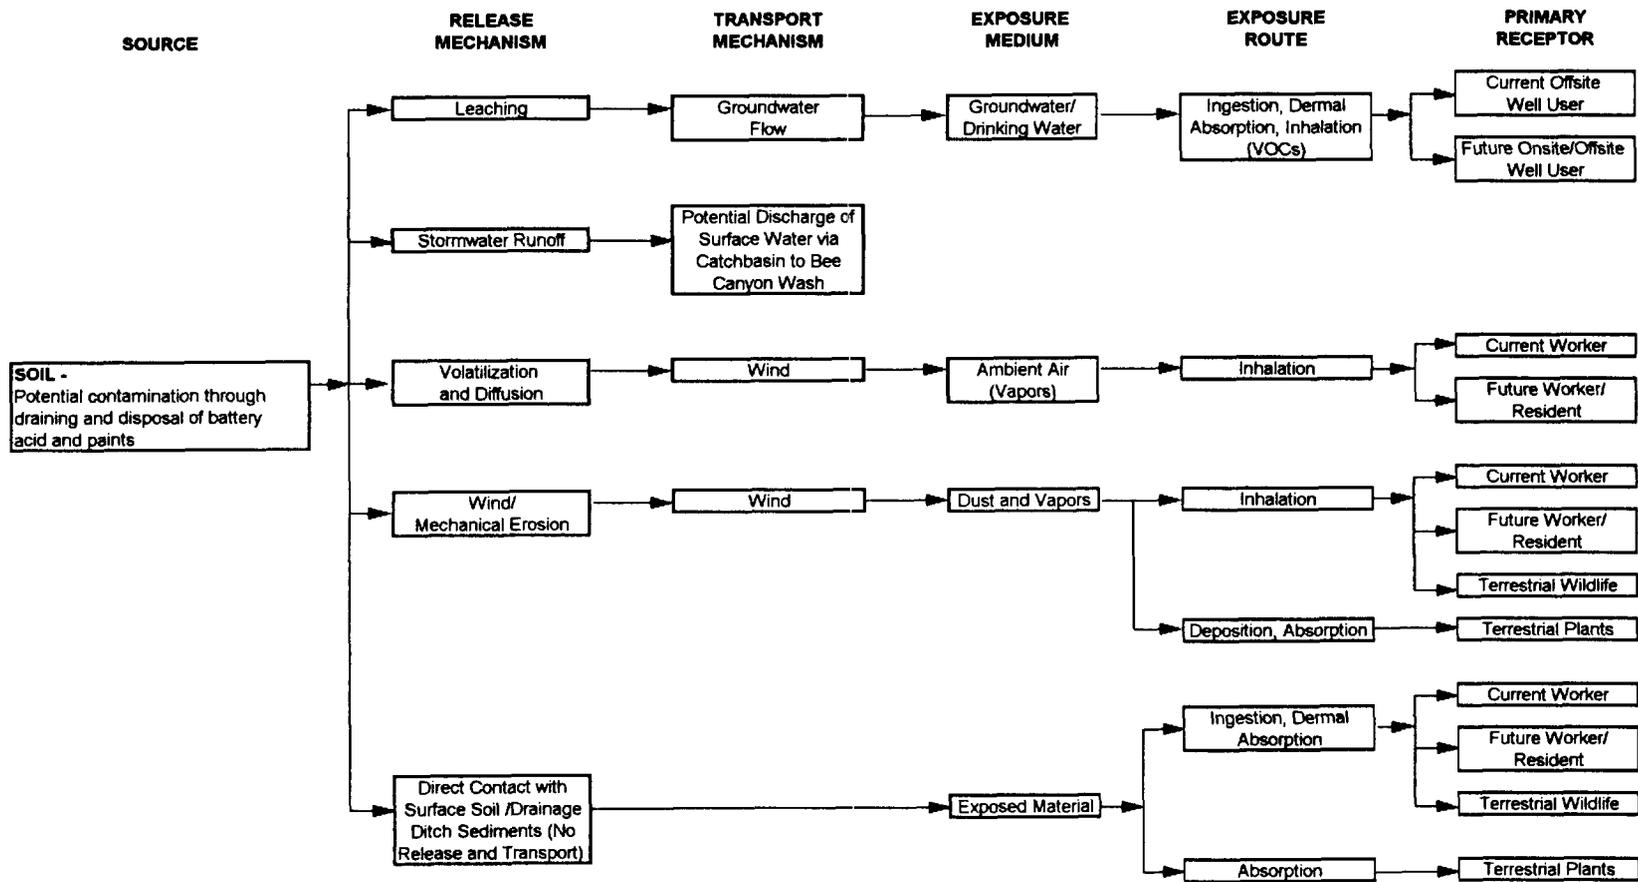
Figure E-14b
Site 14 (Battery Acid Disposal Area):
Conceptual Site Model

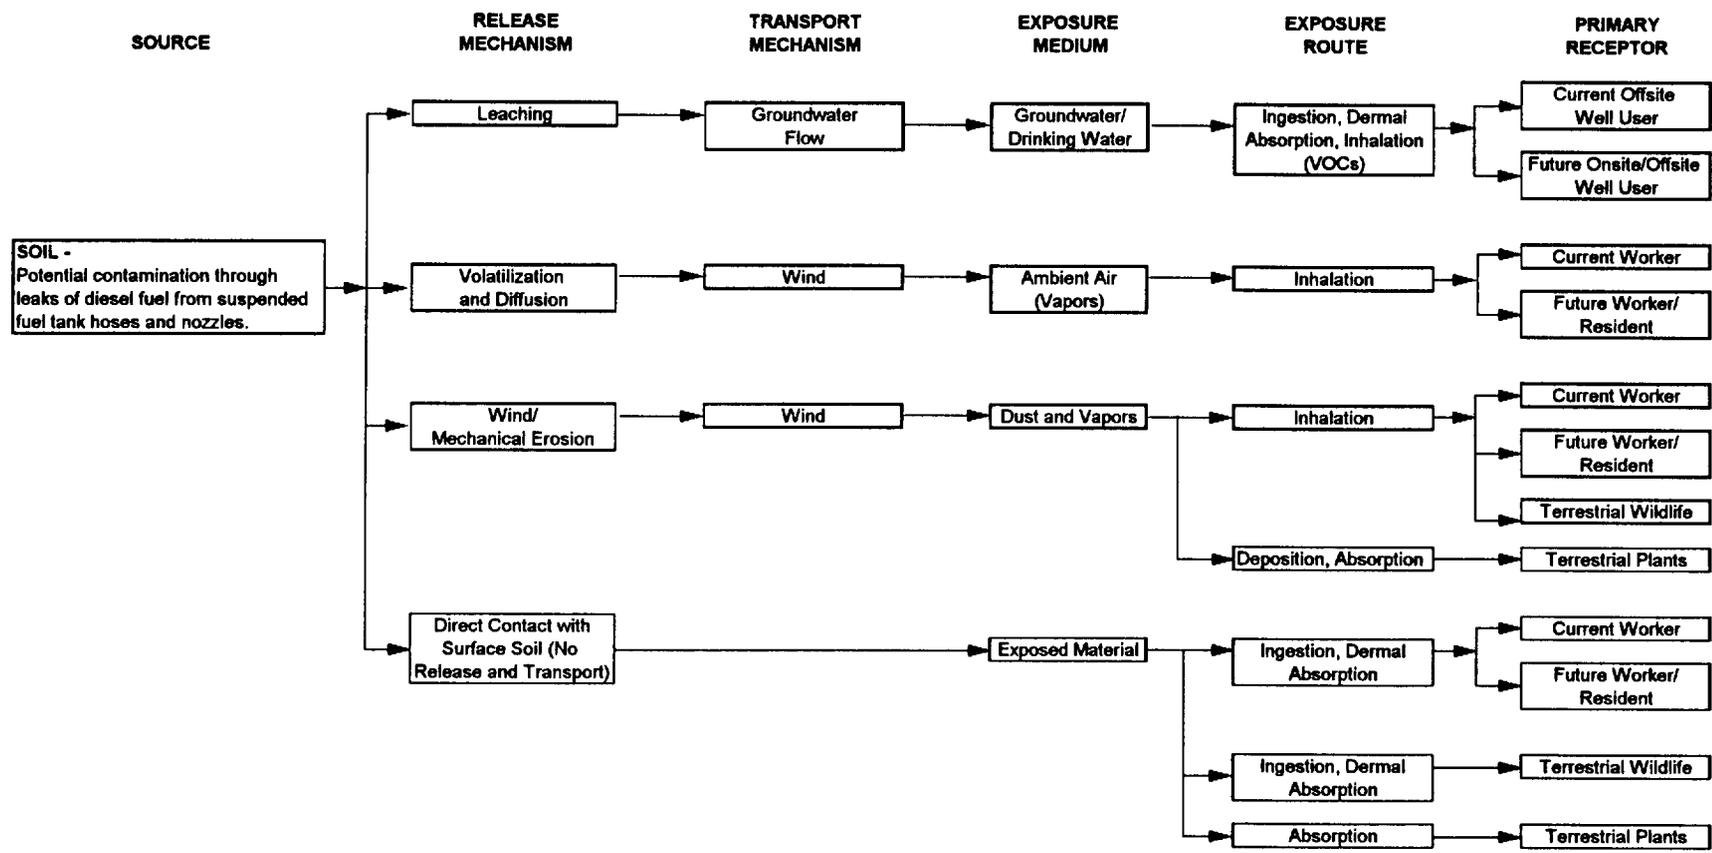
Figure E-15b
Site 15 (Suspended Fuel Tanks):
Conceptual Site Model

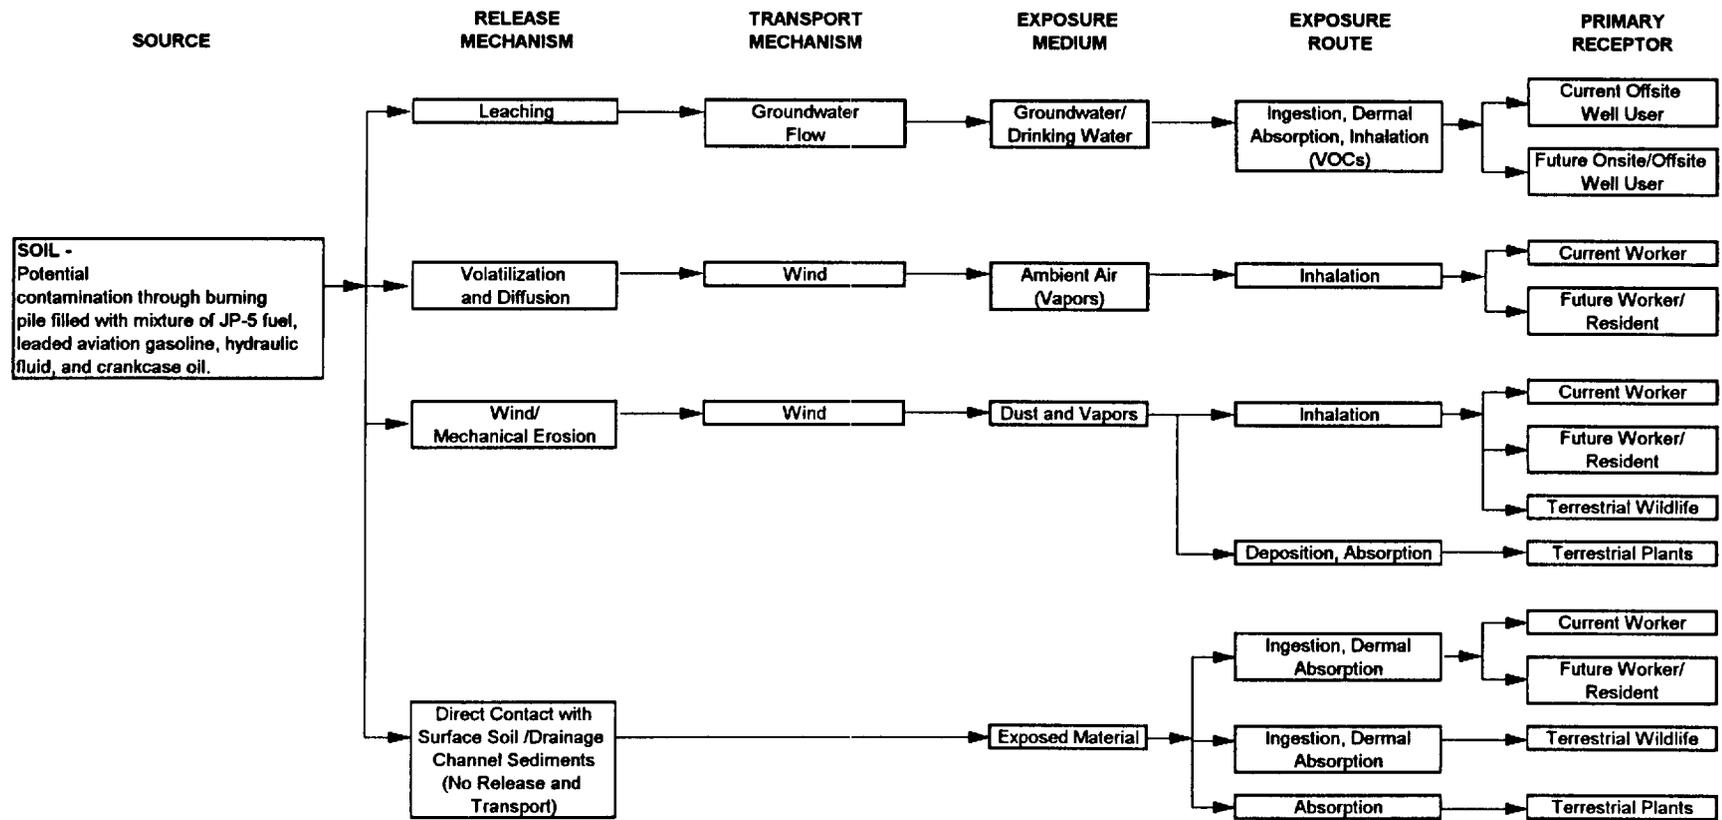
Figure E-16b
Site 16 (Crash Crew Pit No. 2):
Conceptual Site Model

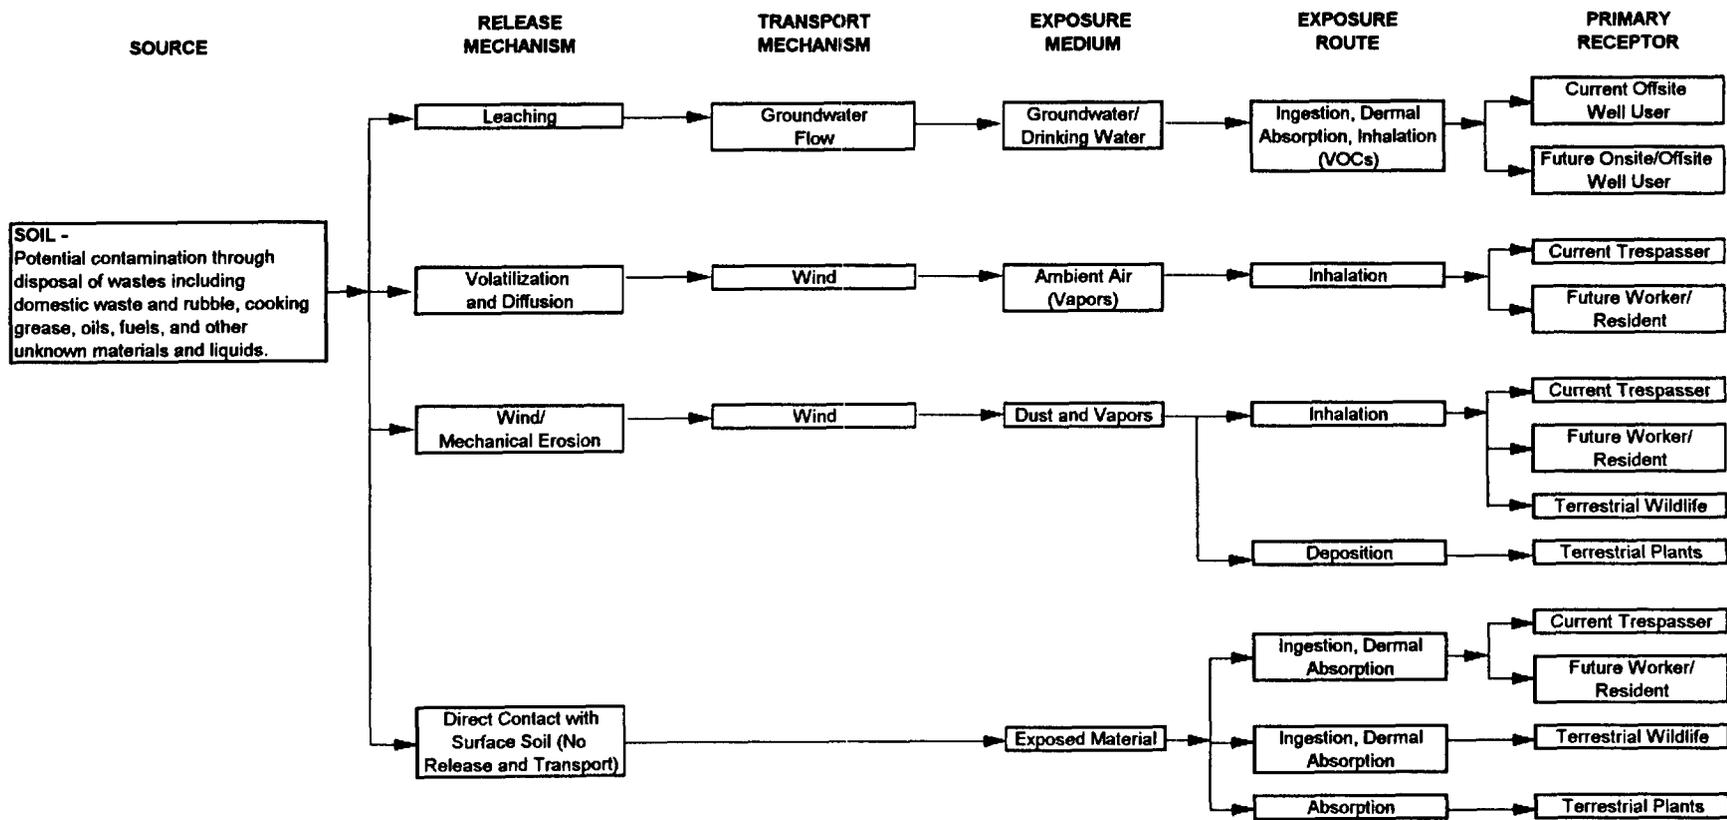
Figure E-17b
Site 17 (Communication Station Landfill):
Conceptual Site Model

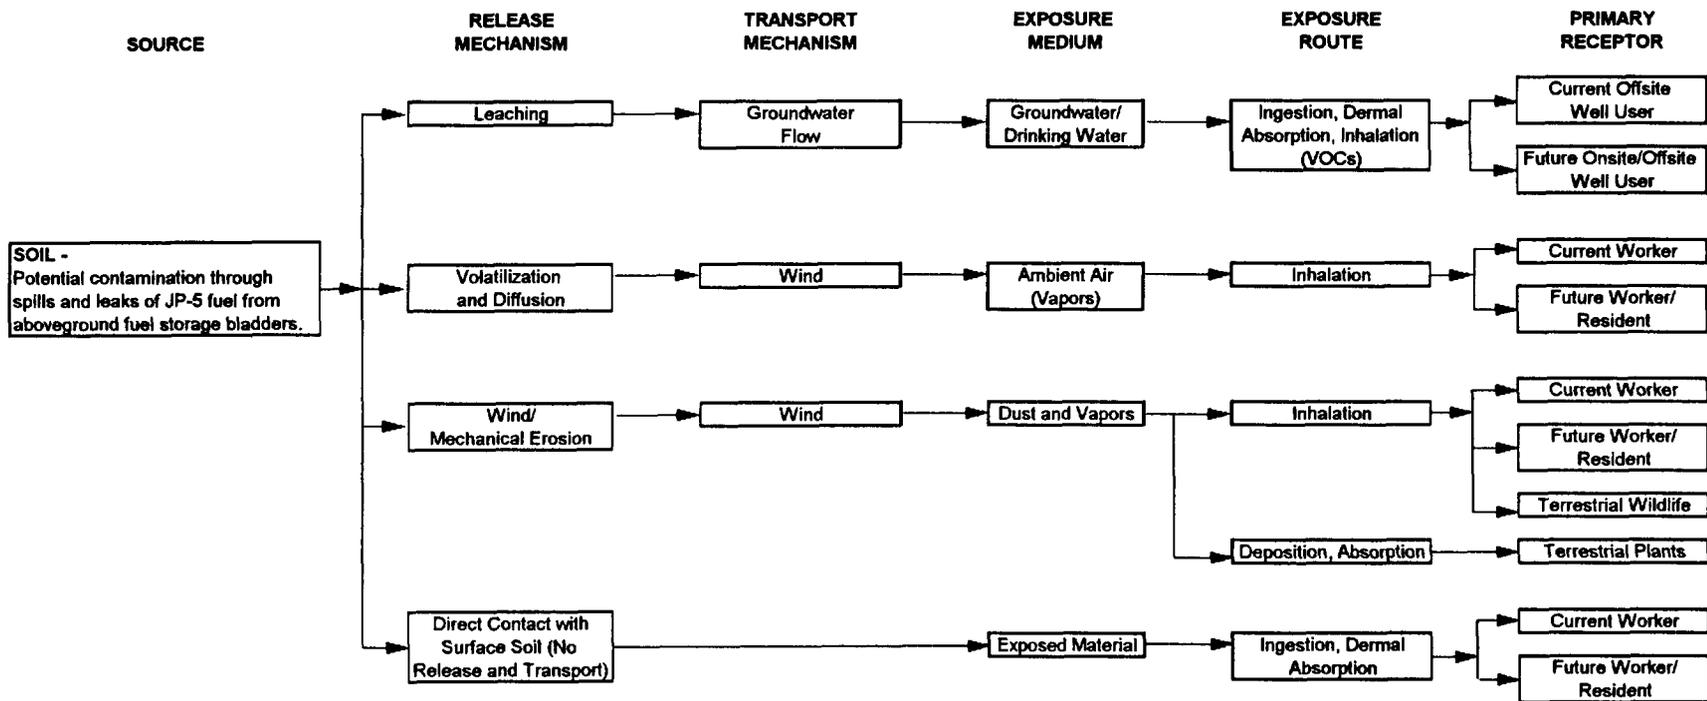
Figure E-19b
Site 19 (Aircraft Expeditionary Refueling [ACER] Site):
Conceptual Site Model

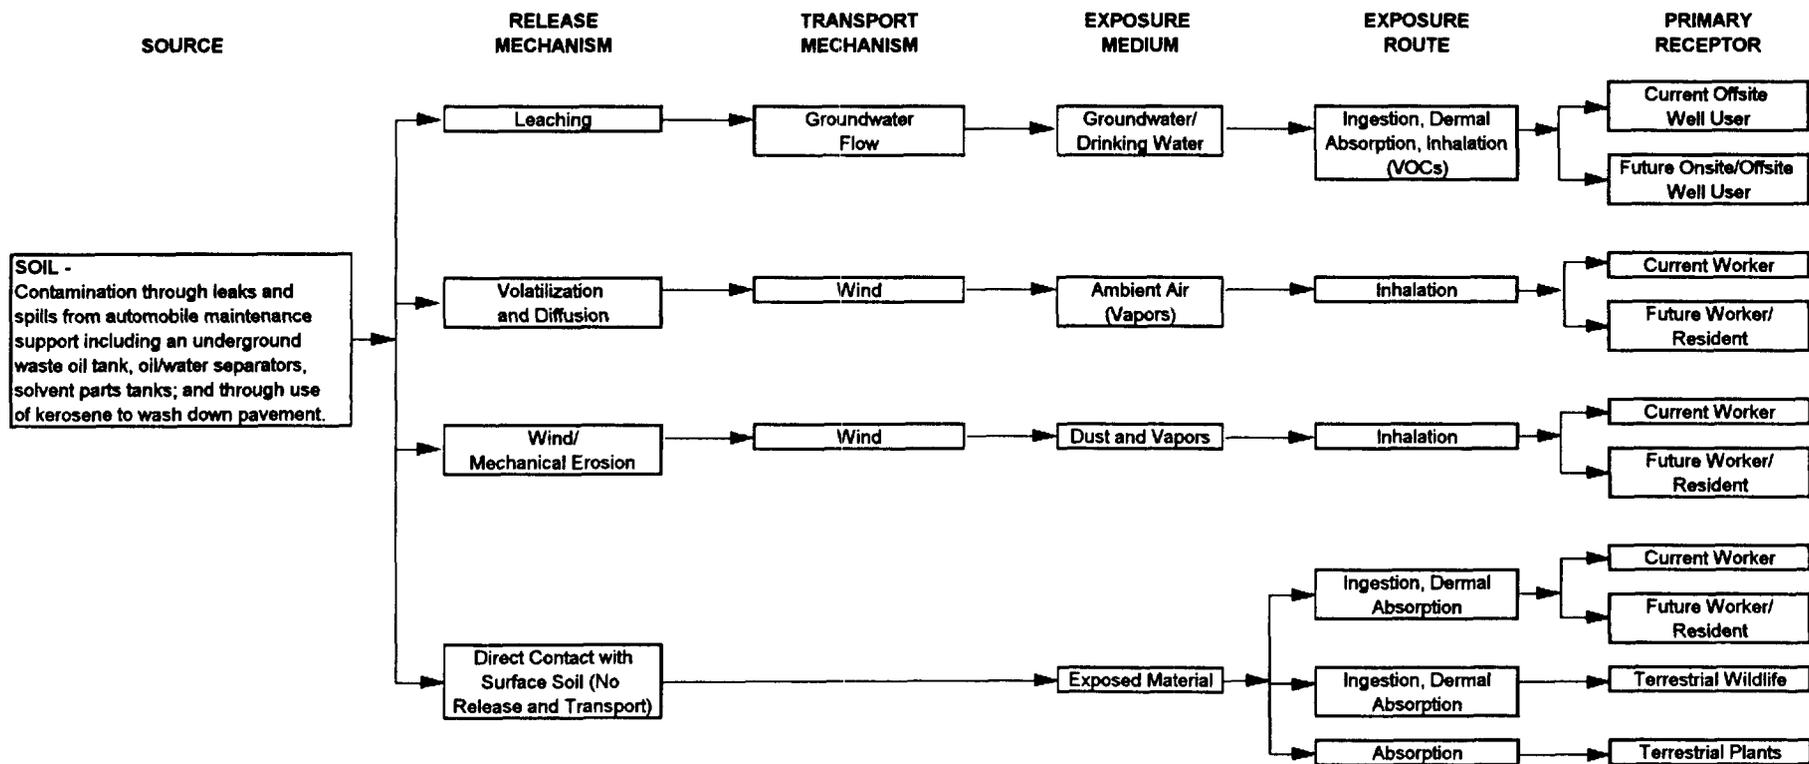
Figure E-20b
Site 20 (Hobby Shop):
Conceptual Site Model

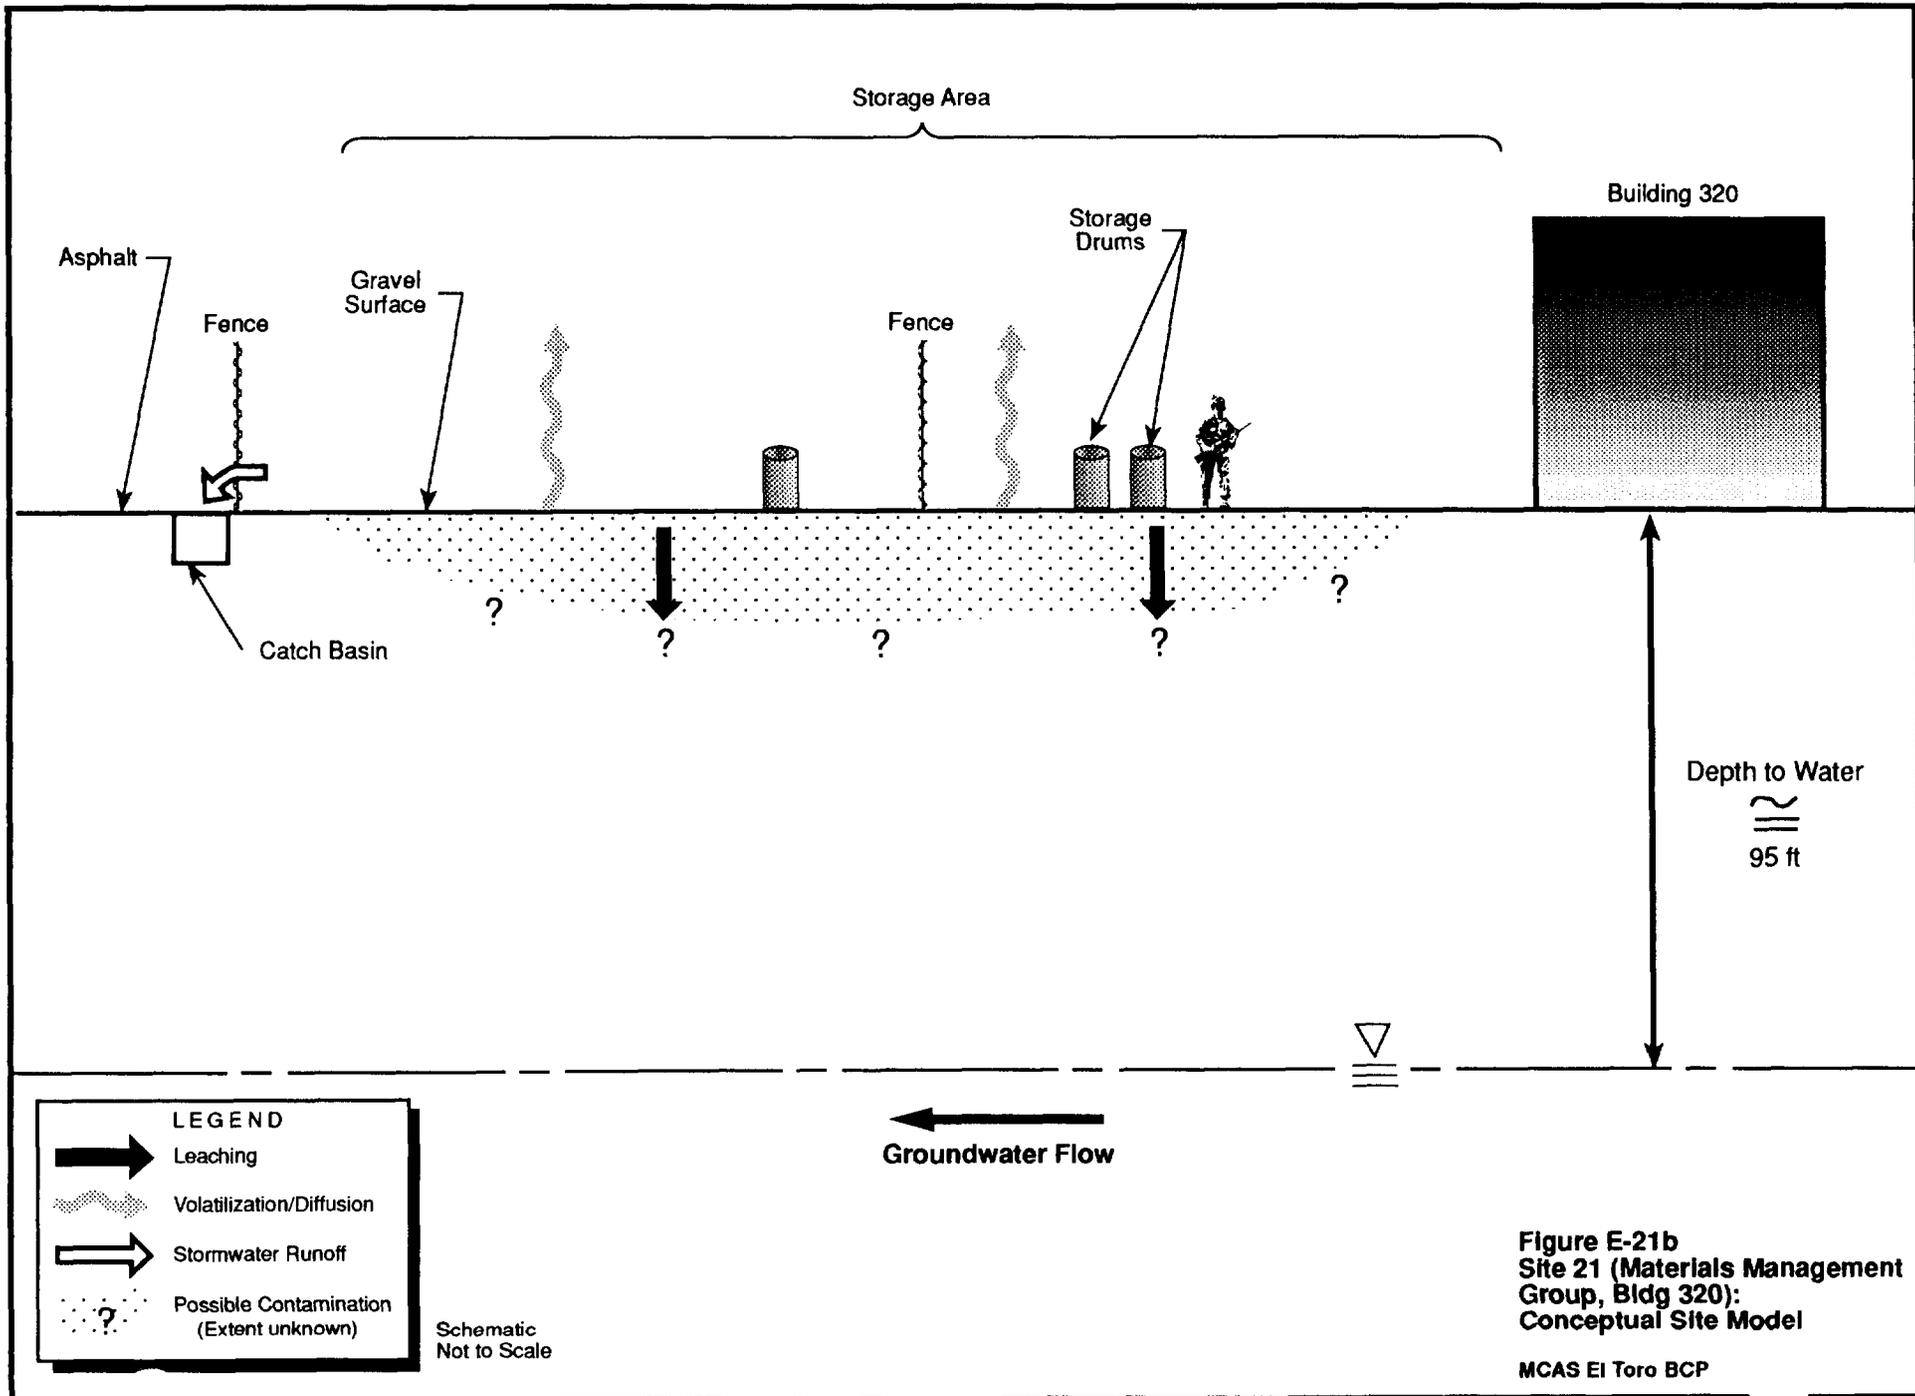
FIGURE E-21a
SITE 21 (MATERIALS
MANAGEMENT GROUP,
BUILDING 320):
SITE LAYOUT

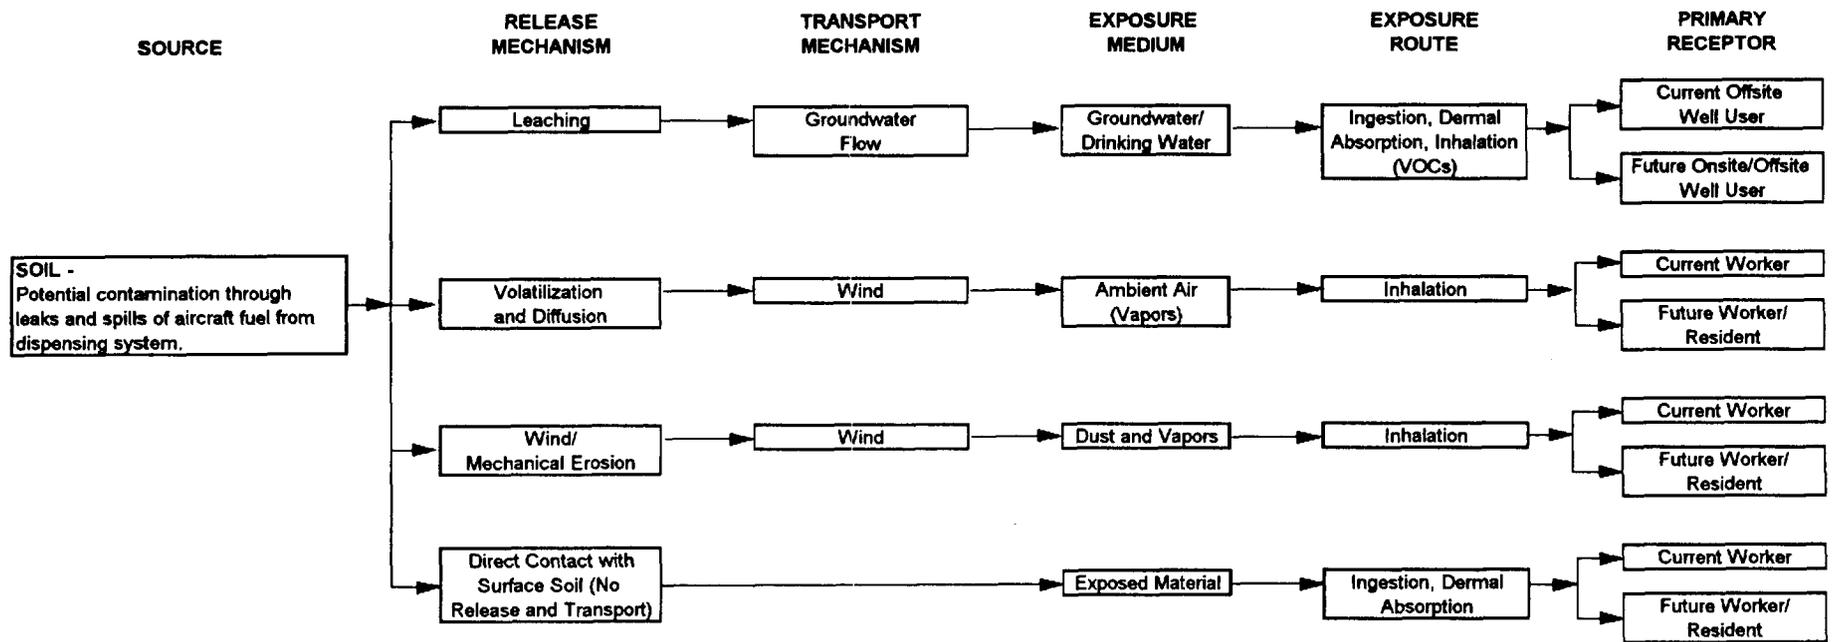
Figure E-22b
Site 22 (Tactical Air Fuel Dispensing System):
Conceptual Site Model

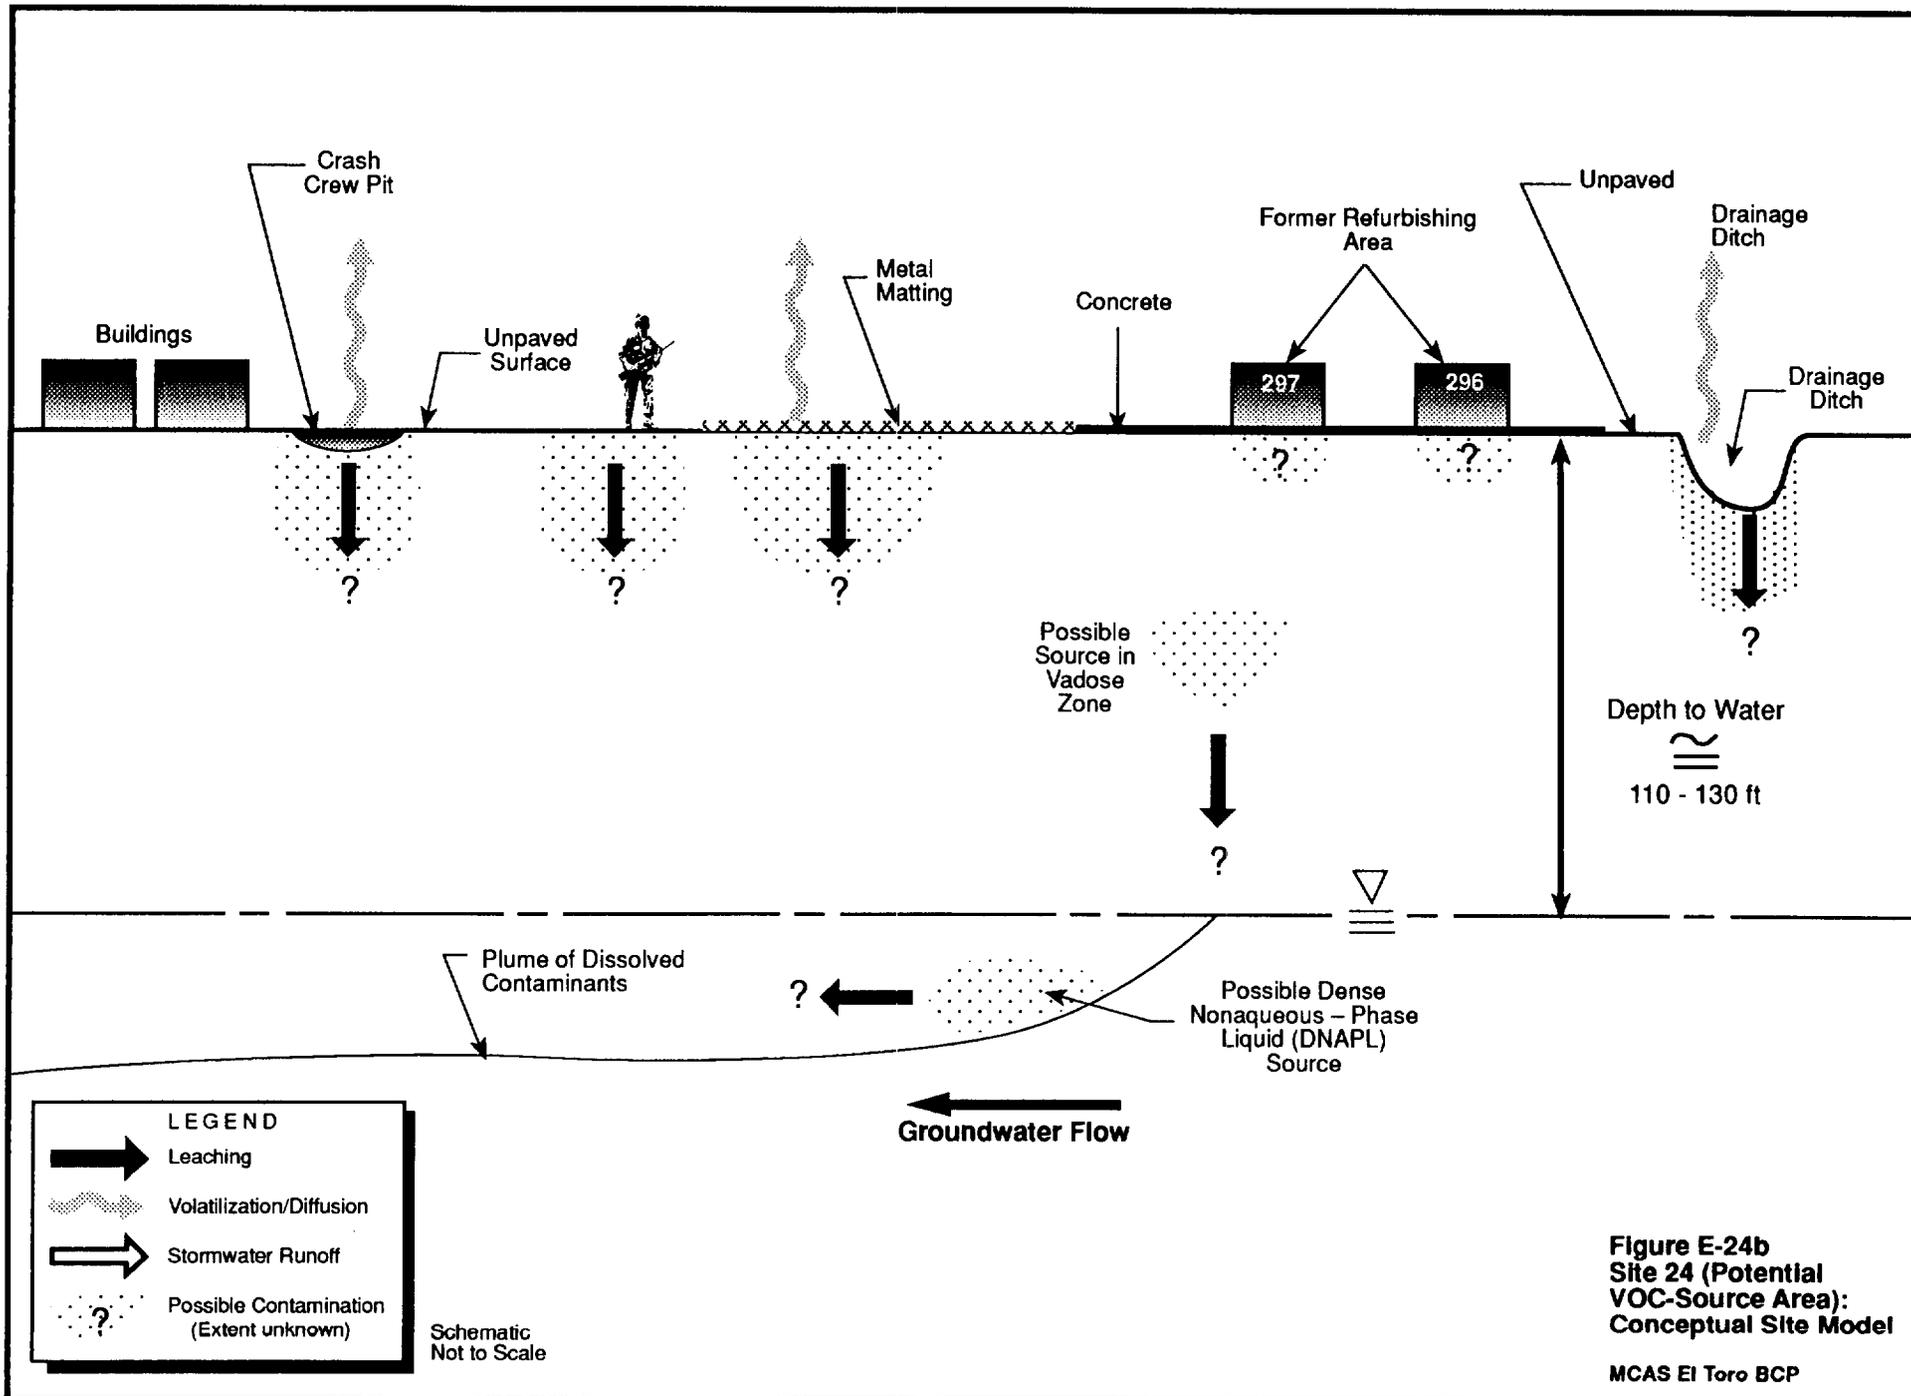
FIGURE E-24a
SITE 24 (POSSIBLE VOC
SOURCE AREA):
SITE LAYOUT

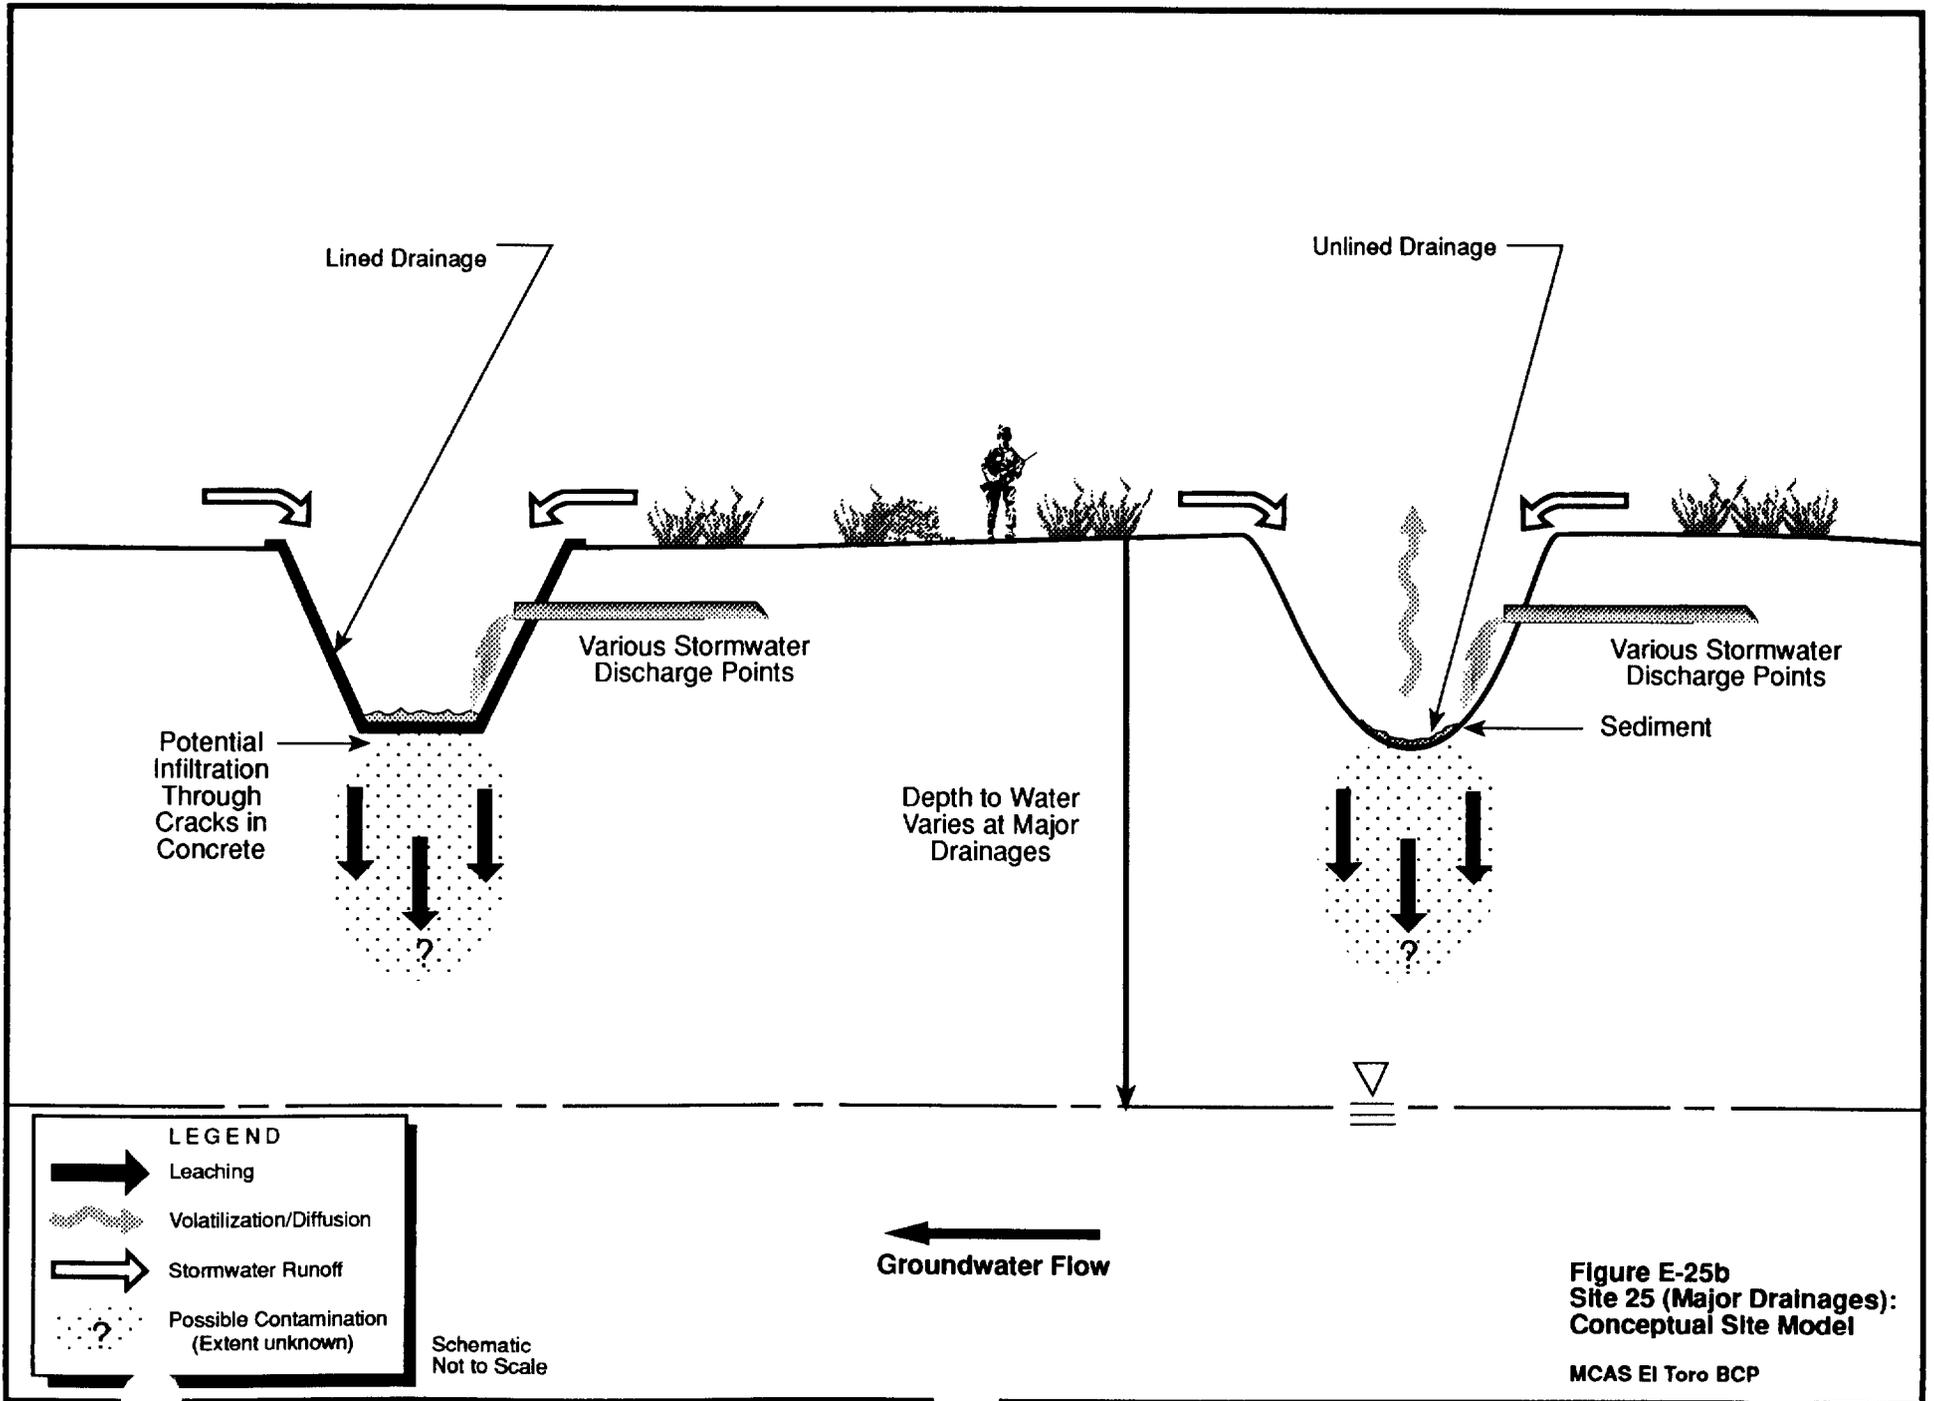
MCAS El Toro BCP

**Figure E-25b
Site 25 (Major Drainages):
Conceptual Site Model**
