FIGURE 3-1
SITES, ZONES, AND OUs
CURRENTLY UNDER INVESTIGATION

MCAS EL TORO BCP

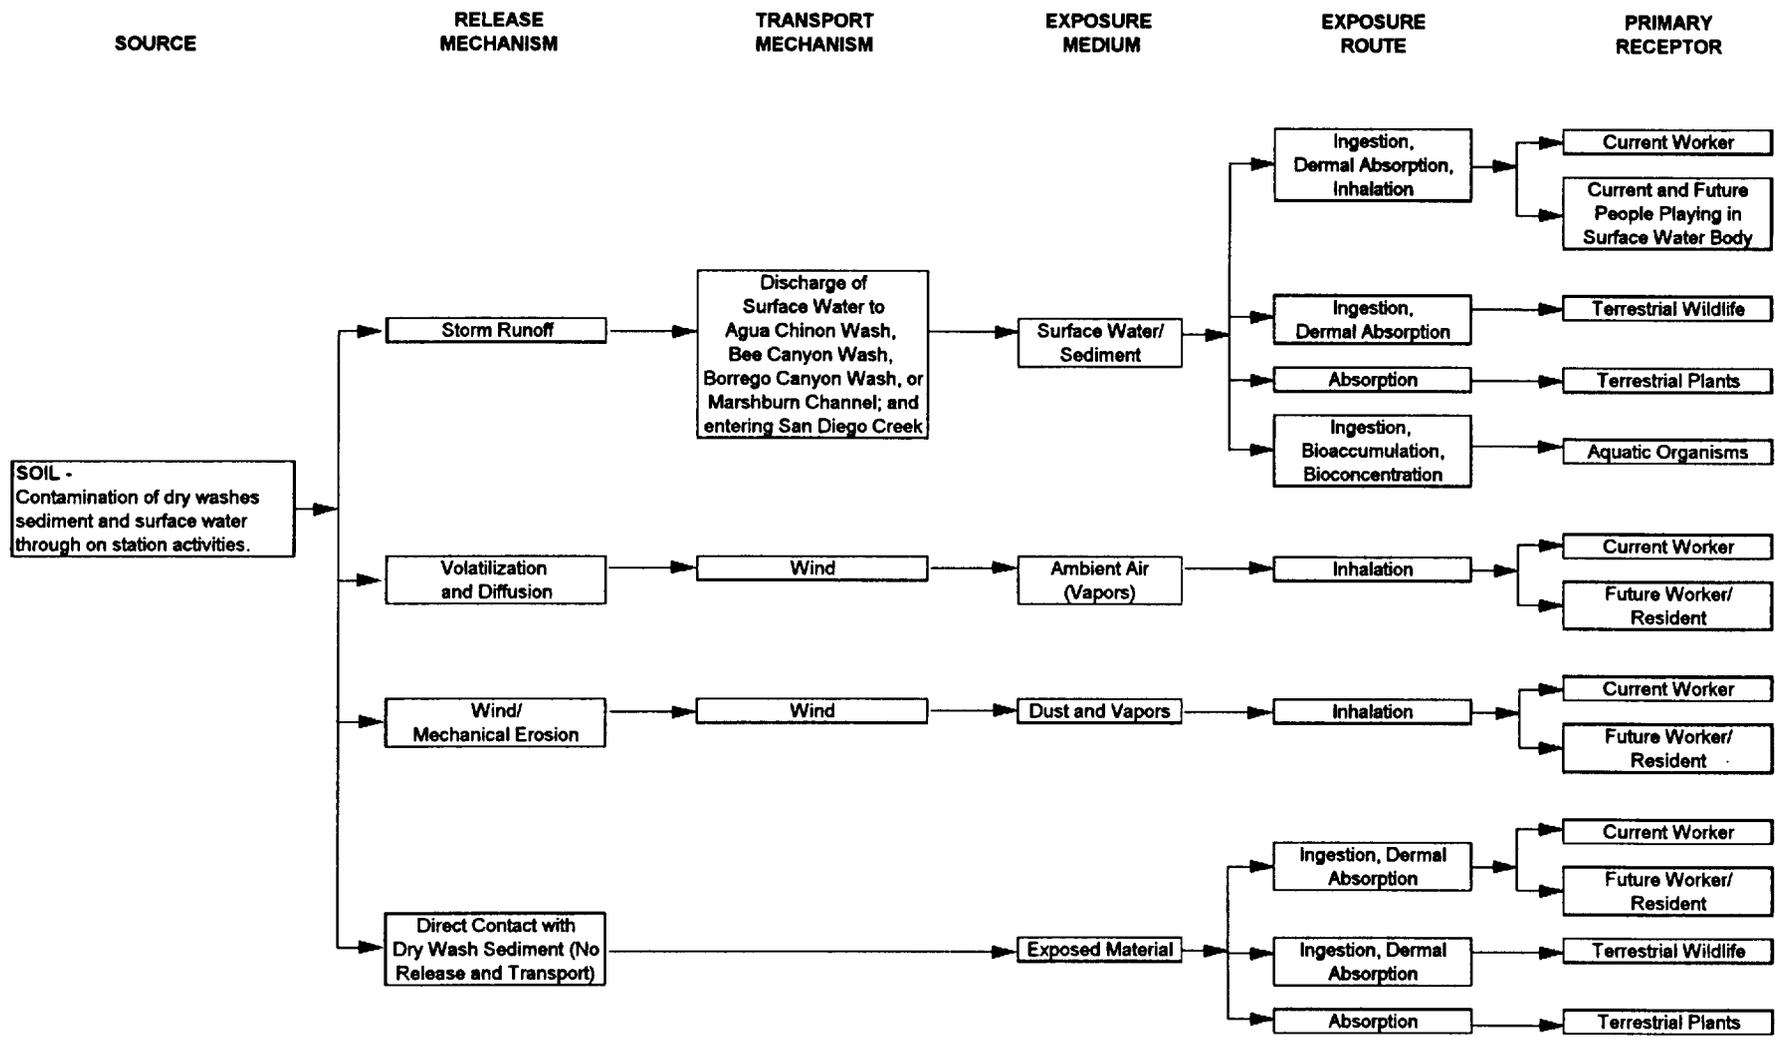
Figure E-25c
Site 25 (Major Drainage):
Potential Exposure Routes and Pathways for Human and Ecological
MCAS EI Toro BCP
