RESTORATION ADVISORY BOARD MEETING NAVAL WEAPONS INDUSTRIAL RESERVE PLANT (NWIRP), CALVERTON MANORVILLE FIRE DEPARTMENT, MANORVILLE NEW YORK WEDNESDAY, JANUARY 29, 2020

TECHNICAL PROGRESS – SITE 7 FORMER FUEL DEPOT UPDATE

FIVE YEAR REVIEW SITE 6A – SOUTHERN AREA FENCE LINE TREATMENT SYSTEM EVALUATION AND 2019 FIELD ACTIVITIES UPDATE

2019 VOLATILE ORGRANIC COMPOUNDS GROUNDWATER INVESTIGATION SITE 2 – FORMER FIRE TRAINING AREA

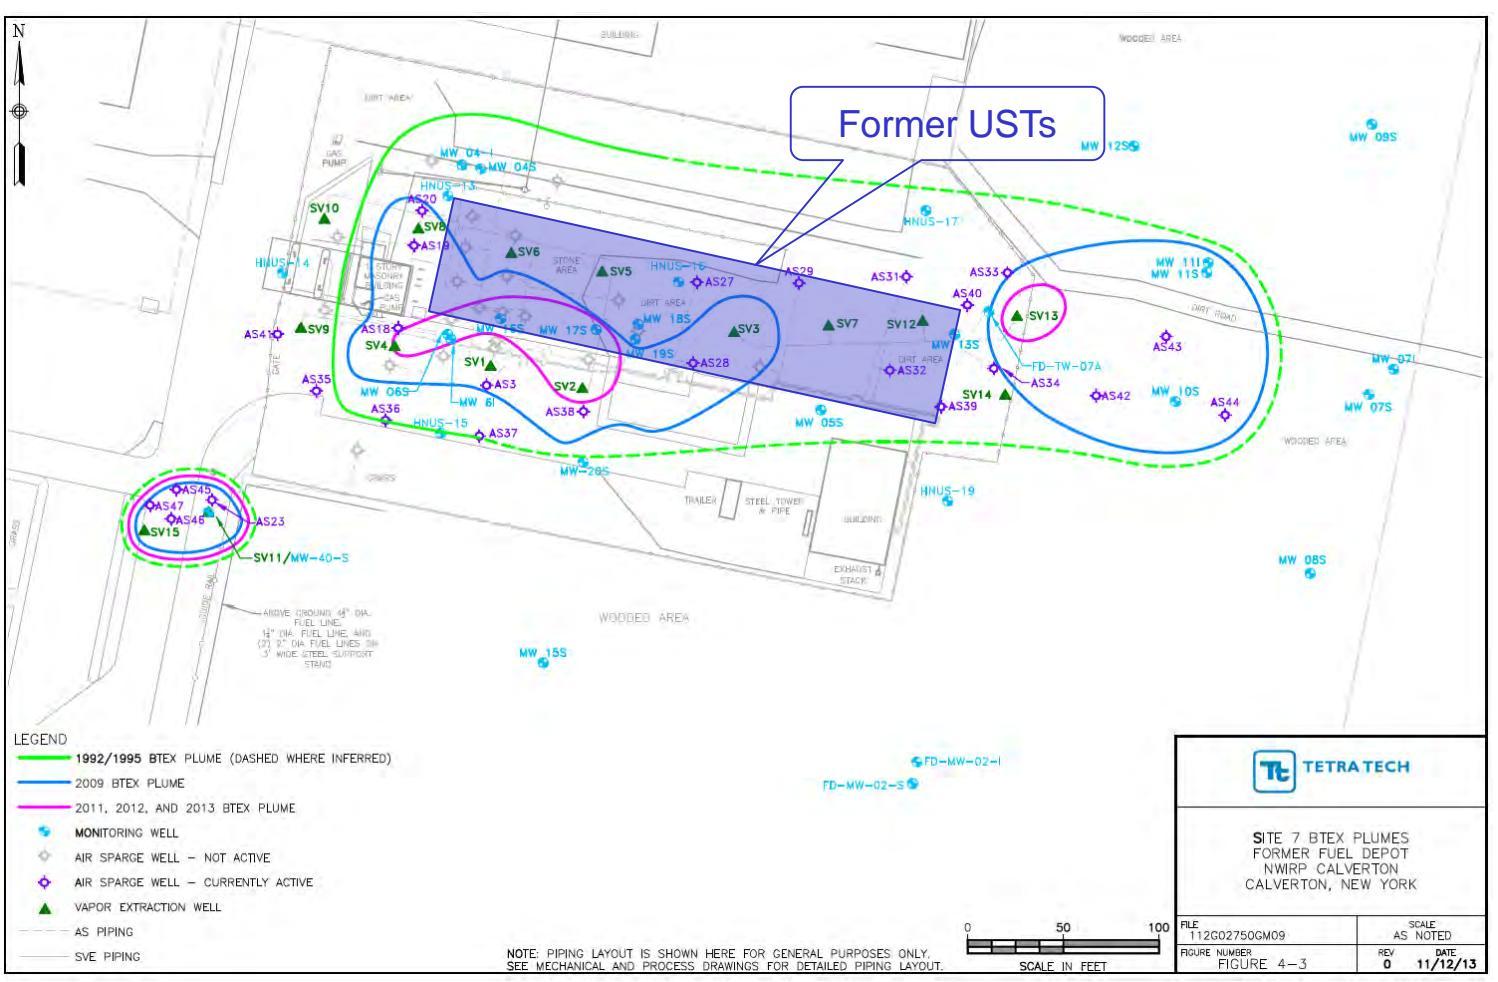
1992/1995, 2009, and 2011 to 2013 Plume Boundaries

- Quarterly and then semiannual sampling
- Rebound and persistent VOC observations led to consideration of supplemental options
 - In-situ chemical oxidation was considered for implementation to address residual VOCs in groundwater
- Observation of NAPL during October 2016 sampling event
 - MW-17S 1.12 ft. observed in October 2016, decreased to 0.14 ft. in February 2017, and 0.21 ft. in March 2017
 - MW-19S 1.05 ft. observed in November 2016, not encountered in February/March 2017
 - MW-16S 0.60 ft. observed in January 2017, not encountered in February/March 2017
 - No NAPL observed in any wells since March 2017

- Fingerprinting identified NAPL as weathered fuel
- Reappearance of NAPL correlated to drop in groundwater table
 - Indicates NAPL was retained in a "smear zone" extending from approximately 16 feet (bottom of the foundation slab) to 23 feet below existing grade (historic low groundwater elevation)

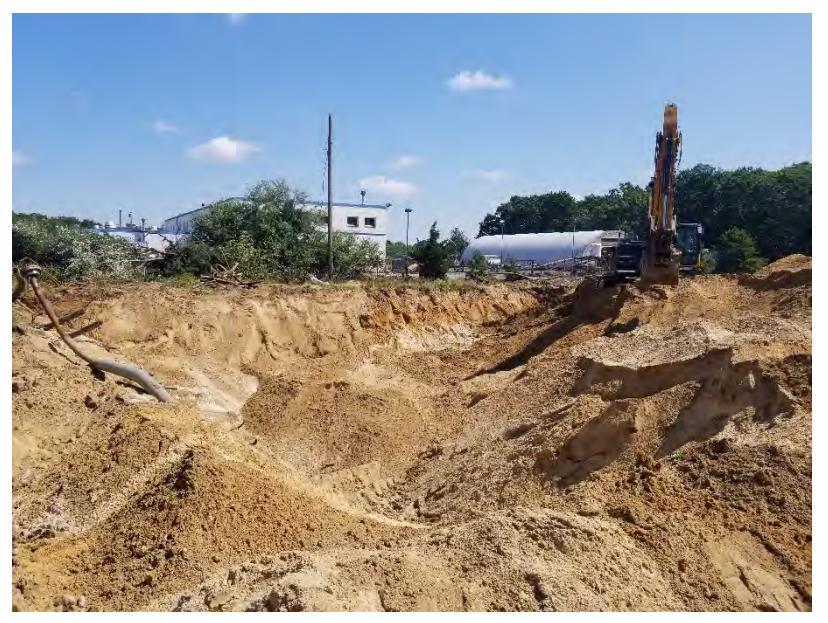
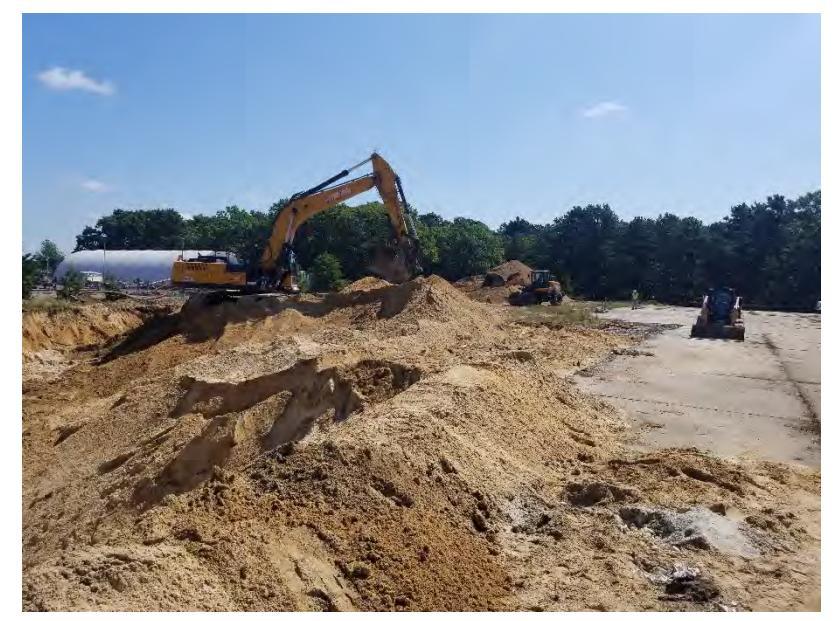
Site Views on August 8

- Mobilization began on-site July 30
 - Utility clearances, installation of erosion control, mobilization of equipment
- Active remedial work began August 7
 - Removal of surface concrete, excavation and stockpiling of clean overburden (above the old UST foundation slab)

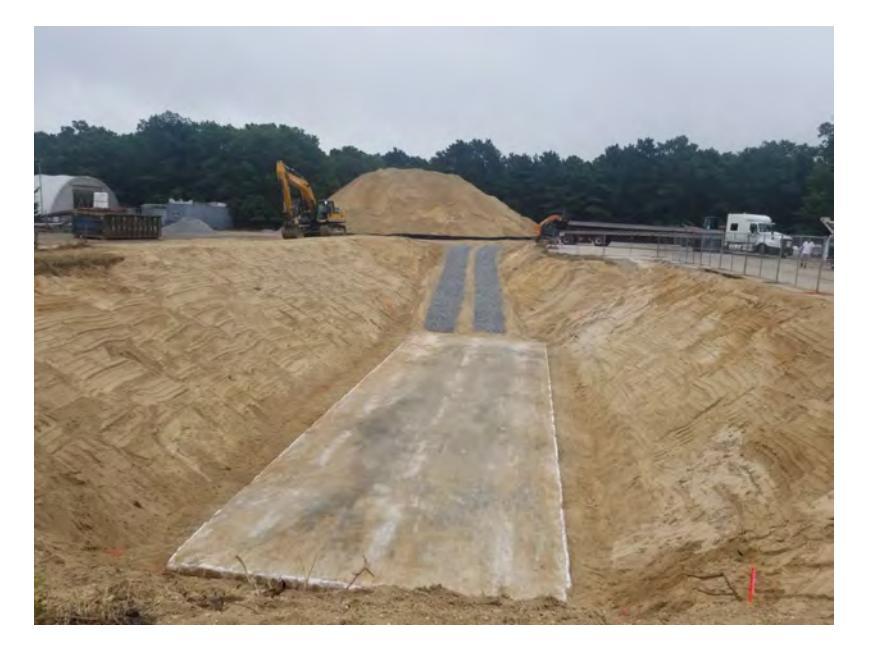
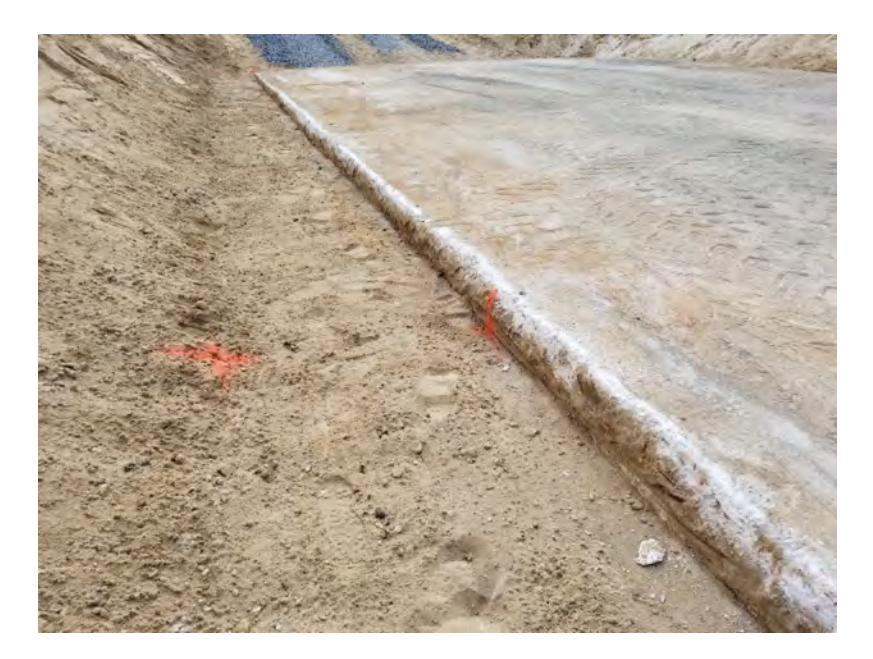
Site Views on August 21

- Temporary Overburden Removal & Stockpiling
 - Mostly fill placed after the tanks were removed in 1995
 - Approximately 3,460 CY removed and stockpiled on-site

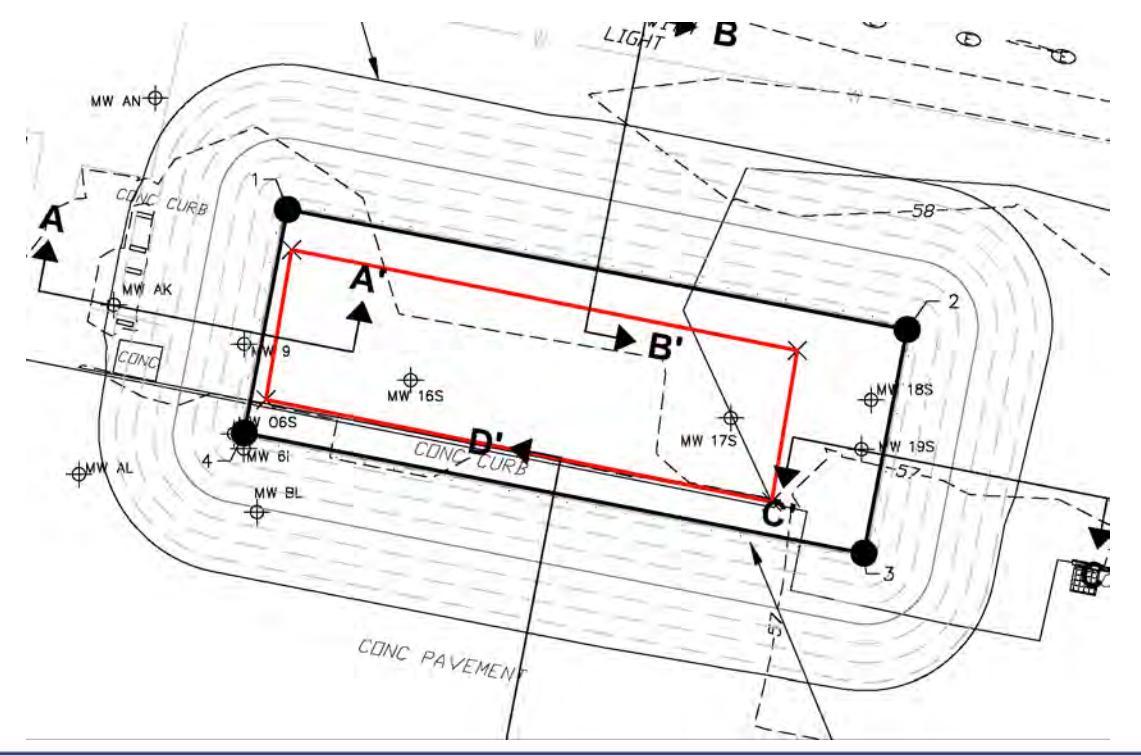
- Foundation Slab Exposure
 - Expected dimensions 90 ft. by 25 ft., actual dimensions 81 ft. by 24 ft.
 - Slab western edge elevation ~47.6 ft., eastern edge elevation ~46.3 ft.
 - MW-19S located ~12 ft. east of slab edge; shoring left unchanged despite smaller slab to make sure this area was excavated due to presence of NAPL in 2016

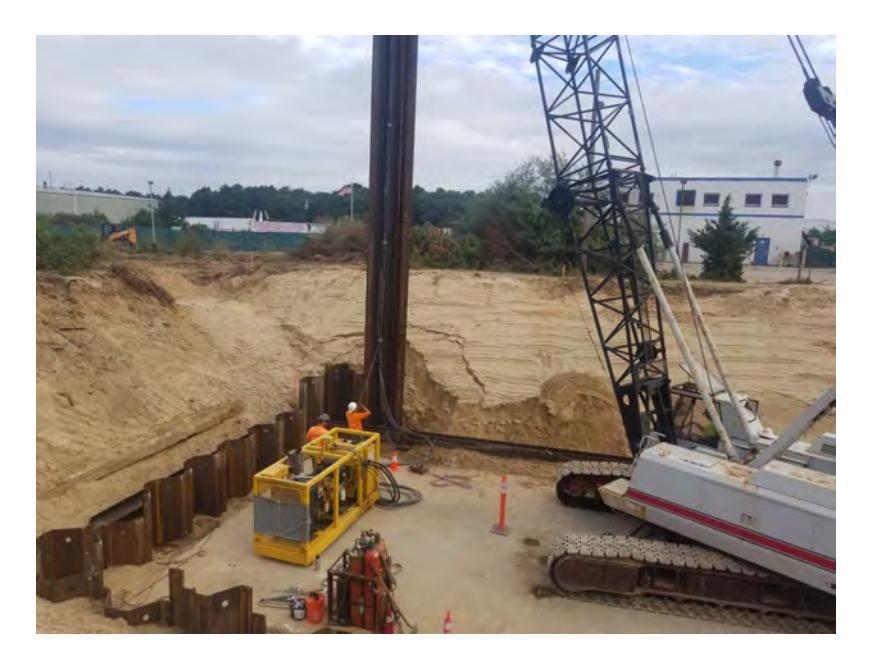
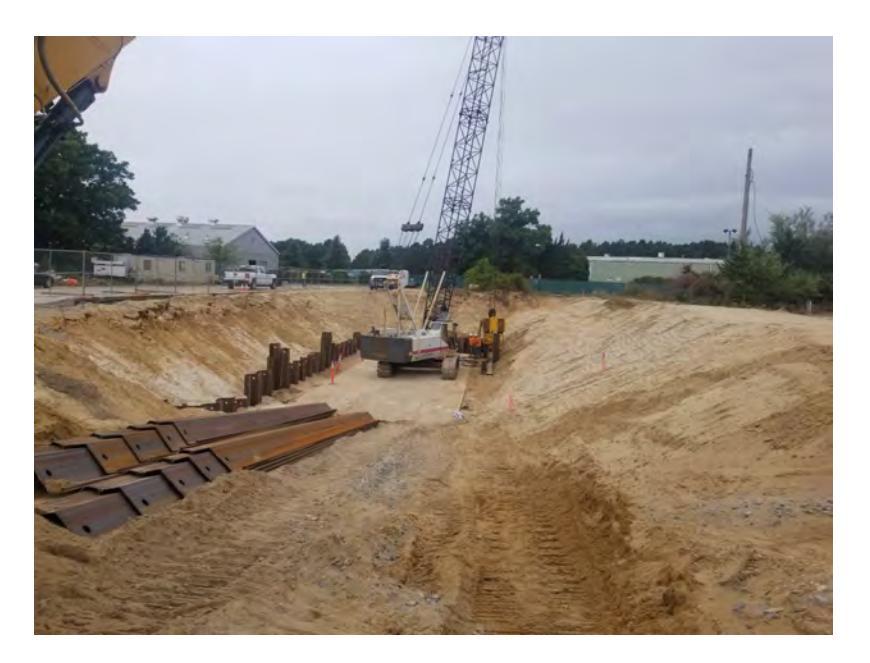
Site Views on August 28

- Shoring Installation
 - Created a 100-ft. by 35-ft. area for excavation of impacted material
 - Shoring with 45-ft. long sheetpiles serves two functions stabilize excavation, and reduce groundwater infiltration

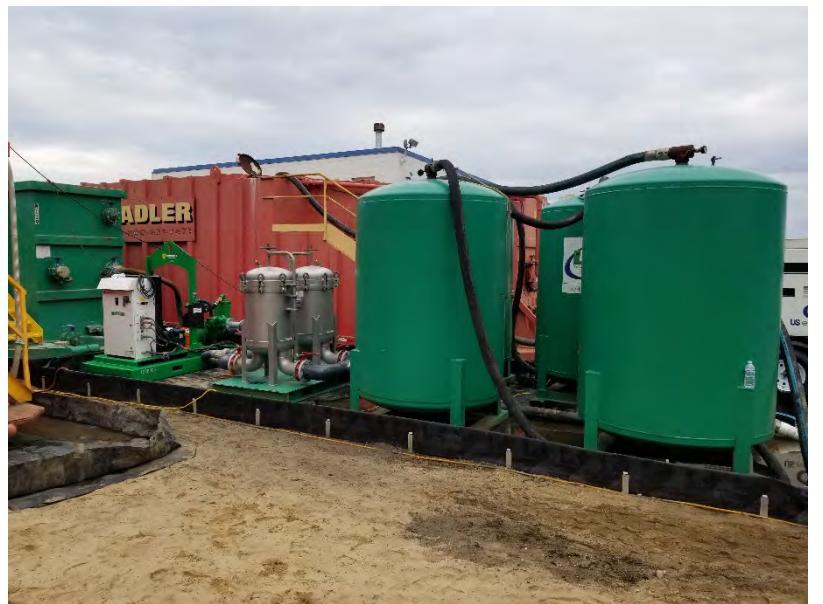
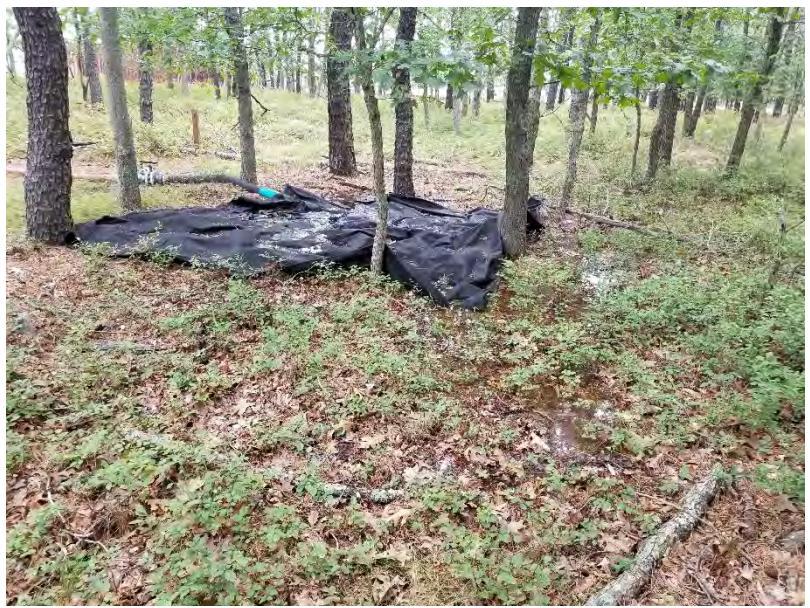
Site Views on September 16

- Dewatering During Excavation
 - Dewatering necessary to control site conditions and prevent contaminant transport
 - Treatment provided by bag filters and granular activated carbon vessels for treatment
 - Discharge of treated water to wooded area east of Site 7
 - System ran at ~300 GPM; effluent samples confirm compliance with discharge limits

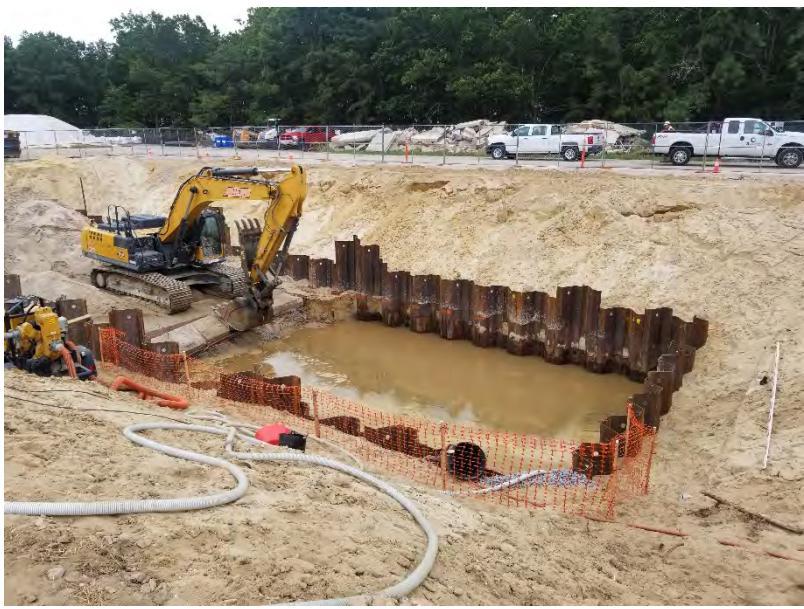
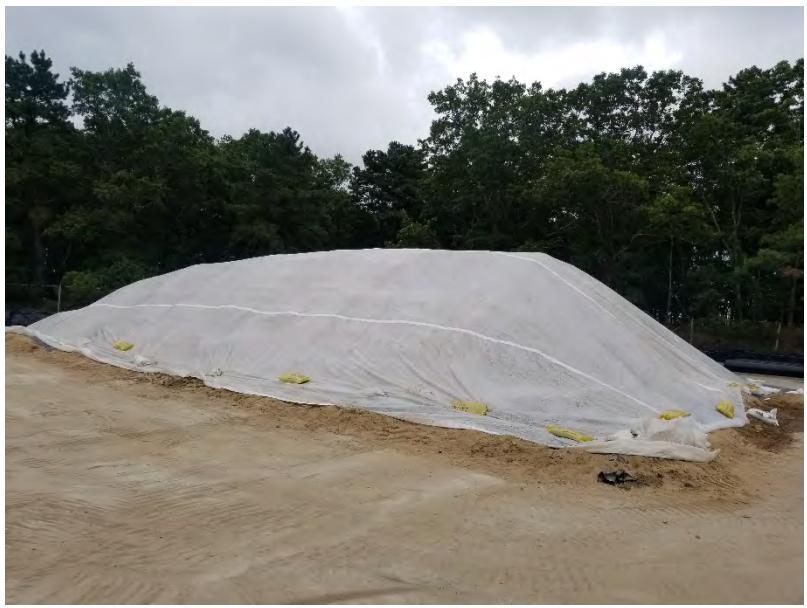
Site Views on September 12

- Slab Demolition / Impacted Material Excavation
 - Soil and slab impacted by fuel removed from west to east
 - Target elevation for bottom of excavation 35 ft. (about 12 ft. below top of slab)
 - Final elevations ranged from 32.5 to 34.4 ft. (about 13-14 ft. below top of slab)
 - Impacted material stored in lined and covered stockpile

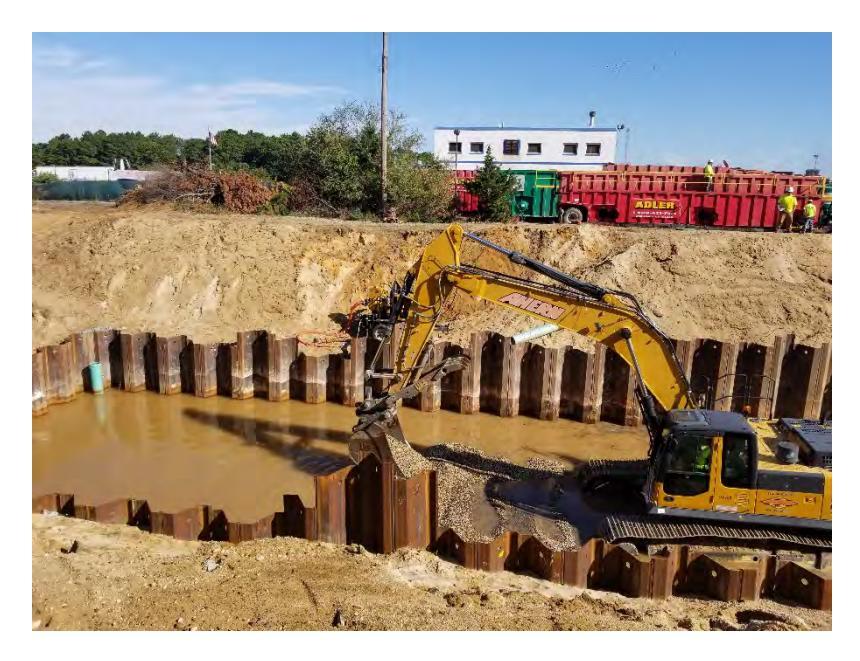
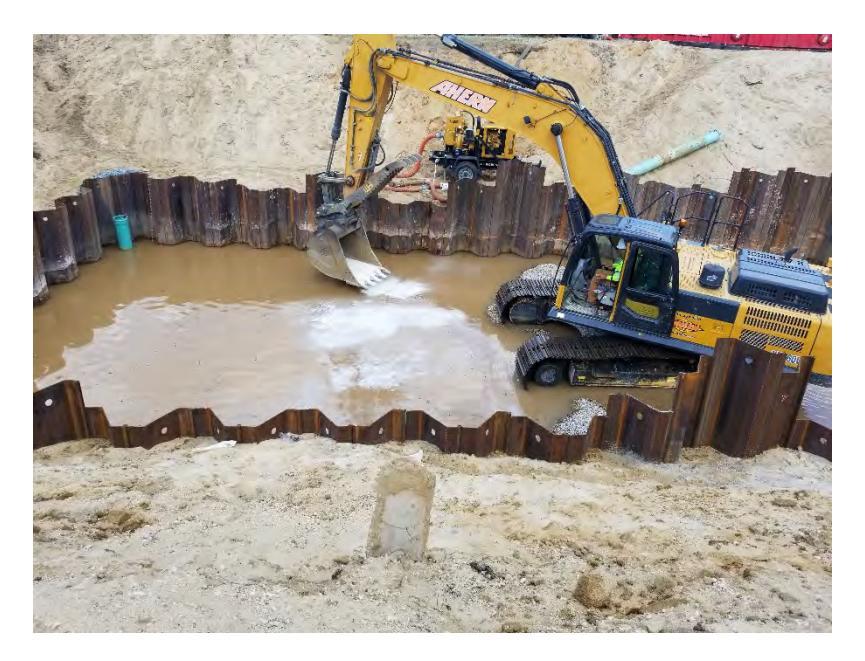
Site Views on September 24

- Stone Backfill & Oxidant Placement
 - Excavation below slab replaced with #57 stone and treated by oxidant addition
 - Approximately 1,436 tons of stone and 1,700 lbs. of oxidant placed
 - Brought excavation back to approximately match pre-demolition slab elevation

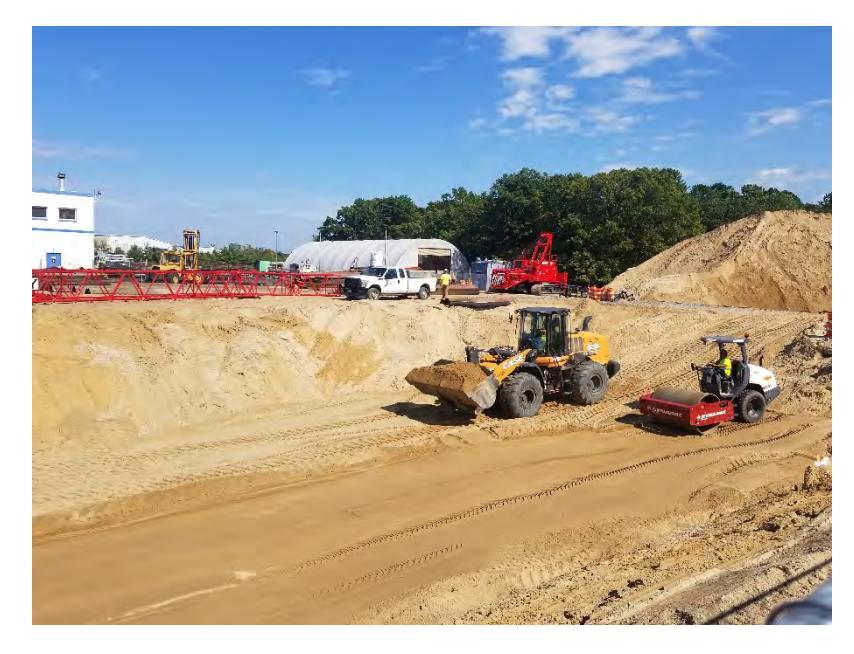
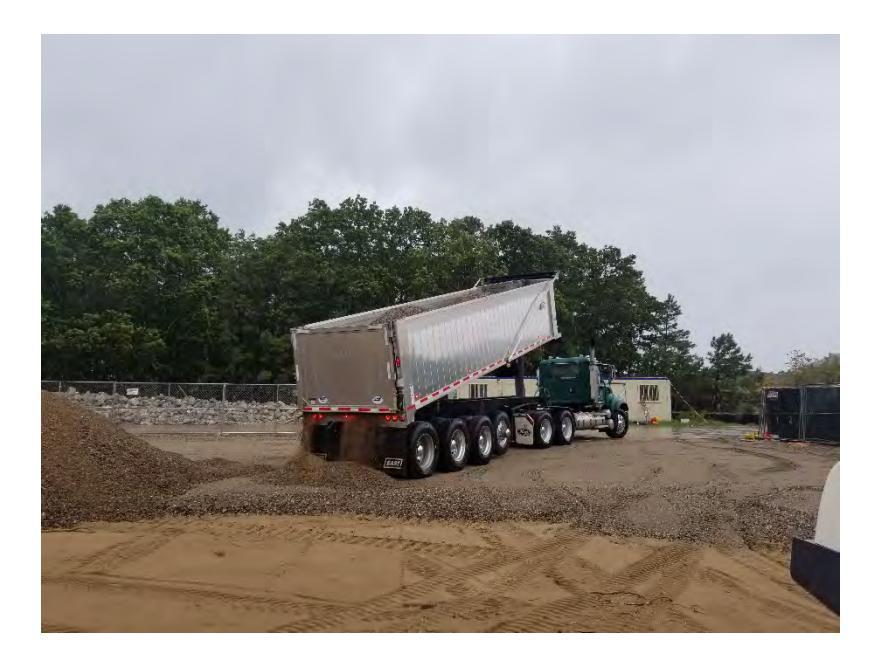
Site Views on October 2 (left) and October 9 (right)
Construction Progress

- Overburden Placement and Surface Restoration
 - Excavated overburden placed and compacted in 1-foot lifts
 - Crusher-run stone layer as the new finished surface
 - Final surface matches pre-excavation surface

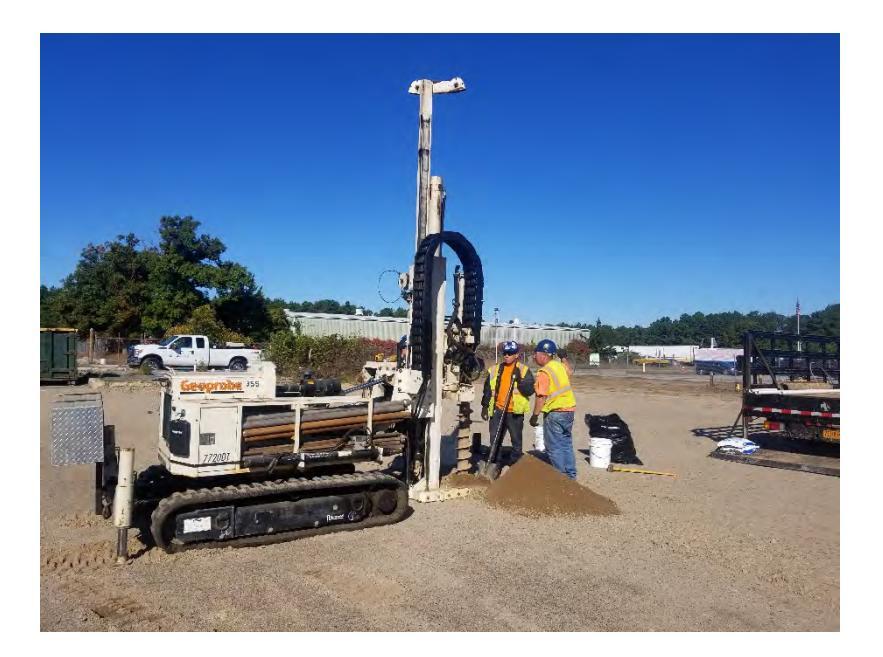
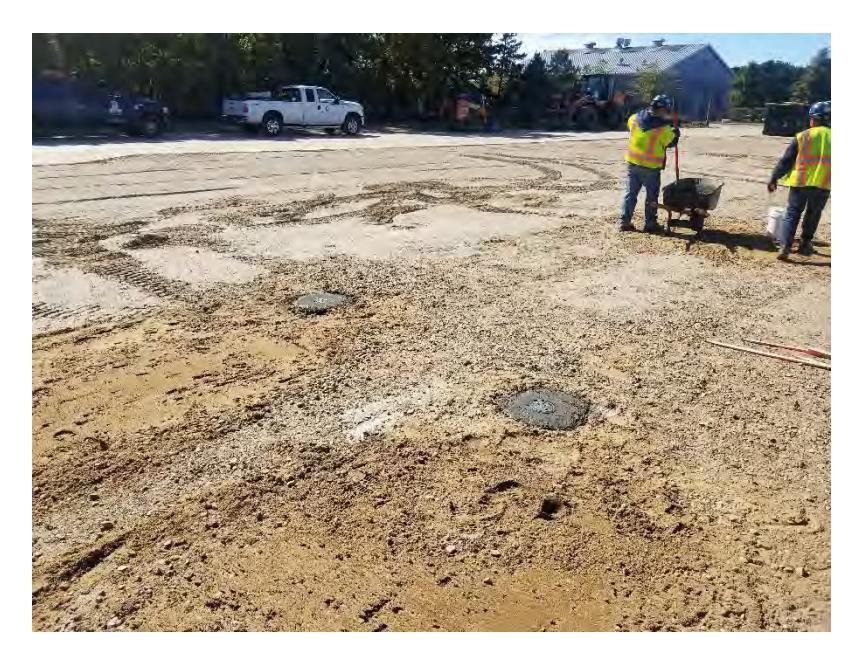
Site Views on October 15

- Monitoring Well Reinstallation
 - Four monitoring wells reinstalled for use in Long-Term Monitoring (LTM) Program
 - Replacements for wells demolished by remedial excavation
 - All wells 25-ft. deep, 2-inch diameter, screened from 15 to 25 ft. below ground surface

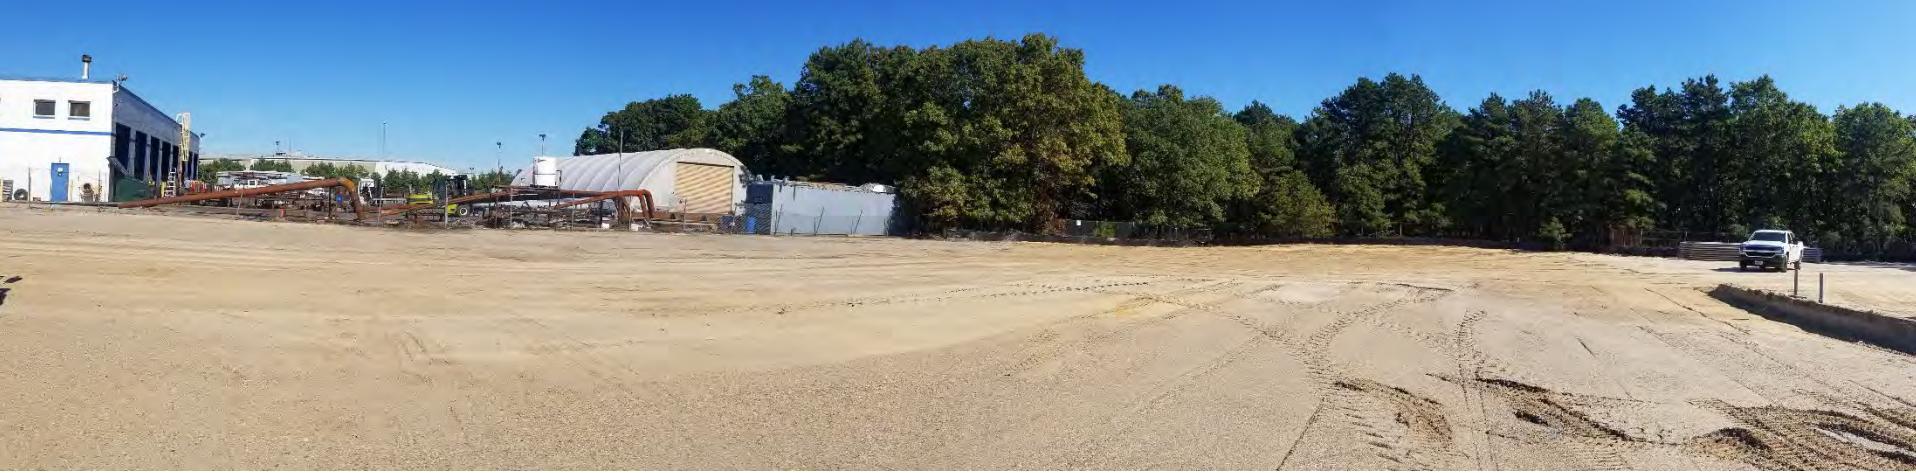
Site View on October 15

- Twelve-week project from start to finish
 - Impacted materials removed:
 - 1,090 CY of soil, 206.11 tons of concrete
 - Based on end-point samples (collected at floor of excavation), while some residual contamination remains (typical), soil within excavated area meets NYSDEC Unrestricted Use Soil Cleanup Objectives (SCOs)
 - Routine LTM Program resumed last fall
 - Residuals may still exist outside of the excavated area, but are likely relatively dilute

A design was completed and the excavation of the concrete slab and soil above and beneath the slab was removed in the fall of 2019. A total of 1,090 cubic yards of impacted soil and 206.11 tons of impacted concrete was removed and disposed at an off-property facility. Based on end-point samples collected at the floor of the excavation, soil within the area meets NYSDEC Unrestricted Use Soil Cleanup Objectives (SCOs).

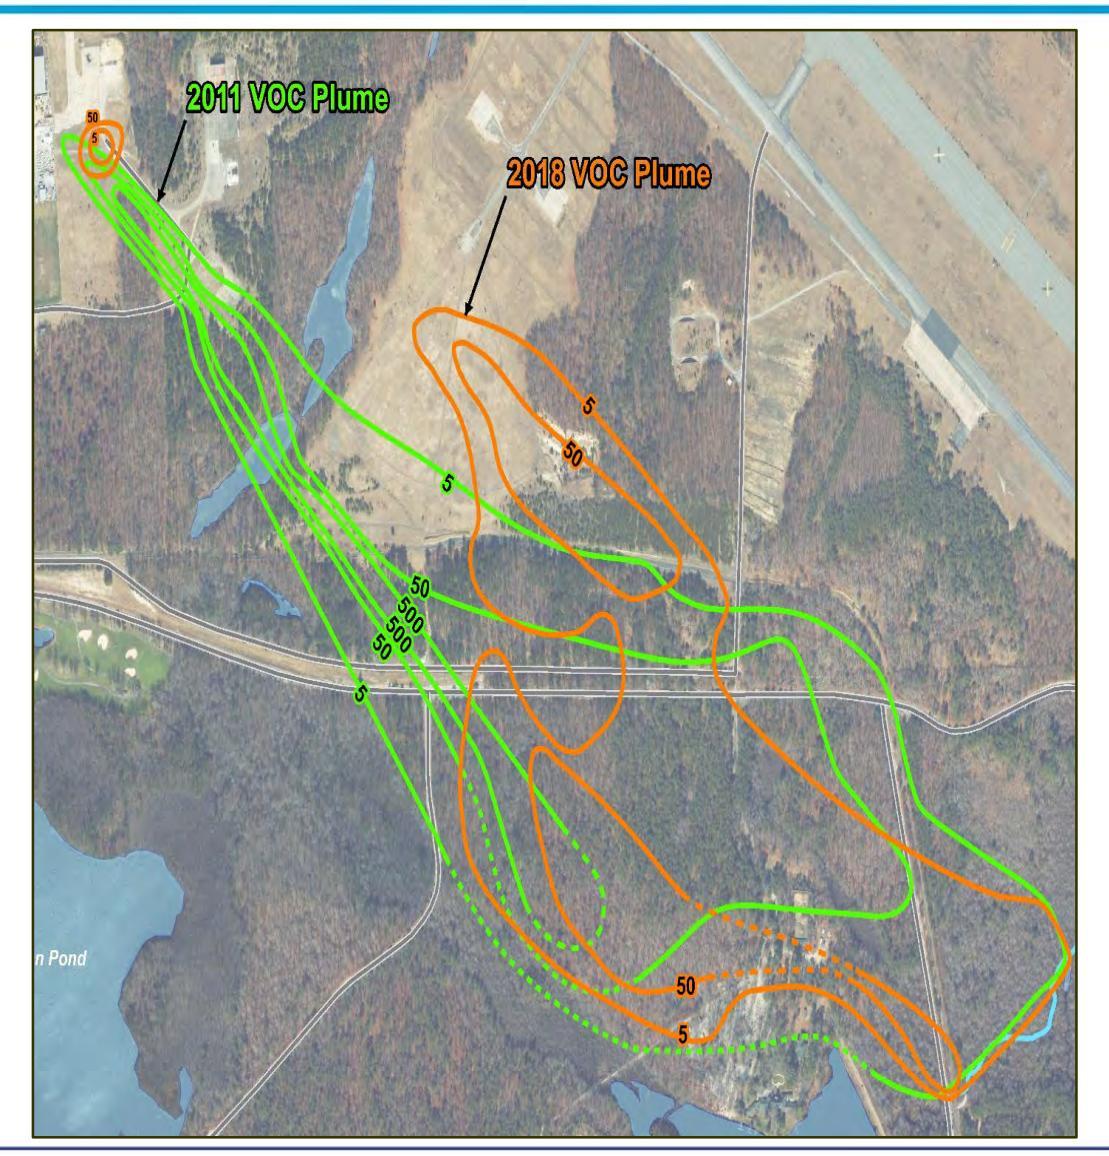
- Winter 2018/2019: Site 6A Southern Area Investigation
- 2011 Plume (375 pounds)
 - On property: 93 pounds
 - Off property: 282 pounds
- 2018 Plume (44 pounds)
 - On Property: 14 Pounds
 - Off Property: 30 Pounds
- Reduction
 - Reduced by 331 pounds through source area removal, biostudy, the treatment system, and attenuation
 500 µg/L: 11.6 to 0 acres
 - -50 µg/L: 95 to 20 acres
 - $-5\ \mu\text{g/L}$: 121 to 86 acres

The 2011 plume was estimated to contain 375 pounds of VOCs. By 2018/2019 the plume had been reduced by 331 pounds through source area removal, the biostudy, the treatment system, and attenuation. Goals have been achieved at the Former Fuel Calibration Area and the FLTS Area. Criteria has been met to permanently shut down the FLTS. The cleanup goals have been met to remove 26 of the 35 on-property monitoring wells from the monitoring program.

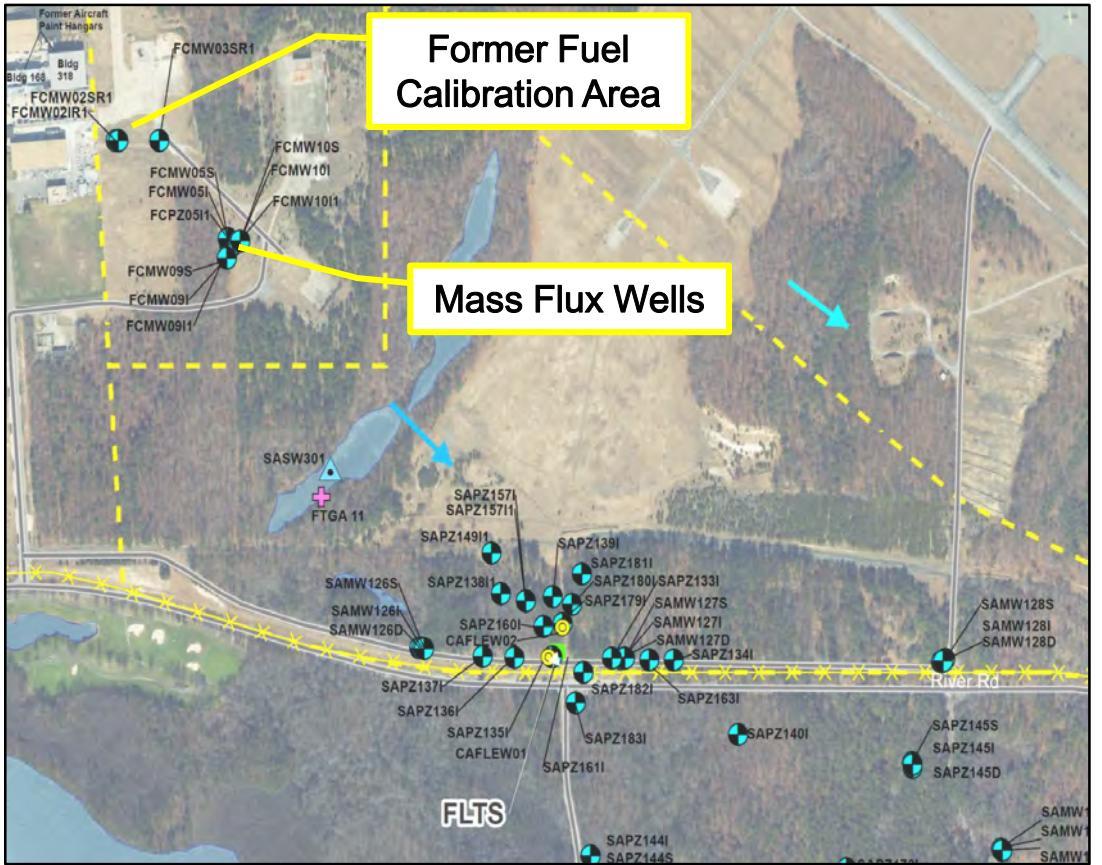
Former Fuel Calibration Area FLTS Evaluation

- Goal for Former Fuel Calibration Area
 - Less than 0.36 pounds/year (lbs/yr) of COCs in groundwater migrating from the Fuel Calibration Area (mass flux)
 - Equivalent to an annual average of COC concentrations less than 6 micrograms per liter (µg/L)
- Current conditions at the Former Fuel Calibration Area
 - Residual fuel contamination, chloroethane, and dichlorobenzenes are present in shallow groundwater but are no longer contributing mass to the Southern Area plume
- Goal has been achieved
 - COCs in groundwater are leaving the source area at a rate of 0.21 lbs/year

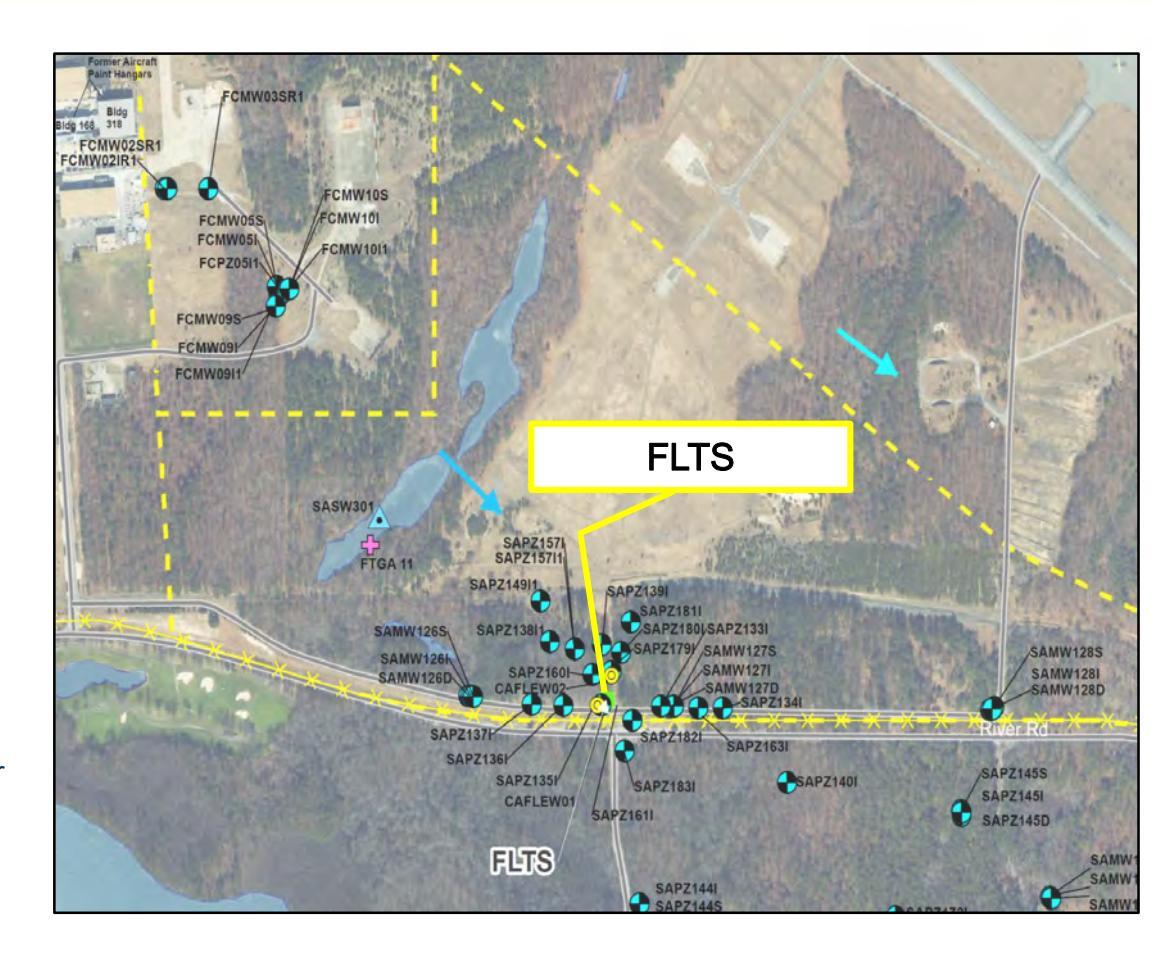
FLTS and Area Monitoring Wells FLTS Evaluation

- Goal for the FLTS influent and monitoring wells
 - COCs entering the FLTS (mass flux): mass is less than 2.2 lbs/yr and less than 10 µg/L
 - –COCs in groundwater are less than 50 $\mu\text{g/L}$
- Current conditions at the FLTS Area
 - COCs in influent groundwater have been below 10 µg/L since February 2018
 - As of December 2018, all results below 50 ug/L
- Goals have been achieved
 - Mass of COCs decreased from 35 lbs/yr (2014) to 0.16 lbs/yr (2019)
 - Results for COCs in groundwater at individual monitoring wells are below 50 µg/L

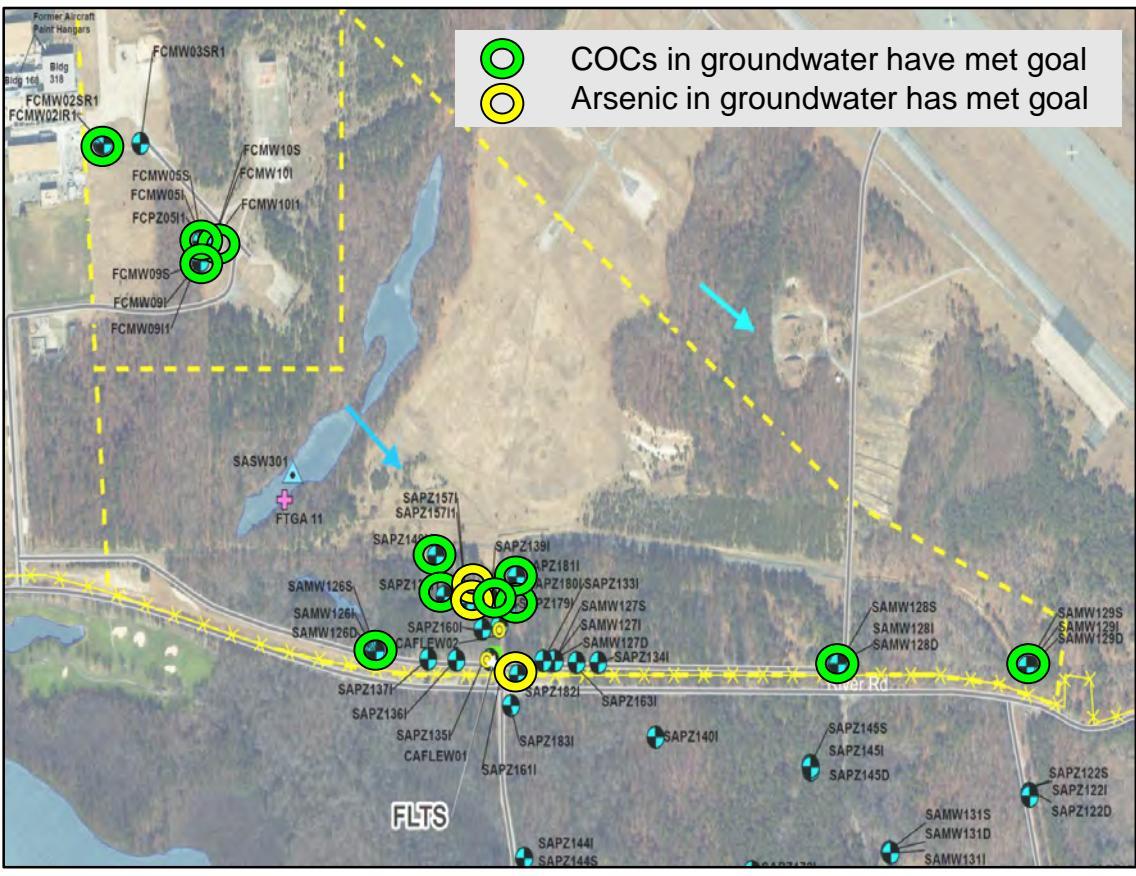
FLTS and LTM Optimization Recommendations FLTS Evaluation

- Permanently shut down the FLTS
- · Goal for removing monitoring wells from the network
 - COCs are below cleanup levels for 4 consecutive events
 - Arsenic in groundwater at 3 monitoring wells are less than the New York State Department of Health (NYSDOH) Maximum Contaminant Level (MCL) for 4 consecutive events
- Current conditions (as of September 2018)
 - COCs in 26 of the 35 on-property monitoring wells have met the goal to be removed from the monitoring program
 - Arsenic in 3 of 3 monitoring wells have met the goal to be removed from the monitoring program
- Goals have been achieved at 26 monitoring wells
 - 26 wells have been below the NYSDOH MCL based cleanup level of 5 µg/L (most of the COCs)
 - Concentrations of arsenic range from not detected to 7.21 below the NYSDOH MCL of 10 µg/L

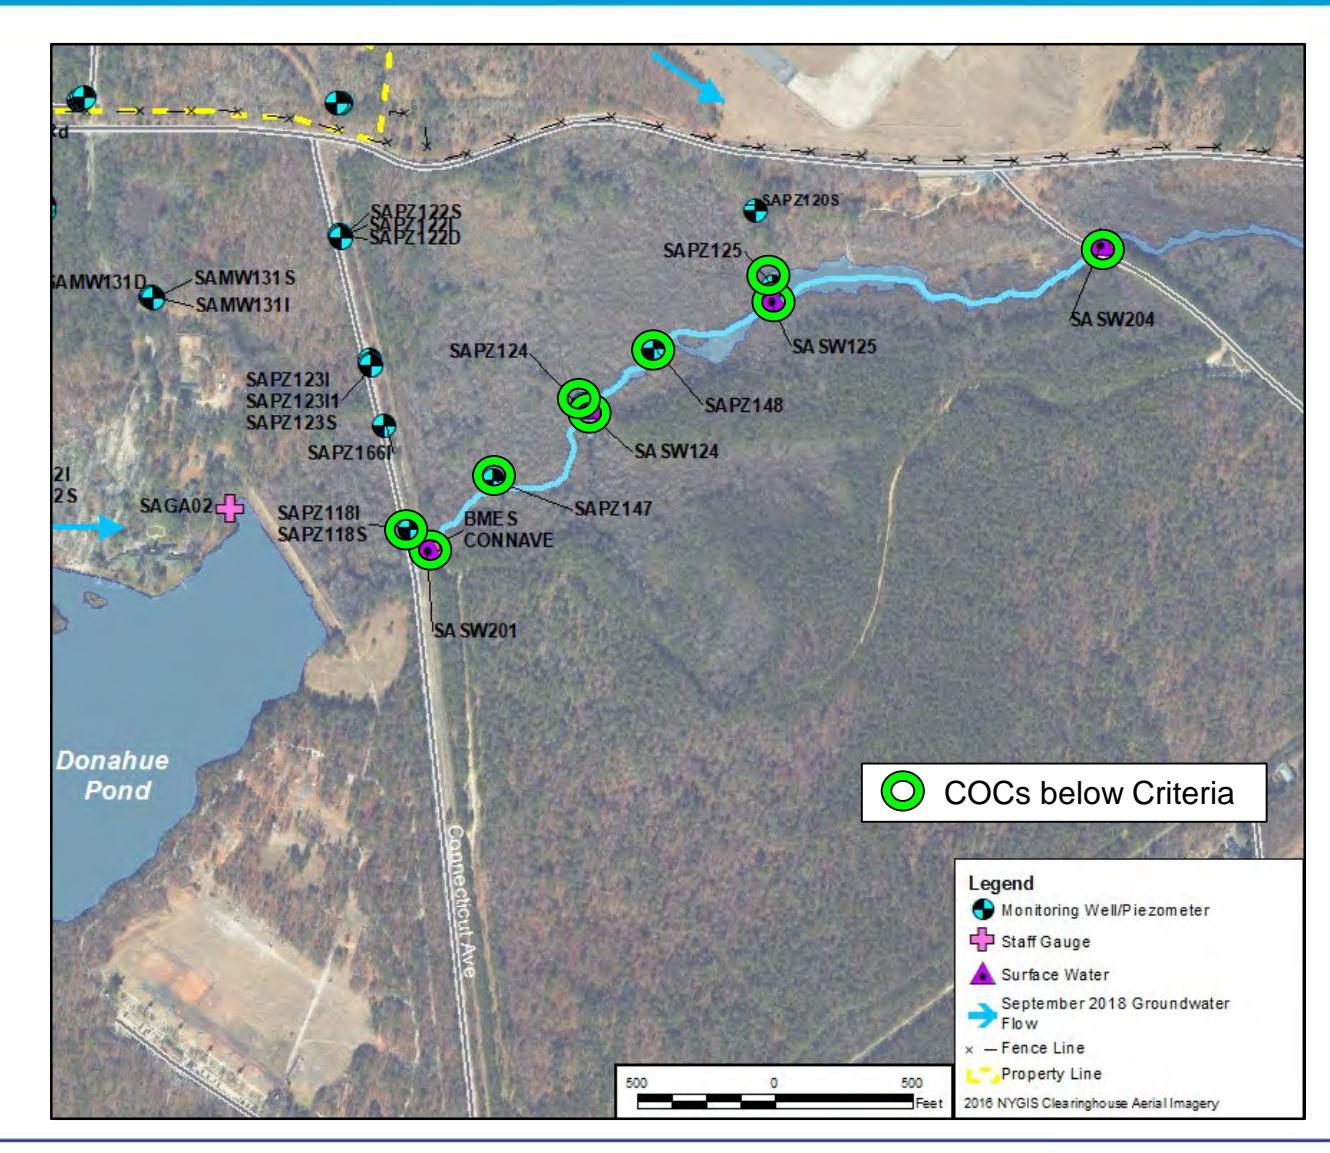
Spring and Fall 2019 Event Site 6A – Southern Area

- Peconic River Sampling
 COCs were below the cleanup levels at the two Peconic River Area monitoring wells
- COCs in pore water and surface water were below the OU3 ecological values

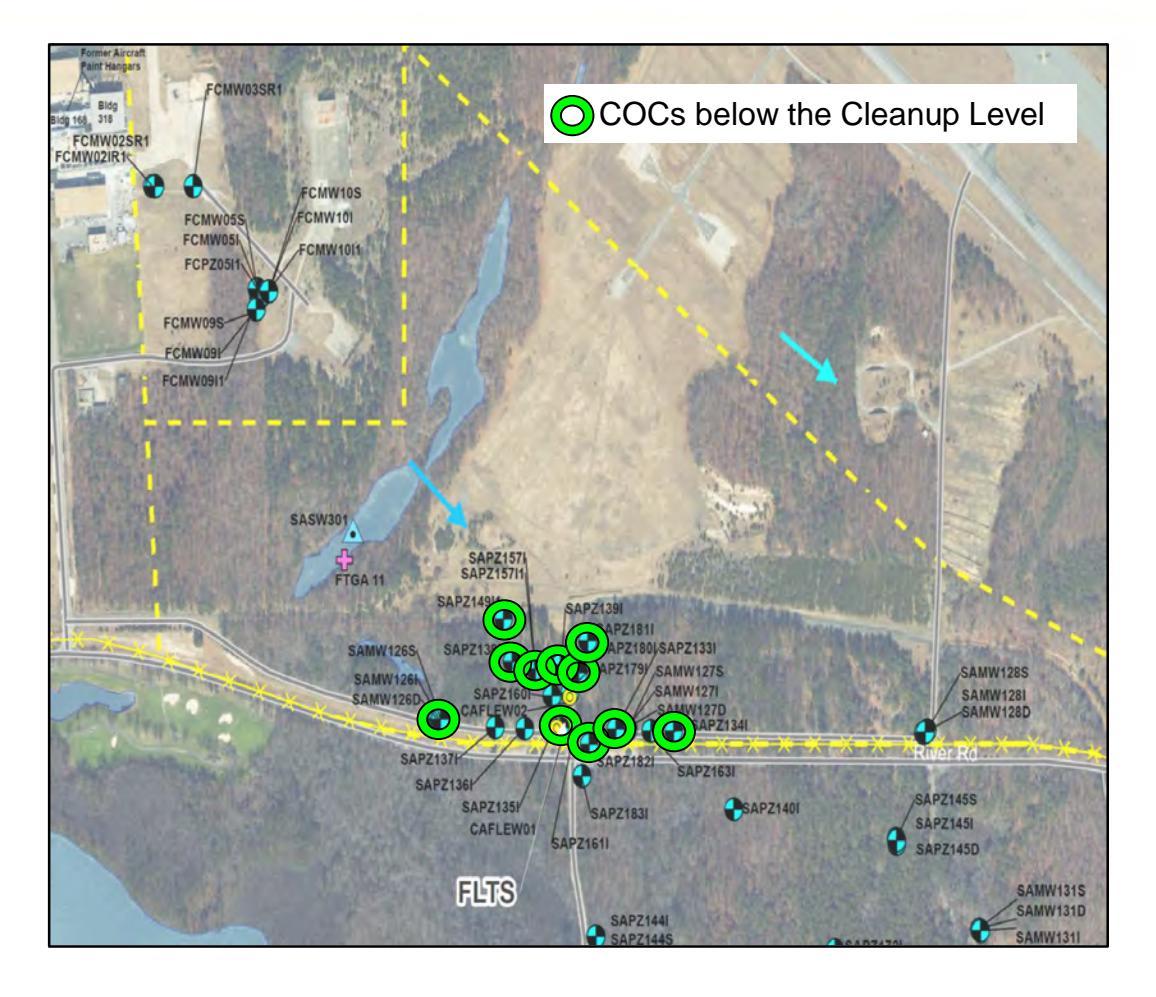
Summer 2019 Event Site 6A - Southern Area

- July 2019: 3 months after system shutdown
 - -Groundwater sampled from 19 monitoring wells at the area of the FLTS
 - -COCs were not detected

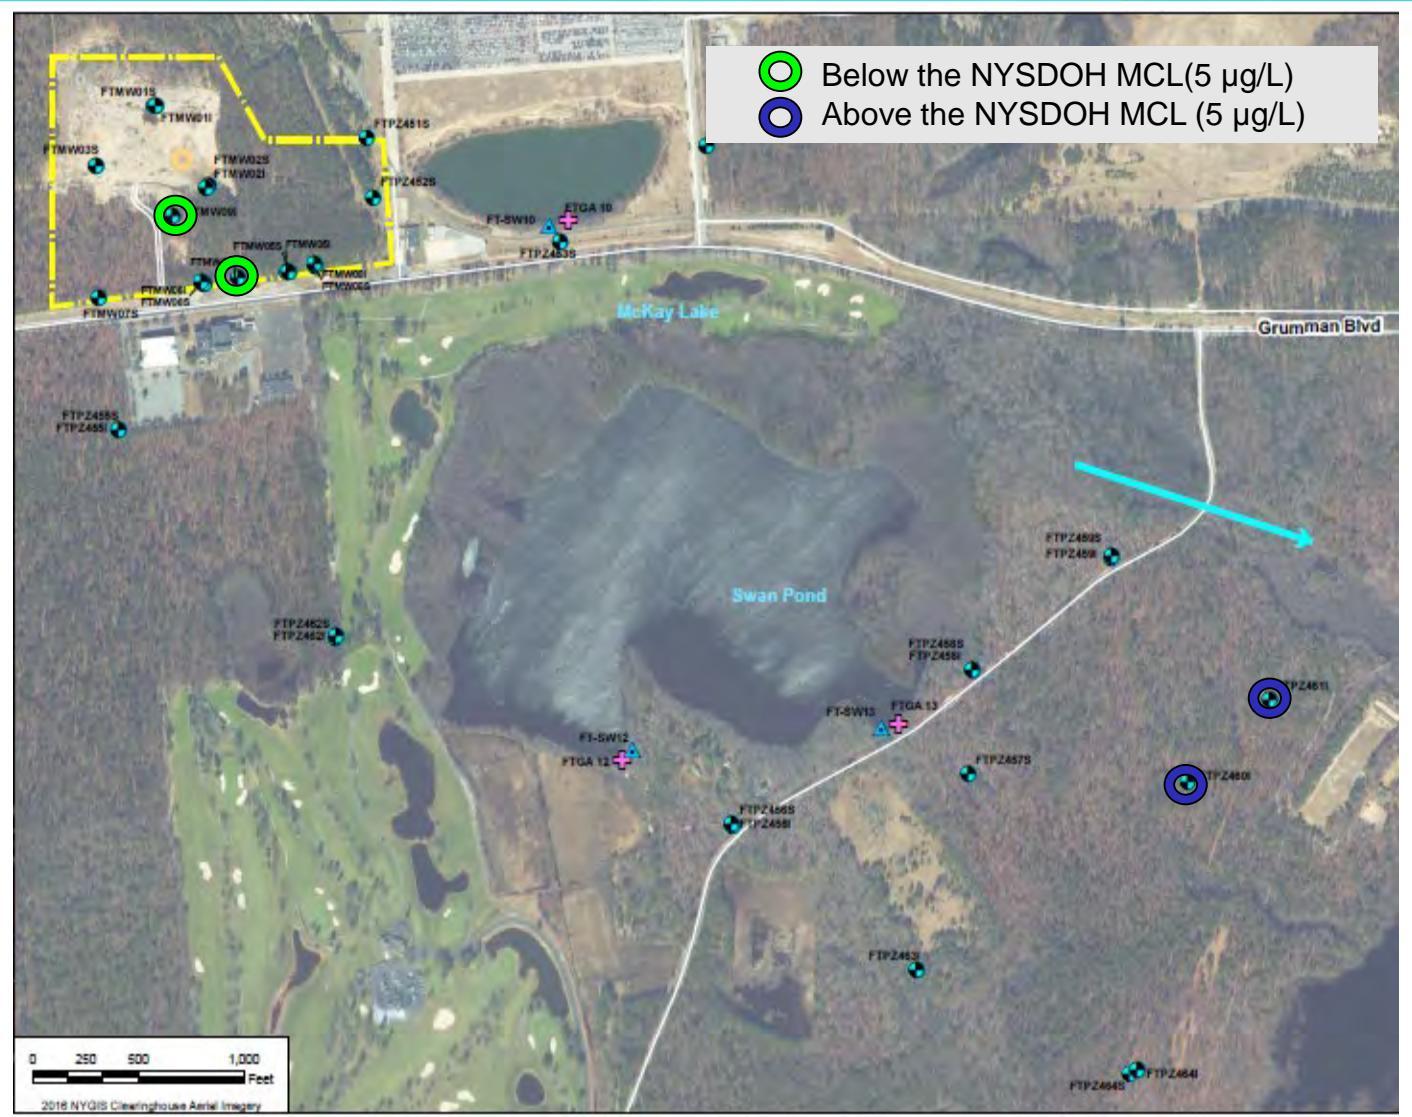
Site 2 – Former Fire Training Area 2019 VOC Results

- VOCs detected in groundwater from the four monitoring wells
- For 2 wells, results exceed the New York State Department of Health (NYSDOH) Maximum Contaminant Level (MCL)

Ms. Esposito inquired about the level of exceedance at the two monitoring wells. Ms. Francisco replied trichloroethene (TCE) was detected at FT-PZ461I at 22.8 μ g/l and at FT-PZ460I at 100 μ g/L and the data is presented on the tag maps in the handouts. She further noted that TCE has been decreasing and degradation products have also been detected in the groundwater sample.
