RESTORATION ADVISORY BOARD MEETING NAVAL WEAPONS INDUSTRIAL RESERVE PLANT (NWIRP), CALVERTON MANORVILLE FIRE DEPARTMENT, MANORVILLE NEW YORK WEDNESDAY, JANUARY 29, 2020

TECHNICAL PROGRESS – SITE 7 FORMER FUEL DEPOT UPDATE

FIVE YEAR REVIEW SITE 6A – SOUTHERN AREA FENCE LINE TREATMENT SYSTEM EVALUATION AND 2019 FIELD ACTIVITIES UPDATE

2019 VOLATILE ORGRANIC COMPOUNDS GROUNDWATER INVESTIGATION SITE 2 – FORMER FIRE TRAINING AREA

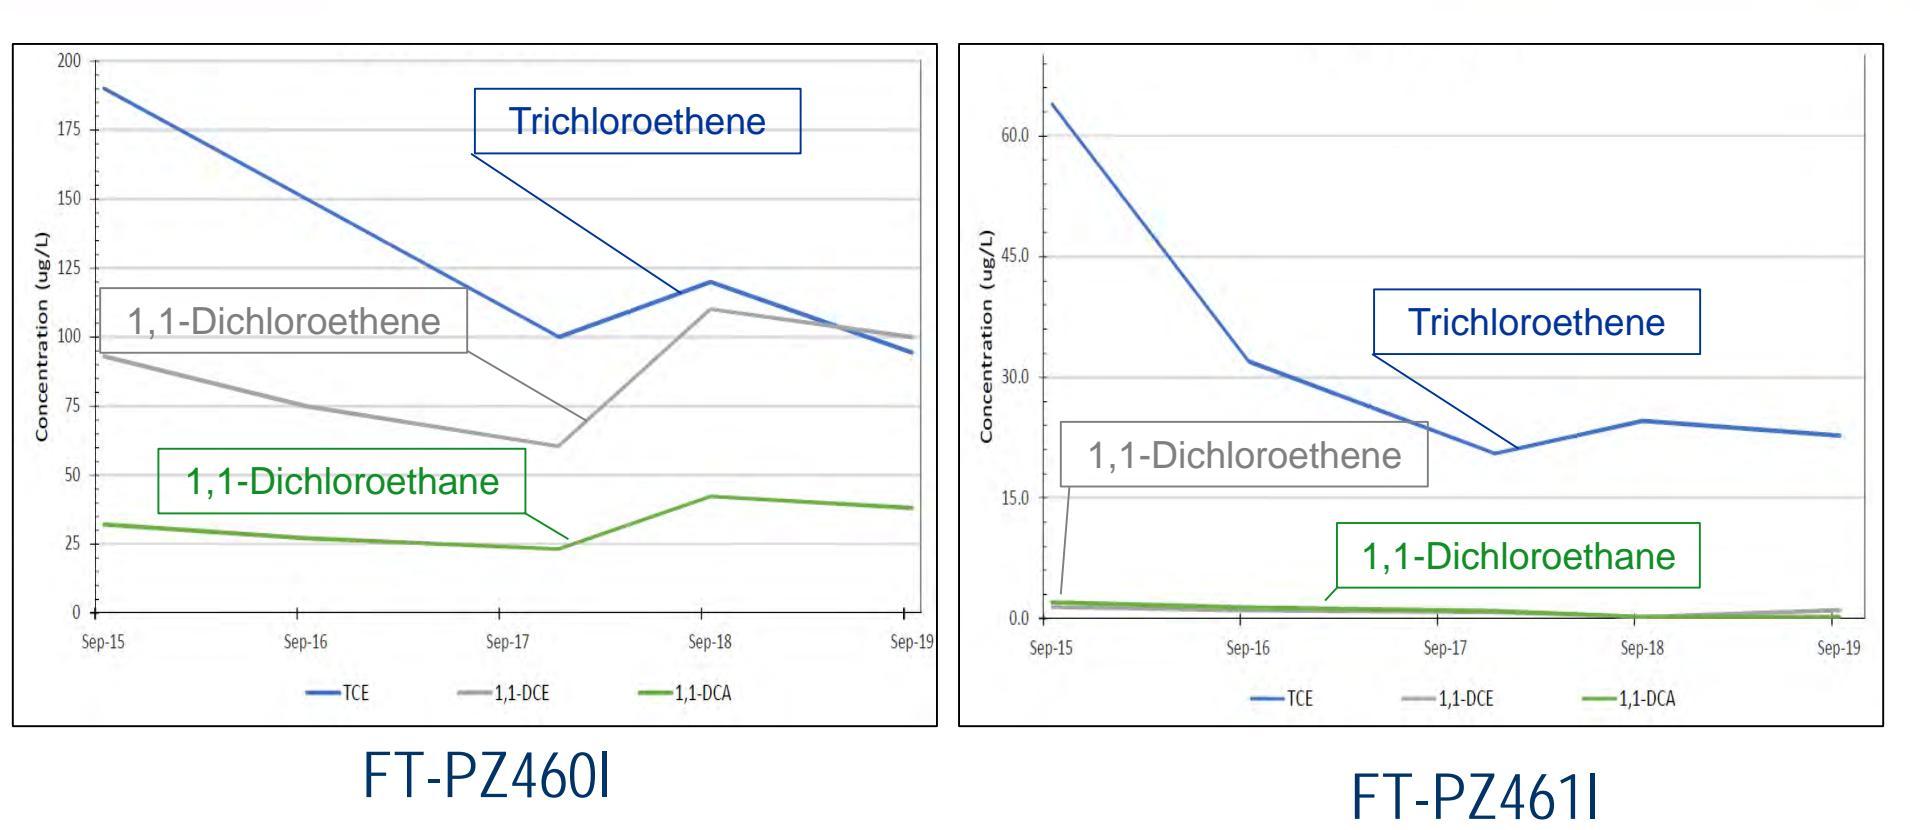
Site 2 VOC Trends Off Property

• June 2012: trichloroethene detected at 600 μ g/L at FT-PZ460I and 74 μ g/L at FT-PZ461I.

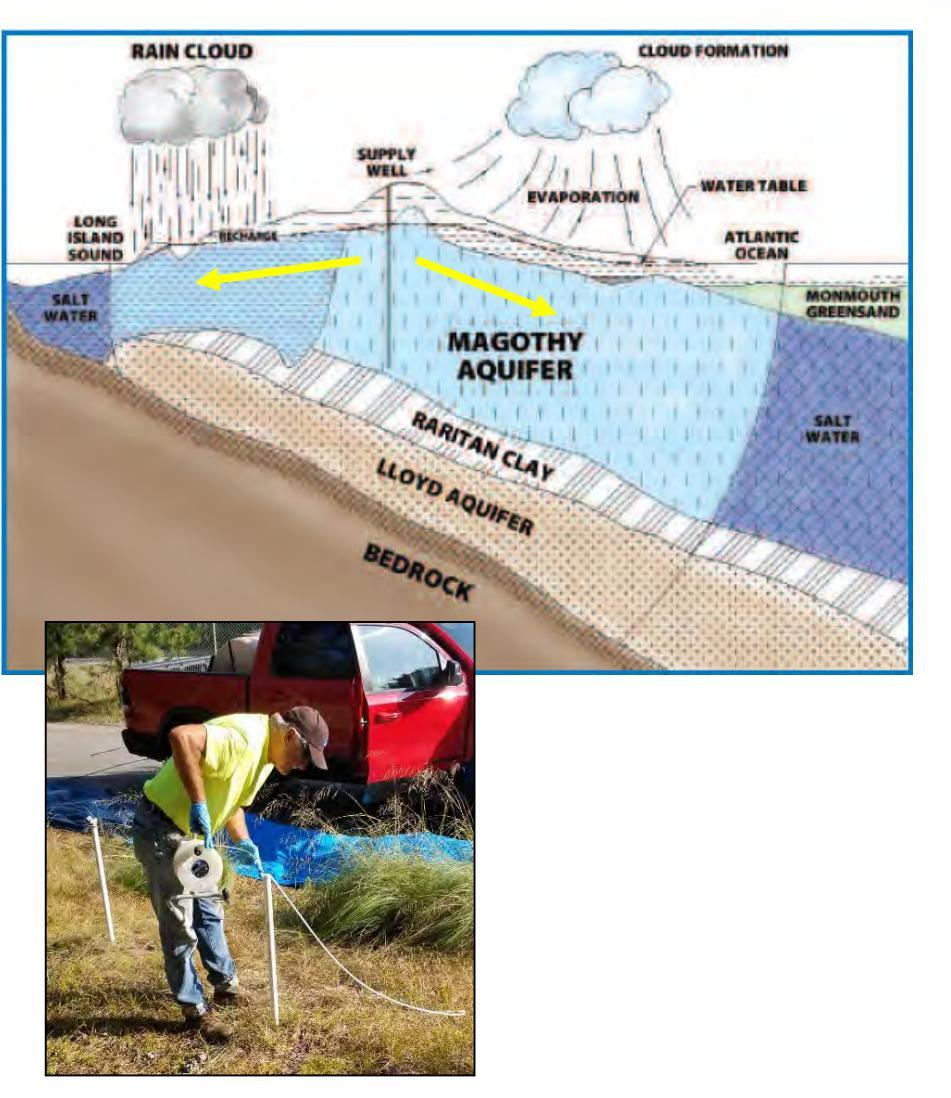
Groundwater Flow

- Water level elevations are used to determine the direction of groundwater flow
- Groundwater flows from higher to lower elevation
- Groundwater typically flows the same direction that the land surface slopes (down hill)
- Piezometers are used to measure the elevation of groundwater relative to sea level
 - -Groundwater elevation is collected by measuring the depth in feet from the top of the piezometer to the groundwater
 - -The elevation of groundwater is calculated using the depth of the water level and surveyed elevation
- By collecting groundwater elevations from an extensive well network, an experienced hydrogeologist can determine groundwater flow direction with accuracy

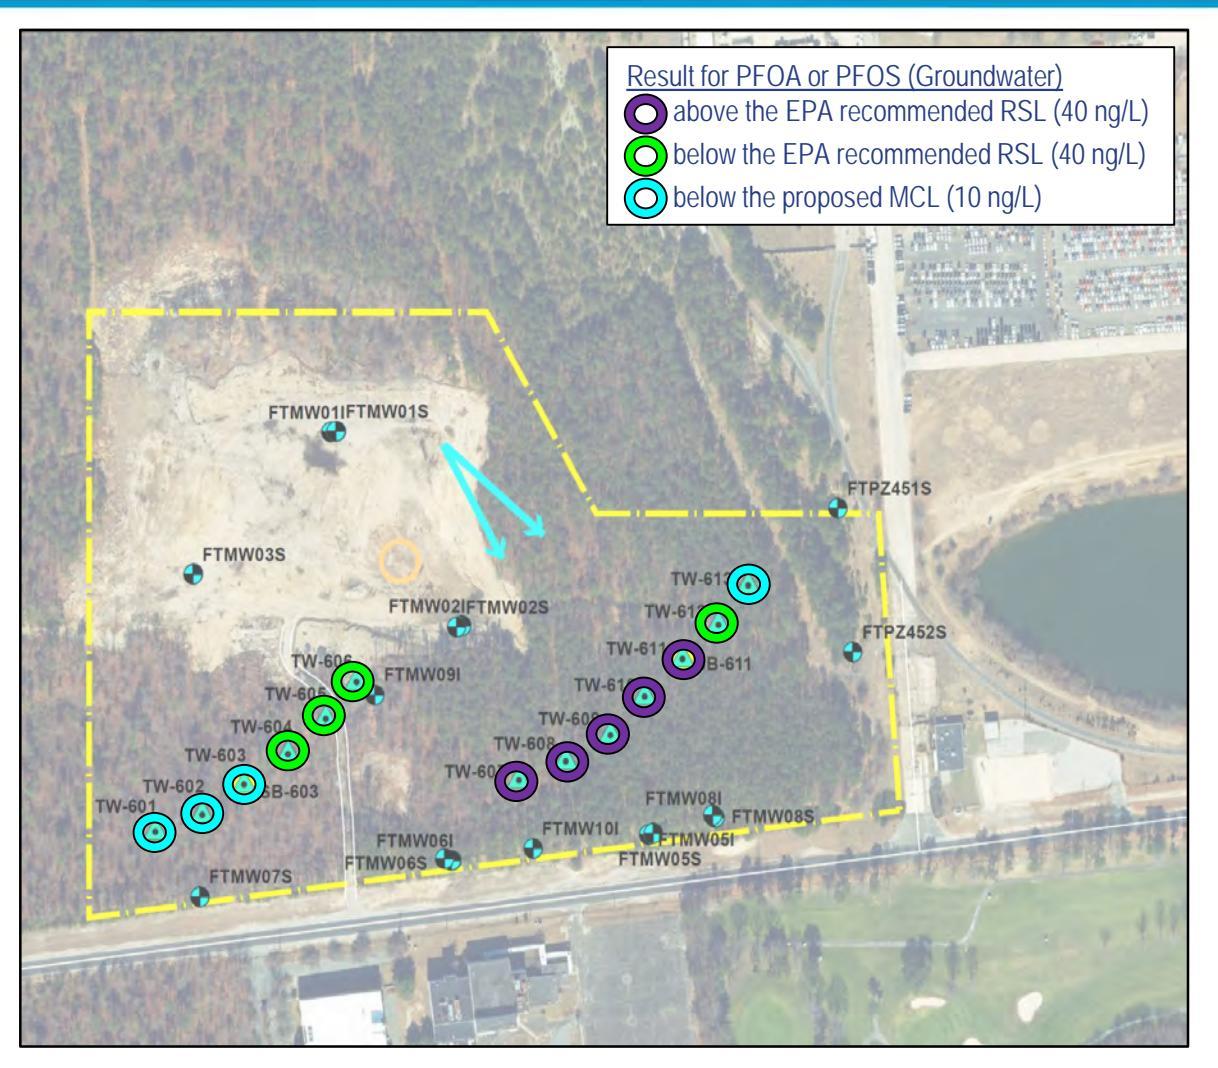
On Property Site 2 PFAS SI

- Site 2 Former Fire Training Area
- Discharged AFFF to extinguish fires during training exercises
- 80 groundwater grab samples were collected from 13 locations
- Results for PFOA or PFOS in:
 - -14 samples exceed the EPA
 recommended RSL
 -66 samples are below the EPA
 recommended RSL
 -59 samples below the New York
 State proposed MCL
- Exceedances are located downgradient of the former fire training ring

At Site 2 – Former Fire Training Area, PFOA and PFOS detected in 14 of the 80 samples exceed the EPA recommended RSL of 40 ng/L. PFOA and PFOS in 21 of the 80 samples exceed the New York State proposed MCL. The exceedances are located downgradient of the former fire training ring.

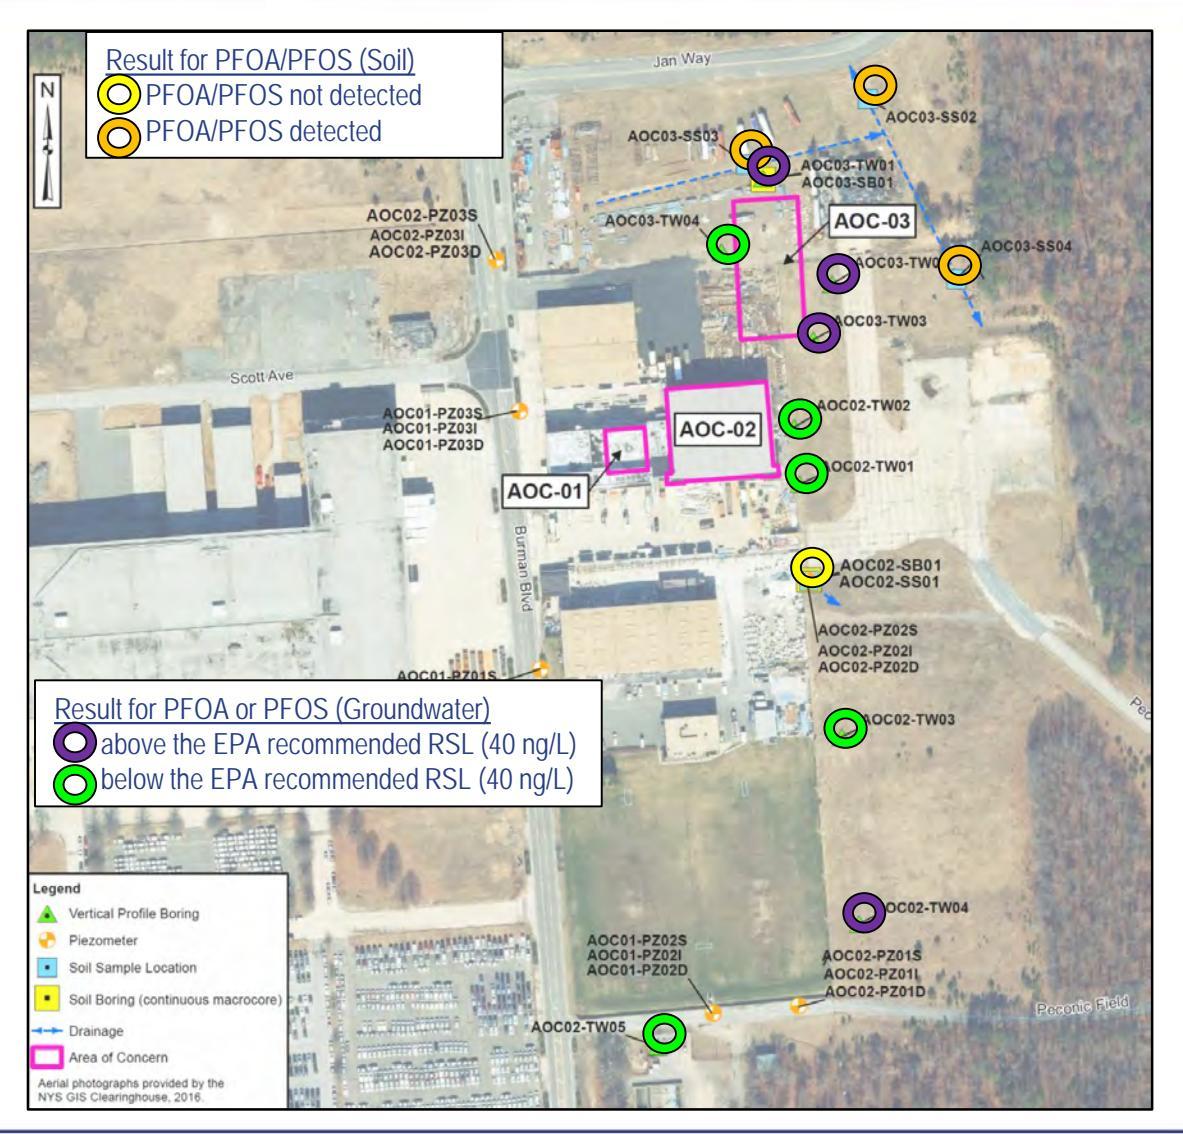
AOC-01, 02, and 03 Facility Wide PFAS SI

- AOC-01 and AOC-02 Aircraft Paint Hangars
- AOC-03 Paint Stripper Building
- Equipped with fire suppression systems containing AFFF
- Groundwater Grab Samples
- 49 groundwater grab samples were collected from 9 locations
- Results for total PFOA or PFOS in:
 - 5 samples exceed the EPA recommended RSL
 - 44 samples are below the EPA recommended RSL
 - 16 samples are below the State's recommended MCL
- Exceedances in intermediate (23 to 48 feet below ground surface) and deep (63 to 68 feet below ground surface) depths
 Soil Samples
- 12 soil samples from 3 locations
- PFOA ranged from not detected to 2.4 J ng/g
- PFOS ranged from not detected to 0.3 J ng/g

Facility Wide SIs covered 12 Areas of Concern (AOCs). At AOC-01 and AOC-02 – Aircraft Paint Hangars and AOC-03 – Paint Stripper Building, a total of 49 groundwater grab samples were collected from nine (9) locations and analyzed for PFOA and PFOS. Five (5) samples exceeded the EPA recommended RSL of 40 ng/L and 44 samples were below the EPA recommended RSL. Sixteen (16) samples were below the State's recommended MCL of 10 ng/L. Twelve (12) soil samples were collected from three (3) locations. PFOA/PFOS ranged from ranged from not detected to 2.4 J ng/g, below the residential RSL of 130 ng/g.

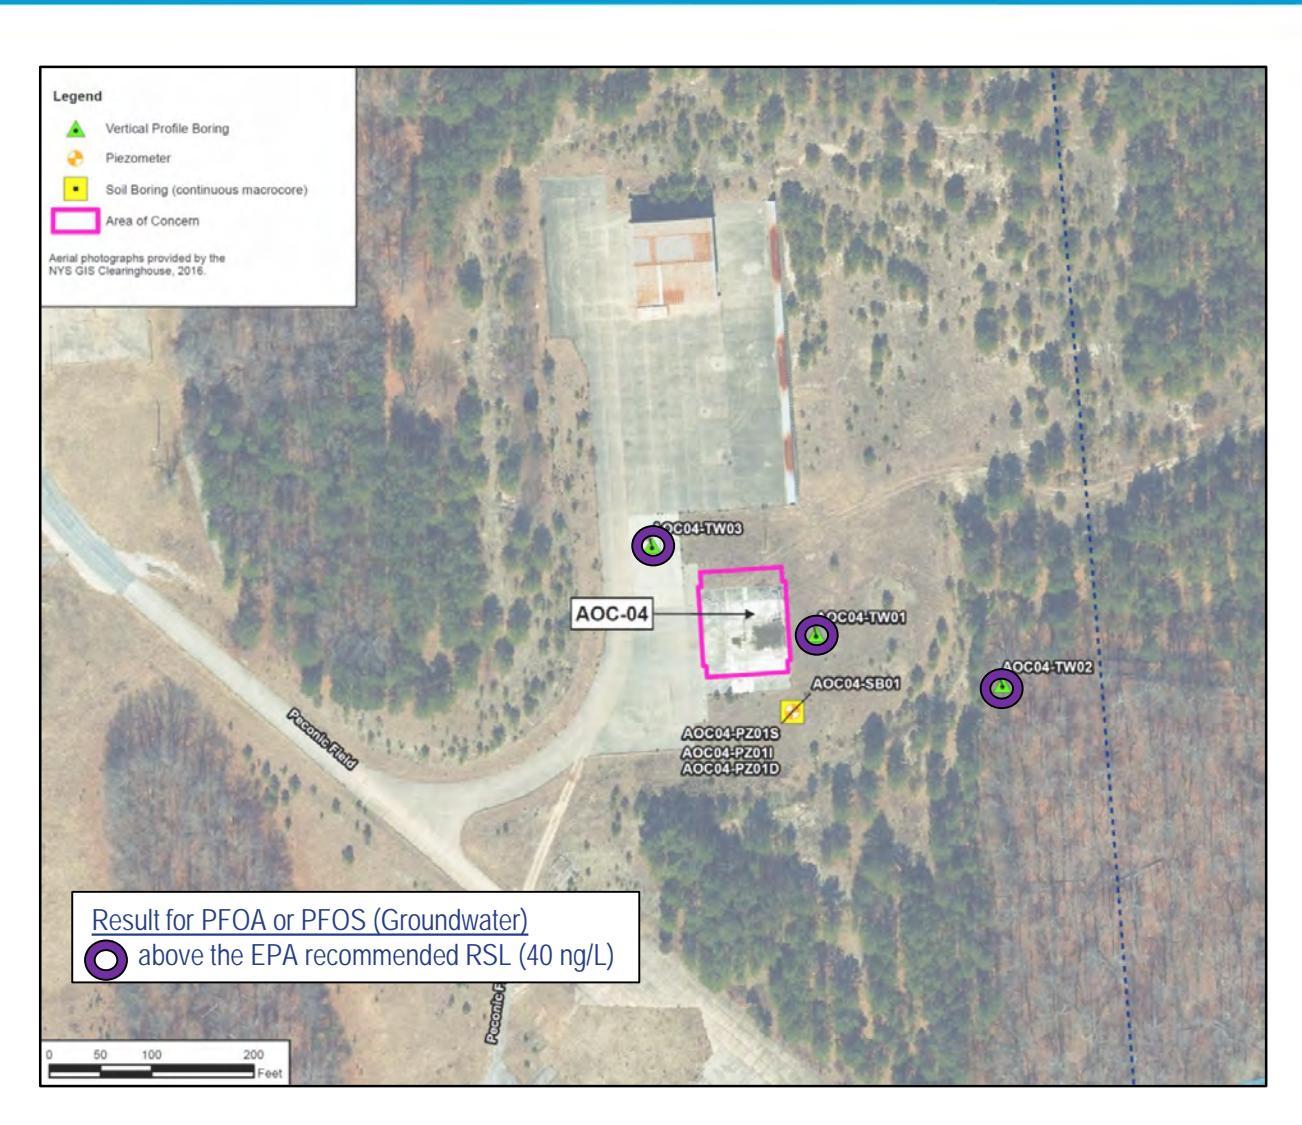
AOC-04 Facility Wide PFAS SI

- AOC-04 Noise Suppression Hush House
- Equipped with fire suppression systems containing AFFF
- 15 groundwater grab samples were collected from 3 locations
- Results for total PFOA or PFOS in:
 - 10 samples exceed the EPA recommended RSL 5 samples are below the EPA recommended RSL
 - 3 samples are below the State's recommended MCL
- Exceedances from 7 to 52 feet below ground surface

At AOC-04 – Noise Suppression Hush House, a total of 15 groundwater grab samples were collected from three locations and analyzed for PFOA and PFOS. Ten (10) samples exceeded the EPA recommended RSL of 40 ng/L and five samples were below the EPA recommended RSL. Of the five samples, three samples were below the State's recommended MCL.

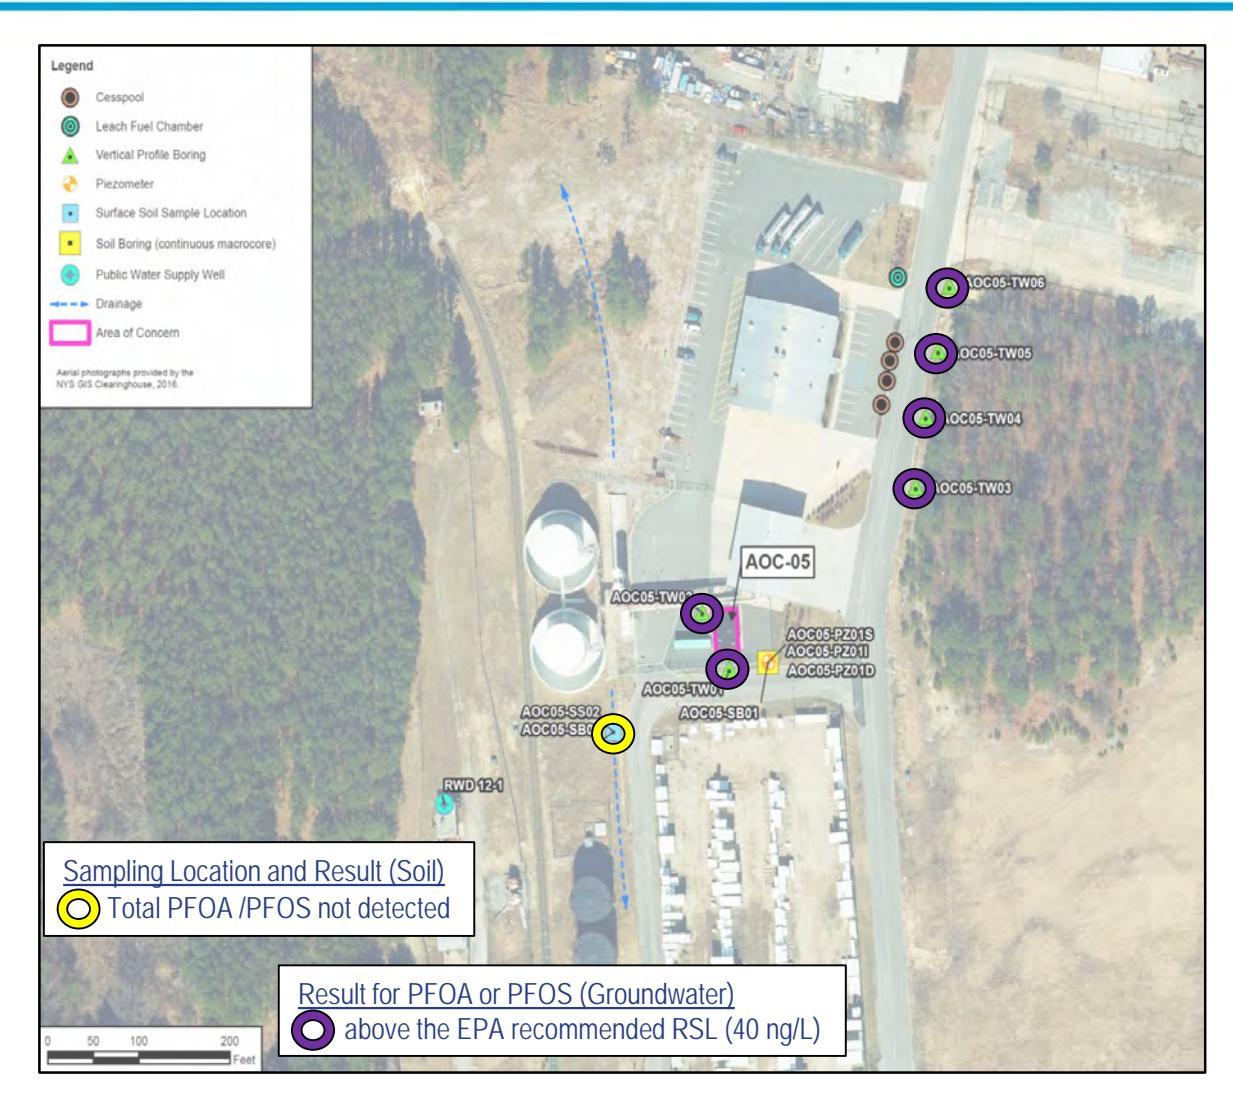
AOC-05 Facility Wide PFAS SI

- AOC-05 Aircraft Fuel Storage Terminal
- Equipped with a fire suppression system containing AFFF
- Groundwater Grab Samples
- 30 groundwater grab samples were collected from 6 locations
- Results for total PFOA and PFOS in:
 - 11 samples exceed the EPA recommended RSL
 - 19 samples are below the EPA recommended RSL
 - 18 samples are below the State's recommended MCL
- Exceedances in at least one sample from each location: 13 to 30 feet below ground surface in the area of the building and 25 to 40 feet below ground surface downgradient of the cesspools

- 3 soil samples from 1 location
- PFOA and PFOS was not detected

At AOC-05 – Aircraft Fuel Storage Terminal a total of 30 groundwater grab samples were collected from six (6) locations and analyzed for PFOA and PFOS. Eleven (11) samples exceed the EPA recommended RSL and 19 samples were below the EPA recommended RSL. Of the 19 samples, 18 samples were below the State's recommended MCL. Three (3) soil samples were collected from one location and PFOA and PFOS were not detected.

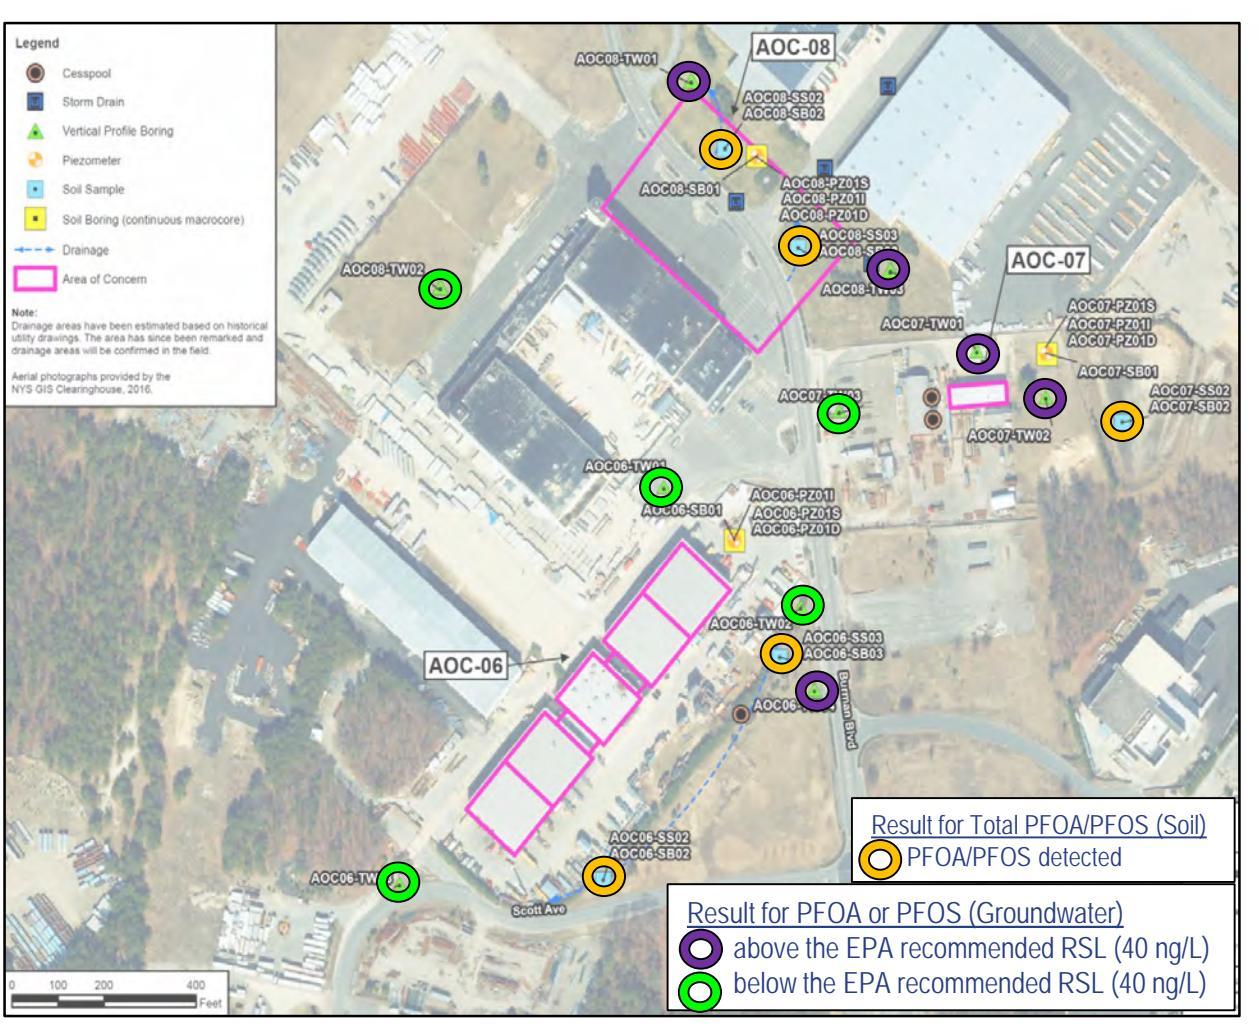
AOC-06, 07, and 08 Facility Wide PFAS SI

- AOC06 Hangars; equipped with fire suppression system containing AFFF
- AOC-07 Fire House; storage of AFFF inside the building
- AOC-08 Equipment Training Area; Discharged AFFF during training of staff on equipment
- Groundwater Grab Samples
- 50 groundwater grab samples were collected from 10 locations
- Results for total PFOA and PFOS in:
 - 7 samples exceed the EPA recommended RSL
 - 43 samples are below the EPA recommended RSL
 - 26 samples are below the State's recommended MCL
- Exceedances from 15 to 42 feet below ground surface
- Soil Samples
- 15 soil samples from 5 locations
- PFOA ranged from not detected to 2.4 ng/g
- PFOS ranged from not detected to 0.3 ng/g

At AOC06 – Hangars; equipped with fire suppression system containing AFFF, AOC-07 – Fire House; storage of AFFF inside the building and AOC-08 – Equipment Training Area, a total of 50 groundwater grab samples were collected from ten (10) locations and analyzed for PFOA and PFOS. Seven (7) samples exceeded the EPA recommended RSL and 43 samples were below the recommended RSL. Of the 43 samples, 26 samples were below the State's recommended MCL. Fifteen (15) soil samples were collected from five (5) locations, PFOA/PFOS ranged from ranged from not detected to 2.4 J ng/g, below the Residential RSL of 130 ng/g.

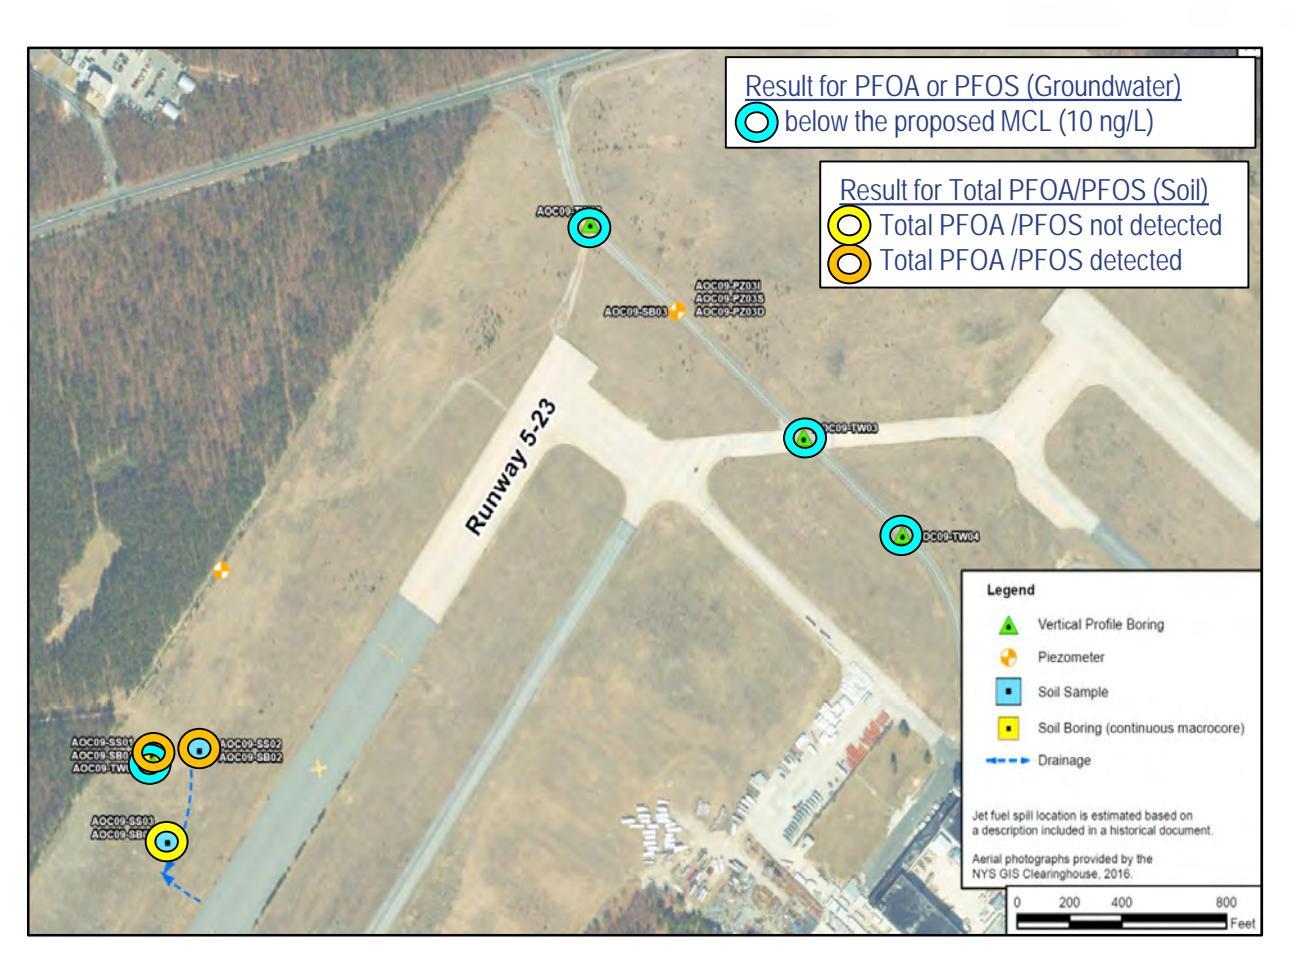
AOC-09 North Facility Wide PFAS SI

- AOC-09 North Jet Fuels Spill
 AFFF released at the spill location; location is uncertain <u>Groundwater Grab Samples</u>
- 20 groundwater grab samples were collected from 4 locations
- Results for total PFOA and PFOS in:
 - 20 samples are below the EPA recommended RSL and the State's recommended MCL
- Soil Samples
- 9 soil samples from 3 locations
- PFOA was not detected
- PFOS ranged from not detected to 1.49 ng/g

At AOC-09 North – Jet Fuels Spill, 20 groundwater grab samples were collected from four (4) locations and analyzed for PFOA and PFOS. Twenty (20) samples were below the EPA recommended RSL and the State's recommended MCL. Nine (9) soil samples were collected from three (3) locations, PFOA and or PFOS ranged from ranged from not detect to 1.49 ng/g, below the Residential RSL of 130 ng/g.

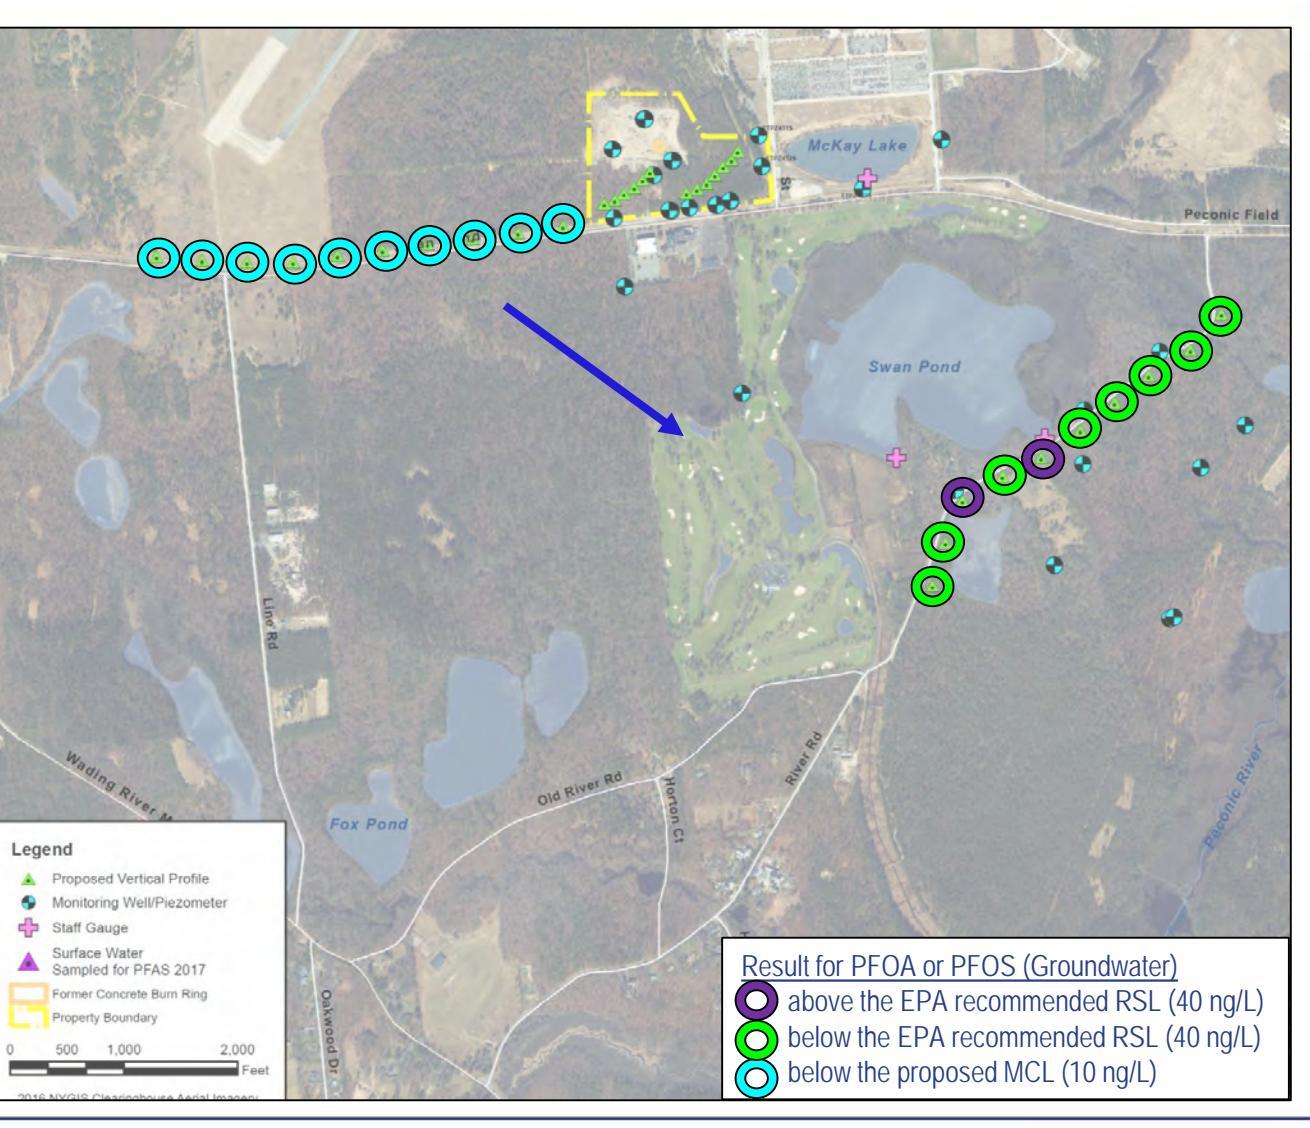
AOC-09 South and Site 2 Off Property Facility Wide PFAS SI

- 74 groundwater grab samples were collected from 10 locations
- Results for total PFOA and PFOS in:
 - 0 samples exceed the EPA recommended RSL

- 50 groundwater grab samples were collected from 10 locations
- Results for total PFOA and PFOS in:
 - 4 samples exceed the EPA recommended RSL
 - 46 samples are below the EPA recommended RSL 26 samples are below the
 - State's recommended MCL
- Exceedances are south of Swan Pond at depths of 26 to 41 feet below ground surface

AOC-09 South, a total of 74 groundwater grab samples were collected from ten (10) locations and analyzed for PFOA and PFOS. All samples were below the EPA recommended RSL and the State's recommended MCL. At Site 2 Off Property, a total of 50 groundwater grab samples were collected from ten (10) locations and analyzed for PFOA and PFOS. Four (4) samples exceeded the EPA recommended RSL and 46 samples were below the recommended RSL. Of the 46 samples, 26 samples were below the State's recommended MCL.

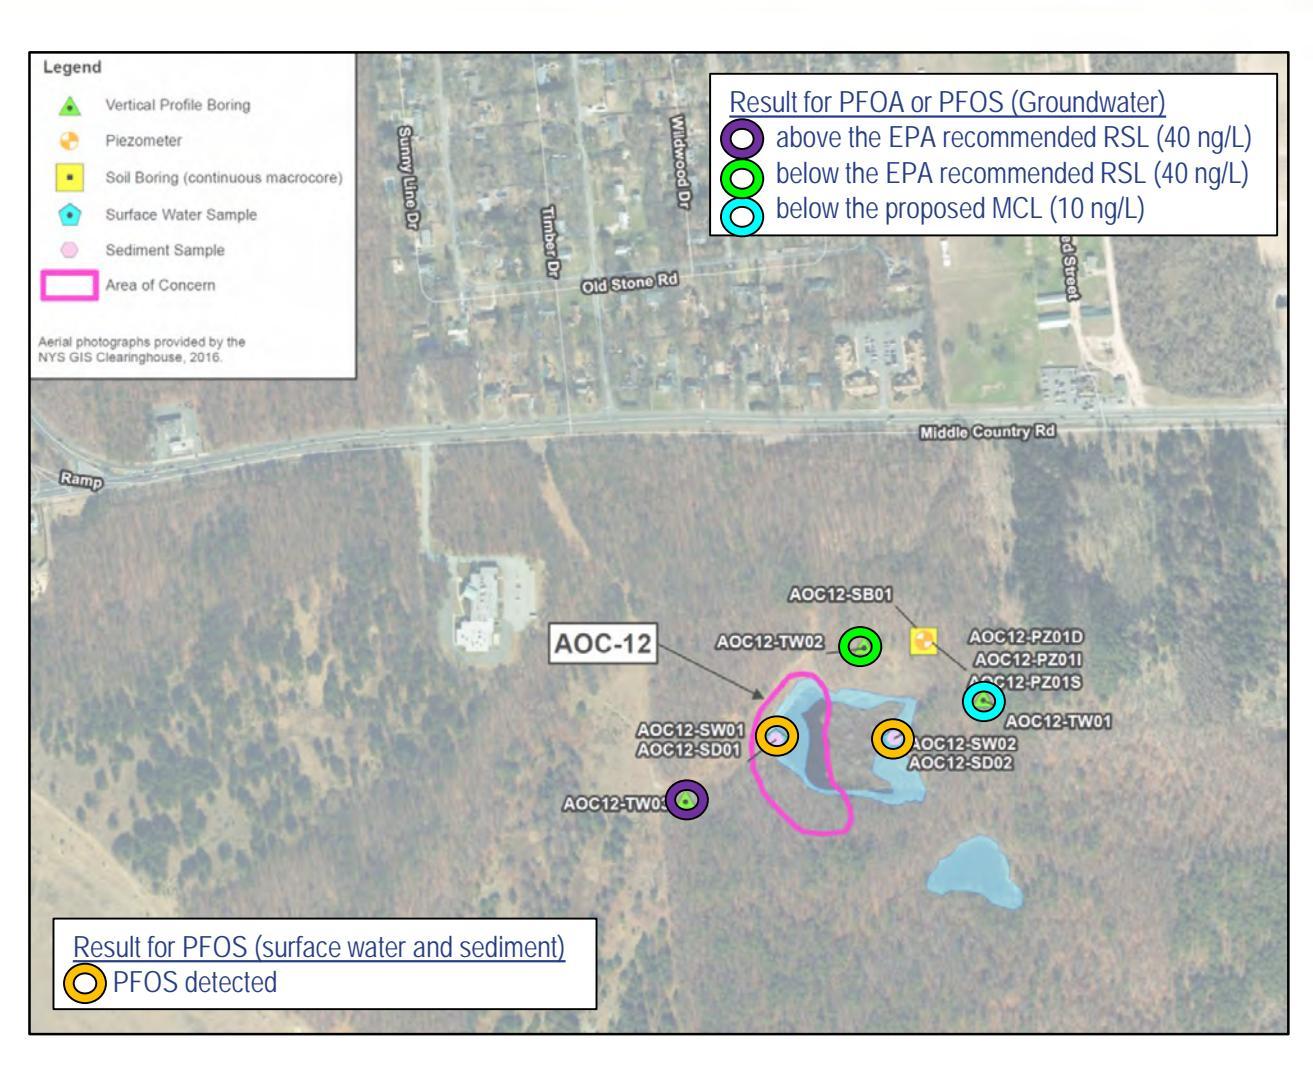
AOC-12 Facility Wide PFAS SI

- AOC-12 Northeast Pond Disposal Area (clean closure)
 Groundwater Grab Samples
- 22 groundwater grab samples were collected from 3 locations
- Results for total PFOA and PFOS in:
 - 1 sample exceed the EPA recommended RSL
 - 21 samples are below the EPA recommended RSL
 - -19 samples are below the State's recommended MCL
- Exceedance is in the upgradient location from 71 to 76 feet below ground surface
- Sediment and Surface Water Samples
- PFOA was not detected in sediment and surface water samples
- Sediment: PFOS ranged from not detected to 0.89 ng/g
- Surface water: PFOS ranged from 2.18 to 7.33 ng/L

At AOC-12 – Northeast Pond Area a total of 22 groundwater grab samples were collected from three (3) locations and analyzed for PFOA and PFOS. One (1) sample exceeded the EPA recommended RSL and 21 samples were below. Of those 21 samples, 19 samples were below the State's recommended MCL. PFOA was not detected in sediment and surface water samples but PFOS was detected in these samples. Screening criteria for sediment and surface water have not been established for comparison to the results.

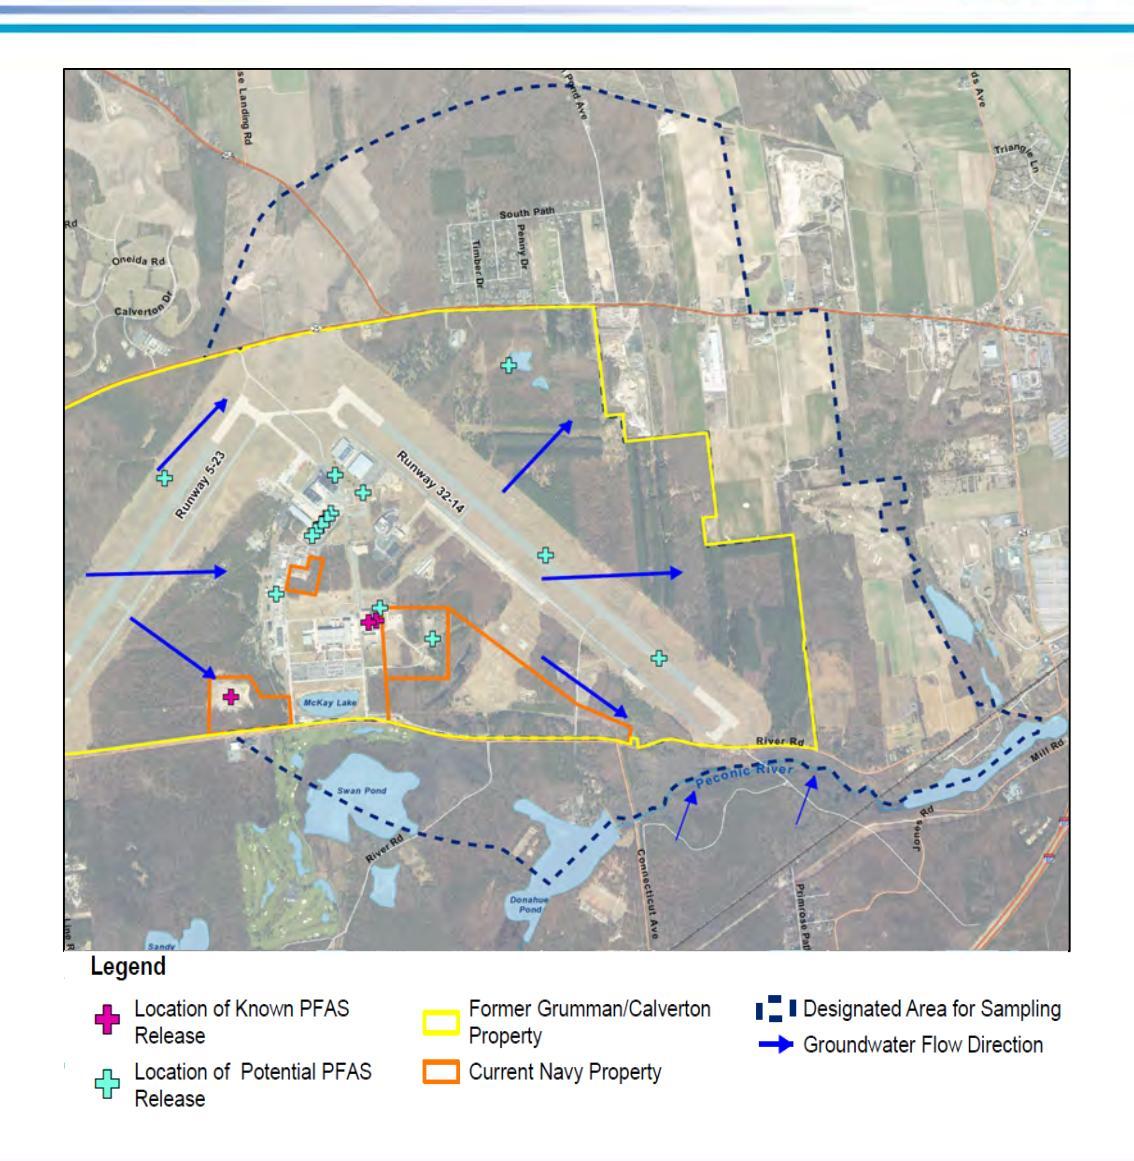
Drinking Water Sampling Facility Wide PFAS SI

- September 2019: Drinking Water Sampling
- Contacted owners at the 14 properties with private drinking water wells sampled in 2018
- Door-to-door handouts to properties that have not responded to past sampling requests
- Resampled 14 drinking water wells
- Results are all below the EPA drinking water health advisory and the New York State recommended MCL

The September 2019 drinking water sampling event consisted of contacting owners at the 14 properties with private drinking water wells that were sampled in 2018. In addition, door-to-door handouts were distributed to properties that had not responded to past sampling requests. The results of the 14 resampled private wells were all below the EPA drinking water health advisory and the New York State recommended MCL for PFOA and PFOS.
