Restoration Advisory Board Meeting Minutes, Naval Research Laboratory – Chesapeake Bay Detachment, Chesapeake Beach, Maryland

MEETING DATE:
 April 17, 2024

Attachment 2 Naval Research Laboratory – Chesapeake Bay Detachment Restoration Advisory Board Meeting Presentation, April 17, 2024

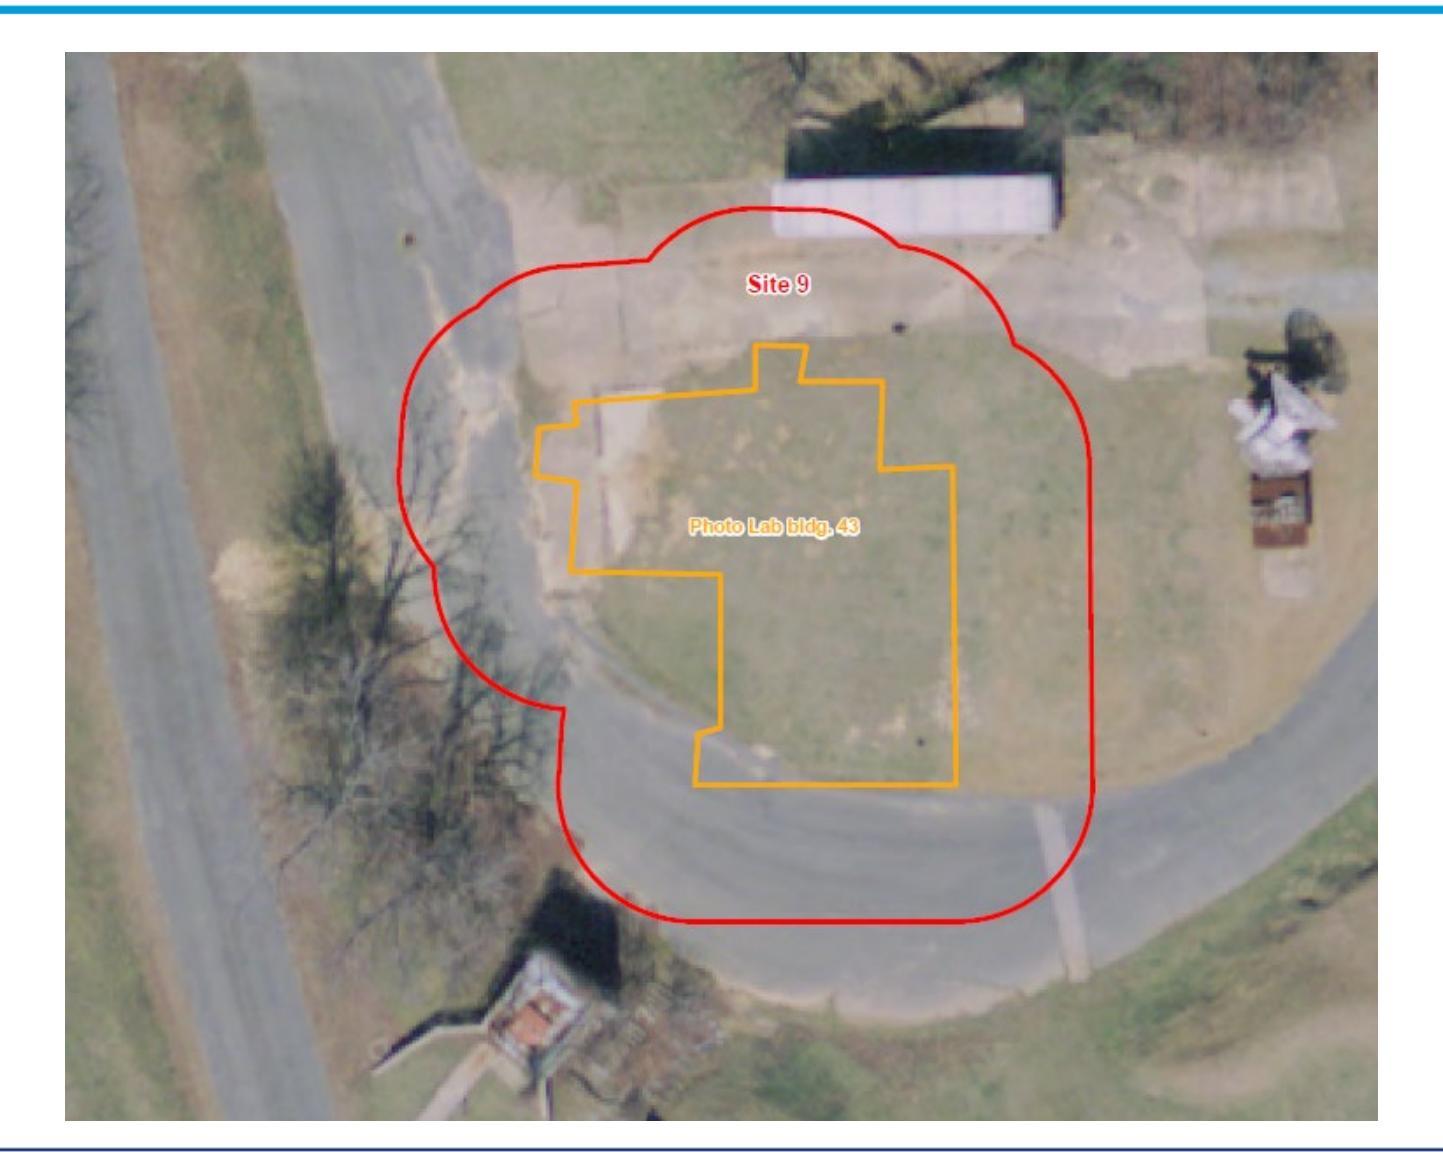
Site 9 – Photo-Processing Discharge

Site 9 Description

- Site 9 associated with a former photo-processing lab that was housed inside the southeast corner of former Building 43.
- Wastewater from the photo-processing lab was reportedly disposed through a drain that discharged to the ground immediately outside the building
 - The photo-processing lab was used once or twice during each year of operation, generating 10 to 15 gallons of waste solution (e.g., sodium thiosulfate, hydroquinone) per event.
- This operation reportedly occurred from the late-1950s until the early-1960s and again from the late-1960s until 1975.
- The building has been demolished and the site is relatively level and covered with grass. The road network that surrounds the former building is still intact.

Former Building 43, which was associated with the photo processing lab, is no longer present. The photo lab was inside the building where wastewater from the photo-processing operation was disposed of through a drain, which discharged immediately to the ground surface outside of the building. The photo processing lab was used once or twice during each year of operation, generating about 10 to 15 gallons of waste (containing sodium thiosulfate and hydroquinone). Photo processing occurred in the late-1950s until the early-1960s and again from the late-1960s through 1975. Ryan reviewed the CERCLA process (Attachment 2, Slide 11).

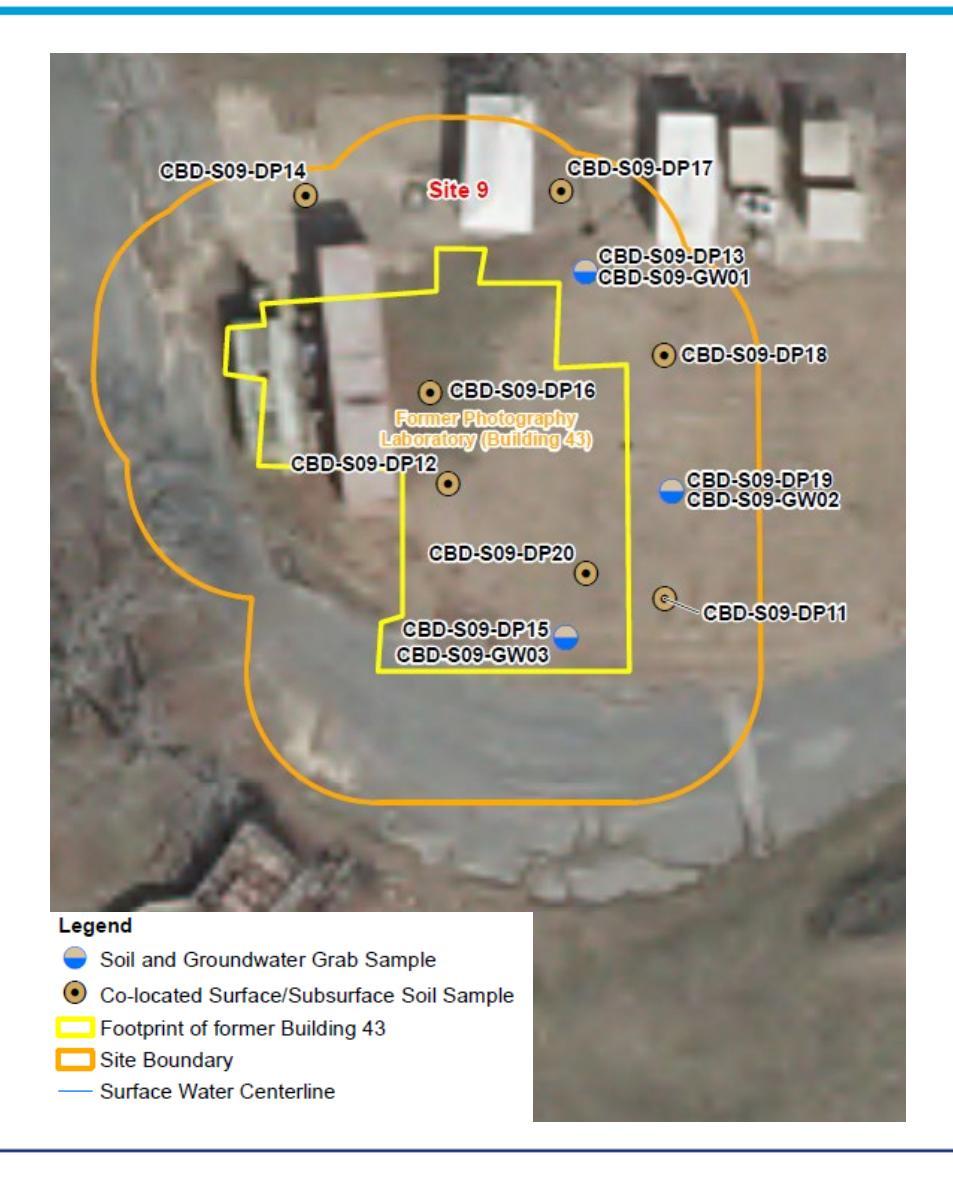
SESI Results

- No detections of hydroquinone in surface/subsurface soil above detection limit
- No detections in groundwater above detection limit
- Limited uncertainty due to detection limits above screening levels
 - Uncertainty discussed and agreed to by regulators during Sampling and Analysis Plan preparation
 - Hydroquinone has short half-life in environmental media and it has been 50+ years since a release

Hydroquinone and sodium thiosulfate weren't chemicals that we previously sampled for, or chemicals that are typically included in our volatile organic compounds (VOCs) or semi-VOCs (SVOCs) analysis groups. The team agreed to go back and take a look at those two compounds. It was determined that hydroquinone did have regulatory screening levels, but that sodium thiosulfate did not have a screening level. There was no comparison that could be completed with the data; therefore, sodium thiosulfate was removed from further investigation. The team agreed to resample for hydroquinone because there was a screening level. This moved us into the SESI. The sampling strategy included pairing up the new soil sample locations with those locations previously sampled in the SI and ESI, as well as collecting groundwater from three temporary wells. The results of the data showed no detections of hydroquinone in the surface soil, subsurface soil, or in groundwater above the detection limit.

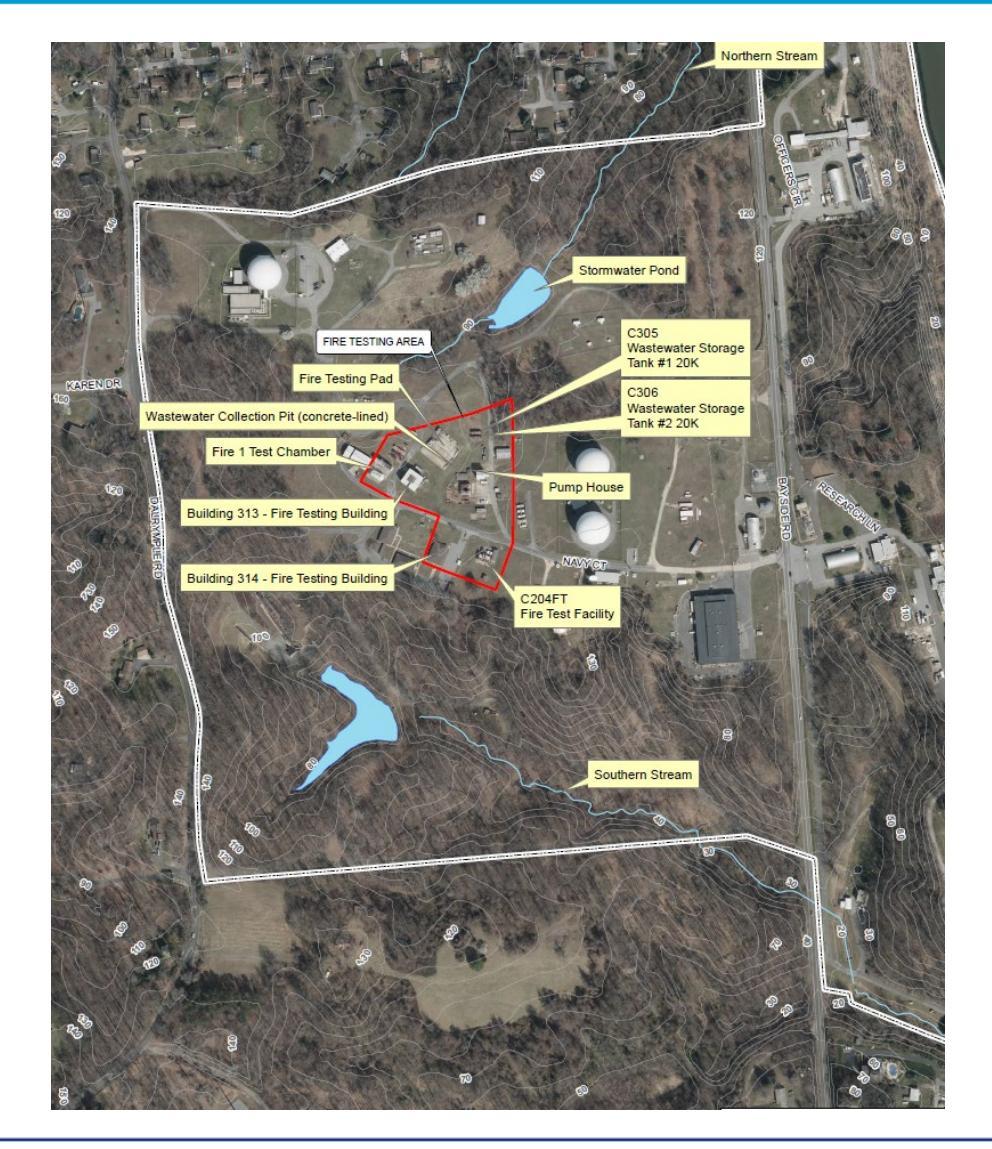
Site 10 On-Base RI SAP

- Objectives
 - Define nature and extent of PFAS in soil, groundwater, surface water, and sediment
 - -Evaluate fate and transport of PFAS in environmental media
 - Evaluate risks to human health and the environment
- Tentative Schedule
 - -Draft SAP for MDE review summer 2024
 - -Final SAP anticipated fall 2024

Amy went over the labels and features on the presentation figures including identifying the different buildings at Site 10, the stormwater pond to the north, and the stream to the south. Ryan indicated that most of these building structures are still present. Andy indicated that the wastewater storage tanks were no longer there; they were demolished in 2020 and disposed of offsite. Most of the soil contamination is in the center (of Site 10).

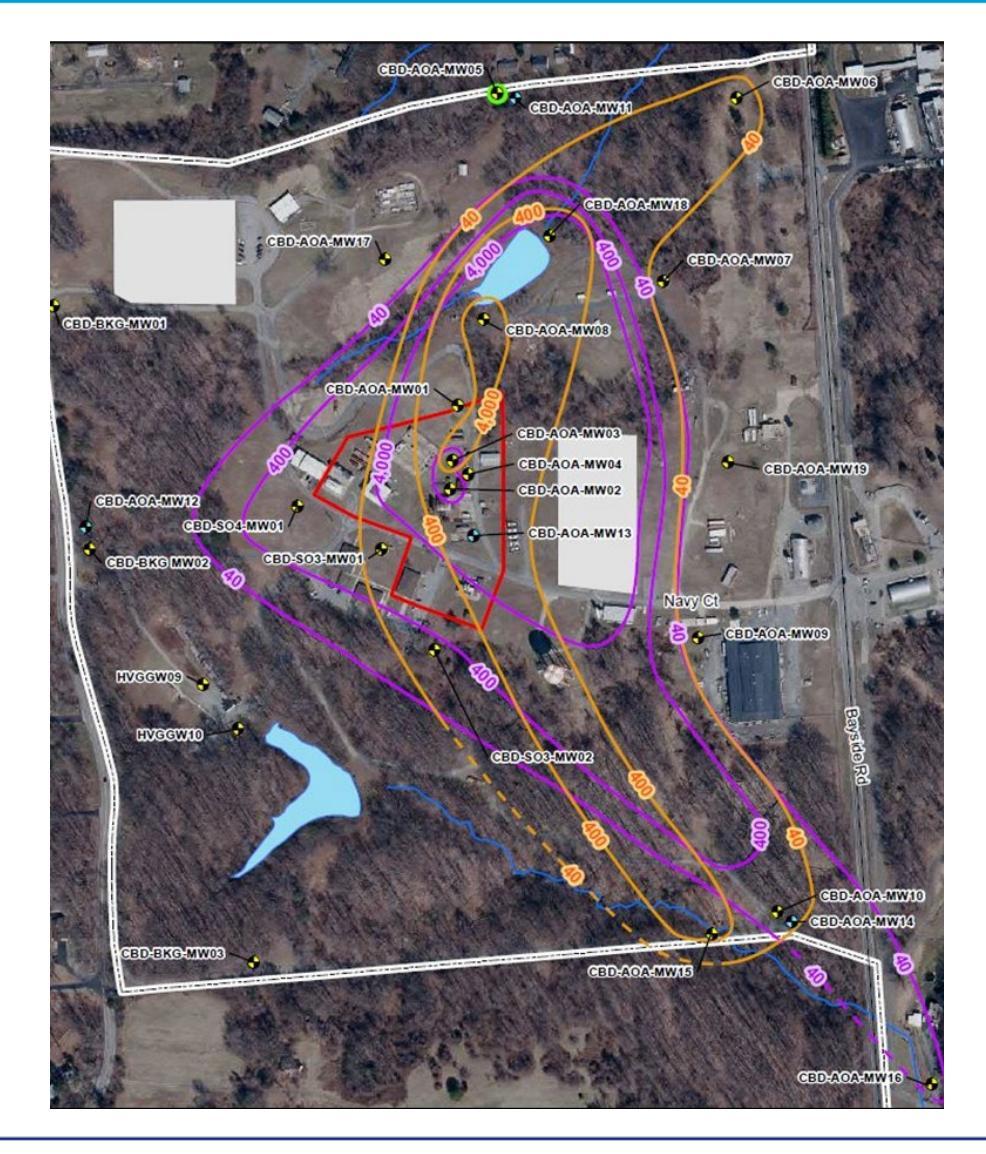
Site 10 Off-Base RI SAP

- Objectives
 - Define nature and extent of PFAS in surficial groundwater, surface water, and sediment
 - Evaluate fate and transport of PFAS in environmental media
 - Evaluate risks to human health and the environment
- Tentative Schedule
 - Draft SAP for MDE review summer 2024
 - Final SAP anticipated fall 2024

Andy presented the PFAS map and indicated that the concerns are to the northeast (NE) and southeast (SE). The Navy wants to add additional monitoring wells to better evaluate concentrations of PFAS in those areas.

Andy indicated there are three monitoring wells that have delineated the eastern extent of the PFAS plume. Groundwater flow follows topography and generally groundwater flow direction is pushing northeast to the stream, and then it pushes southeast following the hill side into the southern stream.

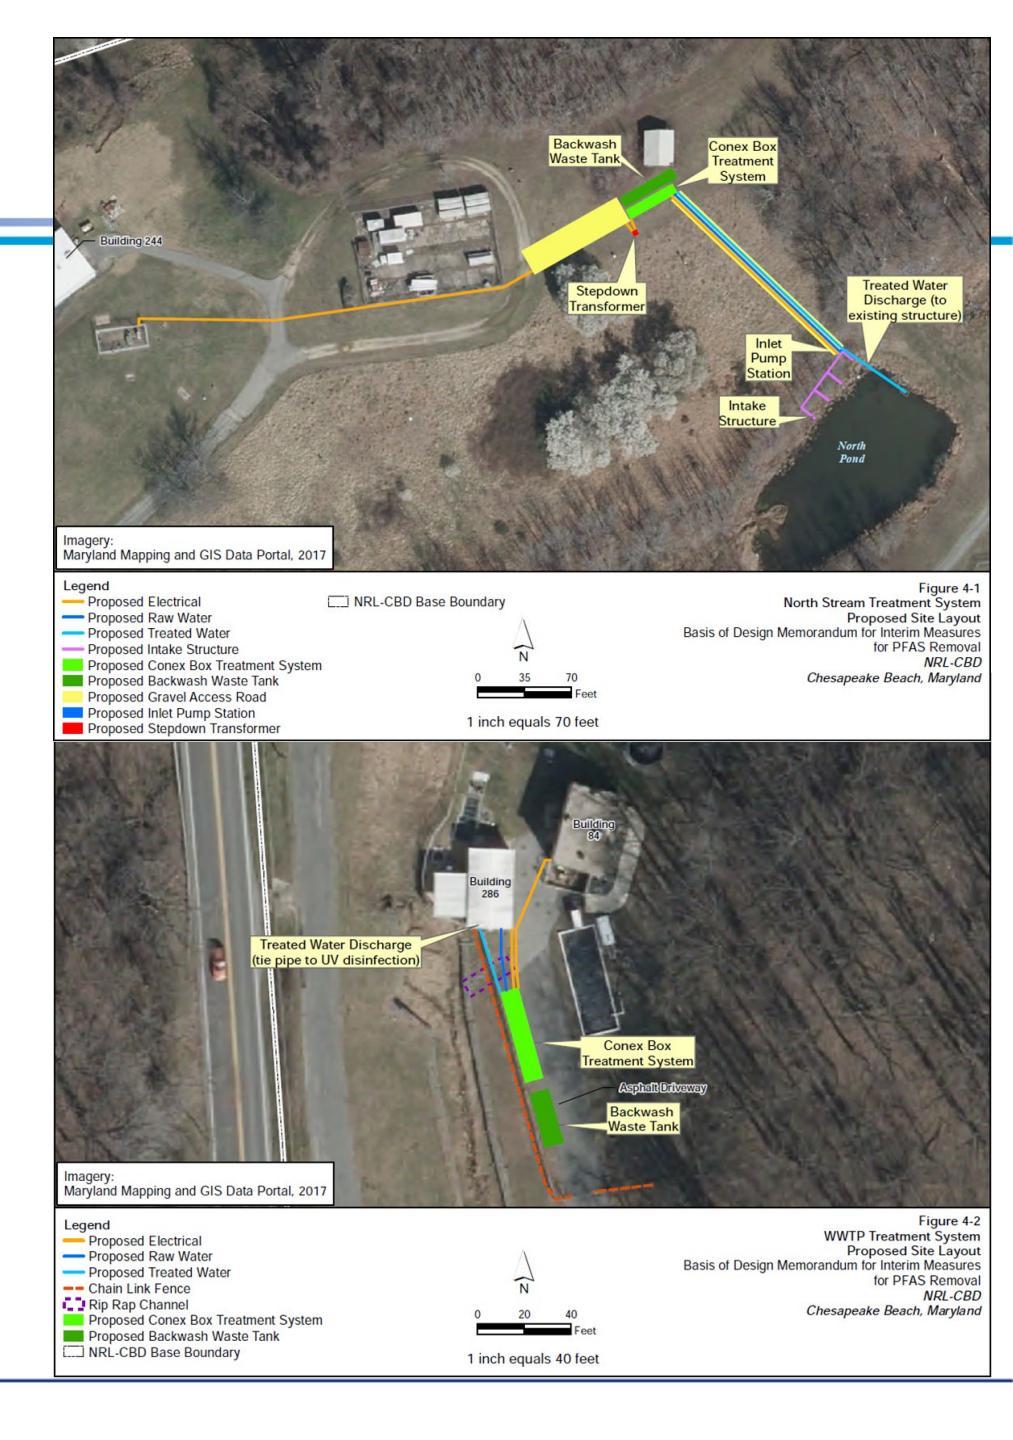
- 100% Basis of Design and Permitting
 - Completing final design and permitting
- Action Memorandum
 - Public comment period anticipated summer 2024
- Treatment Unit Construction
 - Conex treatment units constructed, initial start up testing in-progress

Ryan provided an overview of Interim Measures (IMs) for Site 10. He explained that groundwater is discharging into the north pond as well as entering the sanitary system. The interim measure is a removal action which consists of designing two treatment systems, one for the north pond and a second for the wastewater treatment plant (WWTP). The WWTP was not designed for PFAS treatment so the PFAS treatment system will be added to the current WWTP system. The PFAS treatment systems will be located in CONEX boxes (at each of the two locations). The north pond will have an intake structure installed to convey water to the treatment system. The PFAS treatment system at the WWTP will be inserted at the end of the existing WWTP system to remove PFAS before the water is discharged.

• David asked to look at the north pond figure to look at the intake location (blue line). Is it shared into the riser, or is it going in the structure or back into the pond?

Ryan indicated that it is going into to the overflow structure. There is an overflow structure there currently, and the pond water level goes up to that structure. It overflows into the structure and conveys through a pipe in the dam wall into the down gradient stream. It acts as a kind of an automatic water level. David was worried that the discharge would go back into the pond. Ryan stated no; that won't be the case.

David was worried with PFAS suspended in the water, that the discharge would stir up anything that might be in the pond. Andy indicated that there will be an initial drawdown in the north pond to bring the water level down below the overflow structure. A float switch will monitor the water level in the pond.

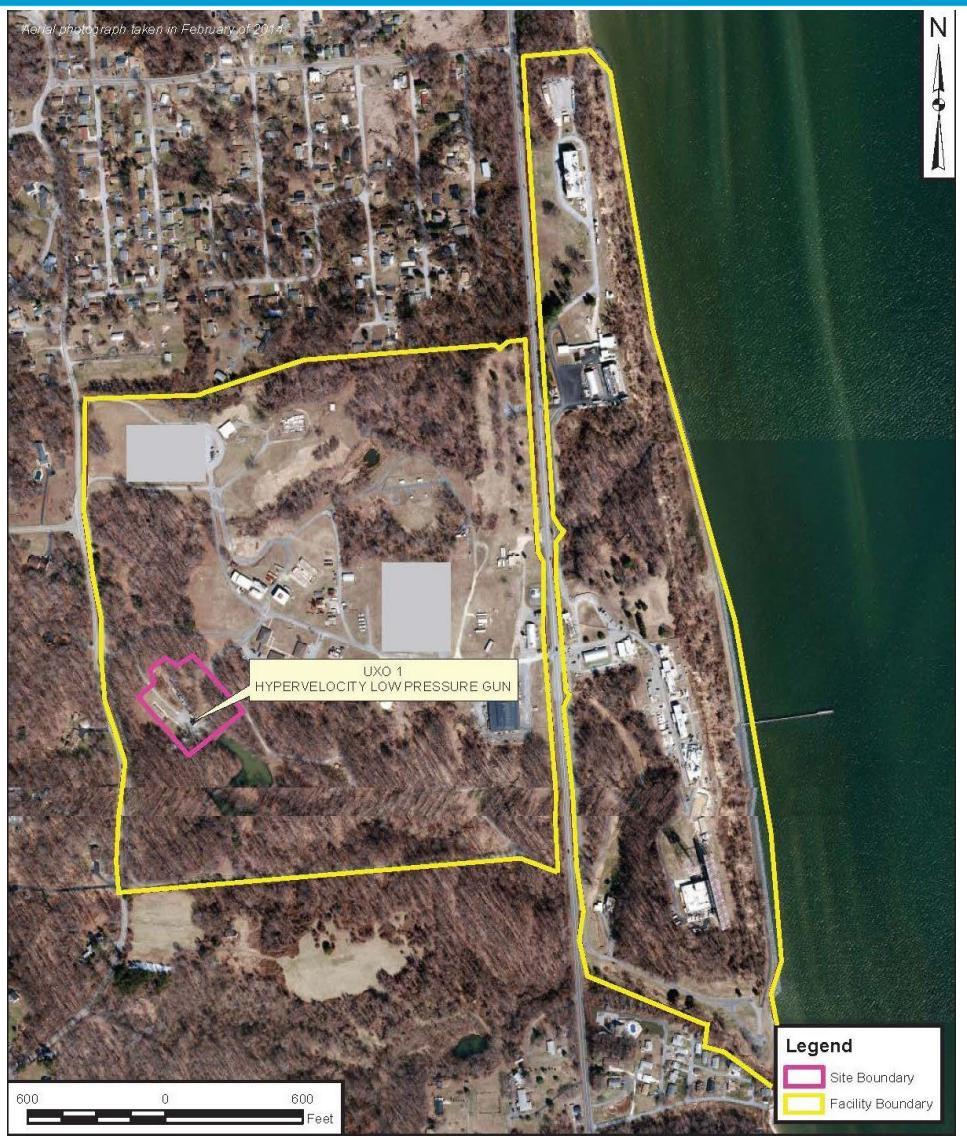
UXO-001 Site Background and Risk

- Site of the former hyper-velocity gun (HVG) testing facility
- Studied impact of high-velocity projectiles on various target materials from 1967 to 1995
- HVG and all support structures removed from site
- Detections of lead in surface soil exceeded the MDE residential soil screening level
- Deteriorating paint chips with known elevated lead levels from the former HVG and support structures are present in surface soil and could serve as continuing source of lead in surface soil

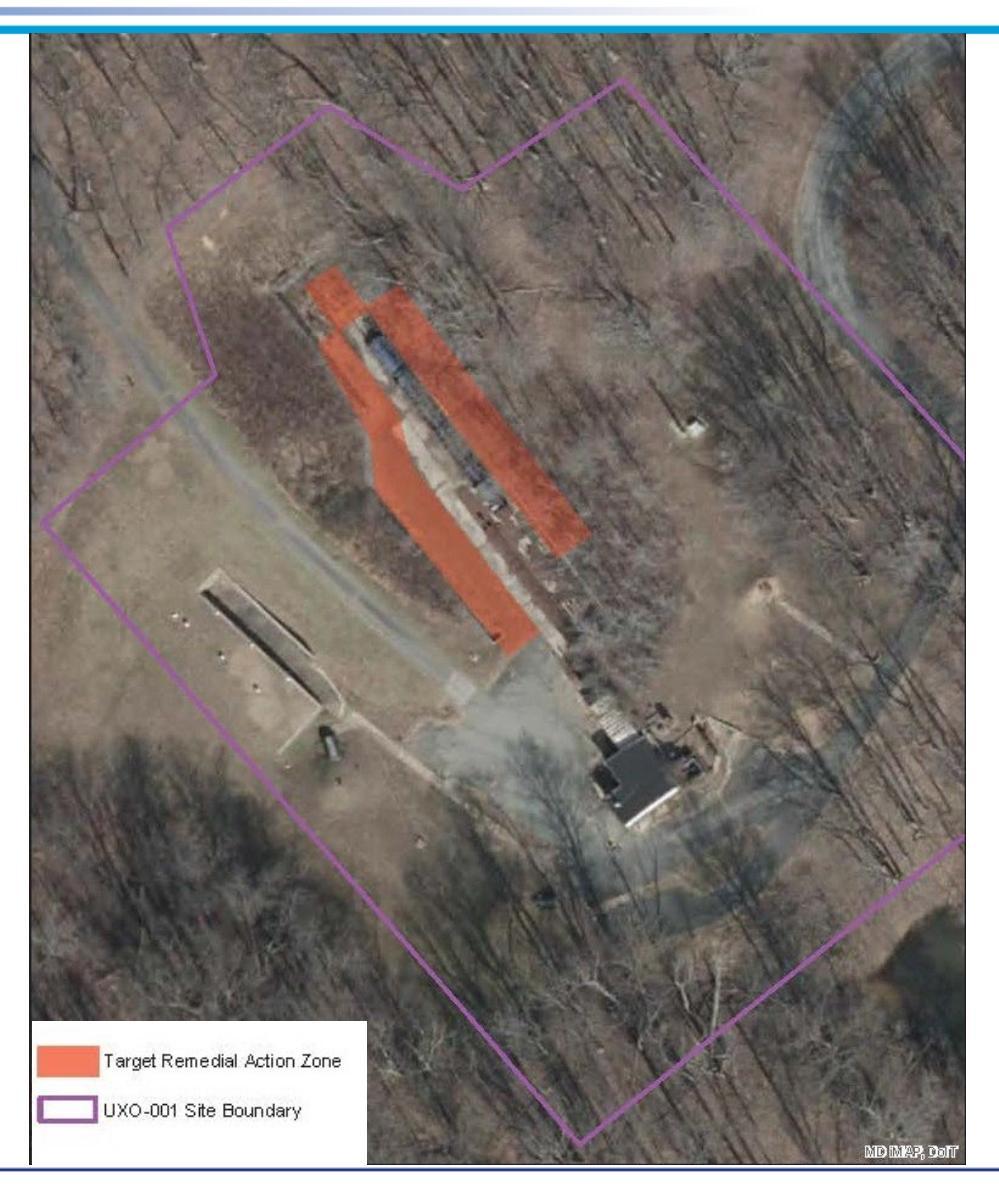
- The Navy proposes to implement Alternative 3

Excavation and Off-Site Disposal as the preferred alternative.
- Under this alternative, approximately 94 cubic yards of lead-contaminated surface soil within an area of 5,072 square feet (0.12 acres) will be excavated from UXO-001.
- Excavated soils will be transported offsite for disposal at a CERCLA-approved facility and the excavated areas will be backfilled with clean fill to existing grade.
- The Navy may modify the preferred alternative or select another if public comments or additional data indicate that another alternative will yield more appropriate results.

Remedial Action Objectives (RAOs) will be provided in the PRAP. Typical screening for lead in soil is 400 milligrams per kilograms (mg/kg) by the EPA, but MDE is using 200 mg/kg as the remedial action goal. Ryan then provided an overview of the types of remedial action alternatives. The Navy is choosing Alternative 3 (Excavation and Off-site Disposal) which will remove impacted soil and dispose it offsite at a landfill. The concentrations detected in the soil were not high enough to be considered a hazardous waste. It is estimated that 94 cubic yards will be removed. Once the PRAP is approved by MDE, it will be open to public comments. The Navy will then address public comments, and the Decision Document will be uploaded into the administrative record.
