## Learned Accident Abstract Safety Lessons

Accident Type: Improper lift and rigging

Type of Work: Relocating precast concrete vault lid

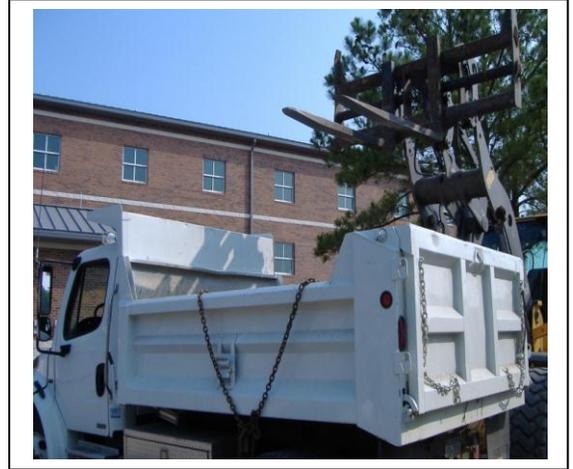
A laborer/spotter while standing on the rear tire of a dump truck, utilizing a take up chain for rigging, was struck on the hardhat when an unsecured “D” ring slipped from a fork causing the rigging chain to forcefully strike the victim in the head knocking him to the ground.

Positive latching device on rigging was NOT employed; EM 385-1-1 Rigging, 15.A.05 Positive Latching Device: *“When hoisting loads, a positive latching device shall be used to secure the load and rigging.”*

Only two of four available lift points on the vault lid were utilized thus causing the load to swing from a horizontal to a vertical position as it was being lifted.

Equipment manufacturer does not permit under fork lifting with this equipment; EM 385-1-1 Machinery and Mechanized Equipment, 18.G.06.c. *Machinery and equipment shall be operated in accordance with the manufacturer's instructions and recommendations.”*

- 1) Applicable AHA’s must address all foreseeable associated risks.
- 2) On-site supervision needs to be proactively involved in developing and enforcing lift plans.
- 3) Personnel must properly use equipment, accessories and tools to safely accomplish tasks.
- 4) Positive latching devices are to be utilized in securing loads to rigging.
- 5) All available lift points are to be employed when lifting loads.
- 6) Use of PPE (hardhat) prevented a more serious injury or possible fatality.
