Safety Lessons Learned Accident Abstract

Accident Type: NEAR MISS MISHAP: Laborer struck by whipping Airline coupling. **(DRAFT)**

Type of Work: Jack Hammering Concrete

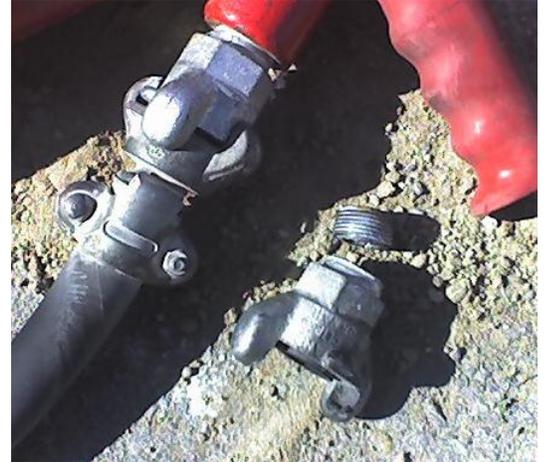
At approximately 1000 on 27 Feb 2007 a local national mason was using a paving breaker (jack hammer) to excavate through concrete for a drain line. The airline coupling attached to the hammer broke, whipped around and struck the operator on the ankle. Only minor injuries with no lost time. He received two days light duty.

- ◆ The old coupling broke due to stress/metal fatigue. (Upon visual inspection of the coupling, no physical/impact damage is evident)

- ◆ All equipment that is permanently issued to shops need to be brought to the tool room for scheduled inspections and maintenance in addition to the operators daily operational check prior to use.
- ◆ Situational awareness is essential in maintaining a safe work environment, and employees must pay attention to the work at hand throughout the workday.

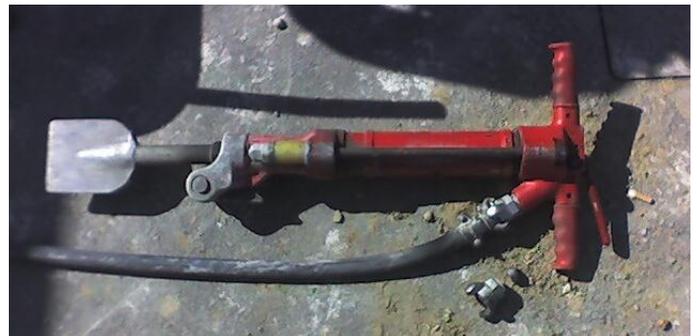
- ◆ Failure to perform proper maintenance. The paving breaker was permanently assigned to the Mason shop and was not inspected by the tool room on a regular basis.
