# Safety Lessons Learned Accident Abstract

**Accident Type:** Pinch Point

**Equipment Involved:** PERI pan decking system

**Type of Work:** Stacking form racks

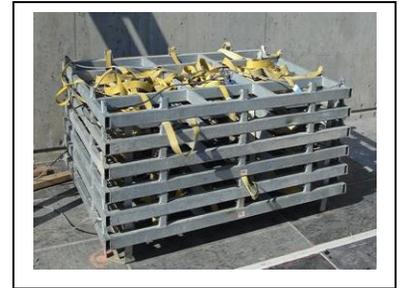
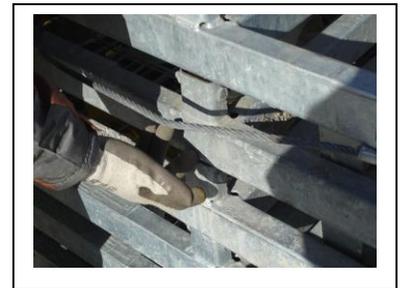
Two workers were stacking the PERI deck form racks for transporting. Each rack is stackable. The bottom of the next higher rack sets on top of thirteen 2 inch projections. Each corner of the rack has feet that fit inside the lower rack. From time to time the feet get caught on the lower rack and the workers shake the stack to free the feet. The workers were shaking the racks to fit them together. As they dropped into place one of the workers right ring finger was in the way of the one of the support projections. Each rack weighs approximately 145 pounds yielding in this case 290 pounds of weight dropping an inch on to the worker's finger. The worker was wearing gloves.

- ◆ Body part caught in a pinch point.

- ◆ Inattention to body position.
- ◆ Pinch points are not identified on the racks.
- ◆ Pinch points were not identified in AHA and were not mentioned during the AHA review.

- ◆ The projections that support the next higher rack create a pinch point.
- ◆ Shaking the racks to settle them (uncontrolled gravity energy release) rather than lifting (controlled movement) the racks to refit them.

- ◆ Pinch point hazard added to AHA.
- ◆ Rack pinch points were discussed with the decking crew.
- ◆ Letter sent to manufacturer to inform it of the mishap.
- ◆ Letter sent to the PERI deck rental company.
- ◆ Workers instructed to lift the rack rather than wiggle it to properly fit both together.
