**FINAL  
NAVAL AIR STATION ALAMEDA RESTORATION ADVISORY BOARD  
MEETING SUMMARY**

April 5, 2007

### **III. Sites 20 and 24 Revised Draft Remedial Investigation Report Presentation**

#### **IV. Offshore Site Inspection Report for Western Bayside and Breakwater Beach Presentation**

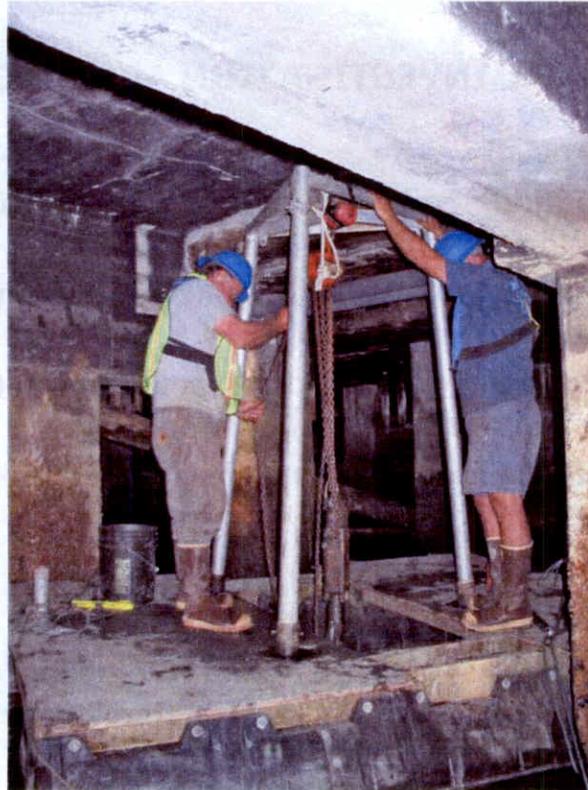
Support vessel for sampling under the roadway at IR Site 24 (sampling platform in background)

The revised draft RI report incorporates the near-shore sampling conducted in September 2006 in the northeastern corner of IR Site 24, where the shelf extends eastward beneath the roadway. The additional samples were collected based on a site visit with the regulatory agencies in July 2006; the Navy agreed with the comments by the regulators from the site visit. No additional sampling was required at Site 20, so no changes were made from the draft RI for Site 20. Site 20 data were presented to the RAB on April 6, 2006. The RI was conducted in accordance with the offshore core study work plan from May 2005. The sediment is the primary medium for both human and ecological exposures. The RI evaluated direct contact with sediment and uptake from consumption of aquatic organisms. All available sediment data were used to calculate risk. Tissue concentrations were based on data from laboratory tests as well as concentrations estimated from sediment. Slides 6 through 10 showed photographs of the field team, field equipment, and sampling.

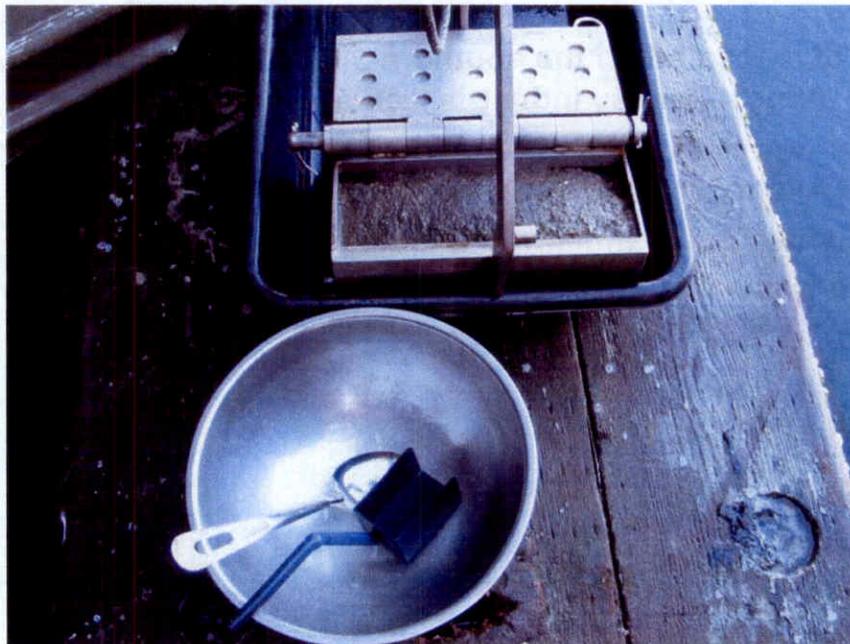
A 10 cm diameter aluminum core tube lined with polyethylene (~4 mil) for the core samples.

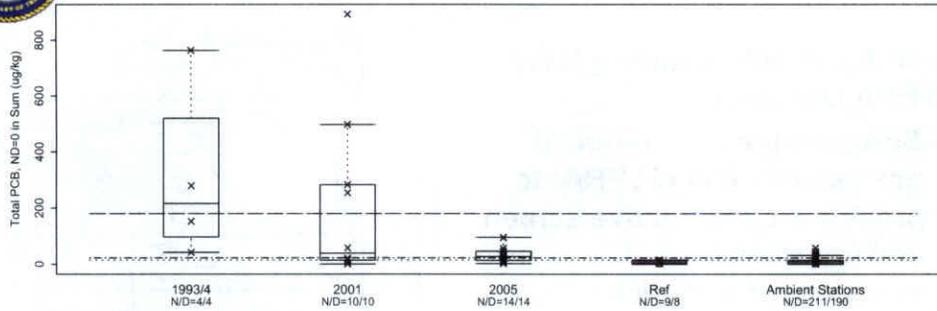
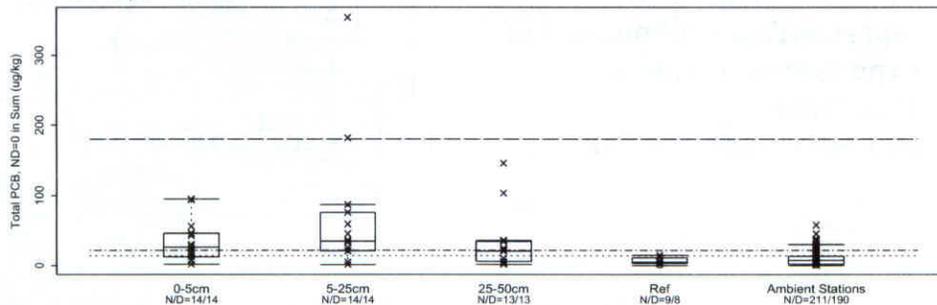
## EXAMPLE SIDE-BY-SIDE BOX PLOT (from IR Site 20)

x = Detected concentration ( $\geq 1$  detect in sum)  
o = Non-detect (all non-detects in sum)  
N/D = number of samples/number detected

----- = Ambient Value (100% fines)  
----- = Eco Screening Value  
----- = ER-M

Ms. Parker introduced Ms. Holder to continue the data analysis portion of the presentation. Outfalls J and K are located under the roadway, and much of the sampling was designed to characterize the area around the outfalls. Box plots and bubble plots are used to evaluate the data in the RI. Data are provided in side-by-side box plots to evaluate distribution across time and depth. Bubble plots depict spatial distribution in surface sediments. Slide 17 showed an example of a side-by-side box plot from IR Site 20. The top plot showed results for surface samples for different years. The lower plot showed results for surface and subsurface samples for 2005/2006. The highest bar depicts the highest concentration detected, and the lowest bar depicts the lowest concentration. The boxes in the center of the data set represent the

concentrations detected between the 25<sup>th</sup> and 75<sup>th</sup> percentiles. Ambient data and risk-based thresholds are also shown for comparison. Data are also depicted for ambient stations where the Water Board and the San Francisco Bay Estuary Institute (SFBEI) collect reference data.

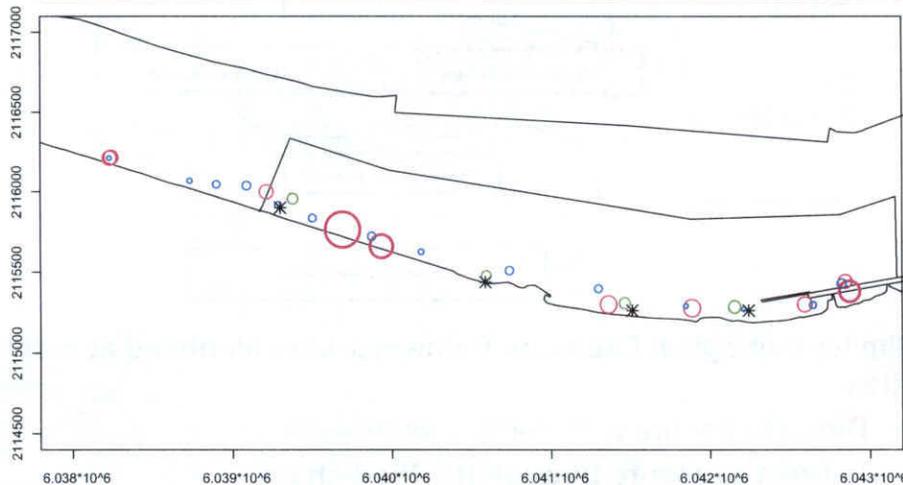
○ 1230 MG/KG maximum  
○ 178.1 MG/KG mean  
○ 92.6 MG/KG median  
○ 20.5 MG/KG minimum

○ 370 MG/KG ERM  
○ 81 MG/KG Eco Screen Value  
\* Outfall Location  
concentration proportional to area of circle

Slide 18 showed an example bubble plot of chromium concentrations. Different years of data are denoted by different colors, and the size of the bubble is proportional to the concentration. A bubble with a thick line indicates that the value exceeded the risk-based threshold. Ms. Sweeney commented that the bubble plot shows that higher concentrations were found in earlier years and that the chemicals may have washed out to sea or evaporated since then. Ms. Holder responded that the higher concentrations for earlier years are also shown in the box plot. She noted that there are different ways to interpret the data. Smaller concentrations in later years may mean that the concentration decreased or that data represent a different location. Conditions may have changed over years, possibly including the deposit of cleaner sediment, within the area of Oakland Inner Harbor shown on the map. Mr. Coe asked if the area shown is near Todd Shipyards. Mr. Macchiarella said that Todd Shipyards would be farther to the right on the map. Mr. Coe commented that the area would be contaminated because ships were sandblasted and the chemicals were washed into the bay. Mr. Macchiarella noted that the box plot for sediment data shows only a single chemical. He noted that the record of decision (ROD) for Site 28, the land part of the Todd Shipyard, is currently being prepared. Ms. D. Smith asked if the bubble plots show concentrations at a single depth or total concentrations for all soil depths. Ms. Holder replied that each point is a single depth. Mr. Humphreys asked where the dog walk park is located. Mr. Macchiarella replied that it is at Site 28.
