## Final NAVAL AIR STATION ALAMEDA Restoration Advisory Board (RAB) Meeting Minutes

November 12, 2015

## Installation Restoration Sites 1 & 2

# Petroleum Program Update Former NAS Alameda

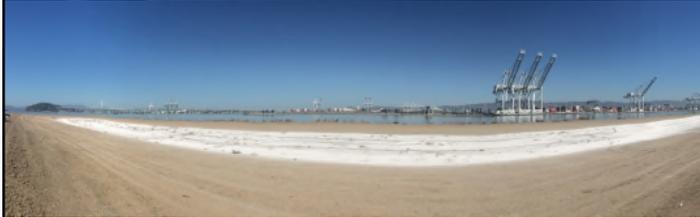
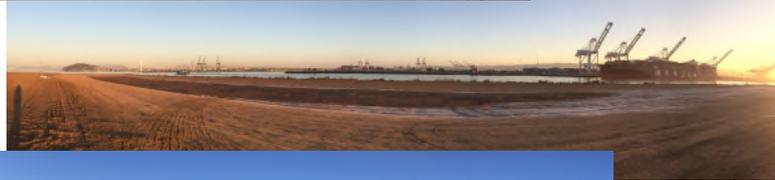
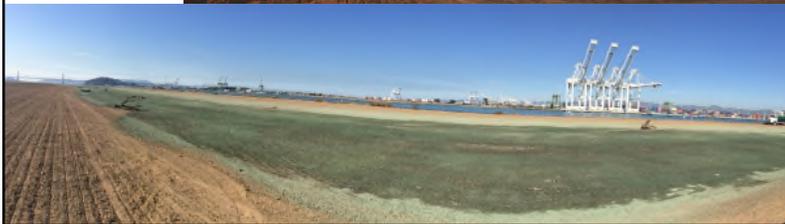
Ms. Linz said the photographs on slide 2 were all taken within a few days of each other. The top photograph shows gypsum and potassium sulfate being added to the soil. The second photograph shows the soil after it was rototilled. The third photograph shows the area after hydromulch was applied. Hydromulch was used to enhance seed germination and erosion control. Mr. McGinnis noted that grasses are used in the seed mix because they grow quickly and have shallow roots that help prevent surface erosion. Ms. D. Smith asked how deeply the seeds were planted. Ms. Linz said about 1-2 inches below the surface, and then they were covered with soil. Ms. Smith said native seeds do not like 2 inches of cover and should be covered with just a half inch of soil. Ms. Sabedra said the contractor recommended the planting procedures based on the seed mix.

Site 1 Wetland

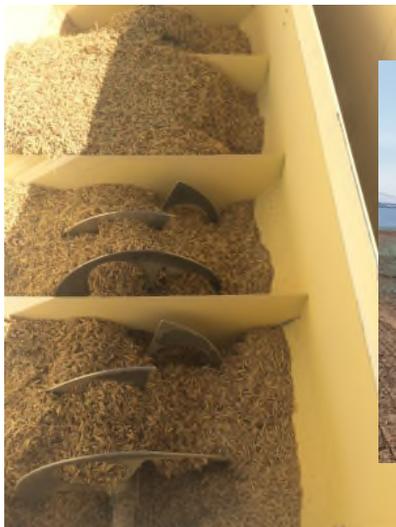
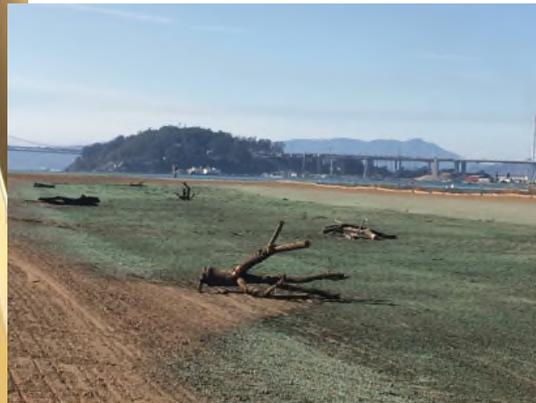
## Site 1 Seeding

The photograph on slide 10 is the Site 1 landfill cover with the seed mixture applied. Ms. Linz noted that it is exceptionally green because it was wet when the photograph was taken. The seeding at Site 2 will take place within a week (mid-November).

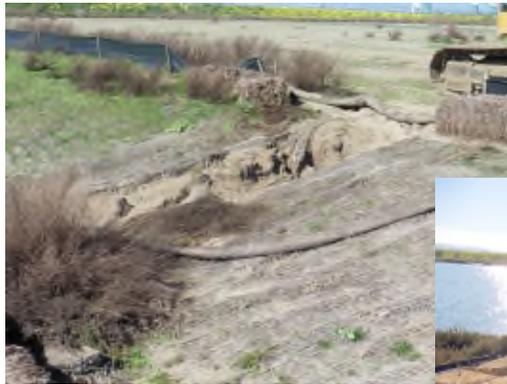
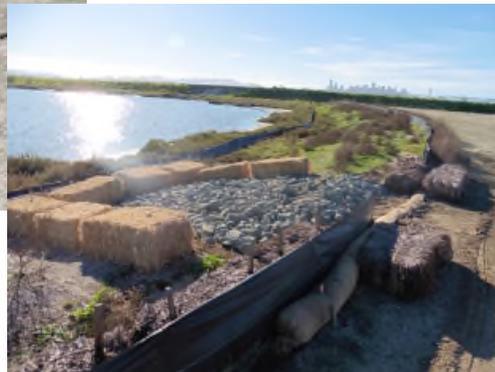
## Site 2 Erosion Repair

During the review of slide 6, Ms. Linz said the contractor is using straw for erosion control. Ms. Smith asked what kind of straw is being used, and noted that it may be introducing non-native seed into the site. Ms. Linz said she will look into the issue of non-native seed being present in straw and thanked Ms. Smith for bringing that to her attention.

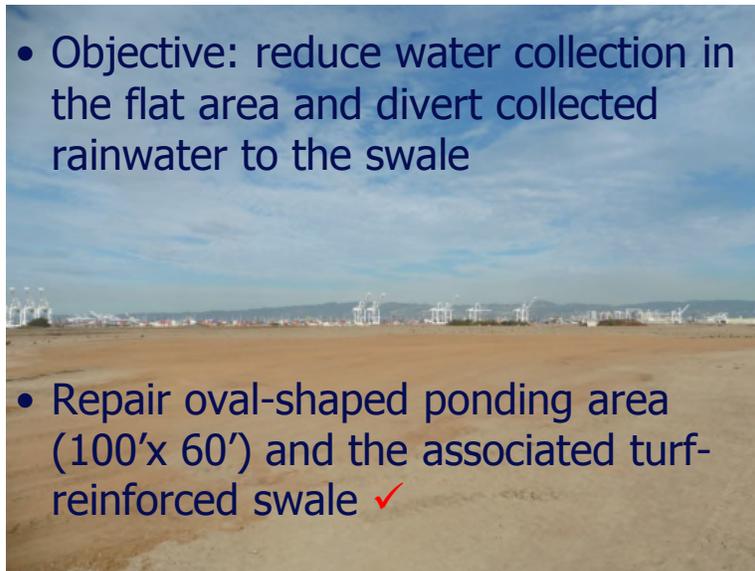
## Site 2 Cover Drainage Repair

During the review of slide 8 Ms. Linz discussed the swale that was built at Site 2 to prevent water collection. Ms. Smith asked why puddling needs to be prevented at Site 2, and noted there is a puddle at Site 1. Mr. McGinnis said the O&M procedures for the cover allow only minimal ponding.

- Objective: reduce water collection in the flat area and divert collected rainwater to the swale

- Repair oval-shaped ponding area (100'x 60') and the associated turf-reinforced swale ✓

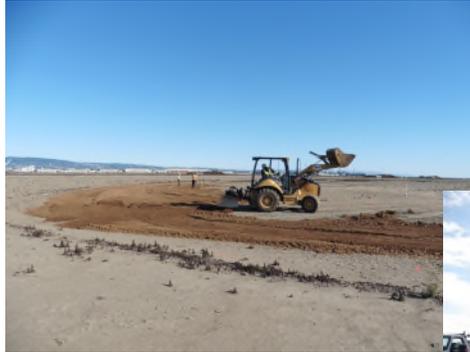
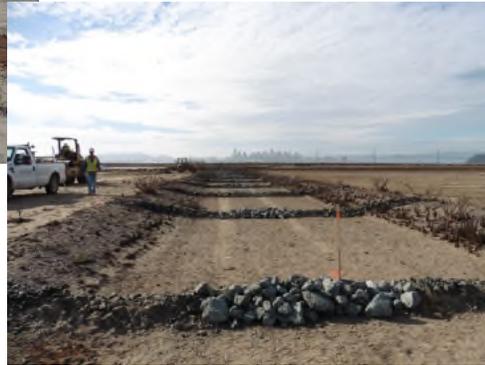
## Site 2 Drainage Repair

Ms. Linz showed photographs of the Site 2 drainage repair on slide 9. The bottom photograph is taken from the top of the swale, and, though it is difficult to tell, the drainage flows west towards San Francisco.

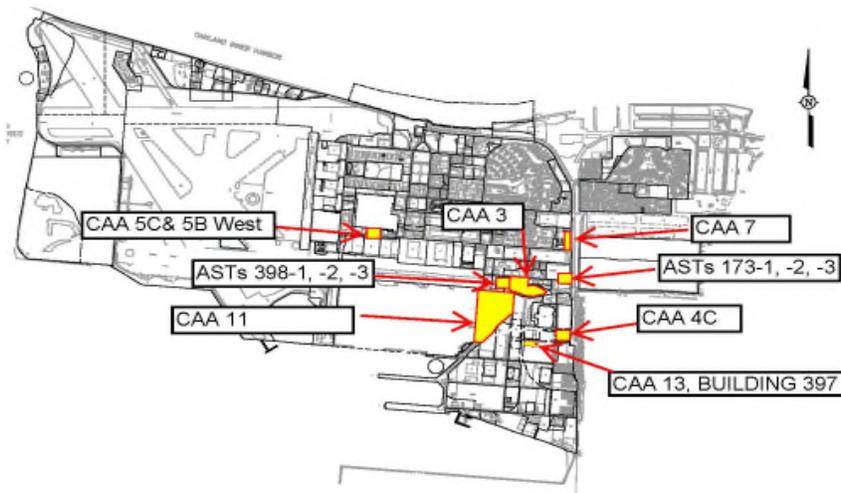
## Petroleum Sites with Current Actions

During the review of slide 4, Mr. McGinnis discussed the map showing the petroleum sites with current activities. He noted ASTs 398 and 173 are not part of this presentation, and added that they are part of the City’s Site A redevelopment area. Ms. Smith asked if those ASTs are located near the gas station; Mr. McGinnis said they are close to the base entrance, near the realty office.

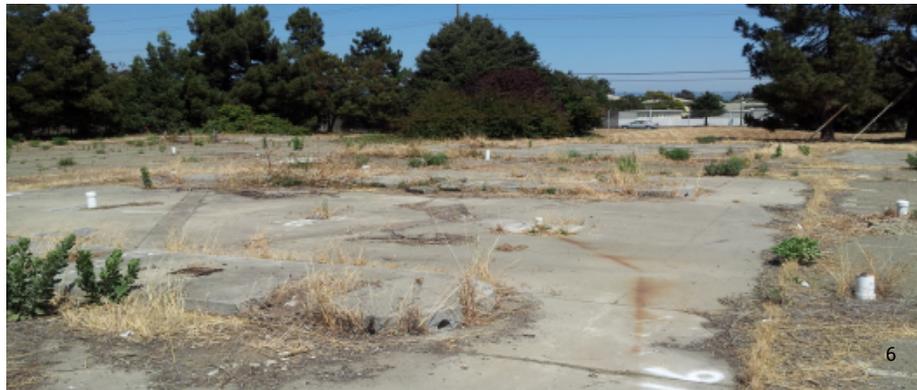
### Corrective Action Area 4C (IR Site 22)

During the review of slide 6, Mr. Torrey asked if CAA 4C is near the soccer field; Mr. McGinnis confirmed that it is. Mr. McGinnis said the white pipes visible in the photograph are part of the in-situ bioremediation (ISB) treatment system. Ms. Smith asked Mr. McGinnis why this site has been so persistent when ISB worked well elsewhere. Mr. McGinnis said the sites being addressed by ISB are not heterogeneous. One site may be original land while another is fill, and a geologic difference can mean the ISB processes underground work differently. Mr. McGinnis said CAA 4C began with in-situ chemical oxidation (ISCO) before the treatment transitioned to ISB. ISCO can rapidly treat petroleum contaminants, but because it relies on direct contact between the reagents and the contaminants, it may not reach the nooks and crannies of the underground environment, so it is followed with ISB.

- Former gas station and car wash (1971-1980)
- All facilities removed (1994-1995)
- Remedial action for gasoline release in 1999, 2004-2006, and 2013-2014.
- Insitu Chemical Oxidation (ISCO) combined with Insitu Bioremediation (ISB)

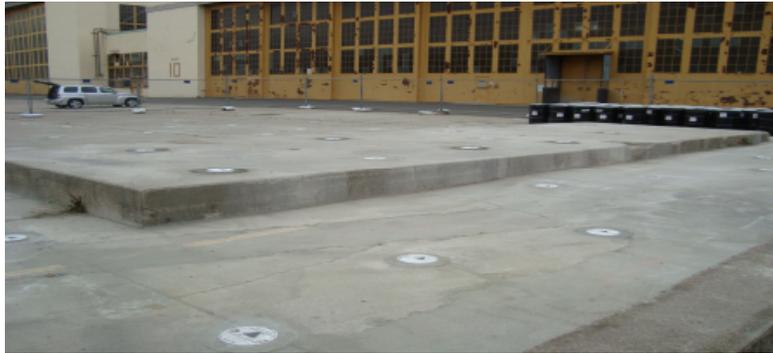
## Corrective Action Areas 5B West and 5C (IR Sites 5 and 10)

During the review of slide 7 Ms. Smith asked how long ago pump and treat remediation was conducted at CAA 5B. Mr. McGinnis said the cleanup could better be characterized as pump and haul, and that phase of remediation took place approximately two years ago. The heart of the plume is now gone, and the Navy continues to work on the edges. The path forward for this site will include a corrective action plan.

- CAA5B West adjacent to former wastewater treatment plant (1973-95)
- 2011-2012 Free product removal, ISCO treatment
- CAA 5C adjacent Bldg 400 and in the vicinity of UST 400-1
- Samples collected during UST removal exceeded cleanup criteria
- Investigation in 2015 to evaluate current conditions and prepare a comprehensive Corrective Action Plan

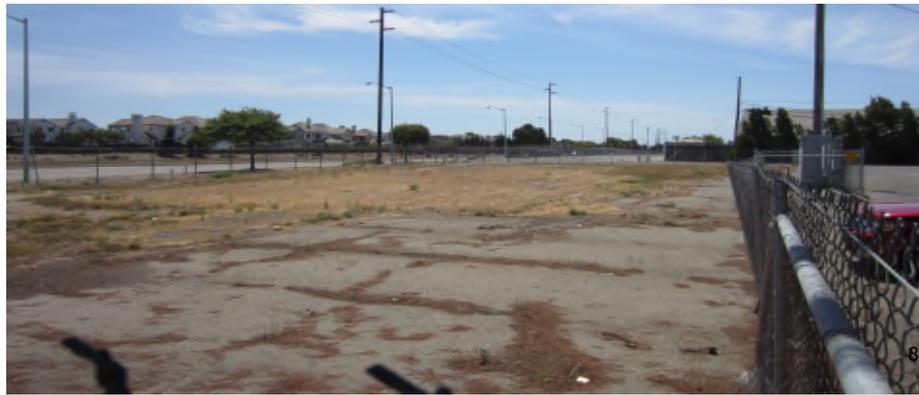
- Former gas station (1951-1997)
- Various remedial actions between 1996 and 2013.
- Ongoing Insitu Bioremediation to remove petroleum compounds in groundwater.

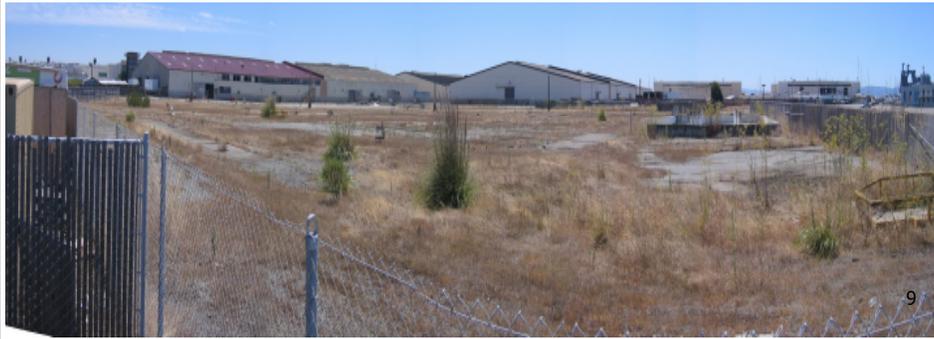
### Corrective Action Area 11 (IR Sites 11, 21, and 27)

During the review of slide 9, Mr. McGinnis explained that Area 37 is a tank farm designation; it is not related to Installation Restoration Site 27. Ms. Smith asked if the rail line in this area has been tested and if it is a possible source of petroleum contamination. Mr. McGinnis said the area has been tested; testing included both soil and groundwater. Mr. Bangert asked if a corrective action plan will be prepared for CAA 11, or if the Navy already has one. Mr. McGinnis said a new/updated corrective action plan is being prepared. Ms. Sullwold asked about the estimated closure date. Ms. Sabedra said the corrective action plan will determine the timeline to closure; however, it will not be a 10-15 year project. The Navy is hoping to transfer that land around 2020. Carol Gottstein (RAB member) asked if the developer will have to wait on that corrective action before beginning work. Mr. McGinnis said the developer would not necessarily have to wait for the corrective action to be completed; however, the Navy would like to have it done before transfer. Ms. Sullwold asked if this area is part of the Area B redevelopment, and Dr. Russell confirmed that it is.

- Building 14 and the "fuel tank farm" (Area 37)
- 45 petroleum features (USTs, ASTs, fuel lines, and misc.)
- Remedial Actions in 2003-2006
- Investigation in 2015 to evaluate current conditions and prepare a comprehensive Corrective Action Plan
- Numerous features can be closed without further remediation

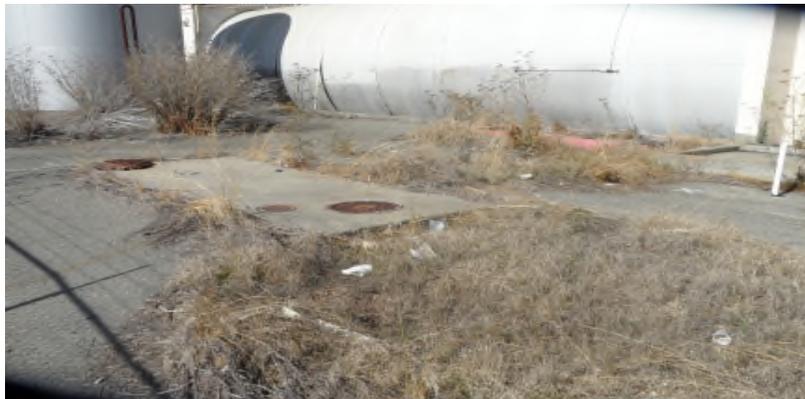
### Corrective Action Area 13 Building 397 (Engine Test Cell)

Ms. Smith asked what Building 397 was used for. Dr. Russell said it was an engine test facility. A valve left open over a weekend resulted in a large petroleum release. He added that the Navy has removed most of the spill and just has minor work to do now. Dr. Russell said the Navy prioritized work at sites with large releases or imminent threats to the environment. Now they are addressing the smaller sites to get them all closed.

- Jet fuel release and excavation of impacted soil in 1991
- Remediation Action 2003 to 2006
- Investigation in 2011 identified residual contamination
- Investigation in 2015 to evaluate current conditions and prepare a comprehensive Corrective Action Plan
