PROJECT NOTE NO. PN-0145-66 CLE-C01-01F145-I2-0054	PROJECT NO. 01-F145-H6
--	---------------------------

CONFIRMATION OF:	CONFERENCE X	DATE HELD	17 December 1992
	TELECOM	DATE ISSUED	24 December 1992
	OTHER	RECORDED BY	Charles Flagg/CH2M HILL
		PLACE	MCAS El Toro
SUBJECT	Marine Corps Air Station El Toro Remedial Investigation/Feasibility Study (RI/FS) Technical Review Committee Meeting Minutes

TITLE: RI/FS TECH REVIEW COMMITTEE MEETING MINUTES

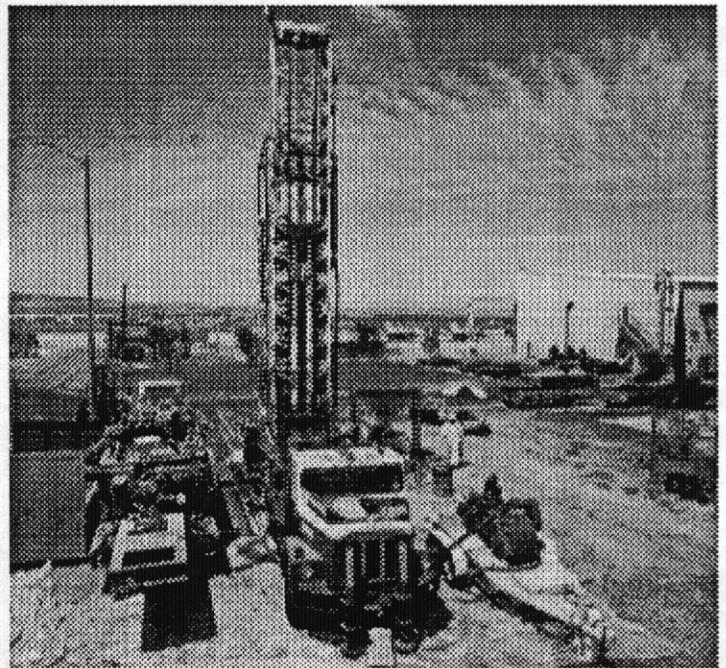
One of nine drilling rigs used to install more than 100 groundwater monitoring wells on and adjacent to MCAS El Toro.
