## Naval Facilities Engineering Command

# Abstract of an Accident

99-13

**Accident Type:**                **Electrocution**  
**Injury:**                        **Fatality**  
**Type of Work:**               **Demolition in Electrical Substation**  
**Equipment Involved:**      **Air Powered Chipping Gun**

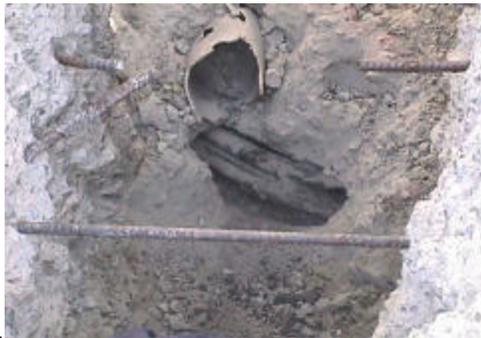
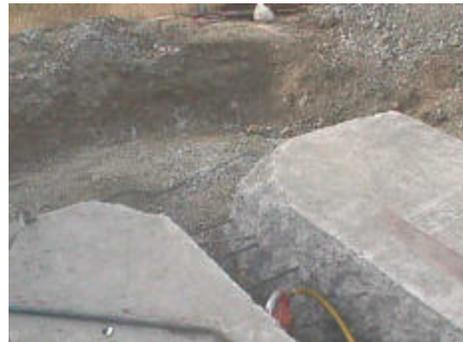
A contractor laborer received an electric shock when the air powered chipping gun he was using penetrated an unidentified live buried 4.16kV cable. Intrusive demolition activities were started under an electrical outage the previous workday (Friday). Worker was clearing obstructions around an inactive conduit that crossed above the live line to allow for planned electrical work accessibility. The Substation was energized at the time of accident.

Unauthorized intrusive activity without an electrical outage in place. Scanning area with electromagnetic or sonic equipment not performed. Non-electrical qualified workers working without qualified supervision on site.

- Accident prevention plan, general task related job hazard analyses, and contract specifications applicable to positive utilities identification and isolation not followed. The site-specific, task-specific JHA was not inclusive as proposed demolition and intrusive activities were not addressed.
- Cable was not located to scale on as-built electrical site plan drawing used by subcontractor as a utility locator.
- No site-specific safety training was provided to non-electrical qualified workers prior to intrusive activities. Worker may have assumed no harm would come from the additional chipping in substation.

- Strict adherence to USACE EM 385-1-1, Section 11.A.02 and 11.J and OSHA 29 CFR 1926.416 and 1926.957 and contract safety requirements for utility identification and coordination of power outages with the appropriate base personnel and ROICC by contractor is critical.
- Each intrusive work activity should be treated as a single event and on its own merit. No work task is too insignificant not to ensure that all required safety precautions are in place.
- As-built's accuracy is questionable, inclusion of field changes not guaranteed. Underground cables shown as schematic connections between two points, not actual physical locations of installed conduits.
- Training as required by USACE EM 385-1-1, Section 01.B.02 and 29 CFR 1926.21 (b)(2) should be initiated prior to field activities to increase worker safety awareness.
