Final
Site Management Plan
Fiscal Year 2023 Amendment

Atlantic Fleet Weapons Training Area – Vieques
Vieques, Puerto Rico

December 2022

Prepared for NAVFAC Atlantic
by CH2M HILL, Inc.
Virginia Beach, Virginia
Contract N62470-16-D-9000
CTO 0004

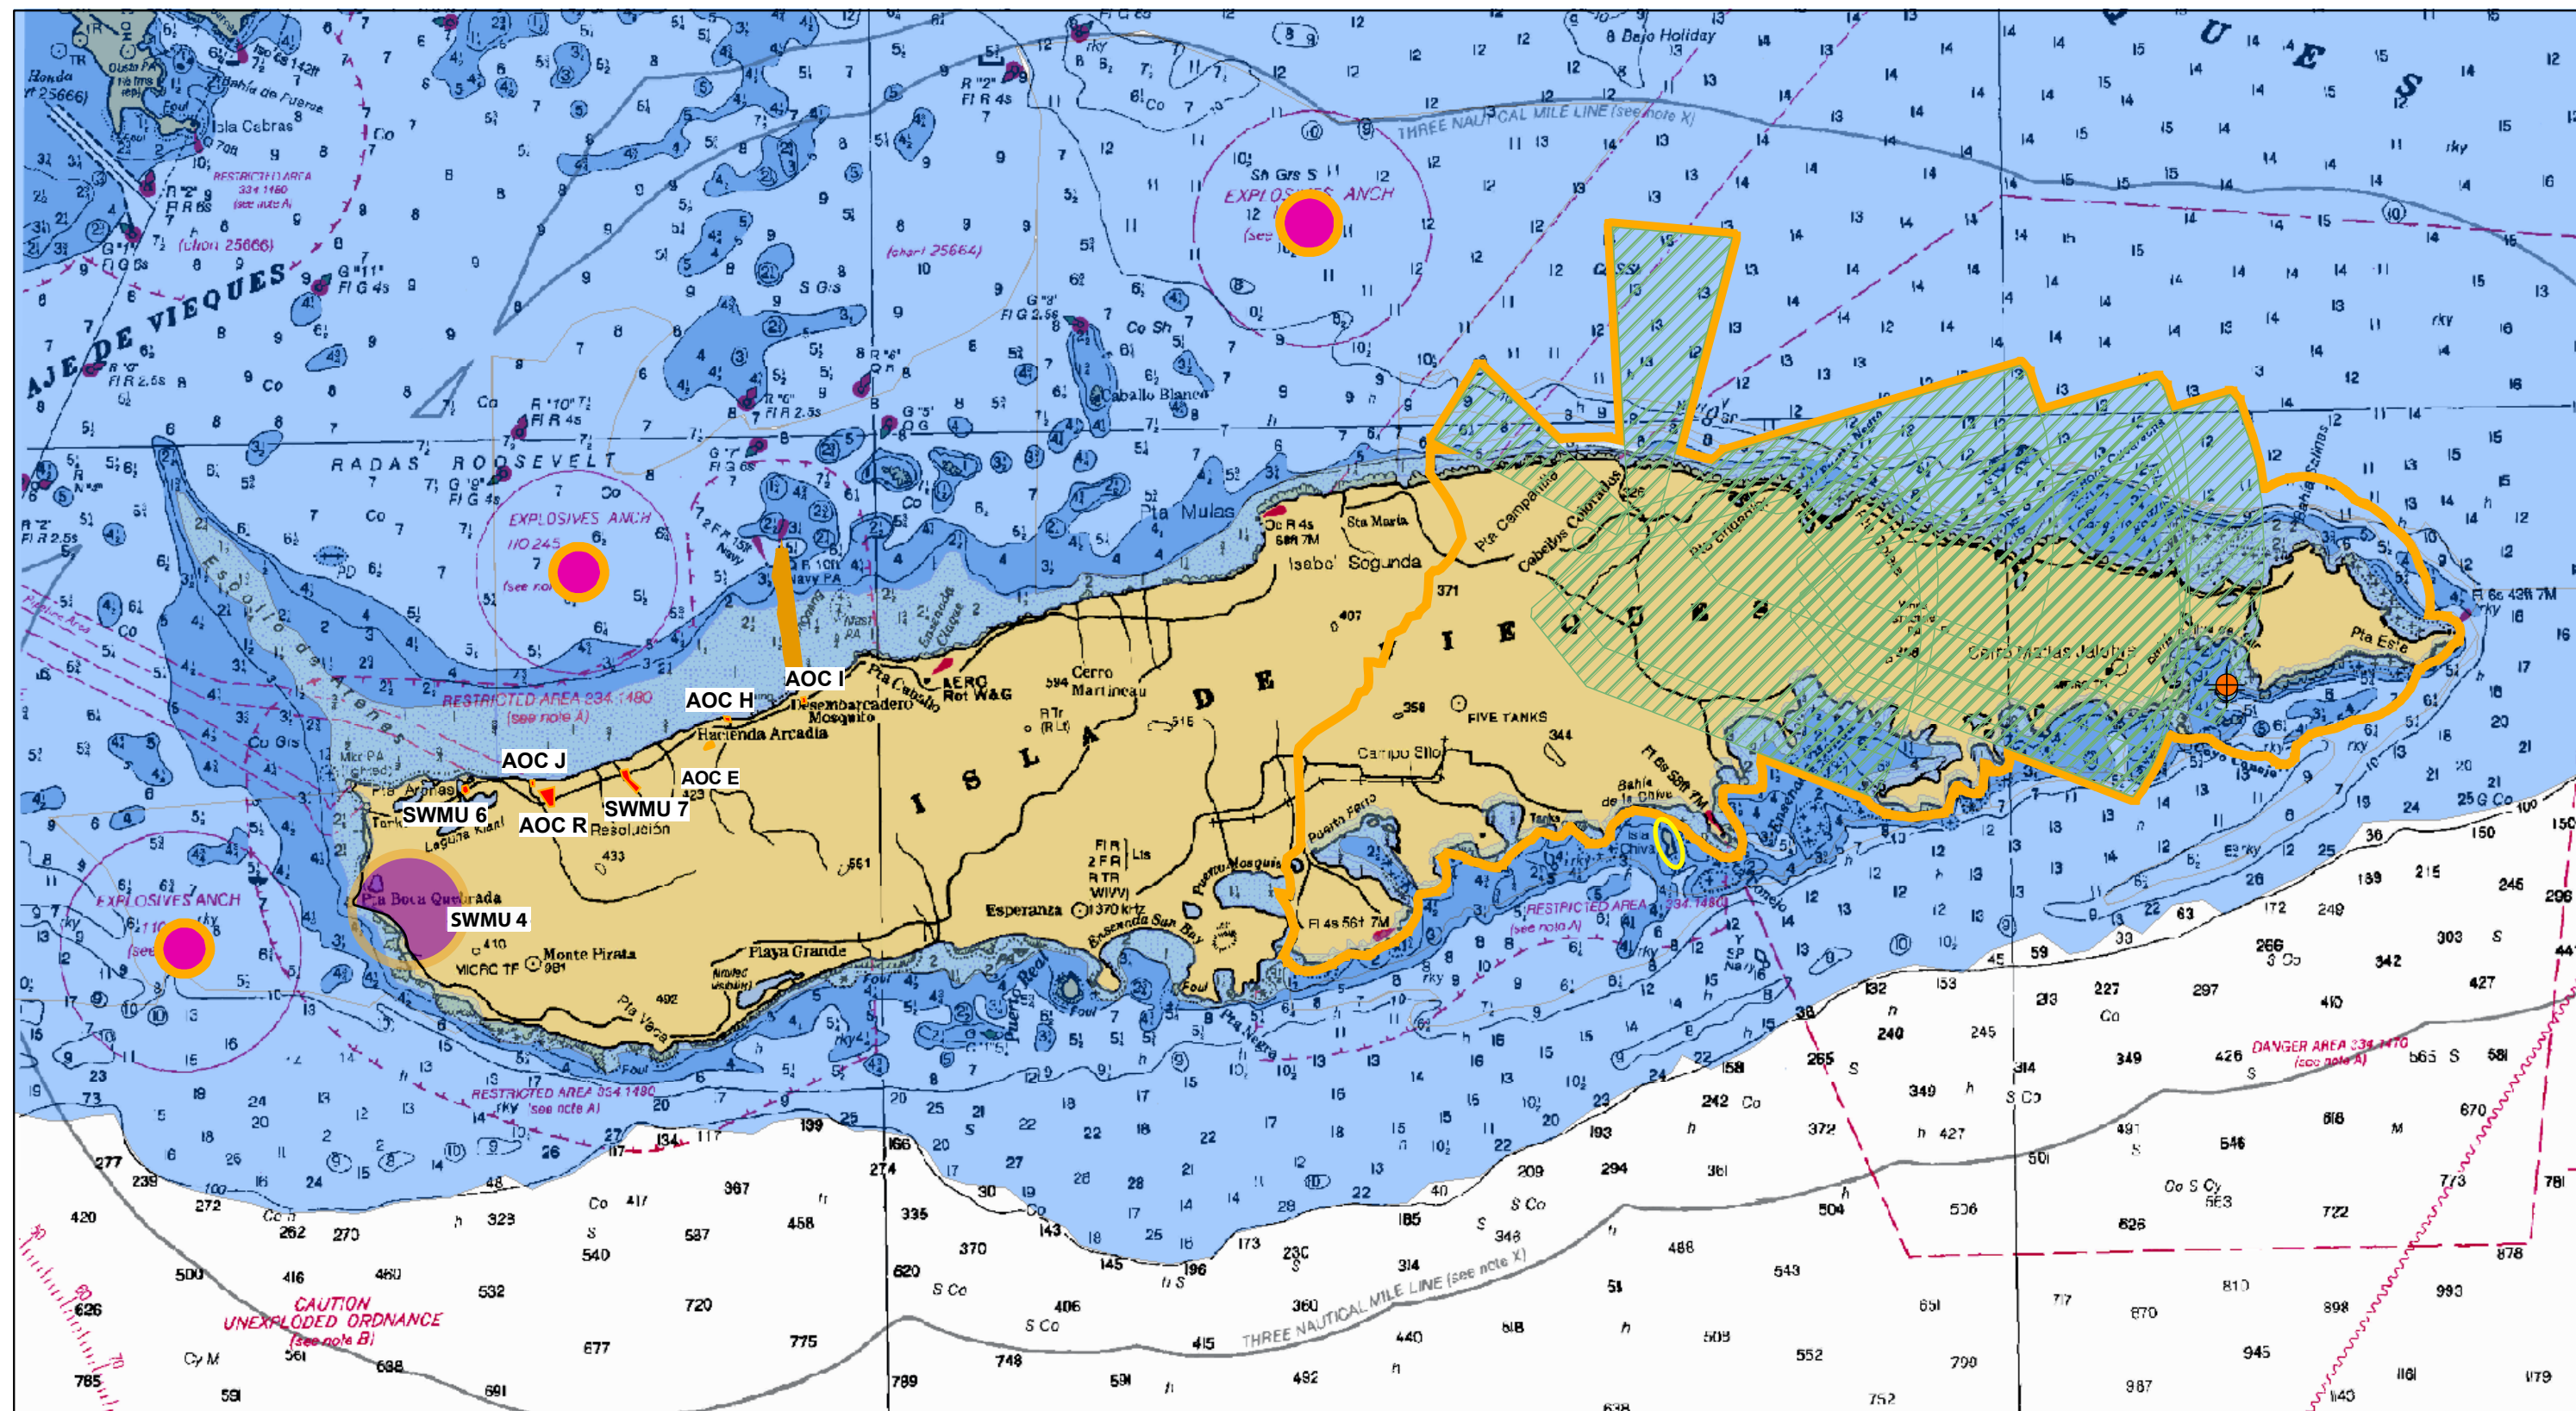
FIGURE 1-2
Vieques Sites Addressed Under CERCLA
Site Management Plan, FY2023
Vieques, Puerto Rico

- Agreed Areas of NPL Site
- Anchorage Location Boundary
- Western Vieques Installation Restoration Sites
- SWMU 4 (Former OB/OD Site)
- Artillery Safety Fan
- Additional Area to be Addressed under CERCLA

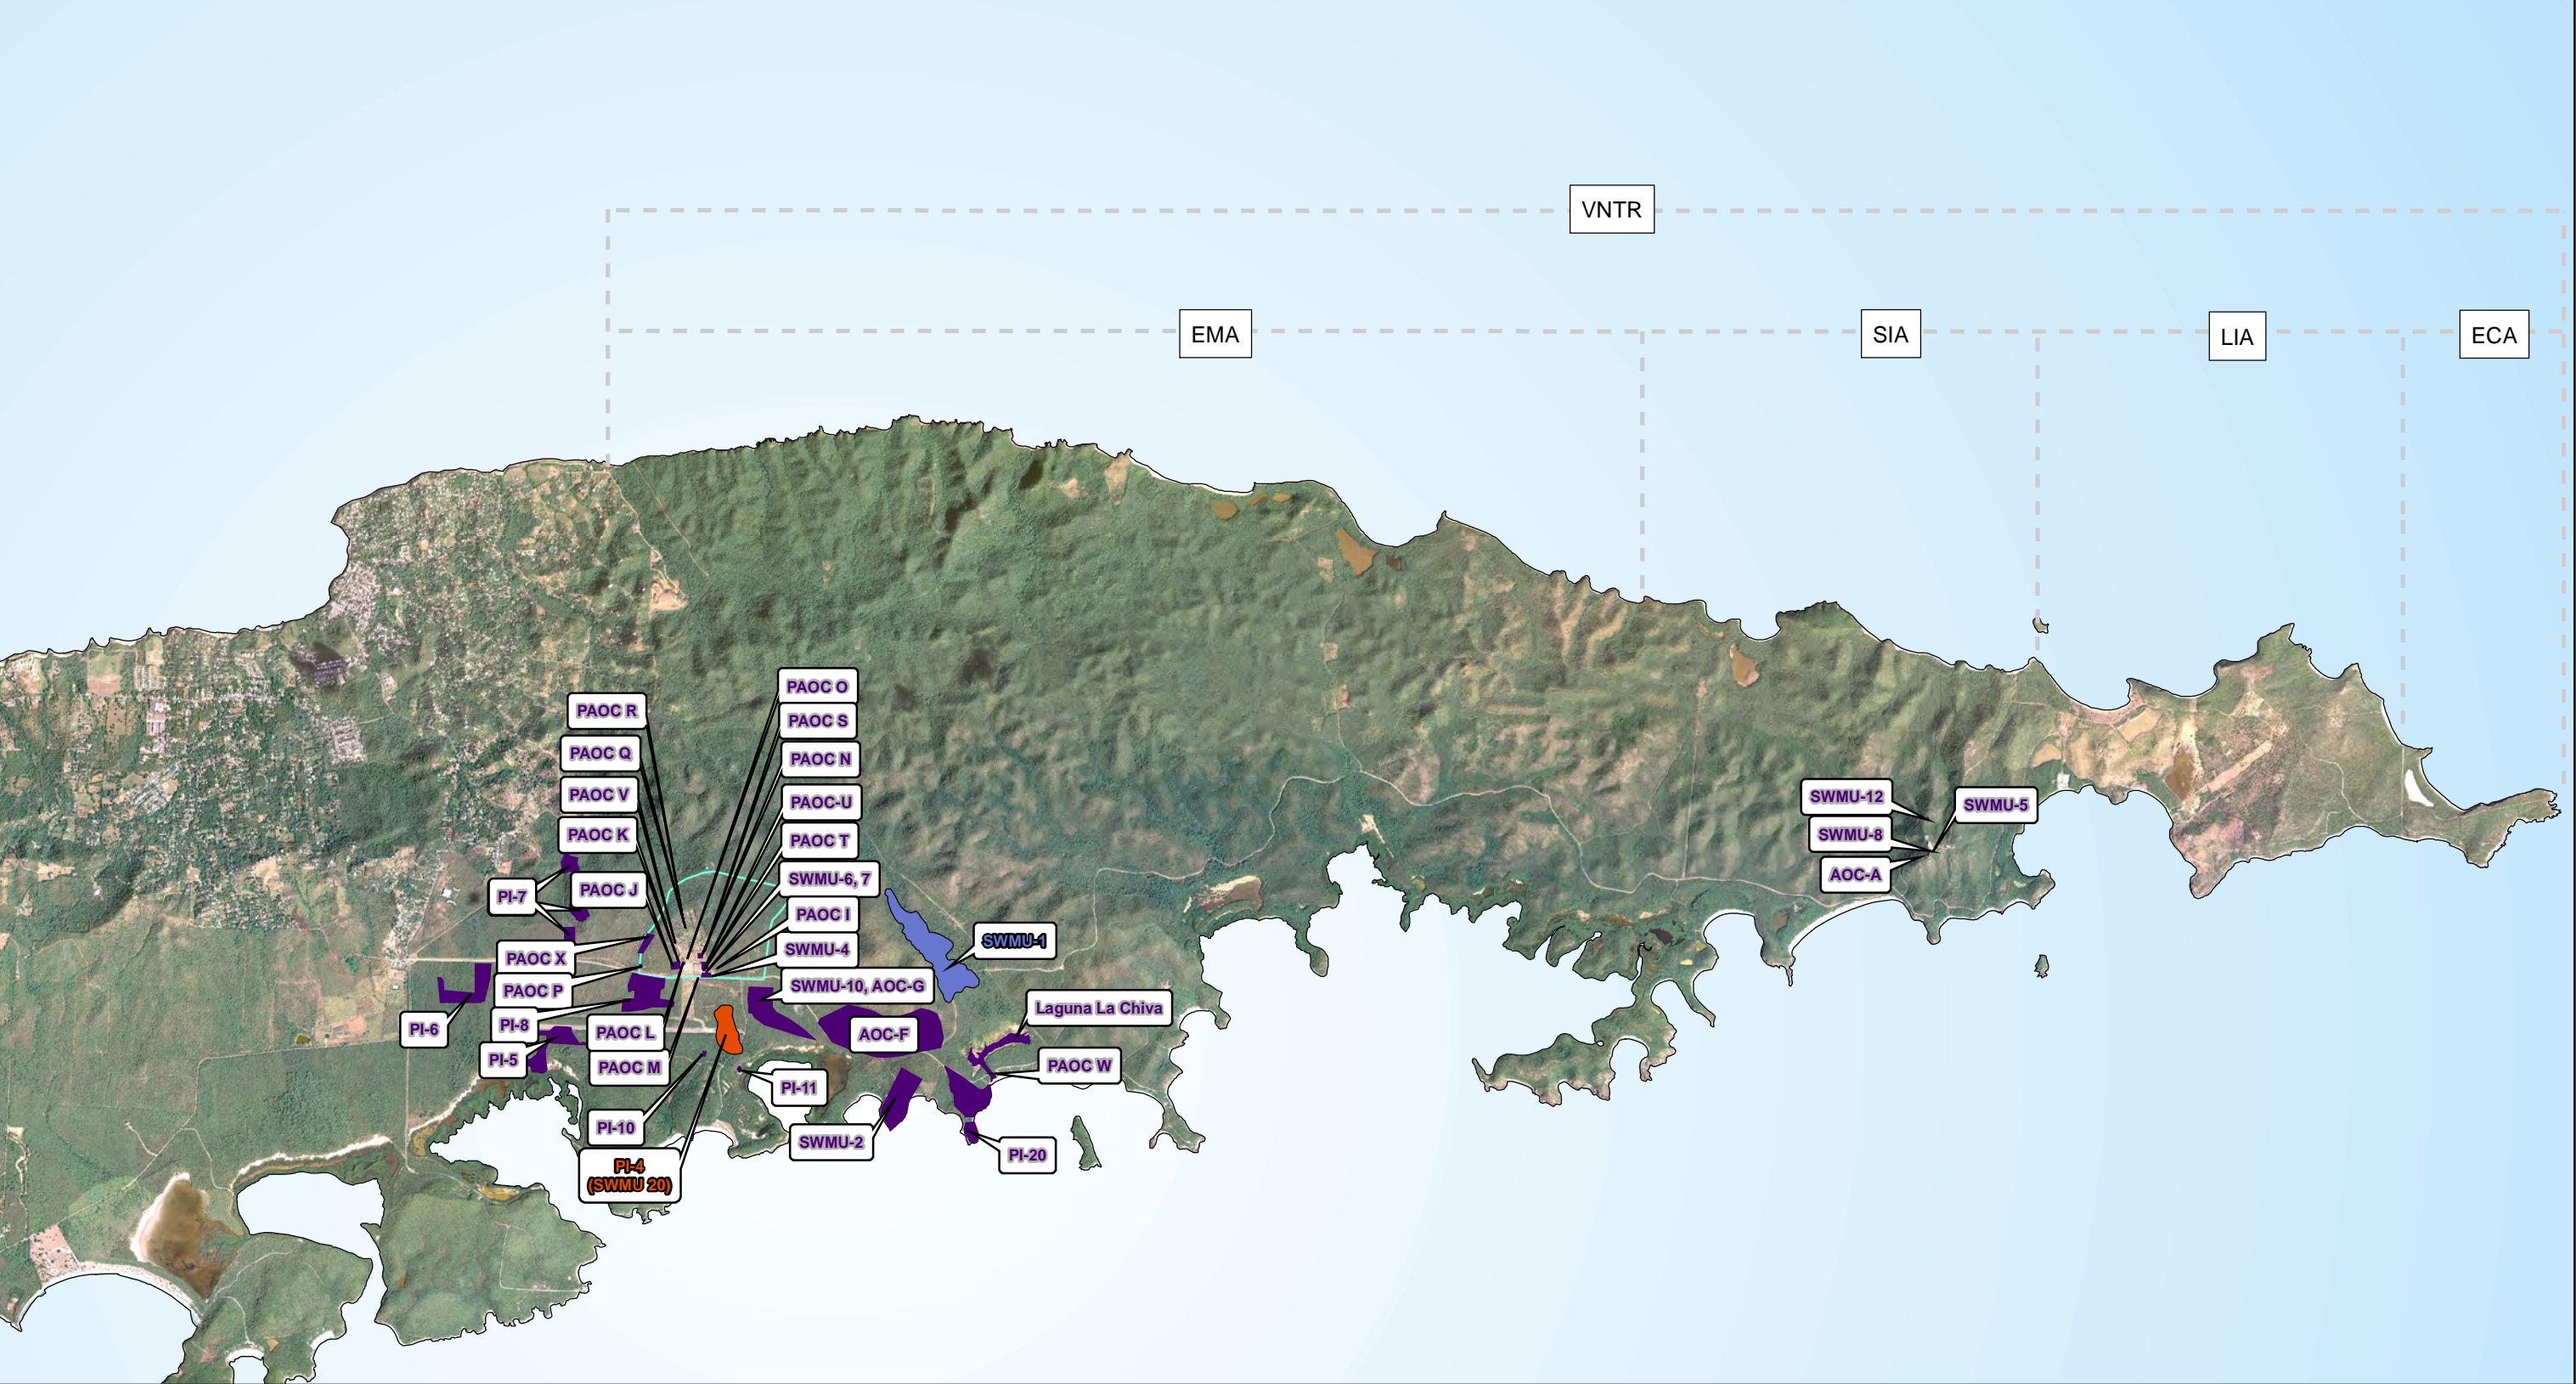
Figure 2-1
East Vieques Installation Restoration Sites
Site Management Plan, FY 2023
Vieques, Puerto Rico

Legend
■ Sites - No Action/No Further Action Decision Document
■ Sites - Feasibility Study
■ Sites - Remedial Action/Long-term Monitoring
■ Camp Garcia

According to the Navy Assessment and Control of Installation Pollutants (NACIP) Initial Assessment Study (IAS) Report, this SWMU was in operation from approximately 1954 to 1978 (Greenleaf, 1984). While this SWMU was operational, it was an unlined landfill that was used to dispose of paper, corrugated containers, cans and food packaging material, rags, scrap metal, and yard waste. Municipal waste from both Camp Garcia and other areas of the VNTR was handled here. Approximately 1,800 to 3,120 tons of wastes were reportedly disposed of in the SWMU 1 landfill, as noted in the IAS (Greenleaf, 1984). The SWMU 1 landfill, the Camp Garcia area, and other IRP sites in the former VNTR are shown in Figure 2-1.

During development of the Description of Current Conditions Report (CH2M, 2001b) and the Environmental Baseline Survey (EBS) (NAVFAC, 2003c), several potential IRP sites were identified based on the review of historical aerial photographs and facility records. This subsection summarizes the status of the 23 photo-identified (PI) and 24 Potential Area of Concern (PAOC) sites that were identified, and in most cases, investigated and determined to require No Action or NFA under CERCLA. Additional detail for the one site (SWMU 20 [formerly PI 4]) that is currently under investigation is provided herein. Site-specific detail for the remainder of the sites, which were determined to require No Action or NFA under CERCLA, is provided in Appendix B1 and past SMPs. The locations of the PI and PAOC sites that are IRP sites are shown on Figure 2-1.

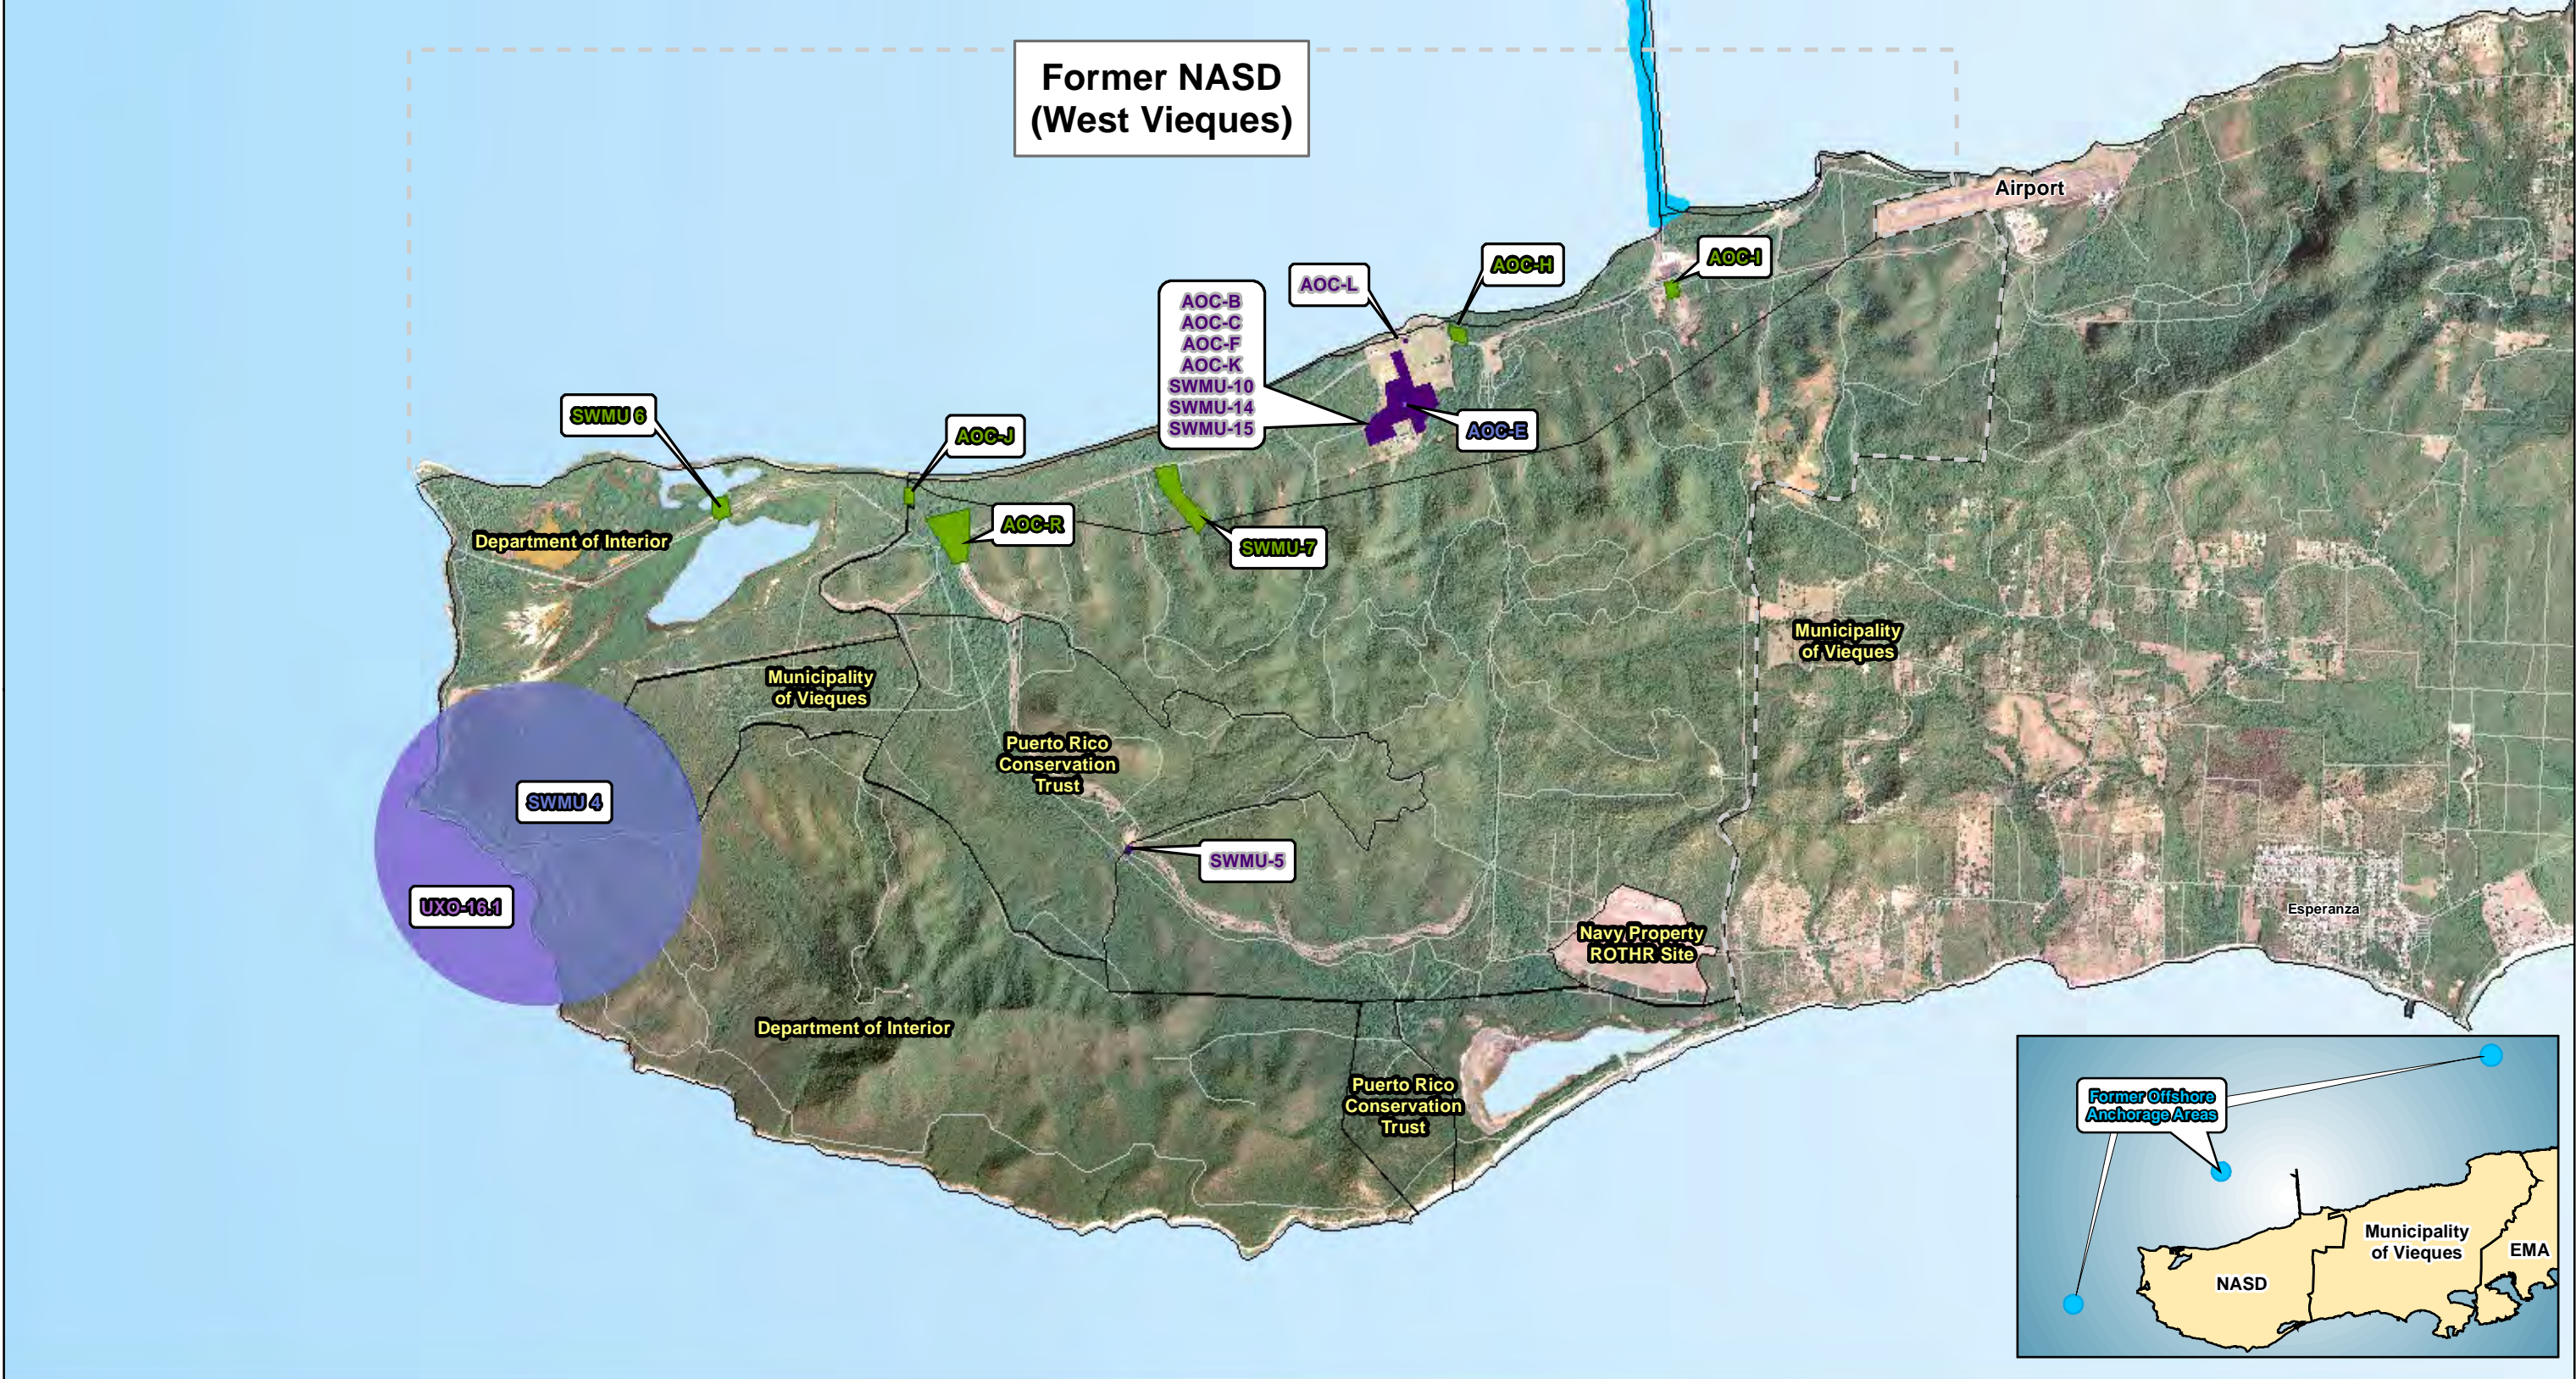
Figure 2-4
Status of Vieques Cleanup Program Sites Under CERCLA
Site Management Plan, FY2023
Vieques, Puerto Rico

73 Total Sites

- 51 sites completed with no further action
- 7 sites completed with long-term monitoring
- 15 sites in RI, FS, PRAP, or ROD phase
