# Restoration Advisory Board Meeting Minutes Naval Research Laboratory – Chesapeake Bay Detachment

MEETING DATE: May 18, 2021

# **Site 10 (Fire Testing Area) Site Inspection Update**

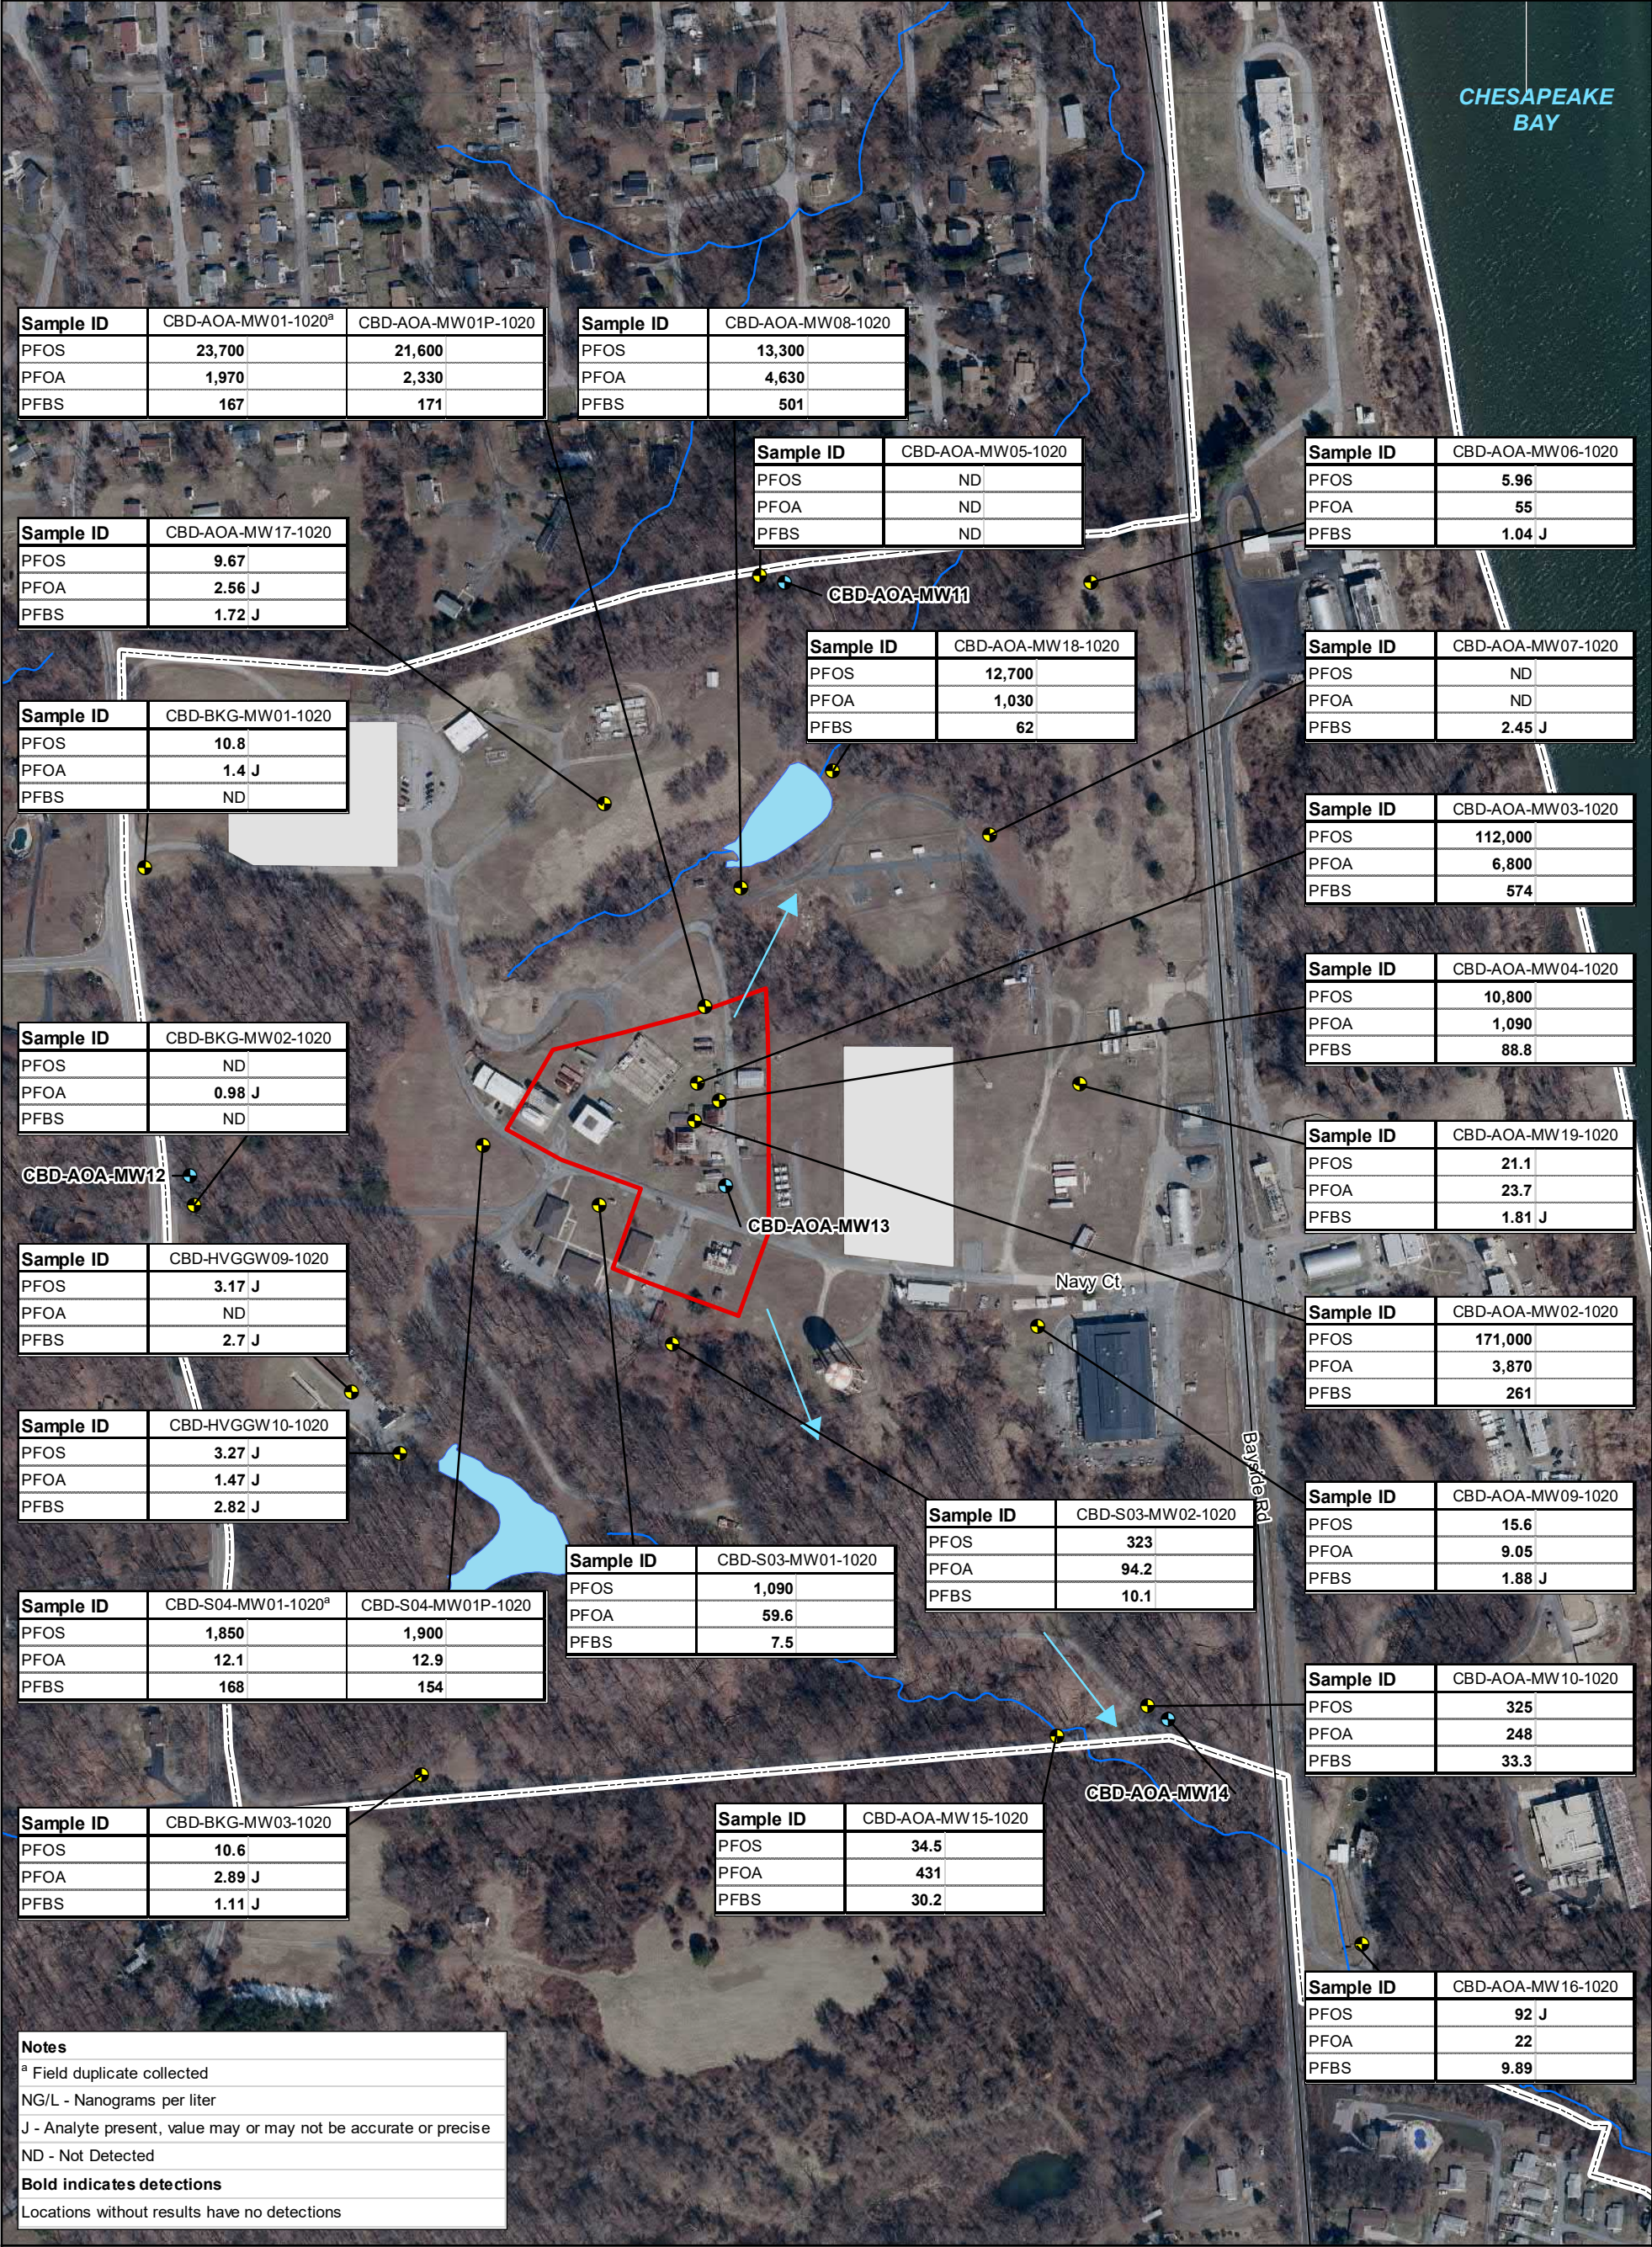
- Subsurface soil was generally collected between 6 and 16 ft below ground surface in areas around fire testing structures that could represent an area of release.
- Generally, PFAS concentrations were higher in subsurface soil than surface soil suggesting downward migration through soil
- Highest concentrations were found in the area of the old burn pad which is the primary source area based on the historical use of the site.

Subsurface soil samples were also collected from the same soil boring locations which surface soil samples were collected; subsurface soil samples were collected from depths of six to 16 feet bgs. In general, PFAS concentrations in the subsurface soil samples were higher than those detected in the surface soil samples, suggesting downward migration of PFAS consistent with the conceptual site model where there were releases from the testing pads. The highest PFAS concentrations were detected in subsurface soil sample SB09 at one to three feet bgs (PFOS at 7,150 ng/g) and six to eight feet bgs (PFOS at 7,950 ng/g), in the vicinity of the old testing pad. There were no PFAS detected in subsurface soil in samples collected south of Navy Court Road.

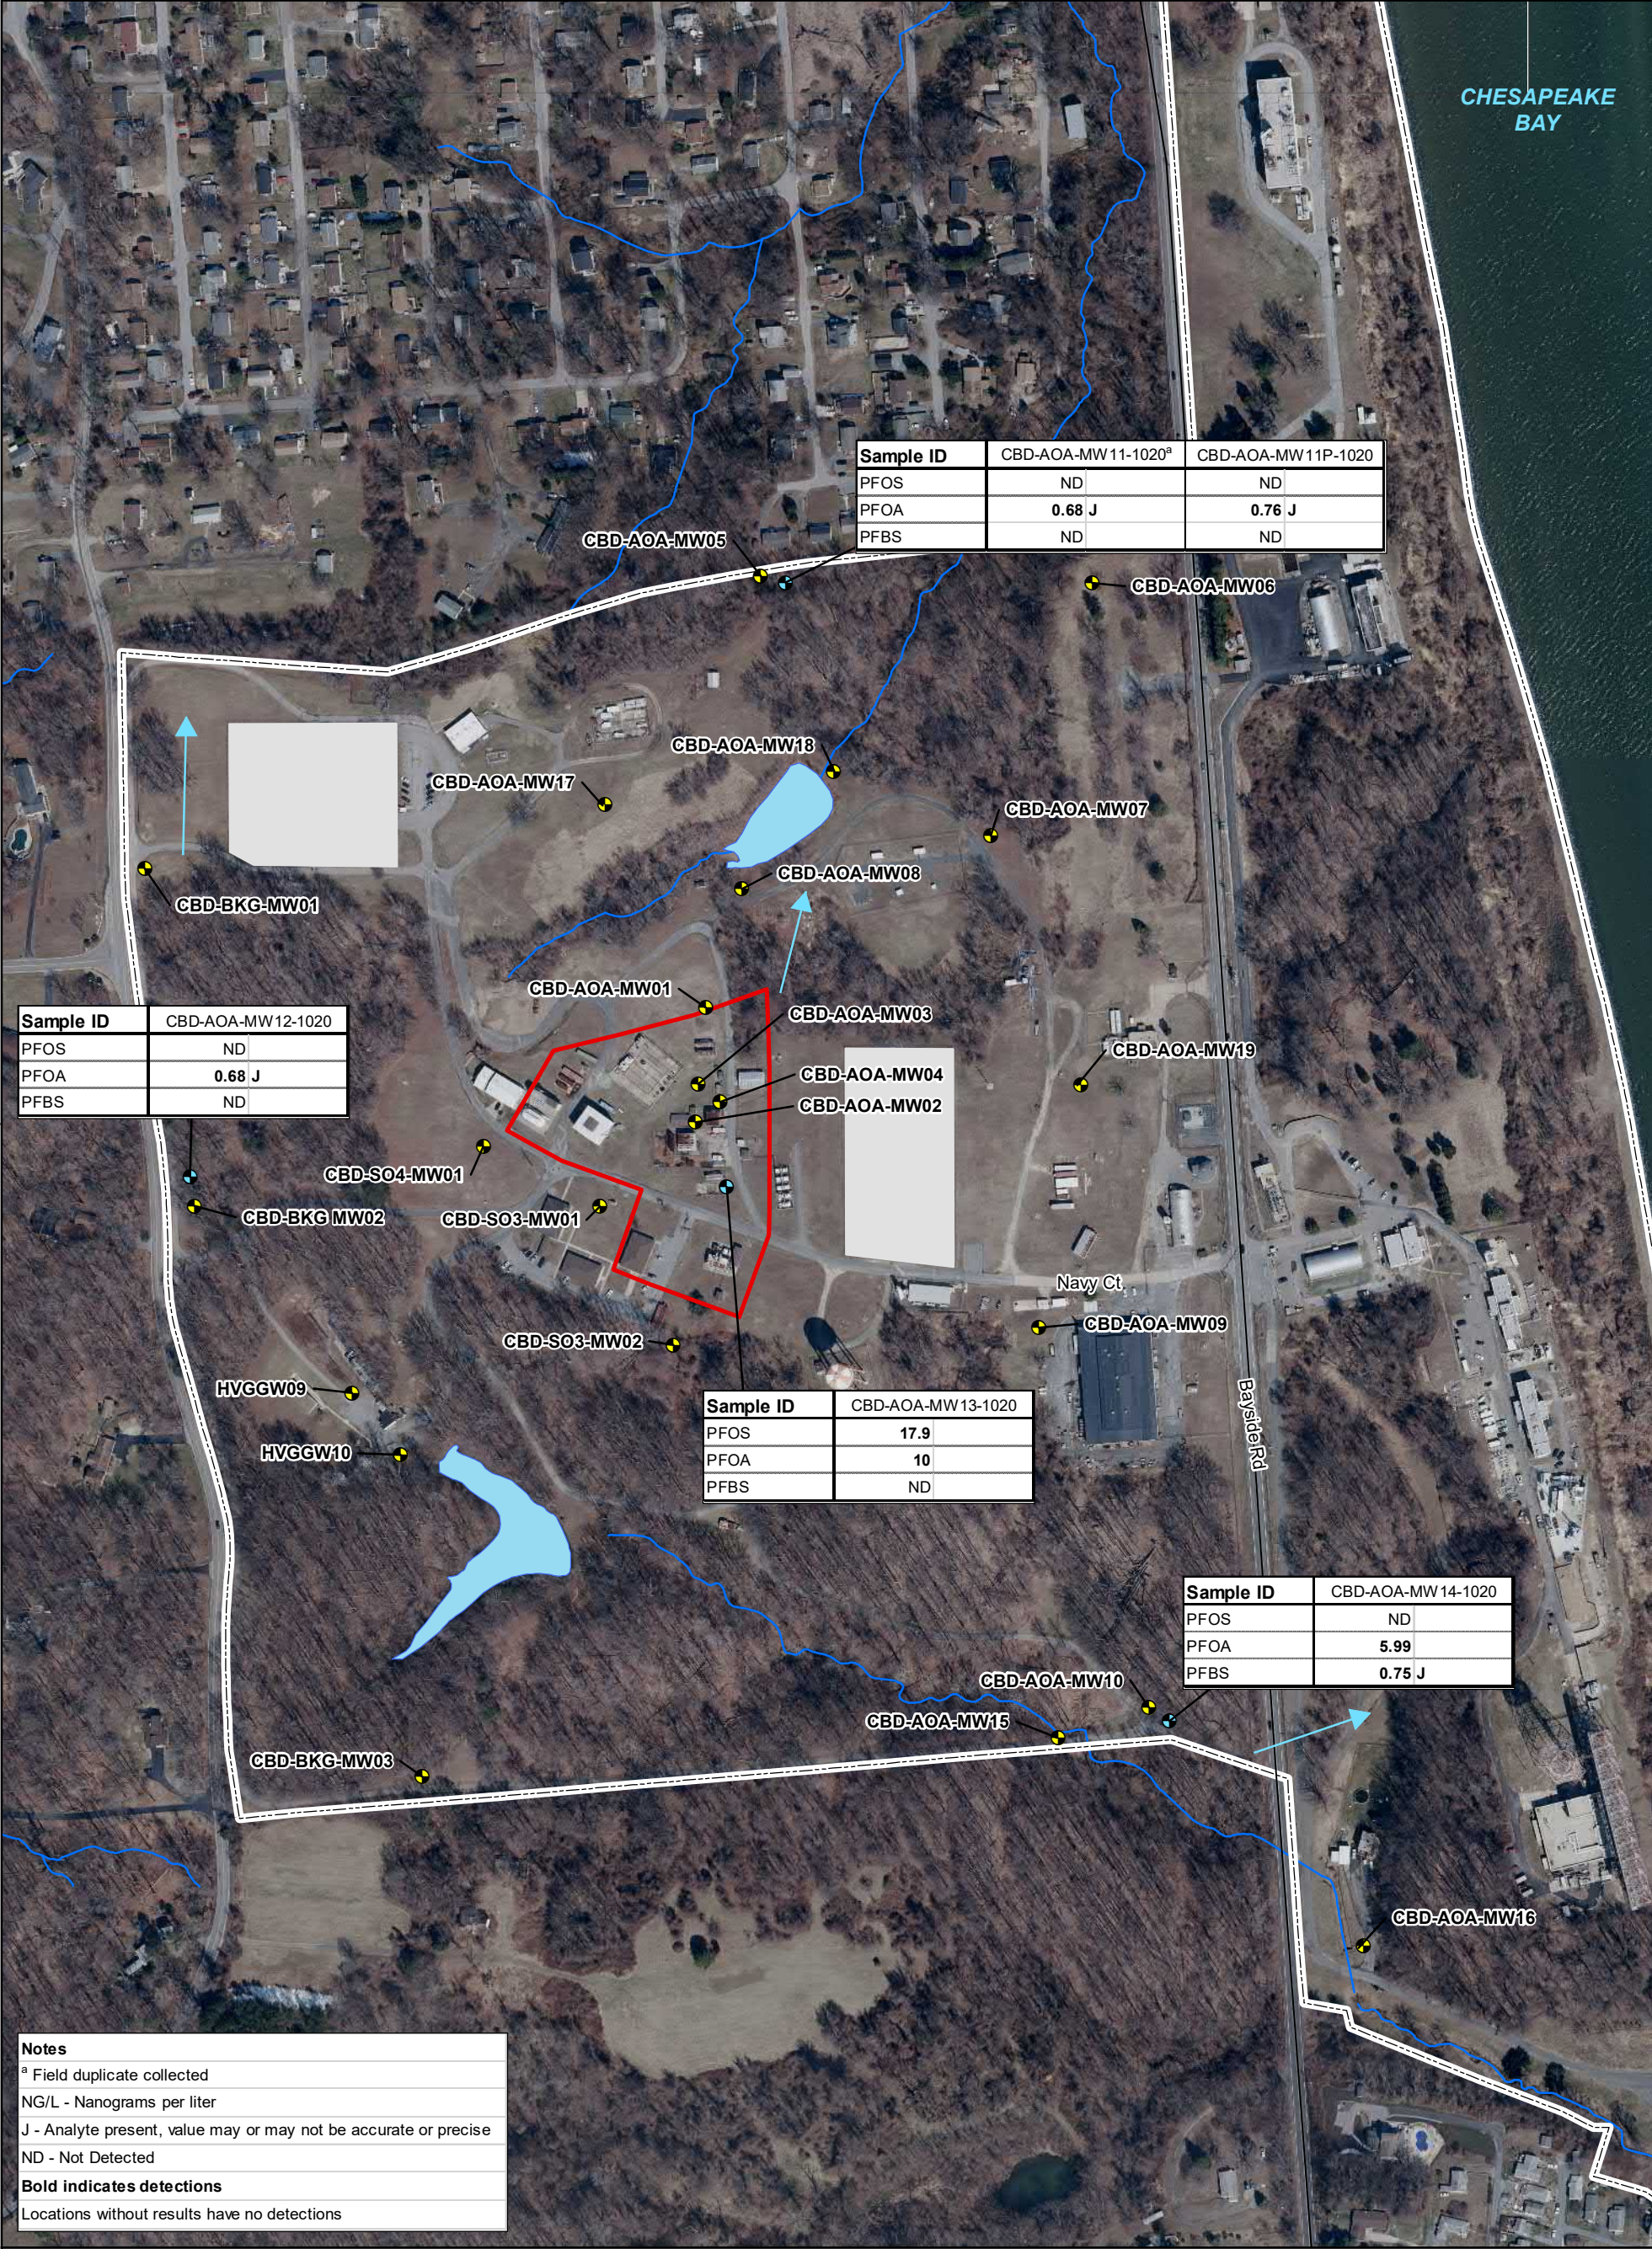
- Shallow groundwater was collected from wells screened generally between 20-30 ft below ground surface
- Highest concentrations were found in the area of the old burn pad which is the primary source area based on the historical use of the site.
- PFAS detection pattern indicates that PFAS are migrating along groundwater flow direction to the northeast and southeast in shallow groundwater

Regarding surficial groundwater, there were 23 monitoring wells sampled, that were generally screened between 20 to 30 feet bgs. The highest concentration of PFAS was detected in monitoring well MW02 (PFOS at 171,000 ng/L), (“equivalent to ppt – parts per trillion”) and the pattern of PFAS detected in groundwater indicates it’s migrating along the direction of groundwater flow to the northeast, as well as to the southeast. For the deep aquifer (Piney Point aquifer), there are four deep monitoring wells on base, generally screened between 200 to 300 feet bgs. Detections of PFAS in these deeper monitoring wells were fairly low, suggesting minimal transmission from the sources coming from the old fire test pad. The highest concentration of PFAS in the deeper aquifer was detected at MW13 (PFOS at 17.9 ng/L).
