Contractor Near Miss Report

Potential Electrical Shock

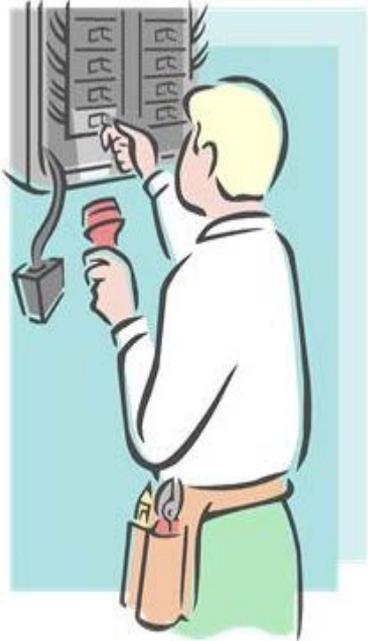
Activity: A public works electrician assigned to disconnect power to a base support contractor's trailer arrived at worksite and found the a sub-contractor had started to disconnect power to the trailer without the PW electrician first disconnecting the base power to the trailer's live supply circuits. The SPAR for the contract stopped the sub-contractor from working to allow the PW electrician to disconnect the base power prior to work continuing. Once the PW electrician had finished disconnecting the base power and the SPAR briefed the contractors regarding the requirements for working live circuits, the contractor was permitted to continuing complete their work.

- Working on a live electrical circuit without proper processes or PPE
- Insufficient prime contractor oversight
- Insufficient work planning and communication to involved stakeholders

- Work requiring actions of a blended crew – government and contractor – must be well coordinated and well communicated to all involved parties
- Work on energize circuits requires careful planning, approval, processes and PPE to ensure the work is performed safely
