Contractor Fatality

Motor Vehicle - Struck by Passenger Van

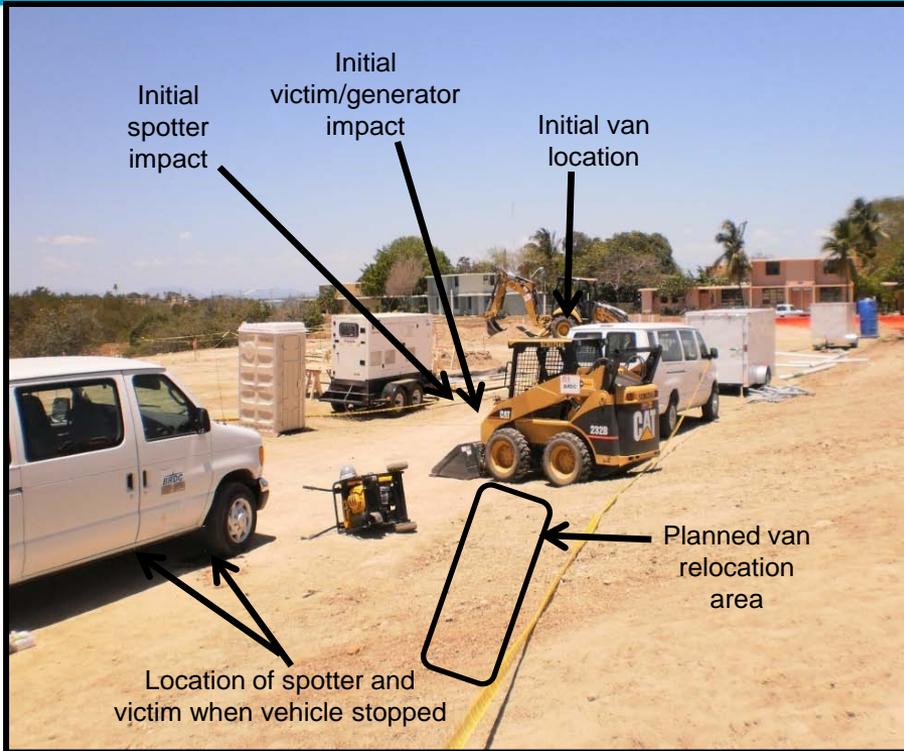
Activity: While working at a housing MILCON construction site, a carpenter was asked to relocate a van to another location at the job site. Once at the new parking location, a worker approached the driver and asked him to move again, because he was blocking an access way. This worker instructed the driver that he would be his spotter. After the spotter was in place behind the vehicle, the driver began moving in reverse. The spotter then noticed another worker moving a portable generator toward a bobcat, that was in his path of travel. He instructed the driver to stop the vehicle. The spotter then went to assist in moving the generator. The driver lost visual contact with his spotter, however continued to move slowly, in reverse, without direction from the spotter. At this point, others on the jobsite began yelling for him to stop. The driver had his foot on both the brake and accelerator, and during the commotion, he simultaneously stepped on the brake and the accelerator. This action propelled the van towards the bobcat, striking the spotter and the worker moving the generator, trapping and dragging both men underneath the van for approximately 40', resulting in fatal injuries to the worker moving the generator and extensive leg injury to the spotter.

- Lack of vehicle control by the driver
- Vehicles being parked and moved in a congested work area
- Improper use of vehicle pedals

- Management of change not recognized. Failure to develop/revise site plan for parking and material receipt.
- Vehicle movement without visual or direction from spotter

- Drivers need to understand the role and importance of the spotter (not to move without direction of the spotter)
- Workers on-site need to be fully mindful of all activity around them, not limited to construction and equipment
