Crane accident: No injuries and there does not appear to be any damage to government property. Job on safety stand down. Crane removed and re certified. Operator removed. Lesson: Operator did not set the brake allowing boom to drift into power line.

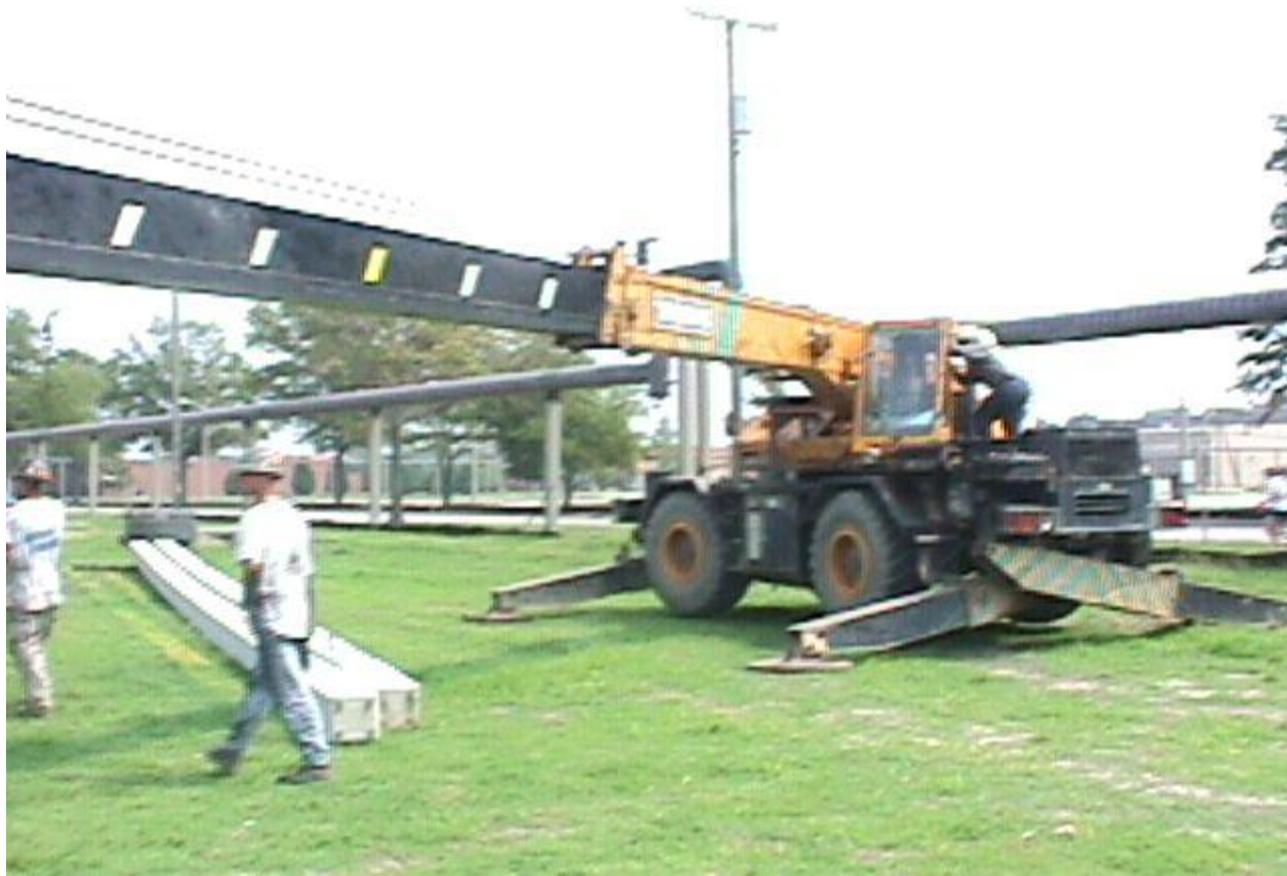
Found crane had hit the high voltage wires on the poles shown behind the crane

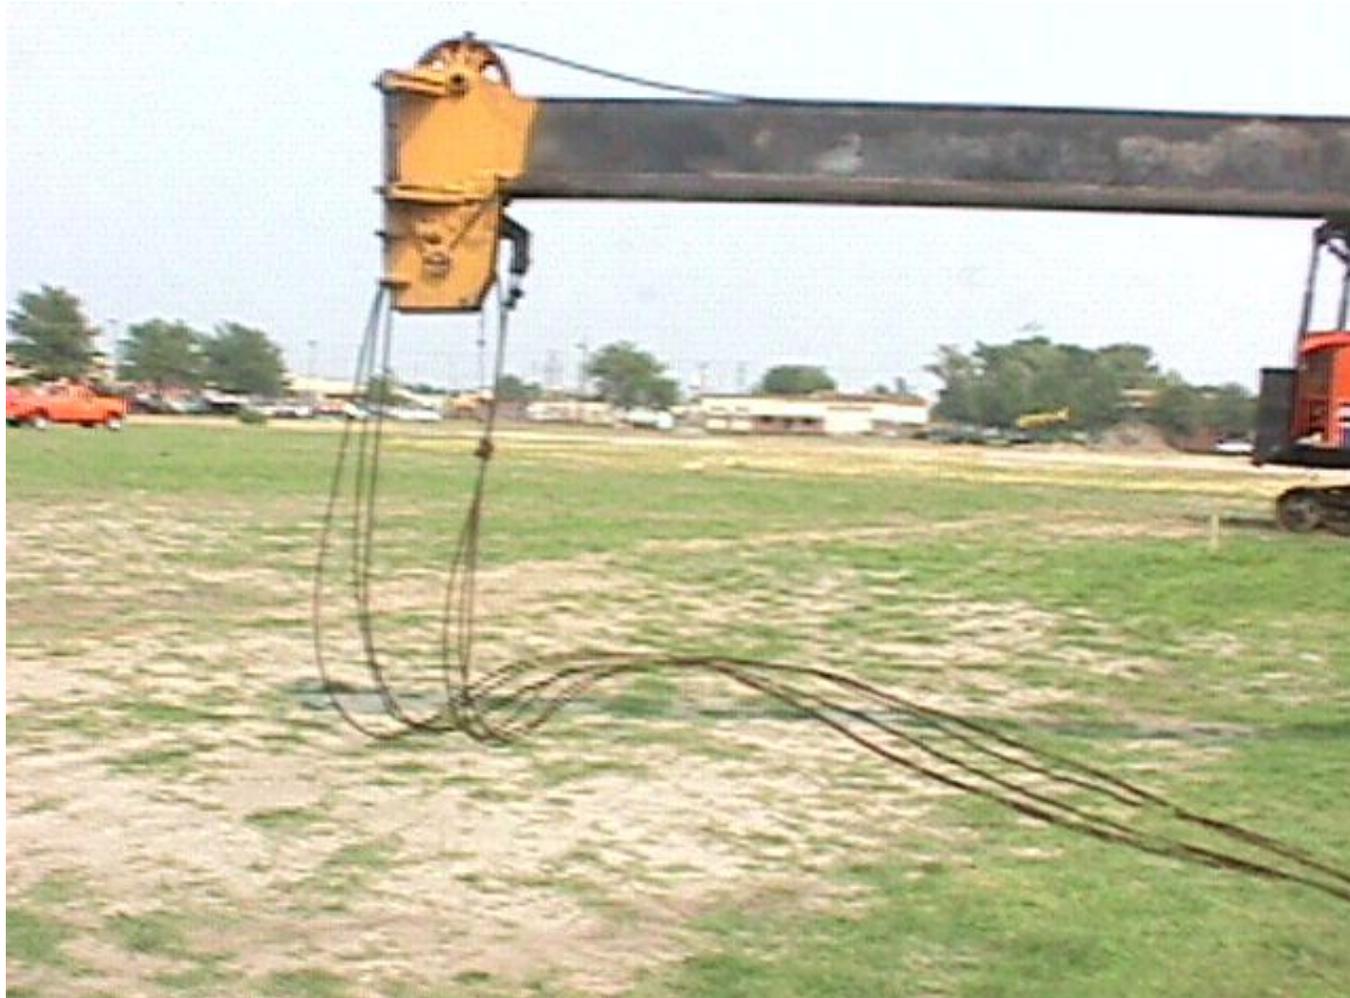
Position of the crane when arrived on site

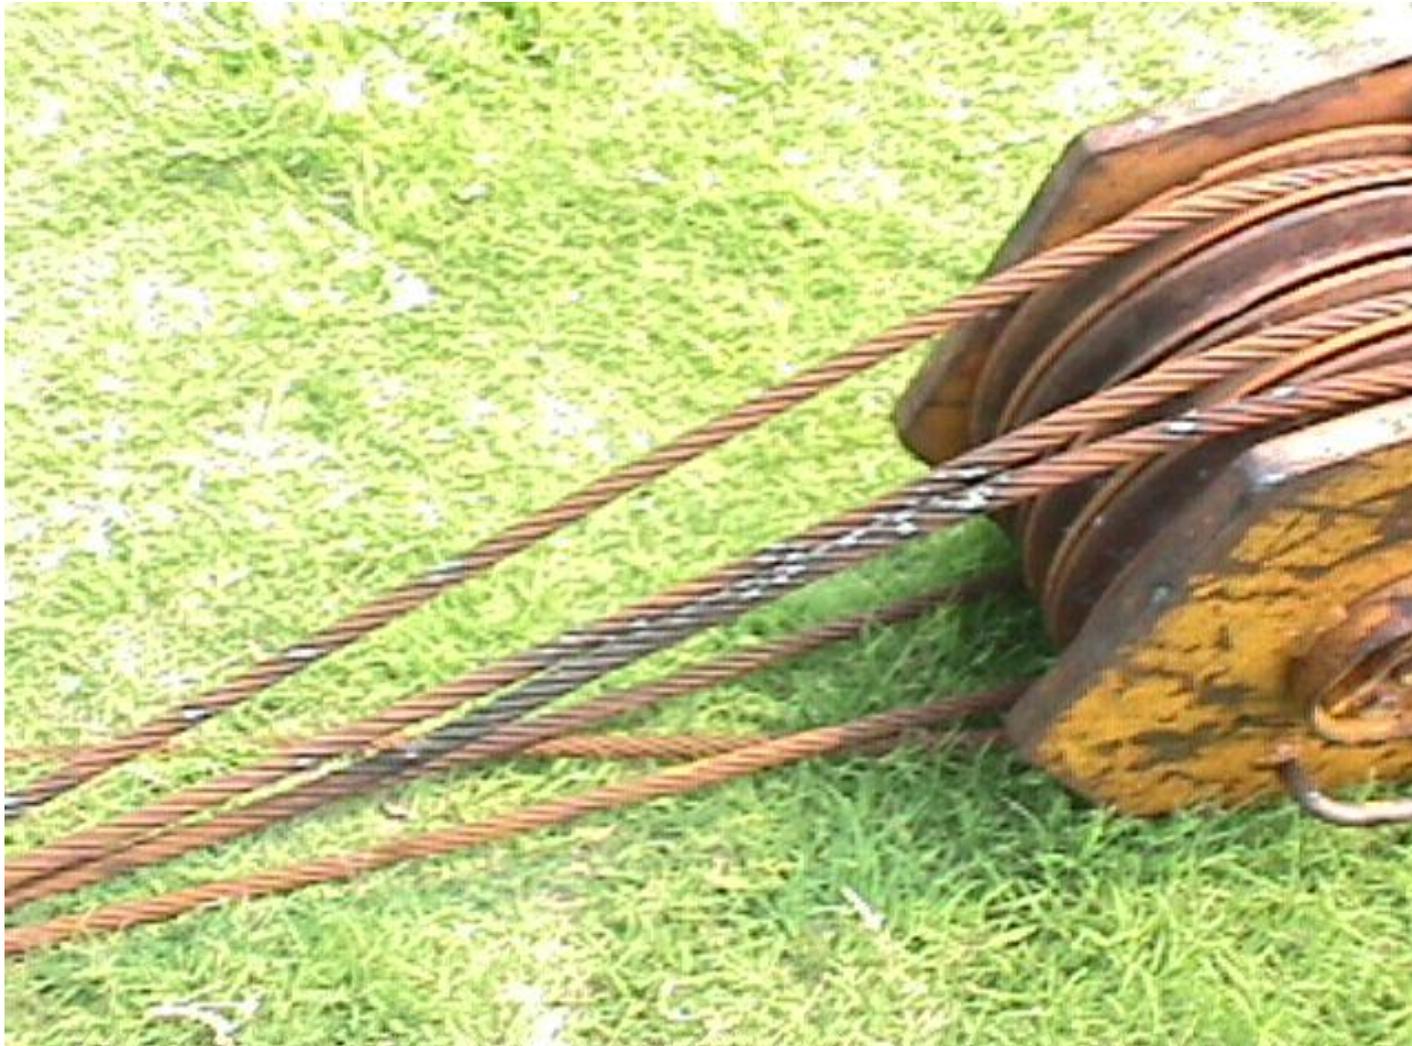
The cable has clearly been burned or shorted and the damage can be seen.

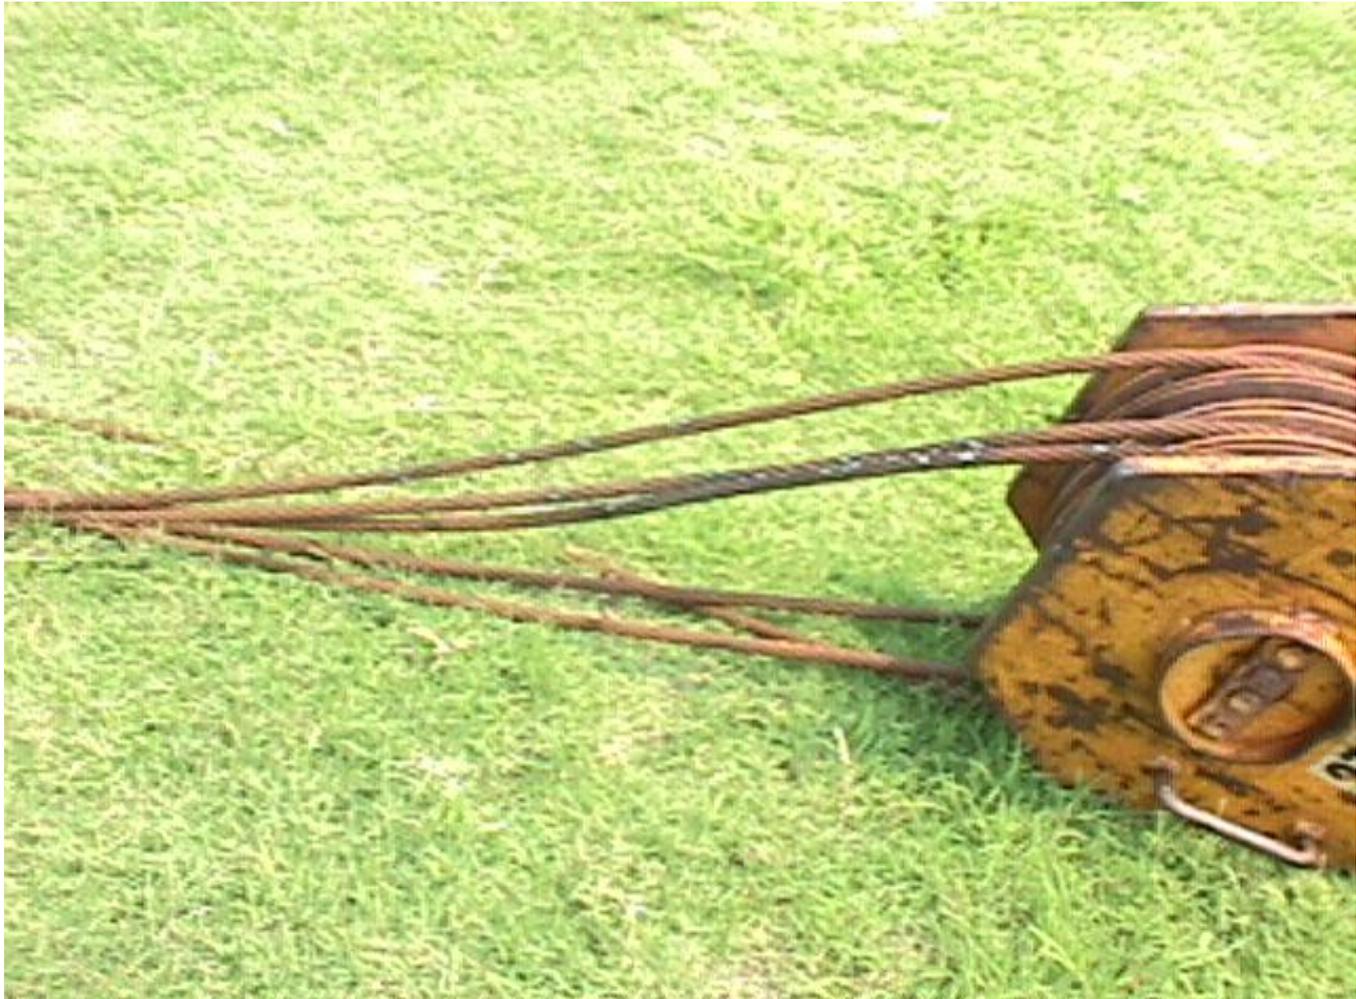
Another angle of the same crane cable.

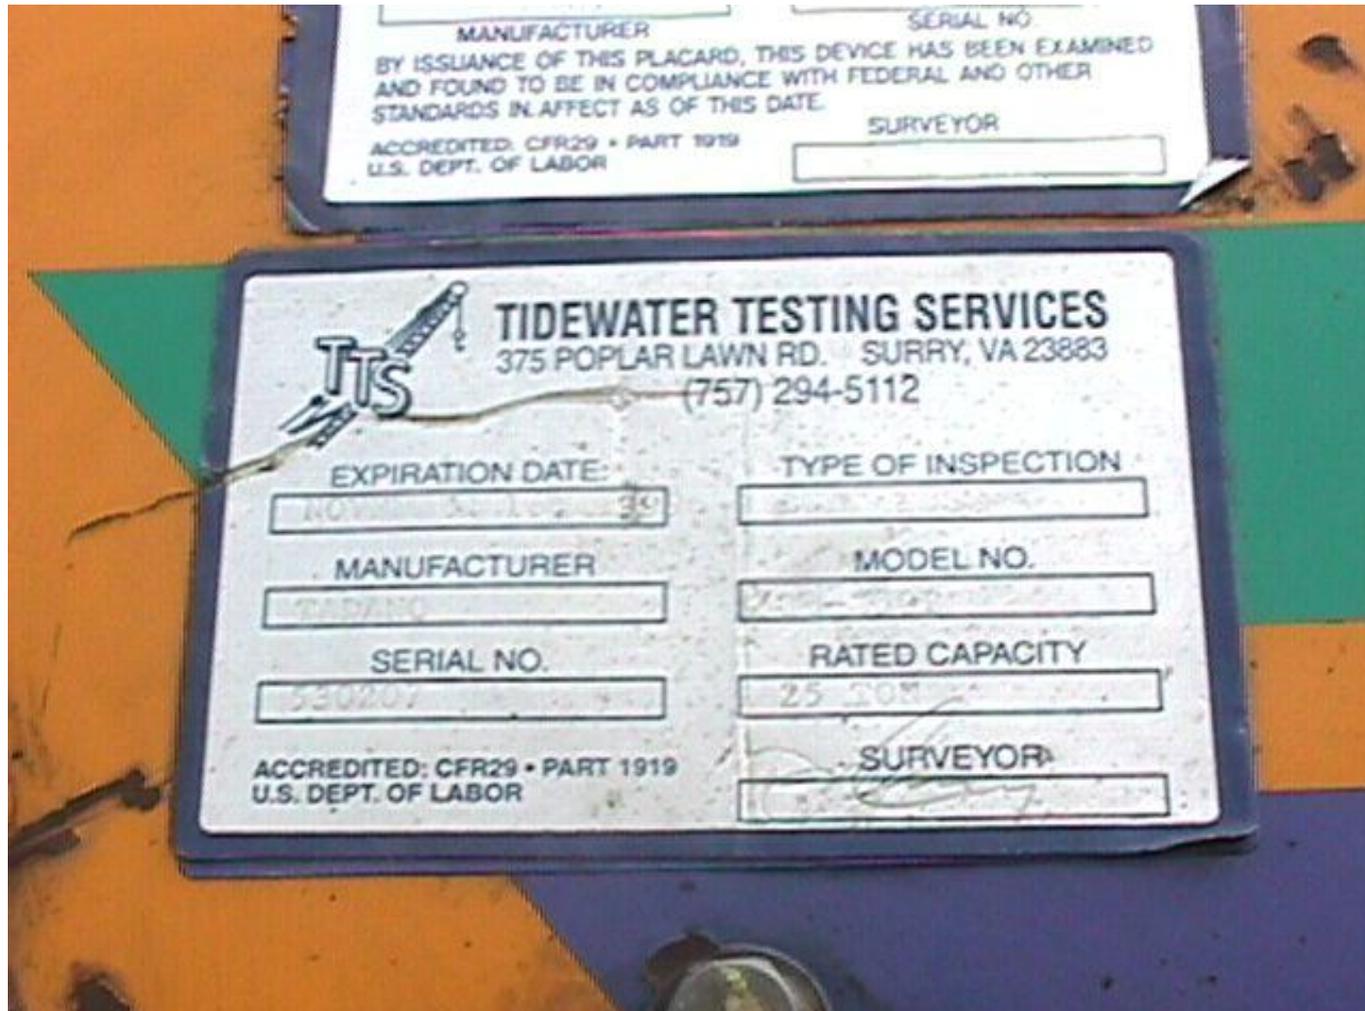
Picture of crane certification mounted on crane
