**Site Management Plan
Fiscal Years 2012—2013**

**Naval Weapons Station Yorktown
Yorktown, Virginia**

Contract Task Order WE23

October 2011

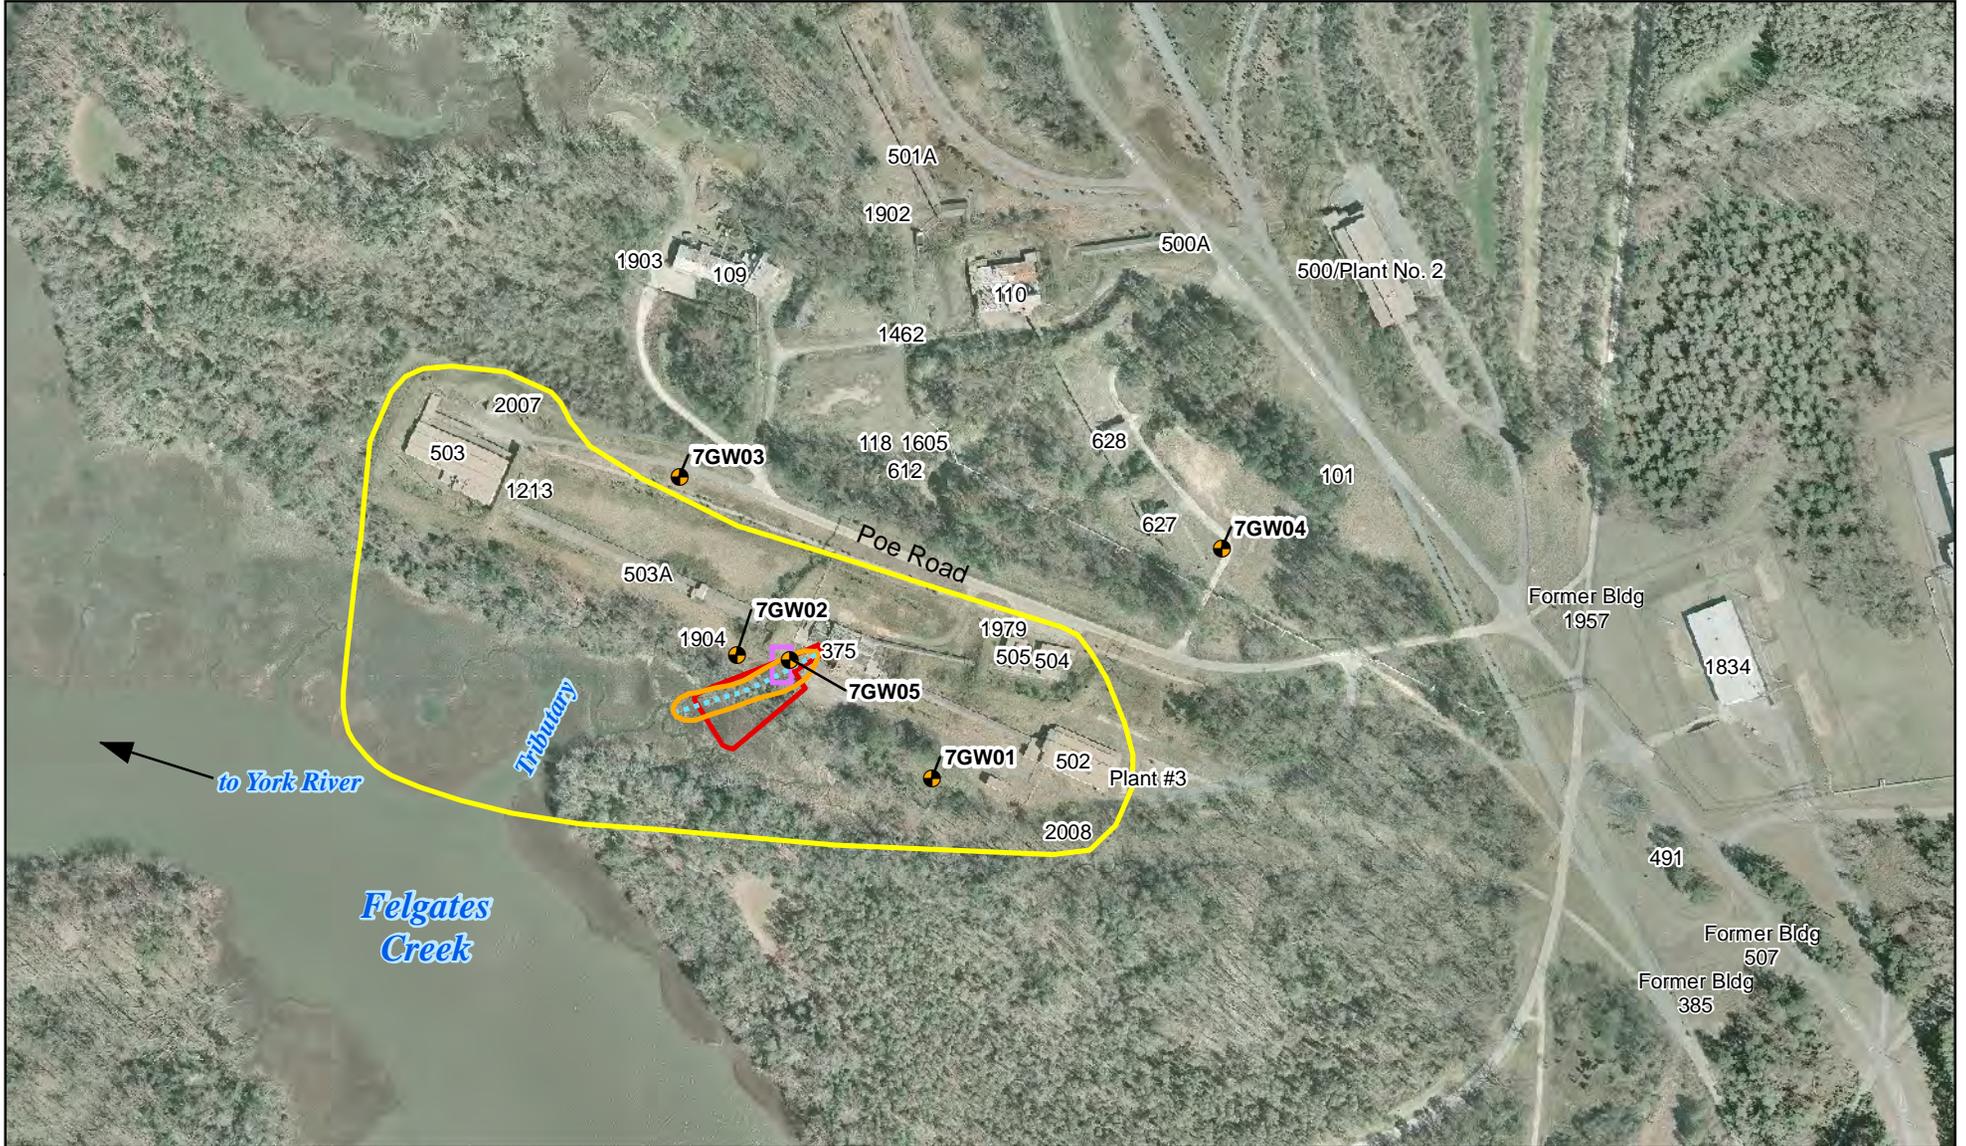
Figure 3-4
 Site 6 - Explosives Contaminated Wastewater Impoundment
 Site Management Plan for FY 2012 to 2013
 Naval Weapons Station Yorktown
 Yorktown, Virginia

Site 6 is located in the northern portion of WPNSTA Yorktown and consists of three areas: an impoundment area, a flume area, and an excavated pit (**Figure 3-4**).

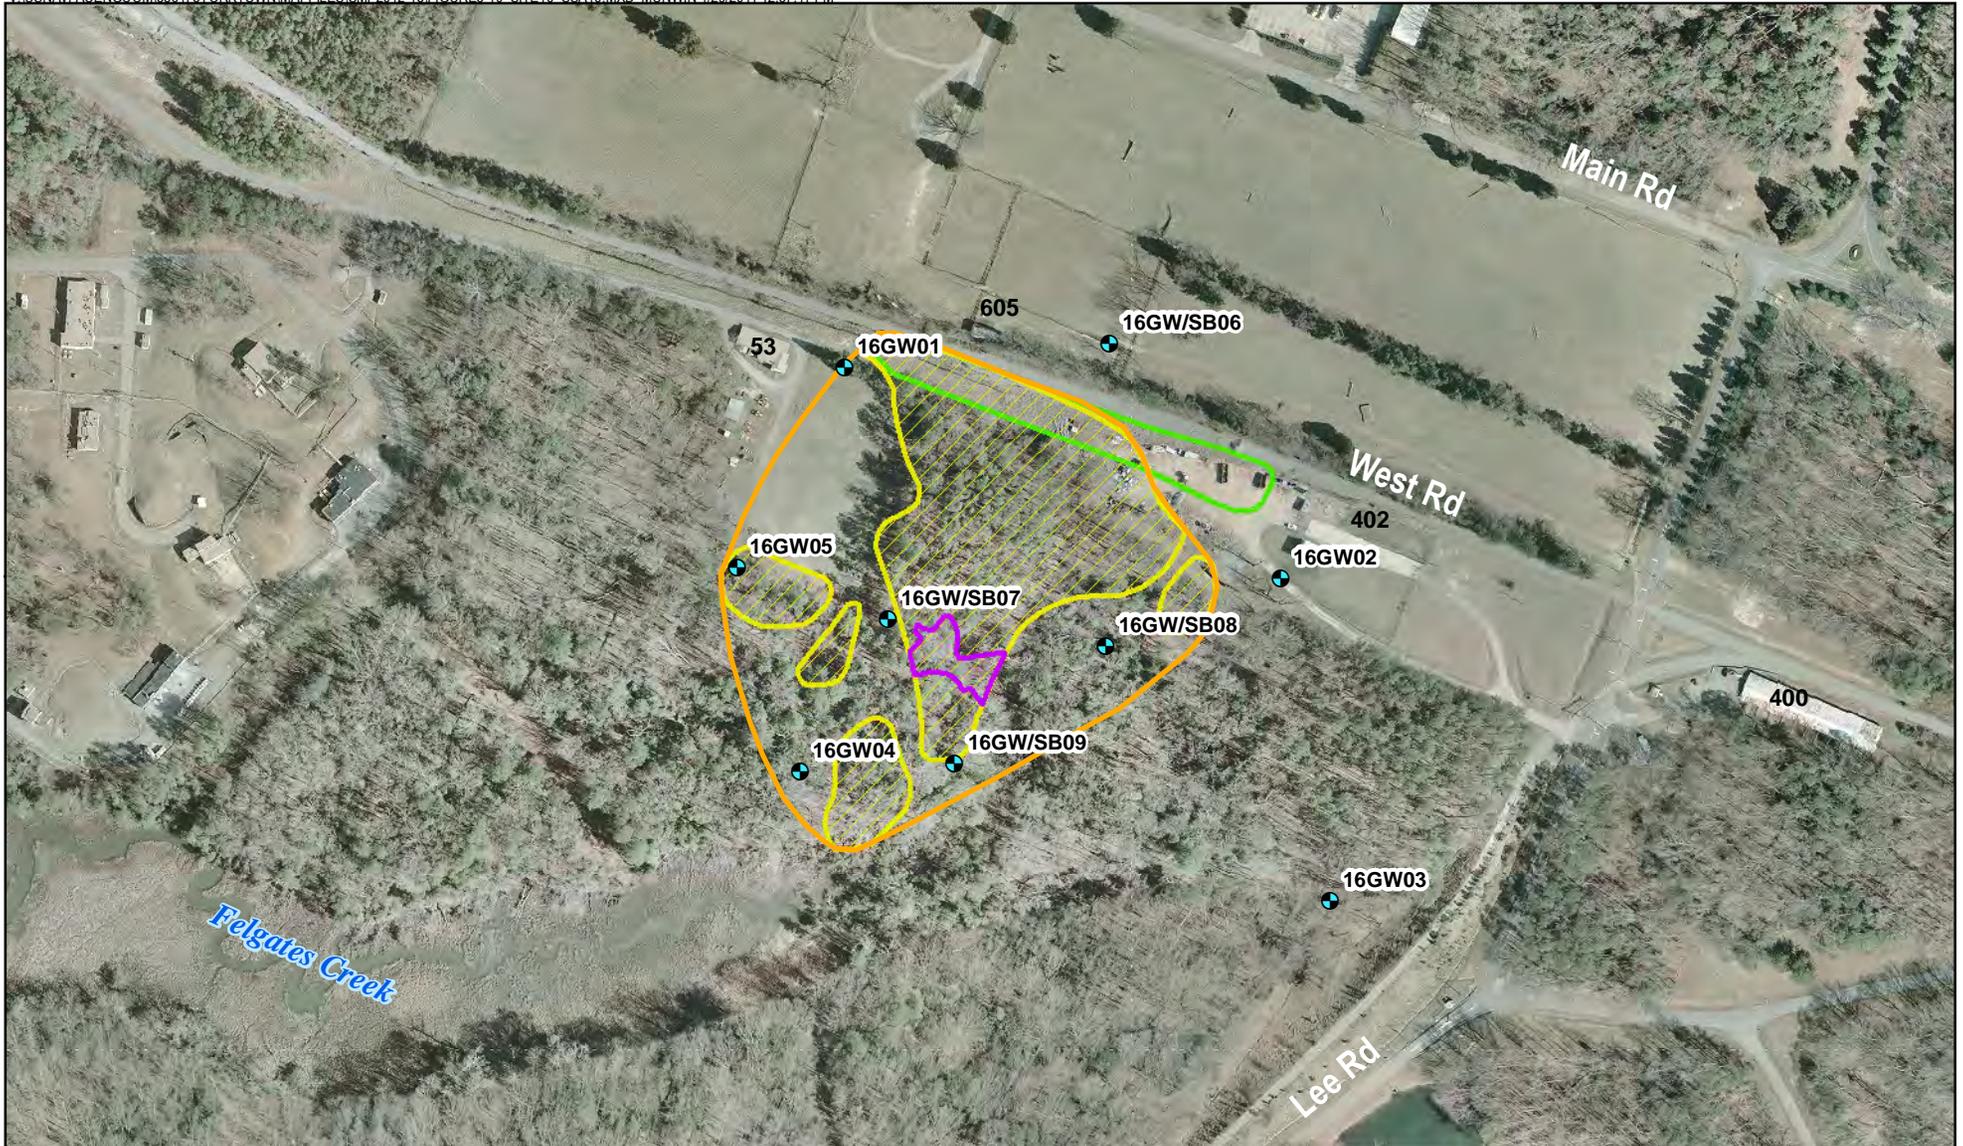
Figure 3-9
 Site 12 - Barracks Road Landfill
 Site Management Plan for FY 2012 to 2013
 Naval Weapons Station, Yorktown
 Yorktown, Virginia

Site 12, the Barracks Road Landfill, currently consists of three former disposal areas: Area A, Area B/C, and the Wood/Debris Disposal Area (**Figure 3-9**). Area A was the former location of an industrial and non-industrial waste incinerator facility. Ash from the incinerator facility was disposed throughout Area A. Area B/C is located adjacent to the access road leading to the former incinerator facility. Area B/C is an area of uneven terrain where ash may have been disposed. The Wood/Debris Disposal Area was created when lumber, wood pallets, and miscellaneous construction debris were disposed of and pushed into a ravine that leads to Ballard Creek.

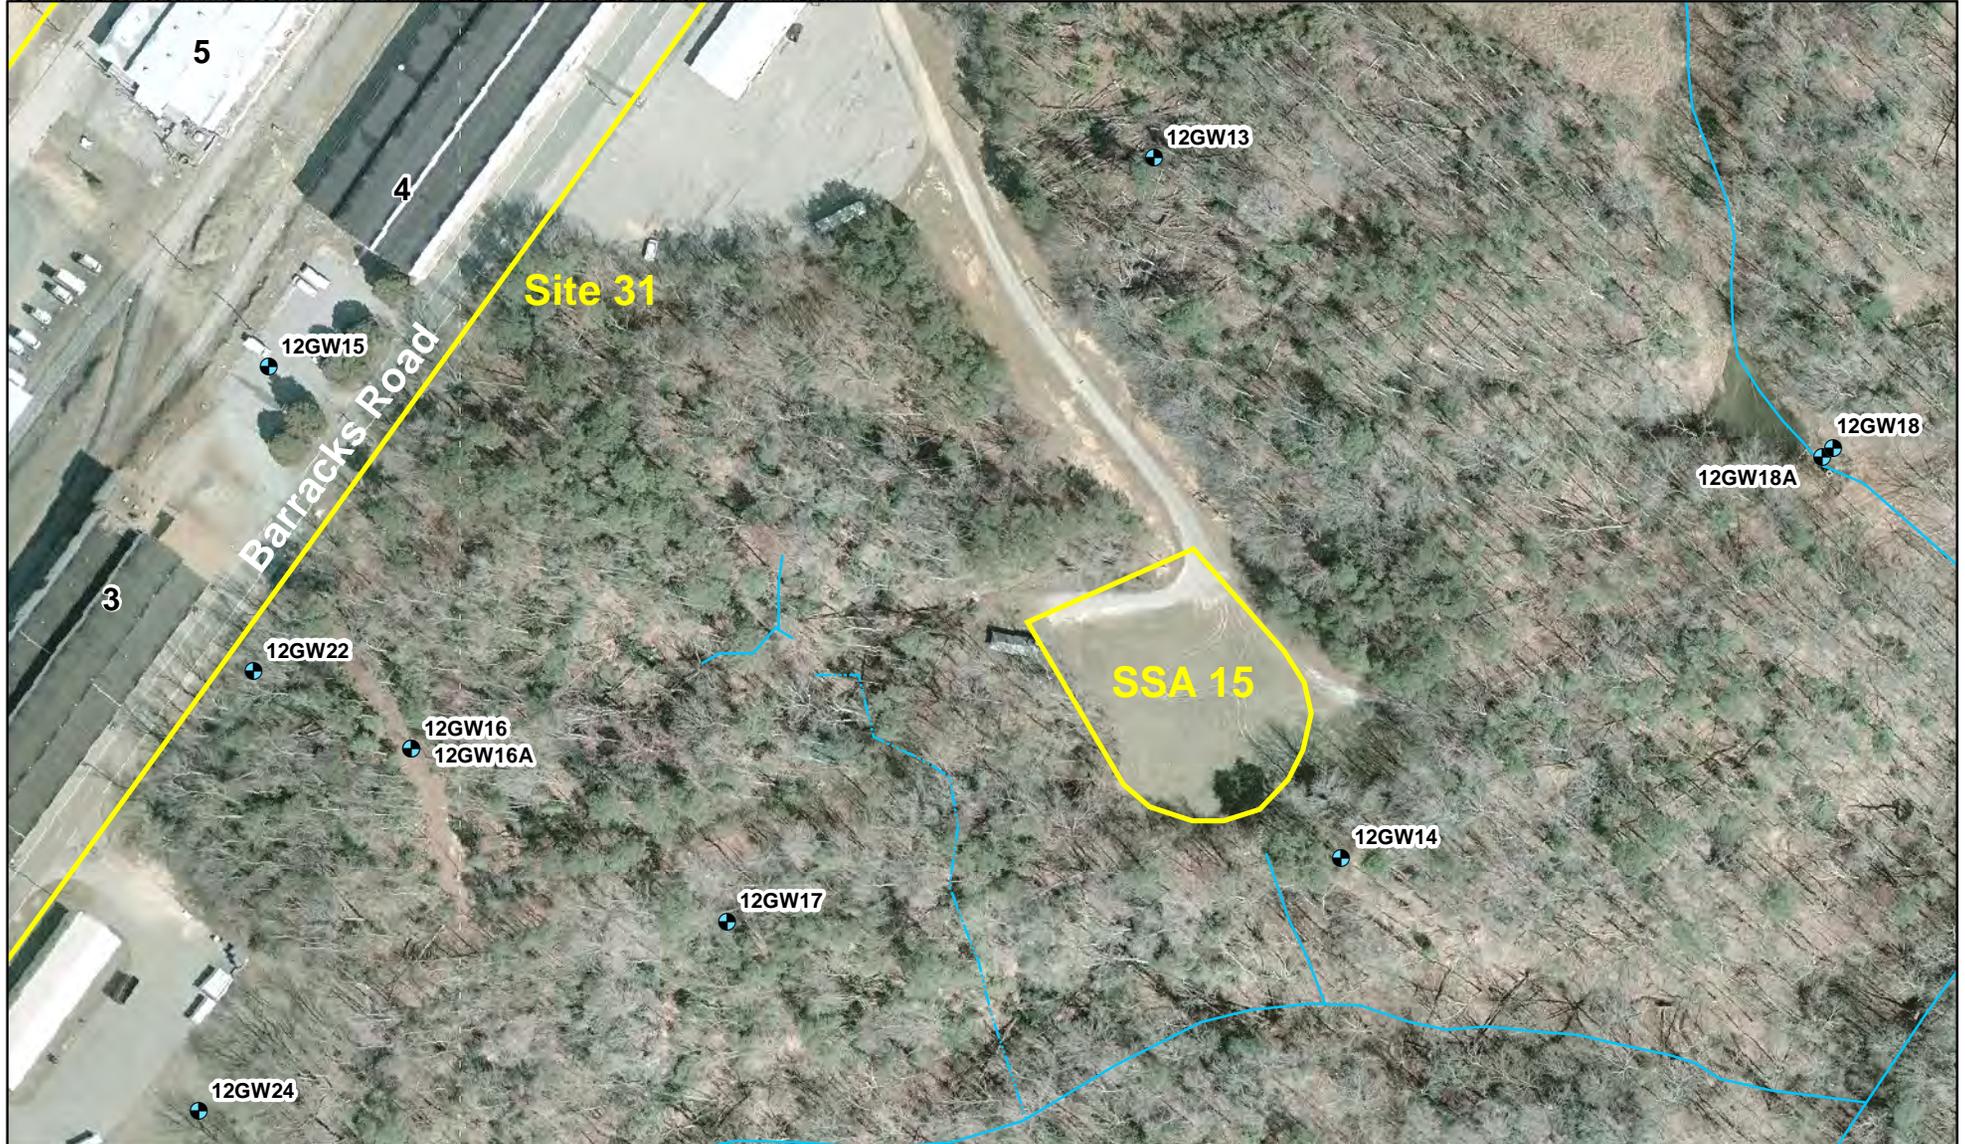
Figure 3-23
Site 34 - Building 537 Discharge to Felgates Creek
Site Management Plan for FY 2012 to 2013
Naval Weapons Station Yorktown
Yorktown, Virginia

Site 34 (formerly SSA 14), the Building 537 Discharge to Felgates Creek, is approximately 0.4 acres and is located in the north-central portion of WPNSTA Yorktown (**Figure 3-23**). A one-lane asphalt road circles around Buildings 458, 459, 460, 537, and 651, which are concrete bunkers set into a hillside. South of the road, the sparsely wooded terrain slopes steeply to a flat marsh wetland area north of the main channel of the Eastern Branch of Felgates Creek. Site 34 consists of a pipe which originates at Building 537 and extends south to Felgates Creek. Nitramine-contaminated wastewater was reportedly discharged through the pipe.
