# Site Management Plan Fiscal Year 2013

Marine Corps Installations East-Marine Corps Base Camp Lejeune  
Jacksonville, North Carolina

January 2013

prepared by **CH2MHILL.**

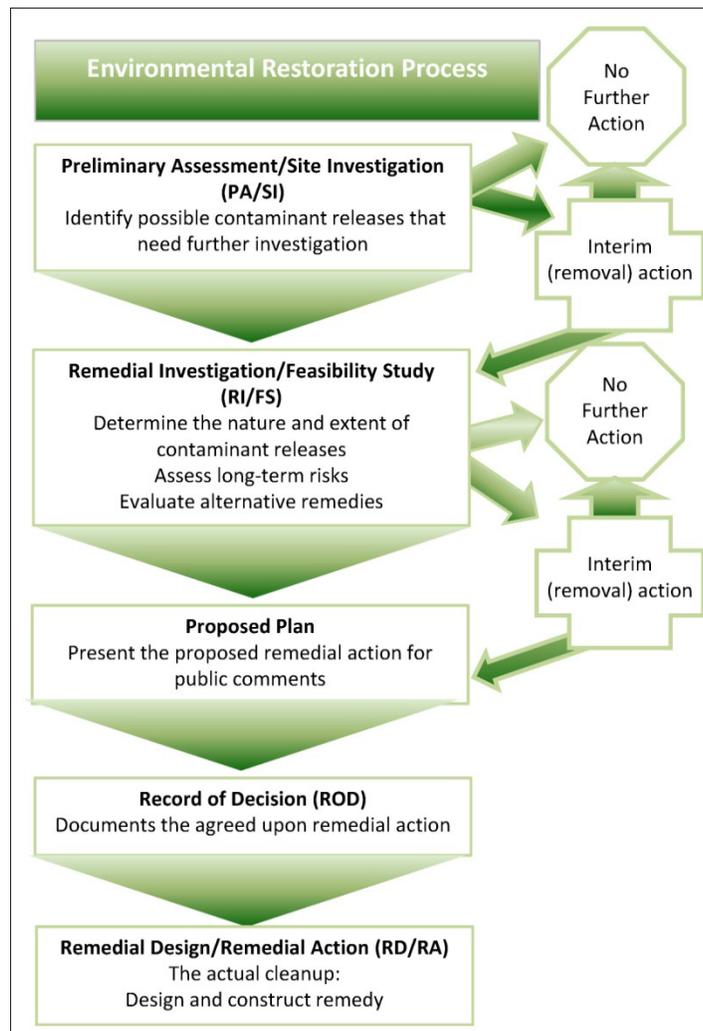
FIGURE 2-2  
CERCLA Process

For most sites at MCIEAST-MCB CAMLEJ, the PA and SI have been completed concurrently as a PA/SI. For MMRP sites, if geophysical anomalies representing potential subsurface MEC are identified during the PA/SI or low-level MC-related constituents are identified, an Expanded SI (ESI) phase is initiated to confirm whether there are site-specific contamination or hazards prior to moving forward with an RI.

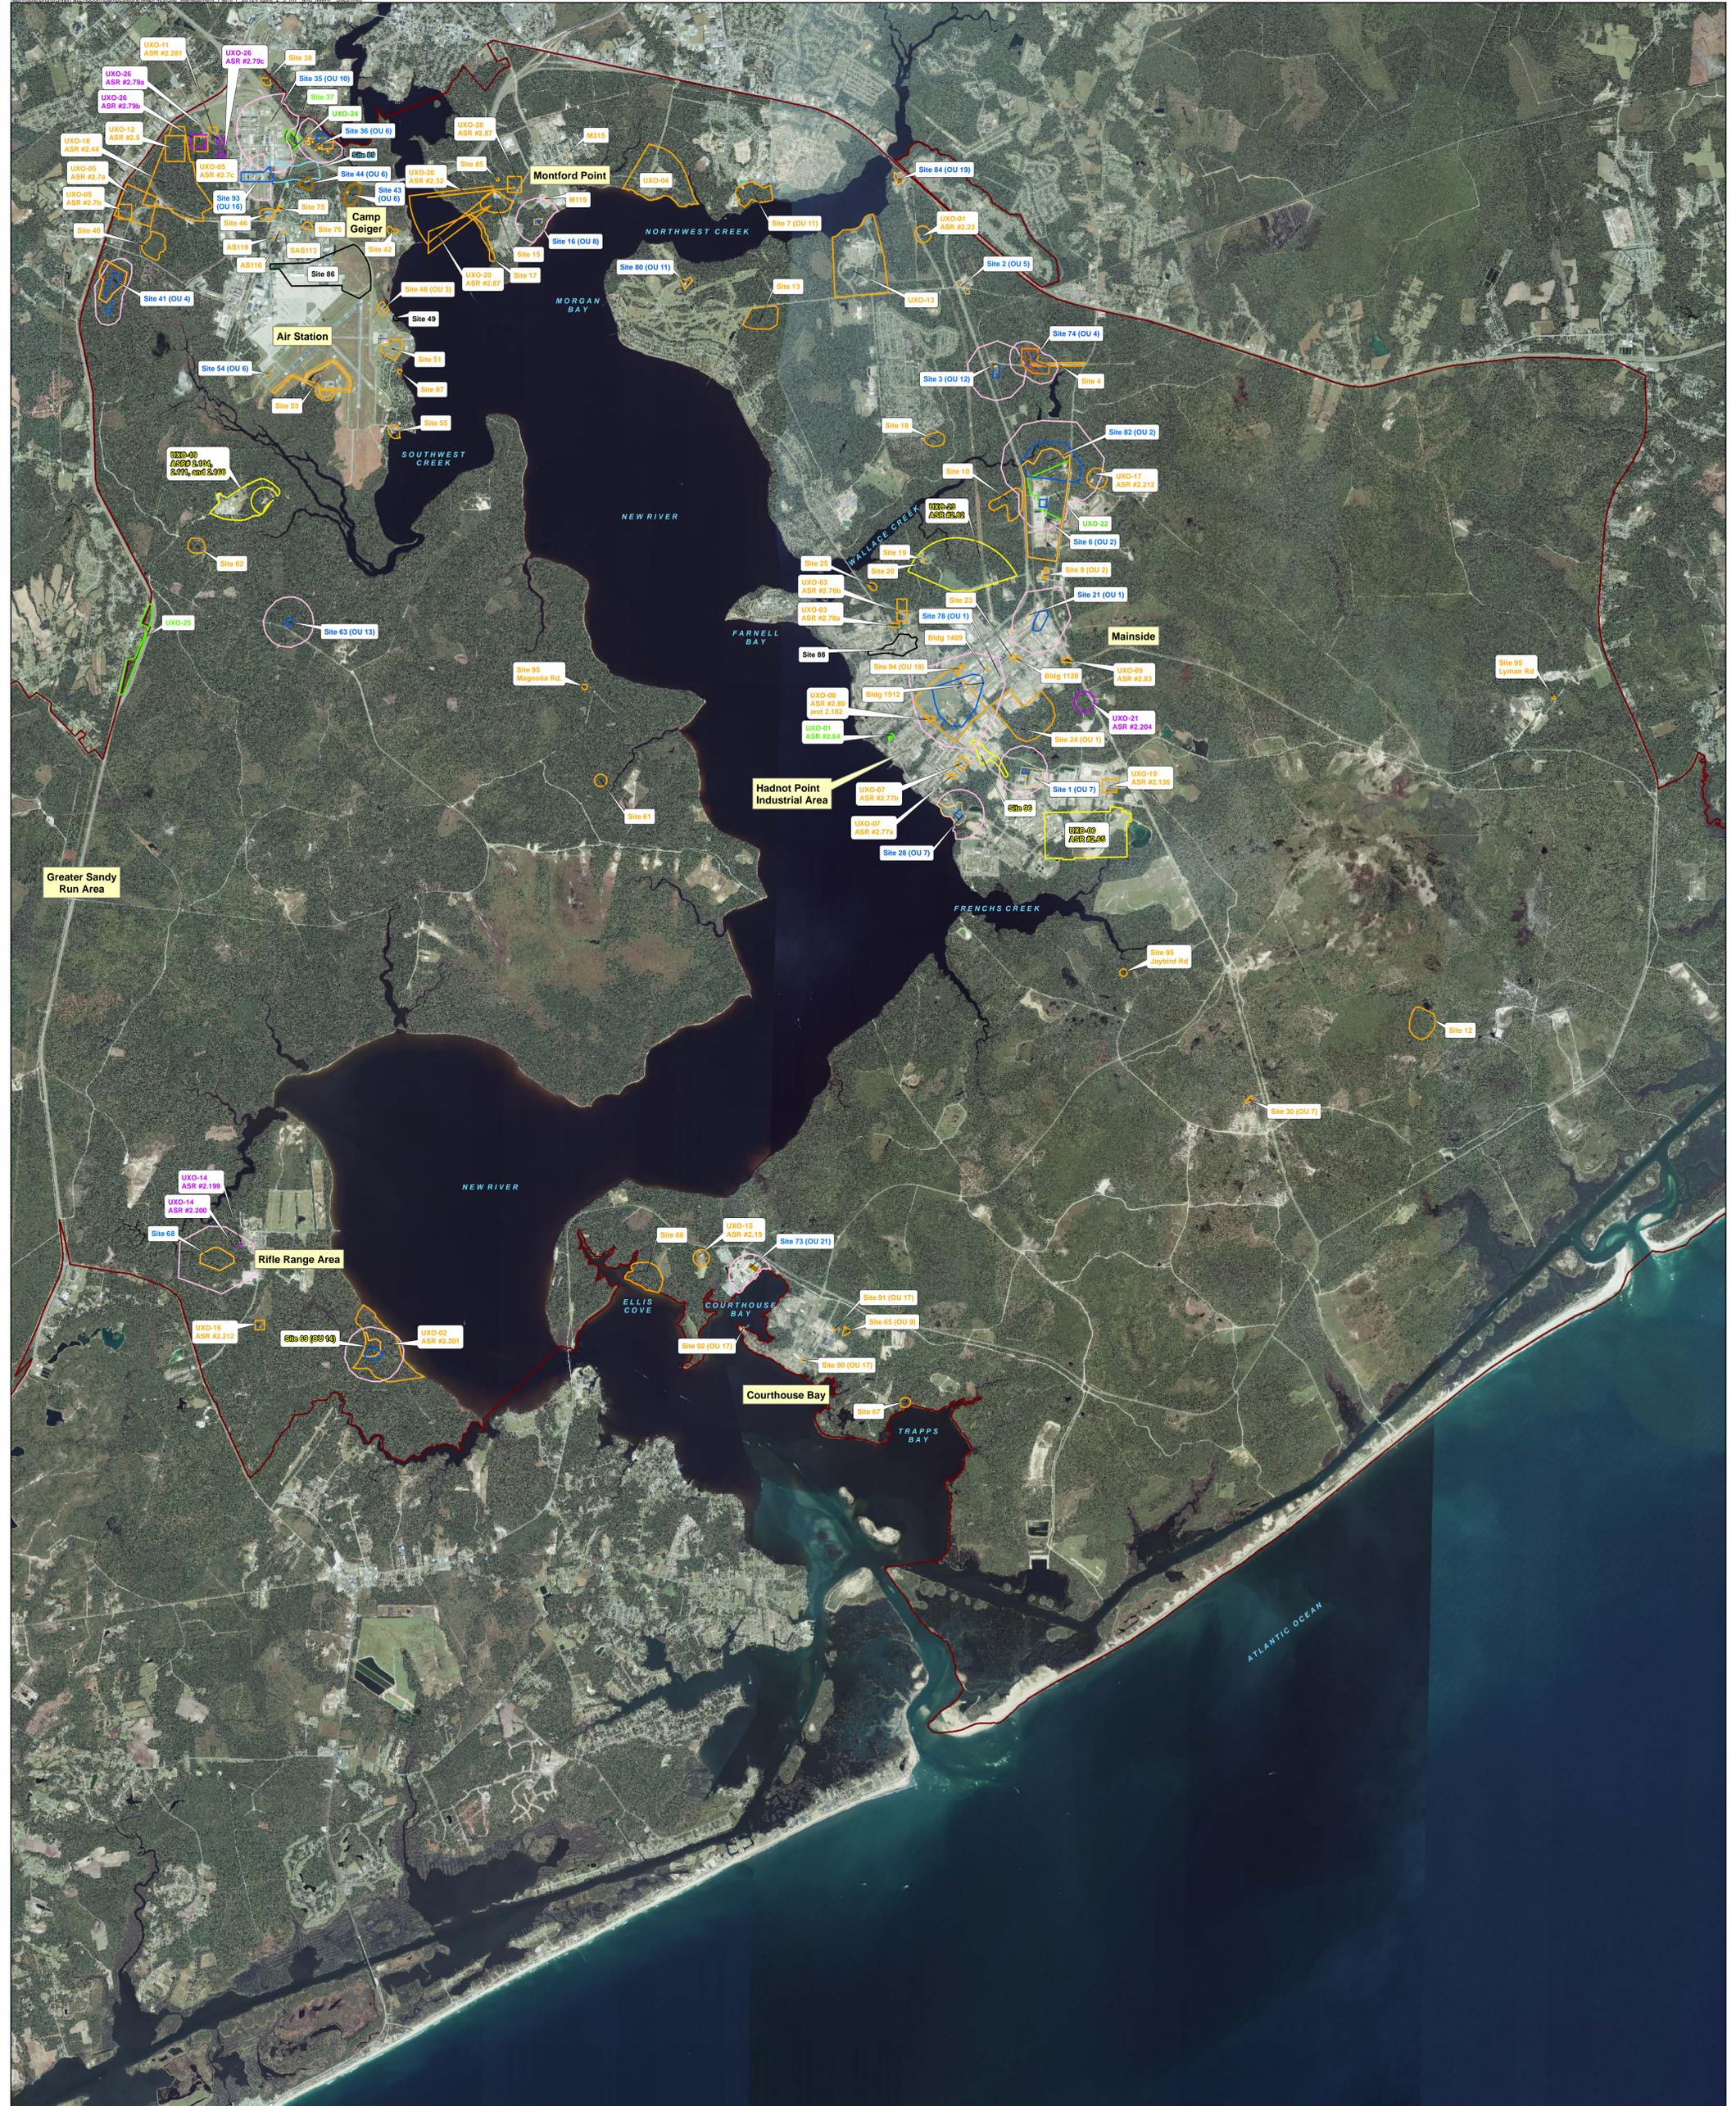
Figure 2-3  
IRP and MMRP Sites  
FY 2013 Site Management Plan  
MCIEAST-MCB CAMLEJ  
North Carolina

A total of 95 sites have been identified under the Base IRP and MMRP (**Figure 2-3**). Of the 68 sites identified in the IRP, 29 are considered currently active (under investigation, remediation, long-term monitoring [LTM], or have land use controls [LUCs] implemented) (**Figure 2-4**), and 39 sites have been formally closed with NFA (**Figure 2-5**). A total of 25 OUs have been identified under the IRP and MMRP to group sites based on geographic location or similar disposal histories (**Table 2-2**). Of the 27 (there two UXO-01 sites considered in this count) sites identified in the MMRP, 11 are considered currently active (**Figure 2-6**) and 16 have been formally closed (**Figure 2-7**).

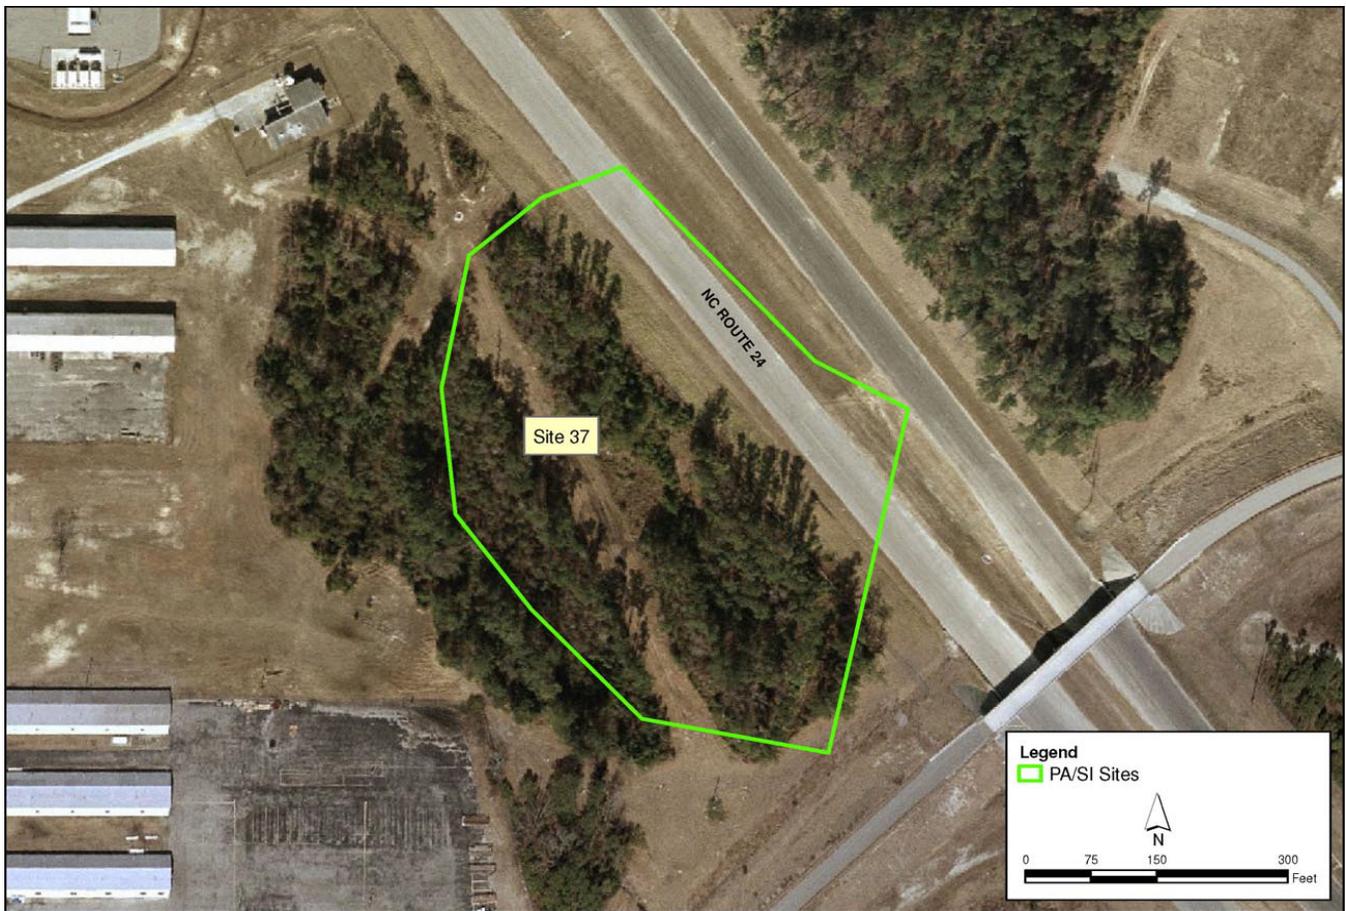
FIGURE 3-1  
IRP Site 37

Site 37, the Camp Geiger Area Surface Dump, encompasses approximately 4 acres in the Camp Geiger area of the Base (**Figure 3-1**). Between 1950 and 1951, Site 37 was used for the surface disposal of wastes including motor parts, garbage, and wood. In 2010, buried munitions were discovered in the vicinity and the area was identified as UXO-24 under the MMRP (Section 3.2.20).

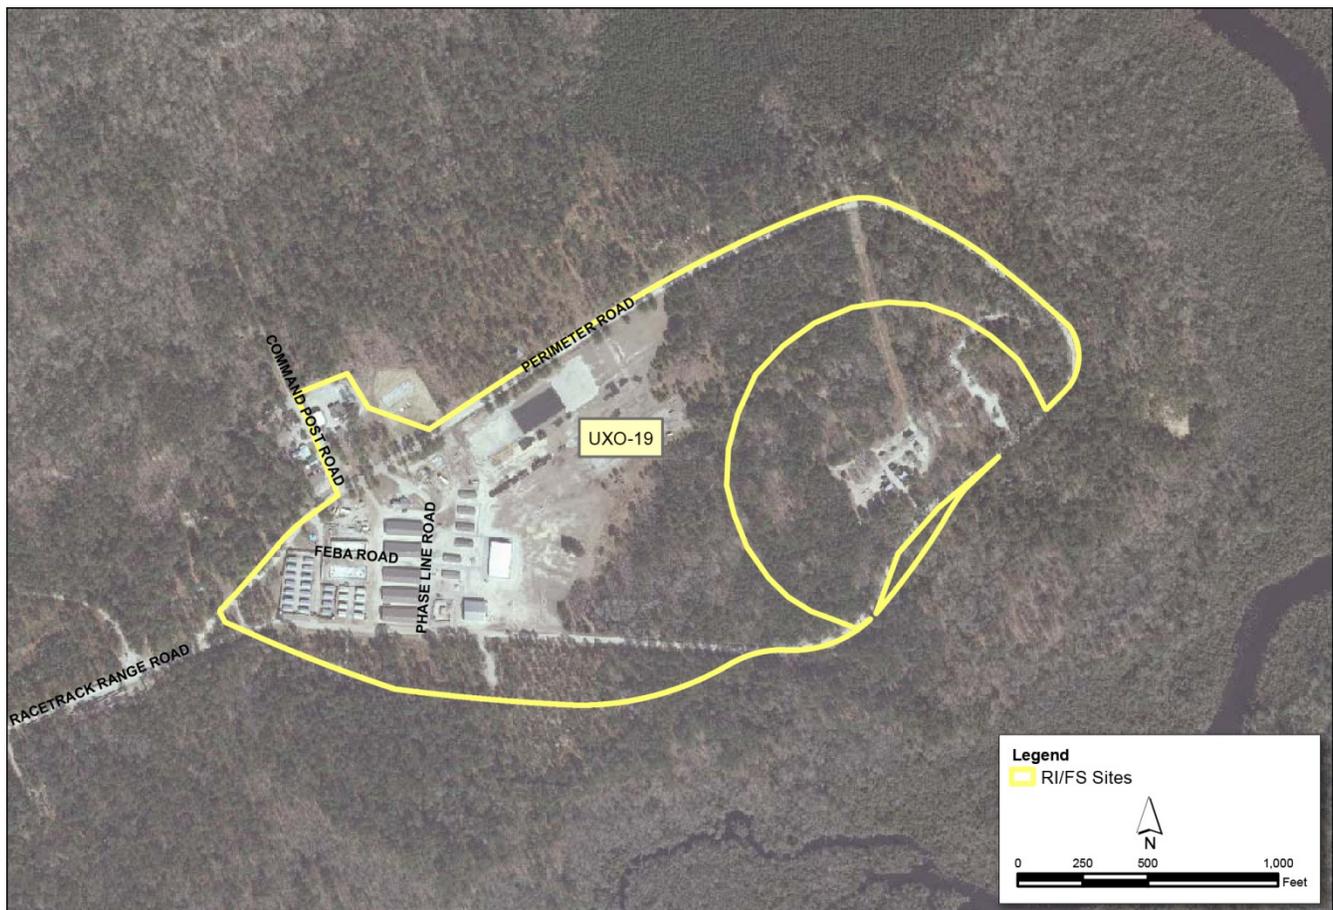
MMRP Site UXO-19 (OU 25), ASR #2.104, ASI #2.111, and ASR #2.168

Site UXO-19 is located within the Camp Devil Dog training area and covers approximately 80 acres (**Figure 5-3**). There are eight overlapping ranges within UXO-19 boundaries and three of them were identified for closure under the MMRP. The M-4 Rifle Grenade Range (ASR #2.104) was used between 1950 and 1960. Reported munitions used were M28 and M29 rifle grenades, white phosphorous hand and rifle grenades, pyrotechnics, and demolitions. The K-22 Practice Hand Grenade Course (ASR #2.111) was used between 1950 and 1960 to practice grenade throwing techniques prior to throwing live grenades. Facilities included a bunker and foxhole. The M115 Hand Grenade Course (ASR #2.168) was used from 1970 to 1977 for high explosive hand grenades. The range consisted of six throwing pits, six control pits, and a barricade with two observation ports.

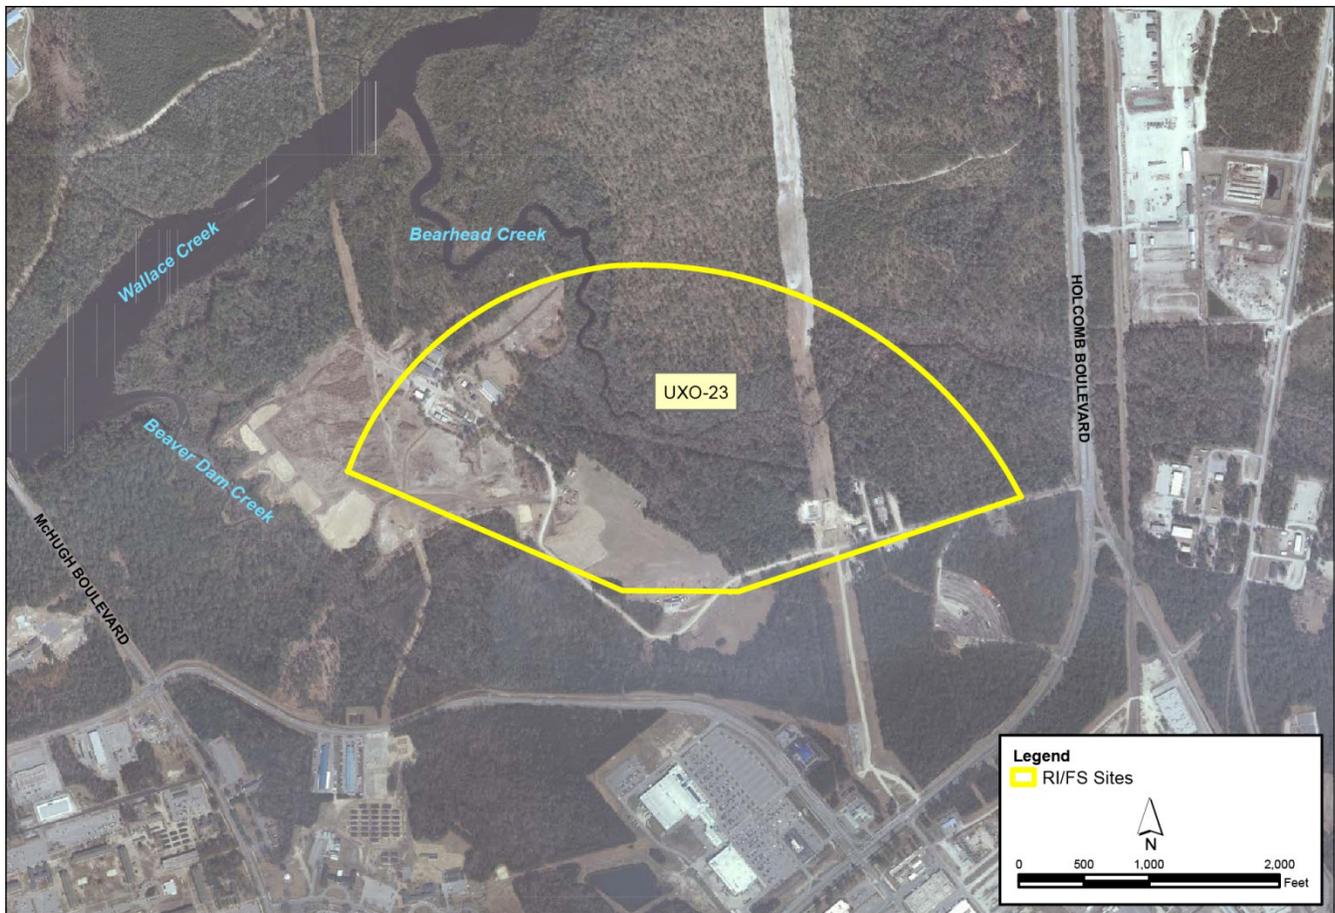
FIGURE 5-4  
MMRP Site UXO-23, ASR #2.82

The D-9 Skeet Range is located west of Holcomb Boulevard and north of Parachute Tower Road and encompasses approximately 187 acres (Figure 5-4). The D-9 Skeet Range was used for recreational shooting from 1953 until it was closed in July 2011. The range was one of four live-fire ranges within a training area known as Area D. The weapons historically accommodated included 12-, 16-, 20-, 28-, and 410-gauge shotguns and sizes of lead shot used on the range included 7.5 mm, 8 mm, 8.5 mm, and 9 mm. Although the total amounts of ammunition used on the skeet ranges are not available, it is estimated that several hundred thousand rounds were fired each year.

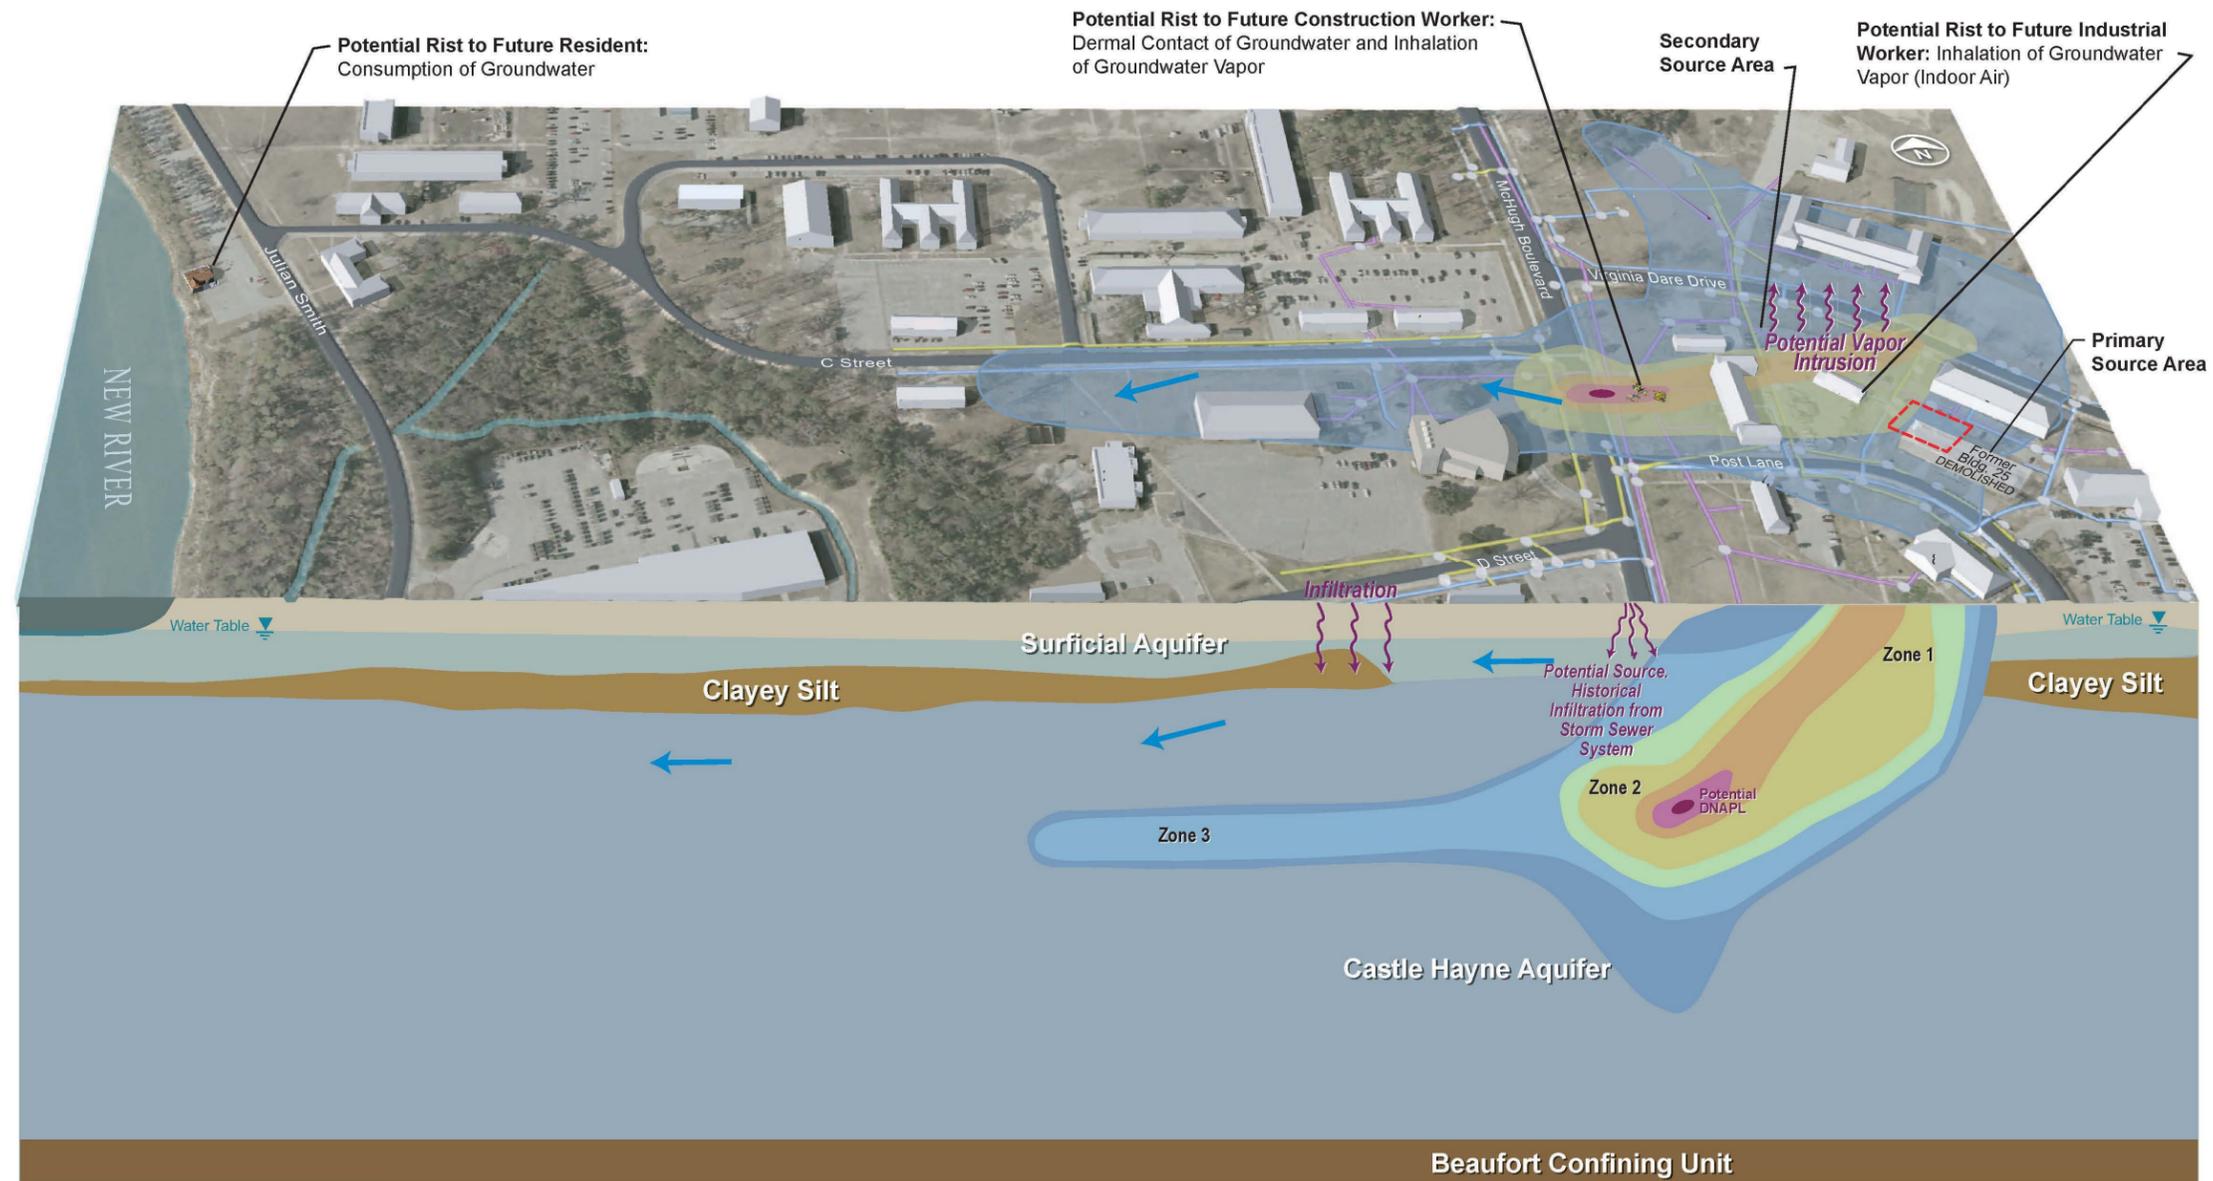
FIGURE 6-7  
 Site 88 Conceptual Site Model  
 FY 2013 Site Management Plan  
 MCIEAST-MCB CAMLEJ  
 North Carolina

Legend		
	Soil Mixing Area	
	Groundwater Flow Direction	
	Potential DNAPL Present	
<b>PCE Concentrations</b>		
NCGWQS: 0.7 µg/L		
	> 100,000 µg/L	
	> 10,000 µg/L	
	> 5,000 µg/L	
	Potable Water Main	
	Storm/Sewer Drainage System	
	Consolidated Wastewater

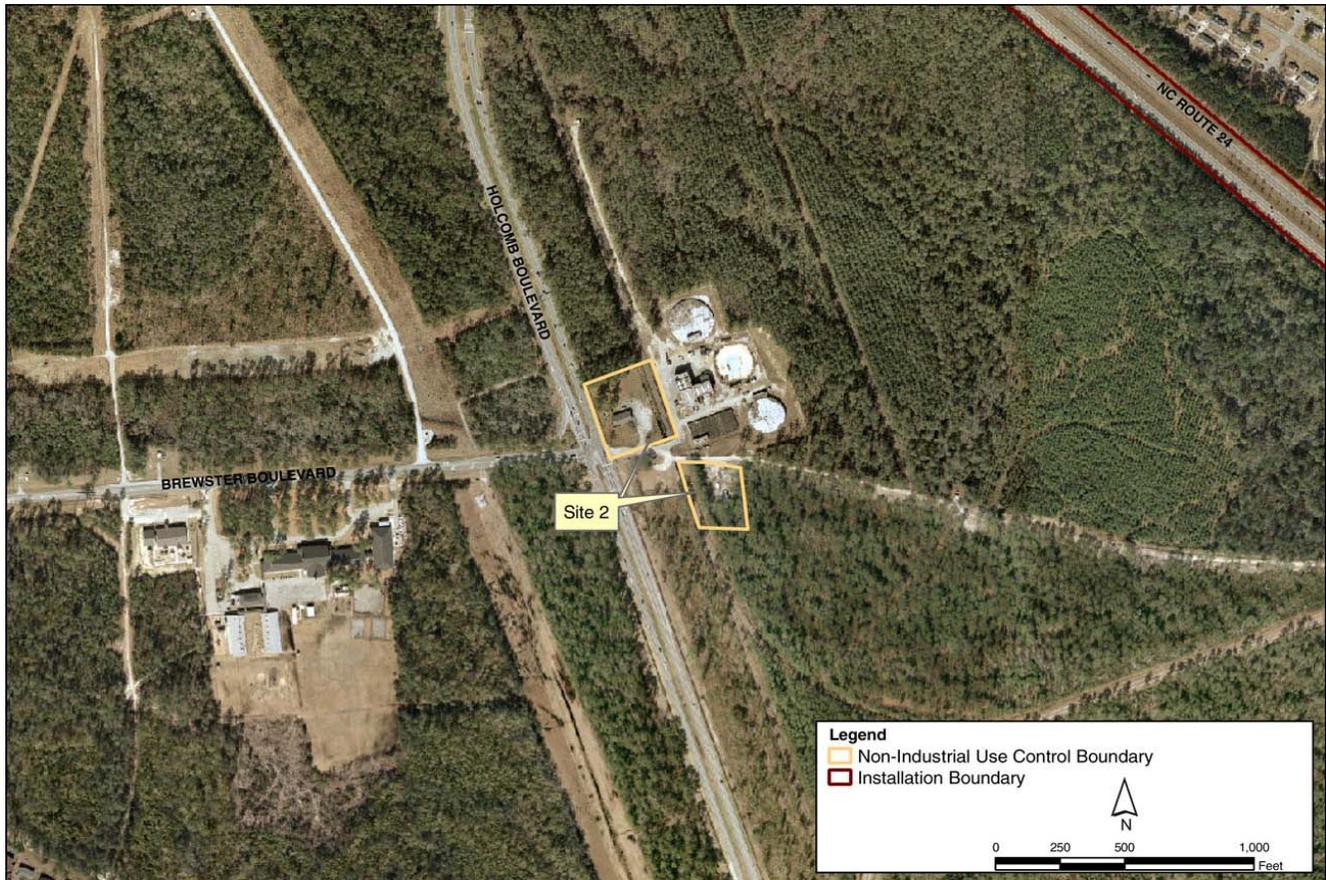
FIGURE 8-2  
IRP Site 2, Operable Unit 5

Site 2, the Former Nursery/Daycare Center, encompasses approximately 5 acres just inside the Main Gate in the northeast portion of the Base (**Figure 8-2**). From 1945 to 1958, an onsite building was used for storing, handling, and dispensing pesticides. Chemicals known to have been used at Site 2 include chlordane, 4,4'-DDT, diazinon, and 4,4'-DDD. Chemicals known to have been stored include dieldrin, lindane, malathion, and silvex. A preliminary soil sampling investigation conducted in 1982 indicated the presence of pesticides, resulting in the transfer of the daycare center to another location.

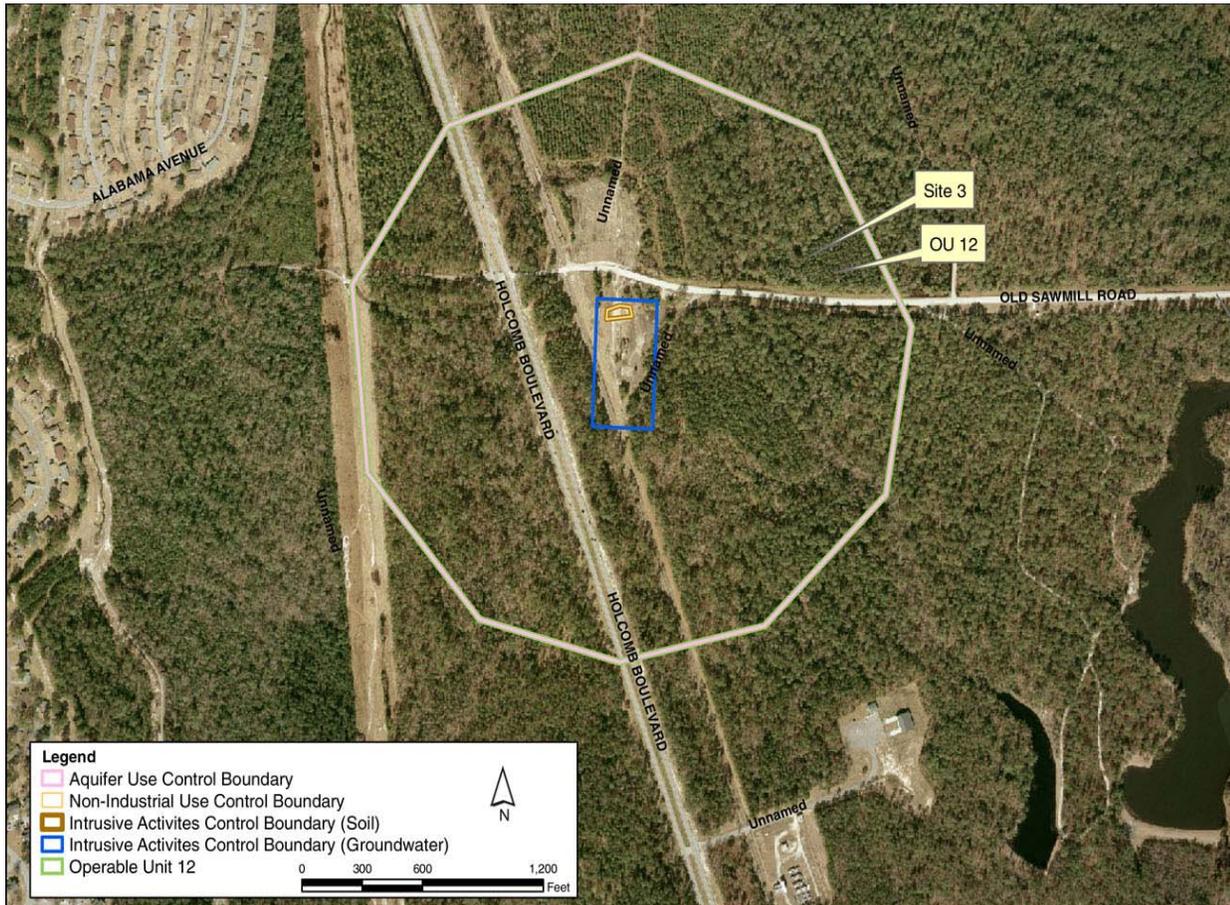
FIGURE 8-3  
IRP Site 3, Operable Unit 12

Site 3, the Old Creosote Plant, encompasses approximately 5 acres on the Mainside of the Base (**Figure 8-3**). The Creosote Plant reportedly operated from 1951 to 1952 to supply treated lumber during construction of the MCI-EAST-MCB CAMLEJ Railroad. An onsite sawmill, reportedly located in the northern portion of the Site, supplied cut timbers for the creosote treatment.

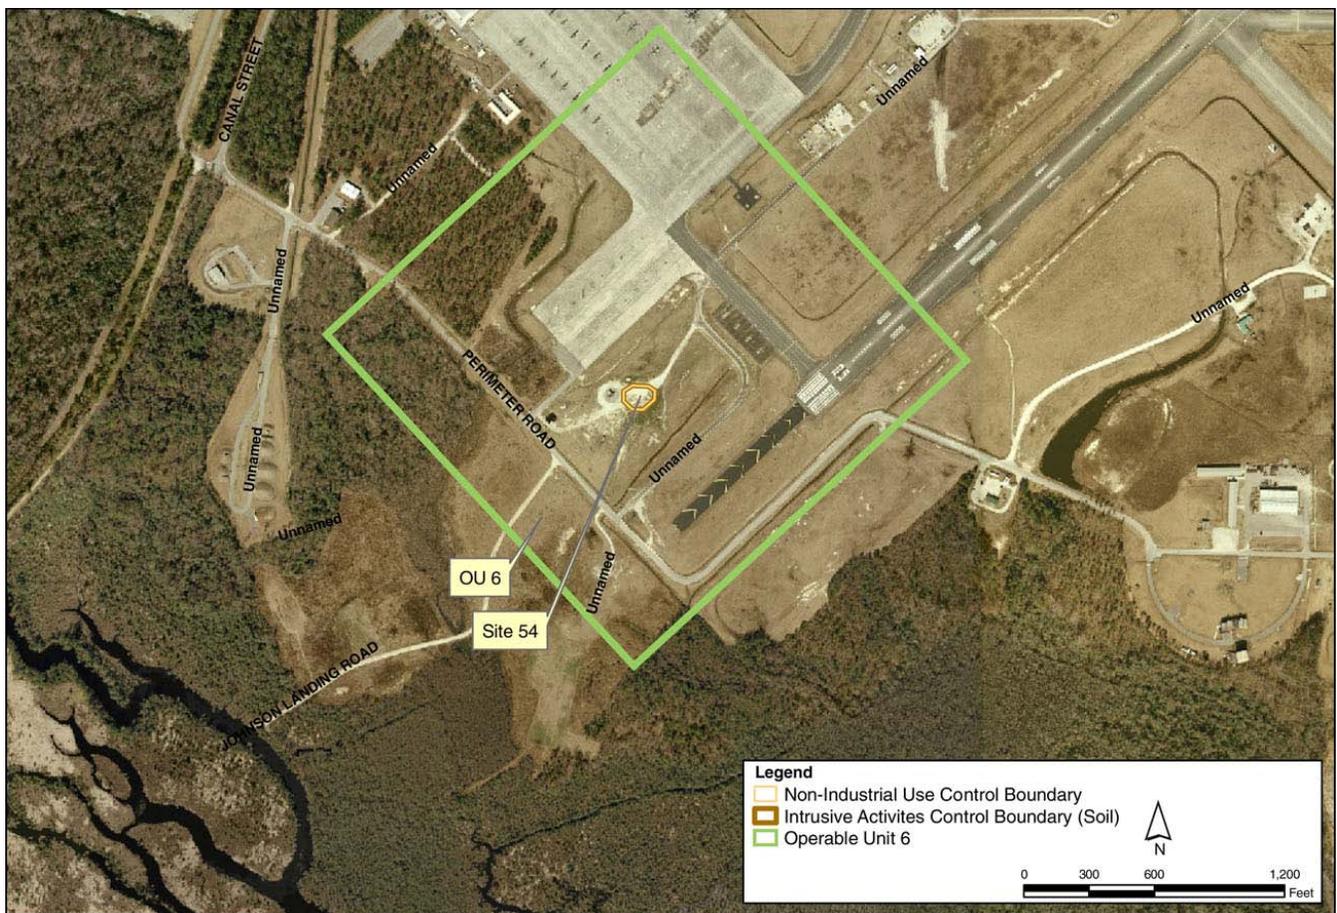
**FIGURE 8-17**  
IRP Site 54, Operable Unit 6

Site 54, the Crash Crew Fire Training Burn Pit, covers approximately 1 acre near the southwest end of Runway 5-23 within the MCAS New River operations area (**Figure 8-17**). OU 6 consists of four sites (Sites 36, 43, 44, and 54) that have been grouped together into one OU because of the similar characteristics of material disposed and geographic location. The site has served as the fire training burn pit since the mid-1950s. The former Crash Crew Fire Training Burn Pit was 90 feet in diameter and situated at the center of this site. Originally, fire training was conducted on the ground surface within a bermed area using jet propulsion (JP)-type fuel, which was stored in an 8,000-gallon UST, northwest of the burn pit. An OWS, located approximately 100 feet southeast of the burn pit, was used for temporary storage and collection of the spent fuel. In 1975, a lined burn pit was constructed and was used until 1999. Beginning in August 2000, the burn pit was converted to a training area that employs clean-burning fuels with operational and engineering controls. It is estimated that nearly 500,000 gallons of POL may have been used at Site 54.

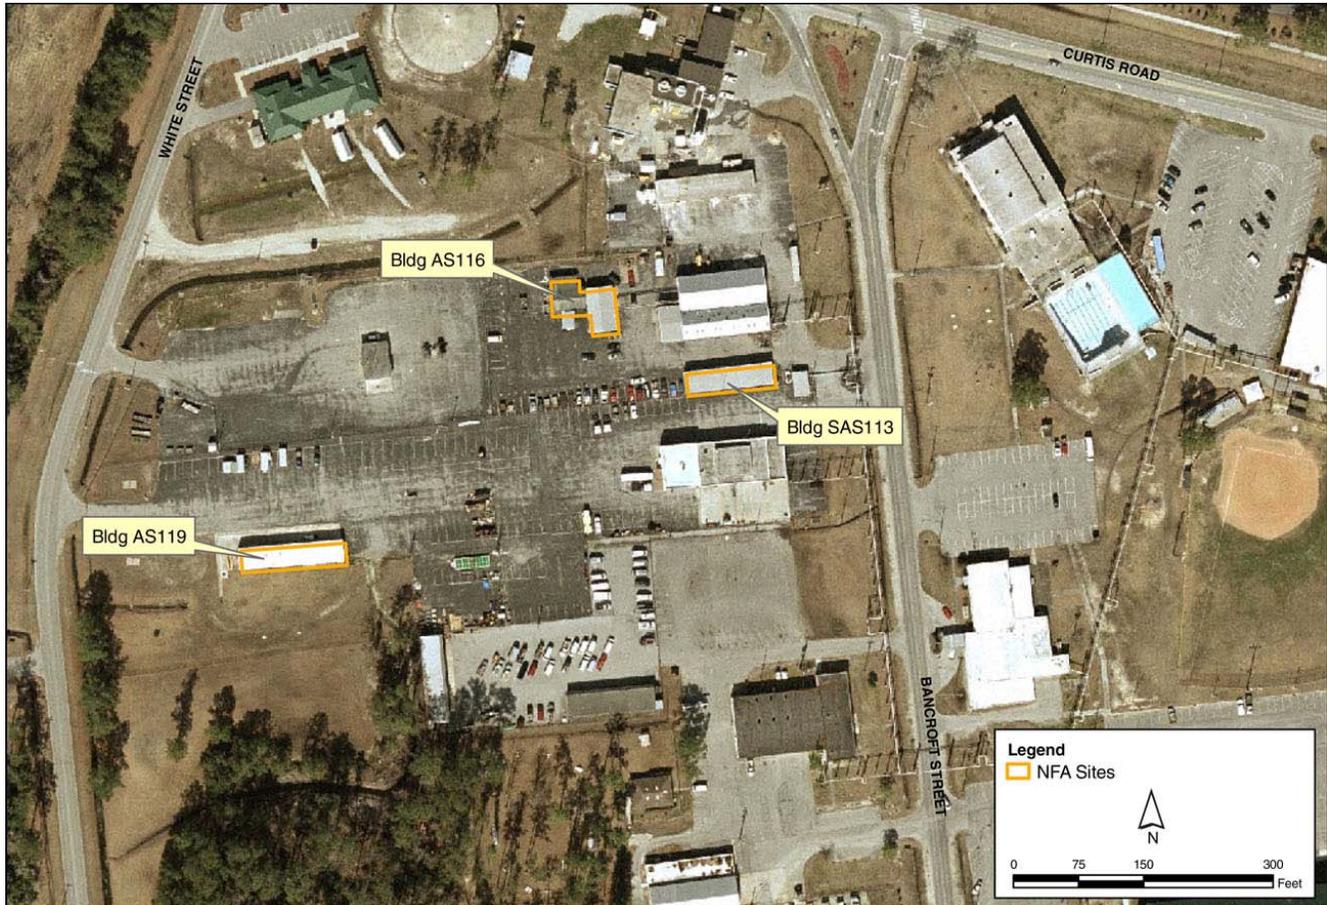
FIGURE 8-32  
MCAS New River Buildings SAS113, AS116, and AS119

Building SAS113 is located 100 feet west of Bancroft Road and consists of a covered four-bay open metal structure, constructed on a 6-inch thick slab. Building SAS113 was constructed in 1986 as a vehicle support area when surrounding buildings were converted into automotive hobby shops. A new automotive hobby shop opened at MCAS New River in 2009 and Building SAS113 is no longer actively used. The waste disposal practices are also unknown.

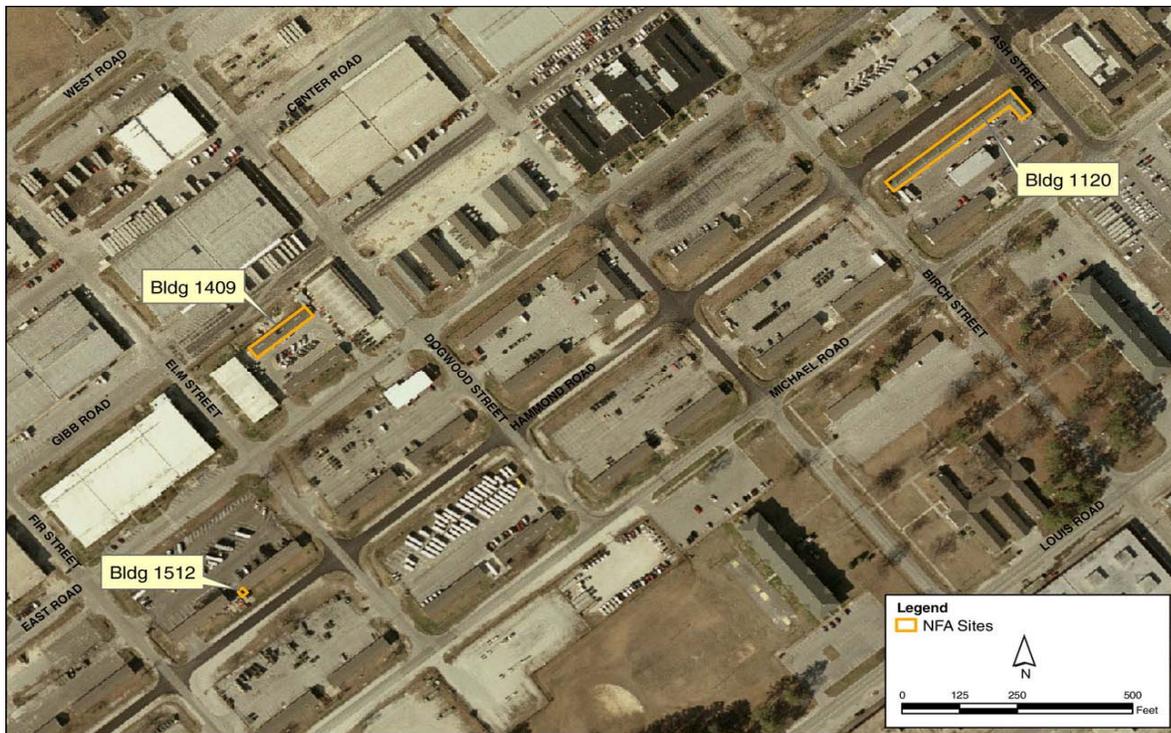
FIGURE 8-33  
Hadnot Point Industrial Area (Buildings 1120, 1409, and 1512)

The HPIA site encompasses less than half an acre and includes Buildings 1120, 1409, and 1512, located in the HPIA. Building HP1120 is located between Hammond Road, Birch Street, and Ash Street (**Figure 8-33**). It was constructed as an automobile hobby shop in 1955 with additions to the building constructed in 1964 and 1969. Building HP1120 has historically been used for auto body repair and painting.

Building HP1512 was historically located between Buildings HP1504 and HP1503 on Hammond Road. The operational history of the building is unknown; however, it is assumed that it was used as an automotive repair support structure for the series of vehicle maintenance buildings in the surrounding area. Building HP1512 is no longer present. The date of demolition is unknown.

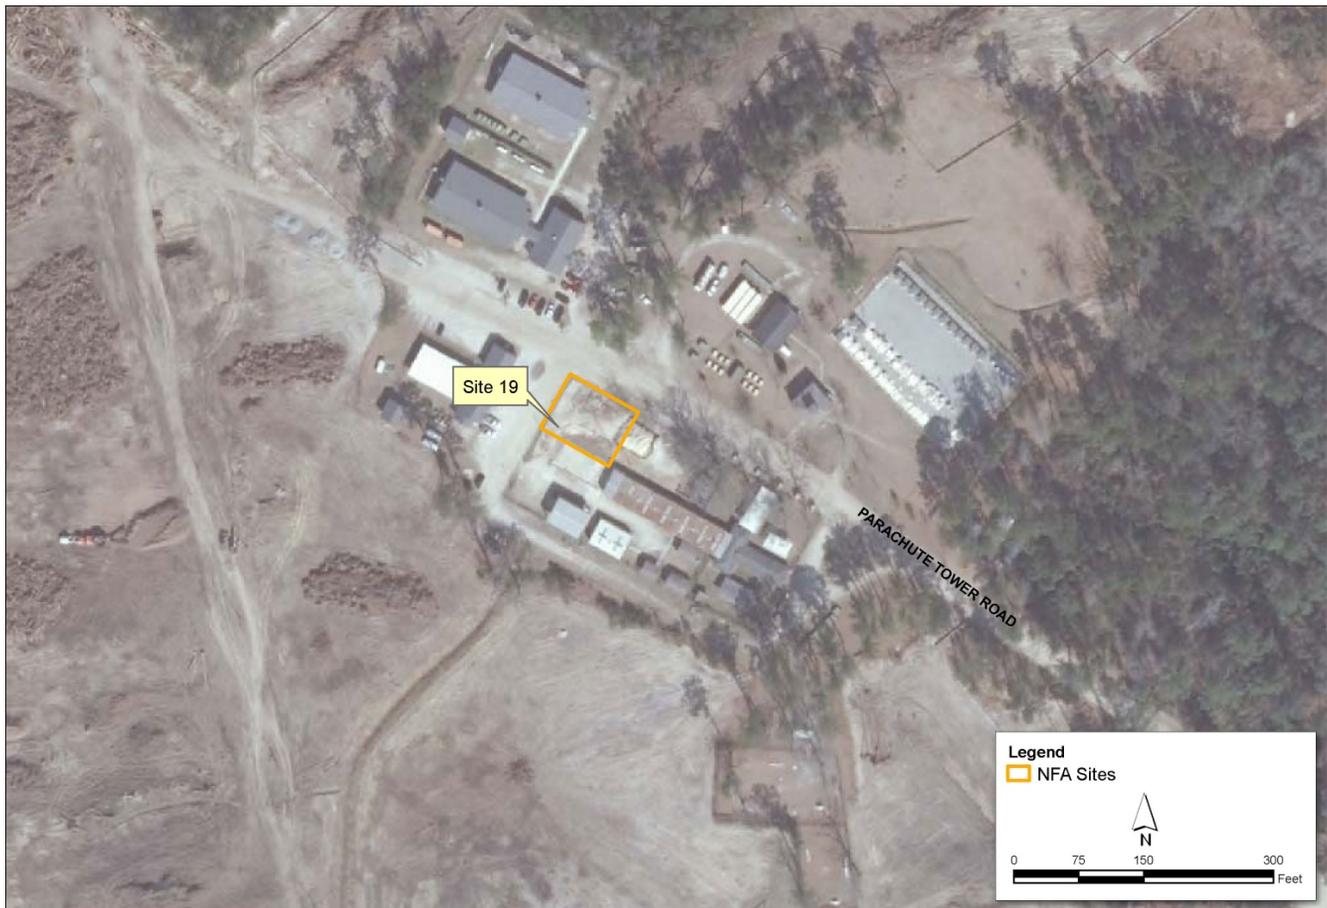
FIGURE 8-42  
IRP Site 19

Site 19, the Naval Research Laboratory Dump, is located within the Former Naval Research Laboratory boundary which encompasses approximately 4 acres located on the Mainside of the Base. From 1947 to 1976, the Naval Research Laboratory was located in the area of the Pest Control Shop (**Figure 8-42**). Activities at the laboratory included using radionuclides (Iodine 131) for metabolic studies on small animals. From 1956 to 1960, approximately 100 dogs were disposed of. Because Iodine 131 has a half-life of only 8 days, potential for residual radiological contamination was considered to be negligible. In November 1980, Strontium-90 beta buttons were found while grading a parking lot. The area was surveyed, and contaminated items were recovered. Soil samples were obtained and the site was cleaned of radioactive substances. Five 55-gallon drums of soil and animal residues were collected along with 499 beta buttons and appropriately disposed offsite.

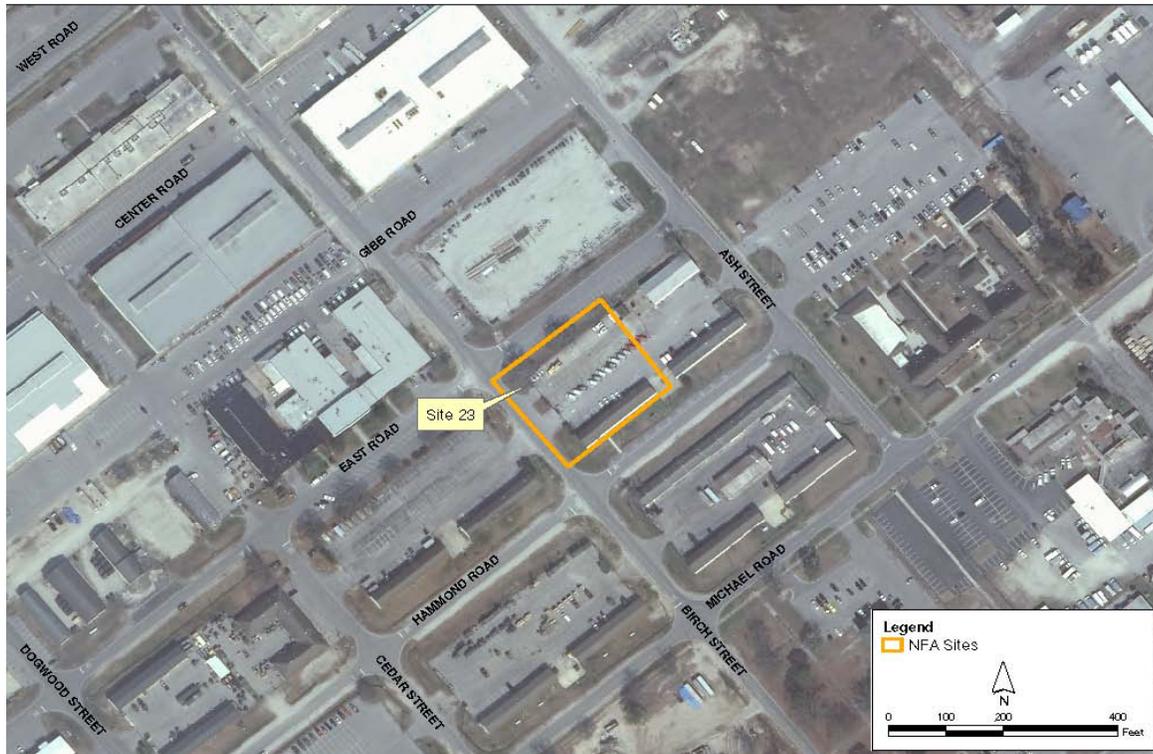
FIGURE 8-44  
IRP Site 23

Site 23, the Roads and Grounds Building 1105, is located in the HPIA, within the boundaries of IRP Site 78, covering less than a half of an acre (Figure 8-44). In 1958, the Pest Control Shop, moved its activities to Building 1105. From 1958 until 1977, Building 1105 was used for storage of insecticides and herbicides, while mixing of the chemicals was performed at Lot 140 (IRP Site 21). Storage and handling procedures at Building 1105 were reportedly adequate to prevent any large spills and to ensure a current safe working environment. Chemicals reportedly stored in Building 1105 included chlorinated hydrocarbons such as DDT and chlordane as well as diazinon, malathion, lindane, mirex, 2,4-D, dalapon, and dursban.

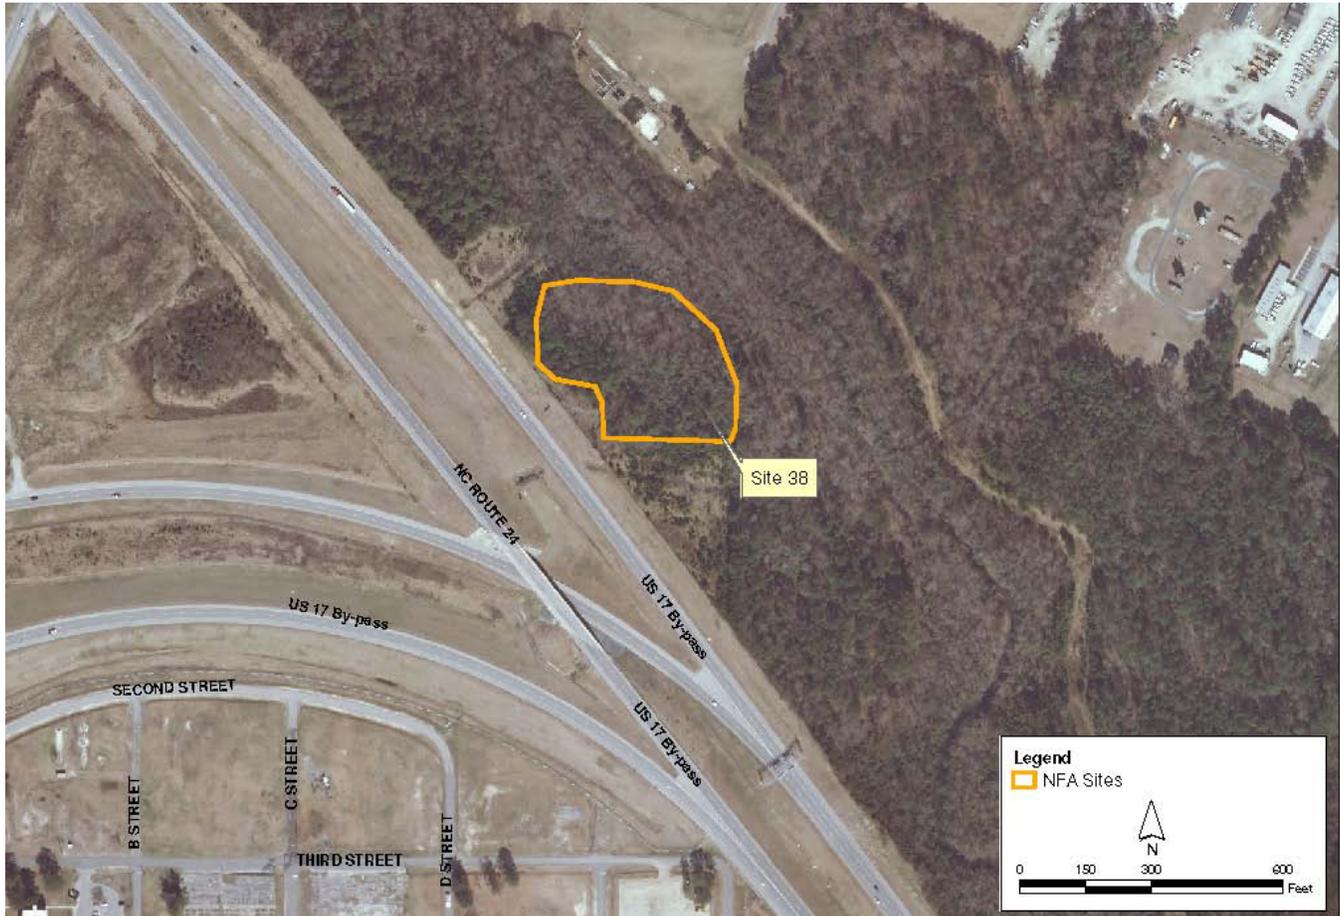
FIGURE 8-48  
IRP Site 38

Site 38, the Camp Geiger Area Surface Dump, encompasses approximately 3 acres in the Camp Geiger area of the Base (**Figure 8-48**). The dates of operation are unknown, but Site 38 was reportedly used for surface disposal of construction debris and branches. During the IAS, evidence of dumping activities was observed.
