# Site Management Plan Fiscal Year 2013

Marine Corps Installations East-Marine Corps Base Camp Lejeune  
Jacksonville, North Carolina

January 2013

prepared by **CH2MHILL.**

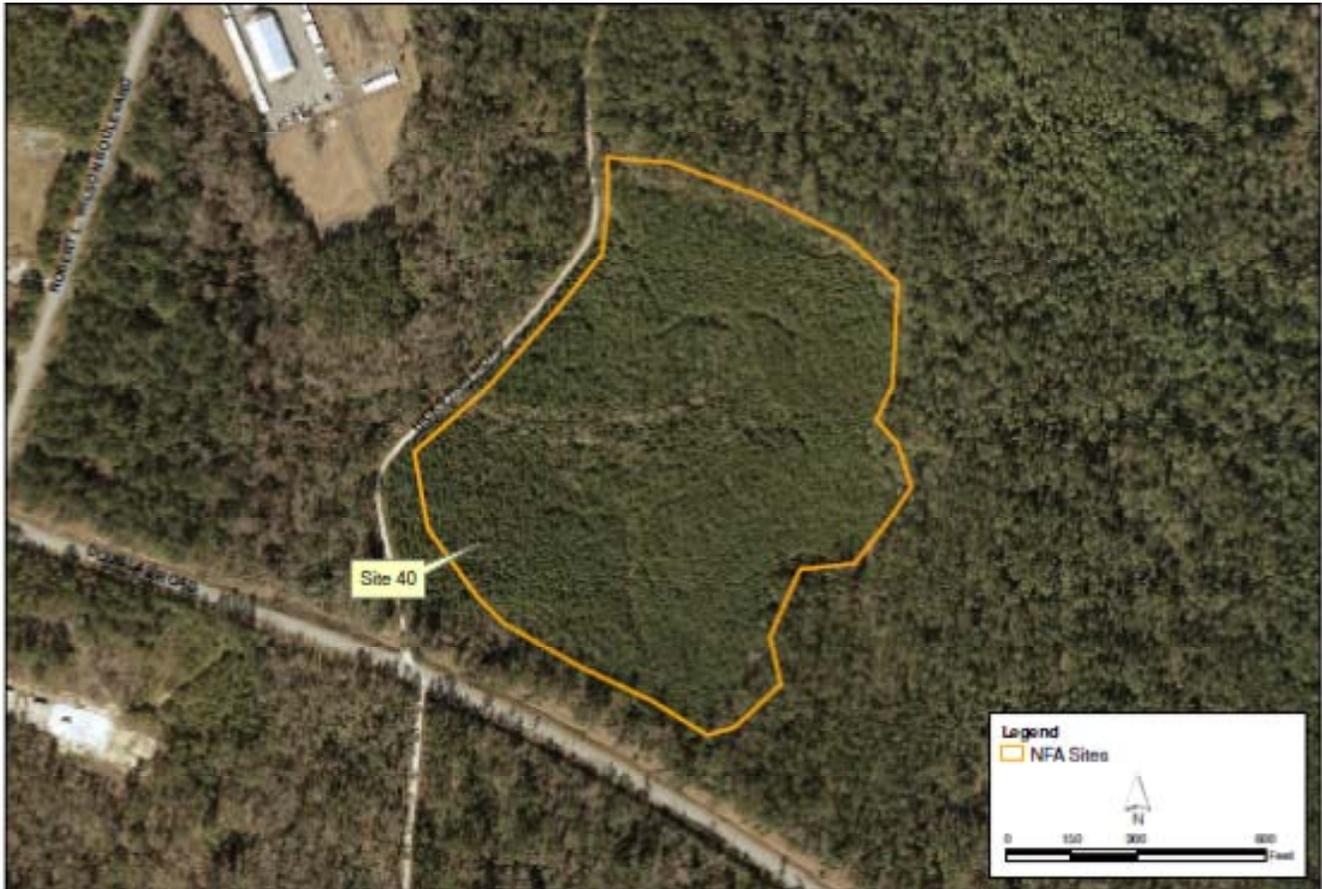
FIGURE 8-49  
IRP Site 40

Site 40, the Camp Geiger Area Borrow Pit, encompasses approximately 22 acres (**Figure 8-49**). Starting in 1969, Site 40 was reportedly used for disposal of auto parts and metal. The former borrow pit dump was reported to have covered an area of approximately 4 to 5 acres within Site 40.

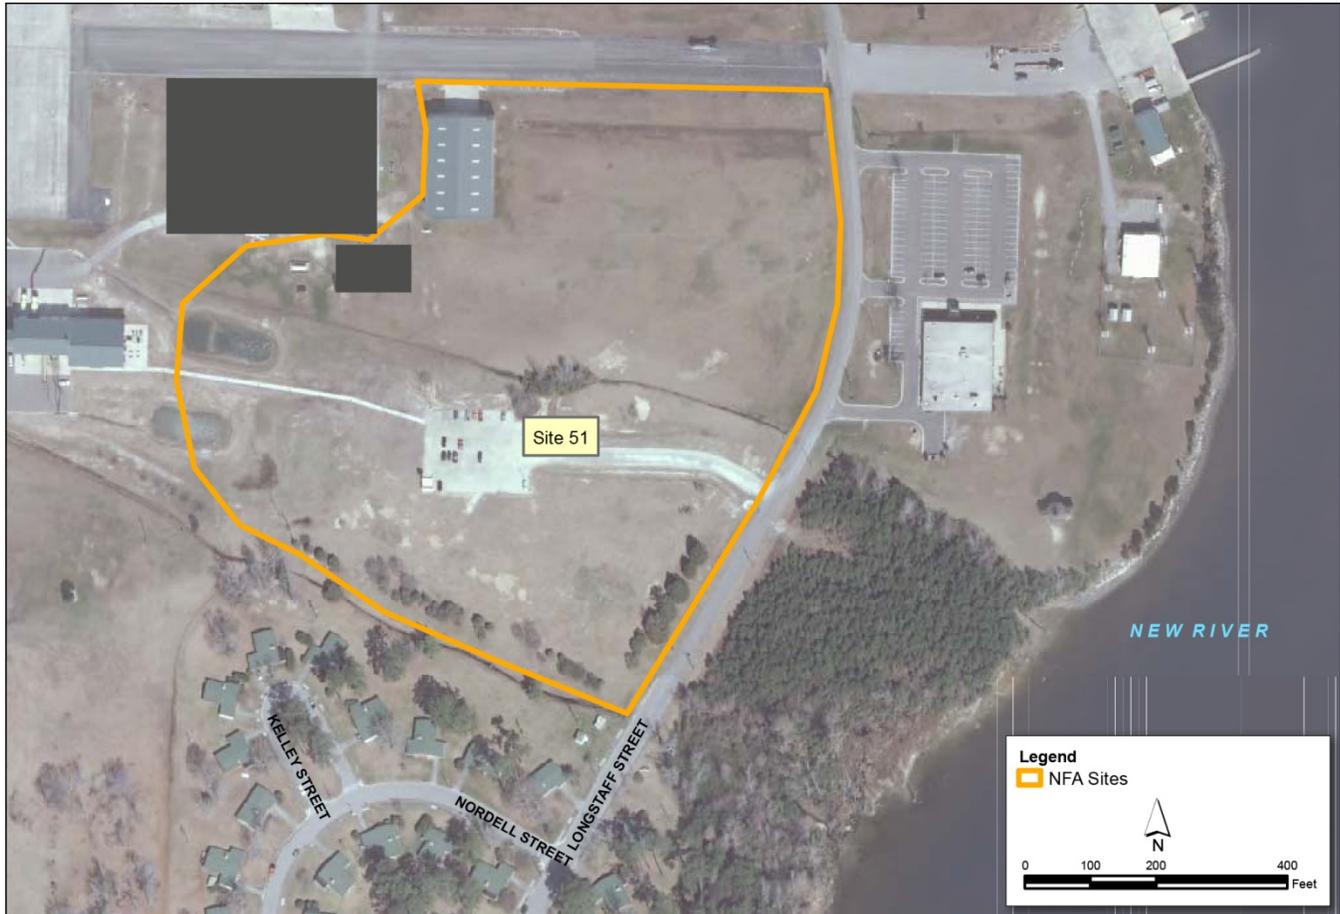
FIGURE 8-53  
IRP Site 51

Site 51, the MCAS Football Field, encompasses approximately 20 to 30 acres in MCAS New River, in the northwest portion of the Base. Site 51 was reportedly the site of empty container disposal between approximately 1967 and 1968 (**Figure 8-53**). Paint cans and hydraulic fluid cans were reportedly disposed.

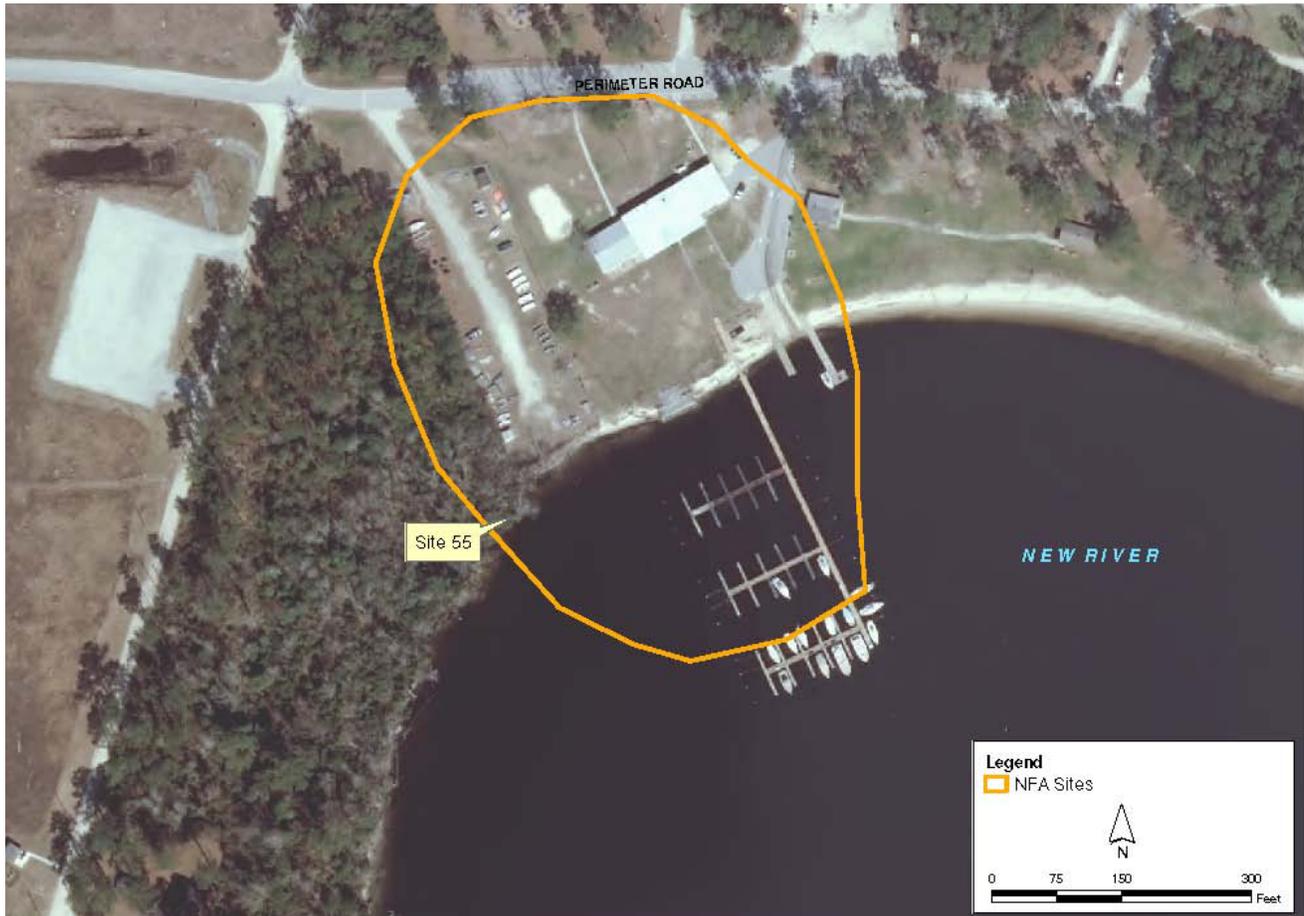
FIGURE 8-55  
IRP Site 55

IRP Site 55, the Air Station East Perimeter Dump, encompasses approximately 6 acres in MCAS New River, in the northwest portion of the Base (**Figure 8-55**). From the 1950s to the 1960s, IRP Site 55 was reportedly used as a disposal area for barrels, tires, trash, metal planking, and telephone poles. The area is currently used as a marina and recreation area by the Air Station.

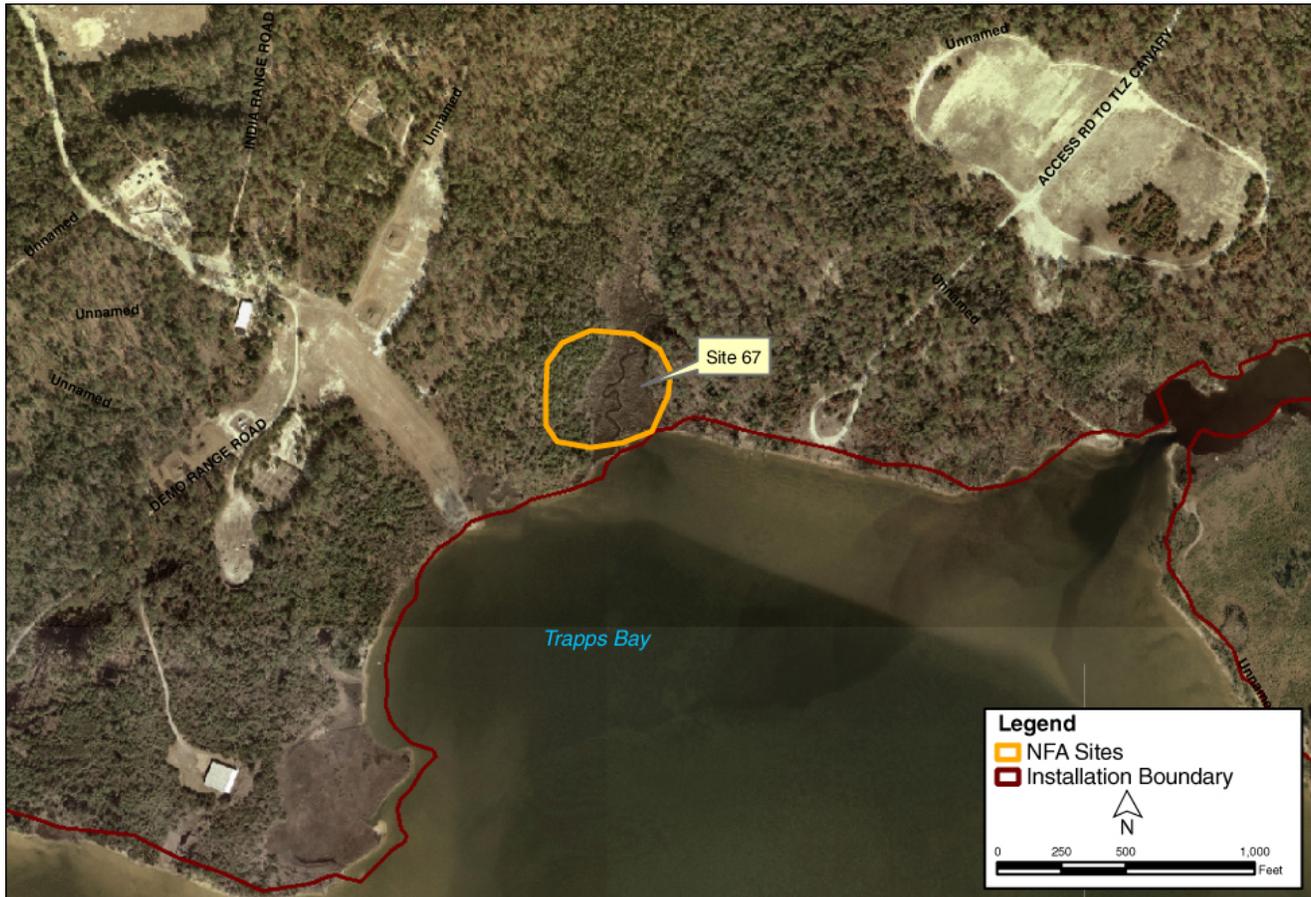
FIGURE 8-60  
IRP Site 67

IRP Site 67, Engineer’s Trinitrotoluene (TNT) Burn Site, encompasses approximately 7 acres located in the Courthouse Bay area of the Base (**Figure 8-60**). In 1951, IRP Site 67 was reportedly used for TNT disposal. Deep pits (2- to 3-feet deep) were dug and unwanted TNT was opened and burned. Complete consumption of all TNT was reported during these procedures.

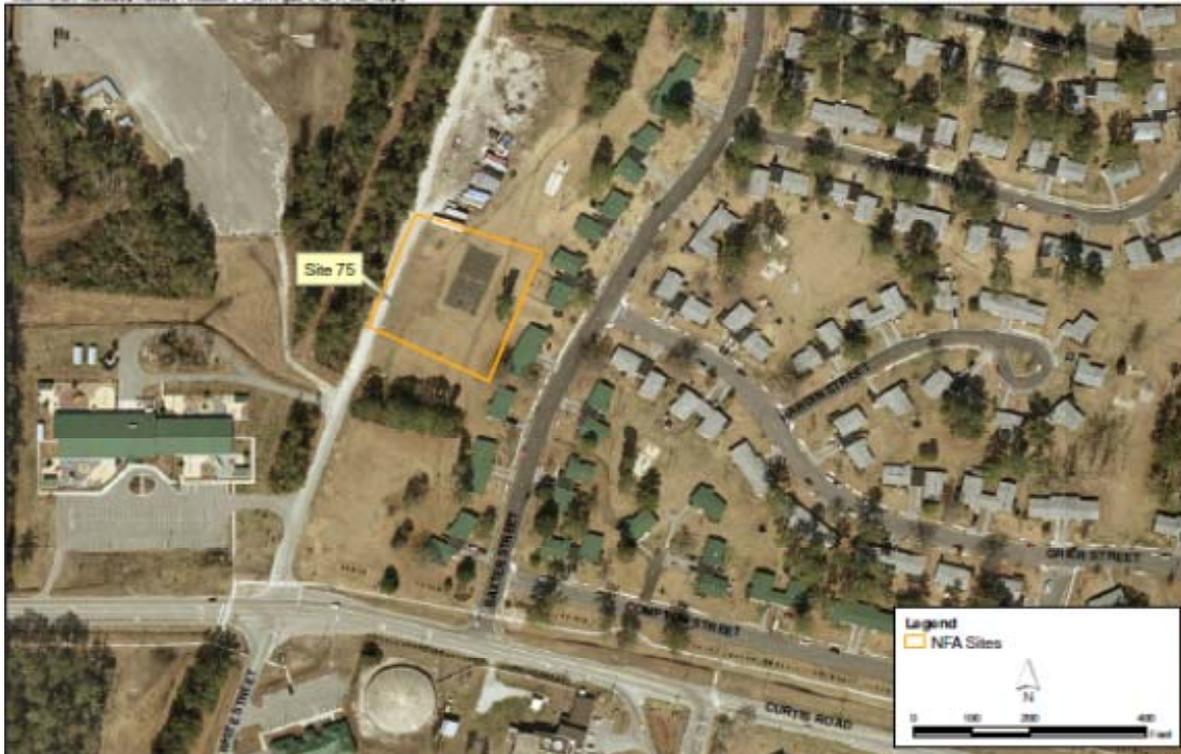
**FIGURE 8-61**  
IRP Site 75

Site 75, the MCAS Basketball Court Site, encompasses approximately 1 acre and is located in the MCAS New River operations area (**Figure 8-61**). Site 75 was reportedly a drum burial area that was used in the early 1950s. The excavation area was an oval-shaped pit approximately 90 feet long by 70 feet wide and was sufficiently deep to have encountered the water table. An estimated 75 to 100 55-gallon drums were placed in this pit. The drums reportedly contained a chloroacetophenone tear gas solution used for training. Additional organic chemicals, such as chloroform, carbon tetrachloride, benzene, and chloropicrin, may have been present in the solution.

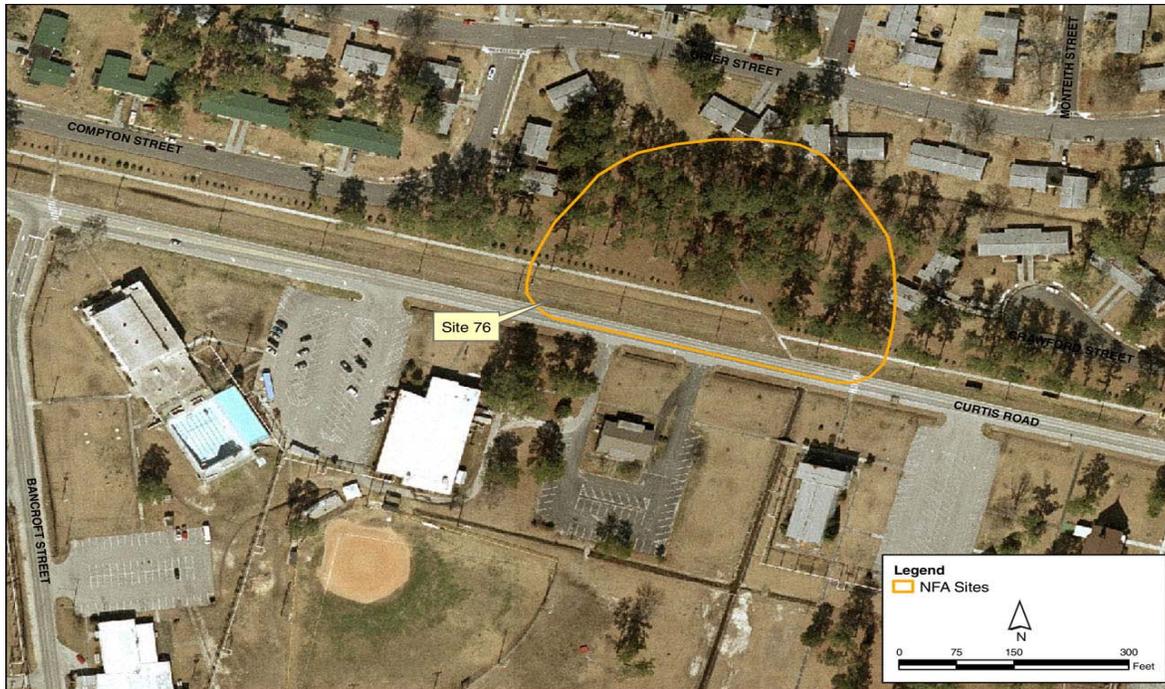
FIGURE 8-62  
IRP Site 76

Site 76, the MCAS Curtis Road Site, is located in the MCAS New River operations area and covers approximately 3 acres (**Figure 8-62**). There are several base housing units to the immediate north of the Site 76 study area. The site was reportedly used as a drum disposal area on two occasions in 1949. The estimated area of the disposal unit is a quarter-acre, and approximately 25 to 75 55-gallon drums were allegedly disposed at this site. The drums reportedly contained a chloroacetophenone tear gas solution used for training similar to that allegedly buried at Site 75. Additional organic chemicals, such as chloroform, carbon tetrachloride, benzene, and chloropicrin, may have been present in the solution.

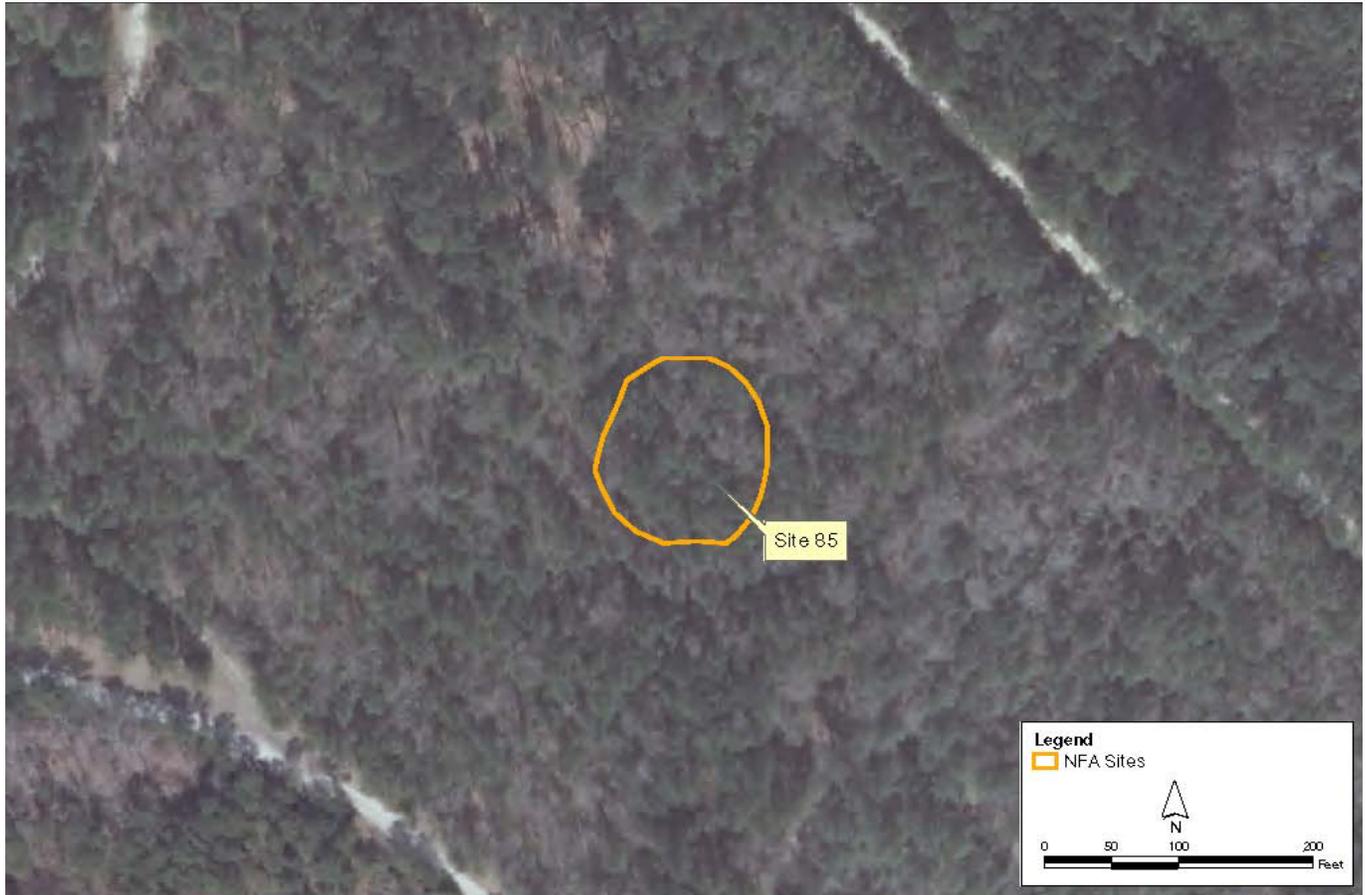
**FIGURE 8-63**  
IRP Site 85

Site 85 covers approximately 5 acres of heavily vegetated land (**Figure 8-63**) in the Camp Johnson area of the MCIEAST-MCB CAMLEJ. During the 1950s Site 85 was used for battery disposal. The site was discovered in 1992 when decomposed batteries used in military communication equipment during the Korean War ear were unearthed as a roadway was being widened. Discarded charcoal canisters from air purifying respirators and battery packs were also discovered throughout the site.

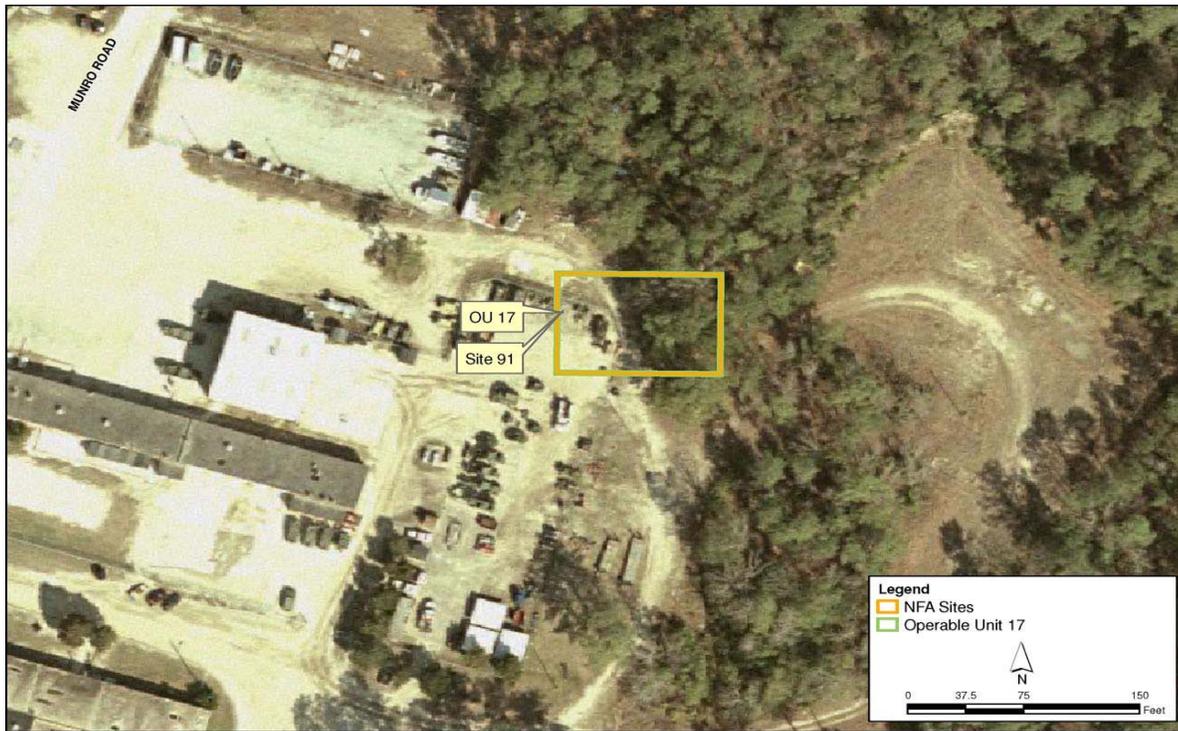
**FIGURE 8-66**  
IRP Site 91, Operable Unit 17

Site 91, Building BB-51, encompasses approximately 8 acres within OU 17, in the southeast portion of the Base in the Courthouse Bay Complex (**Figure 8-66**). OU 17 consists of three sites (Sites 90, 91, and 92) that have been grouped together based on the unique characteristic of suspected waste. All three sites were formerly part of the UST program, but were transferred to the IRP because petroleum related contamination was not identified. Site 91 is currently used by the Marine Corps School of Engineering to train personnel. The site is a former UST basin where two 300-gallon steel USTs, used to store waste oil, were previously located northeast of Building BB-51. The USTs were removed in August 1992. At the time of the UST closure, TPH contamination was detected in the soil samples.

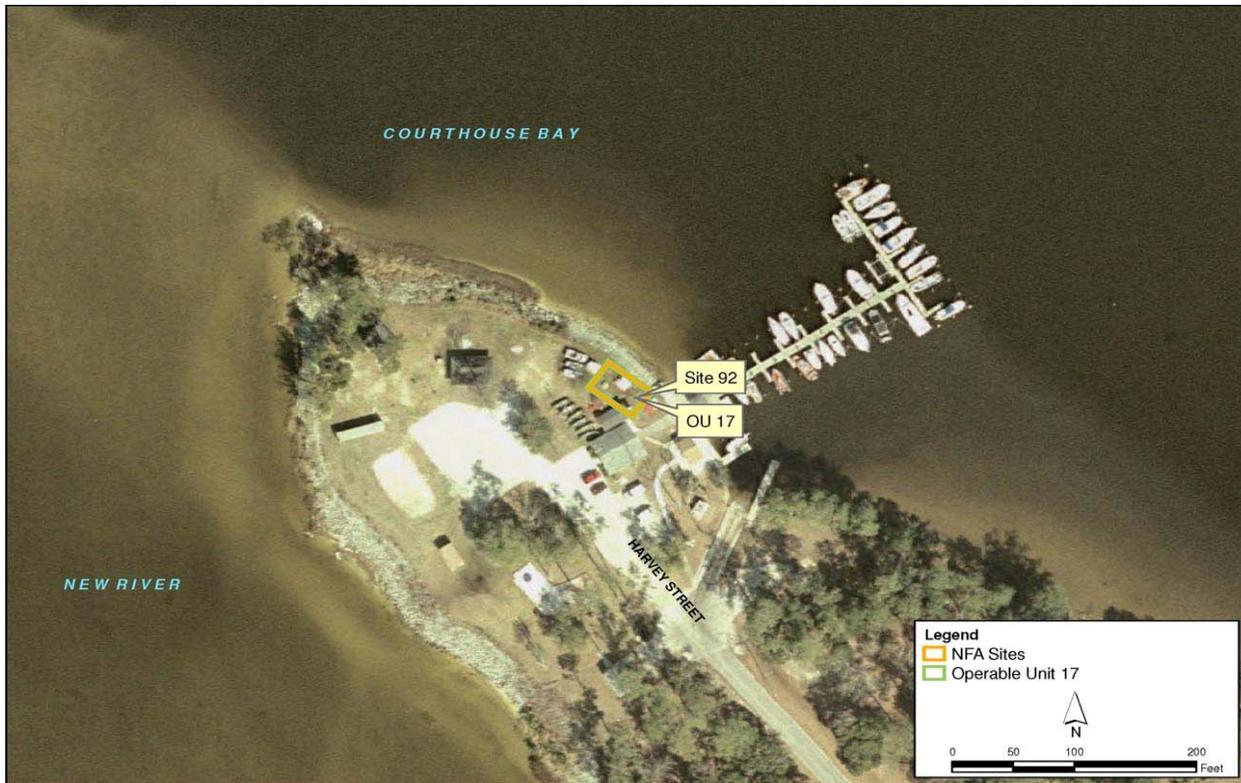
FIGURE 8-67  
IRP Site 92, Operable Unit 17

Site 92, formerly Building BB-246, is located within OU 17, in the southeast portion of the Base in the Courthouse Bay Complex and covers approximately 1 acre (**Figure 8-67**). OU 17 consists of three sites (Sites 90, 91, and 92) that have been grouped together based on the unique characteristic of suspected waste. All three sites were formerly part of the UST program, but were transferred to the IRP because petroleum related contamination was not identified. Site 92 is a former UST basin where one 1,000-gallon steel UST, containing gasoline, were previously located. The UST was installed in 1980, deactivated in 1989, and removed in January 1994. A subsequent SI identified the presence of chlorinated hydrocarbons in the groundwater.

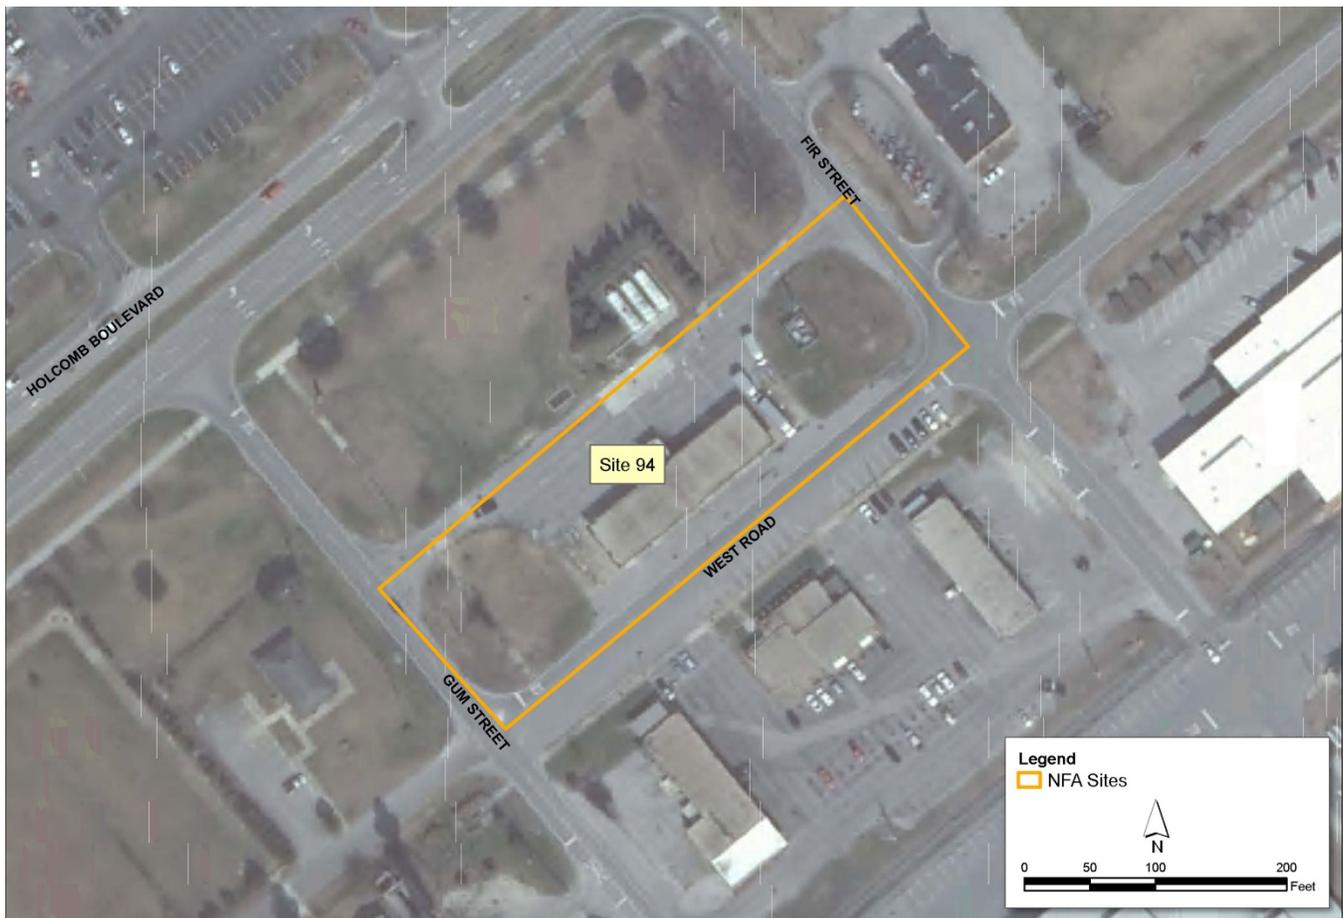
**FIGURE 8-68**  
IRP Site 94, Operable Unit 18

Site 94, the PCX Service Station, covers approximately 2 acres and is located within the HPIA on the Mainside of the Base within the western portion of Site 78 (OU 1) (**Figure 8-68**). PCX Service Station is an active facility, providing refueling services for private vehicles, and consists of a single-story brick structure flanked by three concrete pump islands on two sides. Historical records indicate that two 10,000-gallon and two 30,000-gallon USTs storing various grades of gasoline were installed during the 1950s. The USTs and associated petroleum-contaminated soil were removed in January 1995. During subsequent phases of investigation, free phase hydrocarbons and chlorinated organic contaminants were detected in groundwater. Soil and groundwater contamination resulting from the petroleum releases at the site is currently being remediated under NCDENR’s UST program.

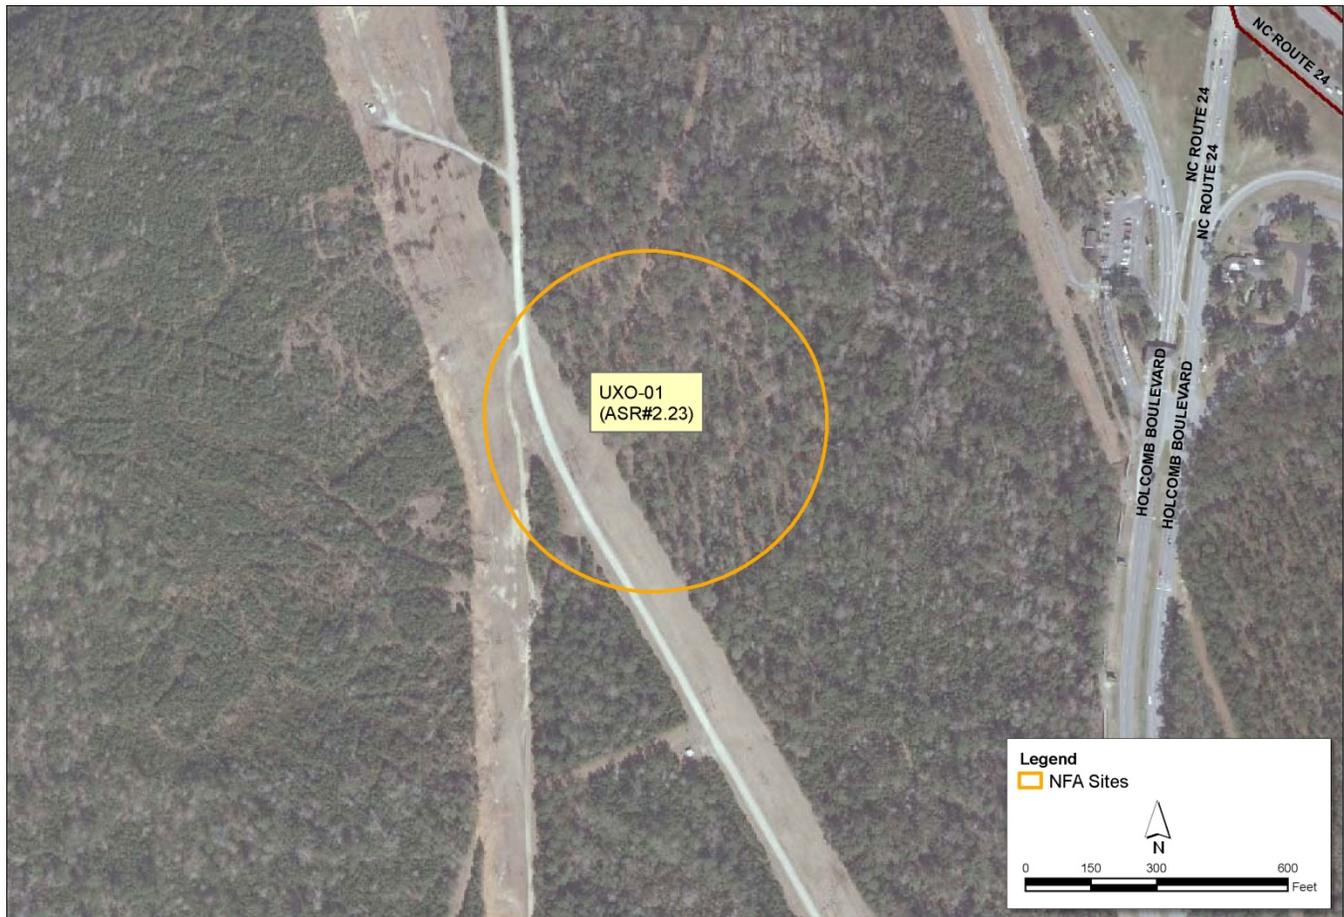
FIGURE 8-70  
MMRP Site UXO-01, ASR #2.23

The Former Live Hand Grenade Course encompasses approximately 10 acres on the Mainside of the Base (**Figure 8-70**). The Live Hand Grenade Course was established under Camp Training Order Number 7-1945, dated March 19, 1945, and was disestablished in March 1946 and no longer used for the firing of live ammunition. During operation of the site, munitions used included fragmentation, offensive, and practice grenades.

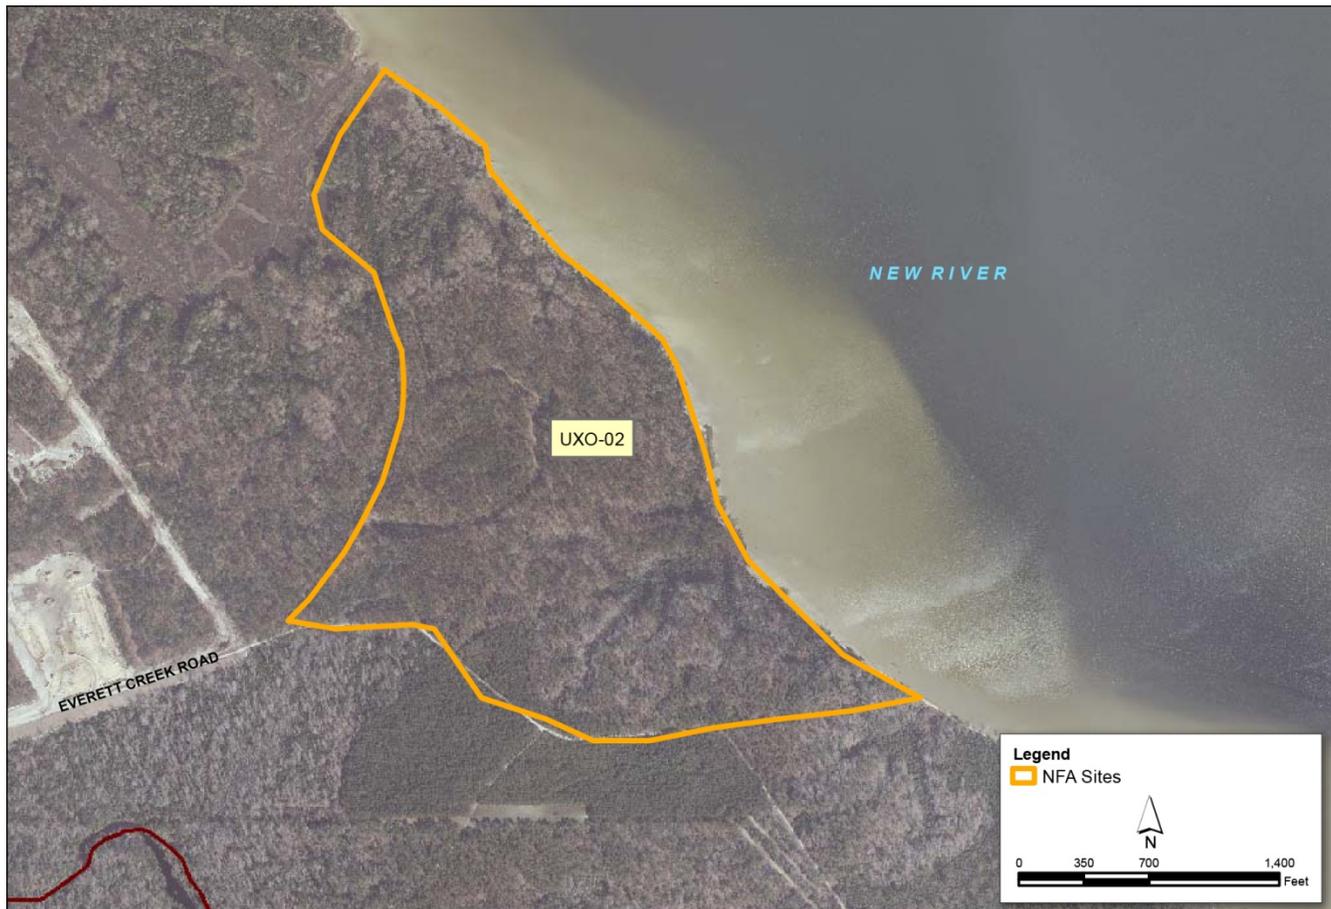
FIGURE 8-71  
MMRP Site UXO-02, ASR #2.201

Site UXO-02, the Unnamed Explosive Range, encompasses approximately 127 acres along the west bank of the New River in the Rifle Range Area of the Base (**Figure 8-71**). UXO-02 encompasses IRP Site 69 (Section 5.1.3). UXO-02 was used as an explosive range from 1973 to 2002; however, the types of munitions employed at this range are unknown.

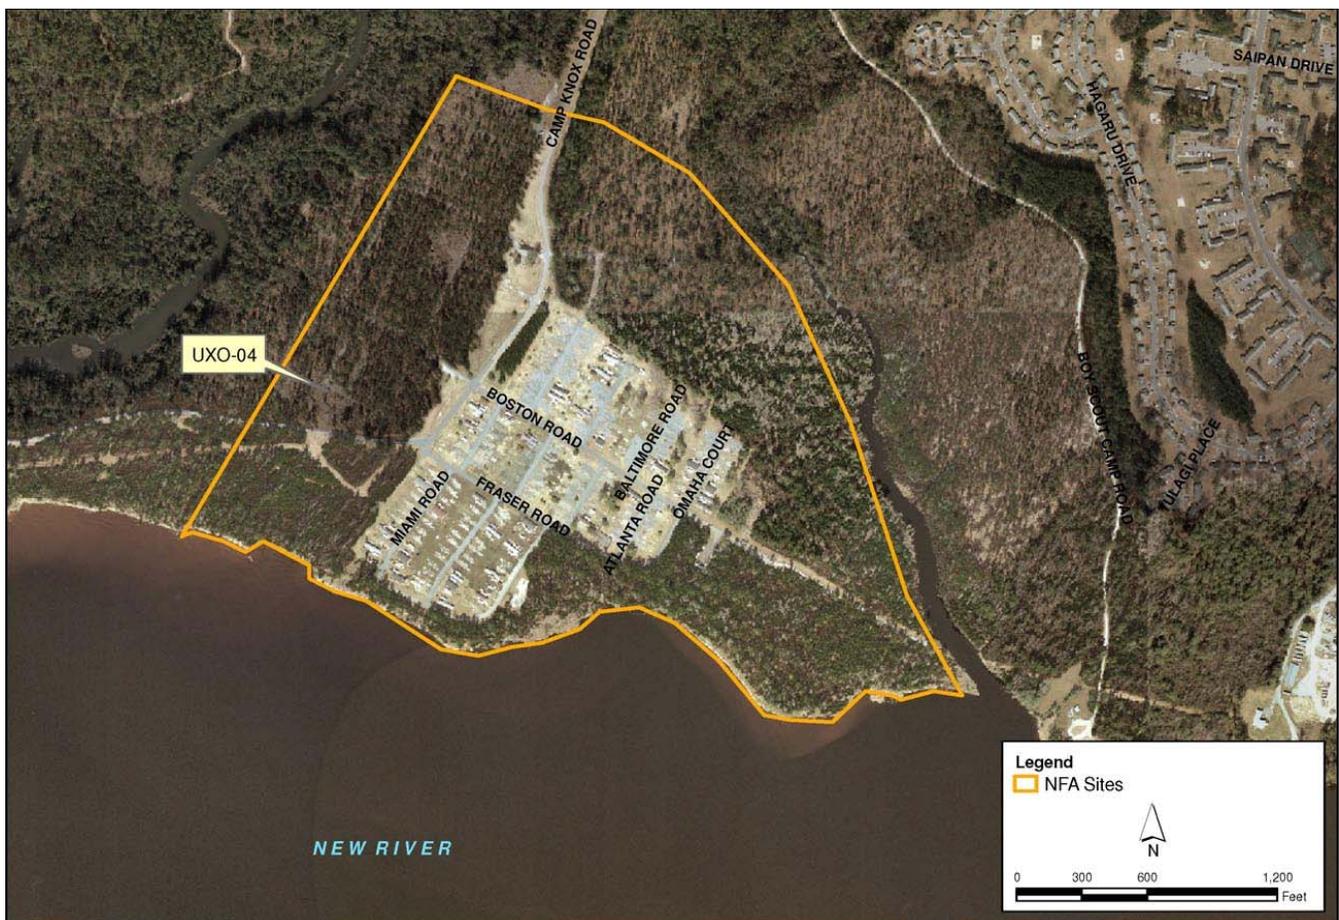
FIGURE 8-73  
MMRP Site UXO-04

Site UXO-04, Knox Trailer Park, encompasses approximately 134 acres in the northern portion of the Base (**Figure 8-73**). The Knox Trailer Park area began as a Civilian Conservation Corps Camp in 1941, responsible for eliminating the source of endemic malaria by draining all surrounding wetlands. This was accomplished by ditching, using dynamite, and spraying diesel oil on water surfaces as a larvicide. Additionally, a dog-training school was located in the southernmost area of the site from 1942 to 1946. The dogs were subjected to overhead rifle and machine gun fire and explosions of charges of dynamite and TNT to simulate battlefield conditions. It has also been reported that the research facilities at Camp Knox conducted testing on body armor during World War II (WW II) through the early 1950s. The research was likely performed indoors, and the amount of ammunition expended for testing purposes is expected to be minimal. From the early 1950s until 2006, the area has been used for residential housing. Sometime between 1974 and 1976, an EOD technician responded to the discovery of UXO in the Knox Trailer Park area. A bulldozer operator uncovered a live WW II MK-II high-explosive hand grenade while conducting excavation activities. A visual inspection of the Knox Trailer Park was conducted in November 2002 by the Base's EOD team, and no UXO was discovered.

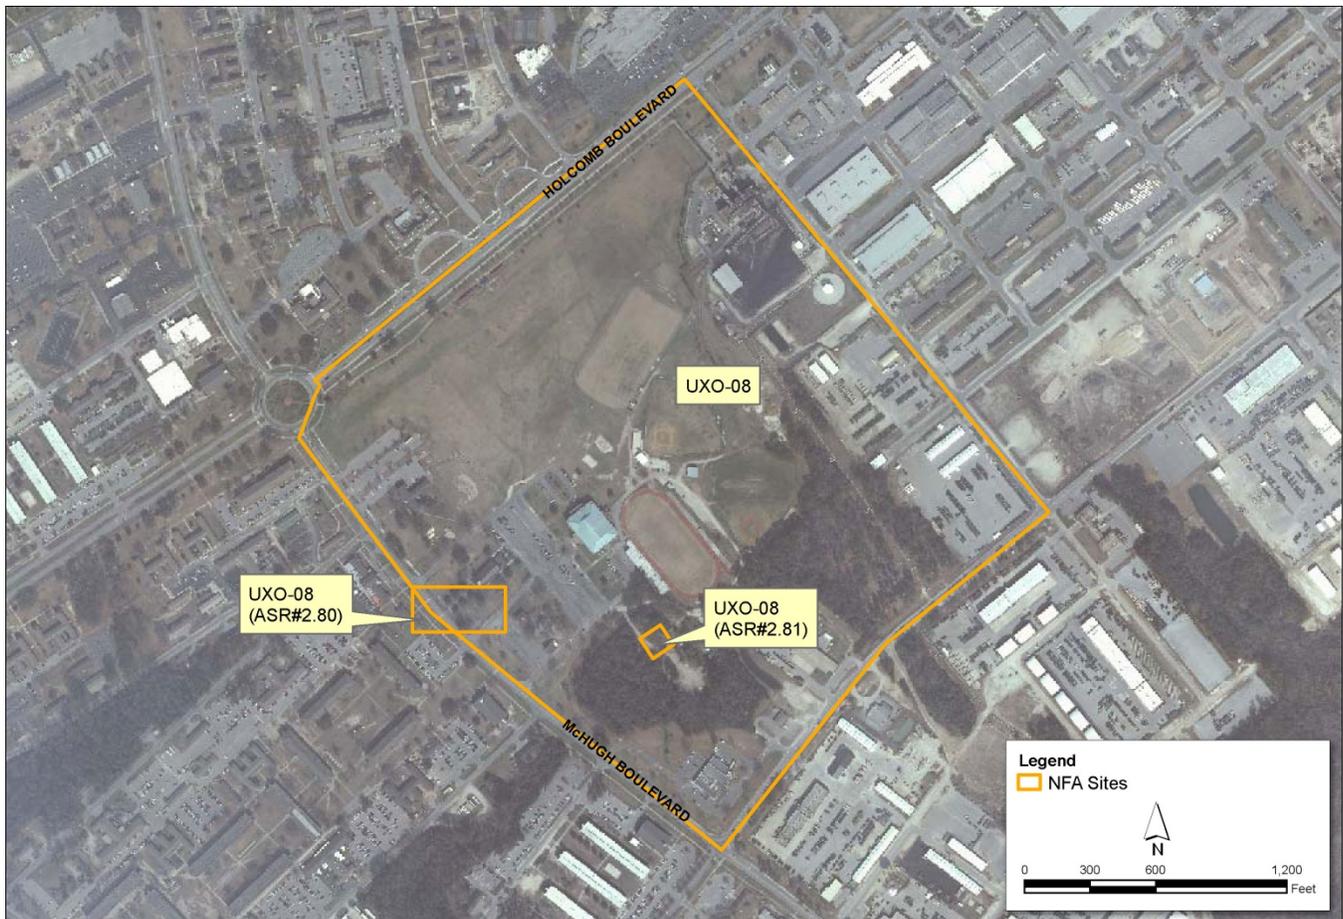
FIGURE 8-76  
MMRP Site UXO-08, ASR #2.182 and ASR #2.80

Located within the boundaries of IRP Site 78, Site UXO-08 encompasses approximately 144 acres in the HPIA (Figure 8-76). Areas within UXO-08 include the 2.36-inch Bazooka Range, the D-7 Gas Chamber, and the Base Chemical Smoke (CS) Chamber and Nuclear, Biological, and Chemical (NBC) Training Trail. The Range Identification and PA Report (USACE, 2001) identified the D-7 Gas Chamber as being located at Building 756. The D-7 Gas Chamber is estimated to have been used from 1953 to 1961, and is thought to have primarily used tear gas. Base maps and the Range Identification and PA Report indicate that the operation of the Base CS Chamber and NBC Training Trail took place from 1985 to 1987. The amount of chemical stimulants used during the facilities operation is unknown. Reports have indicated the presence of a suspected firing range, designated as the MCIEAST-MCB CAMLEJ Cantonment 2.36-inch Bazooka Range. Retired Base EOD personnel have reported the findings of bazooka rounds on several occasions and at various locations within Parade Grounds during the 1970s and 1990s.

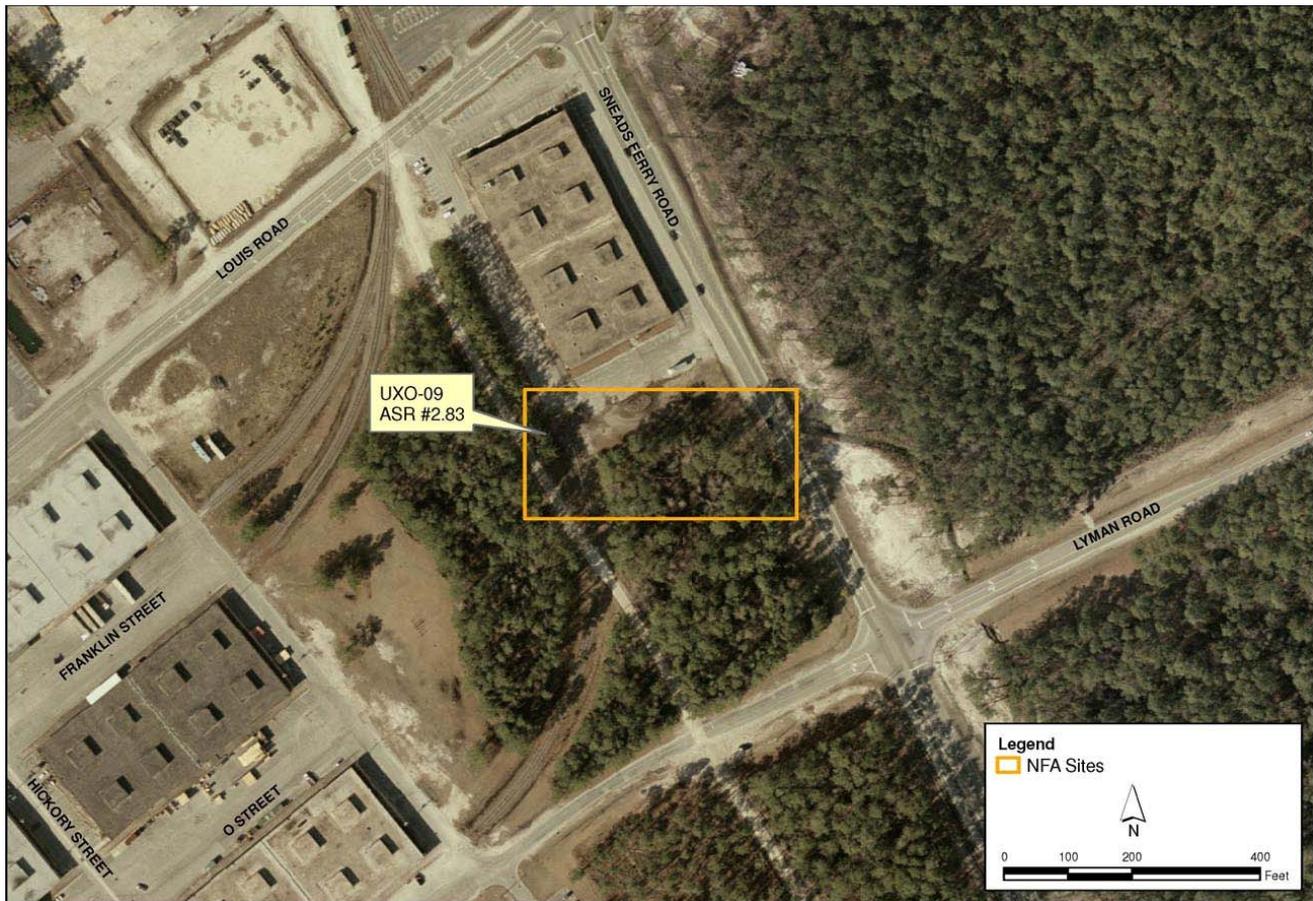
FIGURE 8-77  
MMRP Site UXO-09, ASR #2.83

Site UXO-09 encompasses approximately 3 acres in the HPIA (Figure 8-77). The F-9 Triangulation Range area was established in or prior to 1953. As reported in the ASR Report, interviews with base personnel indicate that the range was used for M-1 rifle target practice. Base personnel also indicated that the original range was most likely 100 feet wide and approximately 25 to 50 feet long, and may have contained a large dirt berm as a bullet stop. Based on interviews with base personnel, former munitions use was limited to small arms ammunition.

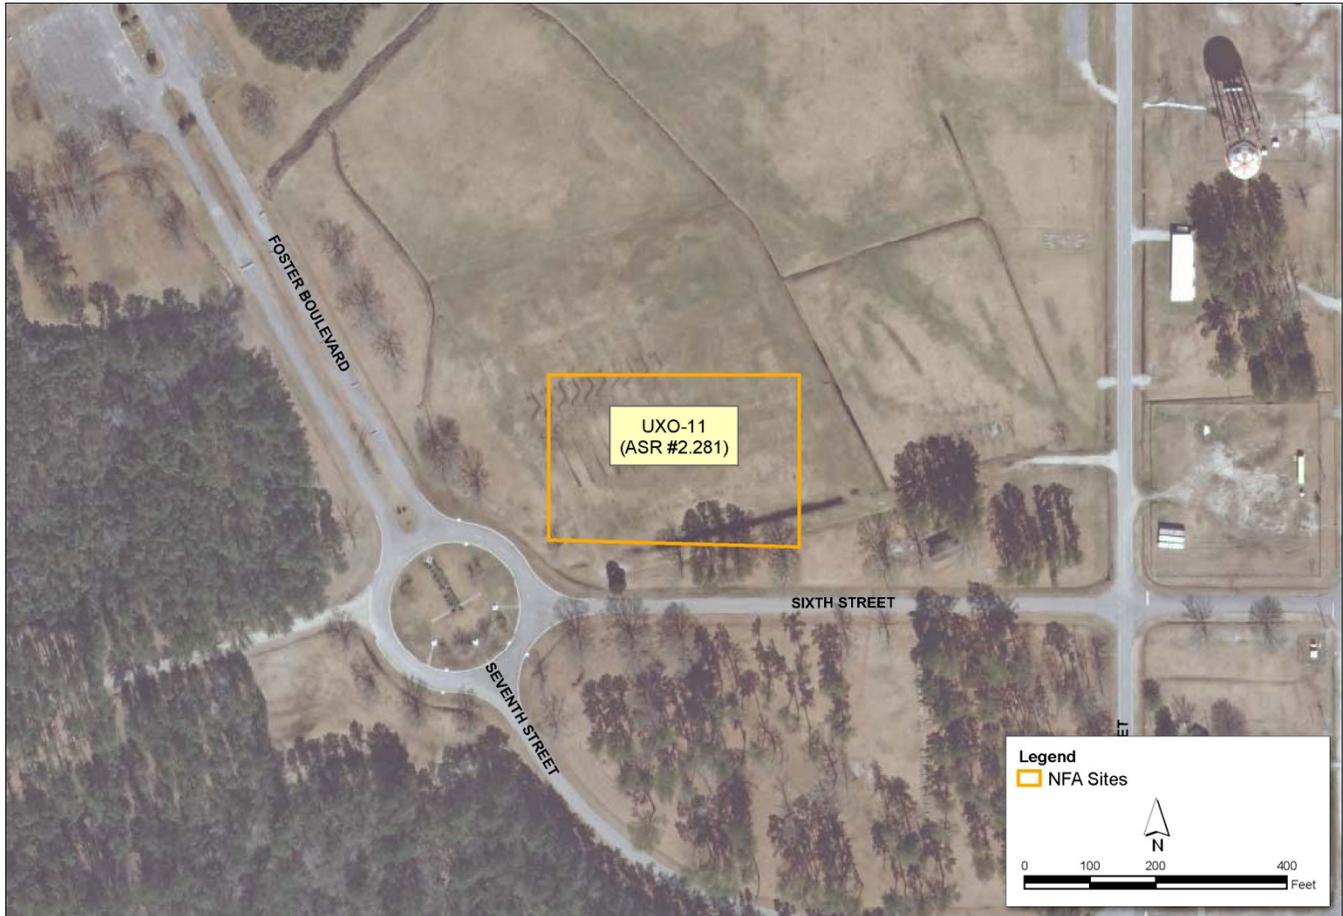
FIGURE 8-79  
MMRP Site UXO-11, ASR #2.281

Site UXO-11, the Practice Hand Grenade Course, encompasses approximately 2 acres located in Camp Geiger in the northwest portion of the Base (Figure 8-79). UXO-11 was reportedly used as a range in 1953. The types of munitions employed at the site are unknown; however, it is assumed that practice hand grenades were used.

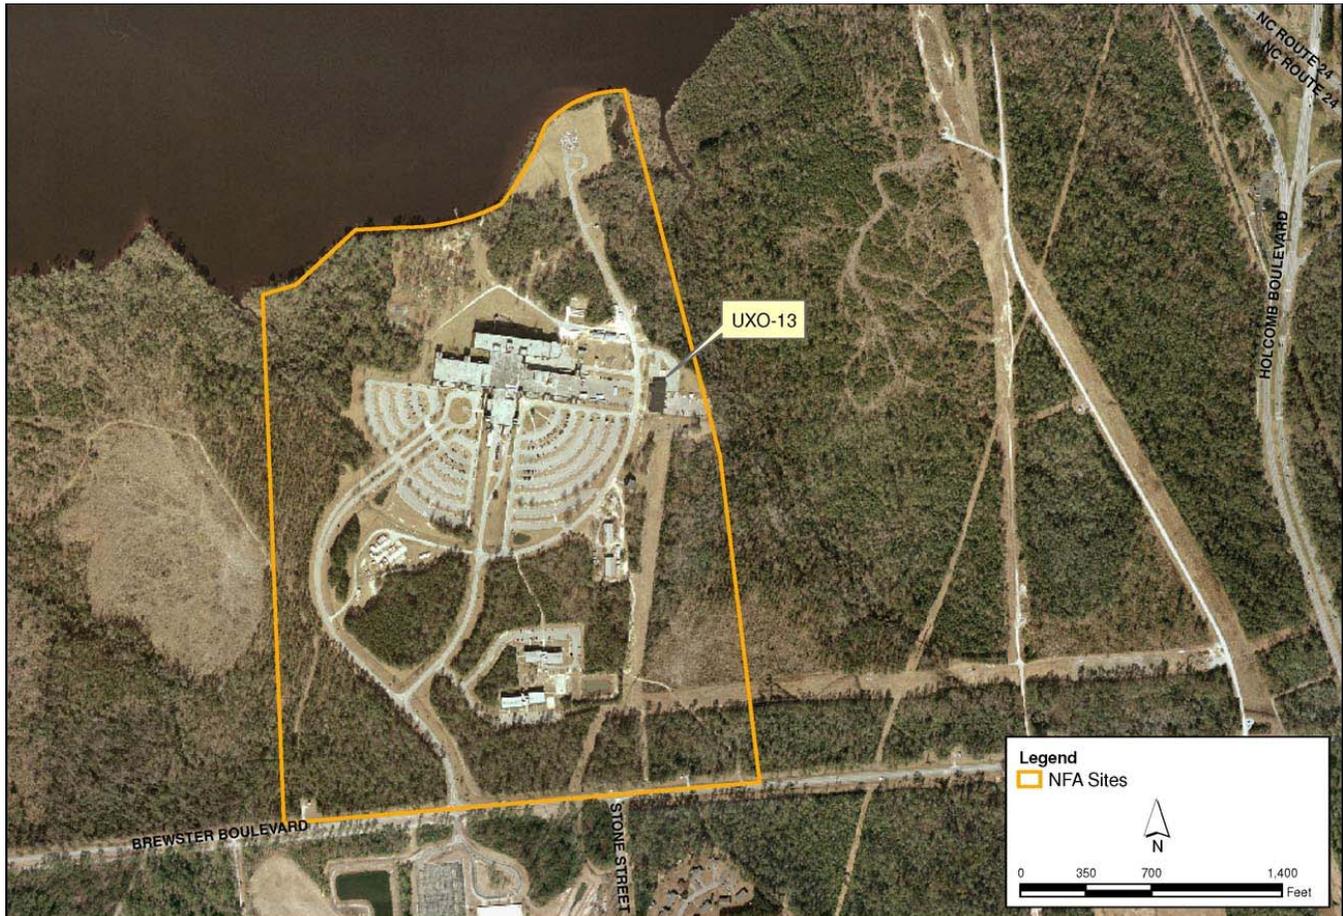
FIGURE 8-81  
MMRP Site UXO-13

Site UXO-13, the Naval Regional Medical Center, encompasses approximately 176 acres located on the Mainside of the Base (**Figure 8-81**). No known historic live fire activities were conducted within this area; rather it was designated as a “Maneuver Training Area” used to train troops in non-live fire operations. UXO-13 was administratively closed on March 24, 2004, due to no known historic live-fire activities on this range.
