# Site Management Plan Fiscal Year 2013

Marine Corps Installations East-Marine Corps Base Camp Lejeune  
Jacksonville, North Carolina

January 2013

prepared by **CH2MHILL.**

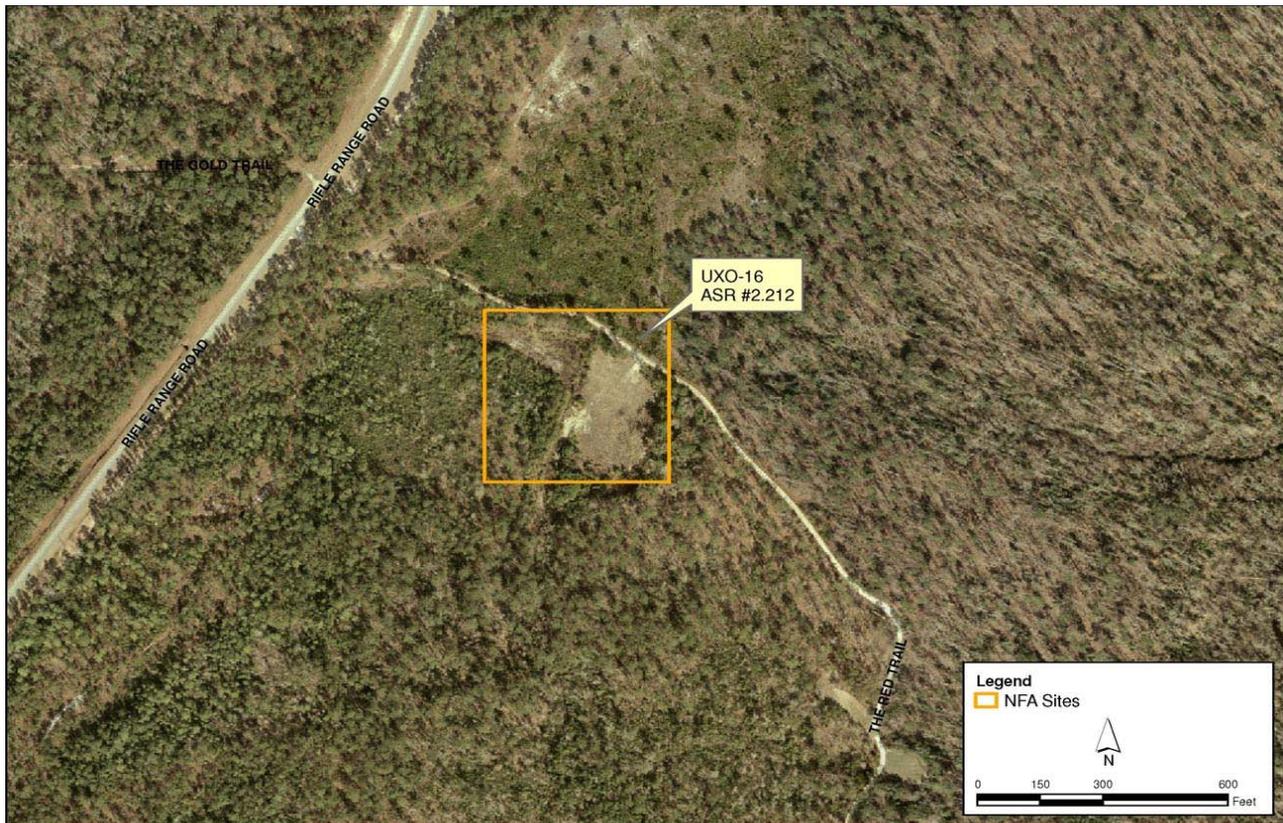
FIGURE 8-83  
MMRP Site UXO-16, ASR #2.212

Site UXO-16, also referred to as Former Gun Positions 41A and 41B, encompasses approximately 4 acres in the Stone Bay area of the Base. UXO-16 was first established during WW II as a training ground and was also used during the Korean War-era as a training ground (**Figure 8-83**). Howitzers were reportedly positioned at Site UXO-16 and fired 105-mm and 155-mm munitions into the K-2 and G-10 Impact Areas; other munitions suspected to be used at Site UXO-16 include 4.2-inch, 81-mm, 120-mm, 175-mm, 4.2-inch, and 8-inch munitions.
