DEPARTMENT OF THE NAVY
CRANE DIVISION
NAVAL SURFACE WARFARE CENTER
300 HIGHWAY 361
CRANE INDIANA 47522-5001

CORRECTIVE ACTION FOR SOLID WASTE MANAGEMENT UNITS

(Updated May 2005)

**NSWC Crane
 Solid Waste Management Units
 & Area of Concern**

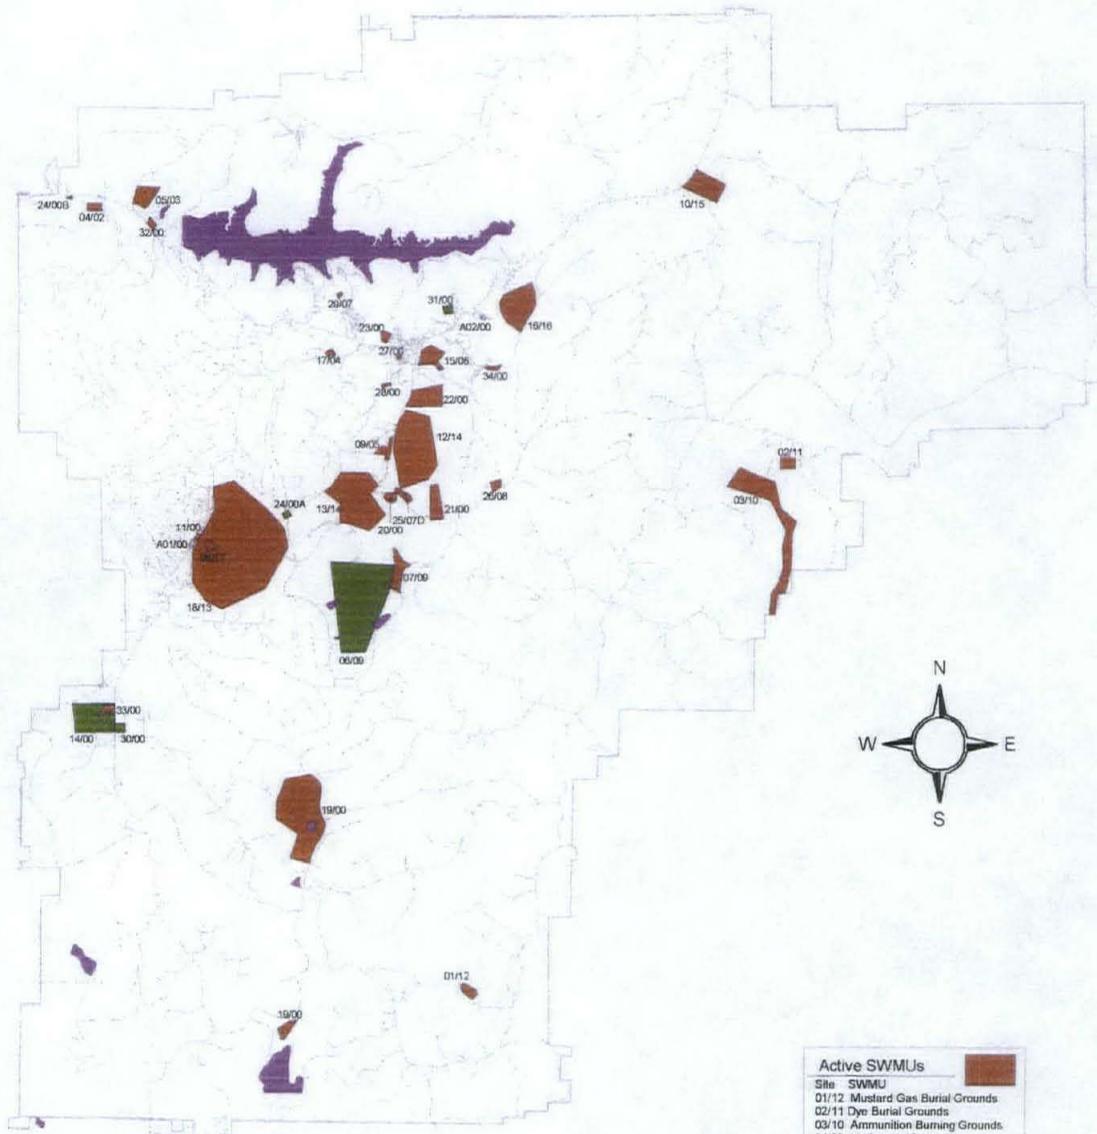
SWMUs Requiring No Further Action

Site SWMU
 06/09 Demolition Range
 14/00 SLF - Li-Battery Burial
 24/00 Sludge Drying Beds A&B
 30/00 Land Farm
 31/00 Comp. Gas Cylinder Site

Area of Concern

Site AOC
 A01/00 Grift Blast Site
 A02/00 B-2044 Drop Tower/Test Rail

Active SWMUs

Site SWMU
 01/12 Mustard Gas Burial Grounds
 02/11 Dye Burial Grounds
 03/10 Ammunition Burning Grounds
 04/02 McCormick Gorge
 05/03 Old Burn Pit
 07/09 Old Rifle Range
 08/17 Building 106 Pond
 09/05 Pesticide Area/R150 Tank
 10/15 Rockeye
 11/00 Old Storage B225
 12/14 Mine Fill A
 13/14 Mine Fill B
 15/06 Roads & Grounds Area
 16/16 Cast Hi-Ex Fill/B146 Incin
 17/04 PCB Cap Borial/Pole Yard
 18/13 Load & Fill Area Buildings
 19/00 Rocket Range
 20/00 CAAA Q/VQC Test Area
 21/00 DRMO Storage Lot
 22/00 Lead Azide
 23/00 Battery Shop
 25/07 Highway 58 Dumpsite A
 26/08 Highway 58 Dumpsite B
 27/00 Illuminant Building, B126
 28/00 Maint. Shop, B1820
 29/07 PCP Dip Tank, B56
 32/00 Tank Farm
 33/00 Bioremediation Facility
 34/00 Old Gun Tub Storage Lot
