**UNITED STATES ENVIRONMENTAL PROTECTION AGENCY
REGION III
841 Chestnut Building
Philadelphia, Pennsylvania 19107-4431**

Re: Naval Air Warfare Center, Warminster, PA

This letter provides EPA comments on Proposed Subsurface Boring Locations for Concrete Lagoons as prepared by HNUS and dated May 26, 1995. Most of these comments were discussed by telecon on June 2, 1995.

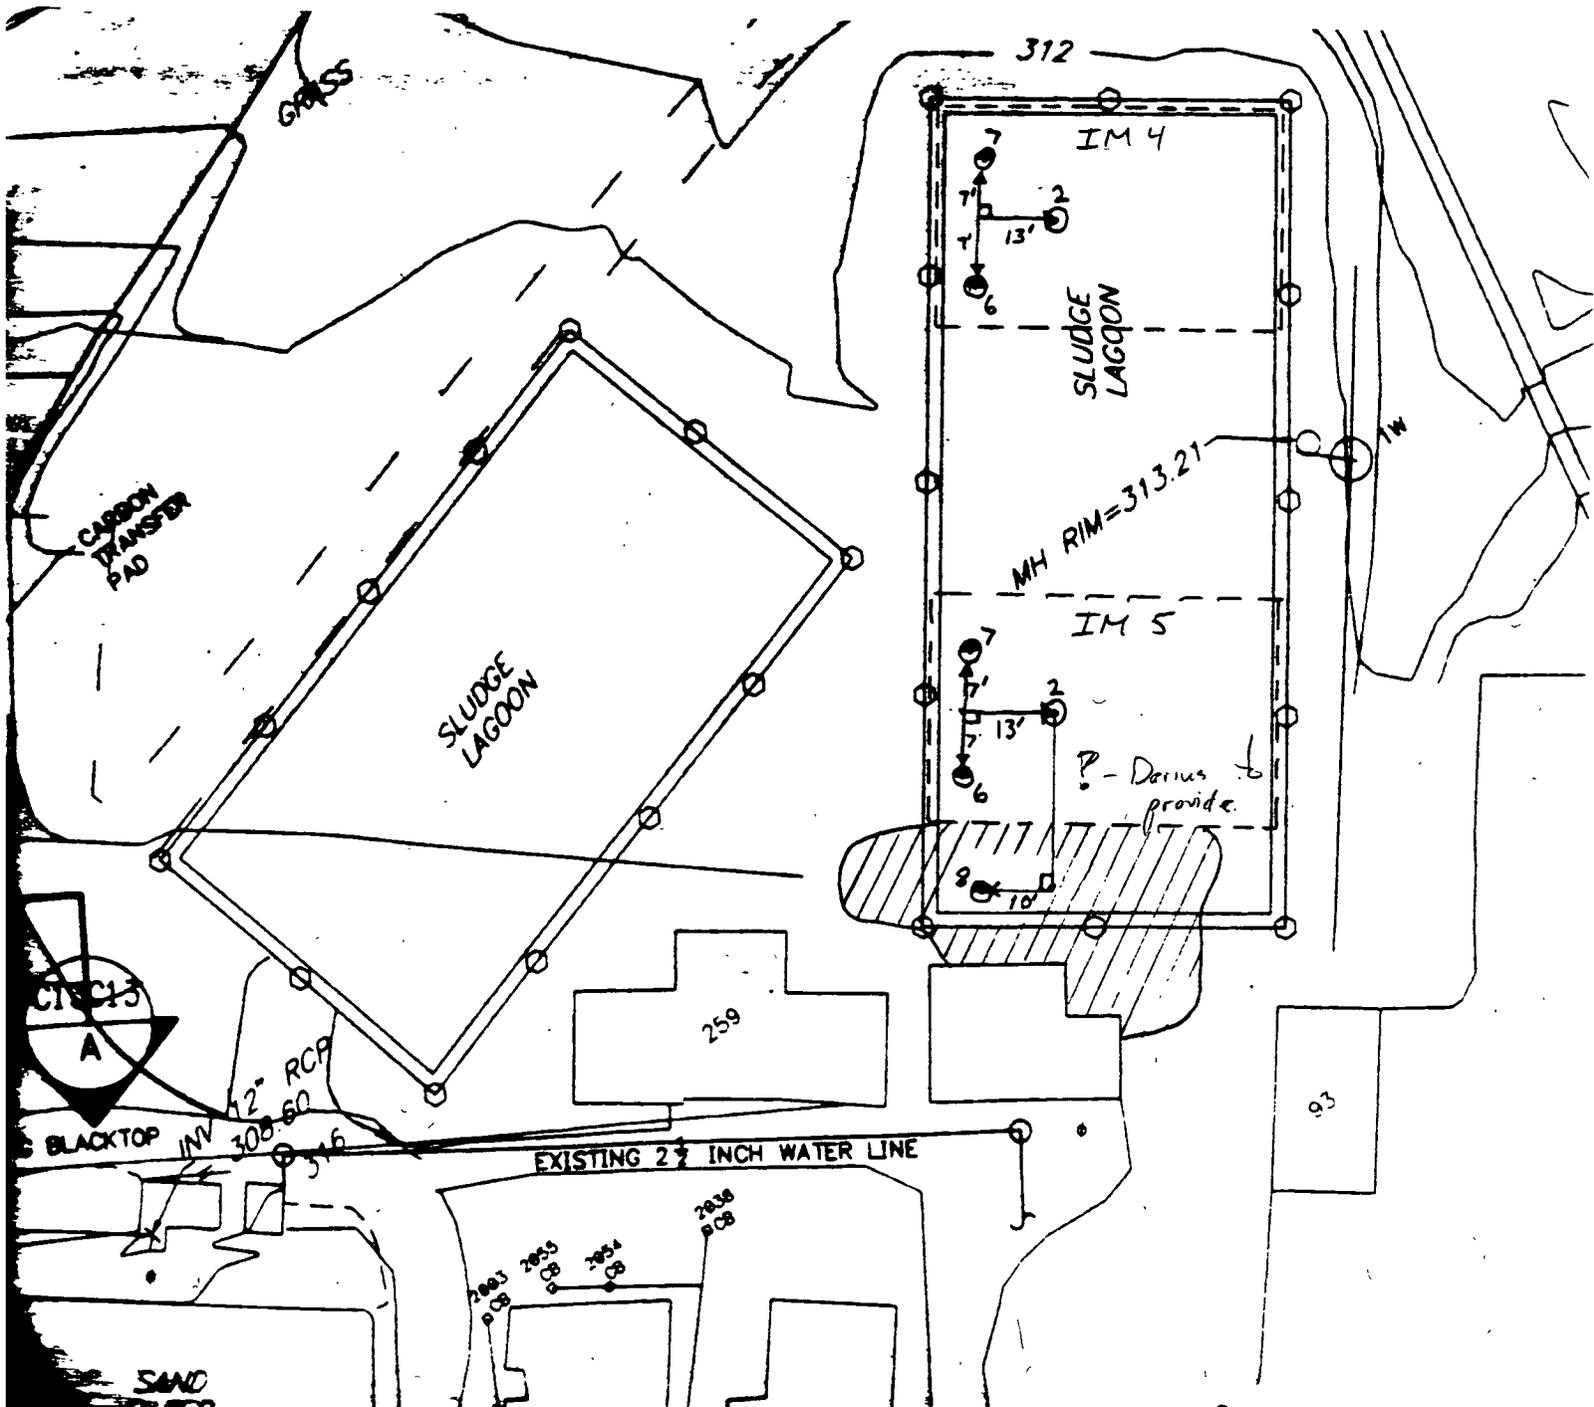
-enclosure to letter of 6/5/95

Note: Map is not to scale.

--- approximate boundaries of unlined impoundments

approximate area of potential spill

● additional soil borings

provided by EPIC, these locations should be as indicated on enclosed Figure A (see additional Soil Borings #6 and #7 for both IM 4 and IM 5).

5. Per previous correspondence, an aerial photo dated March 23, 1959, indicates a potential spill immediately south of IM 5. Aerial photos from subsequent years indicate stressed vegetation in the area of this potential spill. The approximate area of the potential spill is indicated on the attached Figure A. If possible, a soil boring should be conducted within this area at Soil Boring #8 as indicated on Figure A.
