SAMPLING AND ANALYSIS OUTLINE FOR BUILDING 47 BASE REALIGNMENT AND  
CLOSURE ZONE C DEVELOPED NON-INDUSTRIAL AREA GROUP 9 NAS CECIL FIELD FL  
6/1/1997  
ABB ENVIRONMENTAL SERVICES INC

**SAMPLING AND ANALYSIS OUTLINE**  
**BUILDING 47**  
**BASE REALIGNMENT AND CLOSURE**  
**ZONE C, DEVELOPED NONINDUSTRIAL AREA**  
**GROUP IX**  
**NAVAL AIR STATION CECIL FIELD**  
**JACKSONVILLE, FLORIDA**

**June 1997**

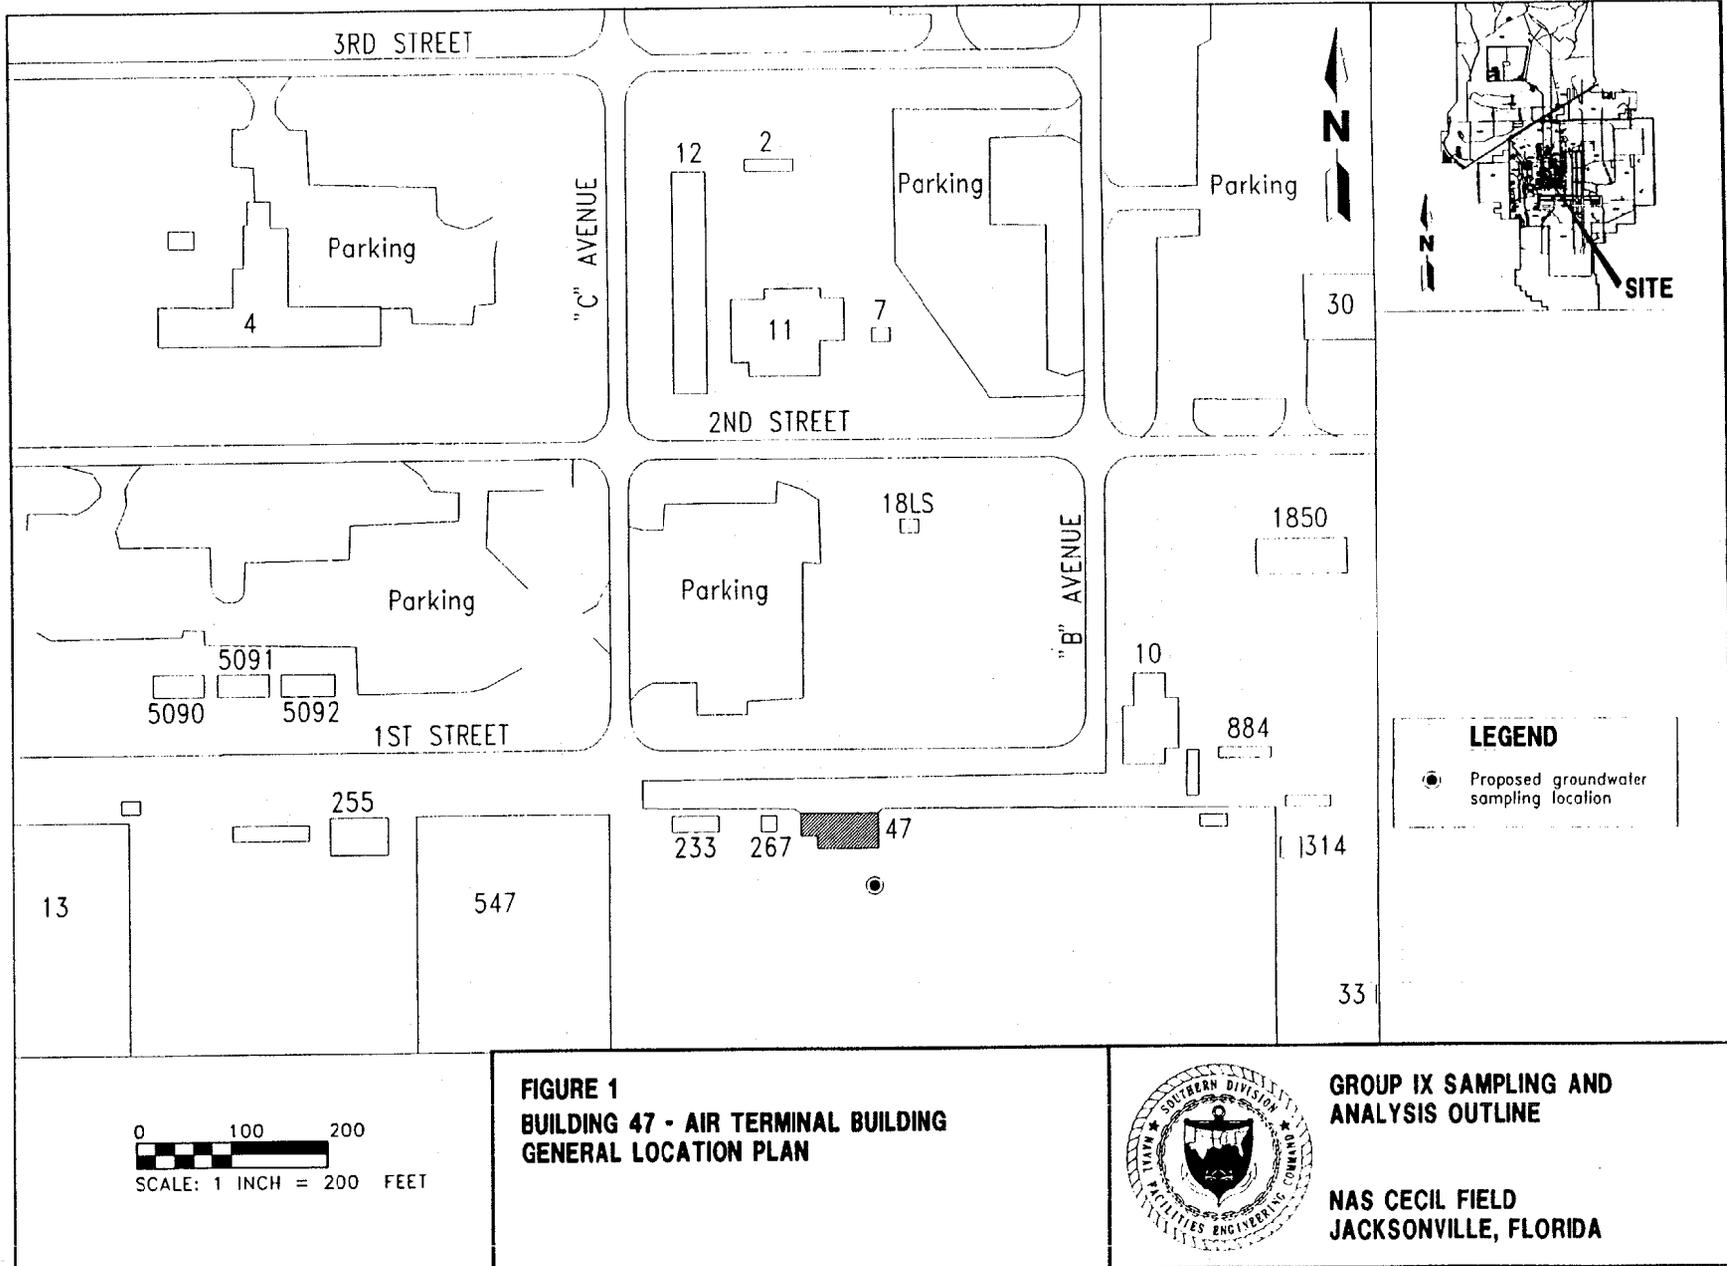
<u>Figure</u>	<u>Title</u>	<u>Page No.</u>
1	Building 47 . . . . .	3

One groundwater monitoring well will be installed downgradient of the former paint storage area. One groundwater sample will be collected and analyzed. The proposed sample location is shown on Figure 1.
