TECHNICAL MEMORANDUM FOR NO FURTHER ACTION AT POTENTIAL SOURCE OF
CONTAMINATION 30 BUILDING 313 MOP RACK DRYING AREA NAS CECIL FIELD FL
1/31/2001
TETRA TECH NUS INC

**Potential Source of Contamination 30
Building 313 – Mop Rack Drying Area**

**Naval Air Station Cecil Field
Jacksonville, Florida**

**TECHNICAL MEMORANDUM
FOR NO FURTHER ACTION**

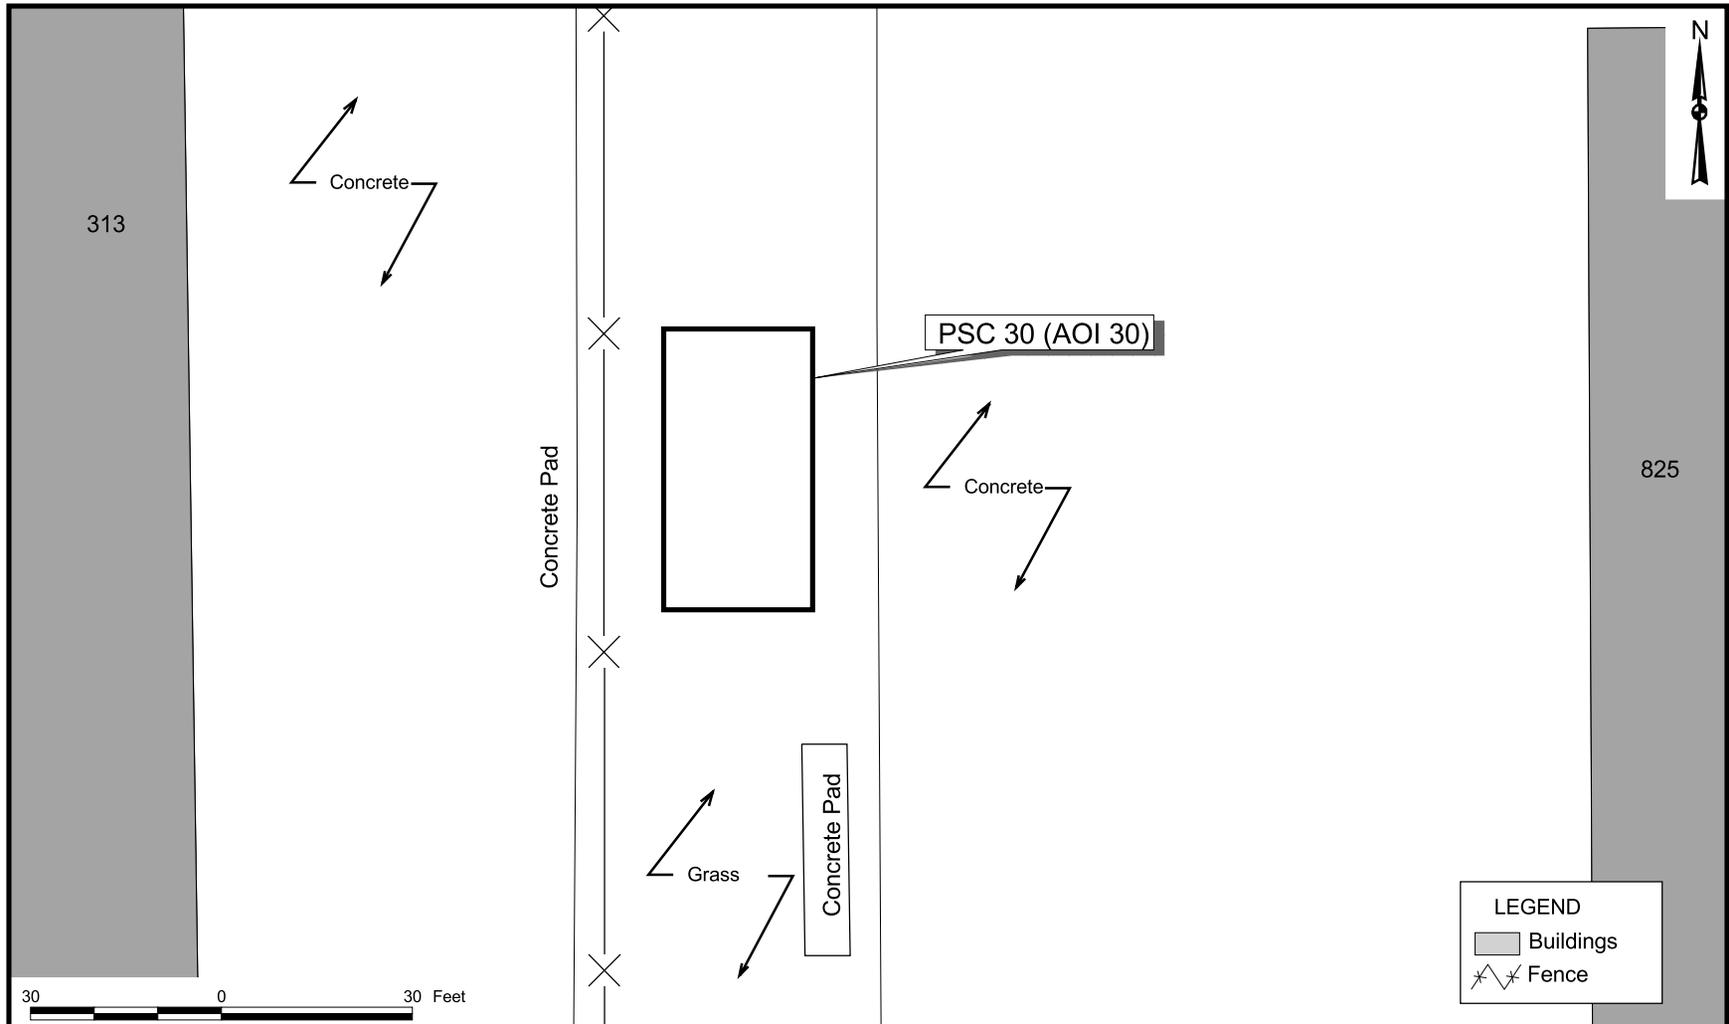
CONTRACT NUMBER 0039	
APPROVED BY	DATE
APPROVED BY	DATE
DRAWING NO. FIGURE 2-2	REV 0

SITE LOCATION MAP
 PSC 30, BUILDING 313 - MOP RACK DRYING AREA
 TECHNICAL MEMORANDUM
 NAVAL AIR STATION CECIL FIELD
 JACKSONVILLE, FLORIDA

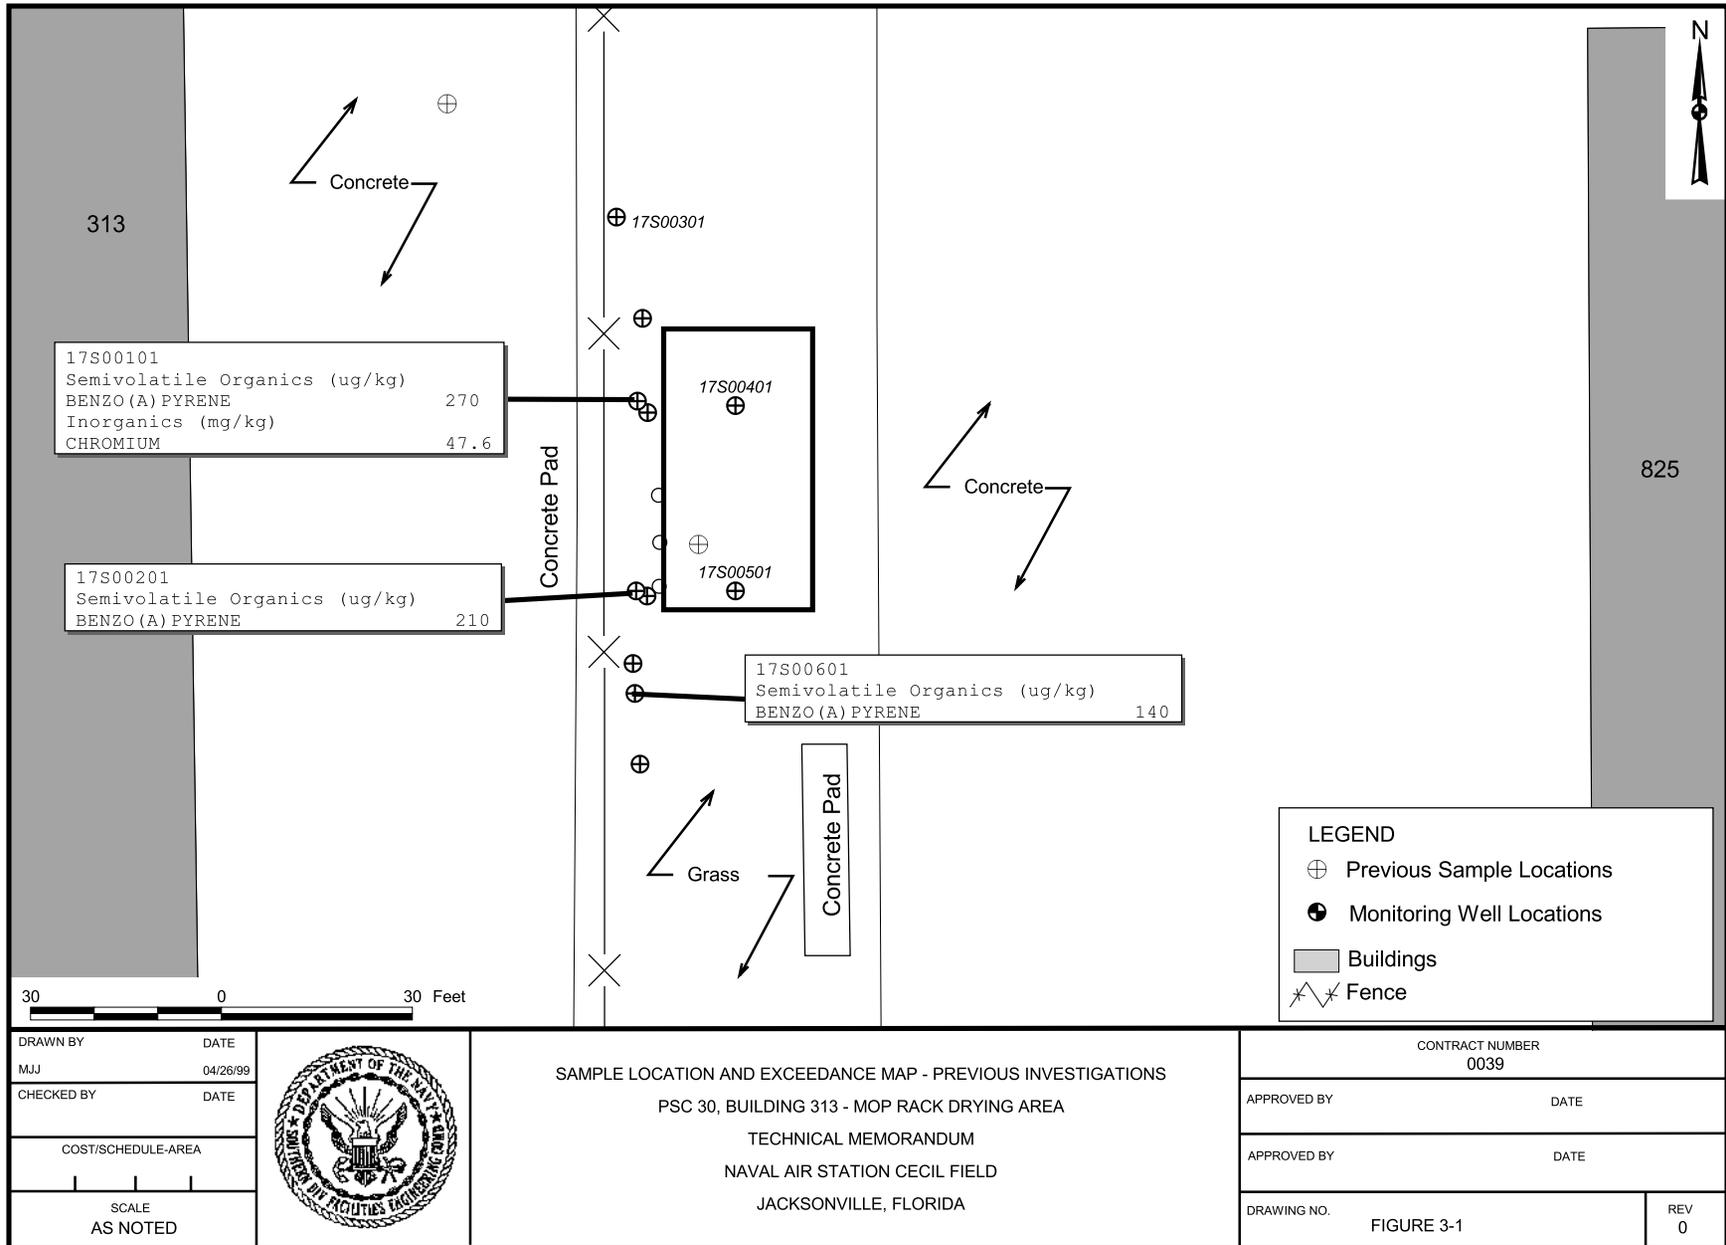
A summary of sampling locations and detected contaminants exceeding criteria from the previous investigations is shown on Figure 3-1.

- Although several organic compounds, pesticides, and inorganic analytes were detected in soil samples collected in the study area, only benzo(a)pyrene (BaP) was detected at a concentration in excess of the Florida Department of Environmental Protection (FDEP) Soil Cleanup Target Level (SCTL) for residential exposure scenarios. It should be noted that at the time the SAR was written the cleanup criterion for Chromium was 290 mg/kg.

- The extent of BaP contamination was not adequately delineated but appeared to be limited.
- Groundwater in the area is contaminated with chlorinated solvents from the adjacent OU 7, Site 16. Remedial action has been initiated at OU 7, Site 16.

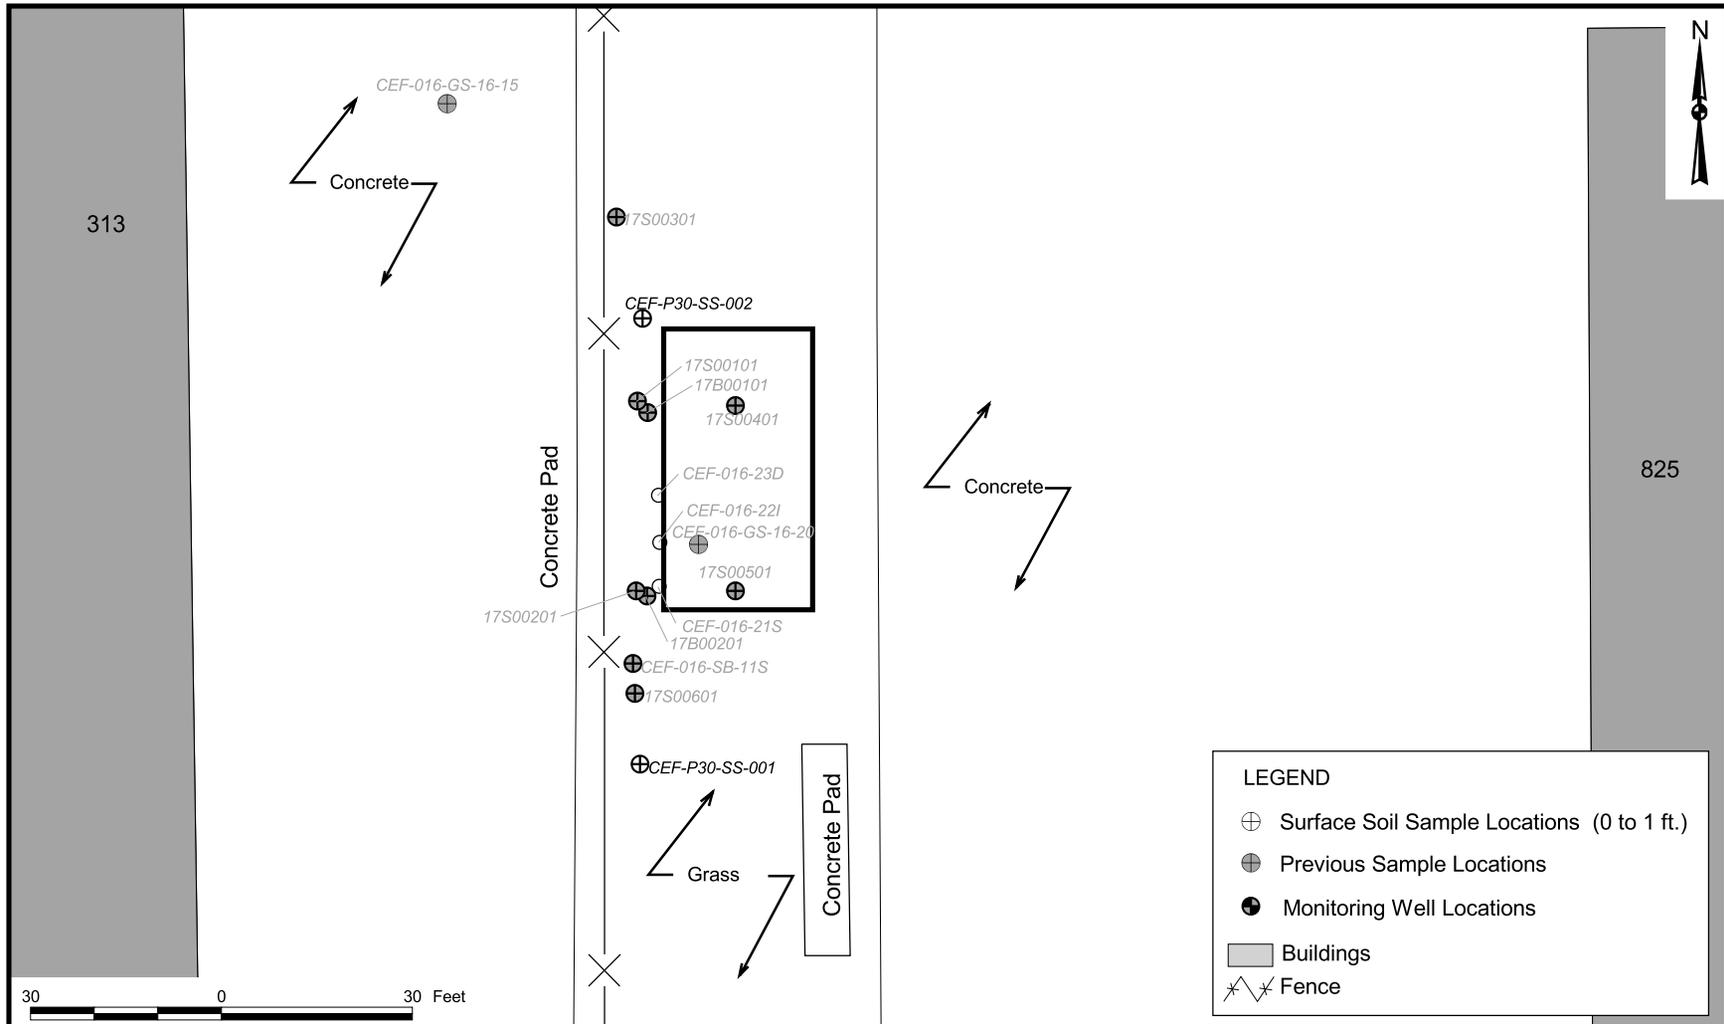
CONTRACT NUMBER 0039	
APPROVED BY	DATE
APPROVED BY	DATE
DRAWING NO. FIGURE 4-1	REV 0

SOIL SAMPLE LOCATIONS
PSC 30, BUILDING 313 - MOP RACK DRYING AREA
TECHNICAL MEMORANDUM
NAVAL AIR STATION CECIL FIELD
JACKSONVILLE, FLORIDA

LEGEND	
⊕	Surface Soil Sample Locations (0 to 1 ft.)
⊙	Previous Sample Locations
⊗	Monitoring Well Locations
■	Buildings
✂	Fence

A soil sampling and analysis event was conducted at PSC 30 in June 1999 to delineate the extent of PAH-contaminated surface soil. The field investigation was performed in accordance with the PSC 30 Sampling and Analysis Work Plan (TtNUS, 1999). Sampling locations are shown on Figure 4-1.

- One surface soil sample (CEF-P30-SS-001) was collected from 0 to 1 foot below ground surface (bgs), 15 feet south of previous soil sample location 17S00601.
- One surface soil sample (CEF-P30-SS-002) was collected from 0 to 1 foot bgs, 15 feet north of previous soil sample location 17S00101.

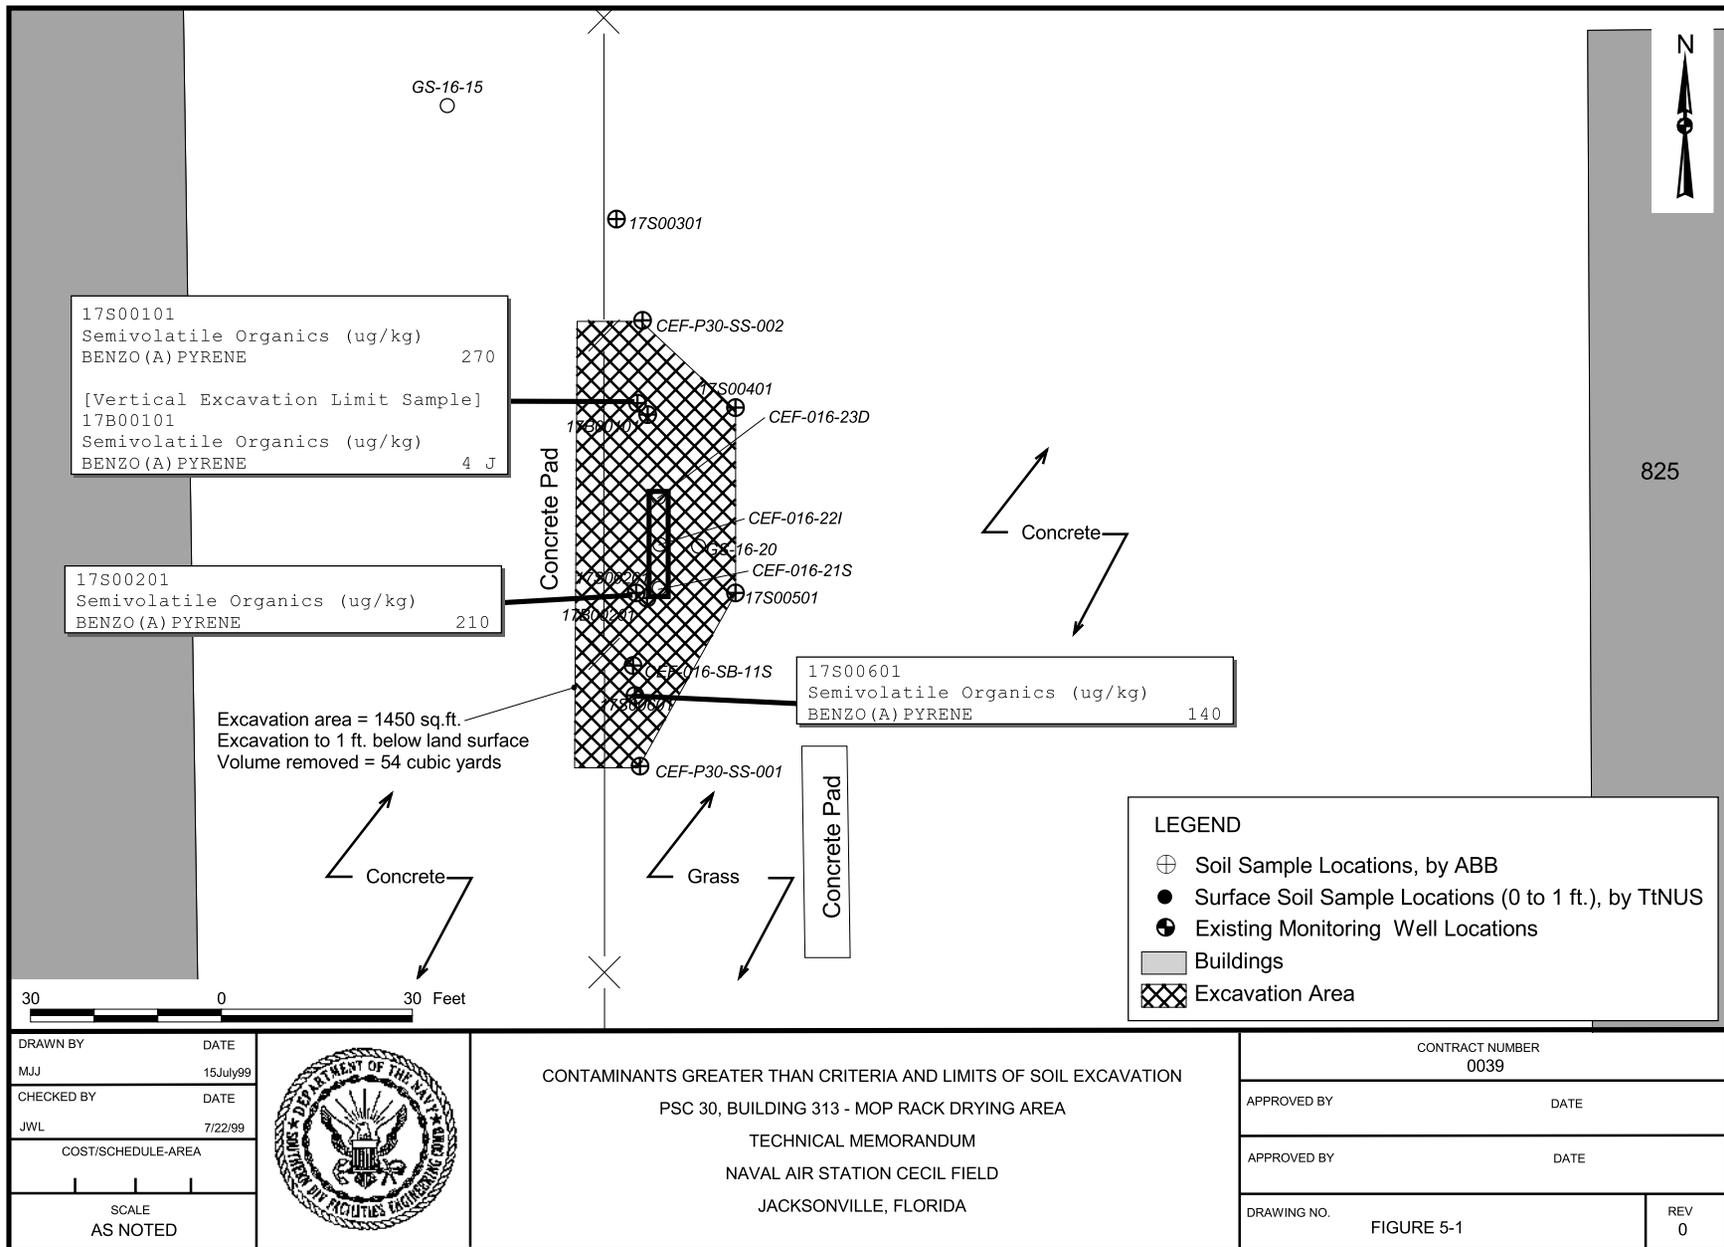
A single excavation area of approximately 1,450 square feet was delineated based on sample locations where the analytical results were less than FDEP SCTLs. The estimated excavation volume for an excavation 1 foot deep is approximately 54 cubic yards. The excavation limits are shown on Figure 5-1.

The results of the sampling and analysis identified the horizontal and vertical extent of PAH contamination. Based on the results of the sampling and analysis, a remedial design (dig and haul package) was prepared for excavation of the delineated area of PAH contamination.
