DRAFT FINAL RESOURCE CONSERVATION AND RECOVERY ACT FACILITY ACT WORK
PLAN VOLUME 1 OF 2 CNC CHARLESTON SC
8/17/1992
ENSAFE

**COMPREHENSIVE LONG-TERM
ENVIRONMENTAL ACTION
CHARLESTON NAVAL SHIPYARD
CHARLESTON, SOUTH CAROLINA**

**DRAFT-FINAL RFI WORKPLAN
CHARLESTON NAVAL SHIPYARD**

August 17, 1992

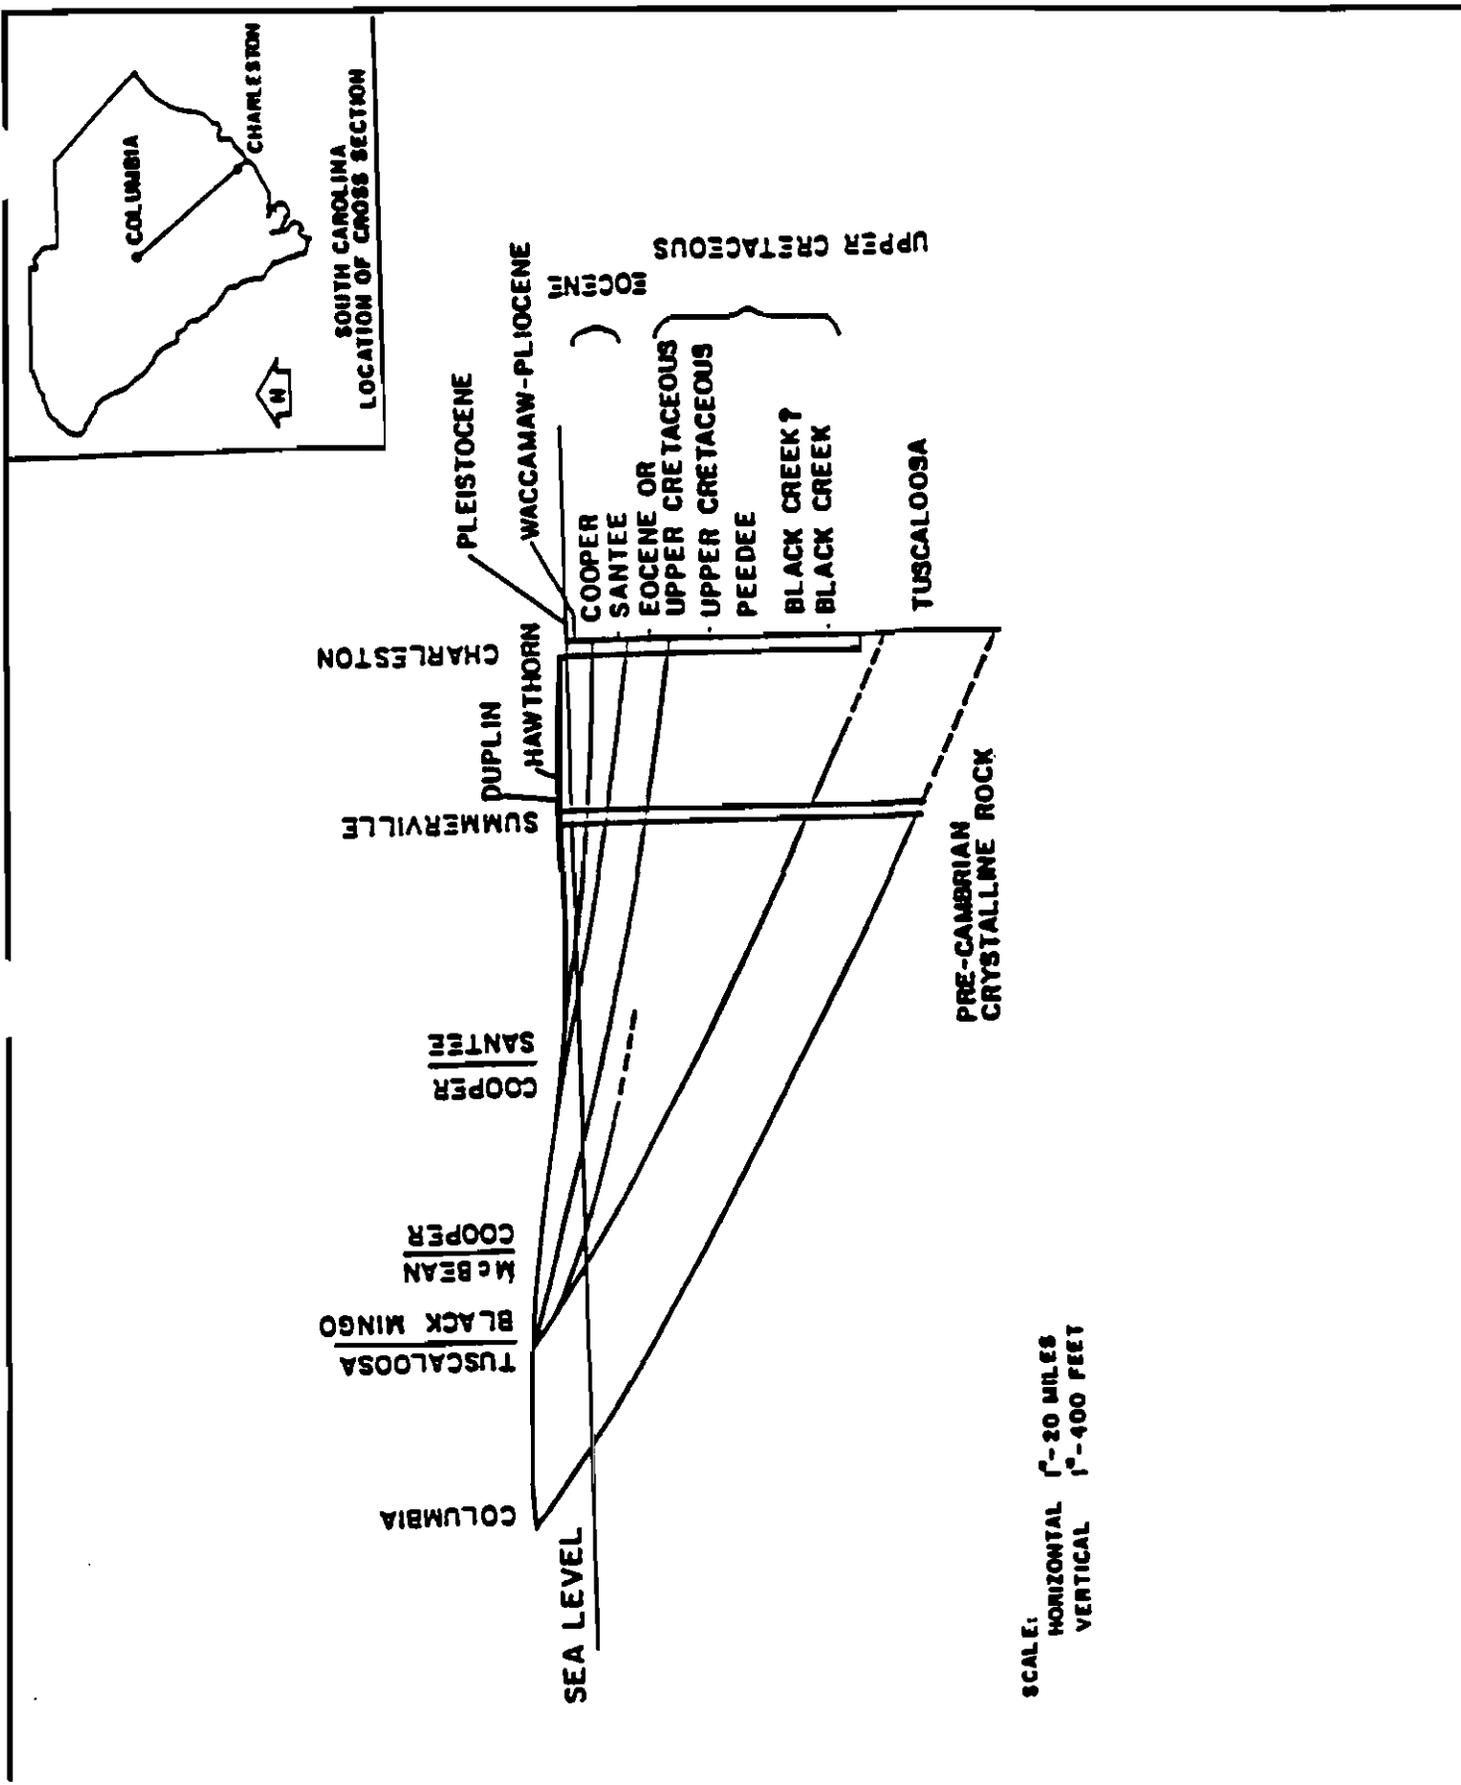
FIGURE 2-3
GEOLOGIC CROSS-SECTION
FROM COLUMBIA TO CHARLESTON,
SOUTH CAROLINA,
INCLUDING NSY

Geology of the Charleston area is typical of the southern Atlantic Coastal Plain. Cretaceous and younger sediments thicken seaward and are underlain by older igneous and metamorphic basement rock (Figure 2-3). Surface exposures at NSY, in the limited areas which remain undisturbed, consist of recent and/or Pleistocene sands, silts, and clays of high organic content. NSY is underlain by a plastic calcareous clay known as the Cooper Marl. The Cooper Marl is,

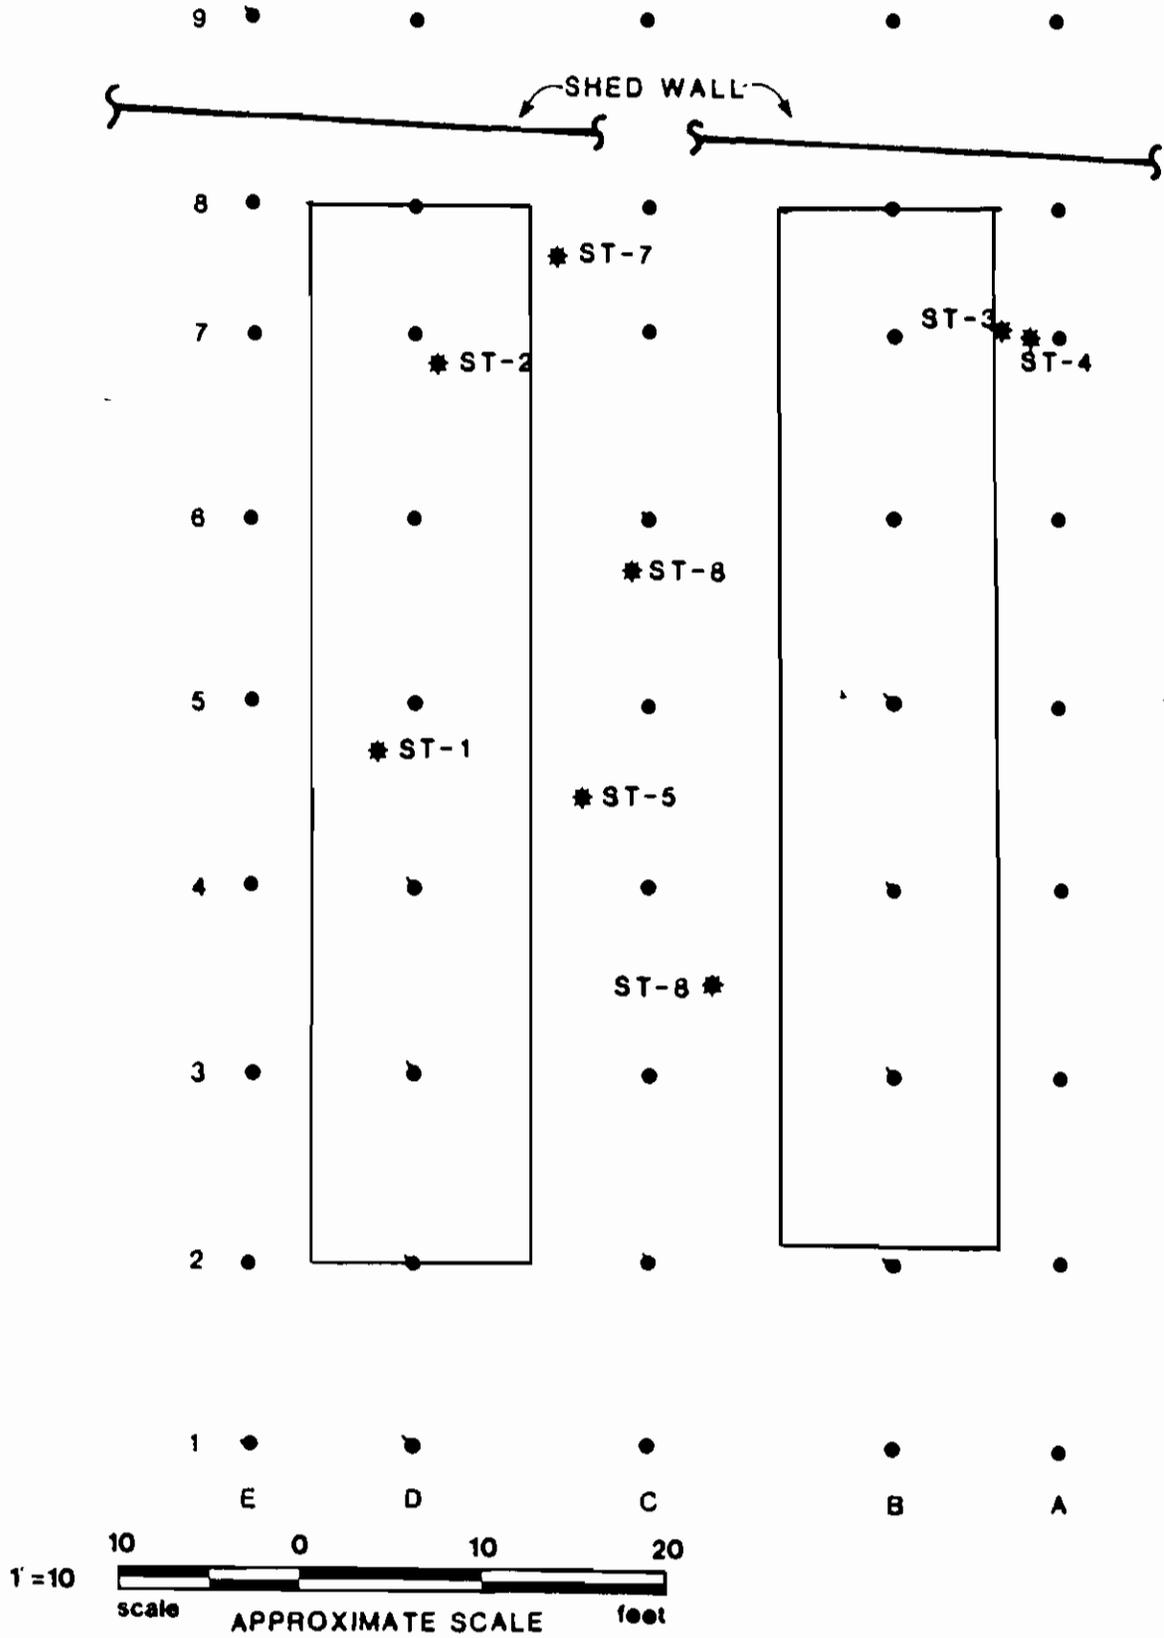
FIGURE 2-11
 DRMO STORAGE SHED
 SAMPLE LOCATIONS
 (FIGURE TAKEN FROM REF. 5)

No spills at the site have been documented. EnSafe conducted two sample events to delineate contamination at the DRMO Storage Shed (Refs. 5 and 7). Fifty-three surface samples (0 to 6 inches) and 159 subsurface samples (1, 2, and 3 feet) were collected and analyzed. Figure 2-11 shows the sample locations at the DRMO Storage Shed and Appendix D presents the analytical data. Samples were assayed for site specific compounds which were known to have been stored at the site. This list of constituents which is presented in Table 2-2 included 20

volatile organic compounds, hydrazine, metals, and four hazardous waste characteristics parameters. Diethyl ether was the only organic compound detected with concentrations ranging as high as 75.8 $\mu\text{g}/\text{kg}$. Except for surface concentrations of lead, metals were detected in most of the samples were at very low concentrations. As presented in the previous section, EnSafe established values from background samples, based on the Student's t test, to determine threshold values for cleanup. Based on the threshold values, clean closure could not be achieved.

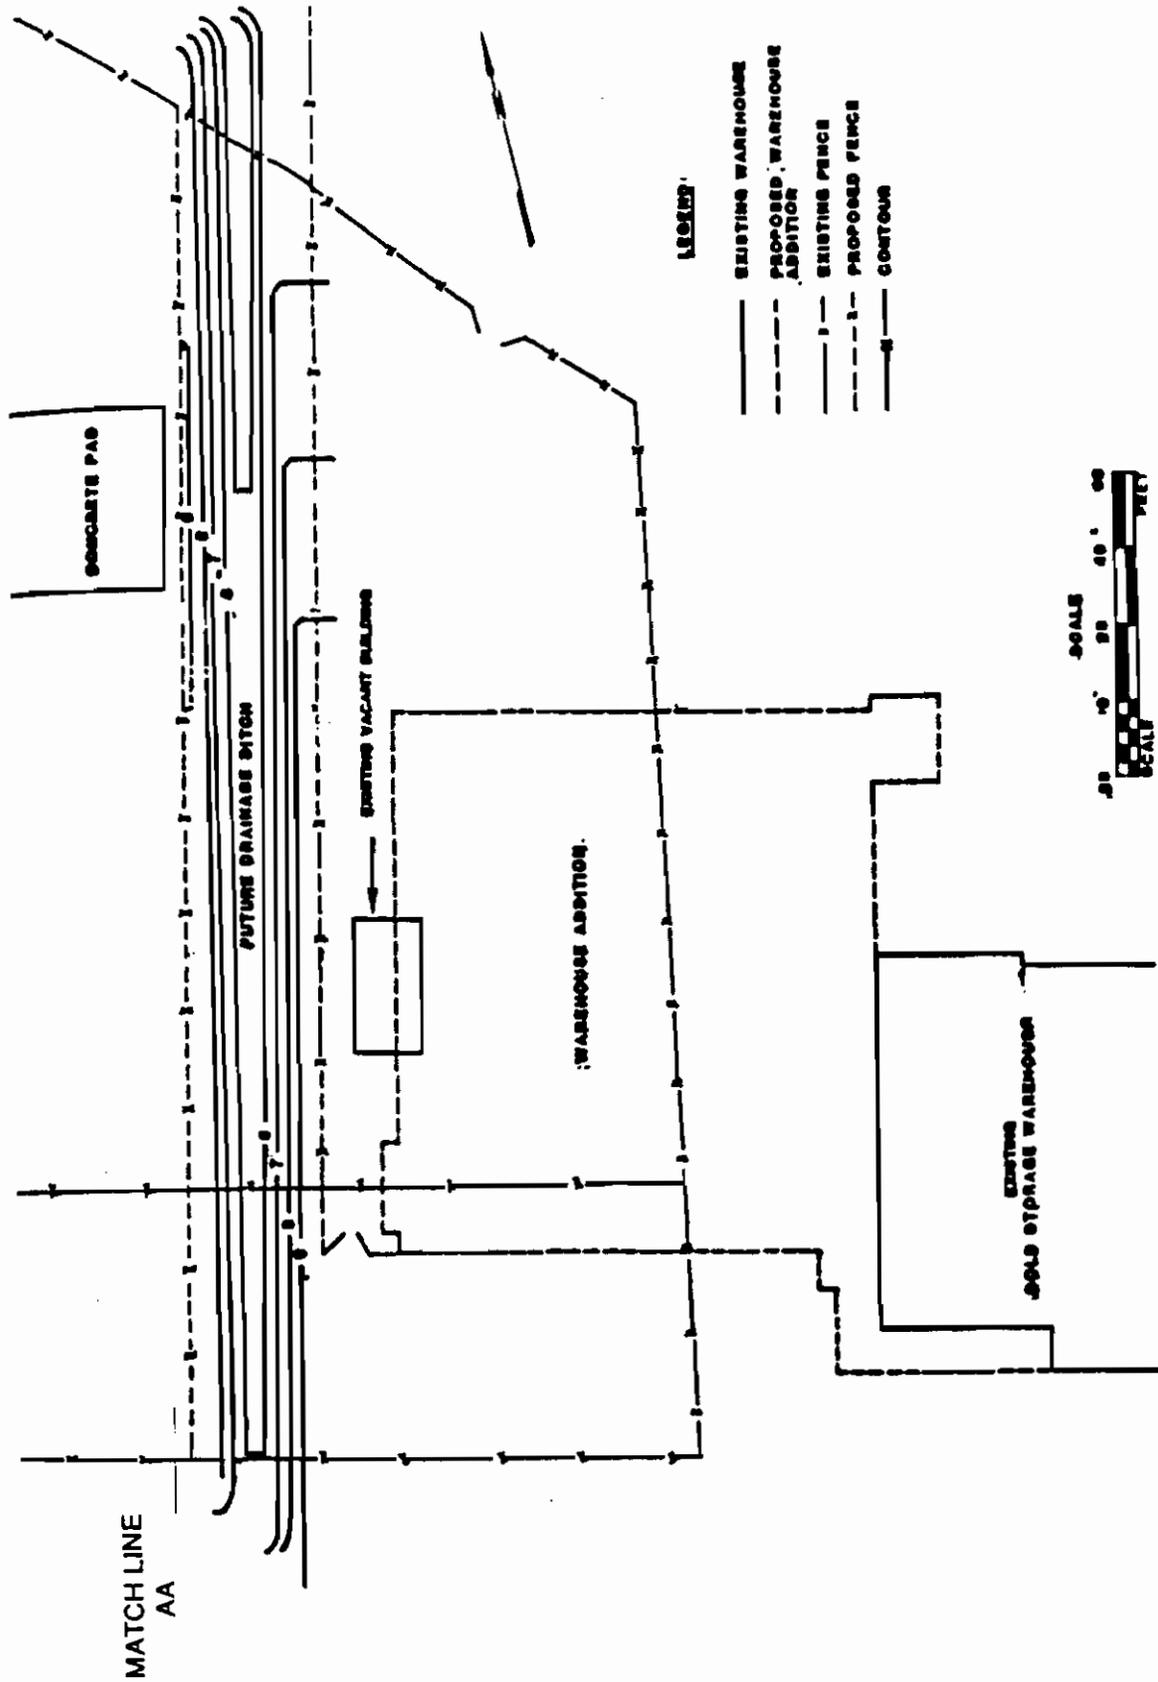
FIGURE 2-15
 PUBLIC WORKS STORAGE YARD
 CONSTRUCTION-AFFECTED PORTION
 (FIGURE TAKEN FROM REF. 3)

A partial closure of this unit was completed in 1986 when a renovation and expansion of the cold storage warehouse (Building #193) was extended into the eastern boundary of the public works storage yard (Figure 2-15). A soil sampling program was completed in March 1986 as part of the requirements for the closure of this unit. Because of the wide variety of hazardous wastes

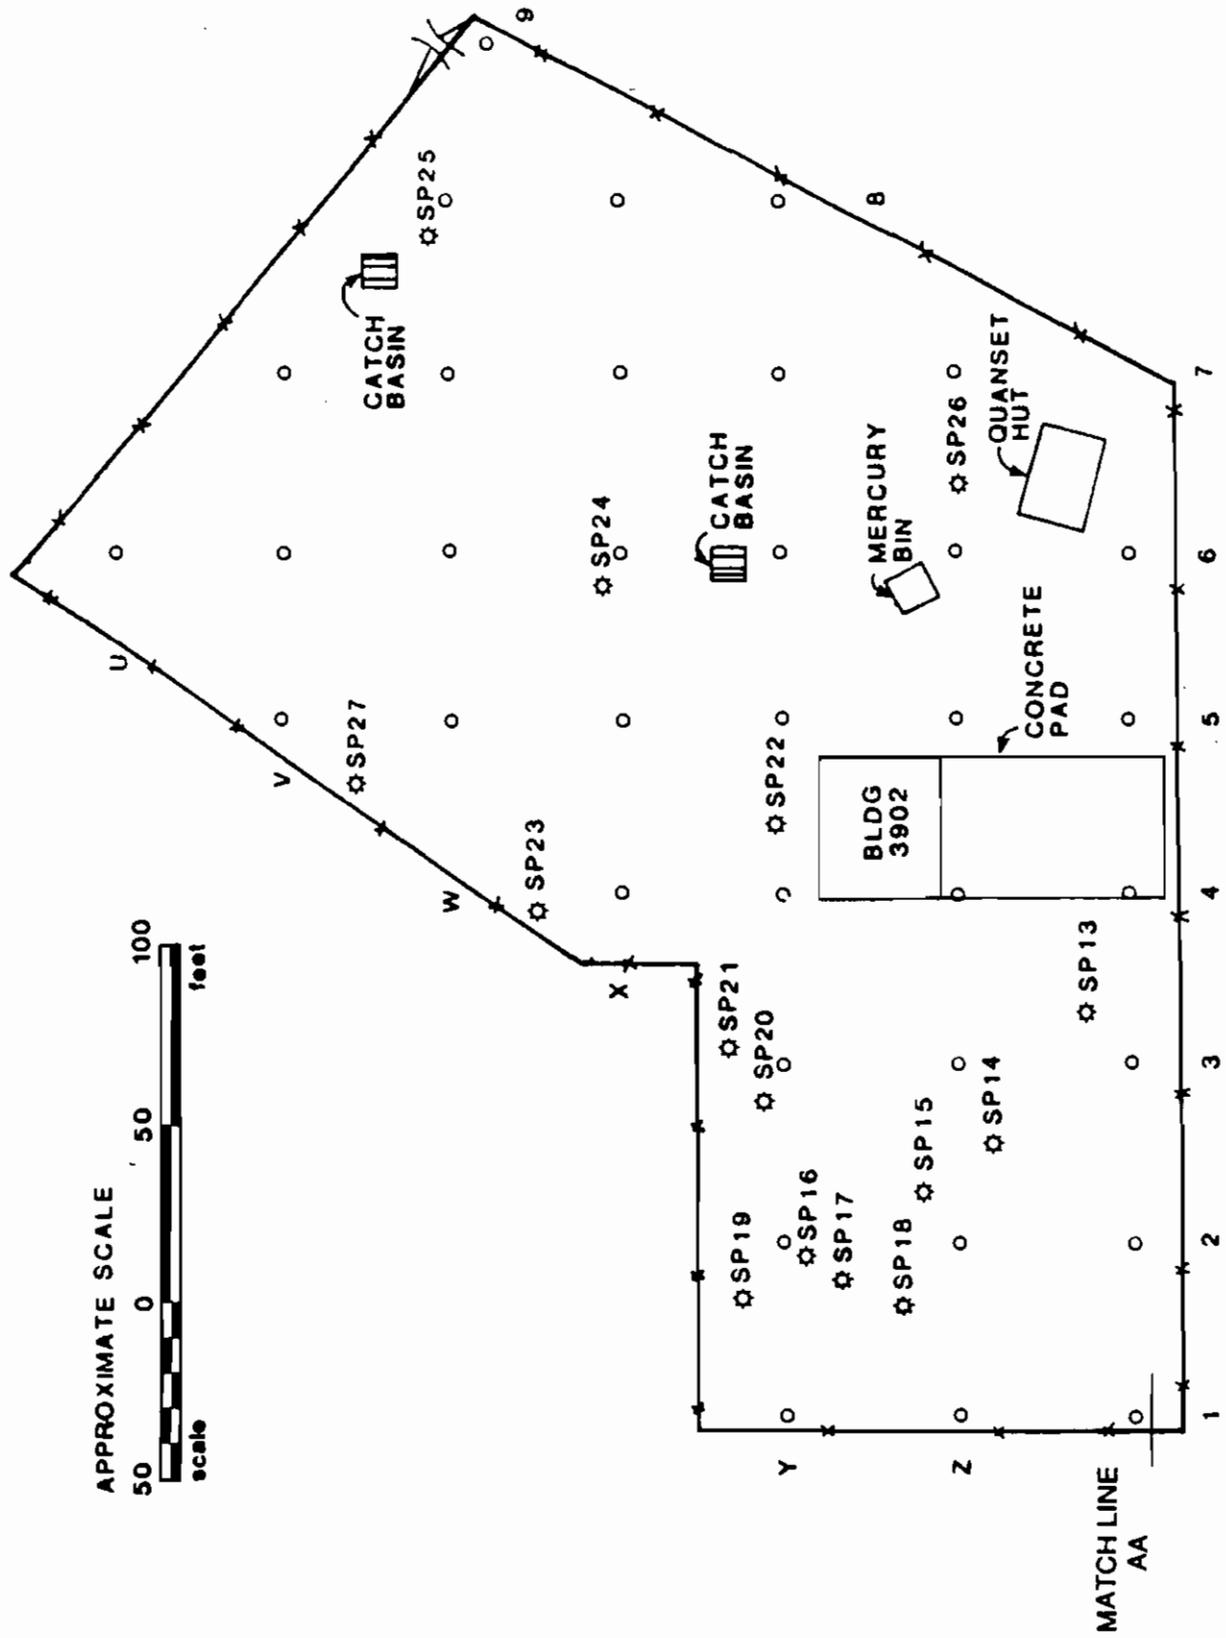
FIGURE 2-16
 PUBLIC WORKS STORAGE YARD
 SAMPLING STATIONS
 (FIGURE TAKEN FROM REF. 5)

Final closure activities in the remaining portion of this unit consisted of removing the final inventory of drums and material, and excavation of any residual contaminated soils. EnSafe implemented a subsurface investigation in 1987. Samples were collected on a 50-foot grid system and areas of obvious staining were independently sampled. The grid system is illustrated in Figure 2-16. Thirty-six sample points were established for sample collection from surface to 6 inches. The new grid system is an extension of the grid established during partial closure of the southern portion of the Public Works Storage Yard. Row AA duplicates row A from the original grid. The soil along row AA was excavated and backfilled during partial closure activities. An investigation by Southern Division and EnSafe representatives identified 15 additional stained areas or areas of suspected spills and leaks (SP-13 to SP-27). The analytical results for samples collected for the final closure activities are also presented in Appendix F as EnSafe's Table 3, "Evaluation of Soil Contamination Public Works Storage Yard." The threshold values for background samples are presented with the metals data. The background samples are identified by the prefix "BK" and were collected from three residential areas within the NSY.

A supplemental sampling phase was added to further define the vertical extent of contamination in subsurface soils to a depth of three feet. Supplemental samples were collected at 1-, 2- and

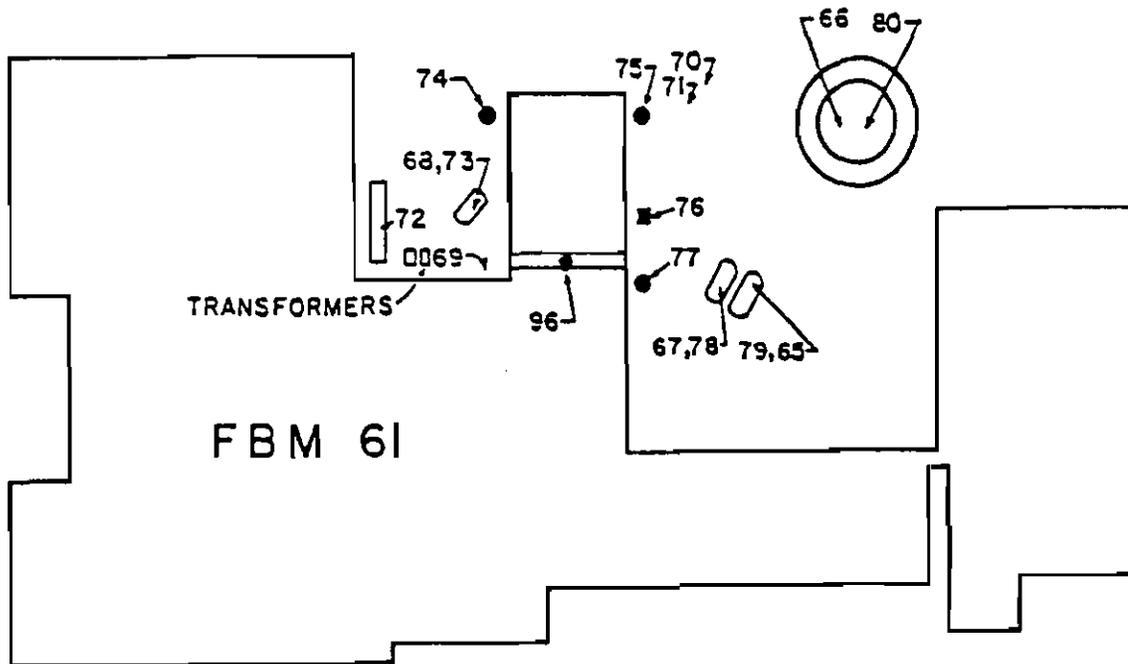
FIGURE 2-23
SWMJ #17
OIL SPILL AREA
(FIGURE TAKEN FROM REF. 2)

- 65 - Tank 25B
- 66 - NS 600
- 67 - 19B
- 68 - Unknown (NSC 700)
- 72 - 5300 gal tank car
- 73 - NSC 700
- 74 - North sump
- 75 - Southeast sump
- 76 - South center sump
- 77 - Southwest sump
- 78 - 19B
- 79 - 25B
- 80 - NS 600
- 96 - Inside sump

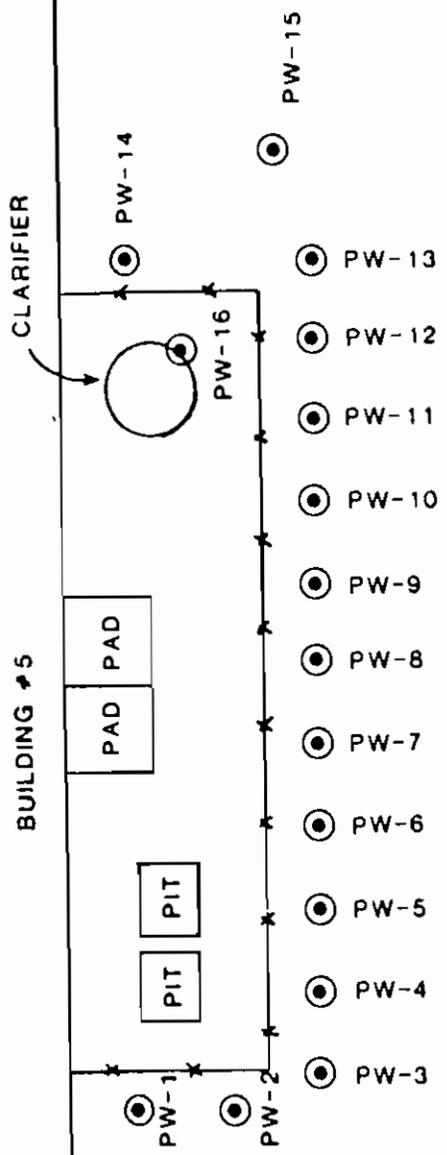
Sixteen soil samples were collected around the perimeter of the treatment tank from directly below the surface of the concrete, as shown in Figure 2-25. The soil samples were analyzed for pH, cadmium, and chromium (Table 2-15). Forty-three of the 48 samples exceeded the threshold values. None of the sample results exceeded the action levels for cadmium or chromium.

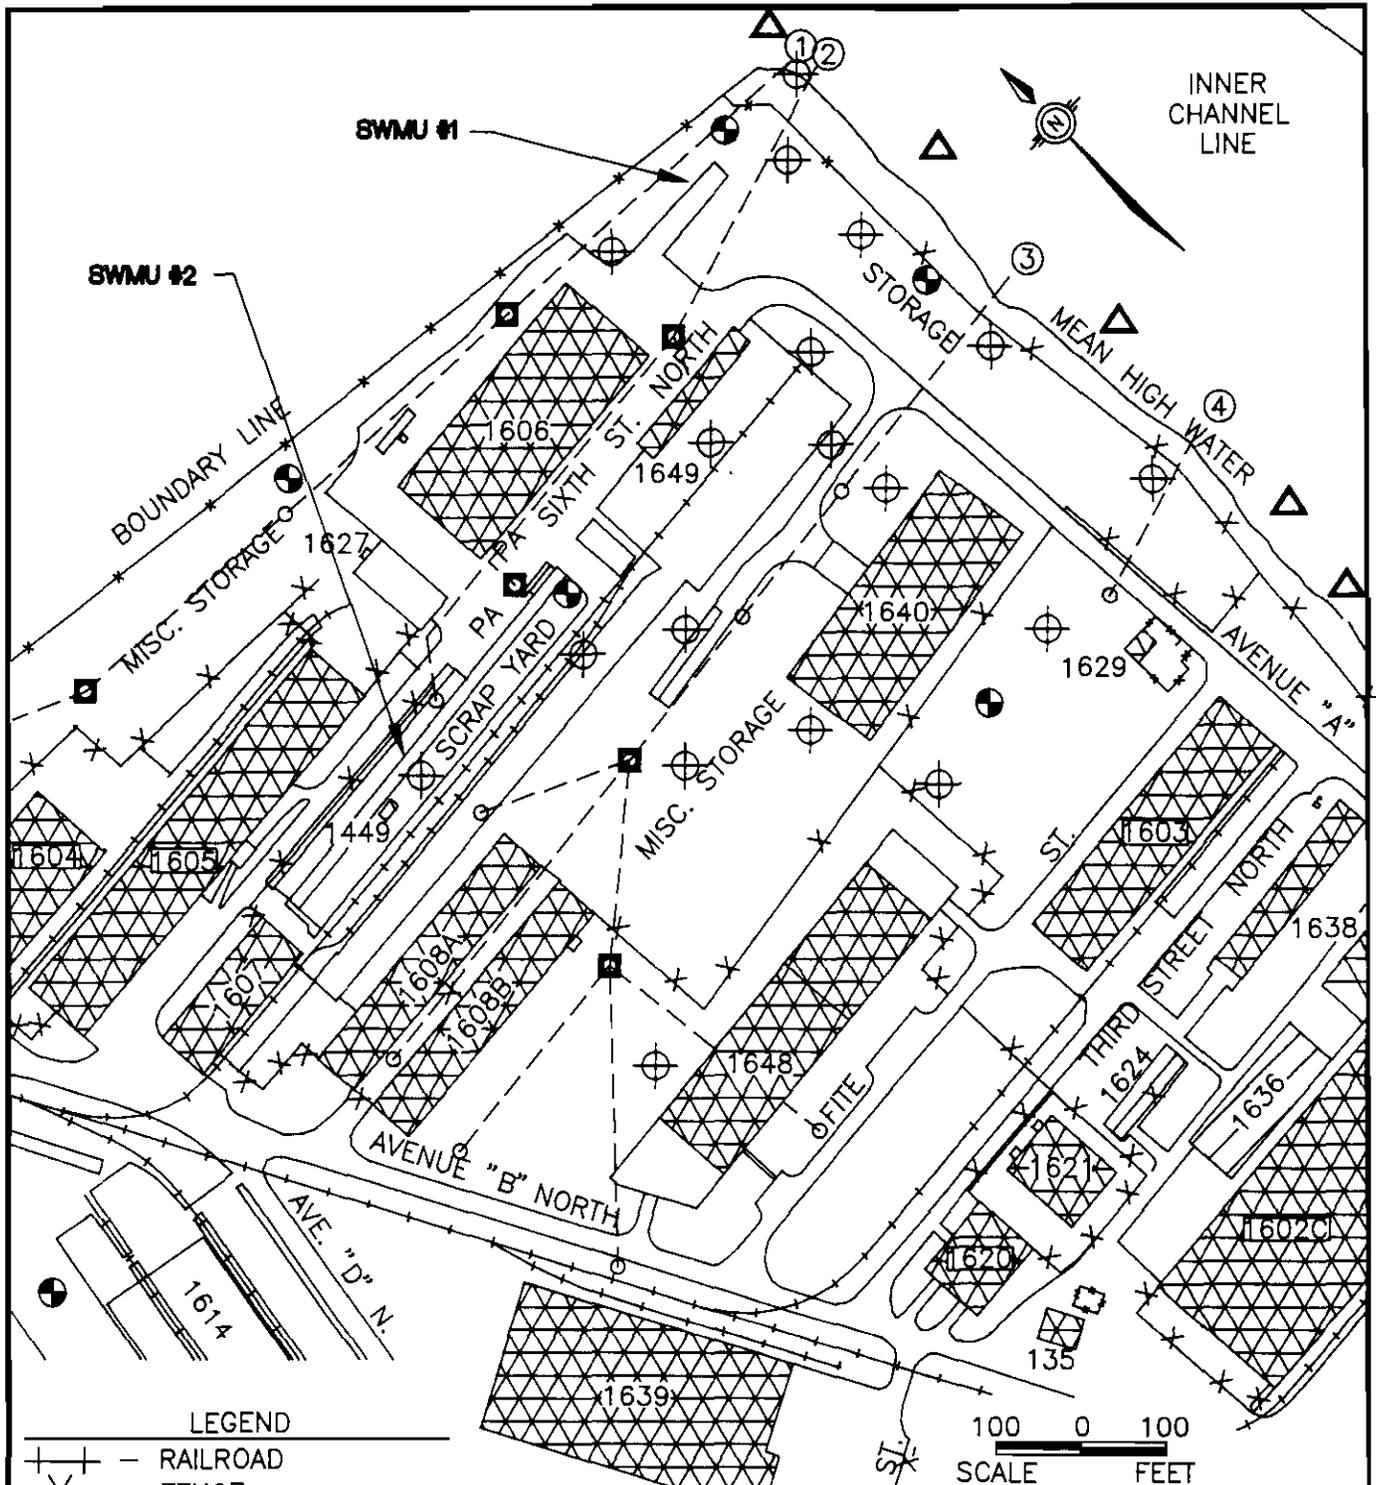
Figure 3-1 shows the proposed soil sample locations; however, the field scientist will have authority to adjust these locations as conditions warrant. A total of ²⁴~~26~~ soil sample stations are planned (includes those borings to be completed as monitor wells). Soil samples will be collected from the surface (0 to 6 inches) and 1-foot interval (6 inches to 1 foot). Data from previous studies (Refs. 5 and 10) show that lead contamination exists at extremely low concentrations below the surface interval. Therefore, subsurface samples (deeper than 1 foot) will not be collected. Seven sediment samples from Cooper River and six sediment samples from the storm sewer will also be collected. All samples will be analyzed for total lead, SW-846 method 7420/7421.

- +—+— RAILROAD
- X—X— FENCE
- PROPOSED MONITORING WELL LOCATIONS
- ⊕ PROPOSED SOIL SAMPLING LOCATIONS
- △ PROPOSED SEDIMENT SAMPLING LOCATIONS
- STORM SEWER SAMPLING LOCATIONS
- ⊖— STORM SEWER SYSTEM
- ⊕ STORMWATER OUTFALL

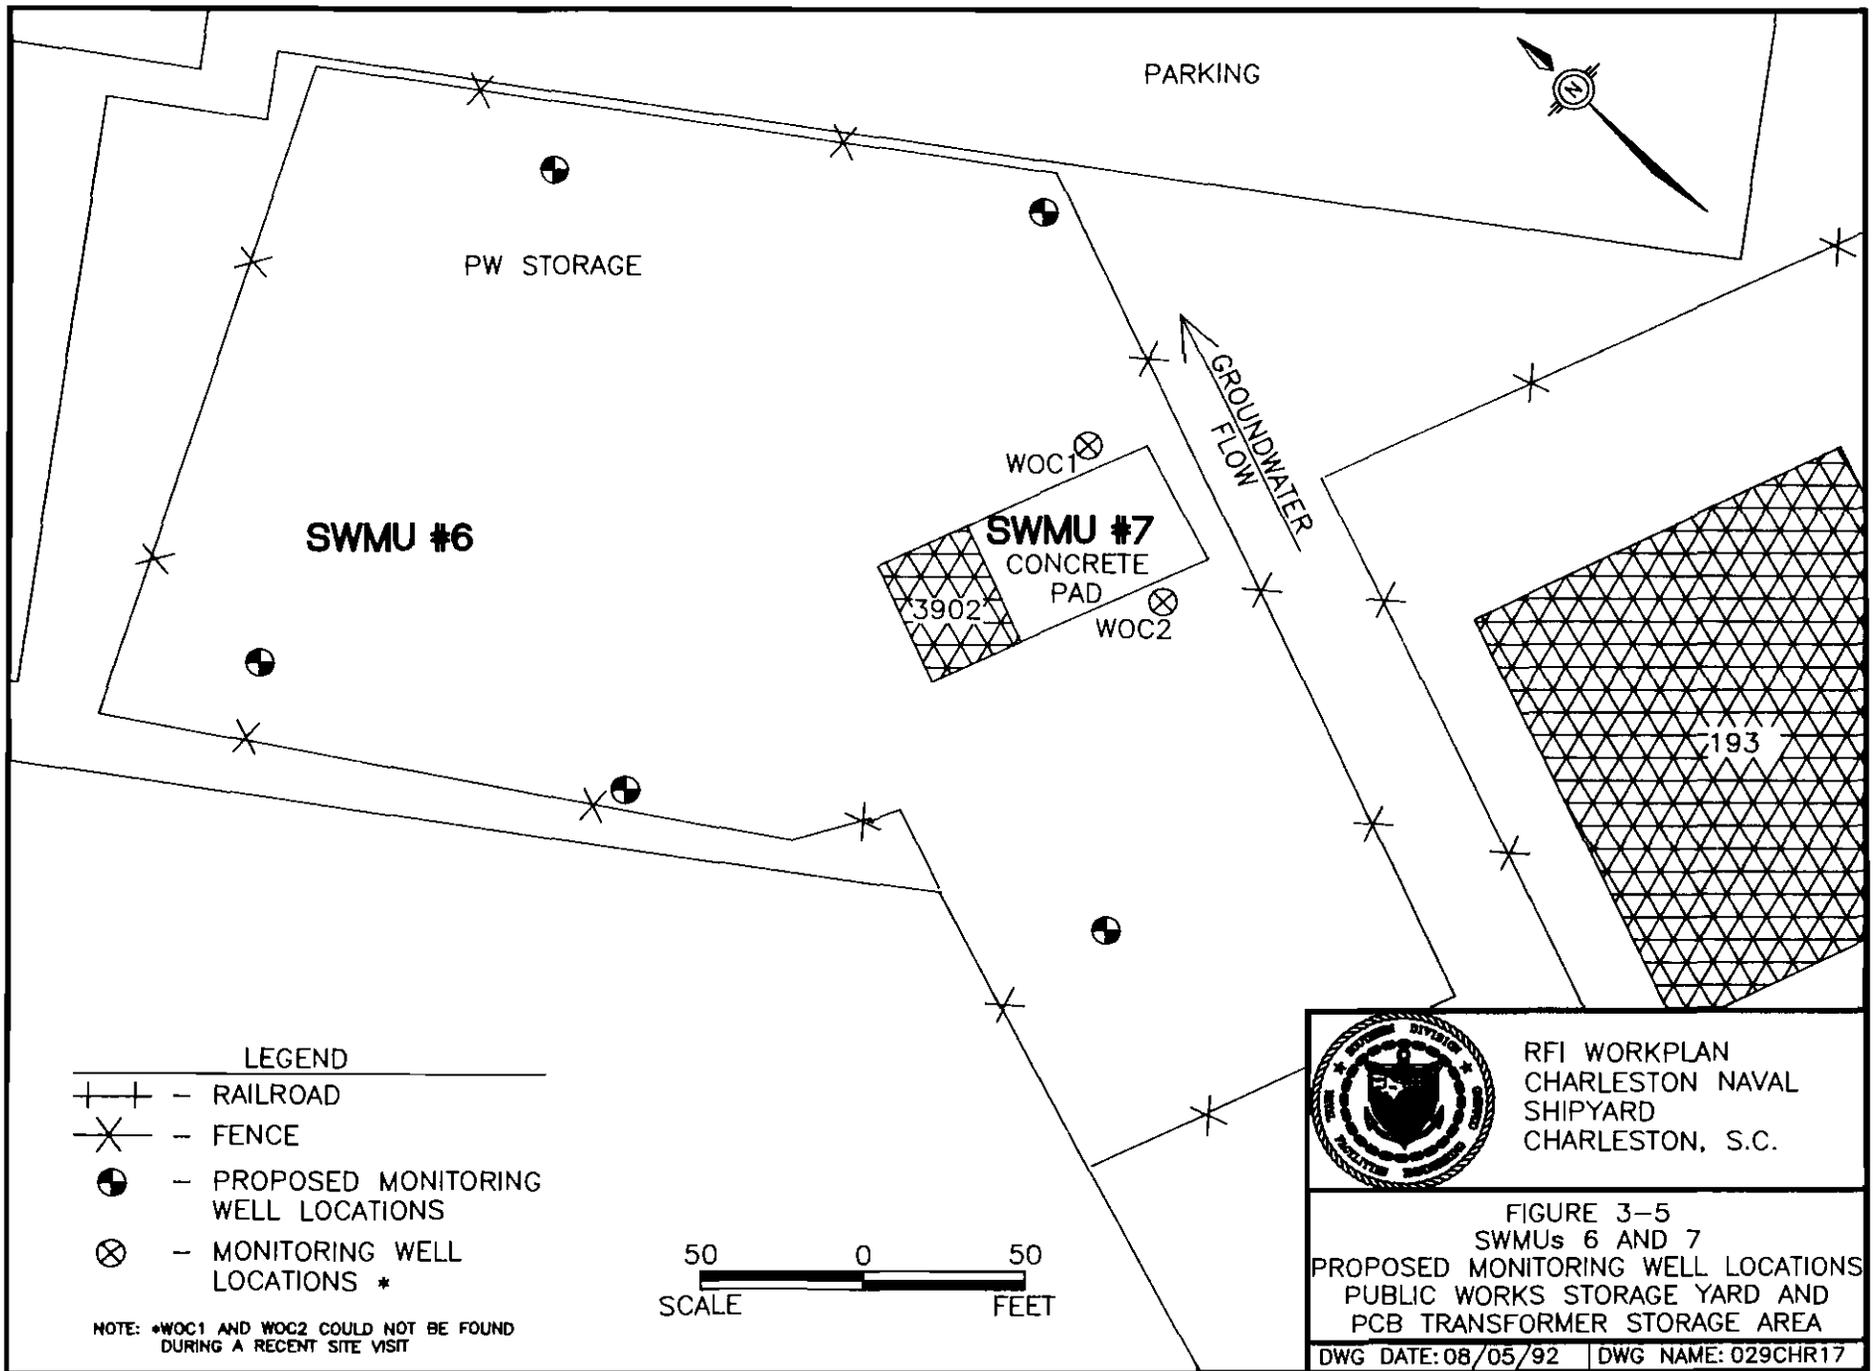
Seven monitoring wells will be installed during the RFI to assess potential impacts resulting from activities at both SWMUs #6 and #7 (Figure 3-5). Two monitoring wells, WOC-1 and WOC-2, were previously installed during the Confirmation Study in 1982 to assess potential releases from SWMU #7. These wells could not be located during a recent site visit; therefore, they will be replaced in the RFI. Five additional wells are proposed to be installed to further

delineate the extent of groundwater contamination already detected at SWMU #7 and to determine if contaminated soils from SWMU #6 have impacted groundwater. Groundwater samples will be assayed for pesticides, PCBs, and the eight RCRA metals (total metals only). The proposed analytical parameters are intended to encompass all constituents of concern for both SWMUs #6 and #7.

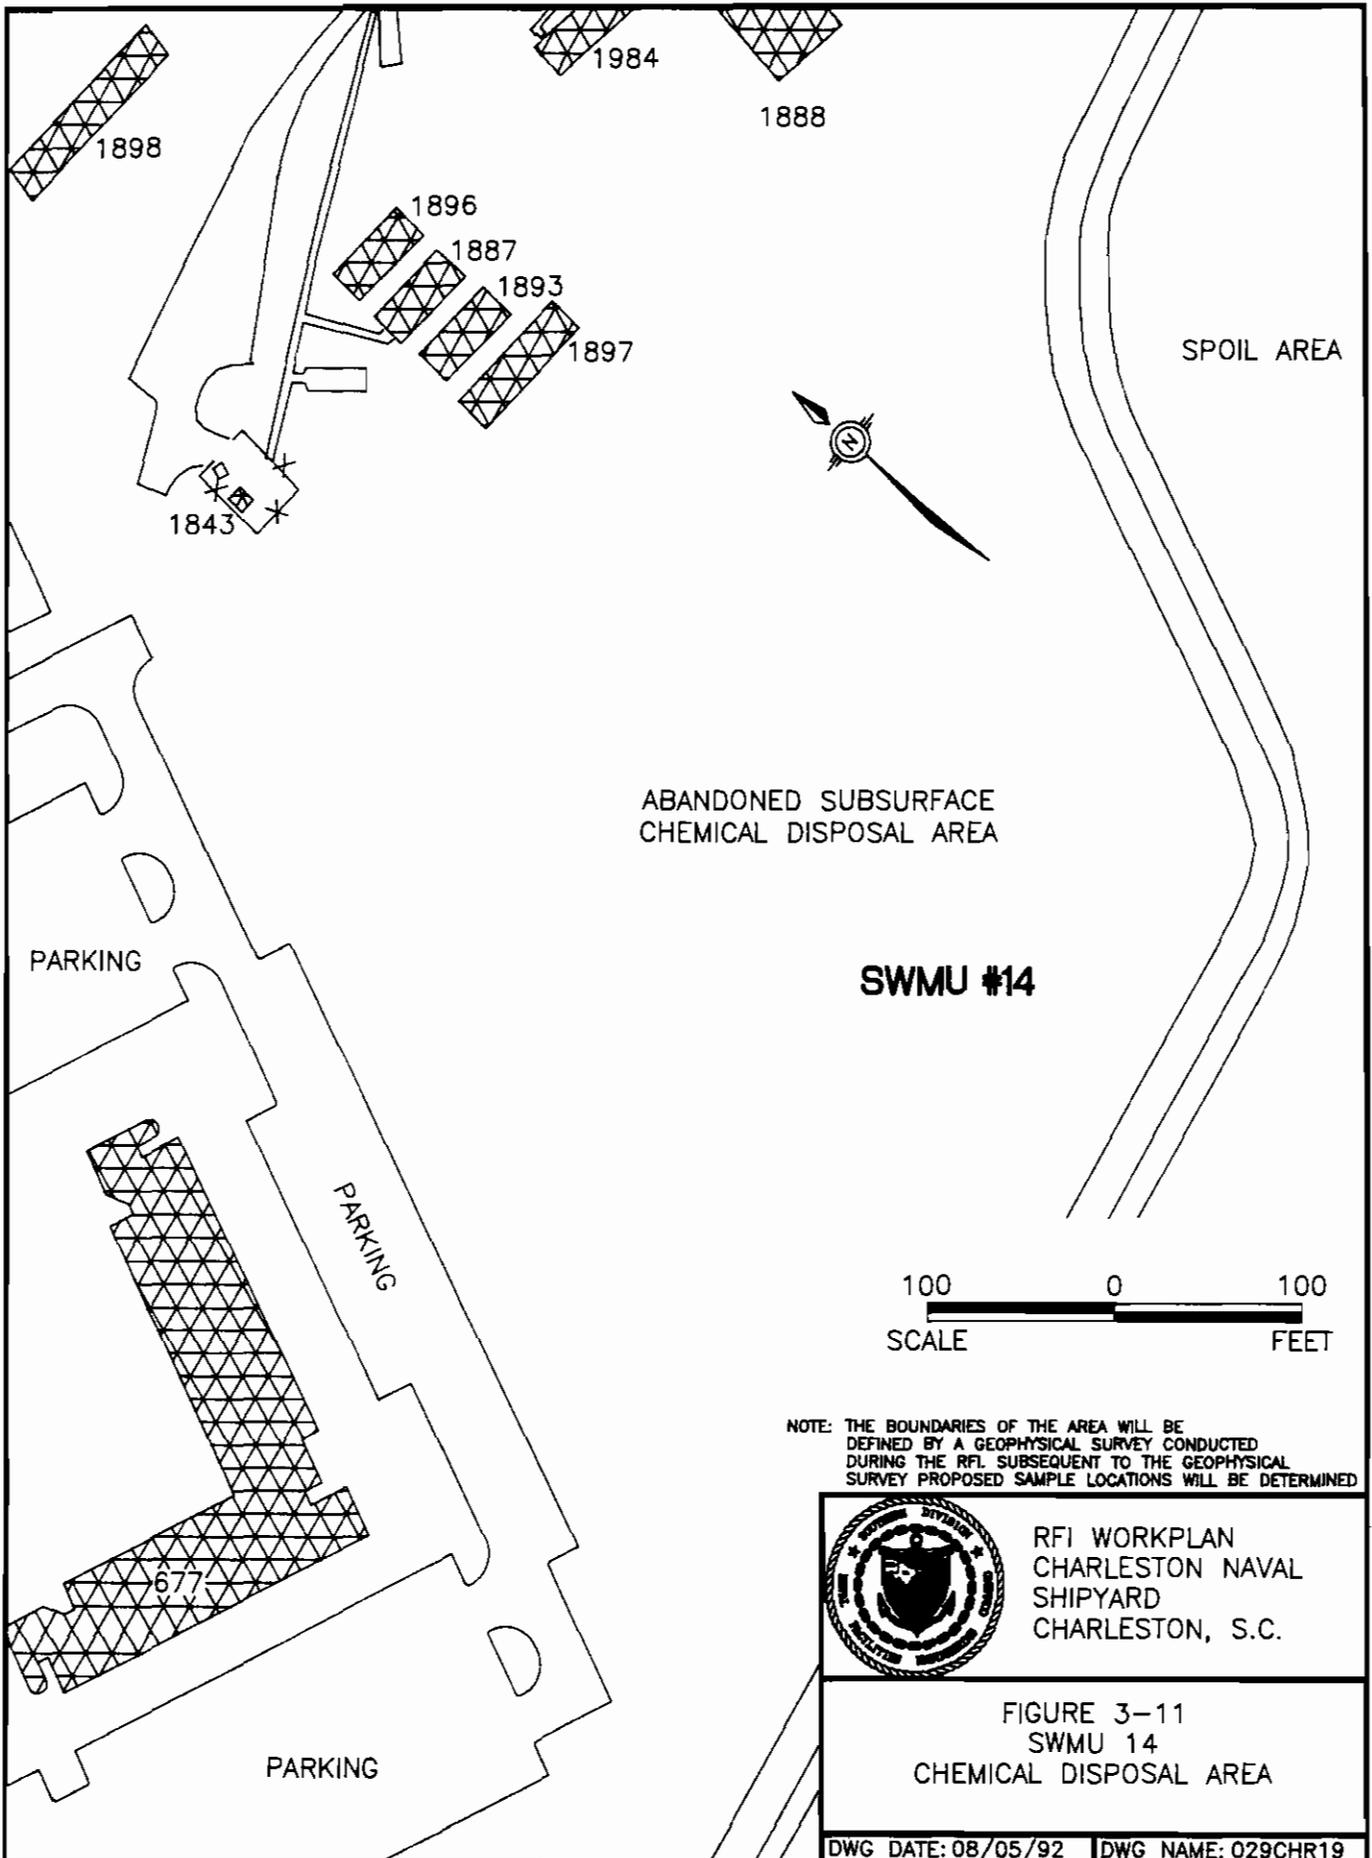
FIGURE 3-11
SWMU 14
CHEMICAL DISPOSAL AREA

ABANDONED SUBSURFACE
CHEMICAL DISPOSAL AREA
