FUEL DISTRIBUTION SYSTEM CONTAMINATION ASSESSMENT REPORT ZONE G
VOLUME I OF III SECTIONS 1 TO 7 CNC CHARLESTON SC
9/10/1998
ENSAFE

**ZONE G
FUEL DISTRIBUTION SYSTEM
CONTAMINATION ASSESSMENT REPORT
NAVBASE CHARLESTON
NORTH CHARLESTON, SOUTH CAROLINA**

**Volume I of III
Sections 1 to 7**

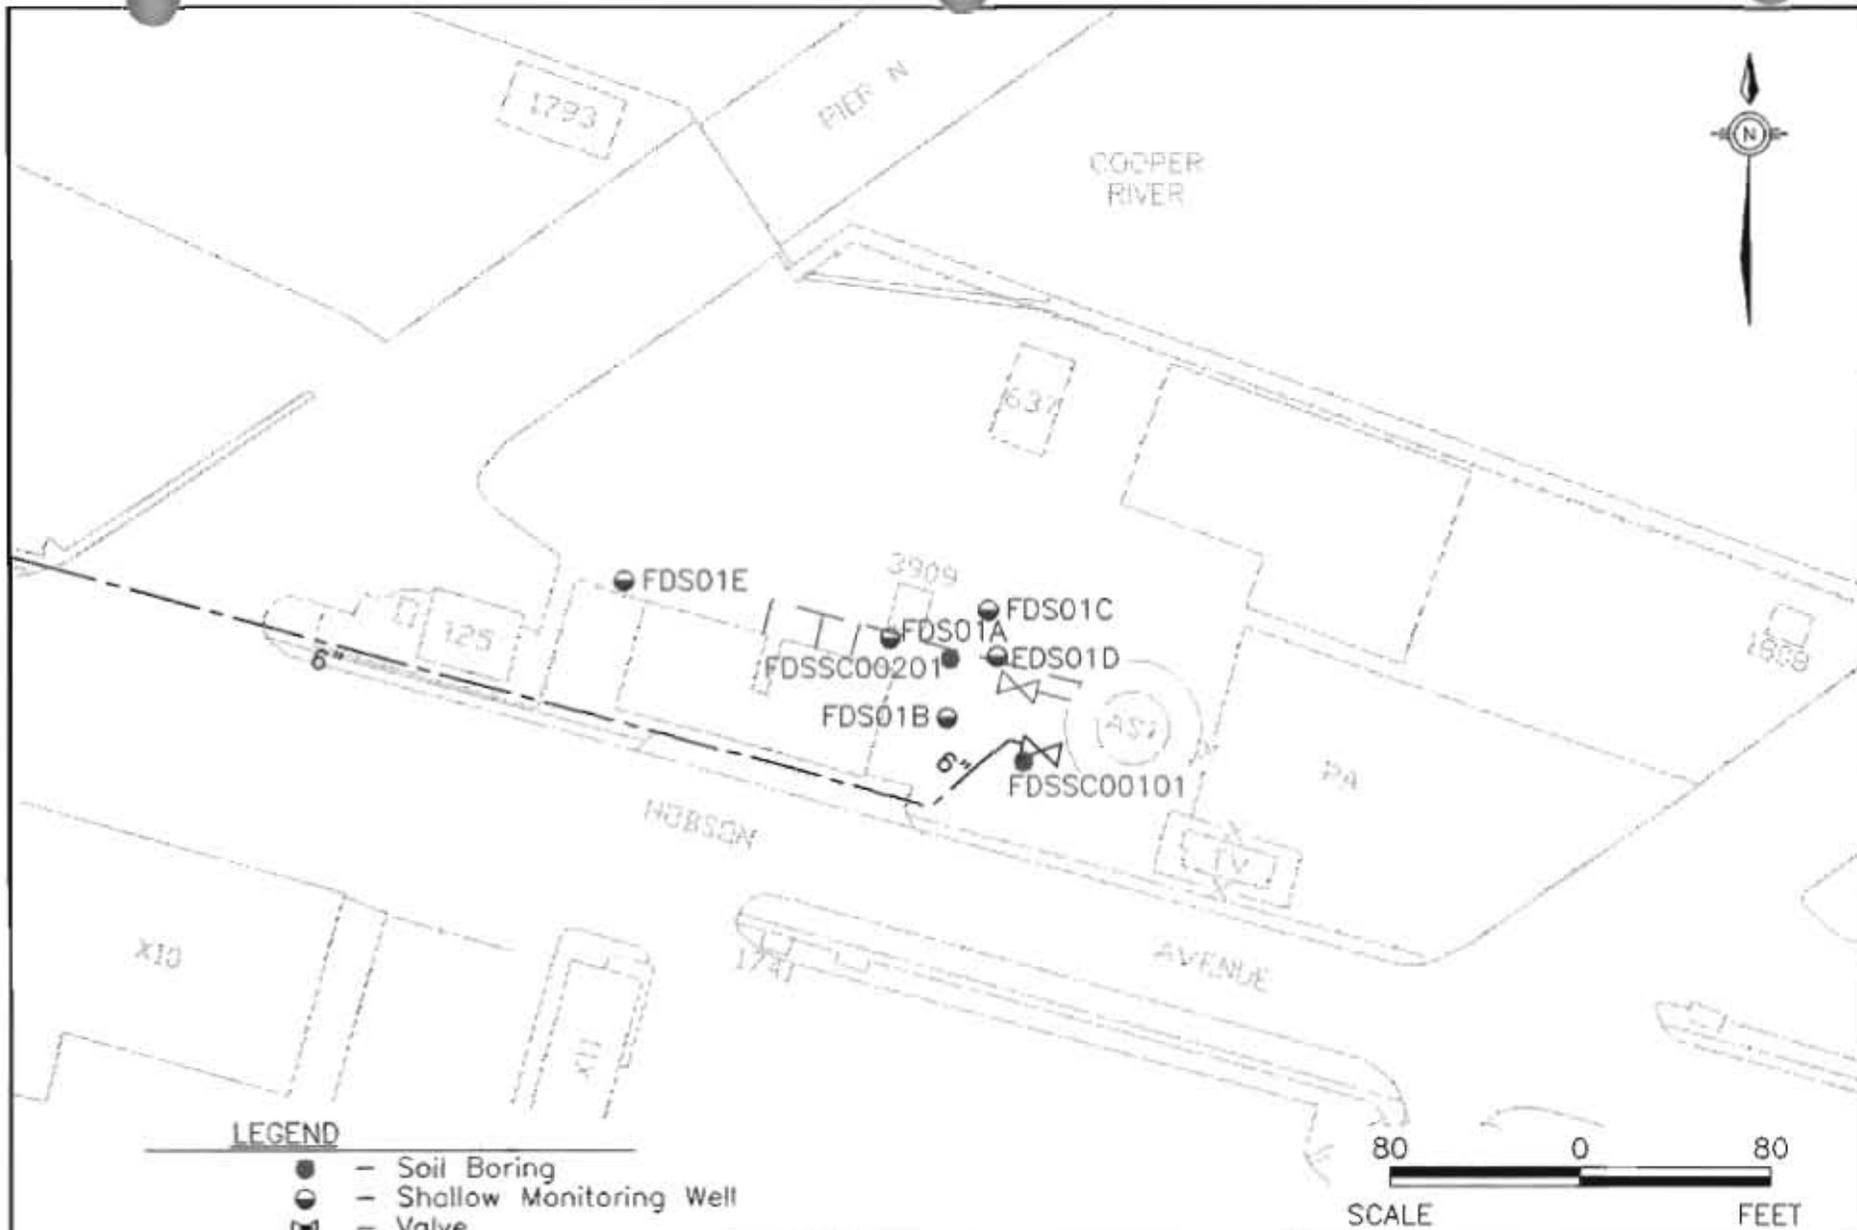
FIGURE 4.2-1
AREA 1
SOIL AND GROUNDWATER
SAMPLE LOCATIONS

Shallow groundwater at Area 1 generally occurs from 2.3 to 3.8 feet bgs. Figures 4.2-2 and 4.2-3 depict the shallow groundwater potentiometric surface and inferred flow direction for the site during low- and high-tide, respectively. Shallow groundwater flow direction changes only slightly between tidal stages. Well FDS01E provides downgradient coverage during low-tide. But during high-tide, flow changes to a more southwesterly direction. Consequently, it appears as though no

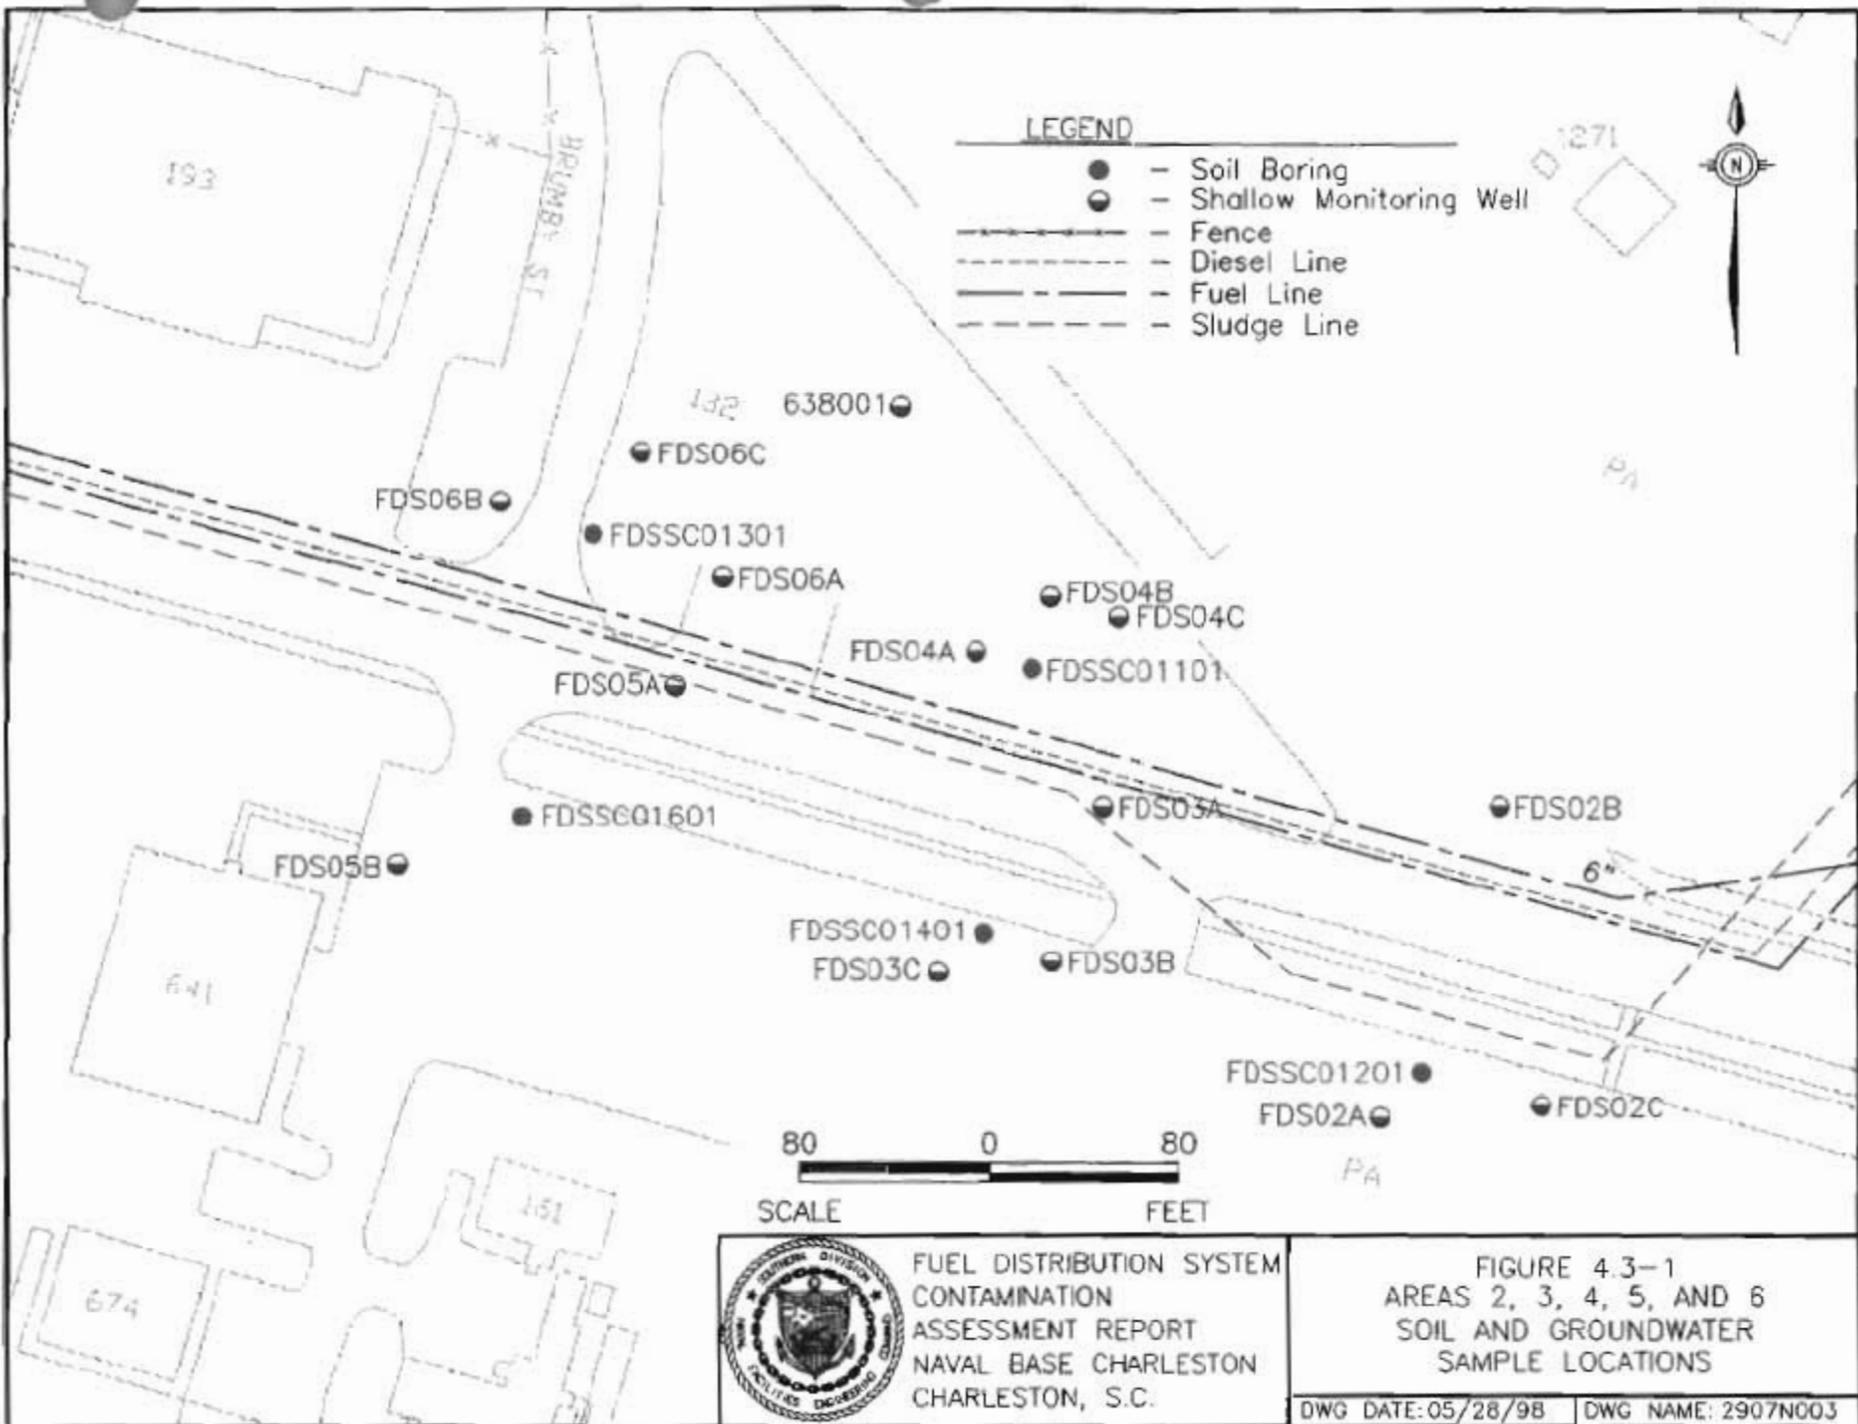
FIGURE 4.3-1
AREAS 2, 3, 4, 5, AND 6
SOIL AND GROUNDWATER
SAMPLE LOCATIONS

Shallow groundwater at Areas 2, 3, 4, 5, and 6 occurs from less than 2.8 to 5.2 feet bgs. Figures 4.3-2 and 4.3-3 depict the shallow groundwater potentiometric surface and inferred flow direction for the site during low- and high-tides, respectively. The overall shallow groundwater flow patterns are relatively consistent, with only minor localized variations between tidal stages.

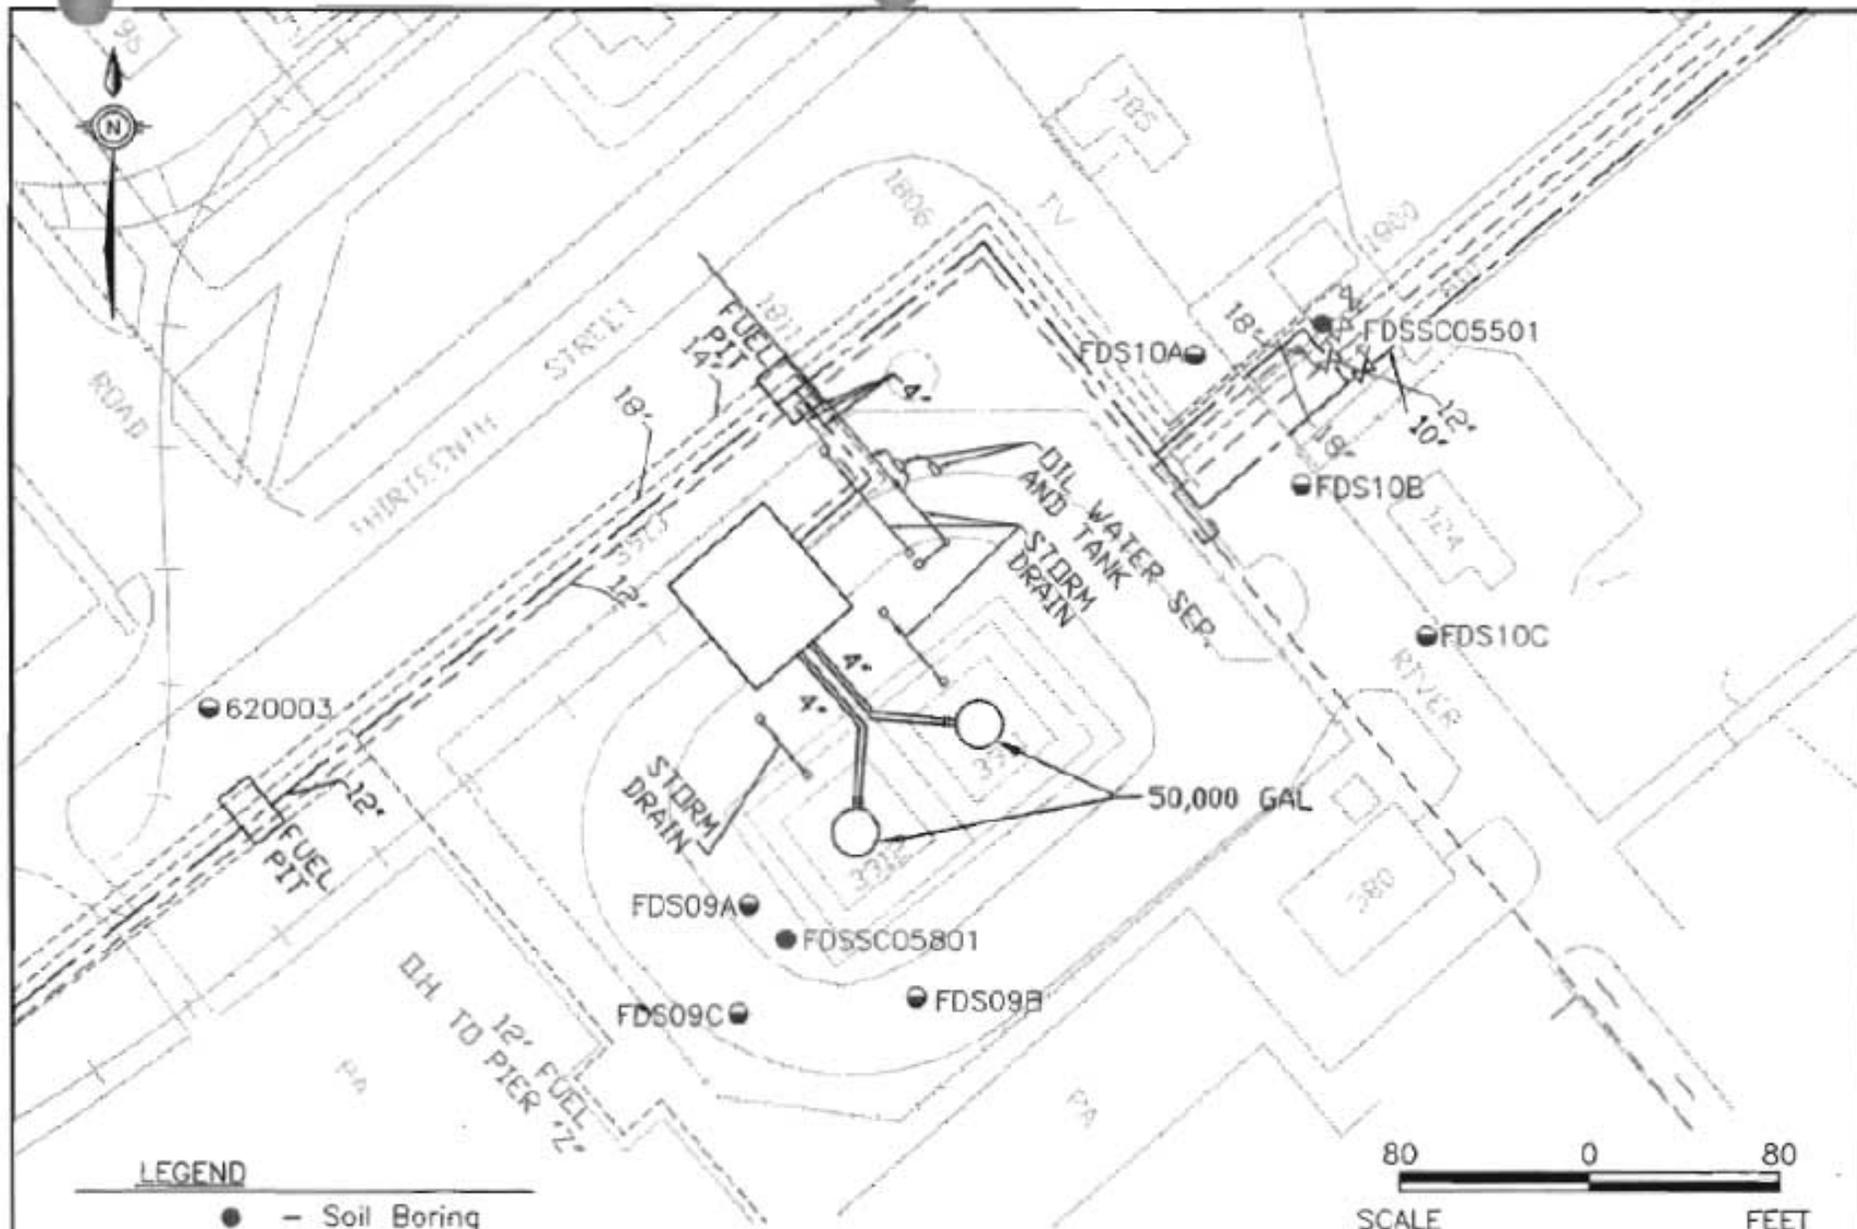
FIGURE 4.6-1
AREAS 9 AND 10
SOIL AND GROUNDWATER
SAMPLE LOCATIONS

Shallow groundwater at Areas 9 and 10 occurs from 1.25 to 3.0 feet bgs. Figures 4.6-2 and 4.6-3 depict the shallow groundwater potentiometric surface and inferred flow direction for the site during low- and high-tide respectively. The overall flow direction was consistent between tides. The gradient was less during high-tide. Changes in groundwater elevation between tides were less than 0.35 feet.

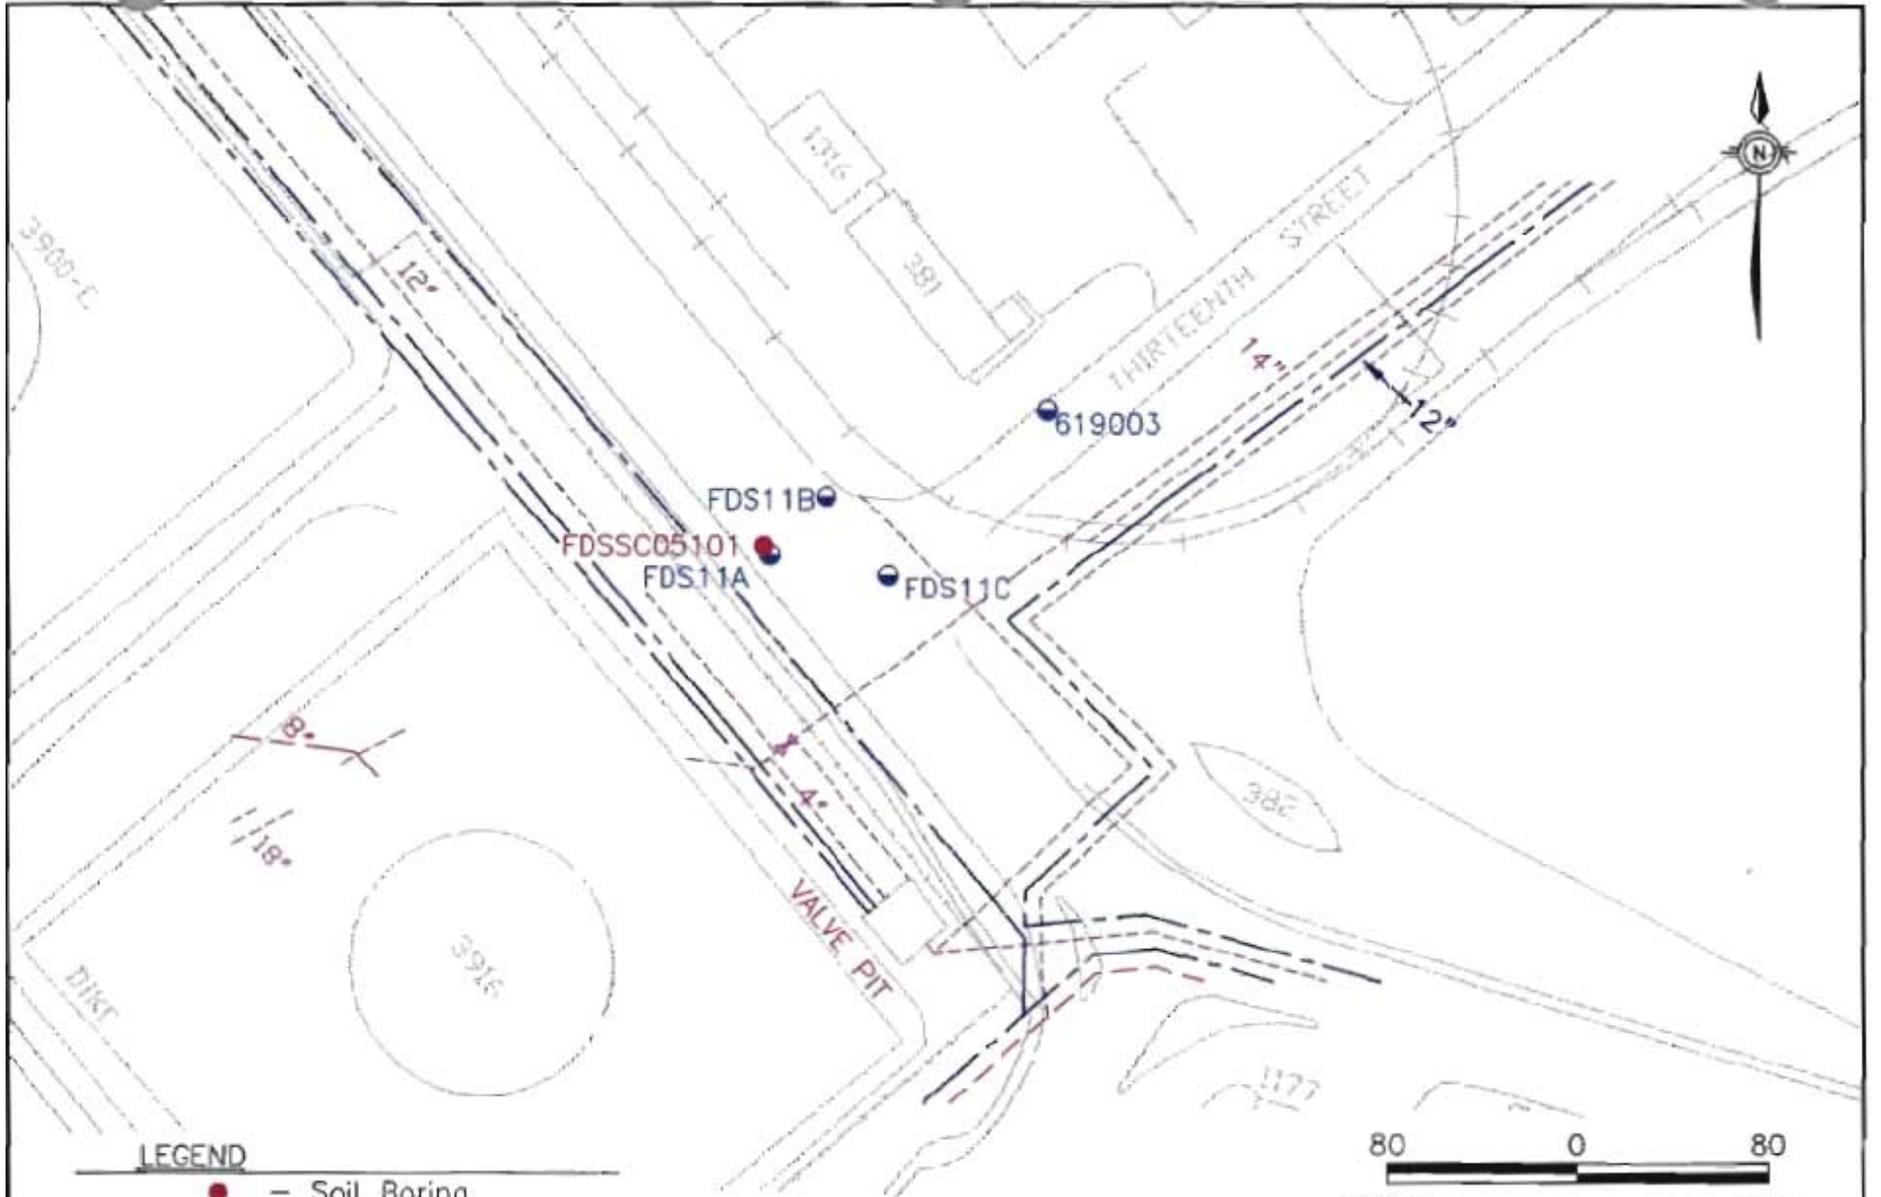
FIGURE 4.7-1
AREA 11
SOIL AND GROUNDWATER
SAMPLE LOCATIONS
DWG DATE: 06/02/98 | DWG NAME: 2907N007

Shallow groundwater at Area 11 generally occurs from 3.8 to 4.25 feet bgs. Figures 4.7-2 and 4.7-3 depict the shallow groundwater potentiometric surface and inferred flow direction for the site during low- and high-tides, respectively. The overall flow direction and gradient were consistent between tidal stages. Tidal variation was less than 0.12 foot. Maximum average calculated groundwater velocity (utilizing the steepest gradient) was 0.018 feet/day based on an average porosity (0.359) and representative hydraulic conductivity (0.37 feet/day) determined during the Zone G RFI (EnSafe, February 1998).
