FINAL ASBESTOS INSPECTION REPORT BUILDING 2NS CNC CHARLESTON SC
10/1/1998
SUPERVISOR OF SHIPBUILDING

BUILDING 2NS

CHARLESTON NAVAL COMPLEX

FINAL REPORT

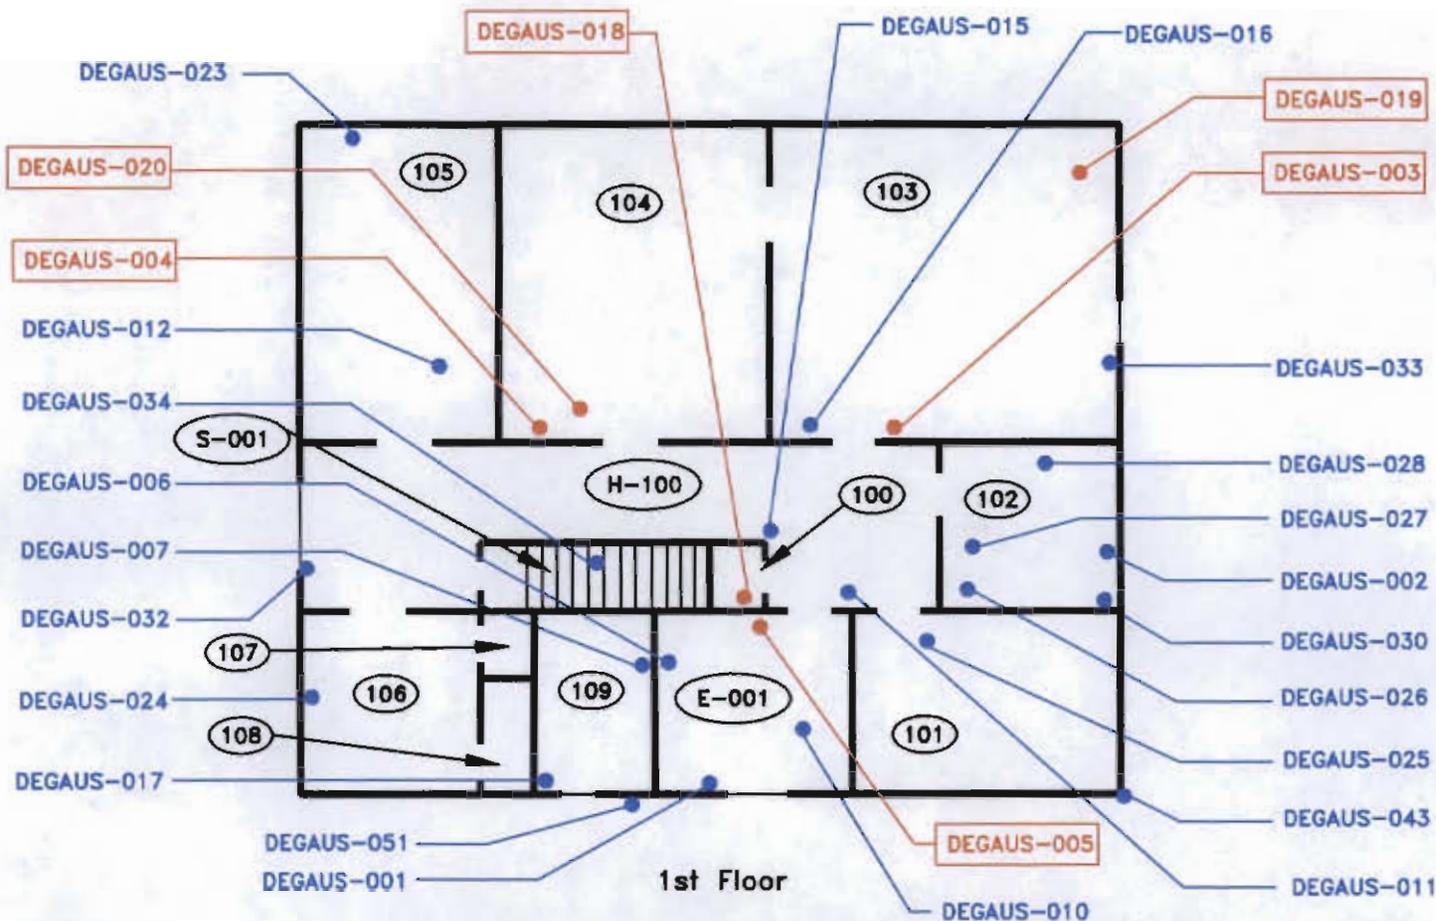
DATE 10-26-98	PREPARED BY: B.D. MURRAY	REV ORIG
SCALE: NONE	SHEET 1 of 4

(xxx) — Indicates unique room number assigned by Inspector

xxxx-xxx — Indicates sample locations which tested positive for asbestos

SAMPLE LOCATIONS
2NS DEGAUSSING STATION
CHARLESTON NAVAL COMPLEX, CHARLESTON, SC

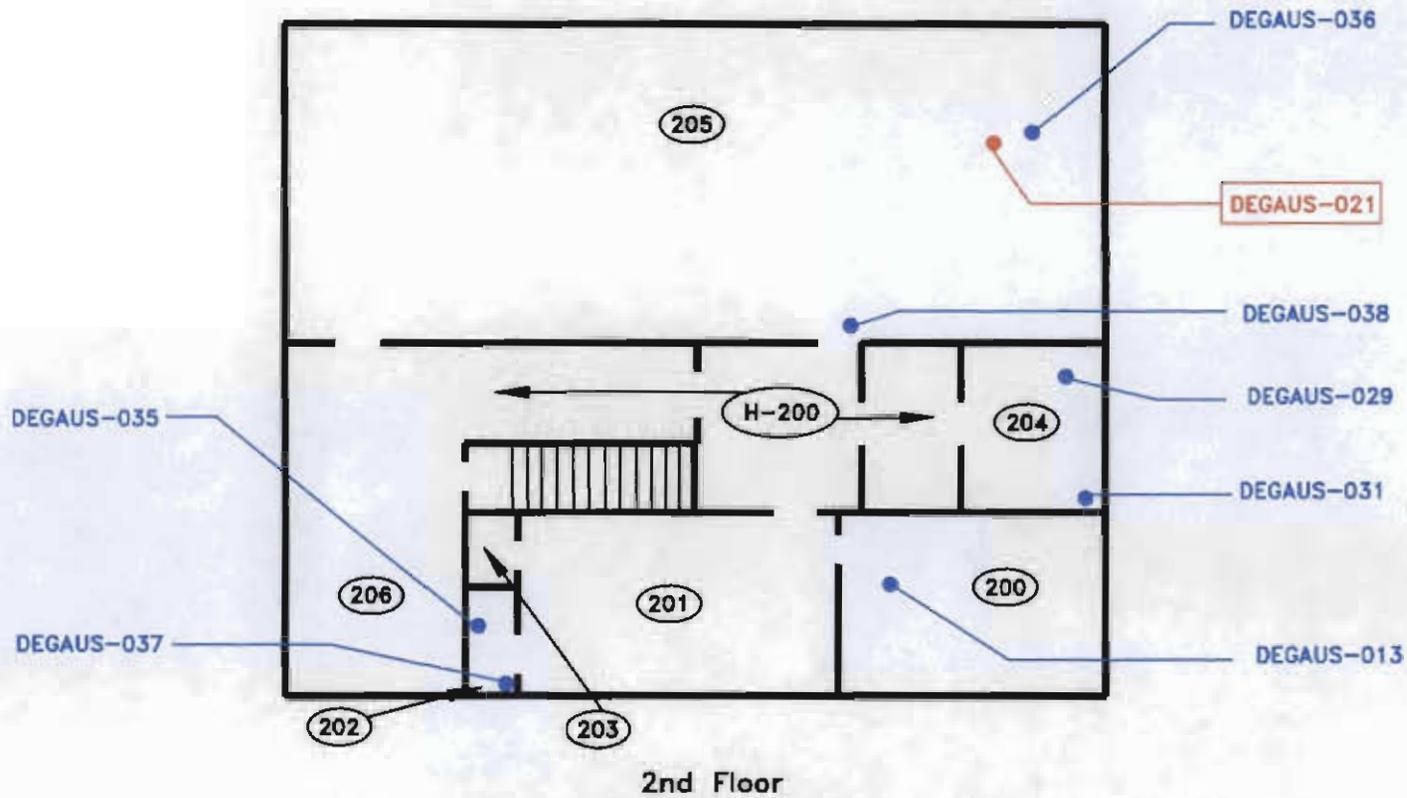
SCALE: NONE	SHEET 2 of 4
-------------	--------------

(xxx) — Indicates unique room number assigned by inspector

XXXX-XXX — Indicates sample locations which tested positive for asbestos

SAMPLE LOCATIONS
2NS DEGAUSSING STATION
CHARLESTON NAVAL COMPLEX, CHARLESTON, SC

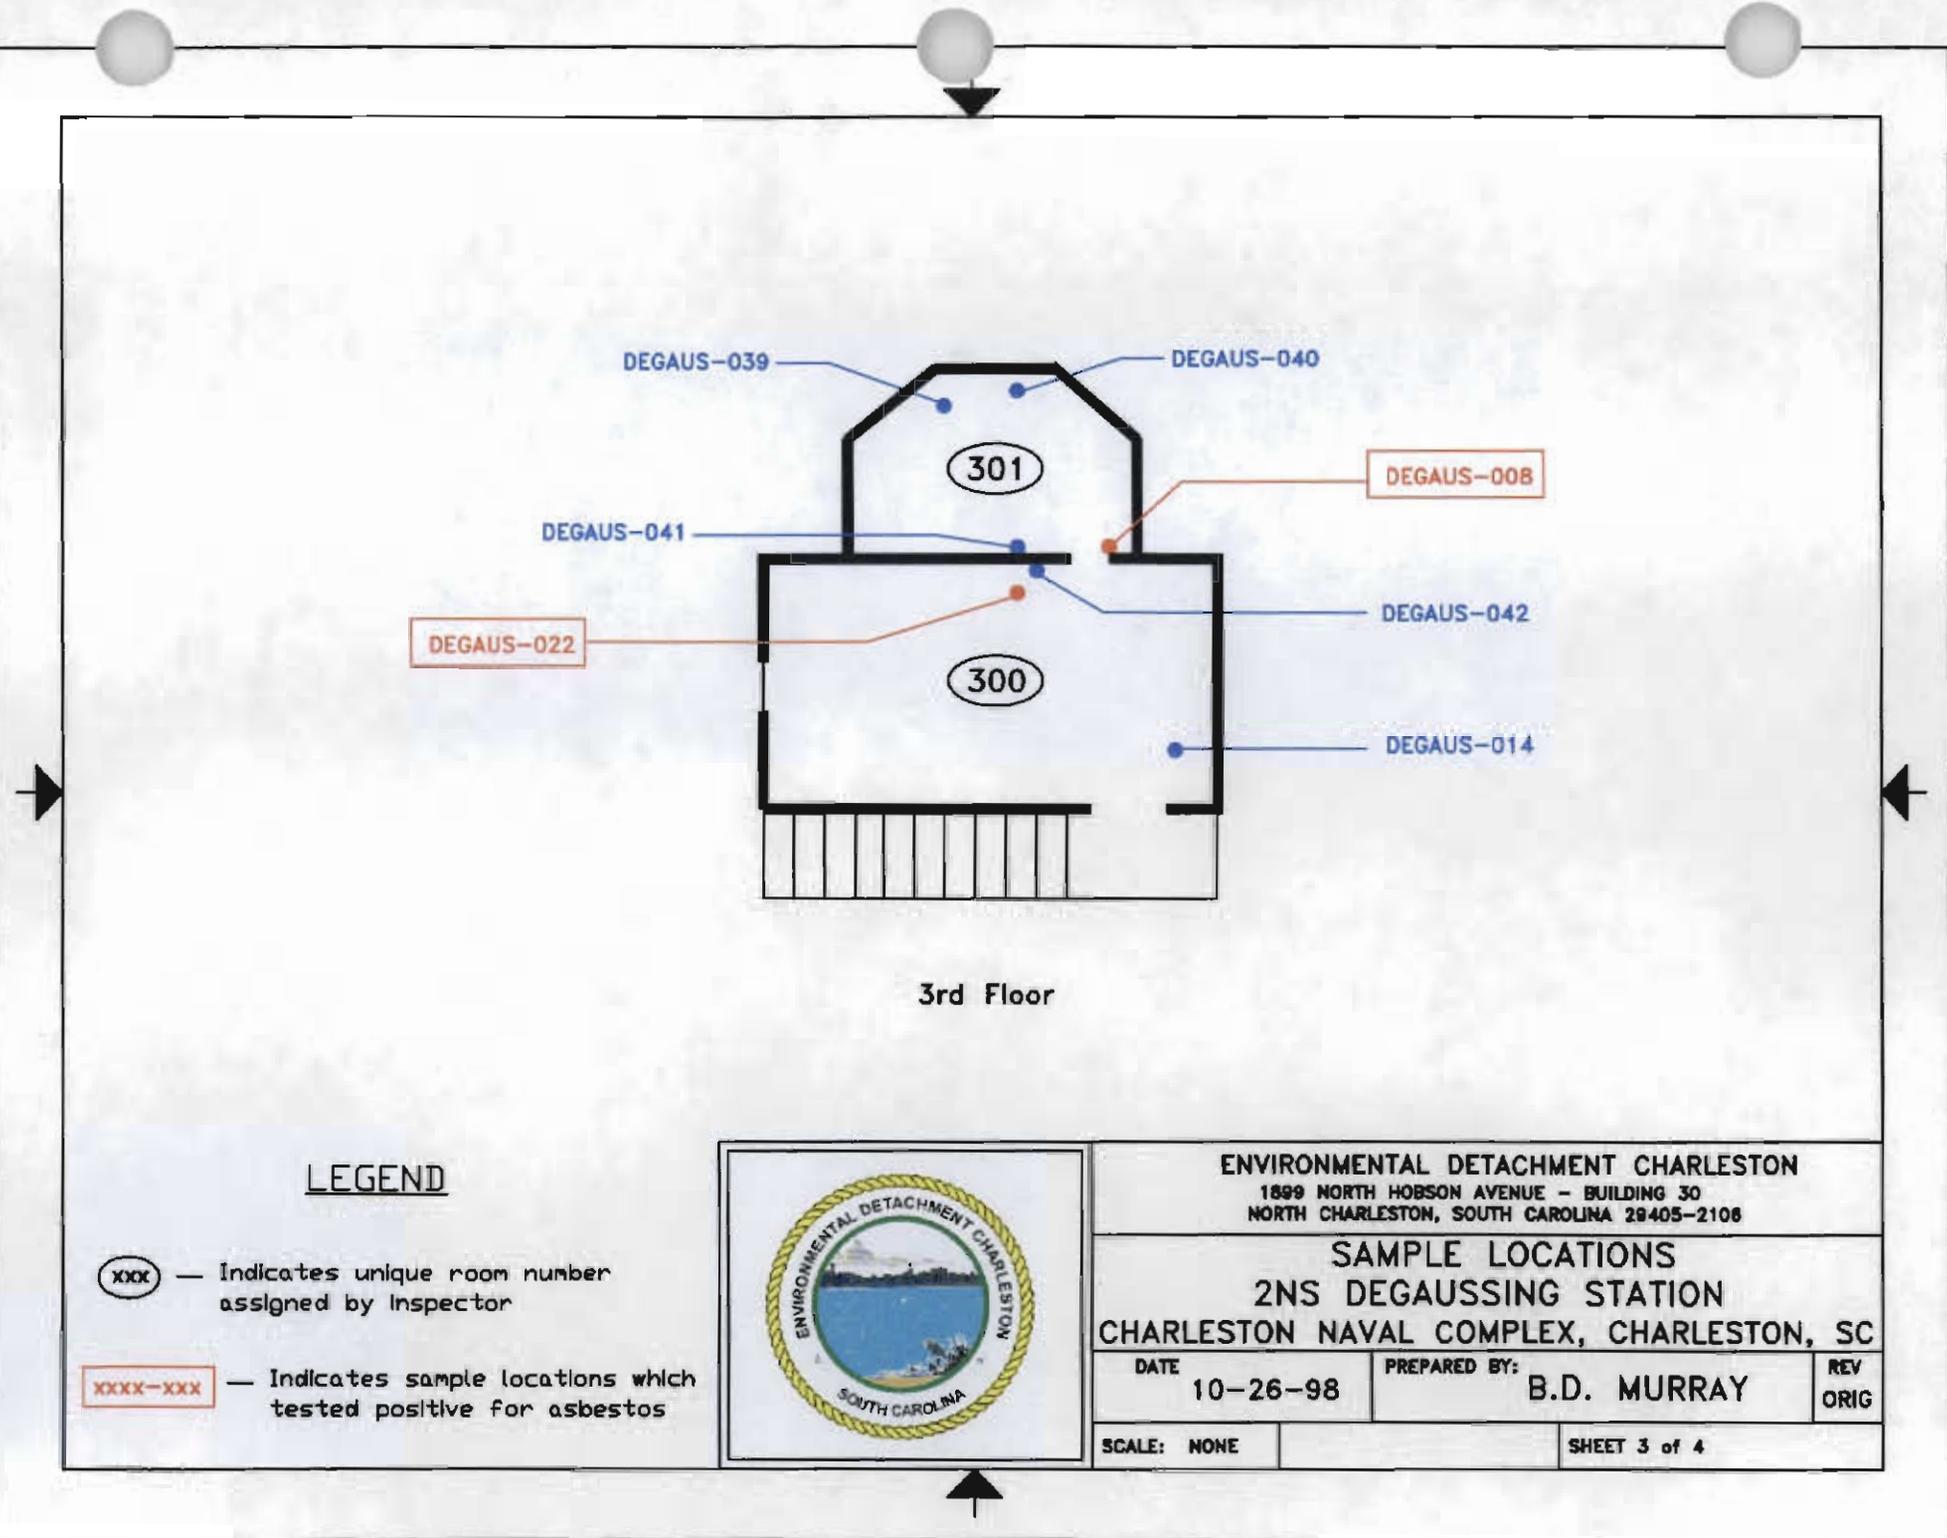
ENVIRONMENTAL DETACHMENT CHARLESTON 1899 NORTH HOBSON AVENUE - BUILDING 30 NORTH CHARLESTON, SOUTH CAROLINA 29405-2108		
SAMPLE LOCATIONS 2NS DEGAUSSING STATION CHARLESTON NAVAL COMPLEX, CHARLESTON, SC		
DATE 10-26-98	PREPARED BY: B.D. MURRAY	REV ORIG
SCALE: NONE		SHEET 3 of 4

(xxx) — Indicates unique room number assigned by Inspector

xxxx-xxx — Indicates sample locations which tested positive for asbestos

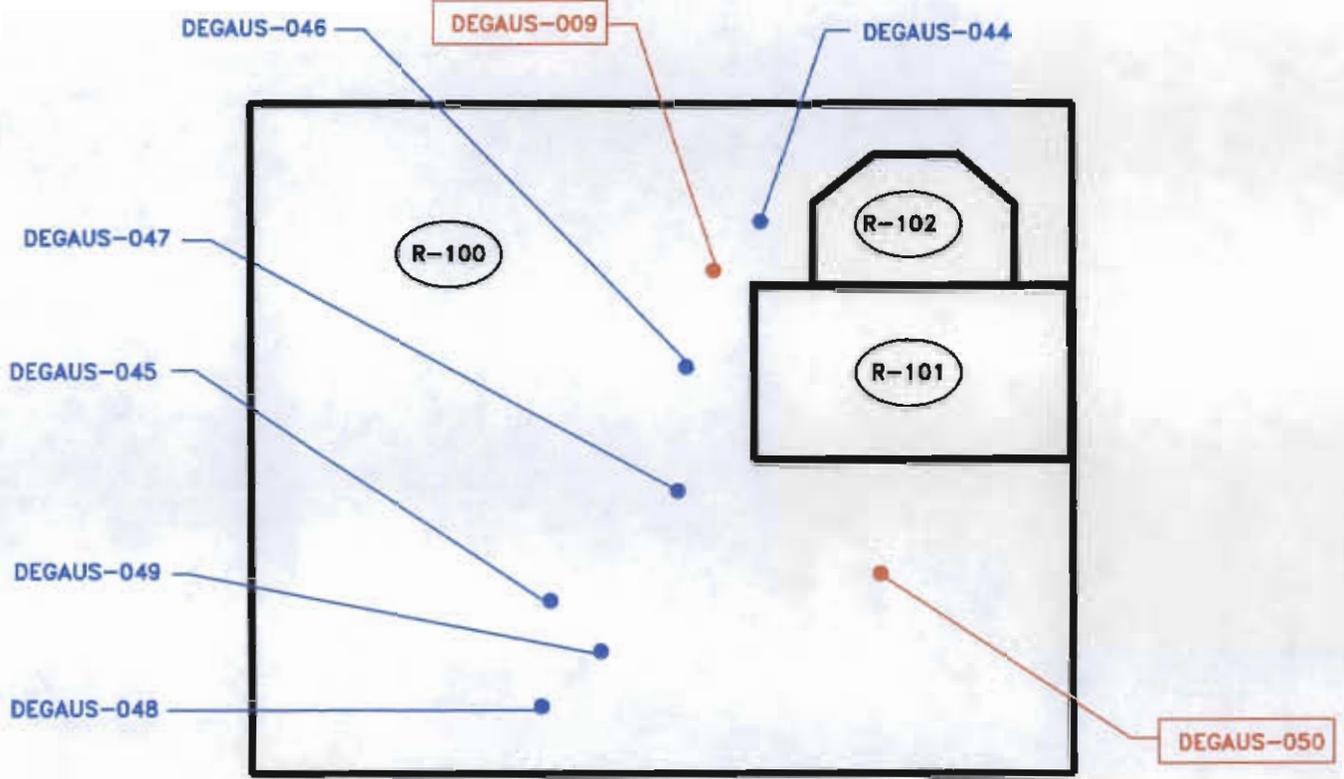
ENVIRONMENTAL DETACHMENT CHARLESTON 1899 NORTH HOBSON AVENUE - BUILDING 30 NORTH CHARLESTON, SOUTH CAROLINA 29405-2108		
SAMPLE LOCATIONS 2NS DEGAUSSING STATION CHARLESTON NAVAL COMPLEX, CHARLESTON, SC		
DATE 10-26-98	PREPARED BY: B.D. MURRAY	REV ORIG
SCALE: NONE	SHEET 4 of 4

Roof

(xxx) — Indicates unique room number assigned by Inspector

xxxx-xxx — Indicates sample locations which tested positive for asbestos
