UNDERGROUND STORAGE TANK (UST) ASSESSMENT REPORT DATED 22 MAY 1998
FOR QUARTERS T WITH SOUTH CAROLINA DEPARTMENT OF HEALTH AND
ENVIRONMENTAL CONTROL REVIEW LETTER CNC CHARLESTON SC
07/14/1998
NAVFAC SOUTHERN

Re: Underground Storage Tank Assessment Report dated 22 May 1998
Quarters "T" Housing (Site Identification # 15405-General File)
Charleston Naval Complex/Charleston Naval Base
Charleston, SC
Charleston County

South Carolina Department of Health and Environmental Control (S.C.D.H.E.C.)
Underground Storage Tank (UST) Assessment Report

Site I.D. #: Unregulated
Facility Name: Charleston Naval Base Complex, Housing Quarters T
Street Address: 1531 Hobson Avenue
City: North Charleston, 29405-2413 County: Charleston

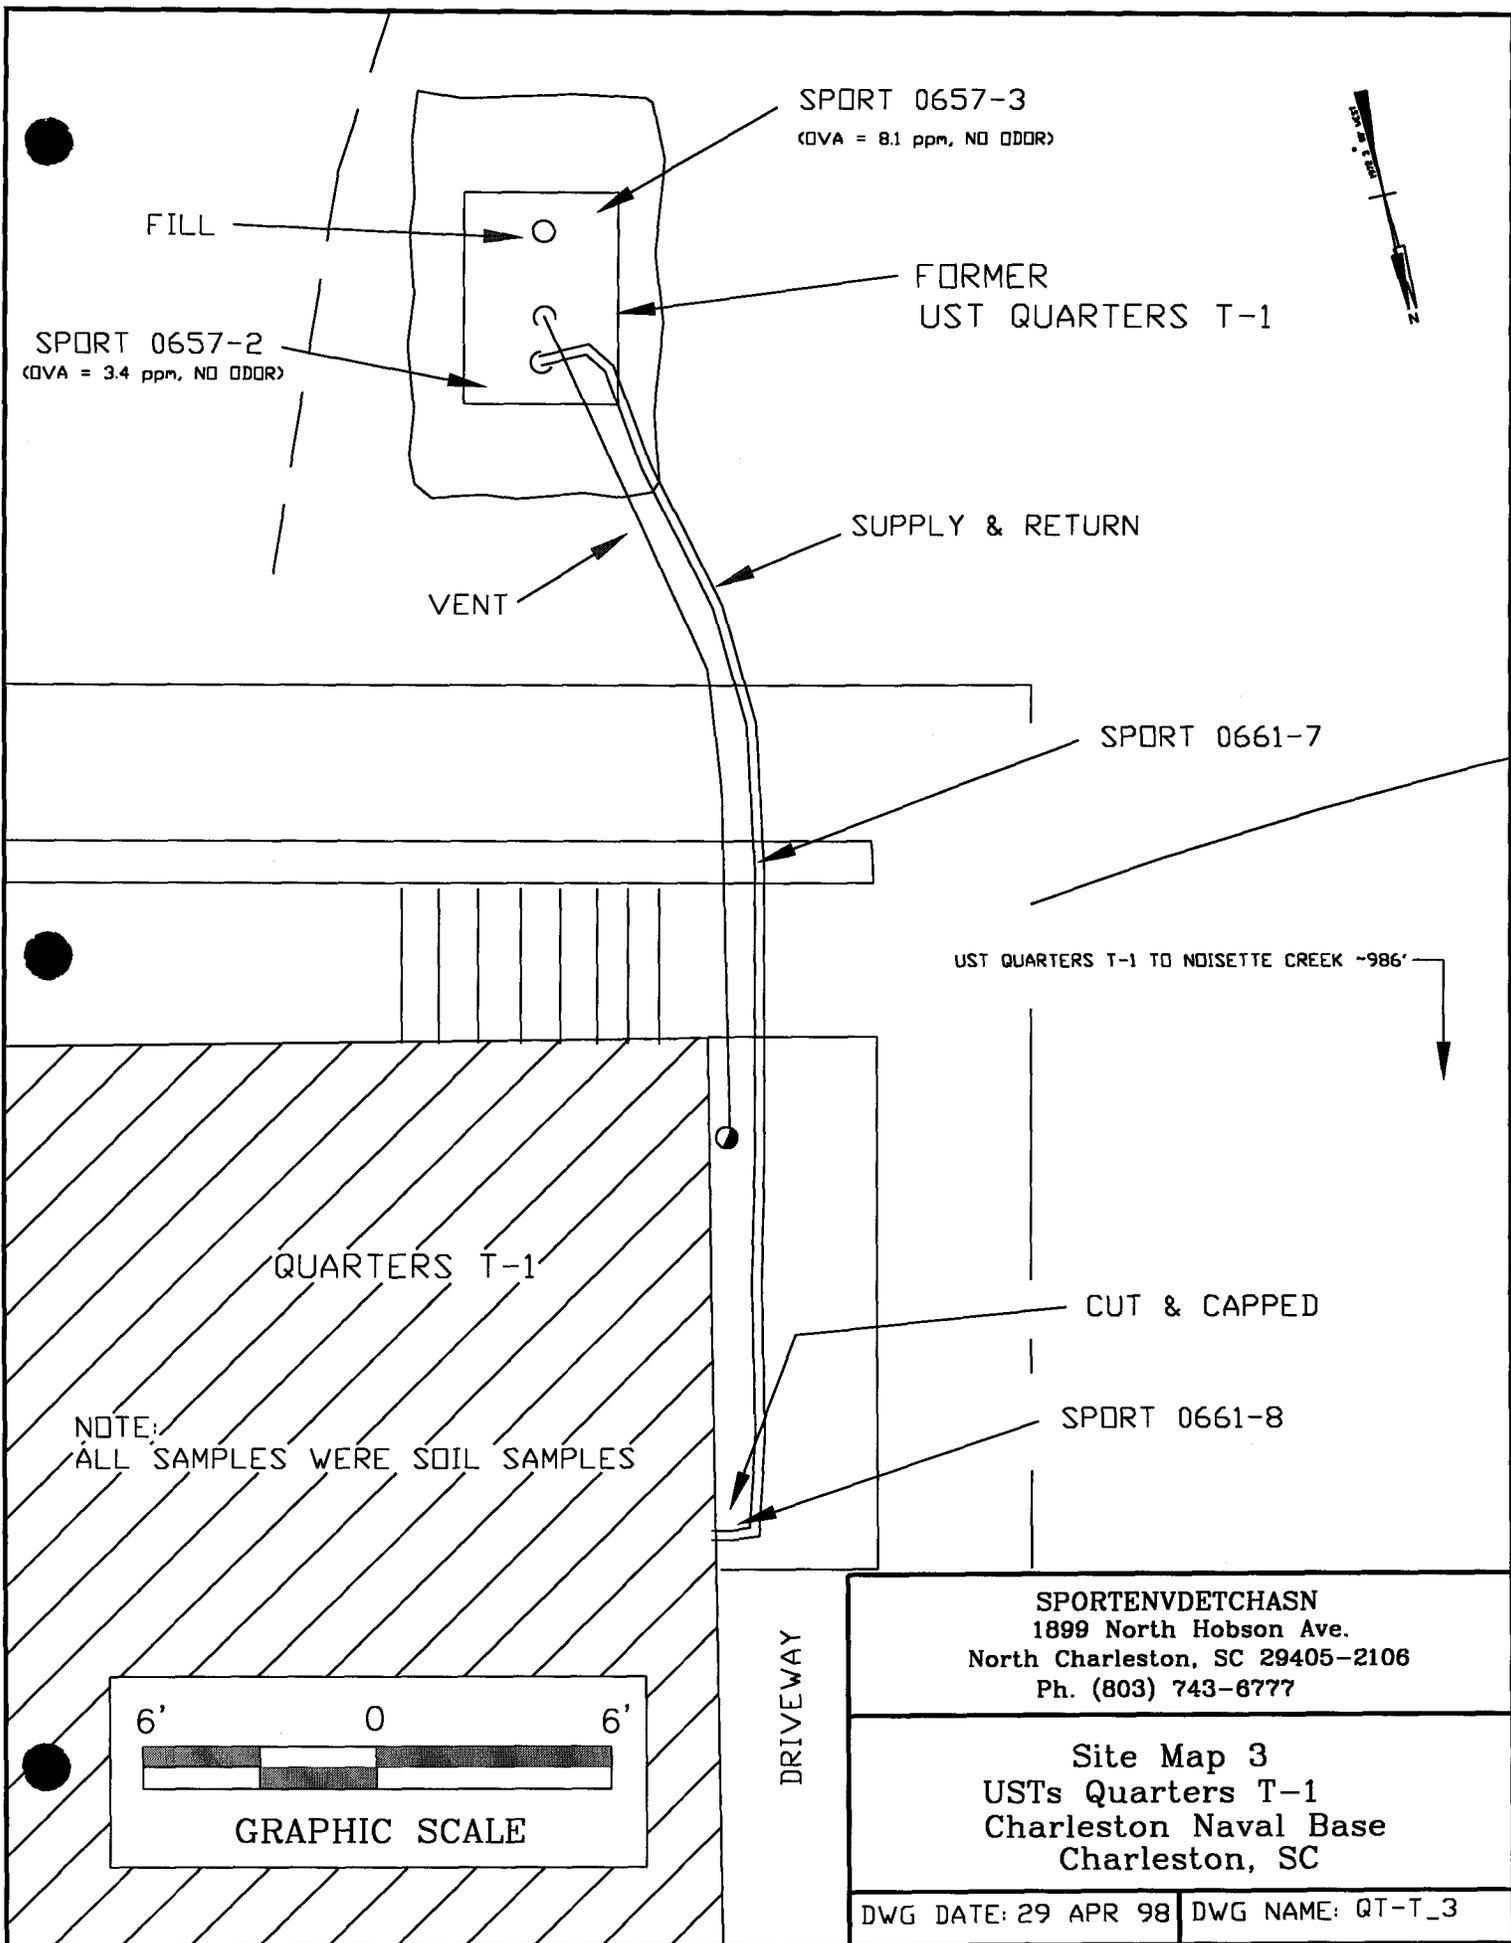
Site Map 3
USTs Quarters T-1
Charleston Naval Base
Charleston, SC

SPORT 0657-3
(OVA = 8.1 ppm, NO ODR)

SPORT 0657-2
(OVA = 3.4 ppm, NO ODR)

SPORT 0661-7

NOTE:
ALL SAMPLES WERE SOIL SAMPLES

SPORT 0661-8

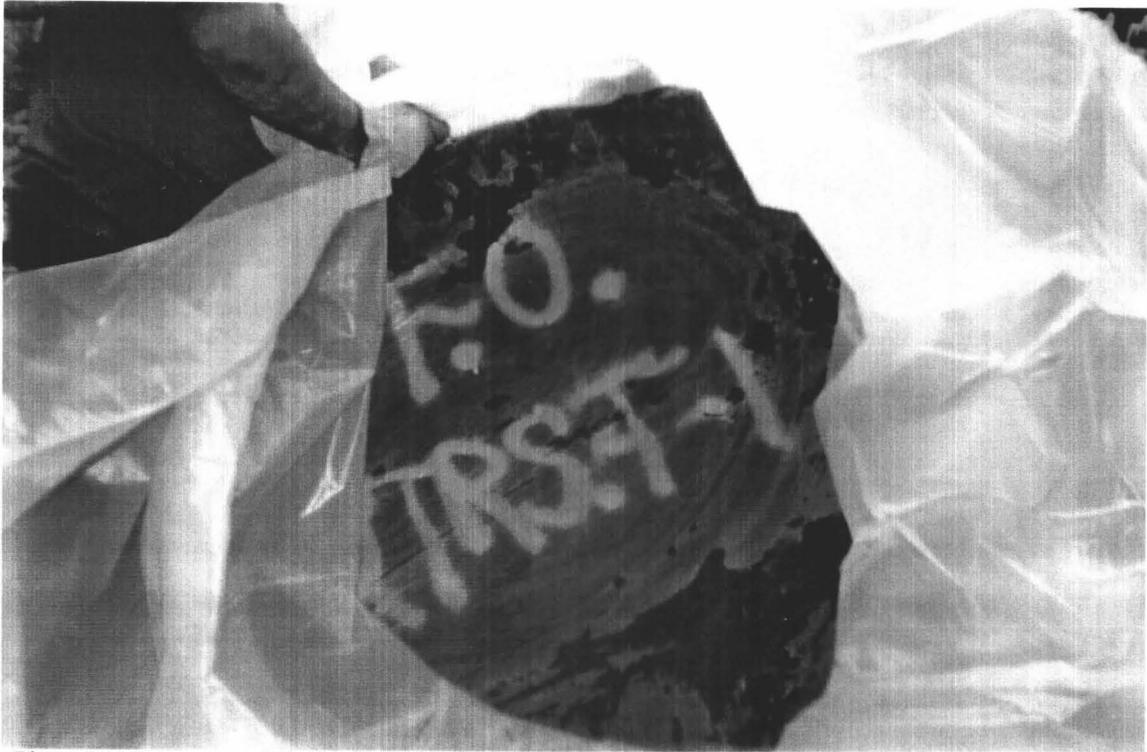
Photo 1: UST Quarters T being wrapped for transport the cleaning and cutting pad.

UST Quarters T-1 was removed, drained, cut open at both ends, and cleaned with a steam cleaner. It was then cut up for recycling as scrap metal. (See Attachment III.)

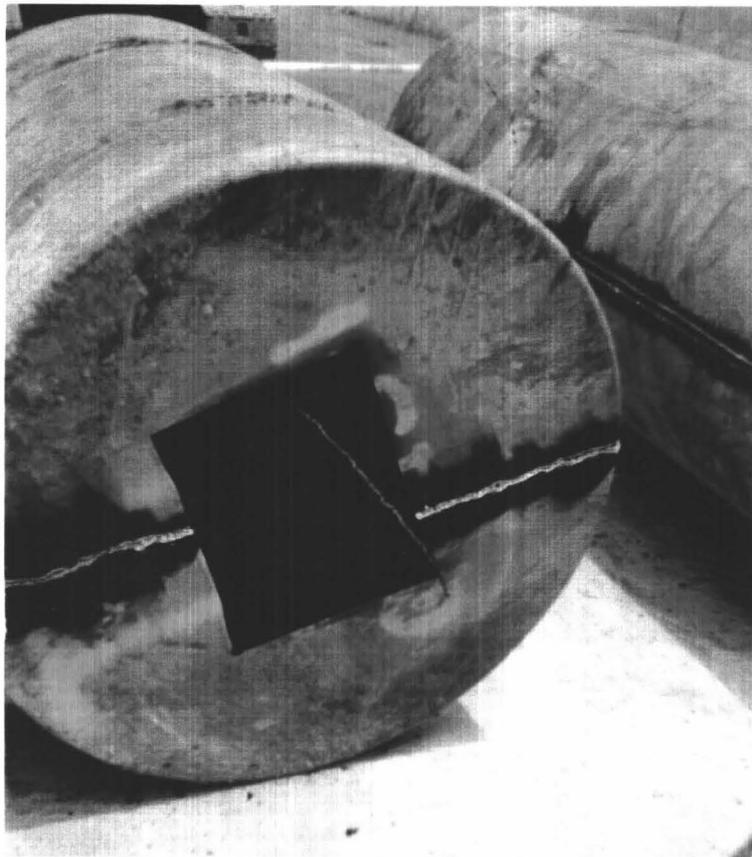
UST Quarters T-1 was covered with a protective coating of pitch. The tank was in good condition and contained no holes and only patches of surface corrosion.

Photo 2: UST Quarters T after cutting and cleaning.
