FINAL SUMMARY OF HYDROLOGIC AND CHEMICAL CHARACTERIZATION STUDIES  
VOLUME 1 OF 3 NAS FORT WORTH TX  
7/1/1994  
ENVIRONMENTAL SCIENCE AND ENGINEERING

## Summary of Hydrologic and Chemical Characterization Studies

U.S. Army Engineer District  
Ft. Worth, Texas

Environmental  
Science &  
Engineering, Inc.

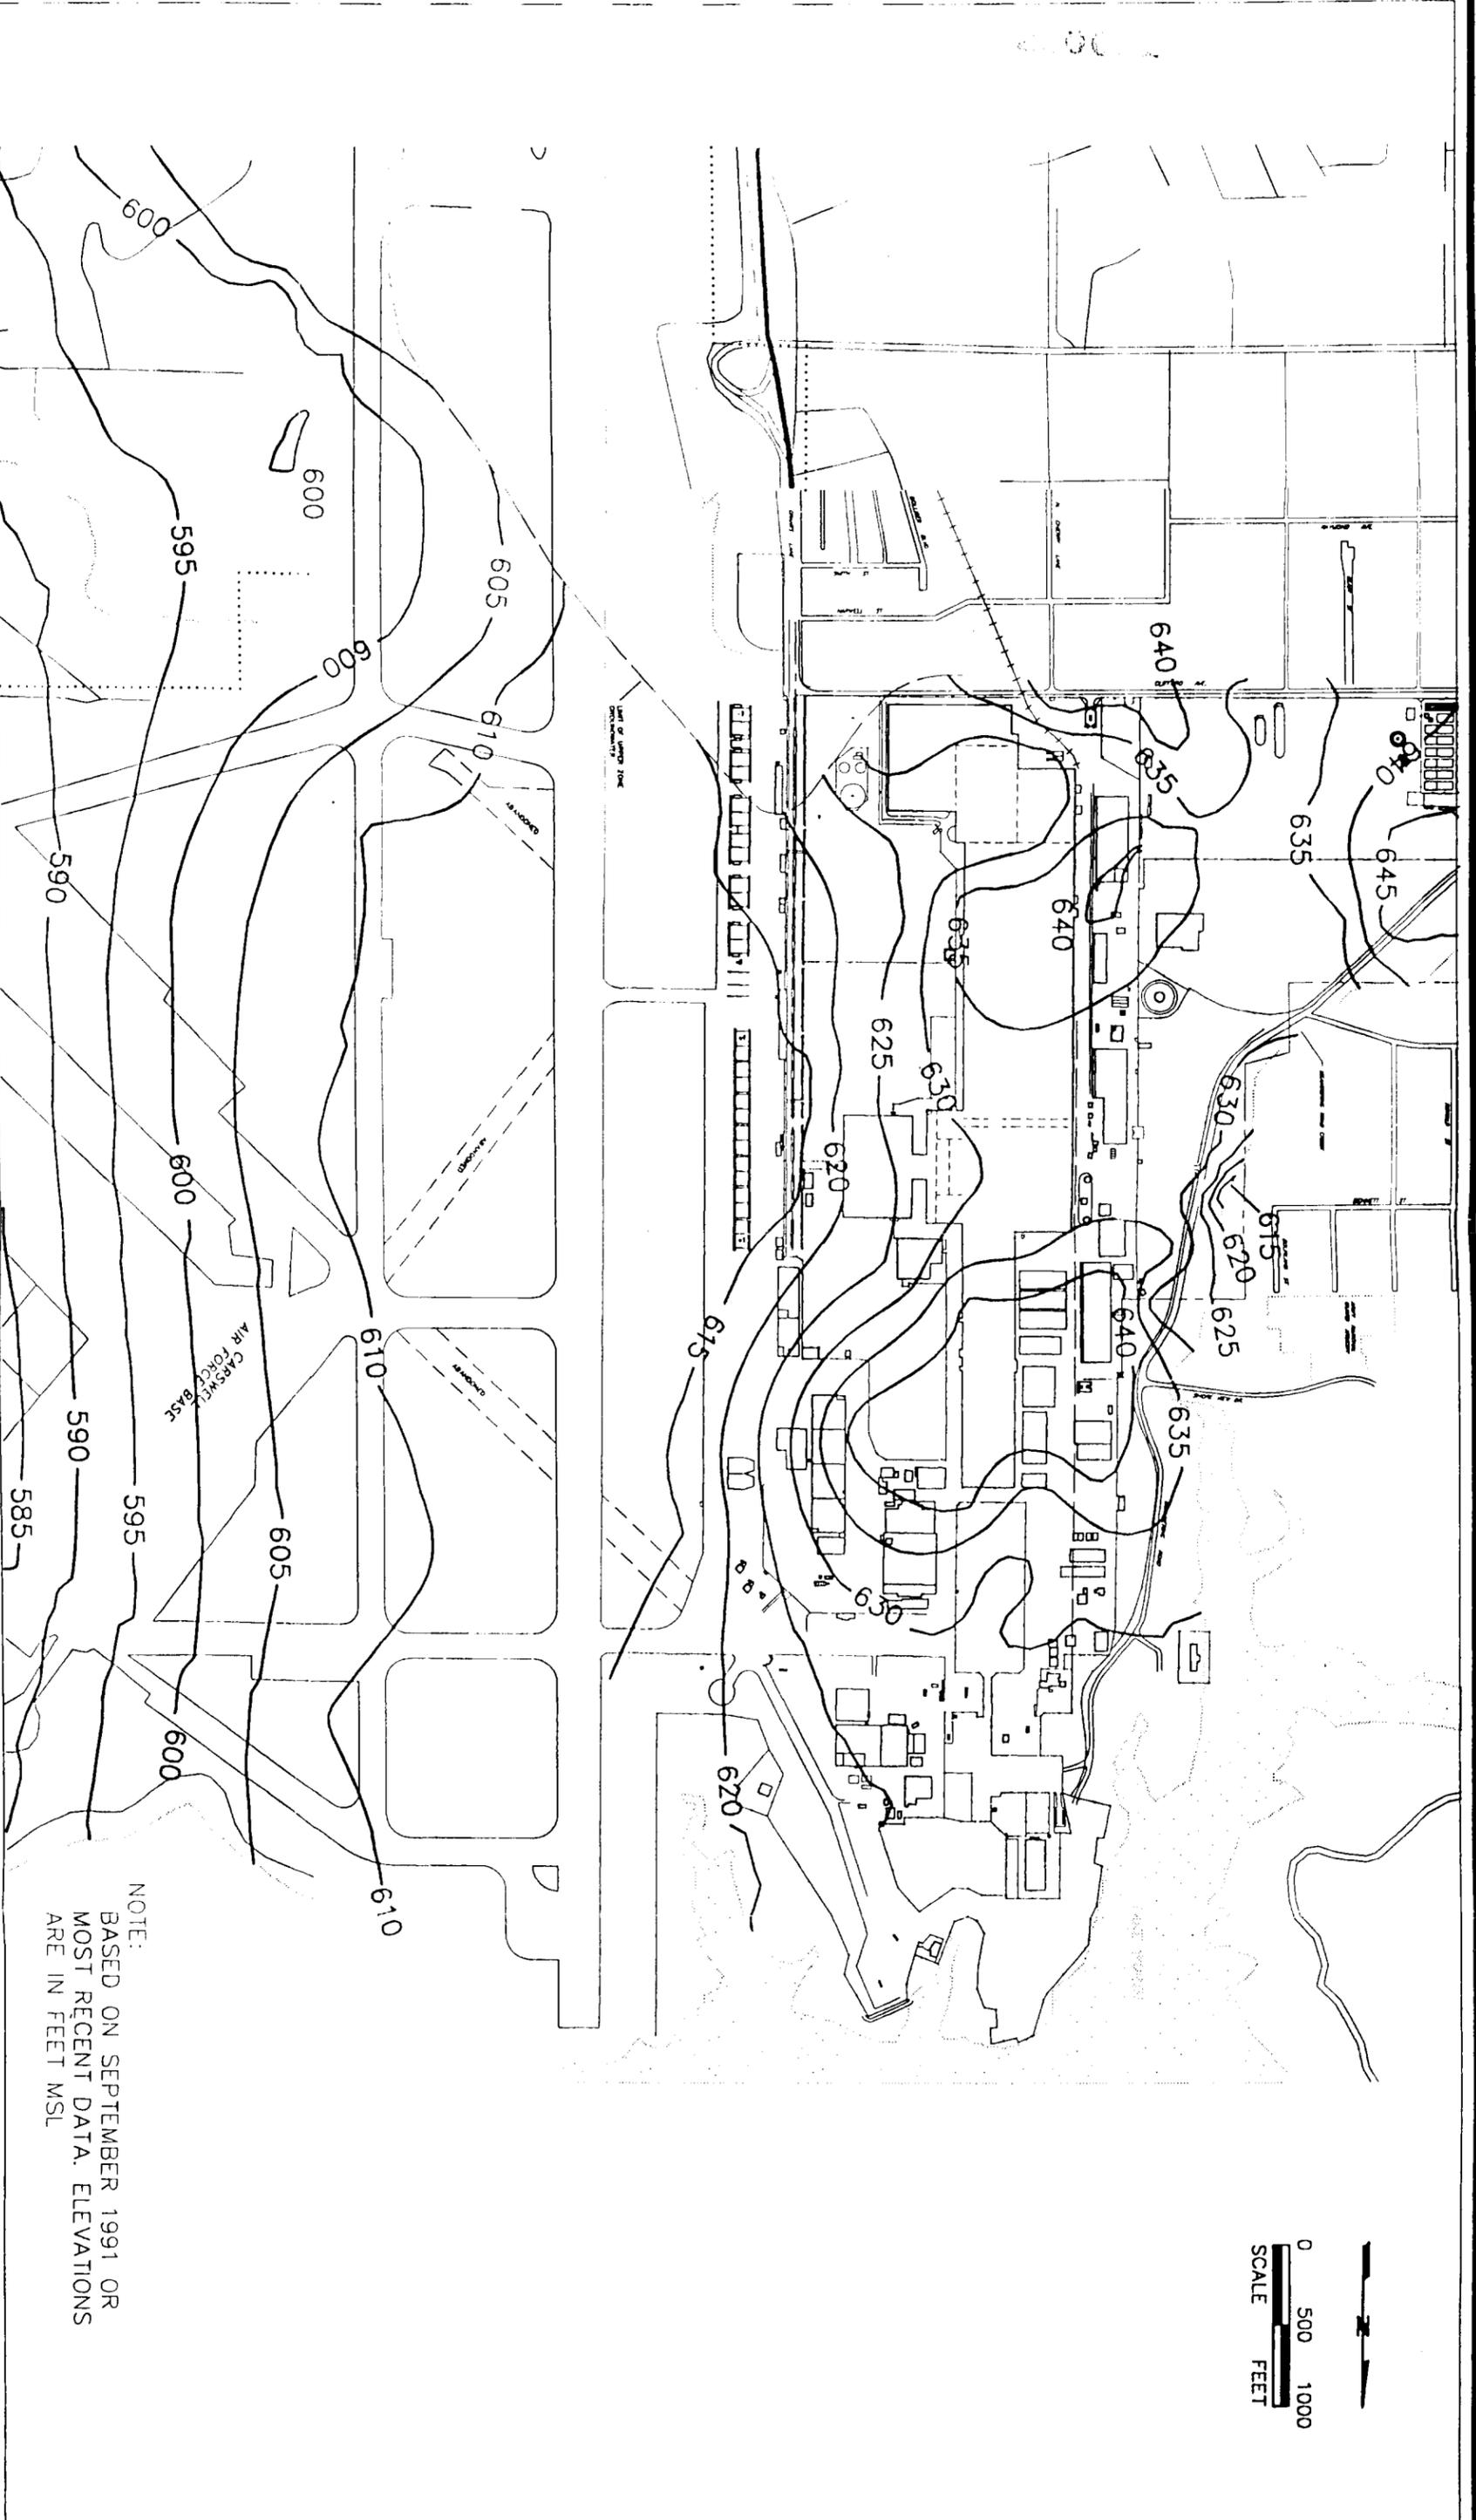
Figure 2.2-5  
 CONTOUR MAP OF UPPER ZONE WATER TABLE ELEVATIONS

NOTE:  
 BASED ON SEPTEMBER 1991 OR  
 MOST RECENT DATA. ELEVATIONS  
 ARE IN FEET MSL

Slug tests were conducted on 25 of the shallow monitor wells to determine the hydraulic conductivity of the aquifer. Although these data only reflect the hydraulic conductivity of a localized area surrounding the tested well, averaging data across a site can provide a generalized site-wide number to be used for site wide flow calculations. As expected in an aquifer of this type, variability can be seen in the hydraulic conductivity across the site, with results ranging from 1.01E-02 centimeters per second (cm/sec) to 9.76E-06 cm/sec. These data lead to a calculated groundwater flow rate that ranges between 0.05 feet per day (ft/day) to 4.51 ft/day (GeoTech, 1992). Discharge from the aquifer occurs as

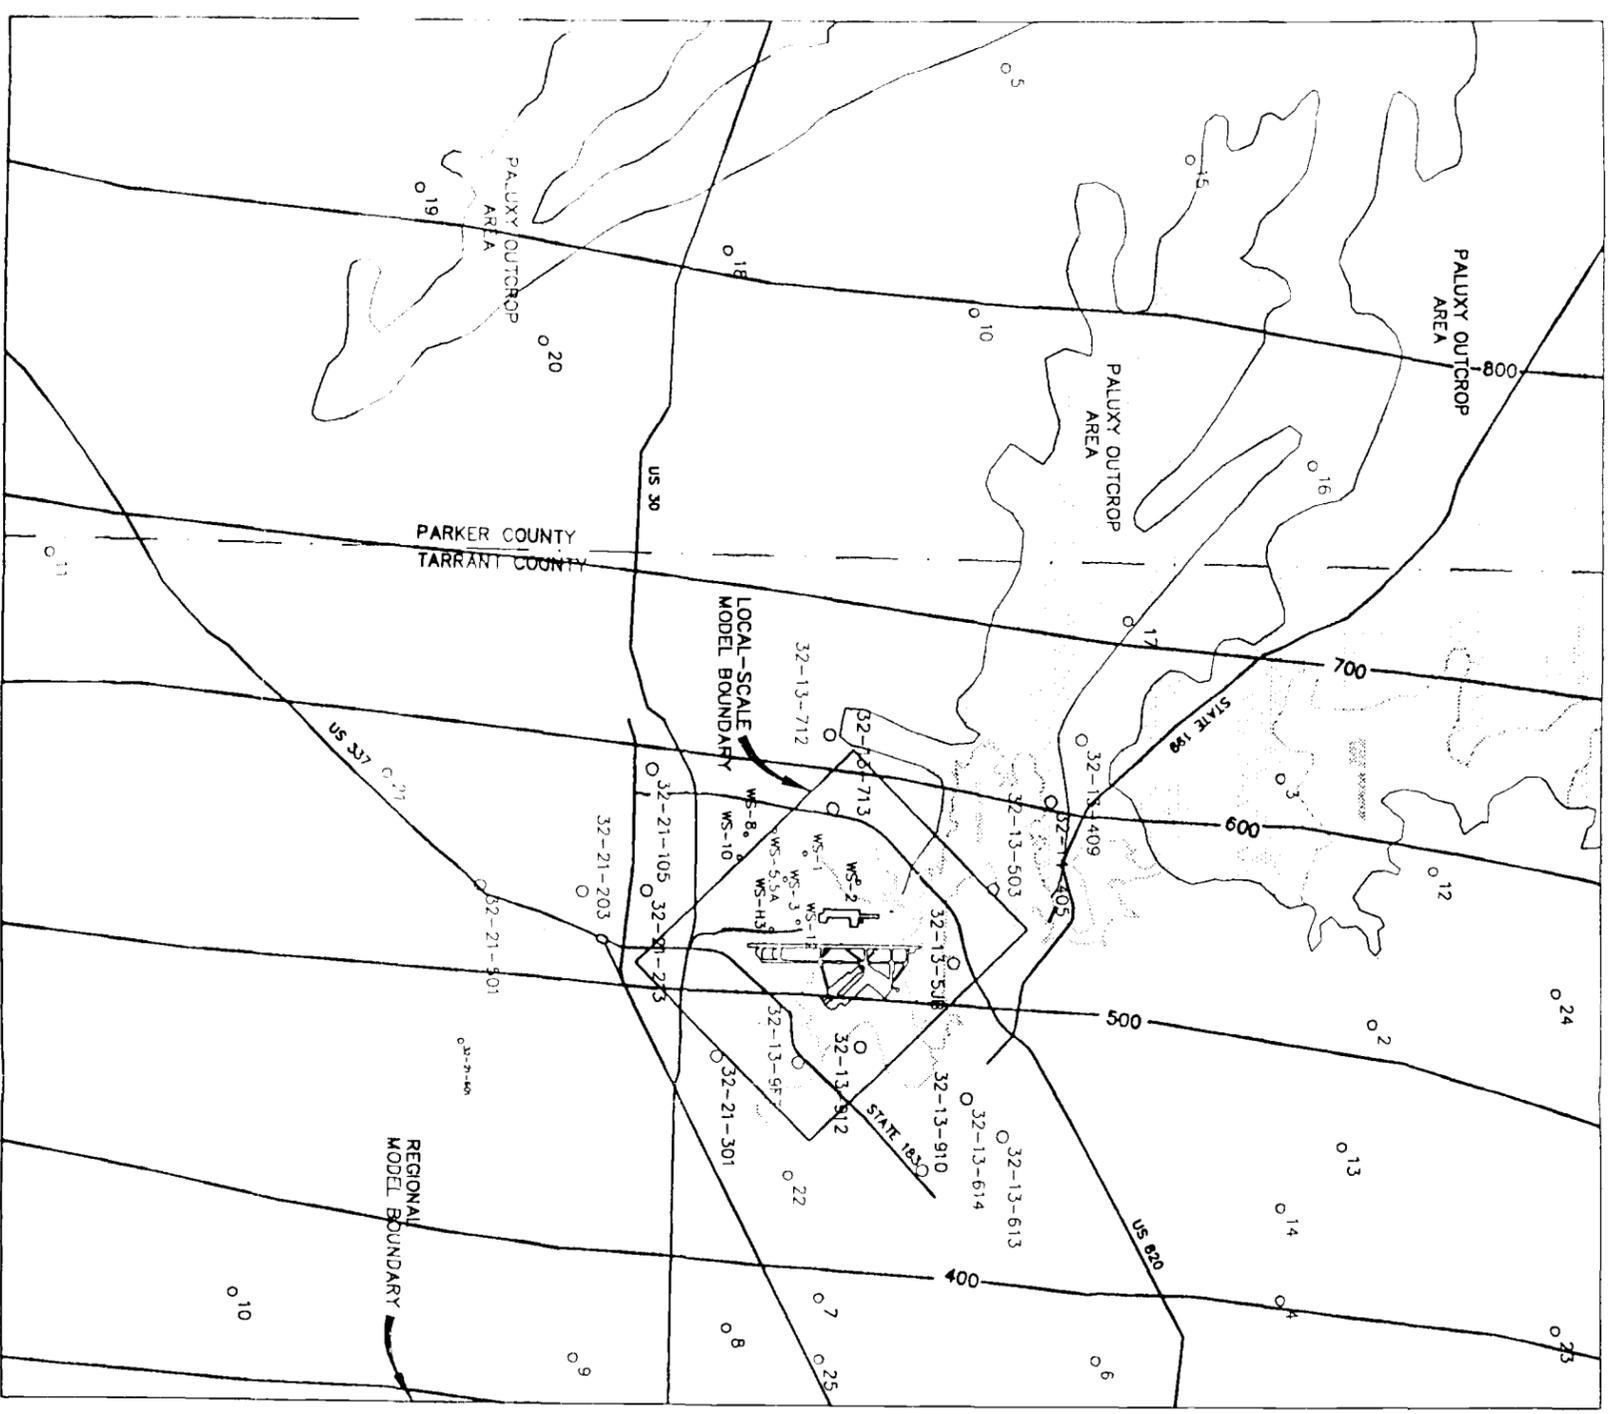
Figure 2.2-7  
 CONTOUR MAP OF REGIONAL HEAD IN THE PALUXY AQUIFER, 1989

NOTE: ELEVATIONS ARE IN FEET MSL  
 SOURCE: NORDSTROM, 1982.

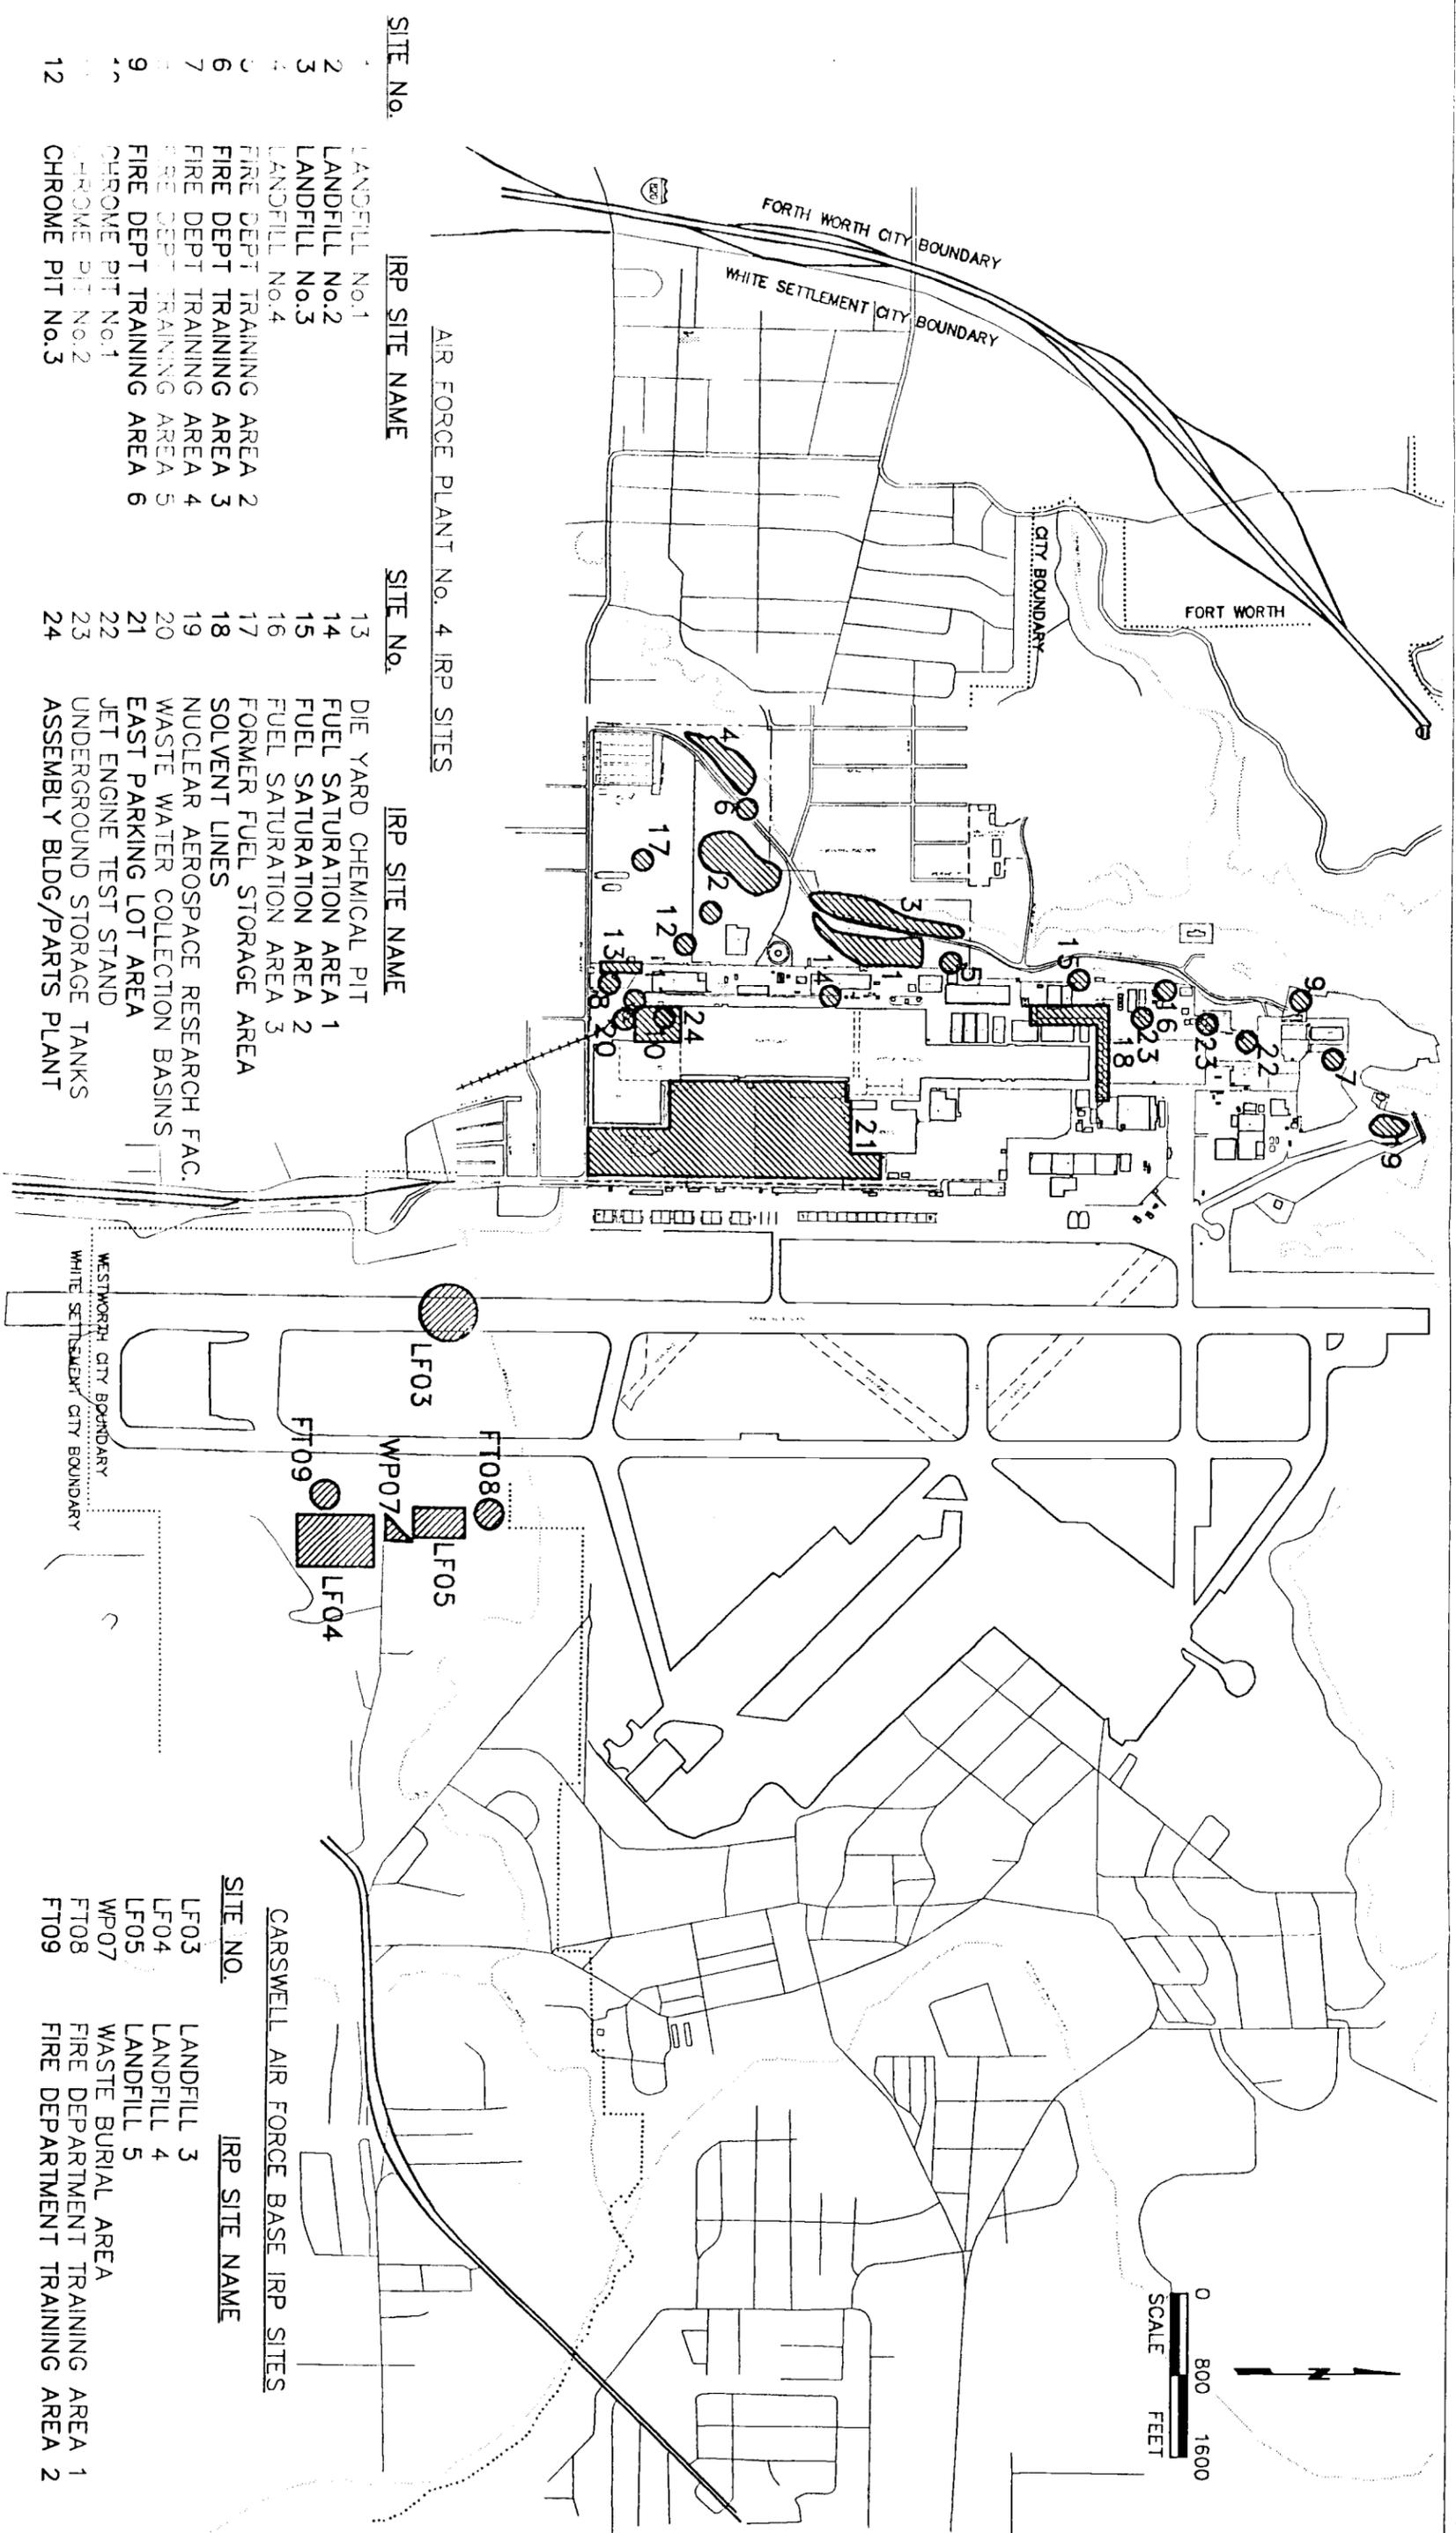
**Figure 3.0-1**  
 IRP SITE LOCATIONS FOR AIR FORCE PLANT 4 & CARSWELL AIR FORCE BASE

1. Site #1--LF01
2. Site #2--LF02
3. Site #3--LF03
4. Site #4--LF04
5. Site #5--FDTA 2
6. Site #6--FDTA 3
7. Site #7--FDTA 4
8. Site #8--FDTA 5
9. Site #9--FDTA 6
10. Site #10--Chrome Pit No. 1
11. Site #11--Chrome Pit No. 2

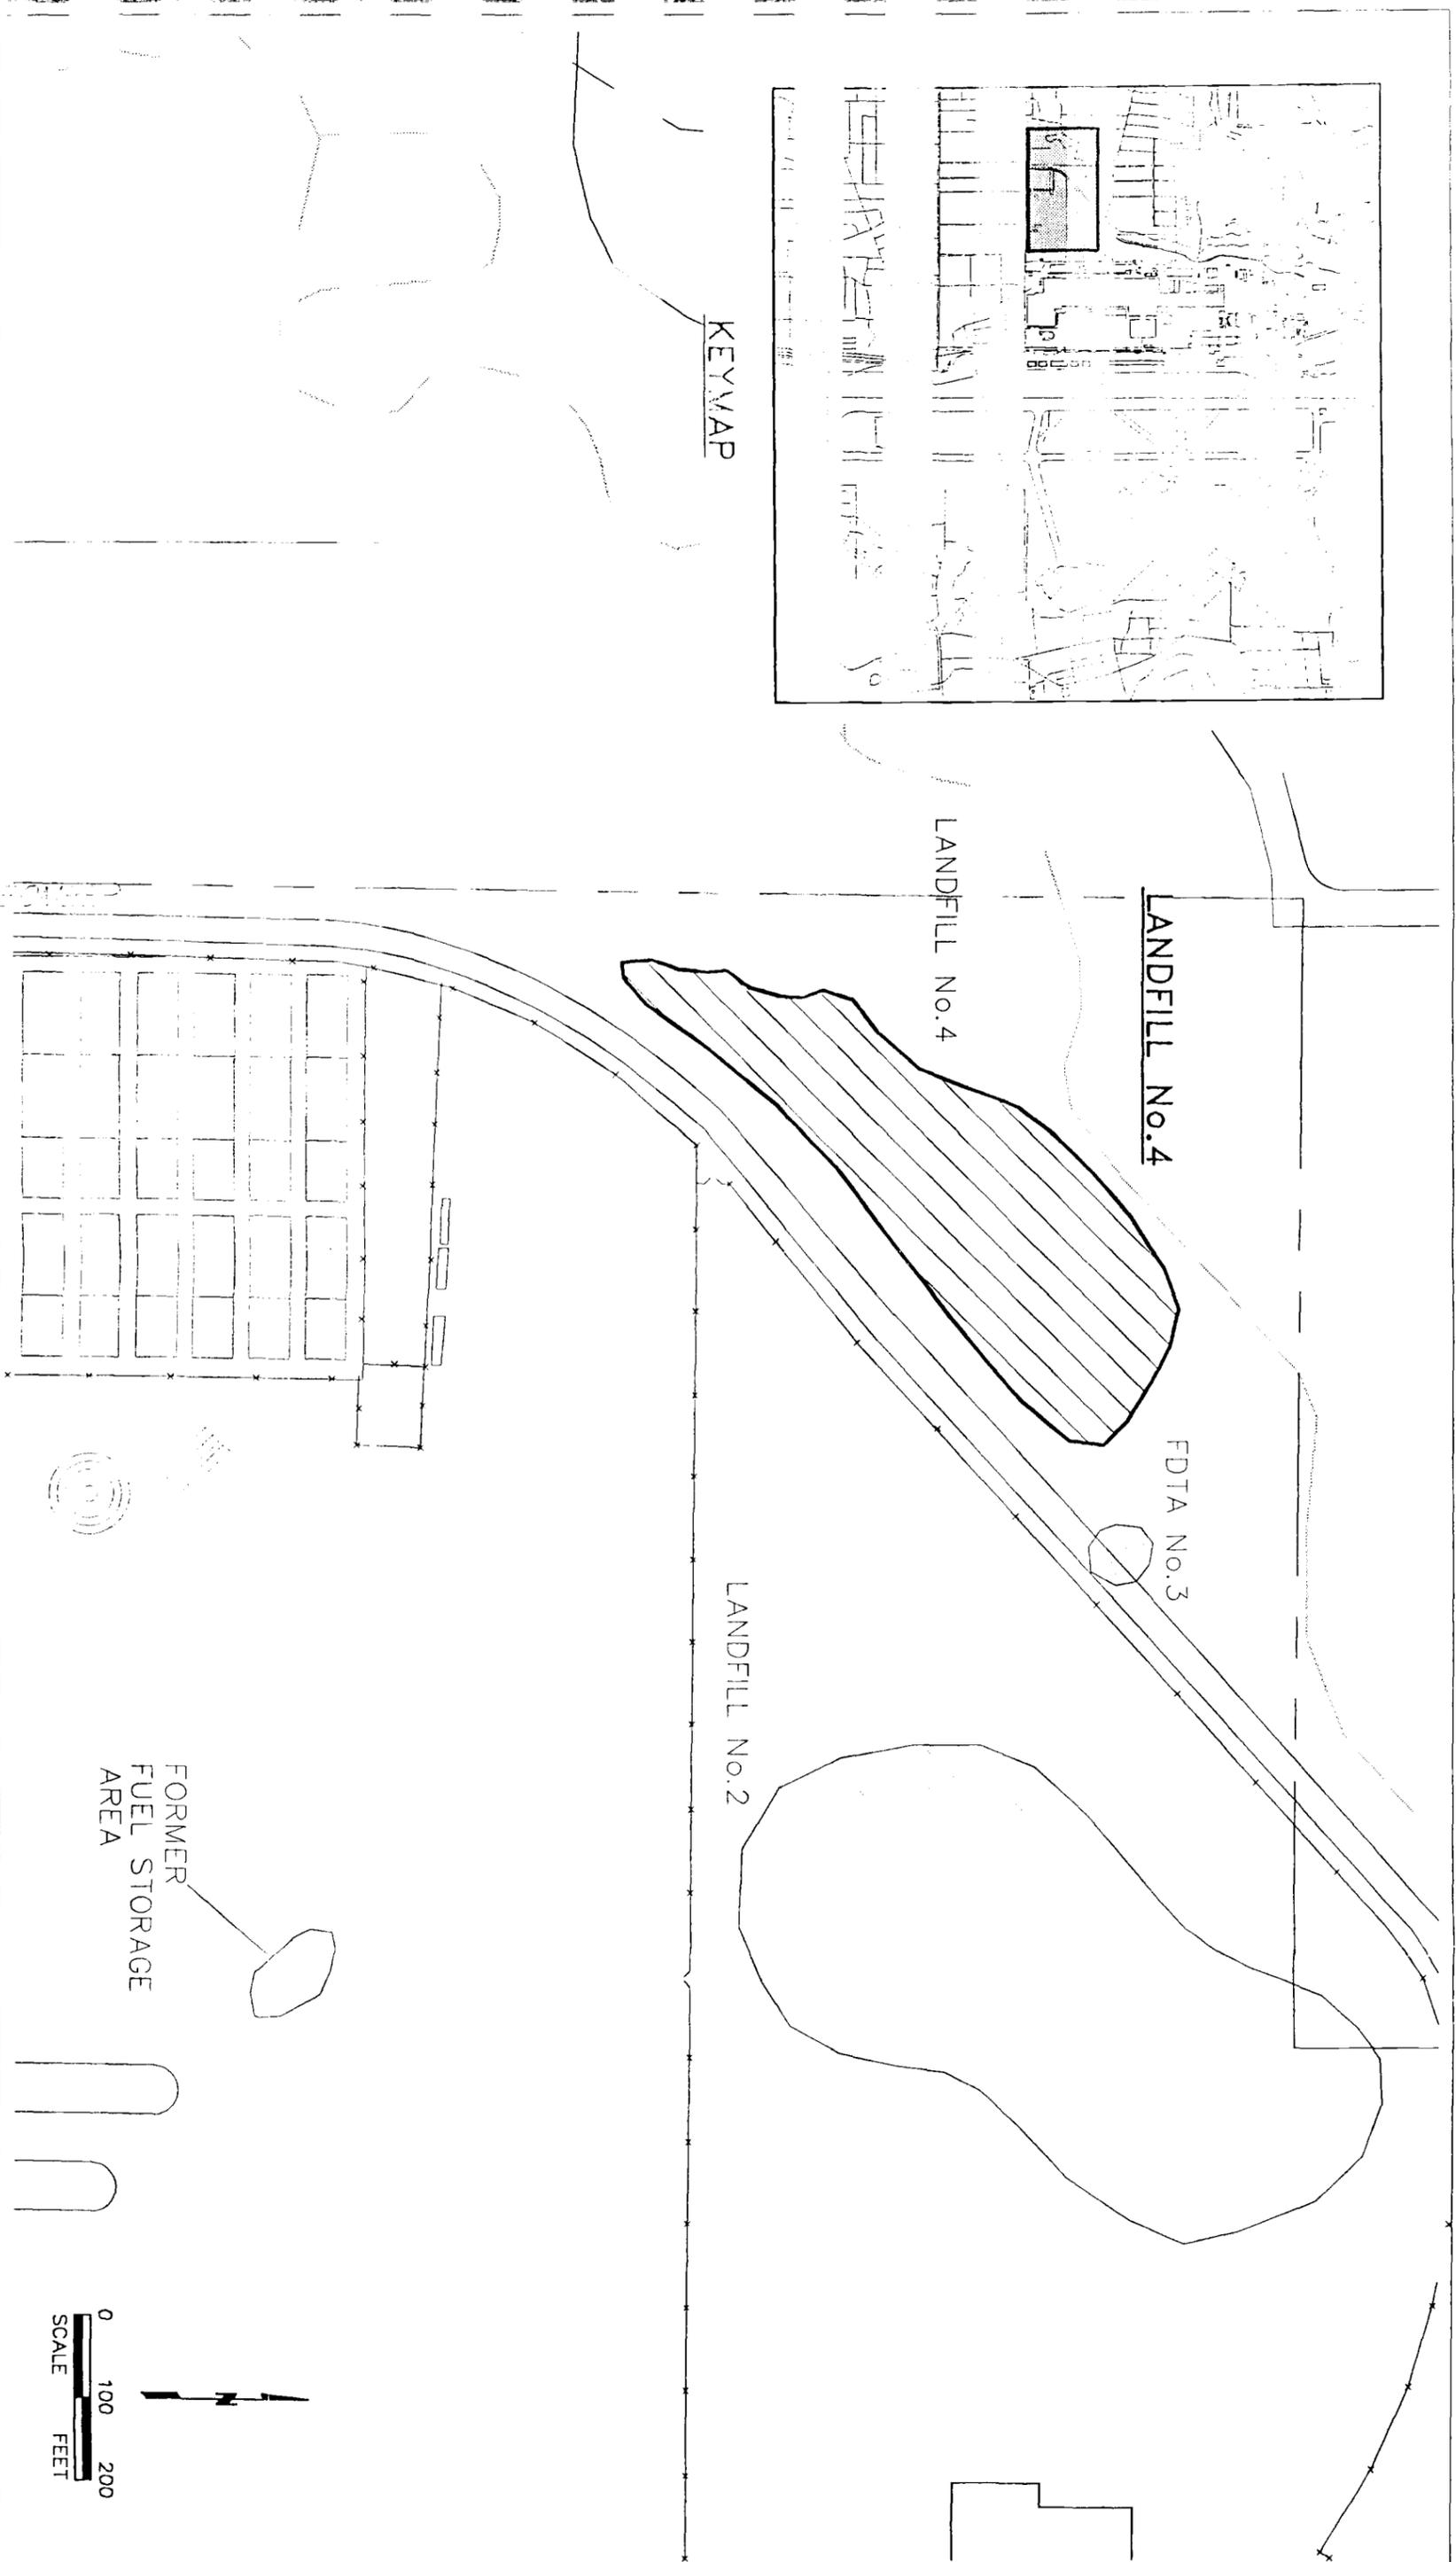
Figure 3.1-7  
SITE MAP - LANDFILL NUMBER 4

LF04 is located near the southwest boundary of APF4 (Figure 3.1-7). This landfill occupies approximately 2 acres west of Meandering Road. LF04 used a low area adjacent to Meandering Road Creek for the disposal of construction debris from 1956 to the early 1980s. Evidence suggests that other types of waste may have been disposed of in LF04 from 1966 to approximately 1973. These wastes may have included small quantities of hazardous waste such as solvents, oils, fuels, and thinners.

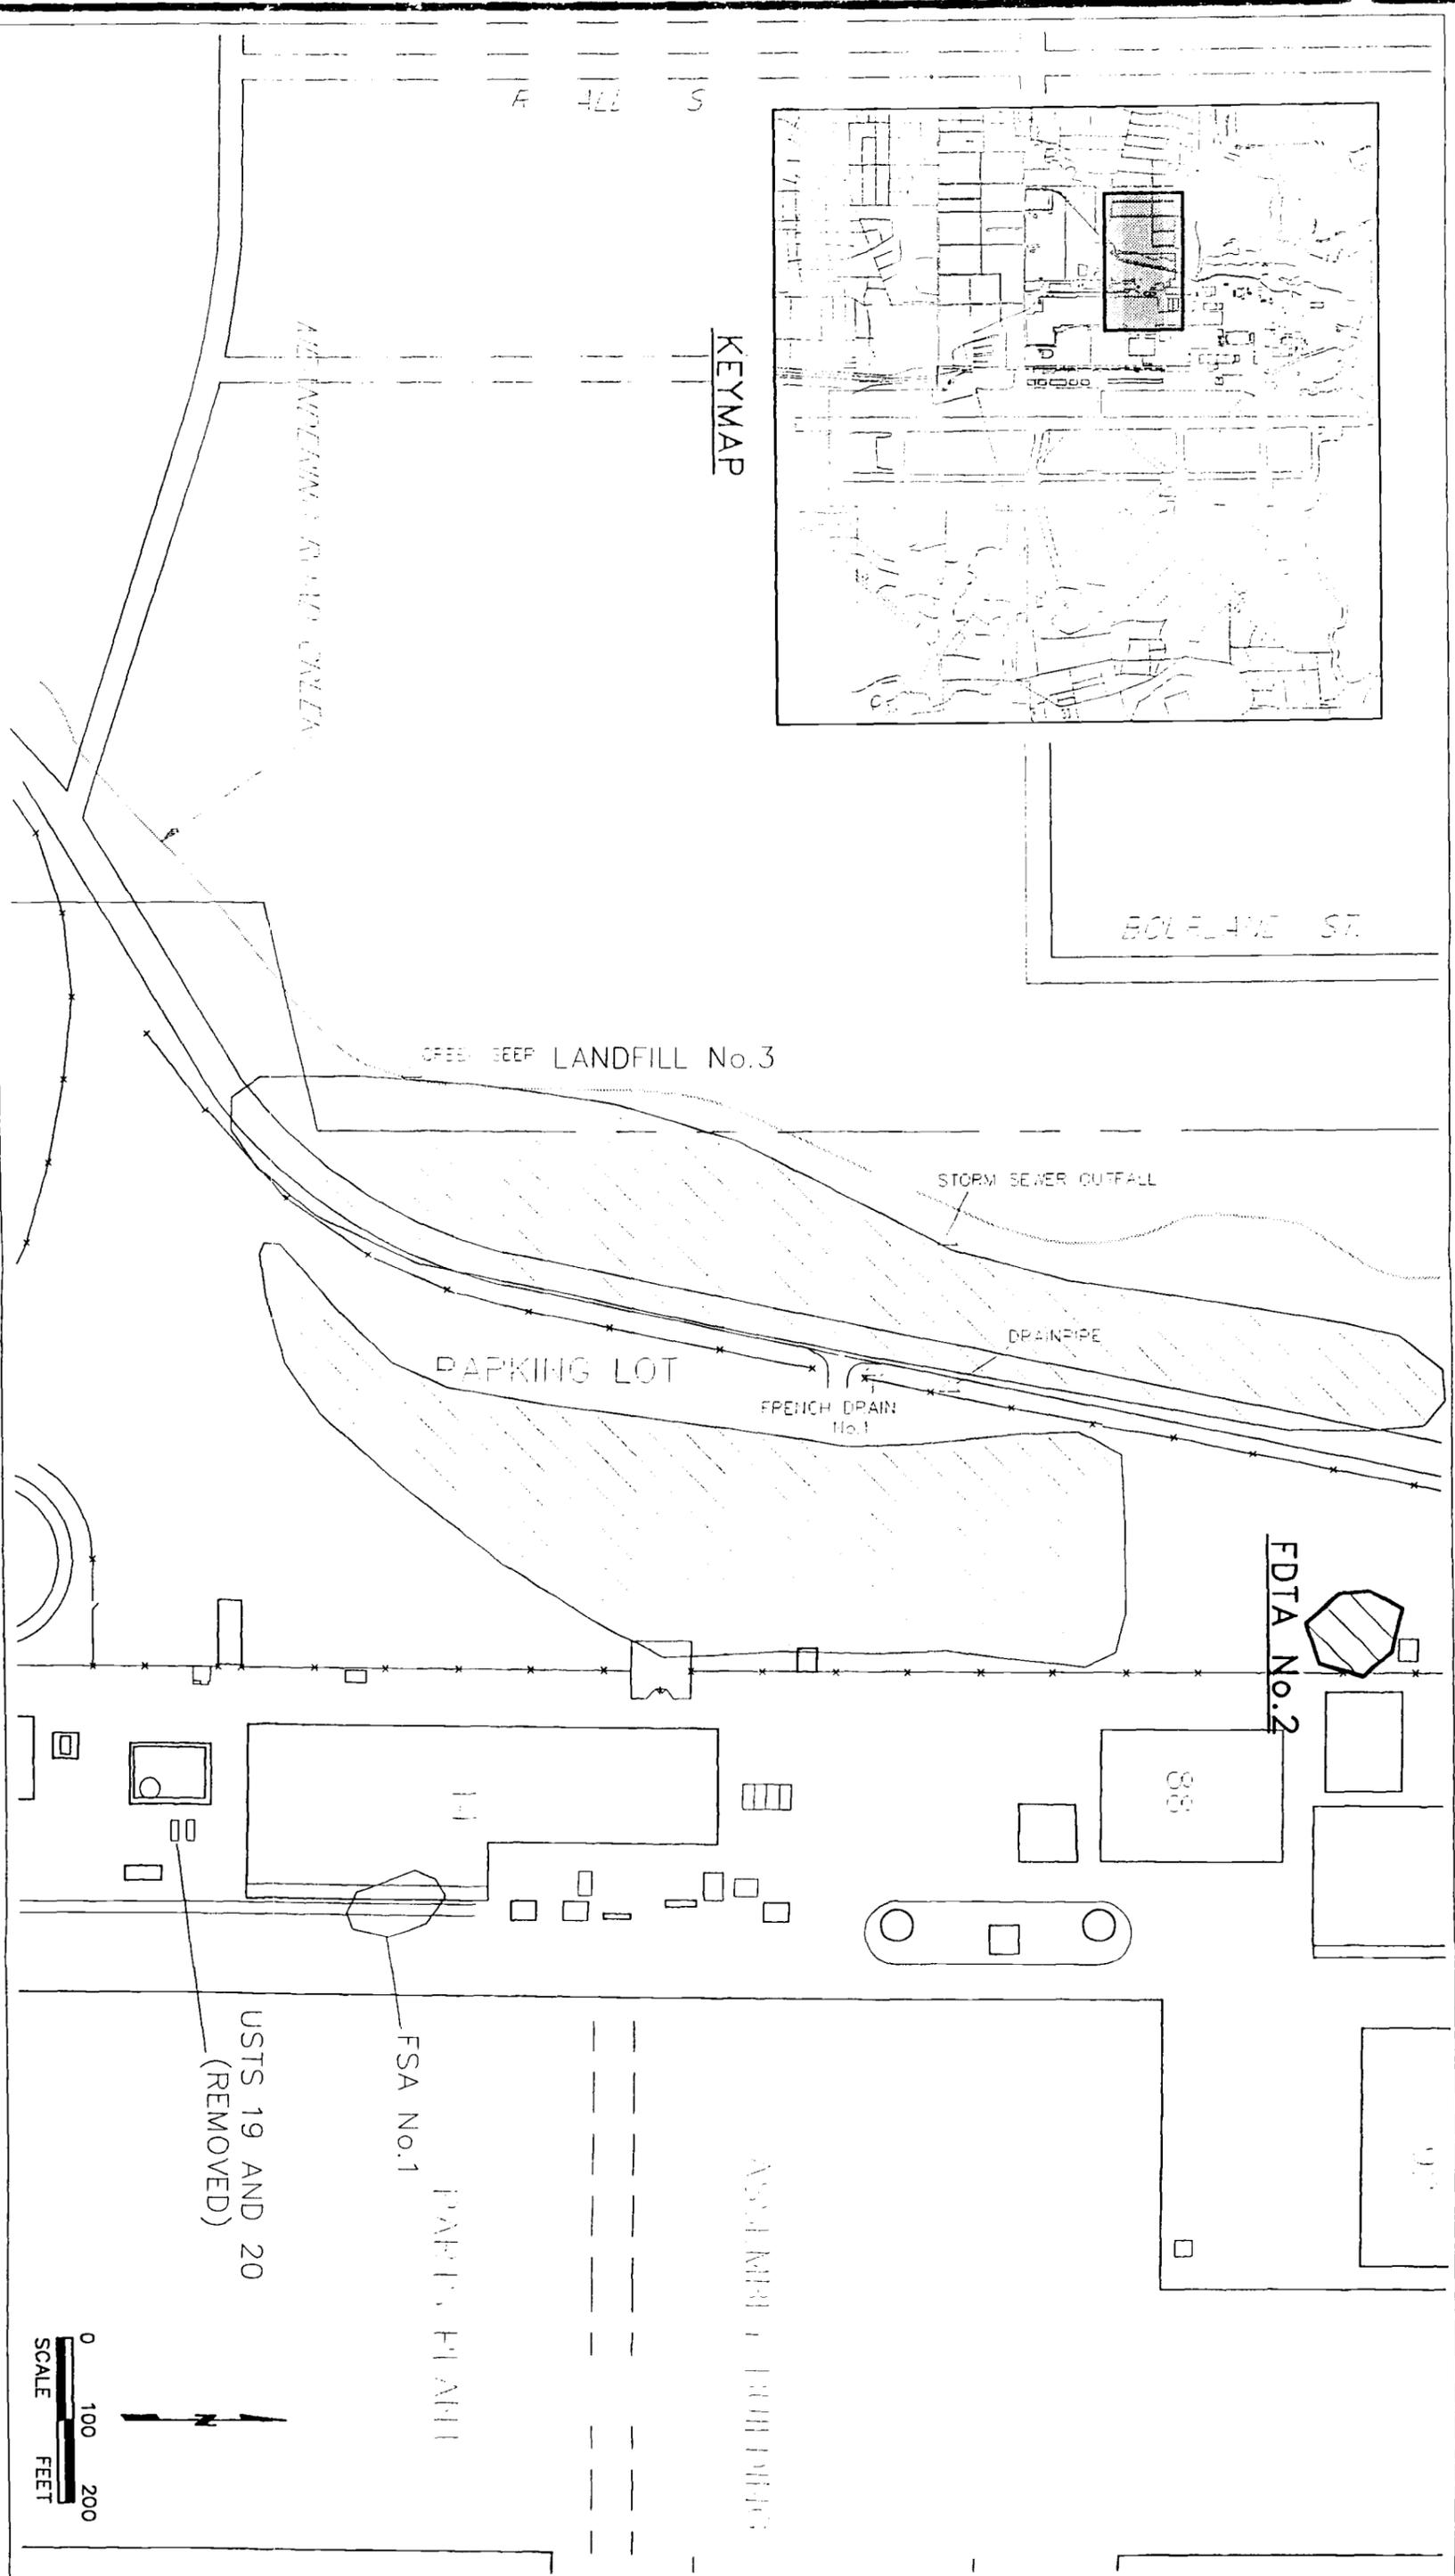
Figure 3.1-9  
SITE MAP - FIRE DEPARTMENT TRAINING AREA NUMBER 2

FDTA 2 was a 50-ft-diameter earthen ring located north of LF01 in the west parking lot (Figure 3.1-9). This location was used for fire training exercises from 1955 to 1956. Exercises were held twice a year with approximately 250 gal of waste oil and fuels used for each exercise. It was suspected that disposal of oils and fuels, and uncontrolled burns may have been more frequent. The site has been graded and paved to provide a parking lot.

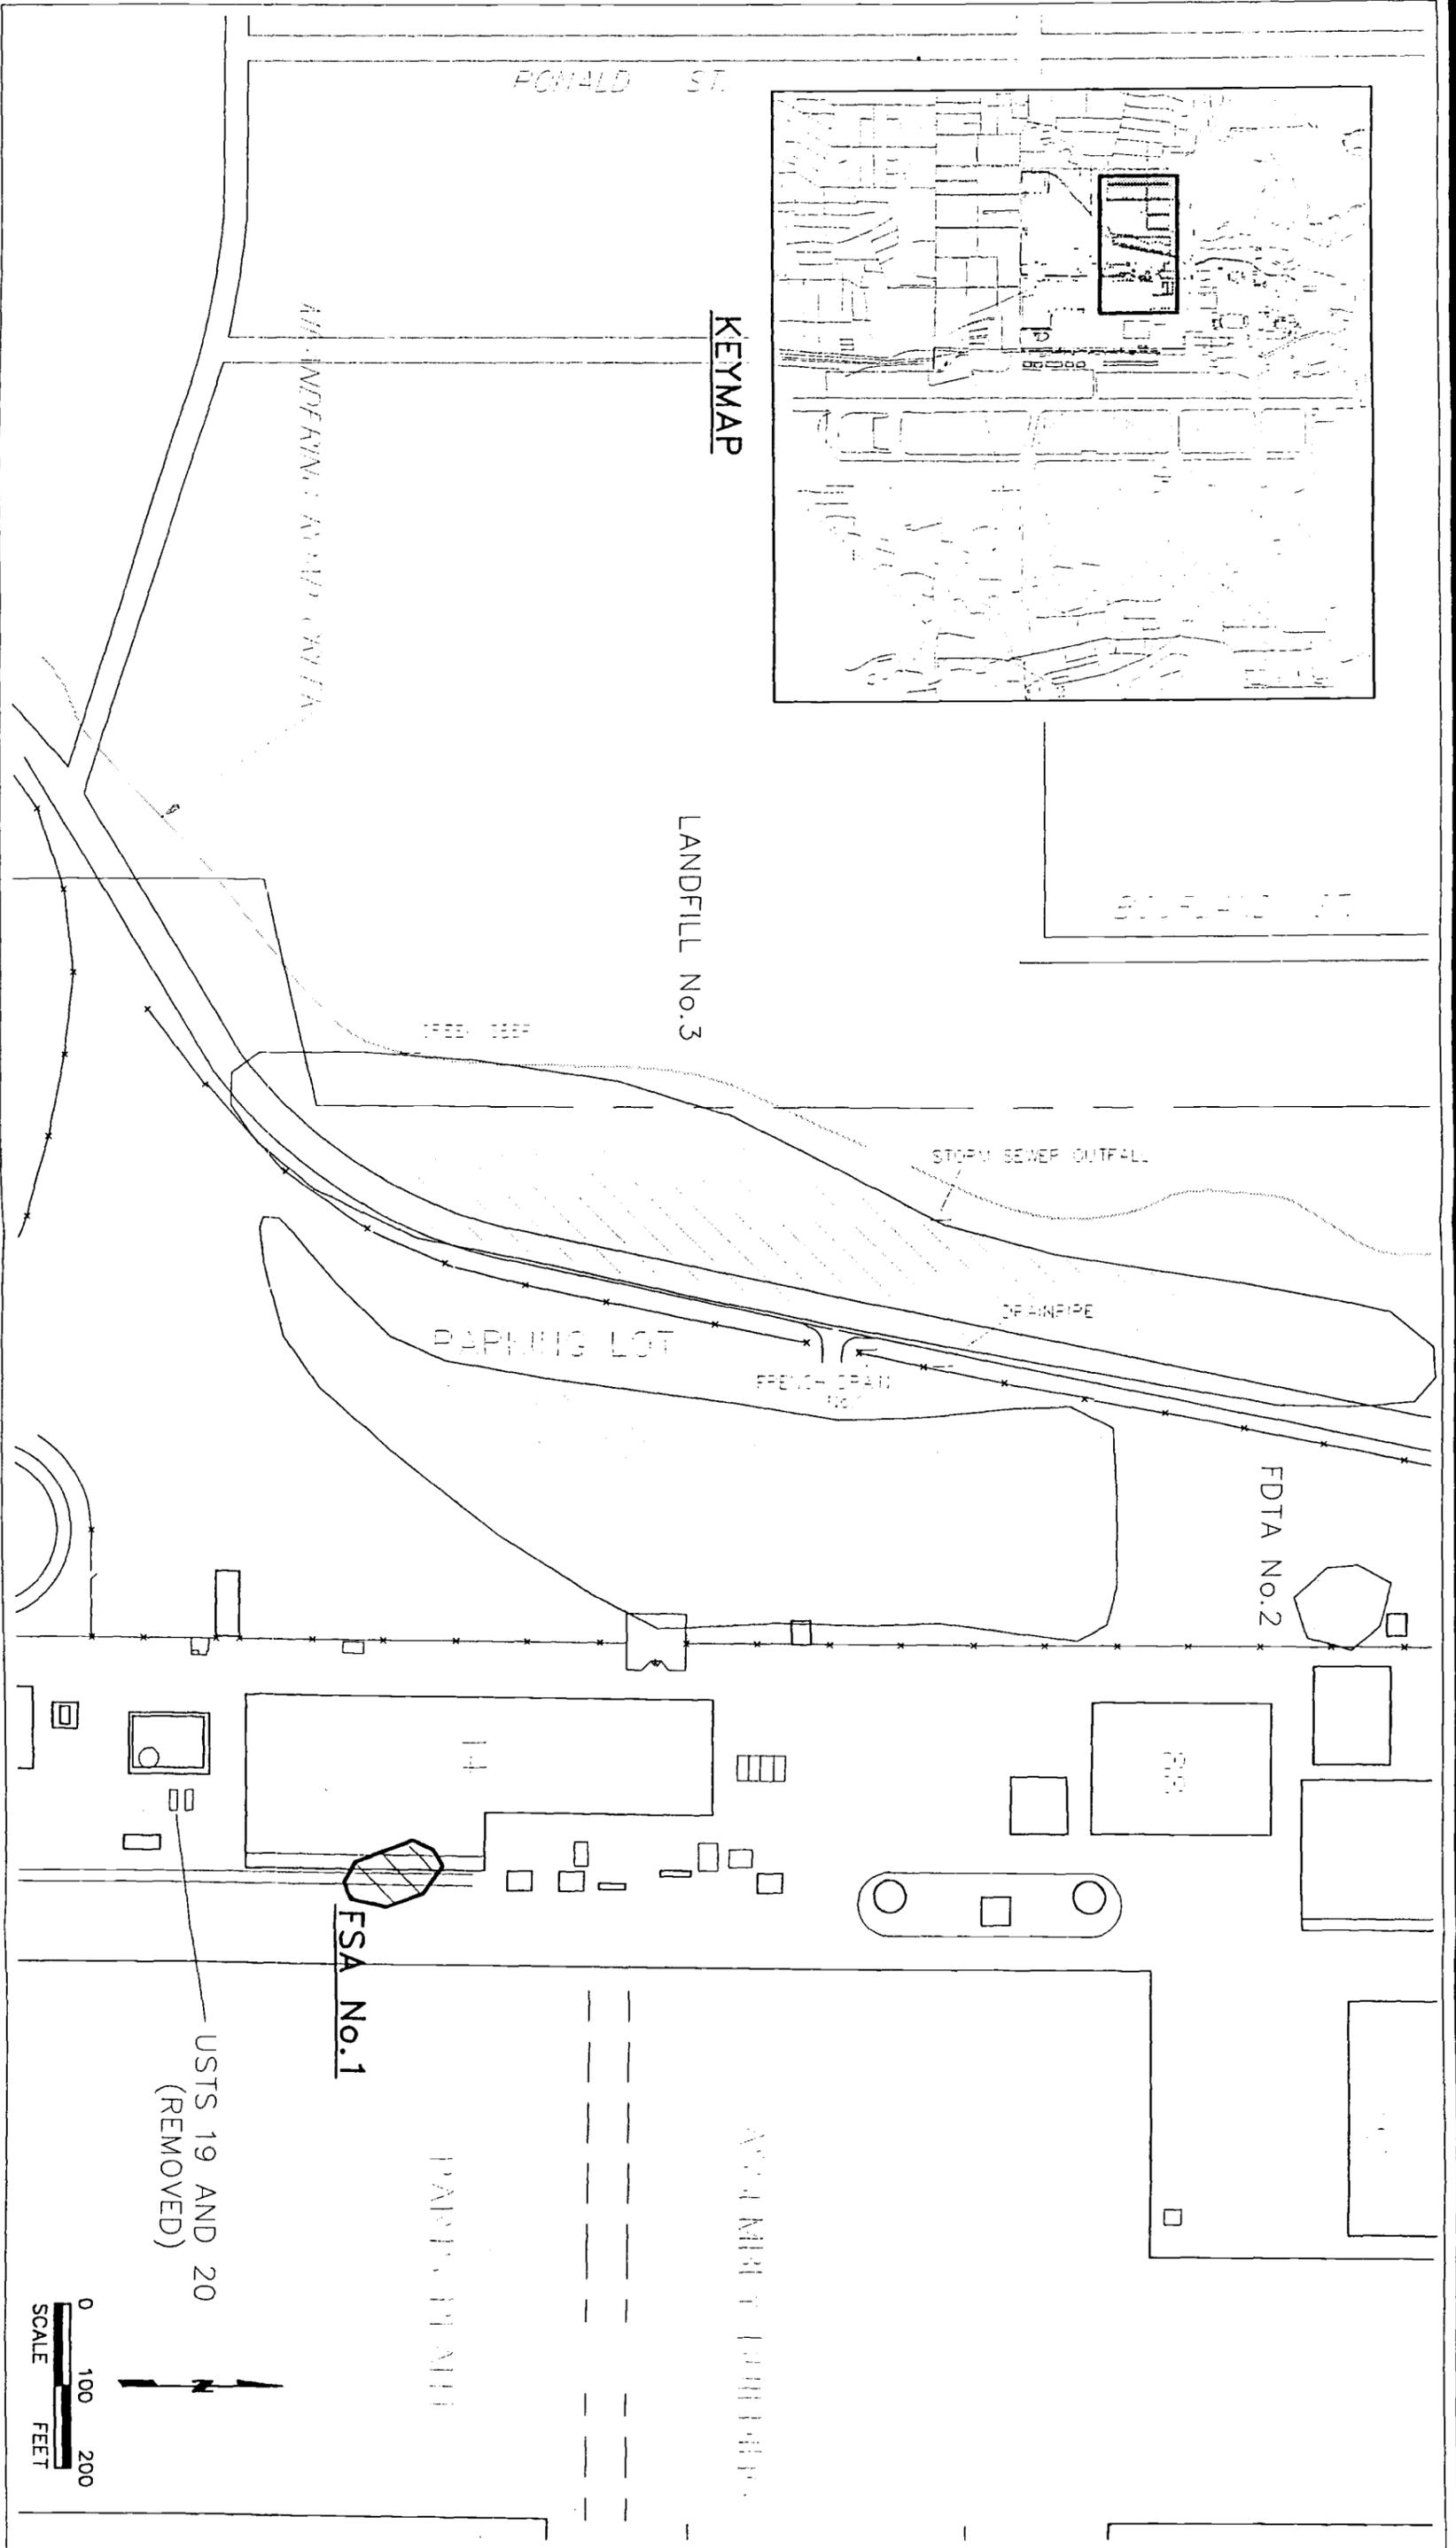
Figure 3.1-27  
SITE MAP - FUEL SATURATION AREA 1

FSA-1 is located south and east of Facilities Building No. 14 (Figure 3.1-27). Groundwater in this area reportedly became contaminated by fuels leaking from the underground distribution system during the mid-1970s to the early 1980s. In 1988, the piping which consisted of 4-inch-diameter JP-4 lines, was abandoned. A fuel pumping station and two 12,000-gal USTs (USTs 19 and 20) were removed prior to December 22, 1988, which was the effective date of Federal Subtitle I regulations. These USTs were formerly located south of Facilities Building No. 14 and contained 2-butanone (UST 19) and xylenes (UST 20).
