FINAL SUMMARY OF HYDROLOGIC AND CHEMICAL CHARACTERIZATION STUDIES  
VOLUME 1 OF 3 NAS FORT WORTH TX  
7/1/1994  
ENVIRONMENTAL SCIENCE AND ENGINEERING

## Summary of Hydrologic and Chemical Characterization Studies

U.S. Army Engineer District  
Ft. Worth, Texas

Environmental  
Science &  
Engineering, Inc.

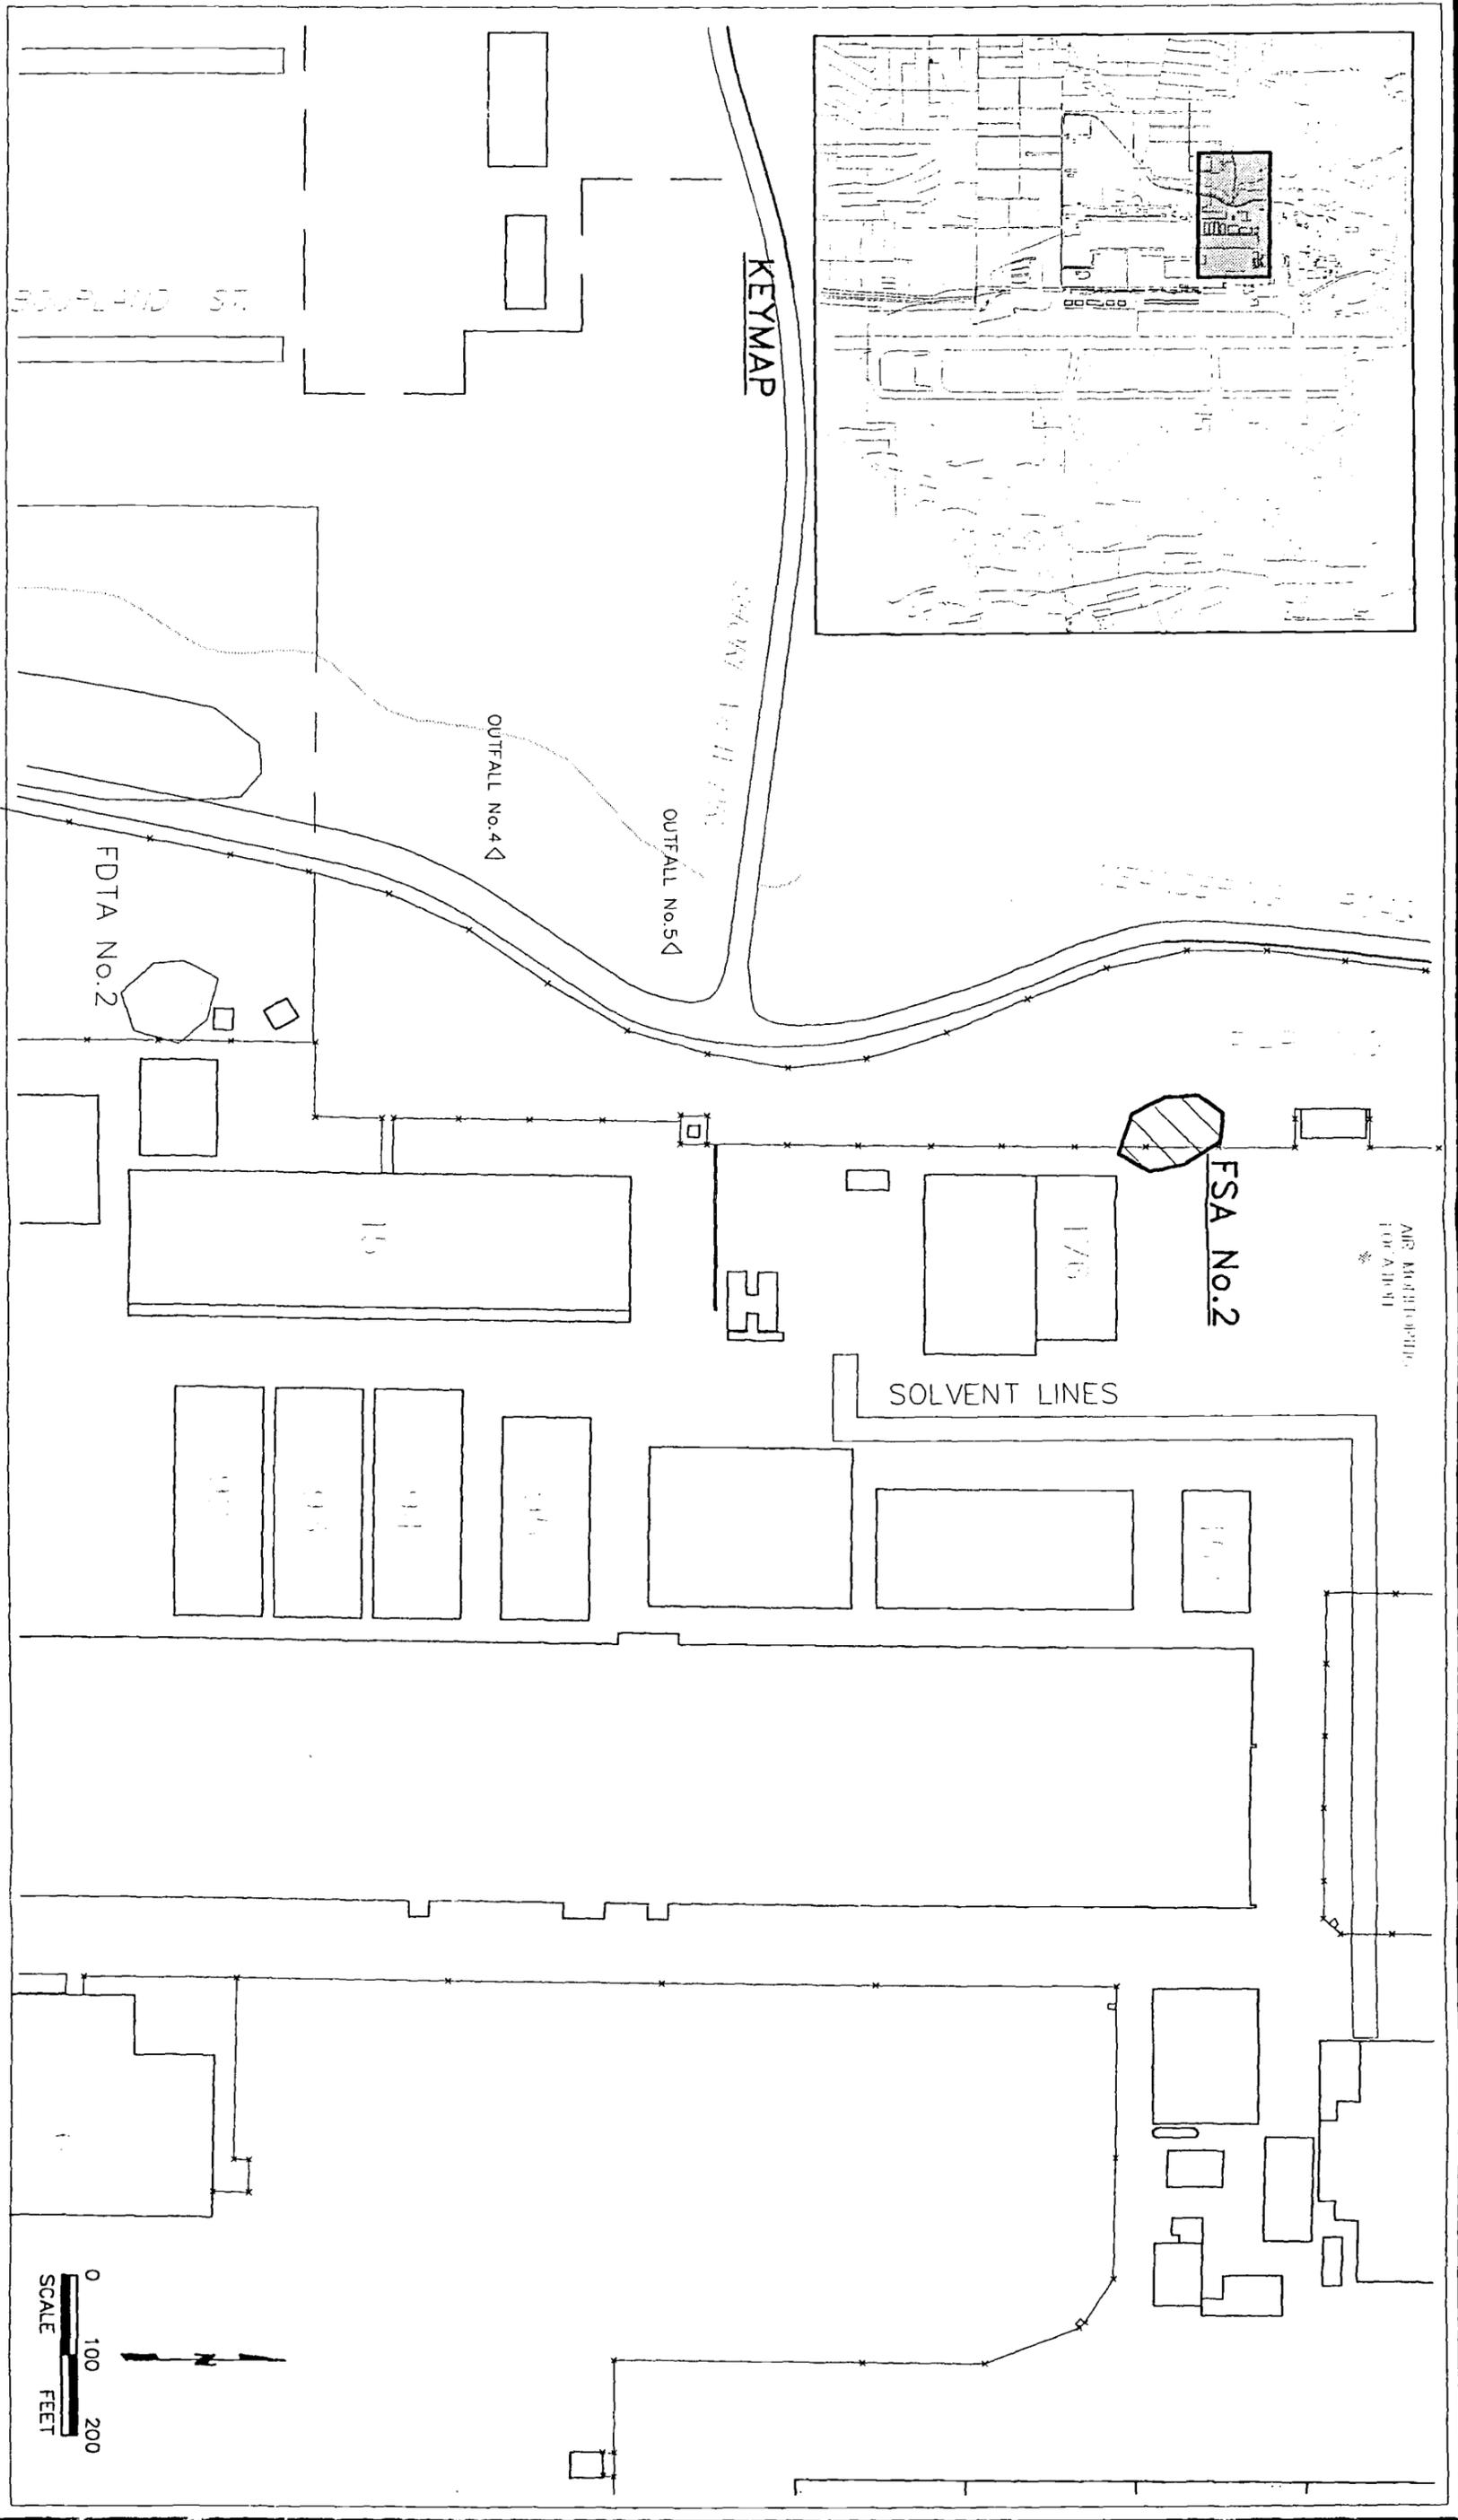
Figure 3.1-29  
SITE MAP - FUEL SATURATION AREA 2

FSA-2, located northwest of Facilities Building No. 176, was reportedly saturated by fuels leaking from a buried fuel pipeline in the 1970s and early 1980s (CH2M Hill, 1984) (Figure 3.1-29).

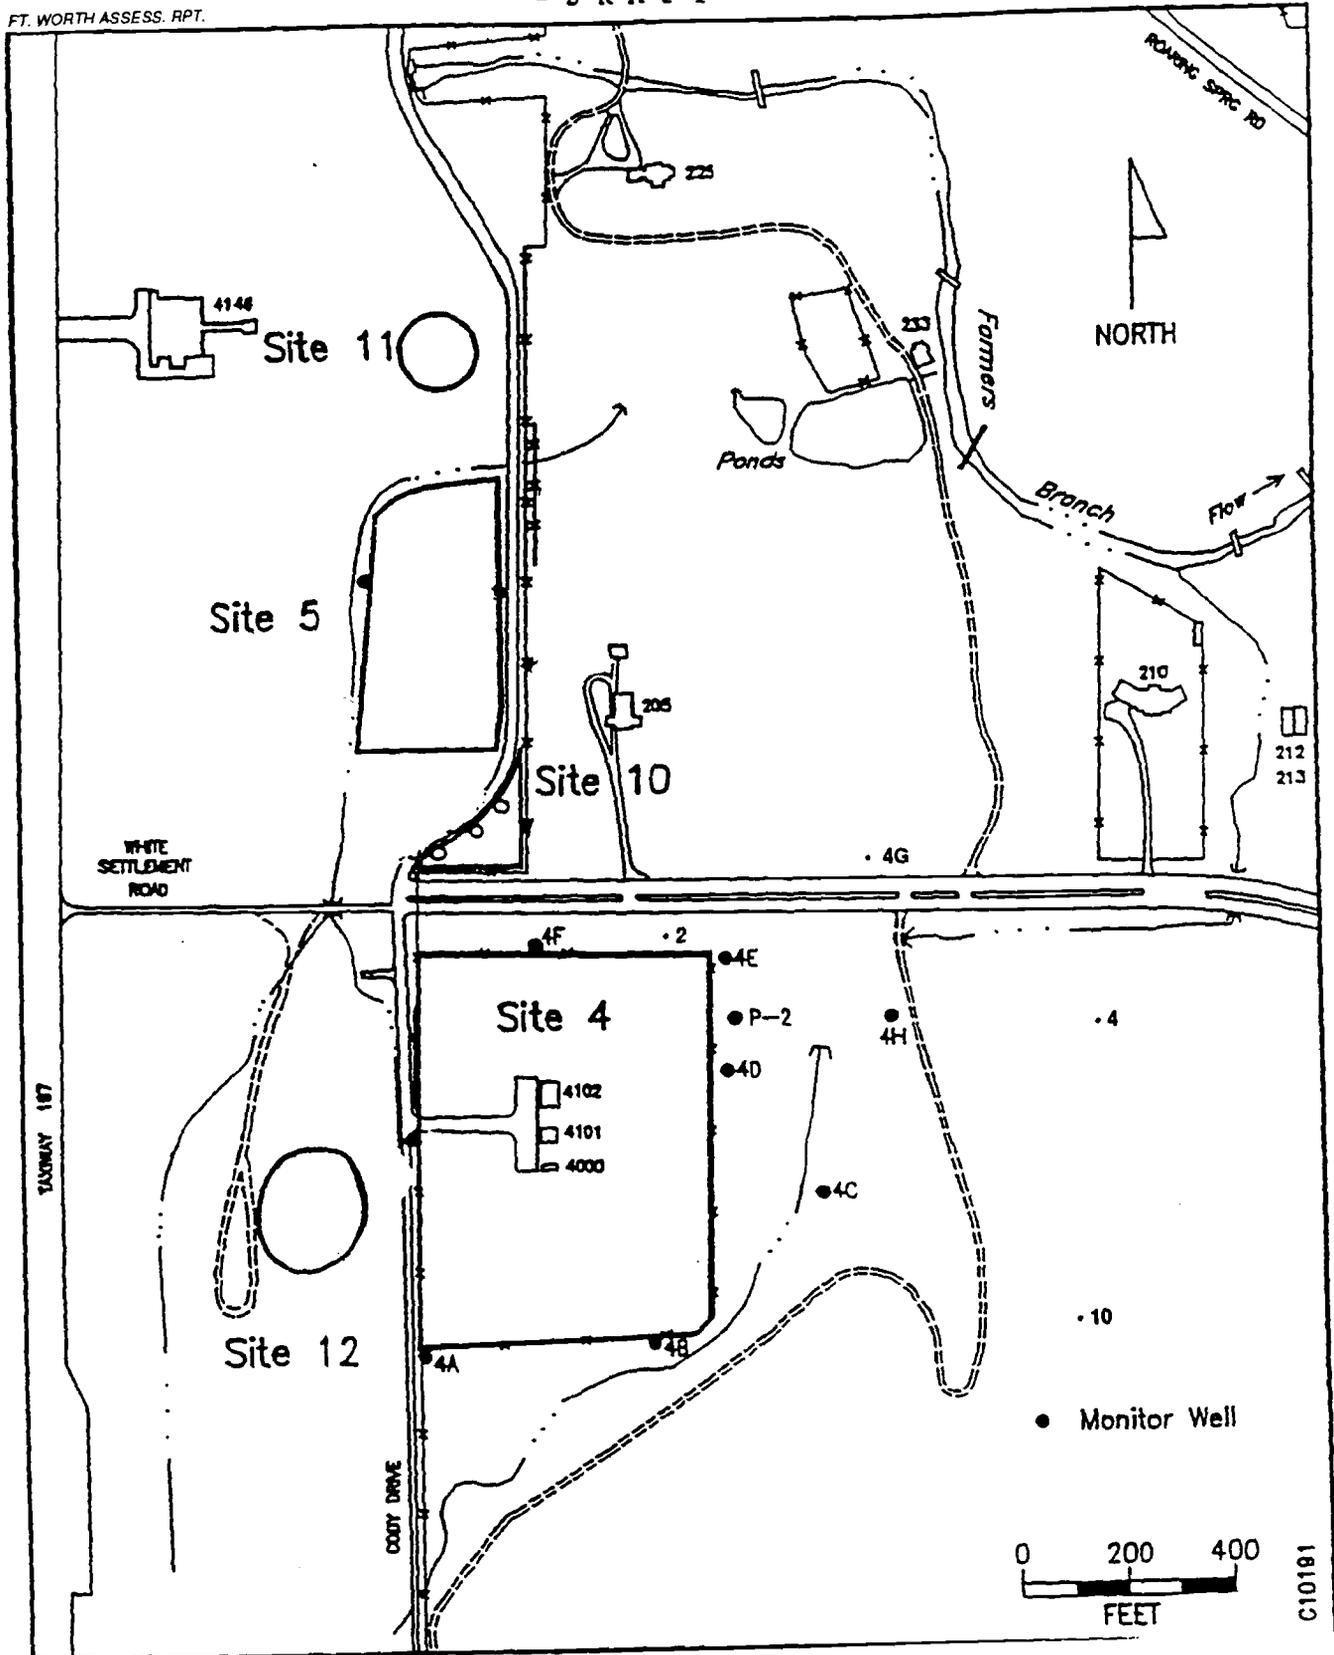
Figure 3.2-7  
SAMPLING LOCATIONS--LF04

The subsurface investigation at LF04 was performed during three separate investigations and included the installation of 12 monitor wells (Figure 3.2-7). Monitor wells 4A and 4B were installed south of the site. Wells 4C, 4D, 4E, 4H,

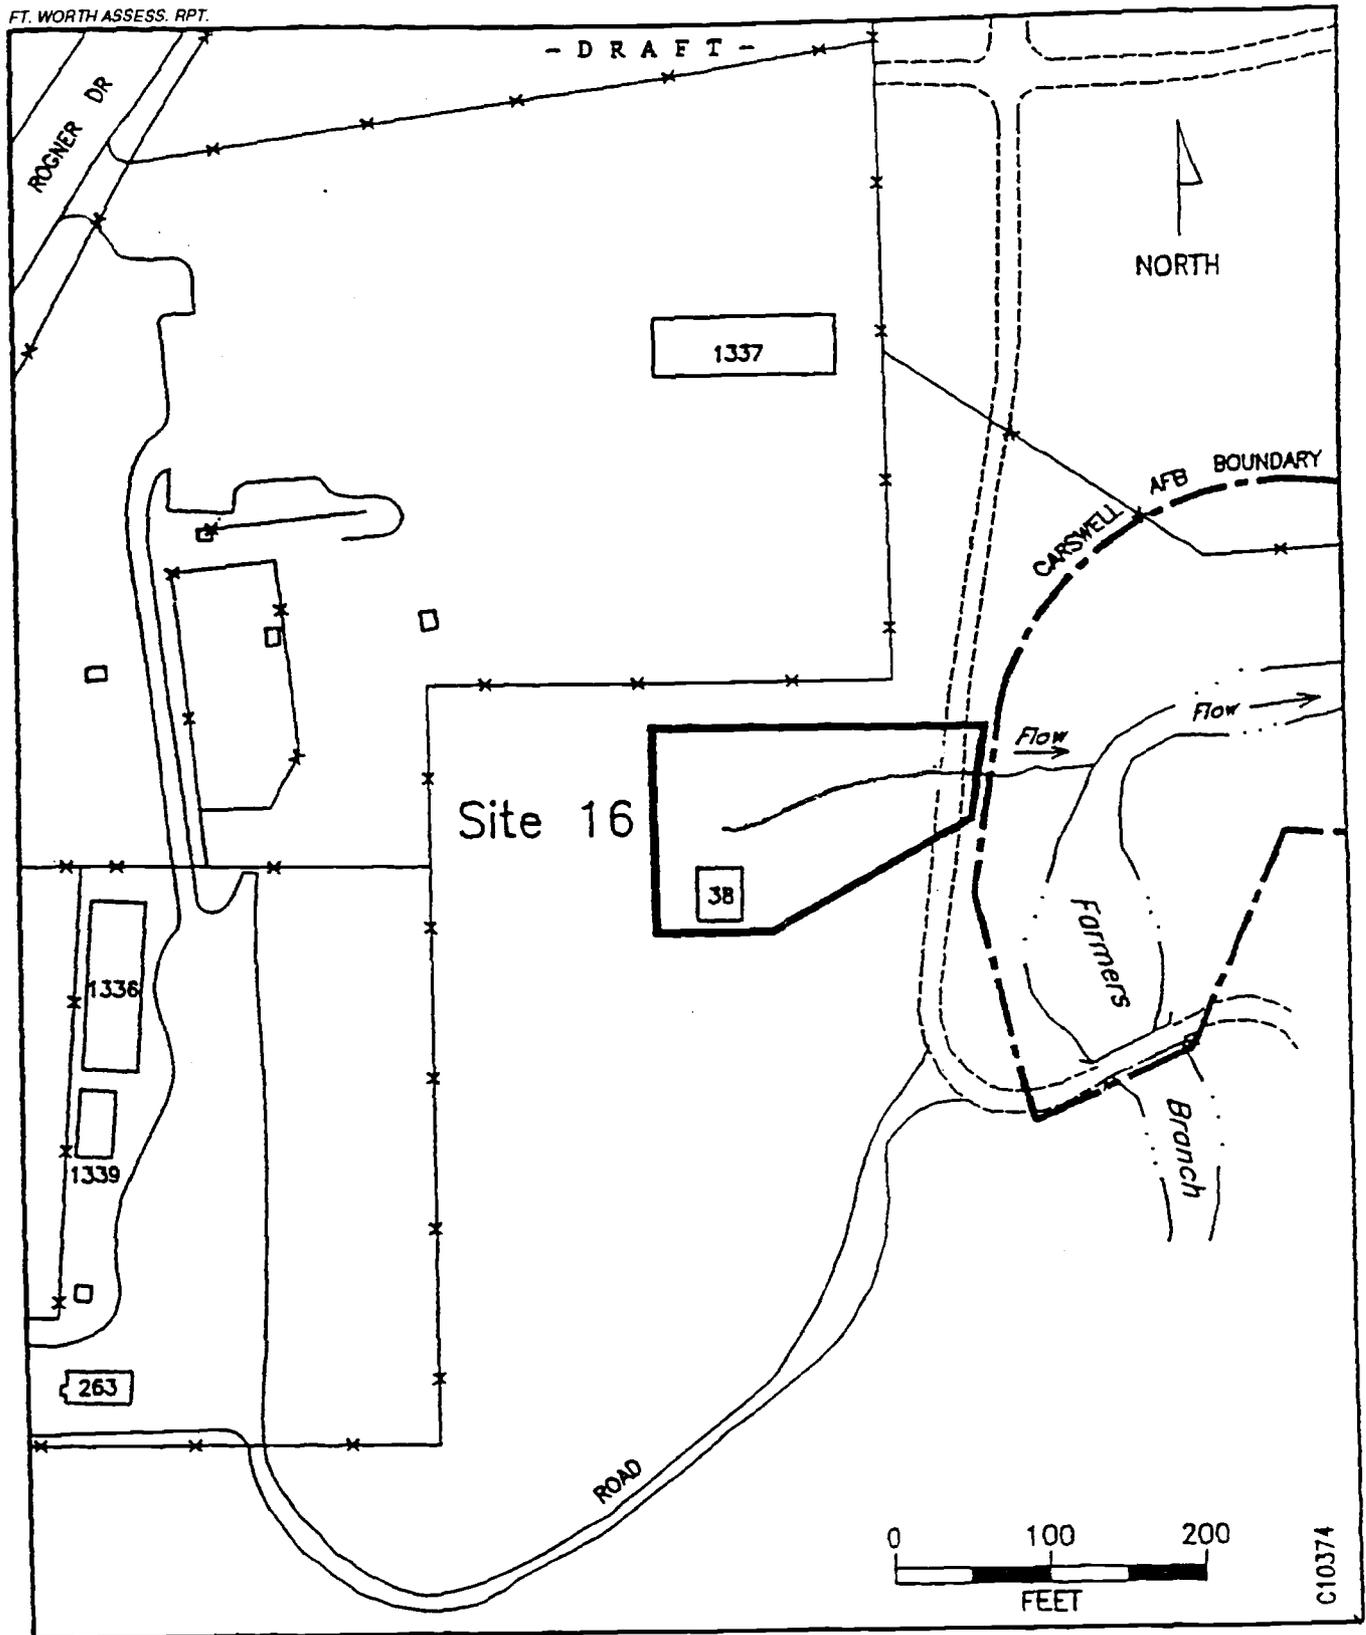
Figure 3.2-20  
SITE MAP--SITE #16 (UNNAMED STREAM)

Site 16 is a small tributary of Farmers Branch that emerges from an underground oil/water separator south of the new communications building (Building 1337), near the confluence of Farmers Branch and the Trinity River (Figure 3.2-20).
