FINAL OFF-BASE COMMUNITY SAMPLING REPORT NCBC GULFPORT MS
9/24/2003
TETRA TECH

NAVAL CONSTRUCTION BATTALION CENTER
GULFPORT
GULFPORT, MISSISSIPPI

Southern Division
Naval Facilities Engineering Command
Contract Number N62467-94-D-0888
Contract Task Order 0143

SEPTEMBER 2003

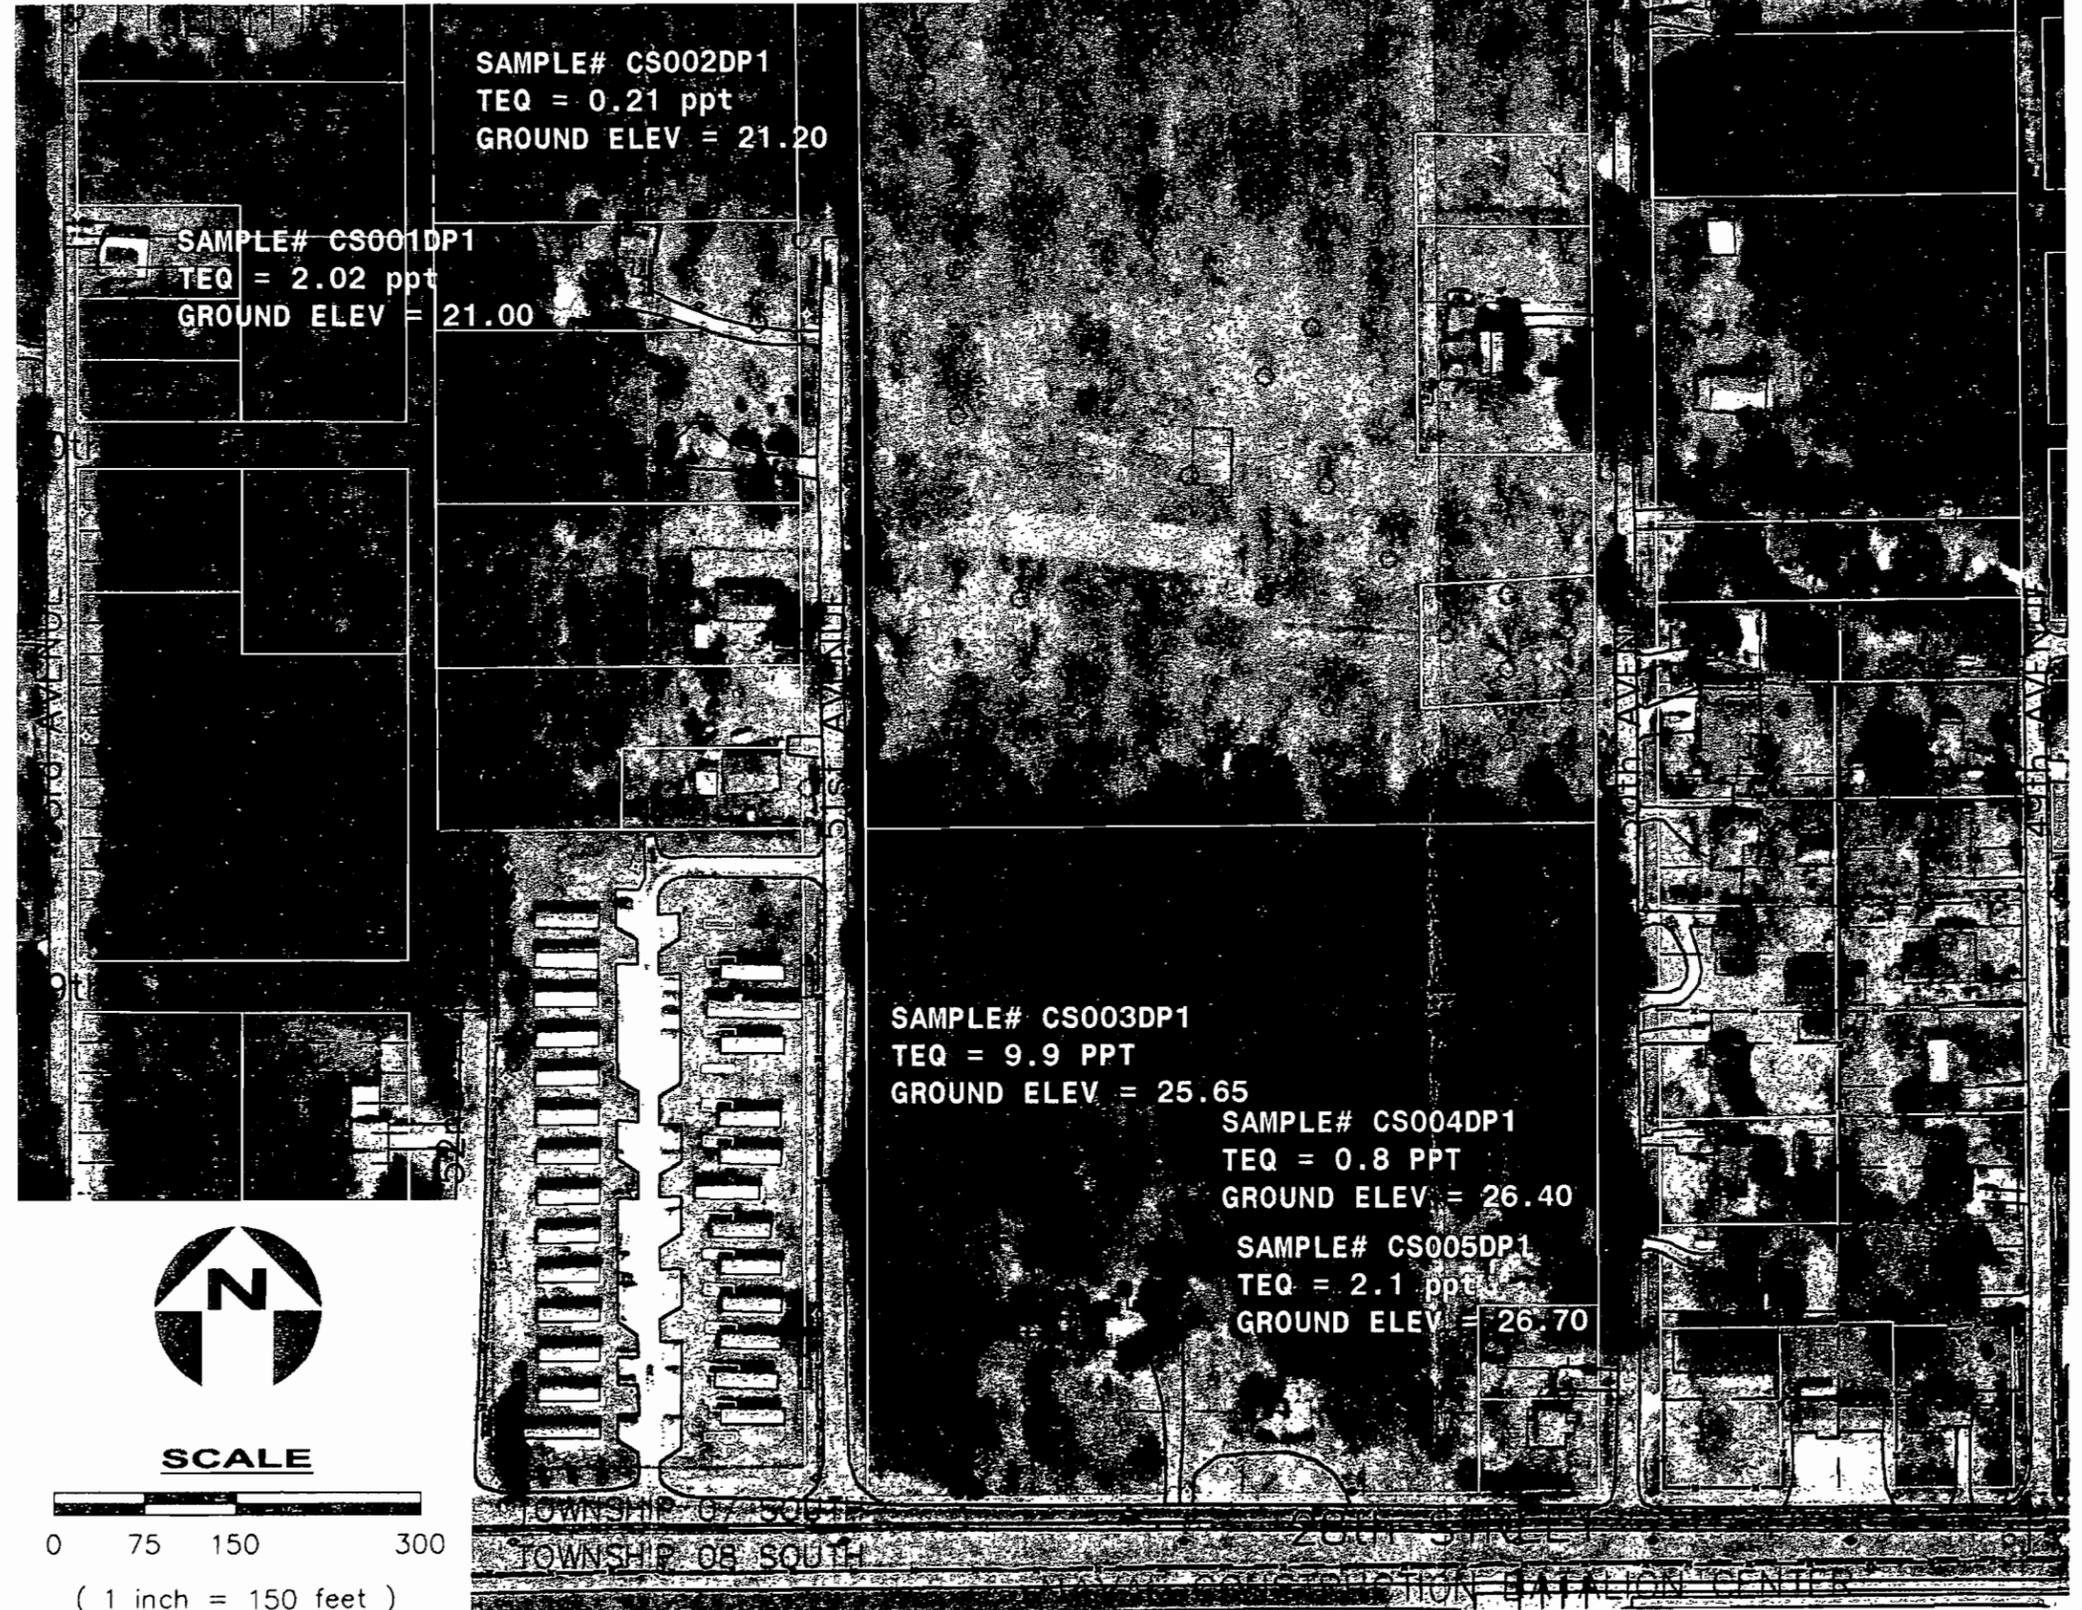
FIGURE B-2

This area is the closest to Site 8 studied for this investigation. A depression on this property extends from 28th Street to the northwest. The concern, as confirmed by interviews with local residents and aerial photography, is that dioxin contaminated sediments from the base may have been transported across 28th Street during large precipitation events and deposited in the depression. Nine grab samples (CS001, CS002, CS003, CS004, CS005, CS006, CS007, CS008, CS009, and CS017), as shown on Figures B-2 and B-3 (Appendix B) were collected from the sediments in the area immediately north of 28th Street, between 53rd and 43rd Avenue. This depression is a likely area for deposition of sediments following storm events.

Of the nine samples (CS001, CS002, CS003, CS004, CS005, CS006, CS007, CS008, CS009, and CS017) collected from the sediments in the potentially impacted area north of the base, two samples exceeded the MDEQ screening level of 4.26 ppt. CS006 resulted in a TEQ of 35.54 ppt and a TCDD of 0.308 ppt. The leading contributor to the TEQ was the detection of a hexafuran. This elevated hexafuran detection commonly results from the presence of octachlorinated biphenylethers (an ingredient of older transformer oils) interfering with the analysis, since both have identical masses and are indistinguishable on the mass spectrographic equipment used in this method. CS003 also exceeded the screening level at 9.87 ppt, due to non-HO related dioxins and furans (primarily OCDD). TCDD was not detected in CS003.

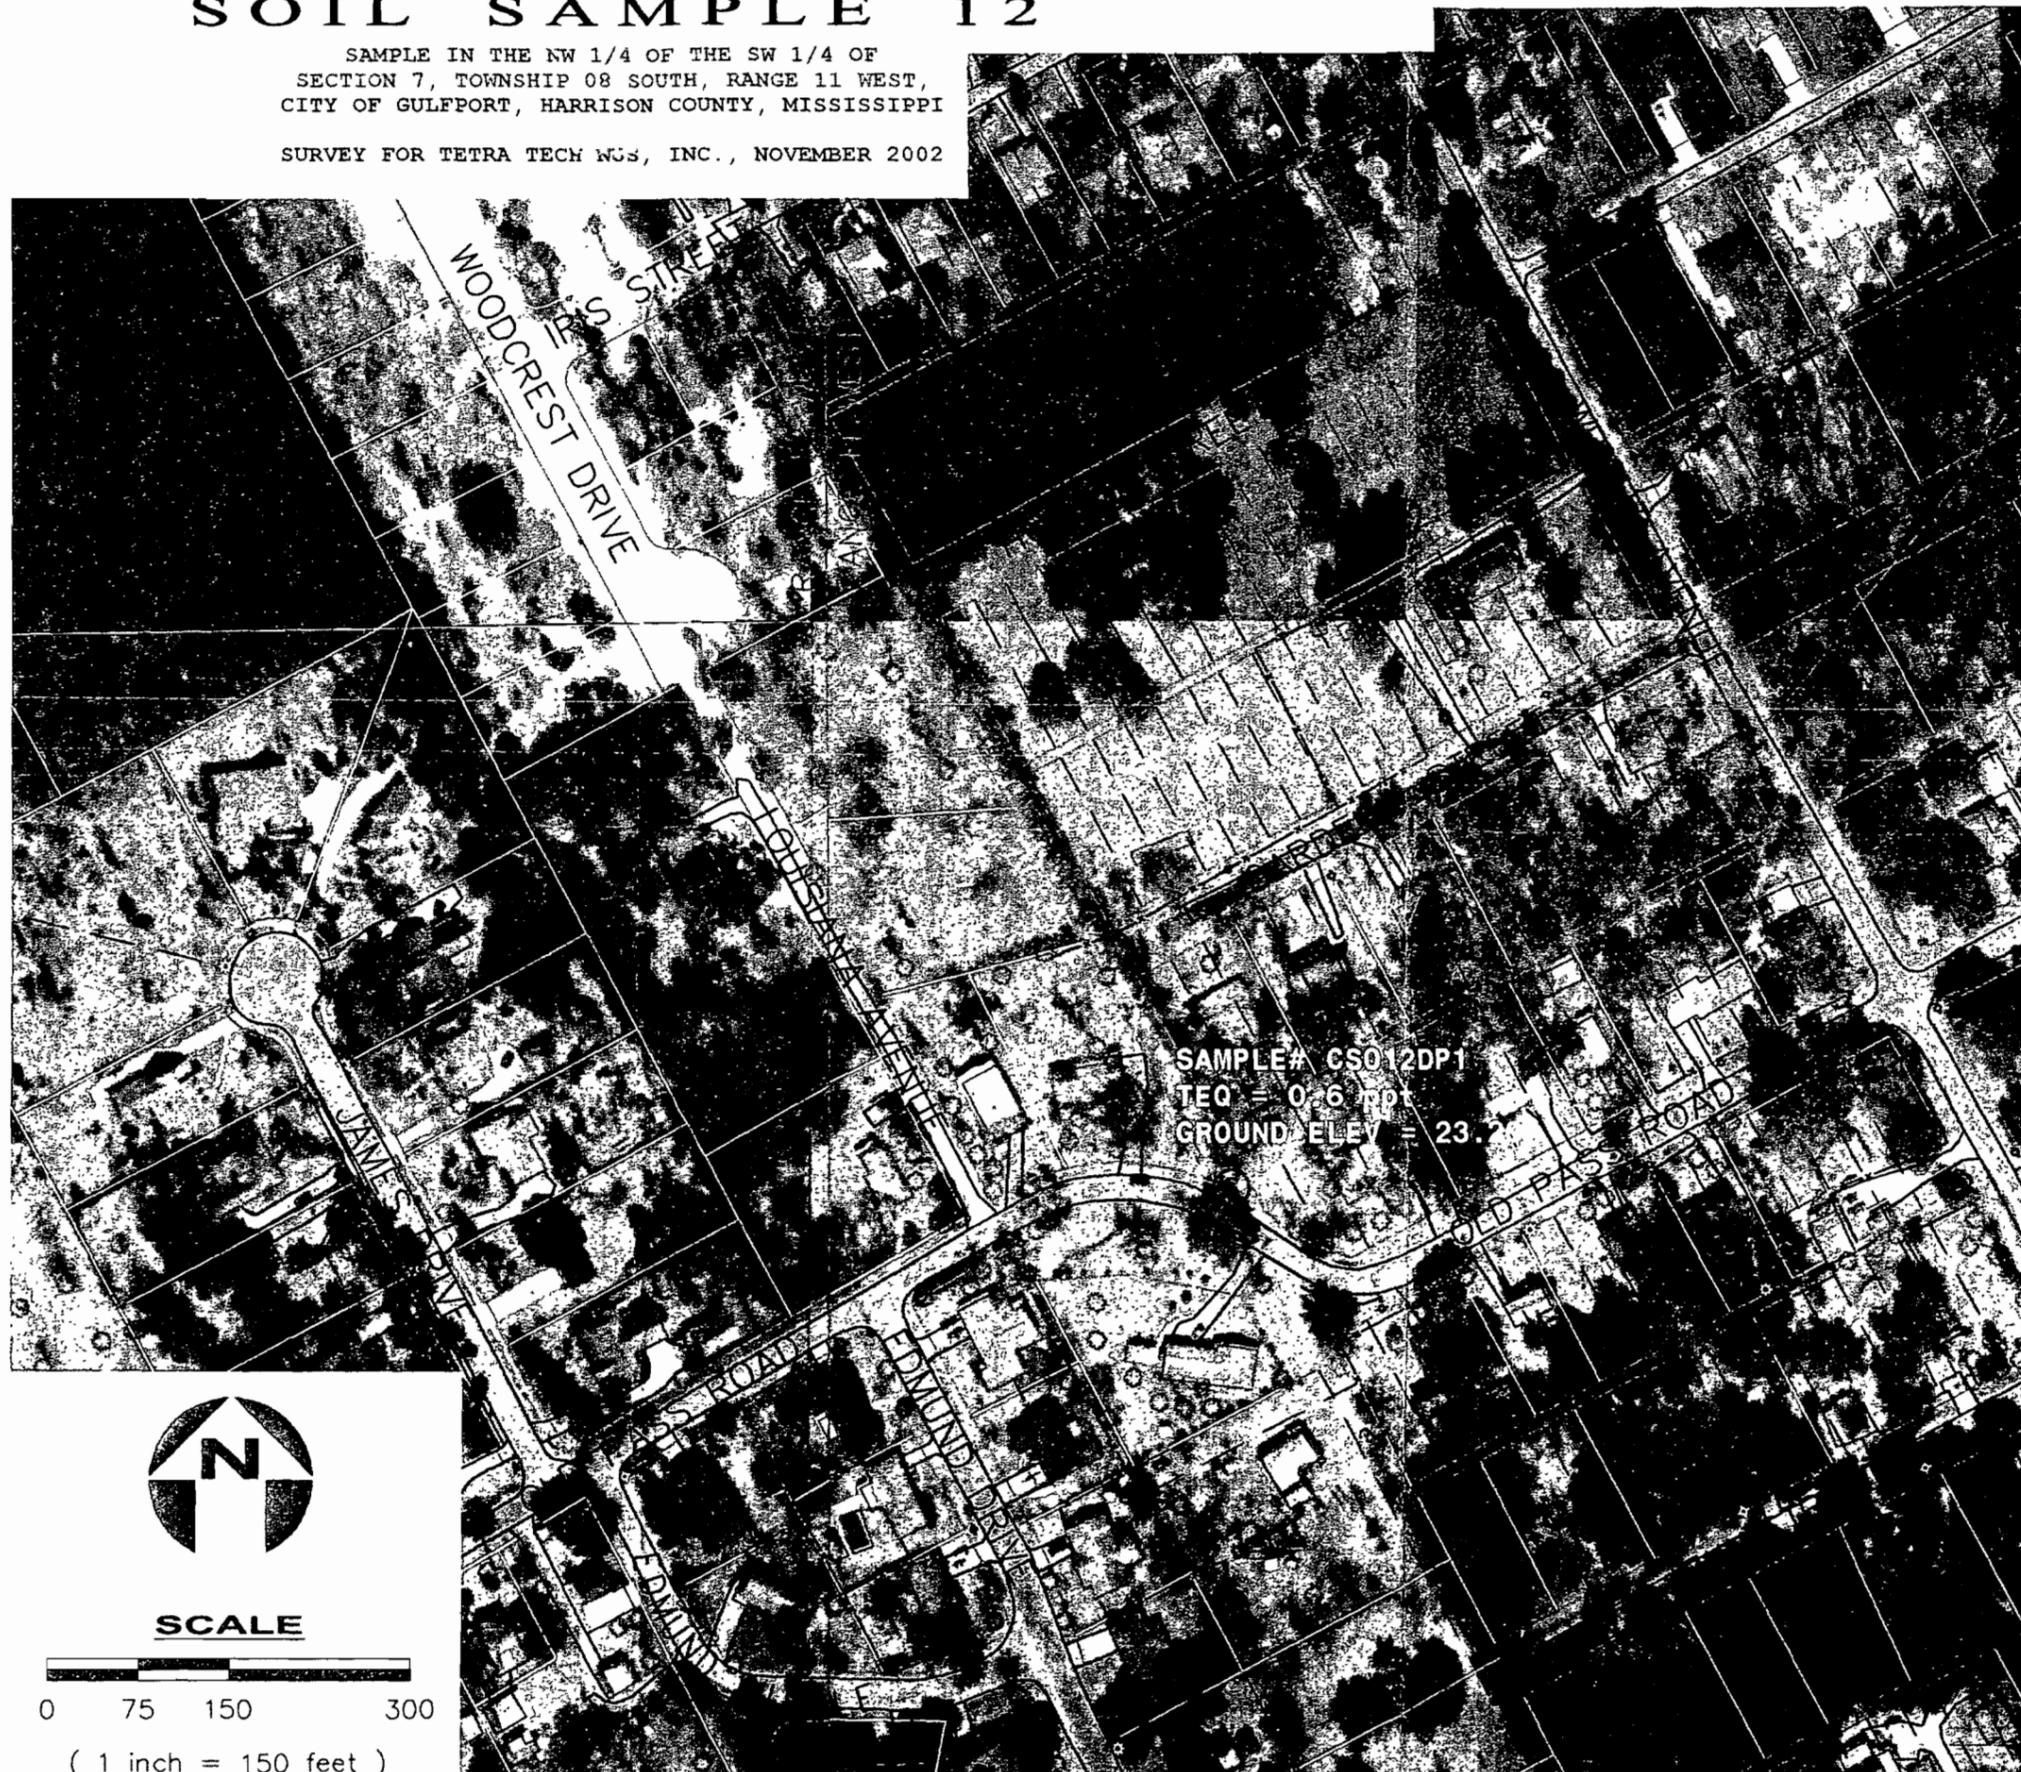
FIGURE B-5

Three grab samples (CS012, CS013, and CS014), as shown on Figures B-5 and B-6, were collected from the sediments within Bear Creek to determine if potentially contaminated sediments were migrating off base via this natural waterway. Samples CS013 and CS014 were recollected and reanalyzed in March 2003 due to an estimated maximum possible concentration (noted as an EMPC) of TCDD above the MDEQ screening level of 4.26 (ppt).

Grab samples (CS012, CS013, and CS104) were collected from the sediments within Bear Creek, approximately 1 mile southwest of NCBC Gulfport. Samples CS013 and CS014 were

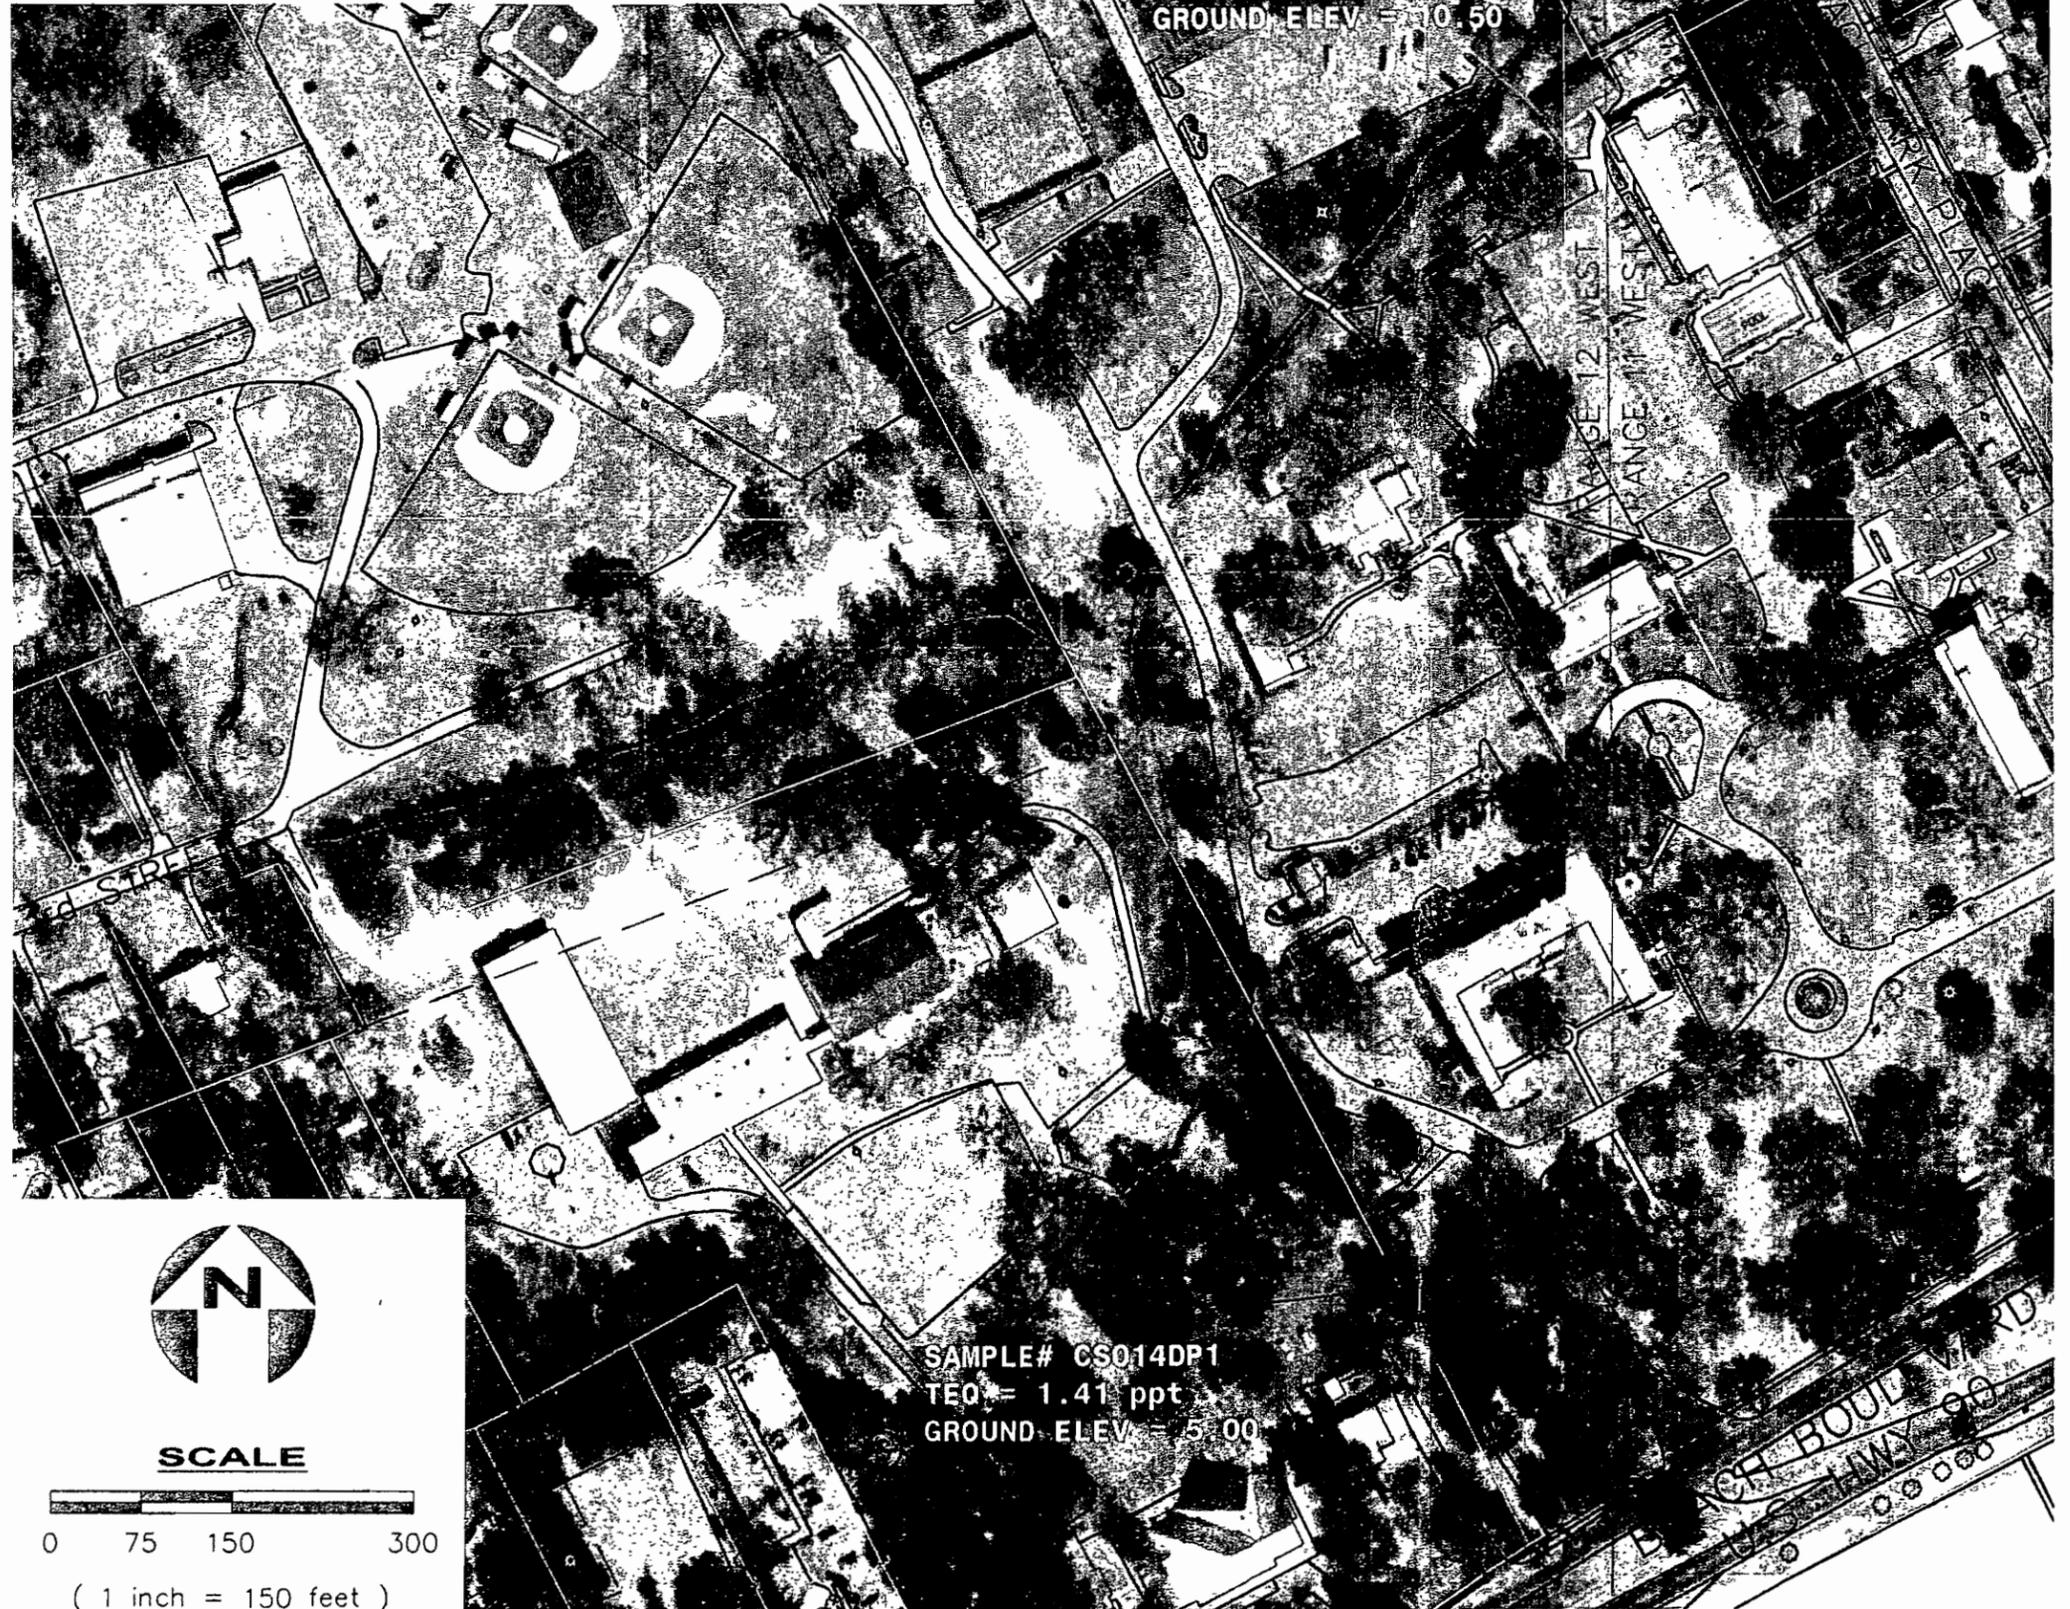
FIGURE B-6

recollected because both had TCDD results above the screening level and an ion ratio imbalance (laboratory quality assurance check) resulting in an EMPC qualifier. Results from CS012 and CS014 (resampled) did not exceed the screening value. The results for CS013 (resampled) did exceed the screening value (5.91 ppt vs. 4.26 ppt) due almost entirely to octa- and hexa-furans. The TCDD result for CS013 was again qualified as an EMPC result, but was only 0.232 ppt.

SAMPLE# CS013CP1
TEQ = 5.68 ppt
GROUND ELEV = 10.50

SAMPLE# CS014DP1
TEQ = 1.41 ppt
GROUND ELEV = 5.00

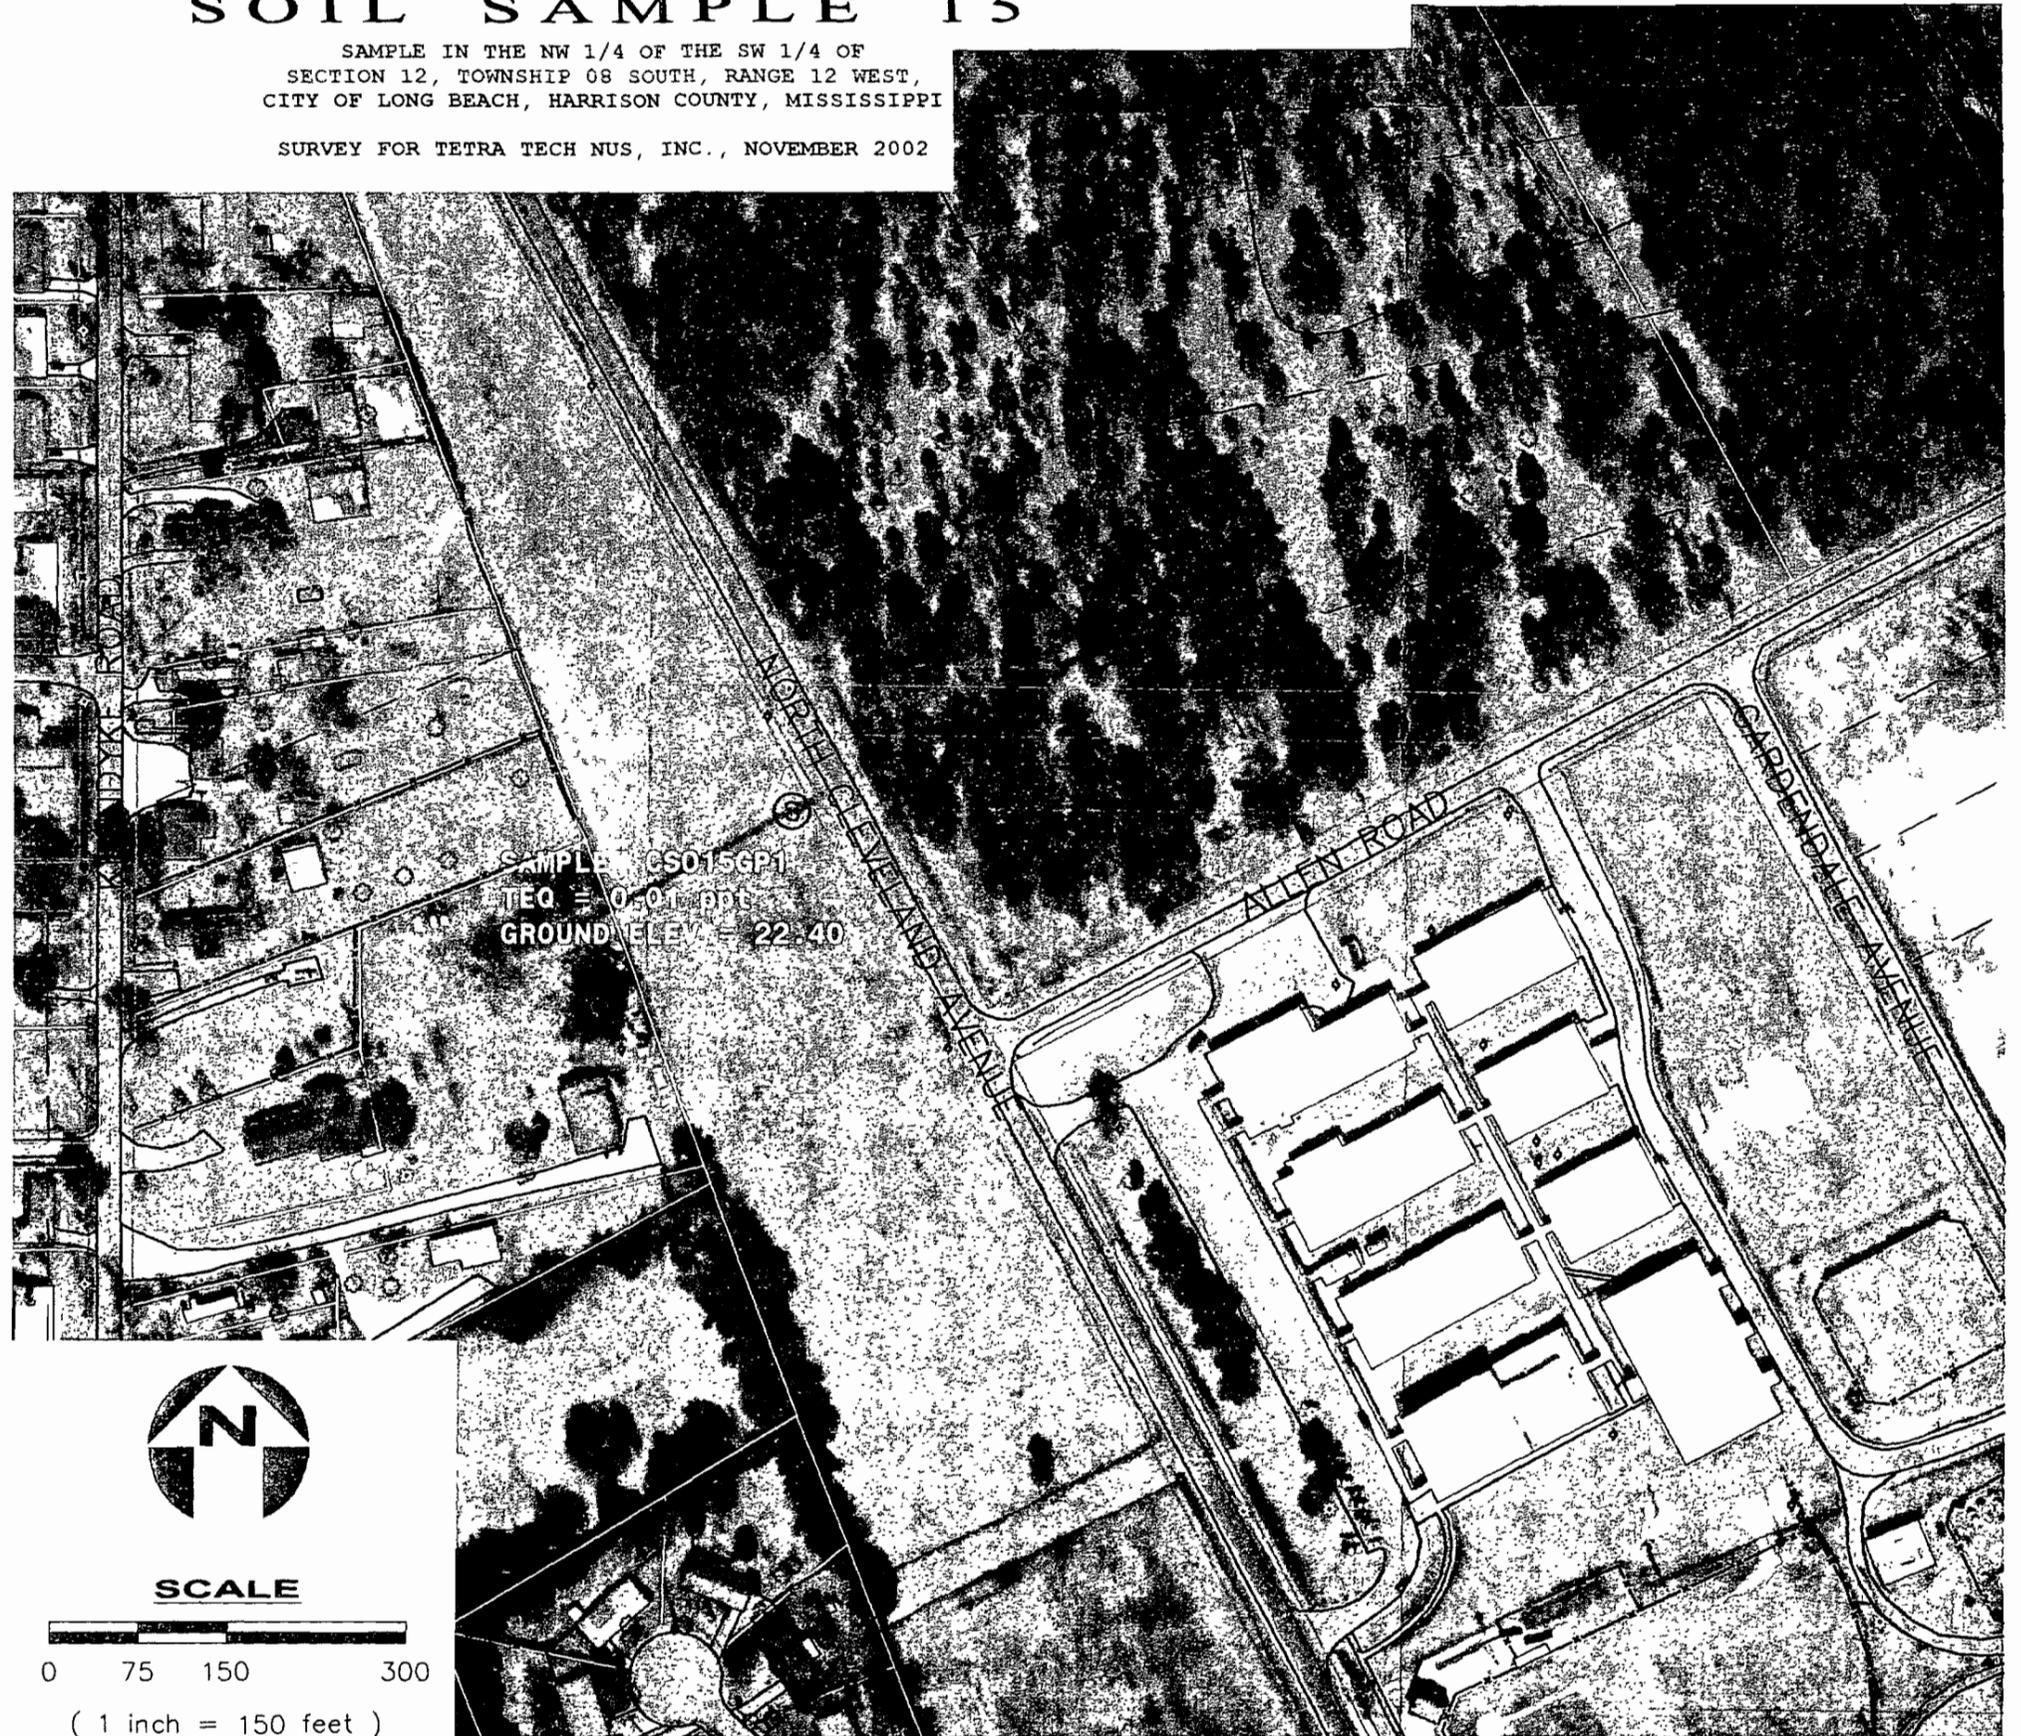
FIGURE B-7

One grab sample (CS015) shown on Figure B-7, was collected from the man-made drainage ditch intersecting Cleveland Ave. This sample was the western-most sample collected in relation to NCBC Gulfport.

Grab sample (CS015) was collected from the man-made drainage ditch intersecting Cleveland Ave., approximately 1.5 miles south-west of NCBC Gulfport. This sample was the western-most sample collected in relation to the base. Results from CS015 did not exceed the screening value.

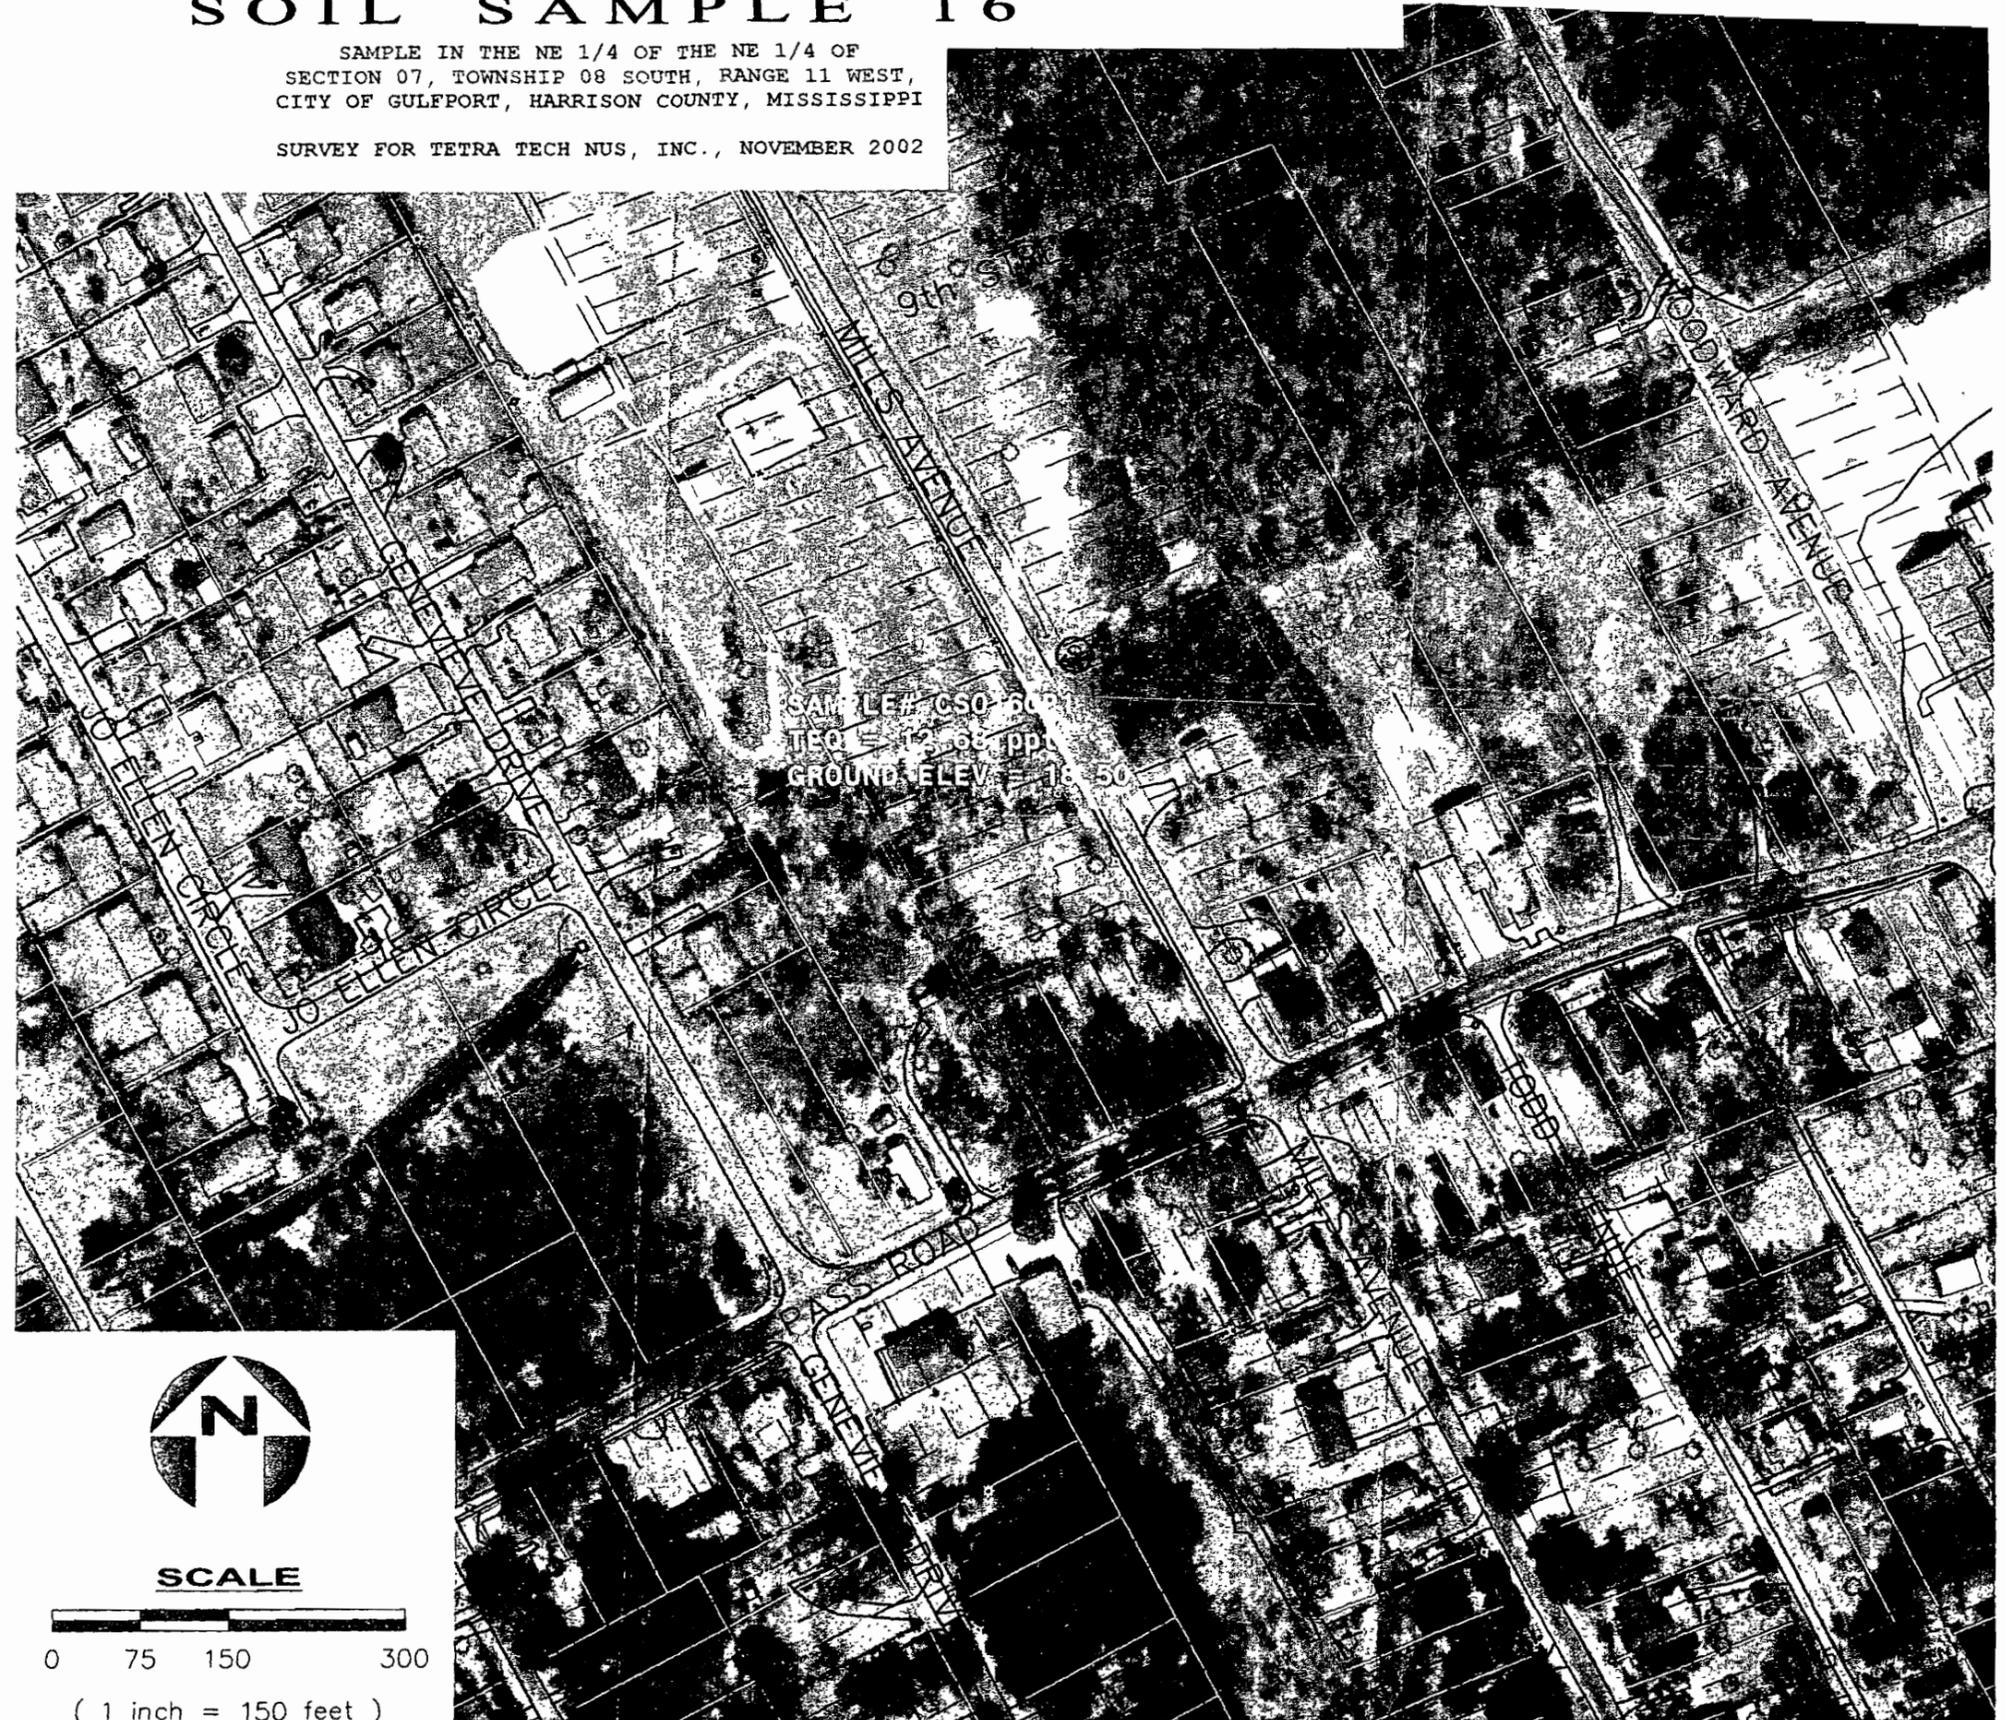
FIGURE B-8

One grab sample (CS016) shown on Figure B-8, was collected from a man-made ditch intersecting Mill Ave, approximately 1 block south of NCBC Gulfport. This ditch system includes surface water flow from the southern portion of the base.

A grab sample (CS016) was collected from a man-made waterway intersecting Mill Ave, approximately 1 block south of NCBC Gulfport. This waterway flows in a westerly direction and provides a potential migration pathway for Dioxin. Results from CS016 (12.68 ppt) exceeded the screening value. No TCDD was detected in this sample, and the dioxins and furans detected in this sample are not related to the manufacture of HO.

Based on the results of the sediment sampling no further investigation should be conducted in the areas identified in this report with respect to dioxin and HO. However, the elevated hexafuran in sample CS006 should be investigated further for the presence of transformer fluid components (PCBs and Chlorobenzene).
