LETTER REPORT REGARDING ONSITE INTERIM CORRECTIVE MEASURES REPORT
NCBC GULFPORT MS
4/9/1998
ABB ENVIRONMENTAL

SUBJECT: Onsite Interim Corrective Measures (ICM) Report, Naval Construction Battalion Center (NCBC), Gulfport, Mississippi; Comprehensive Long-Term Environmental Action, Navy District I, Contract No. N62467-89-D-0317/128

**ONSITE INTERIM CORRECTIVE
MEASURES REPORT**

**NAVAL CONSTRUCTION
BATTALION CENTER
GULFPORT, MISSISSIPPI**

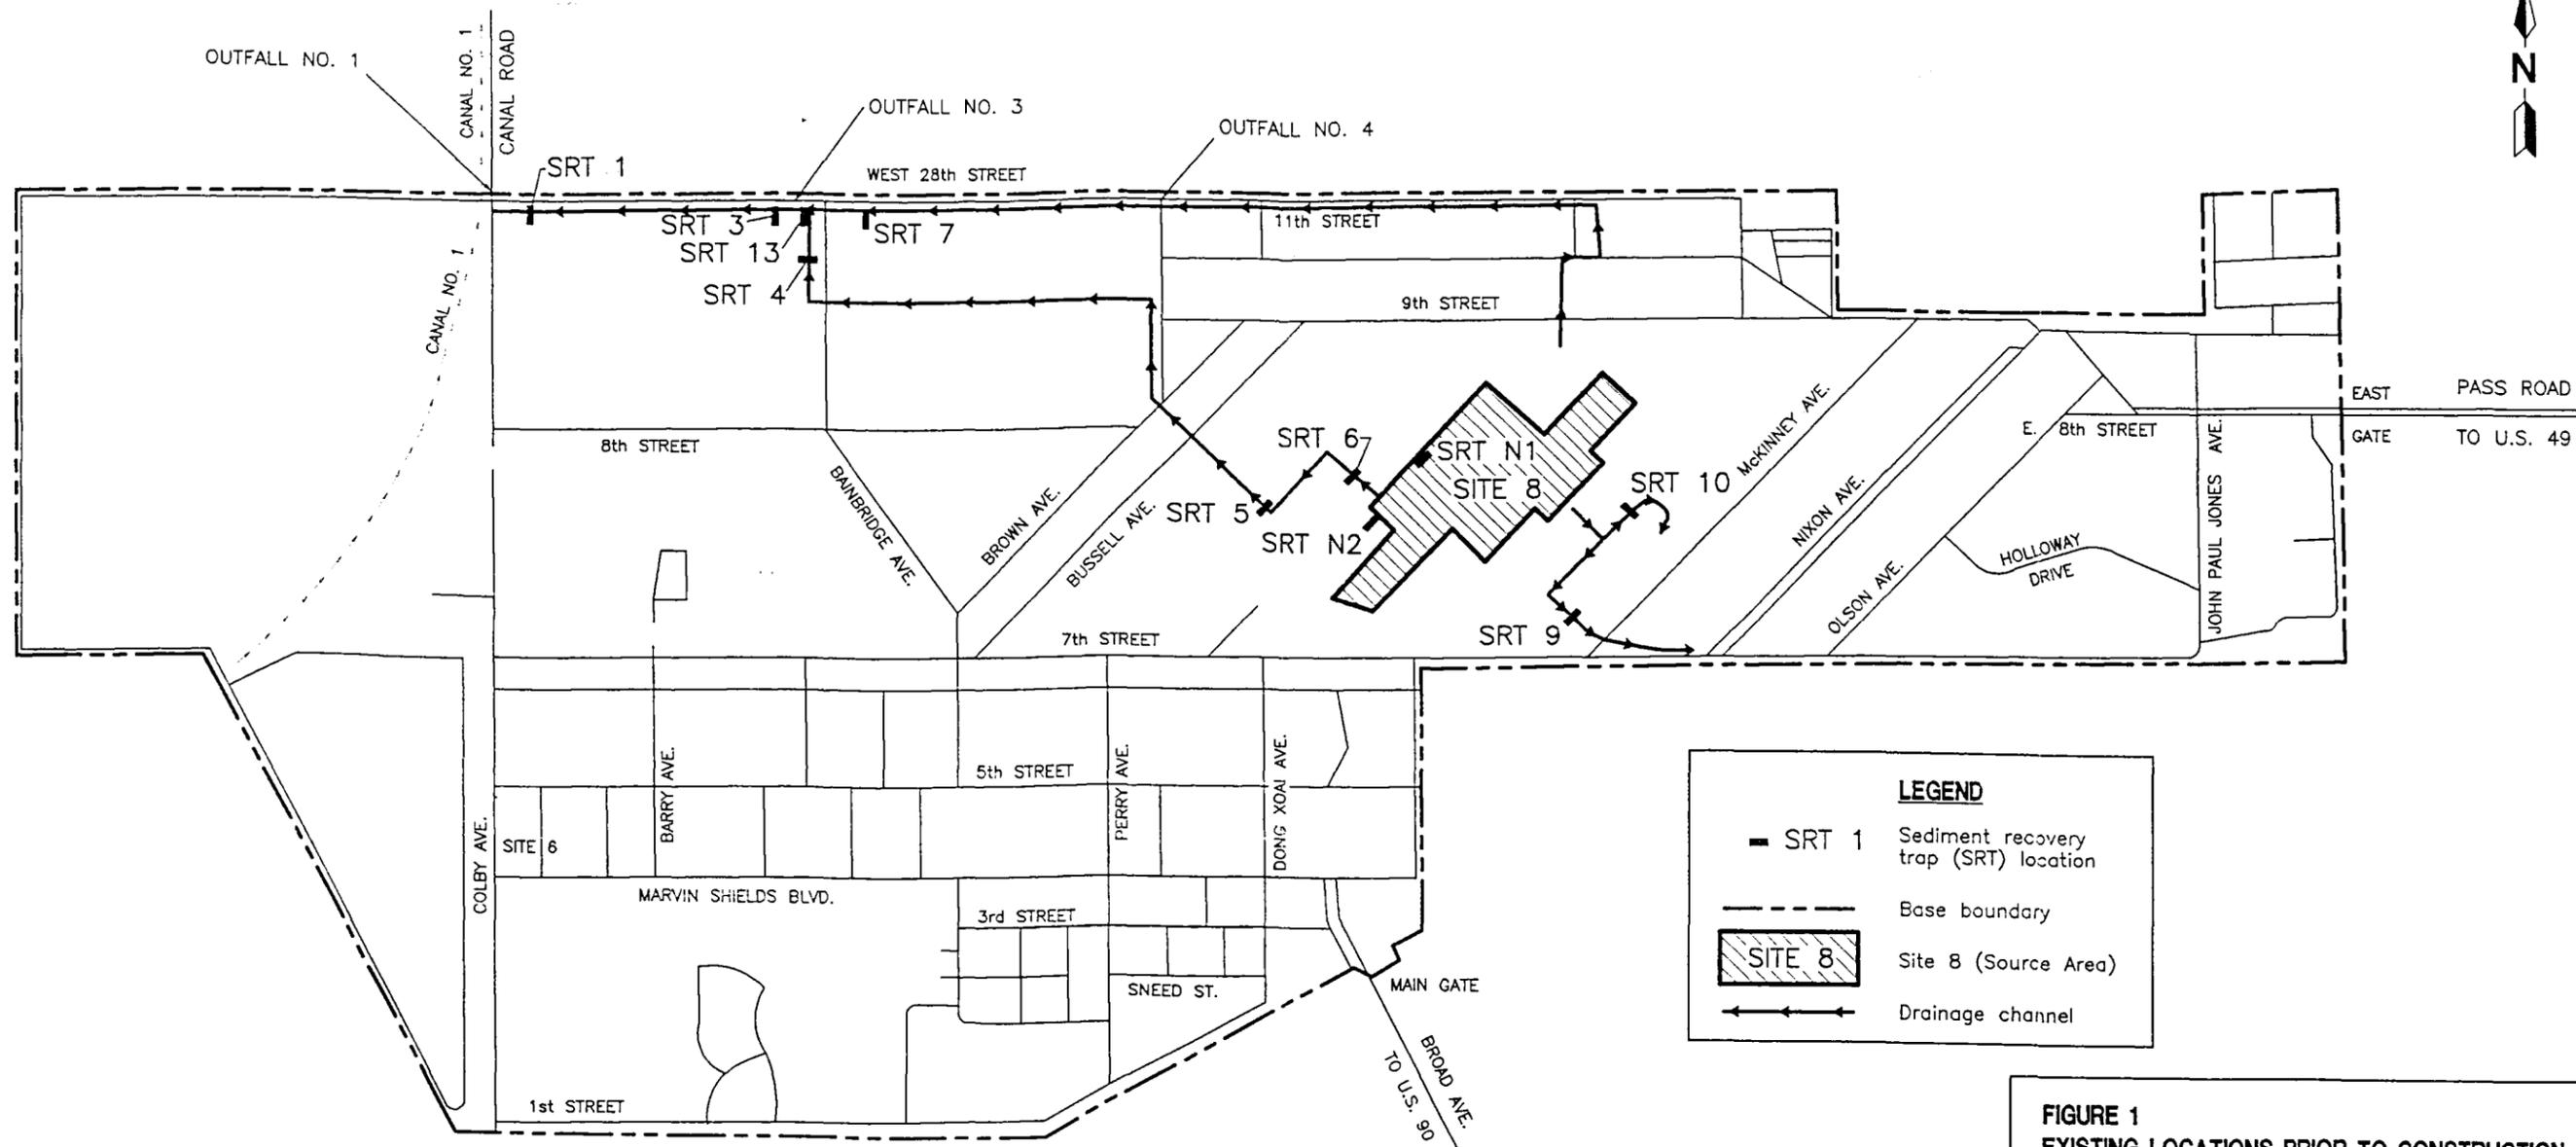
**FIGURE 1
EXISTING LOCATIONS PRIOR TO CONSTRUCTION
ACTIVITIES**

Sampling Activities. During the week of August 21, 1997, sediment samples were collected immediately upgradient and downgradient of SRTs 1, 3 through 7, 9, 10, 13, N1, and N2 (see Figure 1, all figures are located in Attachment A). All of the samples were analyzed for total organic carbon (TOC) and grain size distribution. Six locations were selected for dioxin analysis and include SRT 4, 5, 7, 13, N1, and N2. The samples were collected with a precleaned stainless-steel hand auger and transferred to laboratory-prepared sample jars. They were then shipped to their respective laboratories for analysis.

NOTE:
SRT structures 2, 8, 11 and 12 no longer exist
and the locations are not shown.

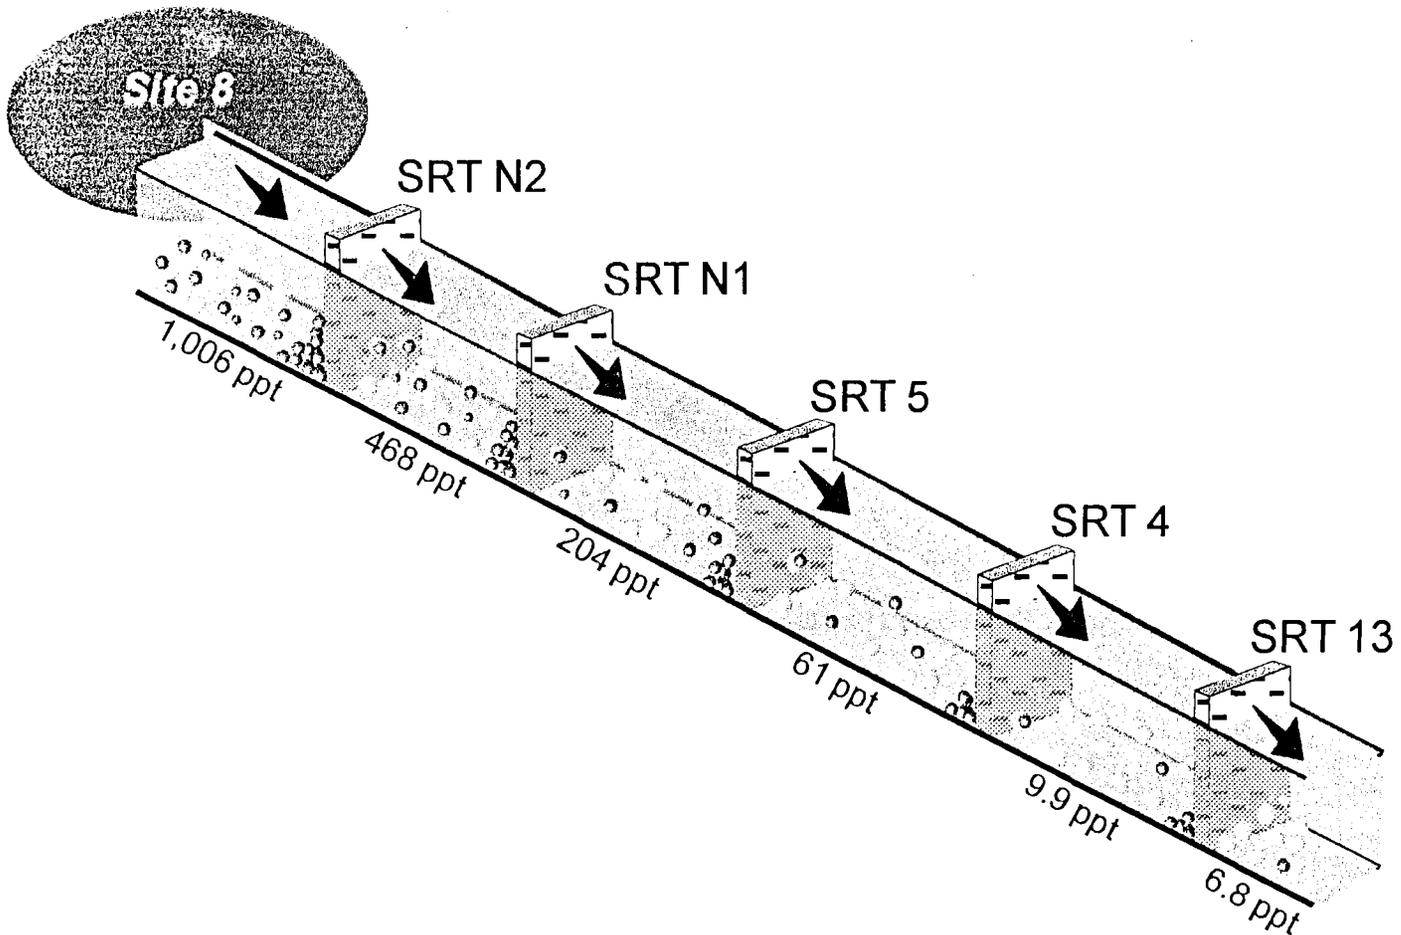
**FIGURE 2
 VISUAL SUMMARY OF DIOXIN RESULTS**

locations at each SRT. It is also noted that the TE values decrease as drainage moves away from the source area. Figure 2 provides a visual summary of this decrease in concentrations.

ppt = parts per trillion
 204 ppt = dioxin concentrations

Sampling Conclusions. The analytical results, provided in Table 1 (all tables are located in Attachment B), for dioxin samples collected from six SRT locations (SRT 4, 5, 7, 13, N1, and N2) indicate decreasing levels for dioxin toxicity equivalent (TE) values when comparing upstream versus downstream

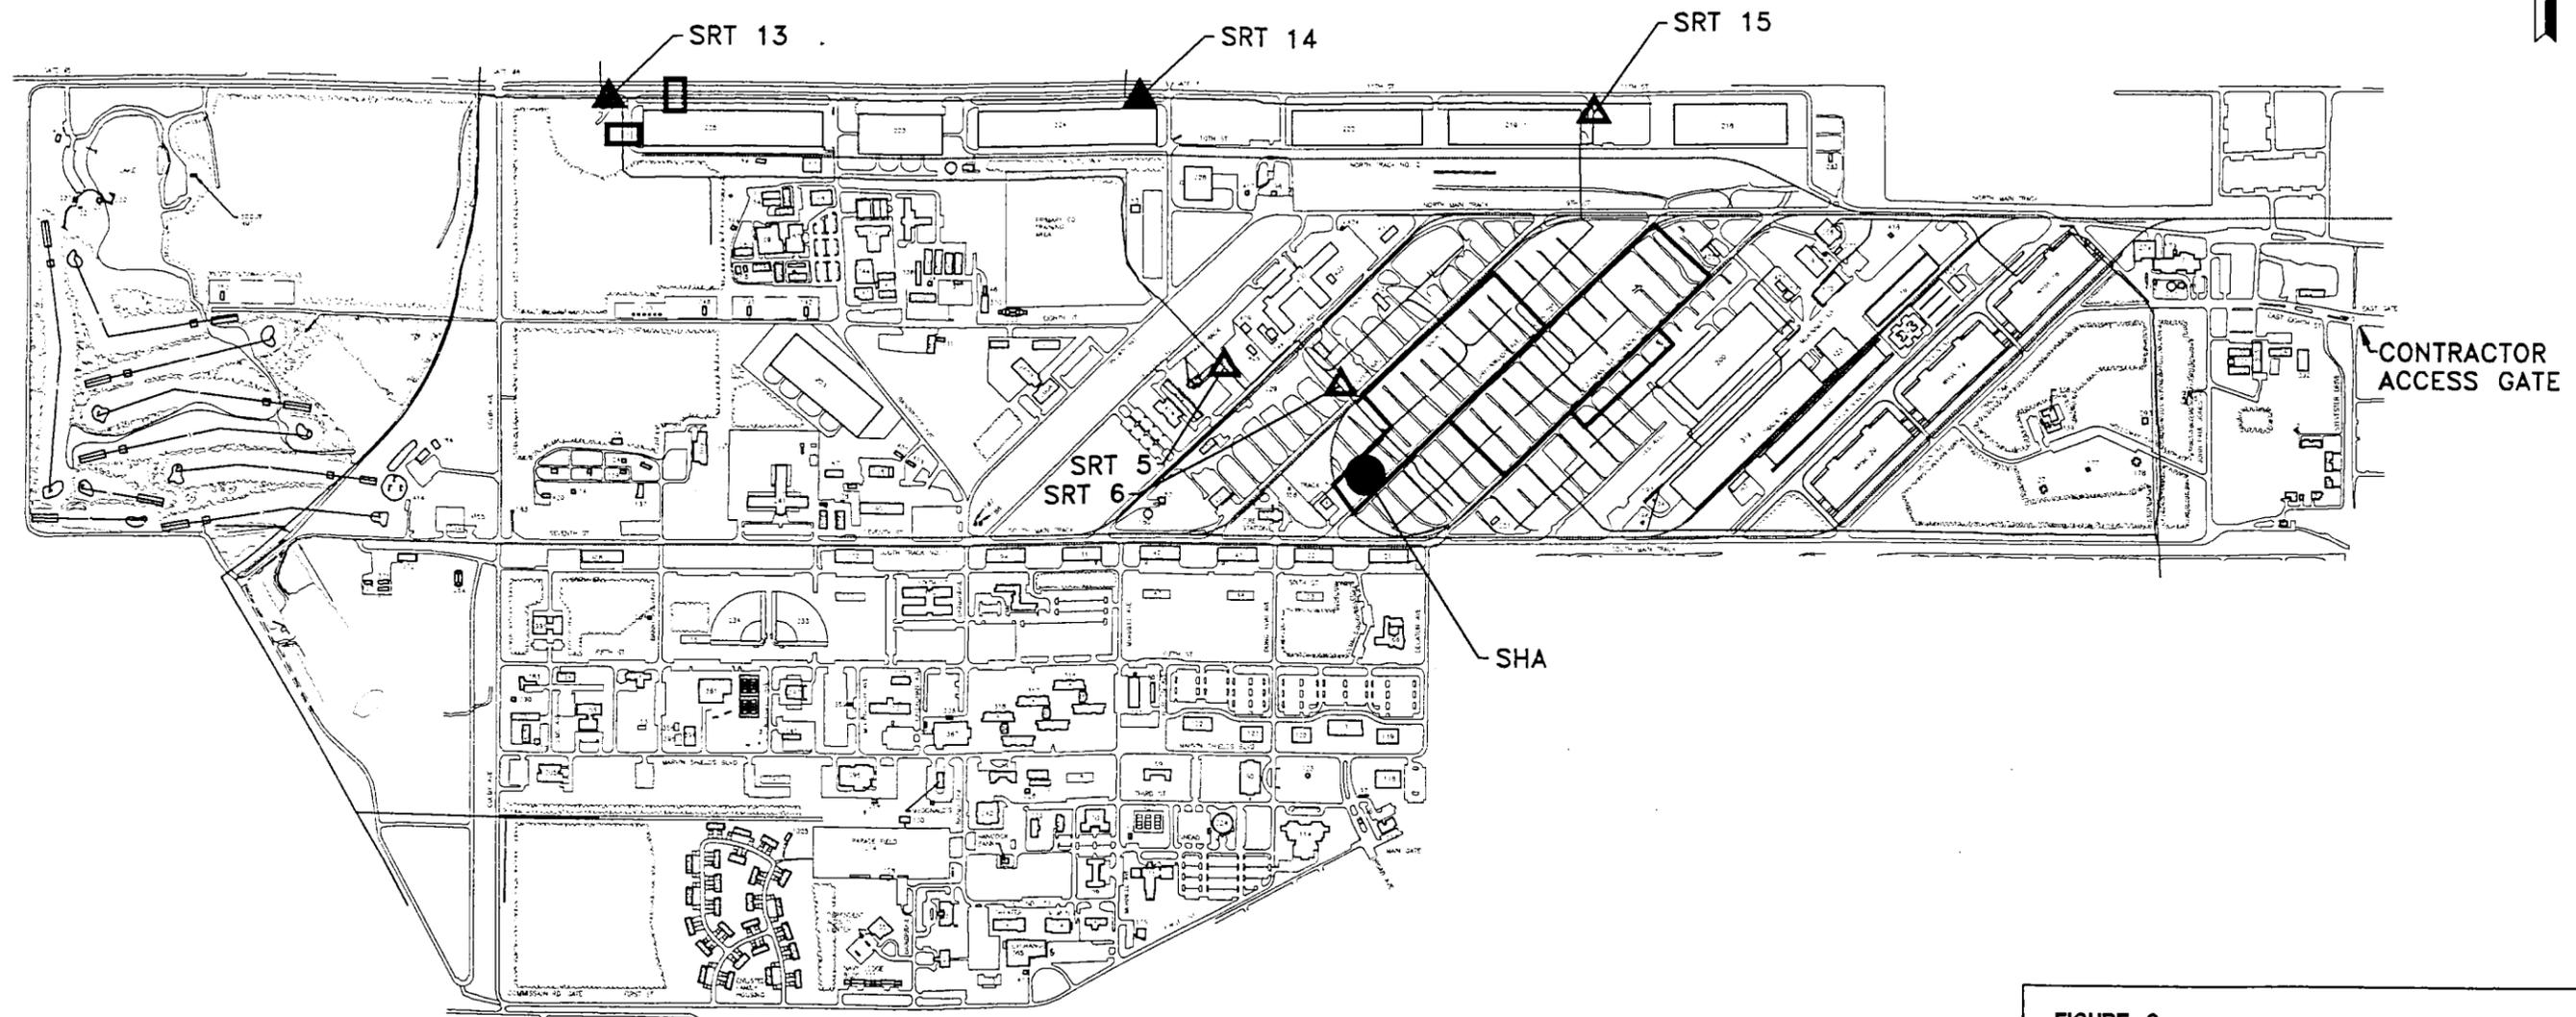
**FIGURE 3
AREAS OF CONSTRUCTION**

Two new SRT structures (SRT 14 and 15) were constructed within the 11th Street ditch along the north base boundary. These structures were built in the same manner as described above. The locations of these structures are shown on Figure 3.

Two existing SRTs were removed from the network that included SRT 4 and SRT 7. These two structures were removed because they no longer function as designed, and both are located immediately upgradient from SRT 13 and considered redundant.

- ▲ Sediment recovery trap (SRT)
- Sediment handling area (SHA)
- Removed SRT locations (SRT 4 and 7)
- △ Sediment recovery trap and ditch modifications

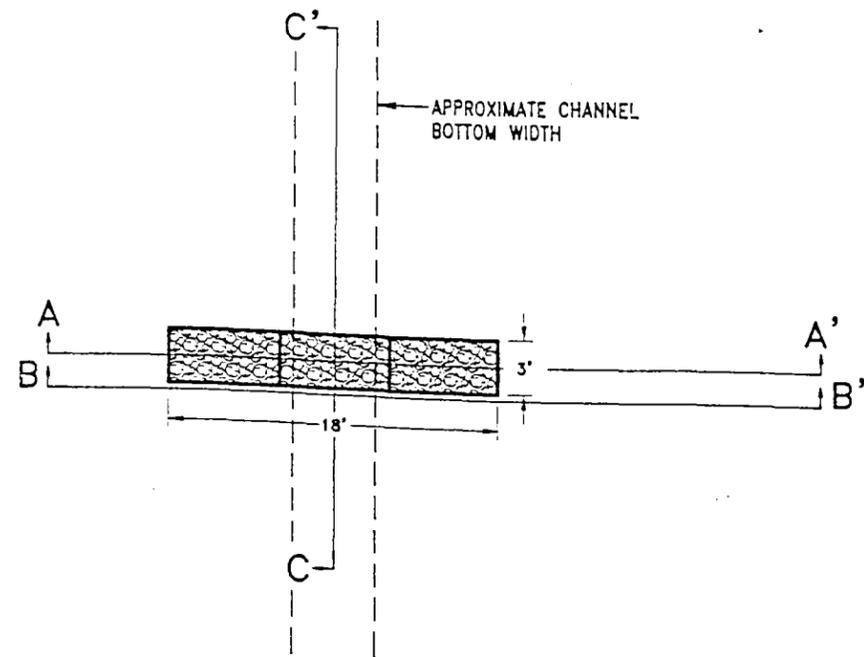
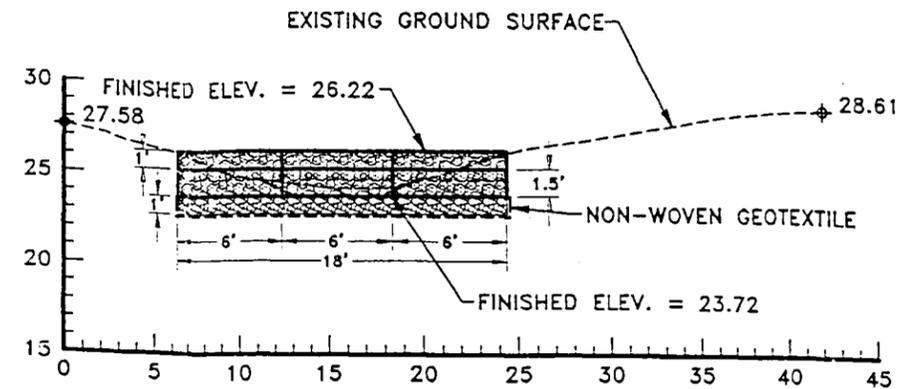
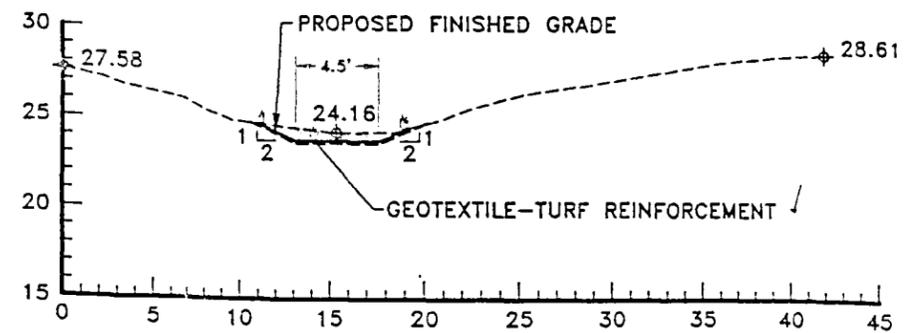
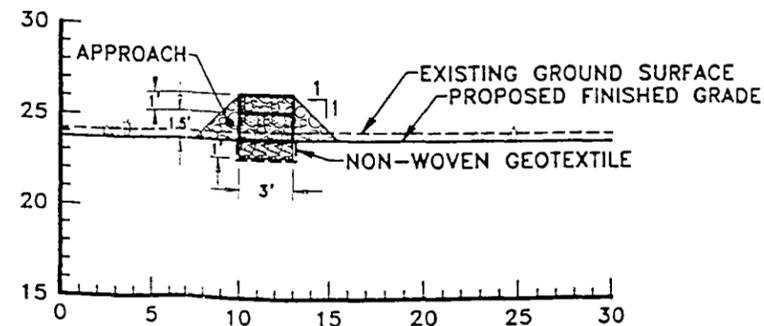
DRAWING 3
SRT 5 DETAILS

Existing SRTs 5 and 6 were removed and replaced with upgraded SRT structures. Preparation for the construction of the SRTs began with excavating a trench across the drainage ditch that extended into the banks on either side. The trench was excavated to a depth of approximately 1 foot below the drainage ditch bottom elevation. Once this was completed, geosynthetic nonwoven material was placed in the trench bottom and the remaining portion was filled with 2-inch-diameter gravel up to the ditch bottom elevation. The nonwoven material was placed into the excavation to protect the integrity of the base material. Gabion cages were then placed on top of the foundation and varied in height from 2 to 2.5 feet. The cages were constructed of galvanized wire coated with PVC. After placement of the cages, 3- to 6-inch-diameter gravel was hand placed into the cages. To complete the structure, 3- to 6-inch gravel was placed on either side at a 1:1 slope to help stabilize the structure and also aid in keeping it free of debris.

DITCH MODIFICATION ACTIVITIES WILL OCCUR ALONG THE DITCH APPROXIMATELY 100' UPGRADIENT AND APPROXIMATELY 75' DOWNGRADIENT OF THE SRT LOCATION. THESE DITCH MODIFICATIONS ARE TYPICAL IN SHAPE OF SECTION B-B' BUT VARY IN DIMENSIONS ALONG THE DITCH AT THE ENGINEERS DISCRETION. GENERAL NOTES CONTAIN CONSERVATIVE EXCAVATED MATERIAL QUANTITIES TO BE USED IN BID ESTIMATES.

Ditch modifications were also completed at SRT 5, 6, and 14. These modifications included the removal of sediment from the bottom of the ditches to provide proper slope. The ditches were also widened to provide more volume storage capacity. After excavation was completed, the soil surface was scarified and seeded with a mixture of Bermuda, Bahia, and Rye grass. A geosynthetic turf-reinforcement material was then placed on the seeded surface throughout the entire ditch where excavation had occurred. This material was installed to eliminate erosion along the modified ditch sections and to allow grass to grow. The installation process began by rolling the turf reinforcement from the downgradient end of the ditch towards the upgradient end. Every 30 feet an anchor trench was installed to hold the material in place during flow events. The matting was also anchored throughout with 12-inch galvanized turf staples. After installation of the matting, the area was seeded again and topsoil was applied. The topsoil was then fertilized and watered before being seeded again and then completed with a straw cover to hold the seed in place.

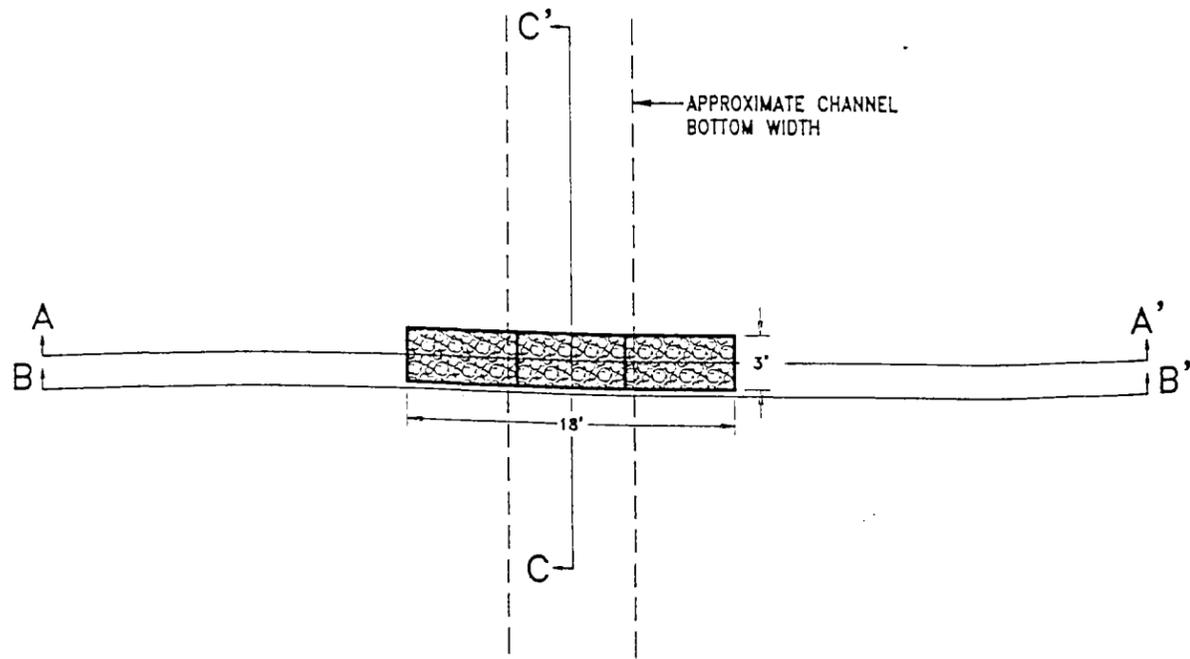
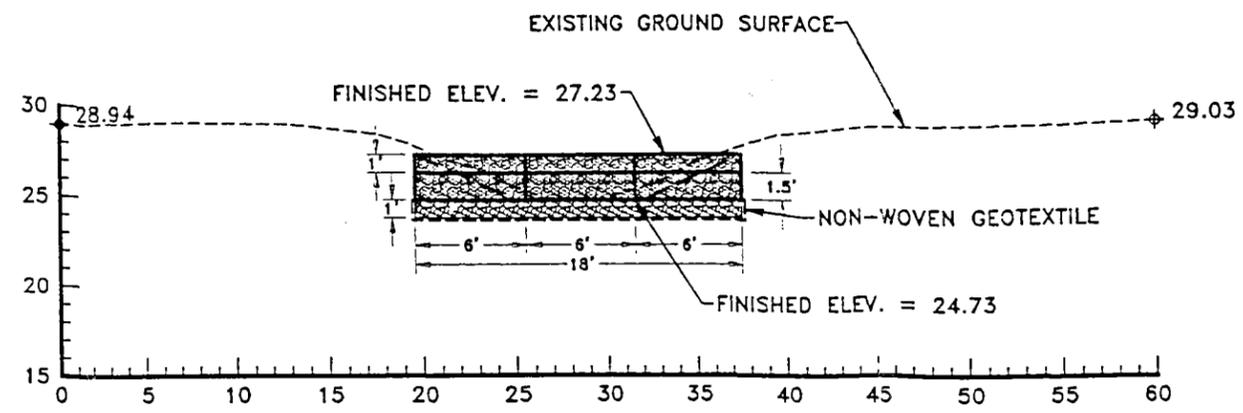
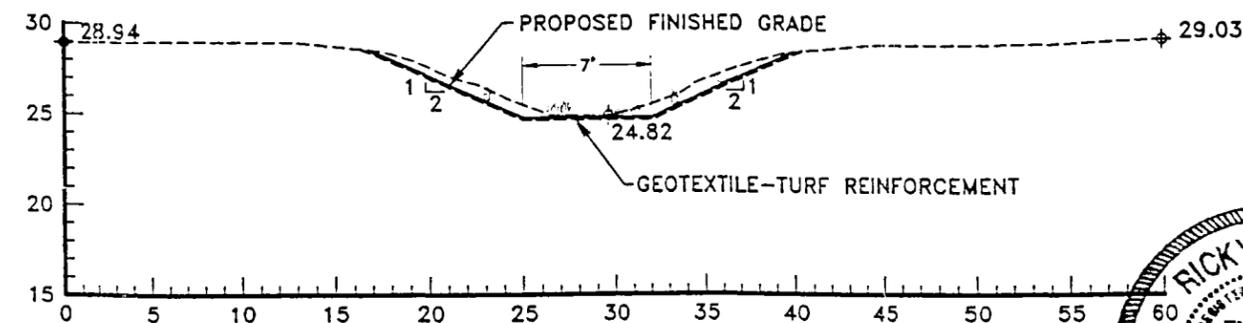
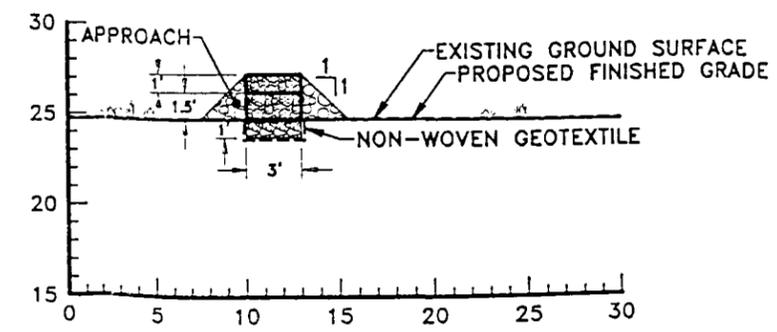
DRAWING 4
SRT 6 DETAILS

NOTE:
DITCH MODIFICATION ACTIVITIES WILL OCCUR ALONG THE DITCH APPROXIMATELY 125' UPGRADIENT AND APPROXIMATELY 25' DOWNGRADIENT OF THE SRT LOCATION. THE DITCH MODIFICATIONS ARE TYPICAL IN SHAPE OF SECTION B-B' BUT MAY VARY IN DIMENSIONS ALONG THE DITCH AT THE ENGINEERS DISCRETION. GENERAL NOTES CONTAIN CONSERVATIVE EXCAVATED MATERIAL QUANTITIES TO BE USED IN BID ESTIMATES.

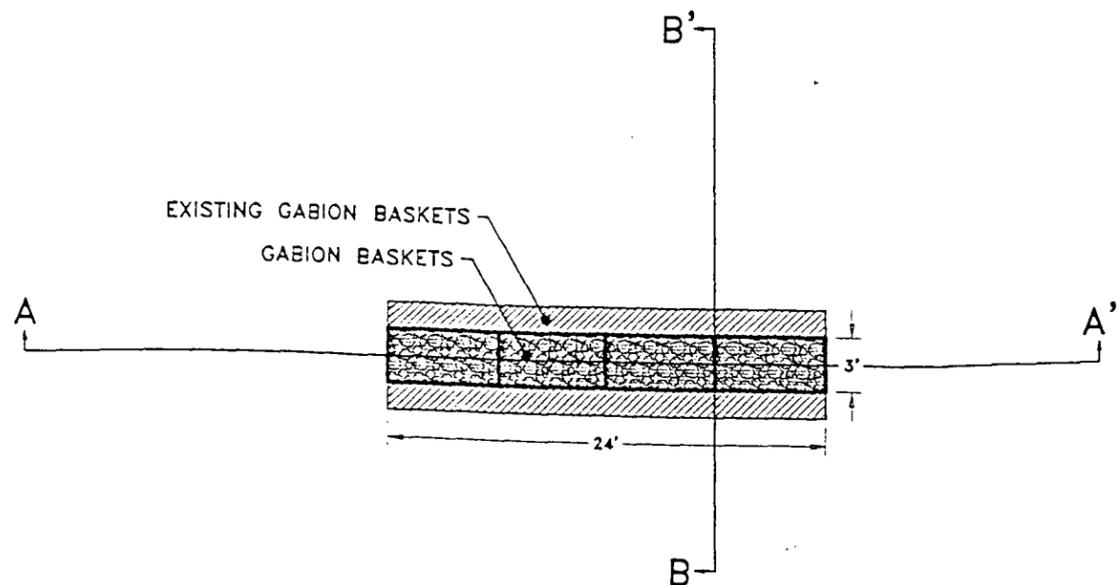
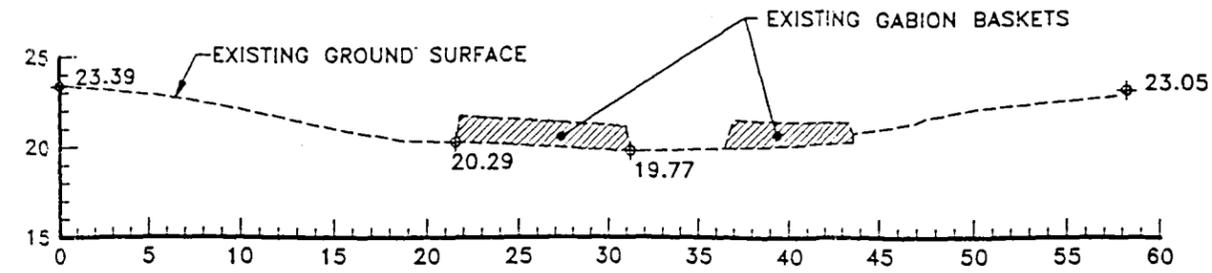
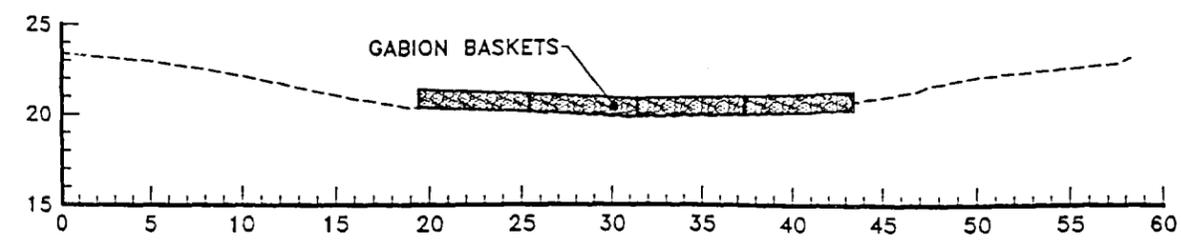
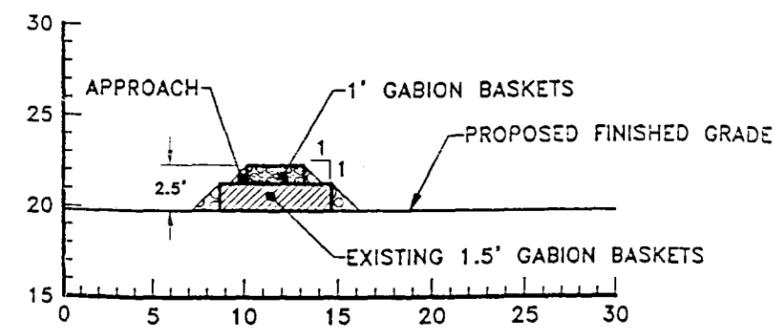
DRAWING 5
SRT 13 DETAILS

The remaining construction activities consisted of retrofitting the existing SRT 13. The structure was originally built to a height that allowed water to rise up over the cage and also flow around the cage ends. To help alleviate this problem, a section of the top gabion was removed, which created a weir that lowered the water level behind the structure. However, during intense rain events, water still flowed around the edges of the structure. The ICM consisted of removing the entire upper layer of the structure and replacing it with gabion cages to lower the entire height. These cages were also tied into the ditch banks to stop flow around the ends. Rock was also placed on either side as discussed above.

1. THE EXISTING 1.5-FOOT HIGH GABION BASKET SHALL BE REMOVED AND REPLACED WITH 1-FOOT HIGH BASKETS. (SECTION A-A').
2. GABION STONE REMOVED FROM EXISTING BASKETS MAY BE REUSED AT THE ENGINEERS DISCRETION.

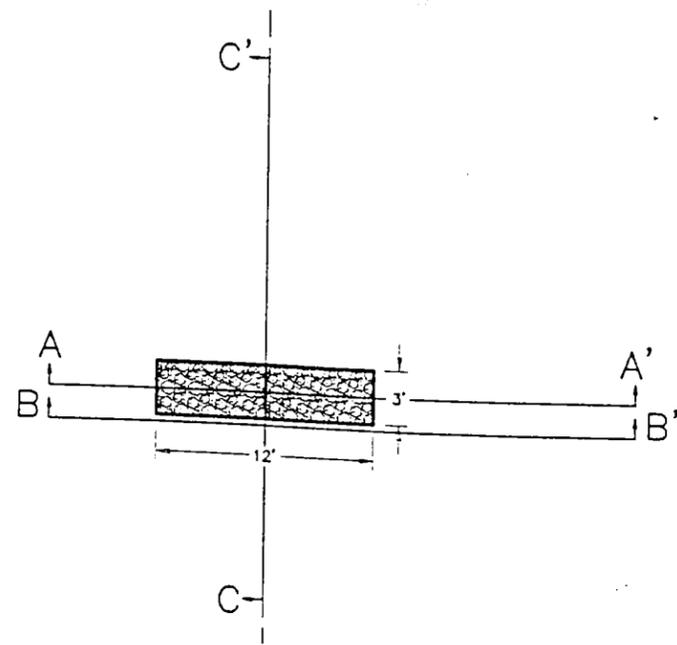
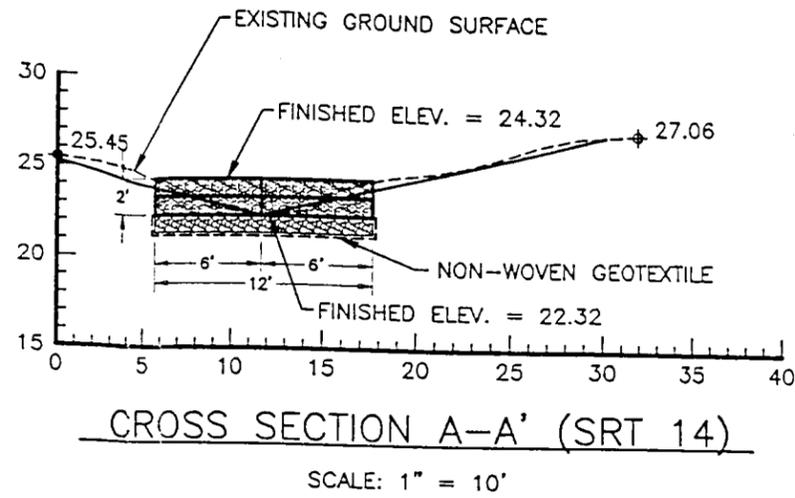
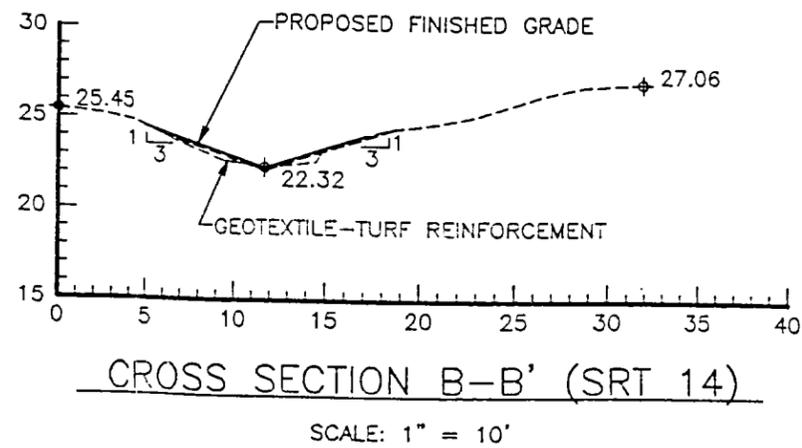
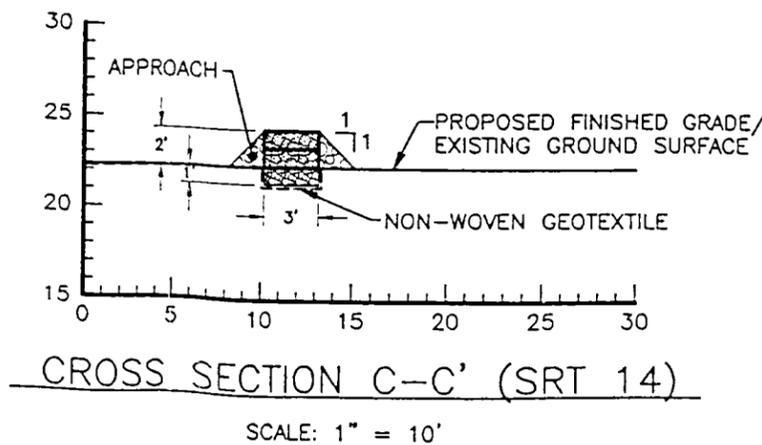
DRAWING 6
SRT 14 DETAILS

NOTE:
DITCH MODIFICATION ACTIVITIES ARE NOT ANTICIPATED AT THIS LOCATION.

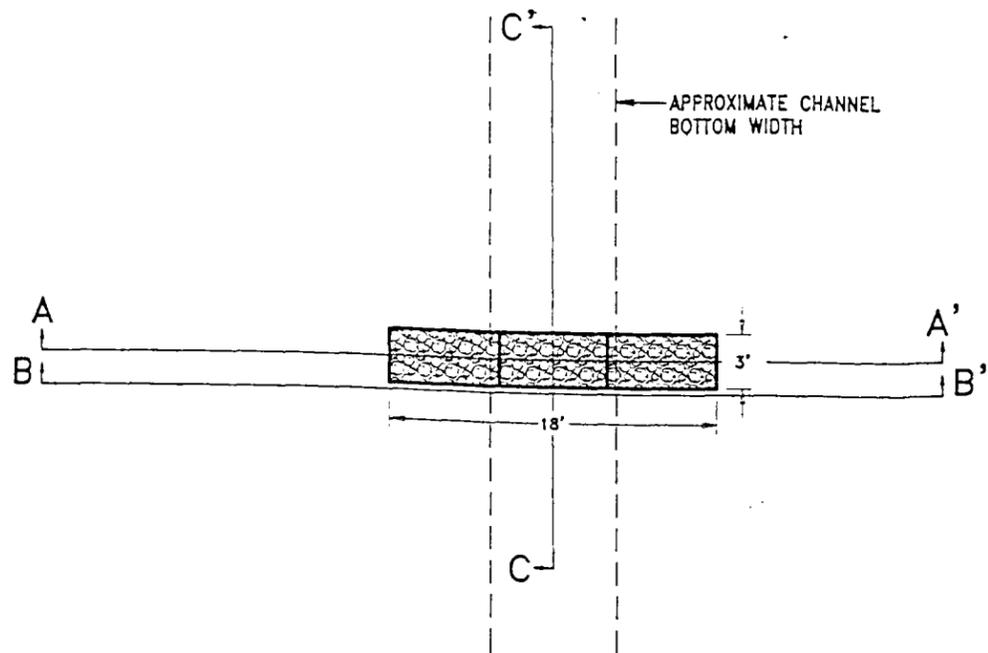
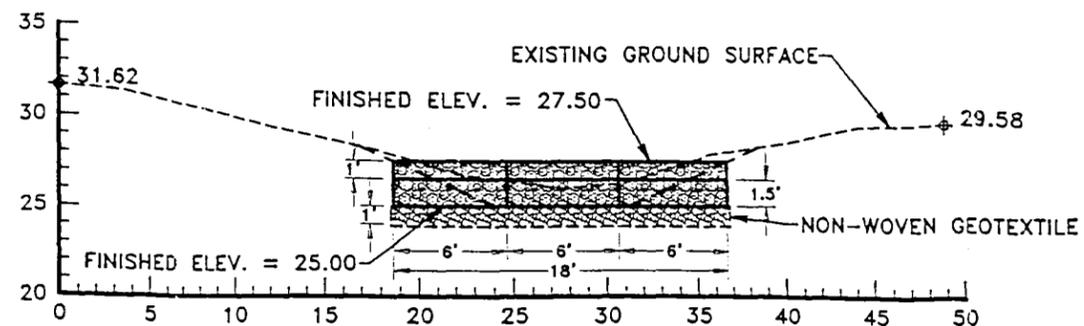
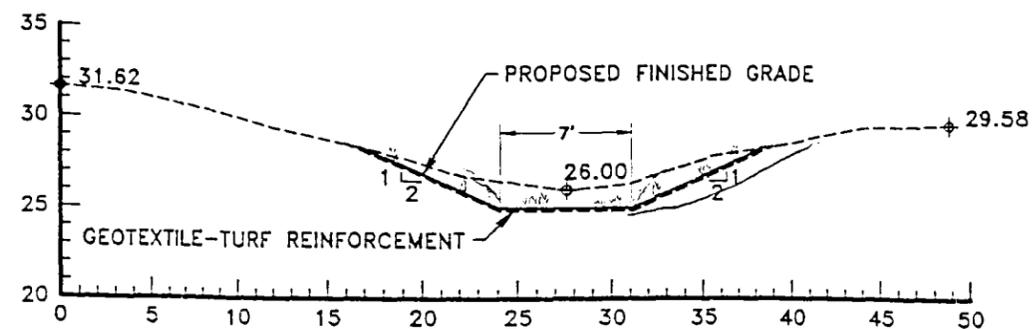
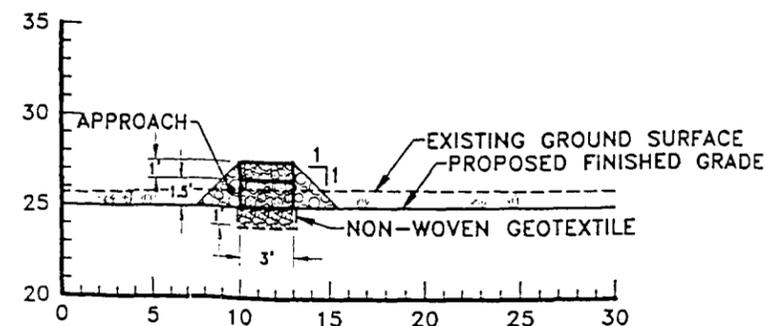
DRAWING 7
SRT 15 DETAILS

DITCH MODIFICATION ACTIVITIES WILL OCCUR ALONG THE DITCH APPROXIMATELY 170' UPGRADIENT AND APPROXIMATELY 25' DOWNGRADIENT OF THE SRT LOCATION. THE DITCH MODIFICATIONS ARE TYPICAL IN SHAPE OF SECTION B-B' BUT VARY IN DIMENSIONS ALONG THE DITCH AT THE ENGINEERS DISCRETION. GENERAL NOTES CONTAIN CONSERVATIVE EXCAVATED MATERIAL QUANTITIES TO BE USED IN BID ESTIMATES.

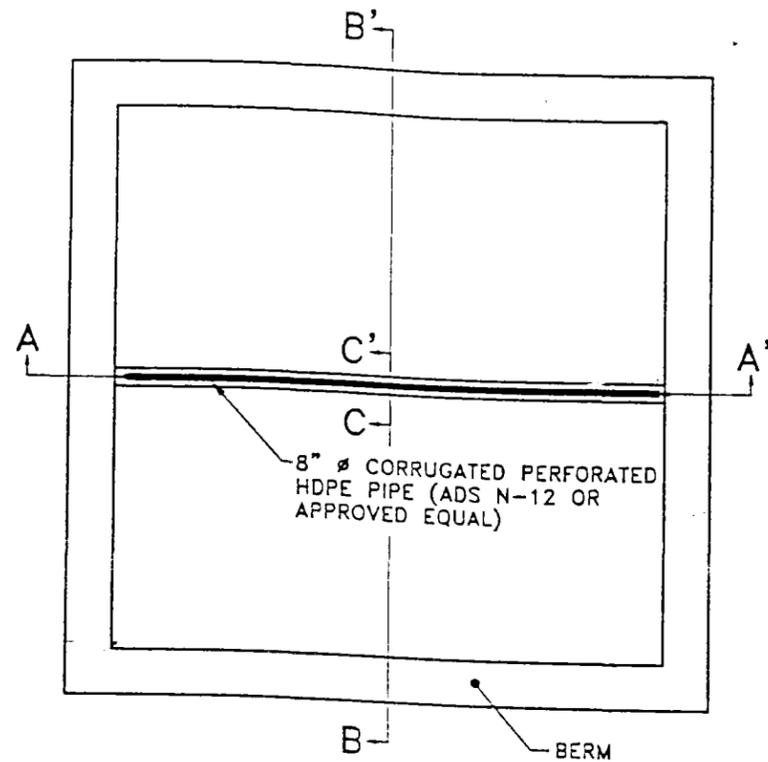
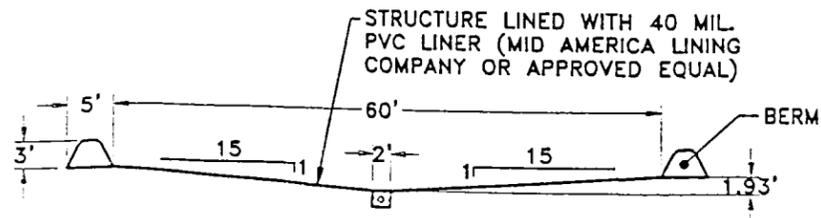
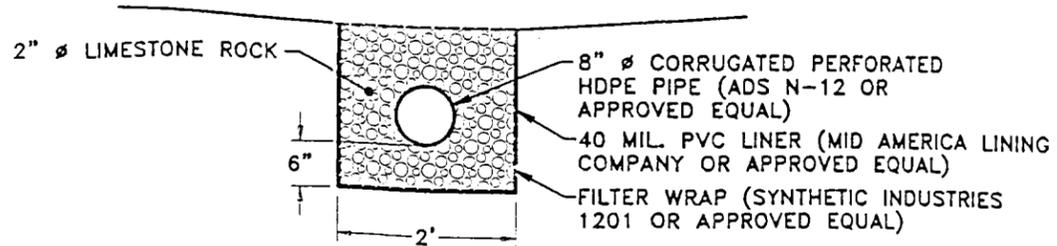
DRAWING 8
SOILS HANDLING AREA

The SHA was constructed on Site 8 to help contain contaminated soils removed from the SRT construction locations. It consisted of an excavation 60 feet by 60 feet that sloped to a center ditch with

a 1:15 slope. The center ditch then sloped to one end with a 1 percent decline. After the area had been excavated, a 40-millimeter thick, polyvinyl chloride (PVC) liner was installed within the excavation for containment purposes. Once the liner had been installed, the center ditch was completed with 2-inch-diameter gravel and an 8-inch-diameter perforated pipe. This pipe was installed so that water from saturated soil brought back to the SHA could be removed. After all excavated soil had been brought to the SHA, the entire structure was covered with a 20-millimeter-thick, PVC liner to isolate the staged soils from rainfall.

1. PVC LINER WILL BE DRAPED OVER TOP OF BERM AND EMBEDDED INTO THE BERM.
2. EXCESS SPOIL MATERIAL FROM CONSTRUCTION OF SOILS HANDLING AREA CAN BE SPREAD ON SITE AT THE DISCRETION OF THE ENGINEER.
3. A COVER SHEET FOR THE SOILS HANDLING AREA OF 20 MIL PVC (MID AMERICA LINING COMPANY OR APPROVED EQUAL) WILL BE PROVIDED AND WILL BE 90' BY 90' IN SIZE.

3. Observations of the structure integrity should be made during each visit by base personnel. If it appears that rock has been shifted downstream, an attempt to replace the rock should occur.
4. The cover on the SHA retains rainwater and potentially could be damaged due to the weight. The water on top of the cover should be pumped off and discharged to the surface on Site 8, as necessary.
5. At the completion of each O&M event, all PPE should be removed, containerized, and discarded.
