Subject: CTO-094; Document Transmittal — *Technical Memorandum — SWMU 19 Soil Sampling and Removal Report; NSA Mid-South RCRA Facility Investigation*

TECHNICAL MEMORANDUM

To: Distribution
From: Phil Atkinson, EnSafe Inc.
Re: SWMU 19 VCA Report
NSA Mid-South, Millington, Tennessee
Date: October 20, 2003 (Revision 0)

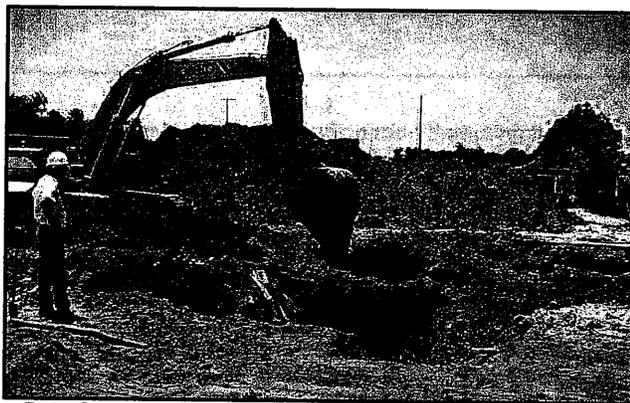
As the excavation continued east beneath the former automotive maintenance garage, two hydraulic lift pits were encountered. The pits, consisting of an approximate 20-gallon hydraulic oil tank and piping housed in a wood enclosure with sand backfill, were removed during the excavation. The sand and wood were stained with petroleum and were placed on the contaminated stockpile. Residual hydraulic oil in the tanks was cleaned with oil absorbent rags, placed into a 55-gallon drum, and properly disposed of on October 16, 2003.

Petroleum-contaminated soil was removed using a track hoe.
