Second Five-Year Review Report

Atlantic Fleet Weapons Training Area – Vieques Vieques, Puerto Rico

December 2023

Prepared for NAVFAC Atlantic by CH2M HILL, Inc. Virginia Beach, Virginia Contract N62470-21-D-0007 CTO N6247021F4140

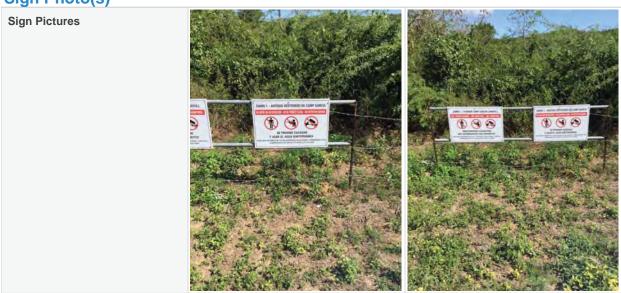
3	<u></u>		
Is Sign Present?	Yes		
Is Pole/Post/Gate/Platform Present?	Yes		
Is Sign Damaged?	No		
If Damaged, Does Sign need to be repaired/replaced?	No		
Is the Post Damaged?	No		
Is Hardware In Place?	Yes		
Is Hardware Causing Damage to Sign?	No		
Additional Notes About this Sign	Sign legible and intact

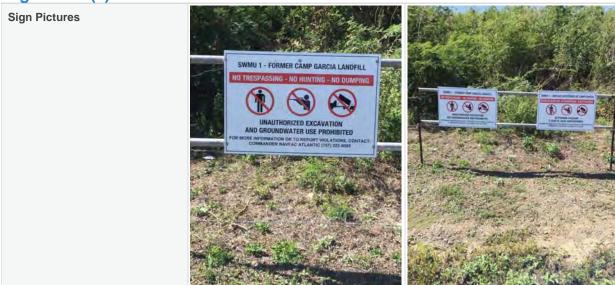
Is Sign Present?	Yes	
Is Pole/Post/Gate/Platform Present?	Yes	
Is Sign Damaged?	No	
If Damaged, Does Sign need to be repaired/replaced?	No	
Is the Post Damaged?	No	
Is Hardware In Place?	Yes	
Is Hardware Causing Damage to Sign?	No	
Additional Notes About this Sign	Sign legible and intact

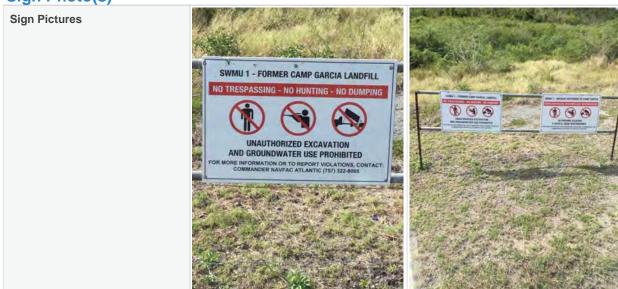
Is Sign Present?	Yes	
Is Pole/Post/Gate/Platform Present?	Yes	
Is Sign Damaged?	No	
If Damaged, Does Sign need to be repaired/replaced?	No	
Is the Post Damaged?	No	
Is Hardware In Place?	Yes	
Is Hardware Causing Damage to Sign?	No	
Additional Notes About this Sign	Sign legible and intact

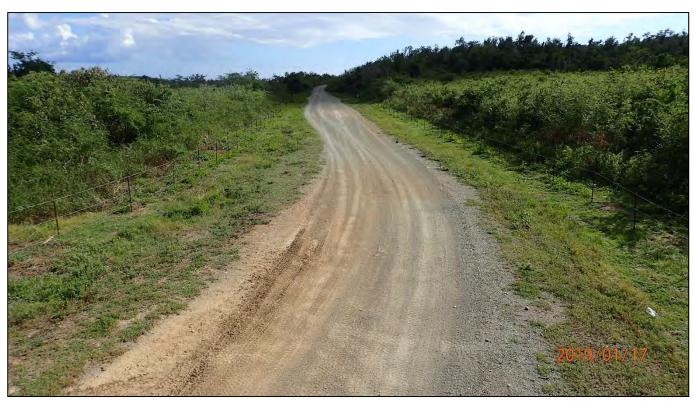
Fence facing south (1/17/2019)

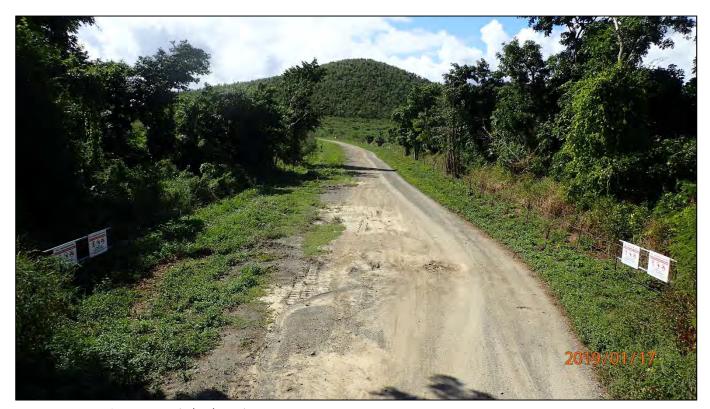
Fence and signs facing west (1/17/2019)

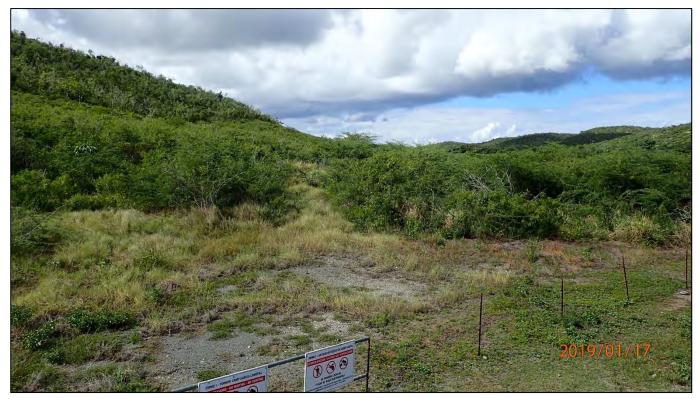
Historical road overgrown facing north (1/17/2019)

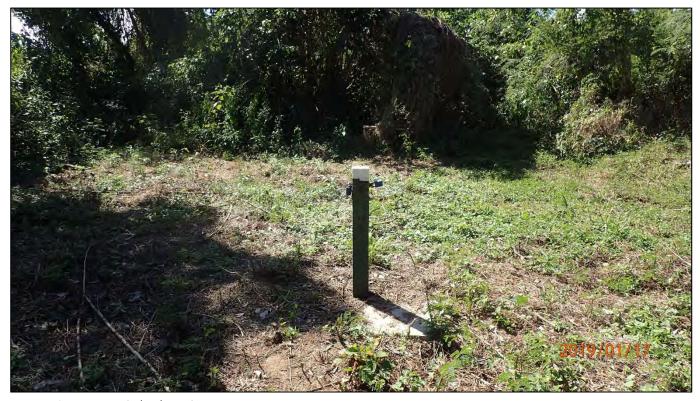
MW-02 facing west (1/17/2019)

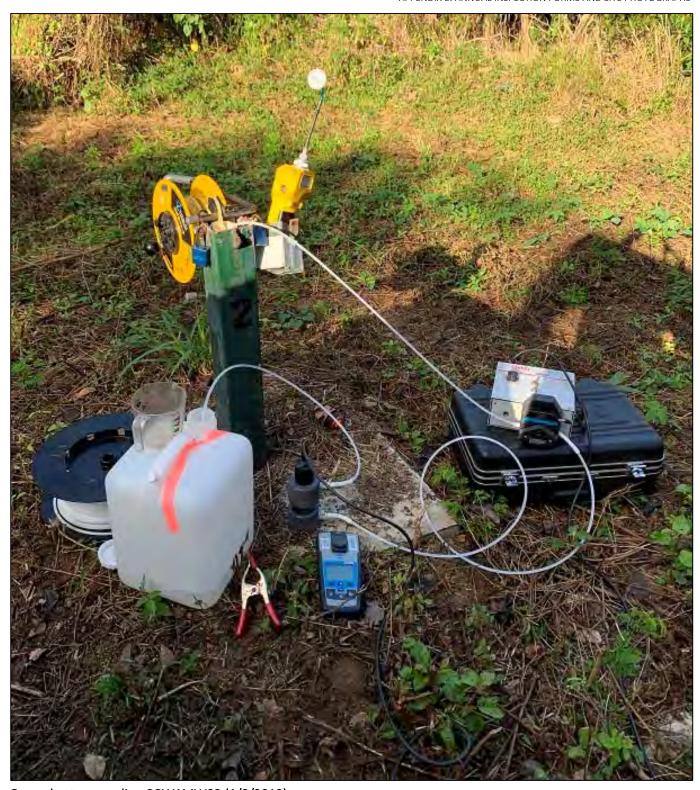
Groundwater sampling CGW1MW02 (1/8/2019)

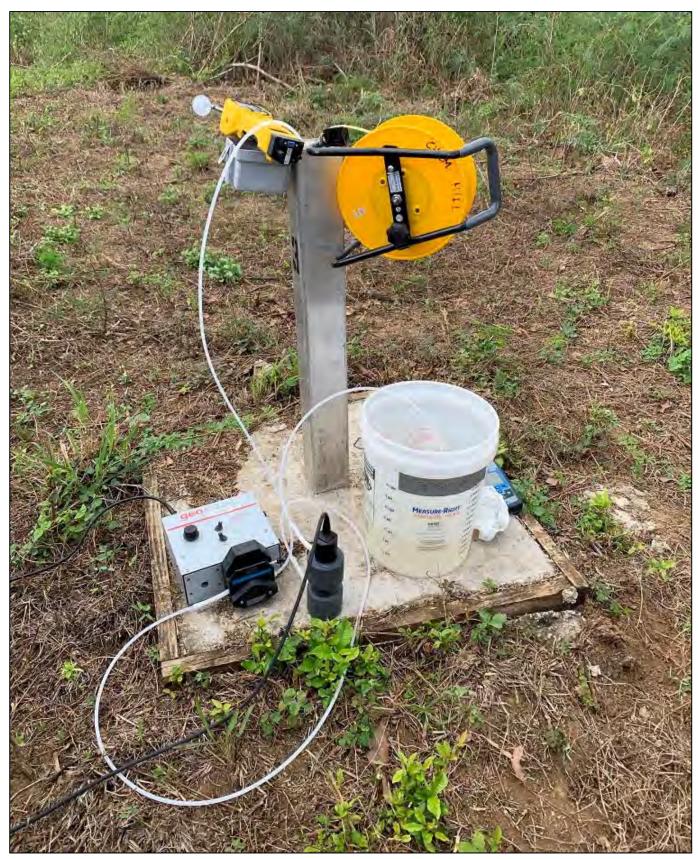
Groundwater sampling CGW1MW03 (1/7/2019)

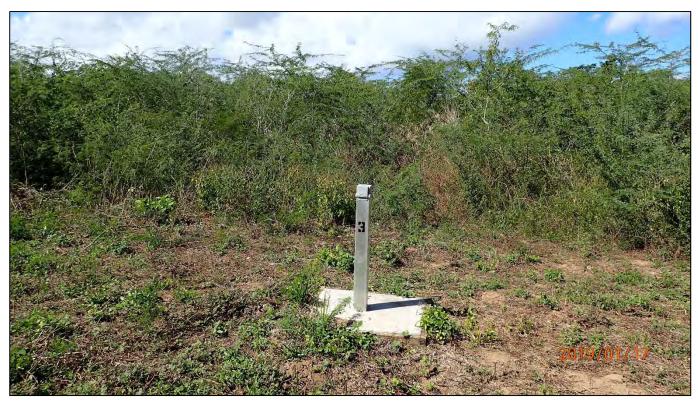
MW-03 facing north (1/17/2019)

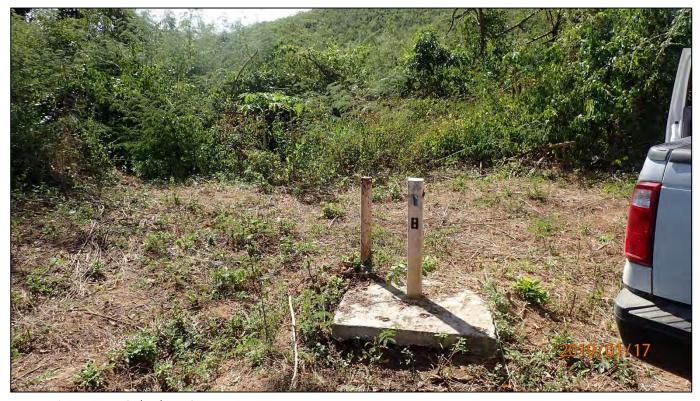
MW-08 facing west (1/17/2019)

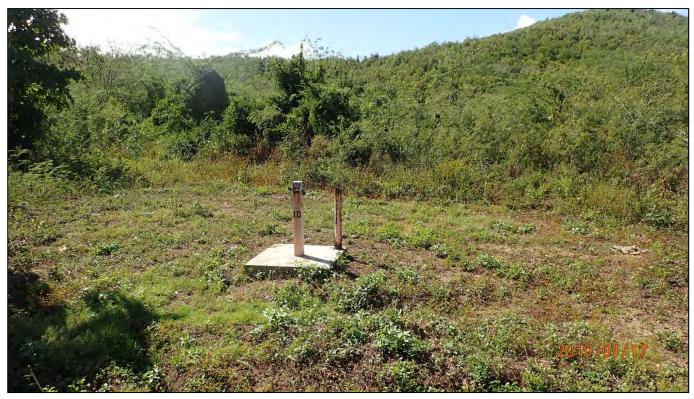
MW-10 facing west (1/17/2019)

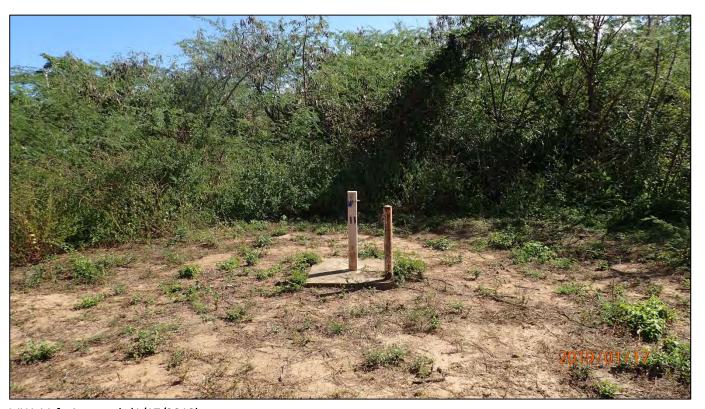
MW-11 facing south (1/17/2019)

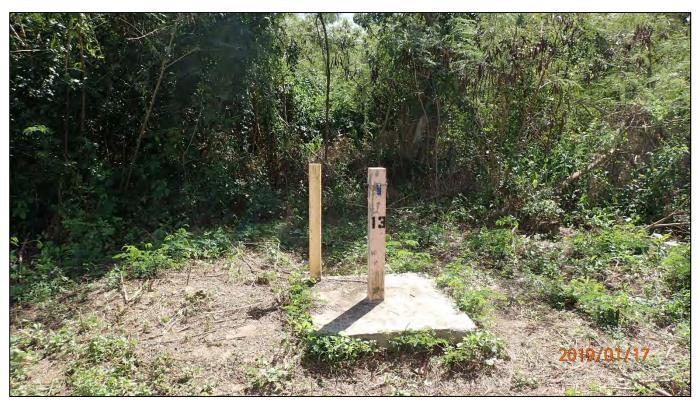
MW-13 facing west (1/17/2019)

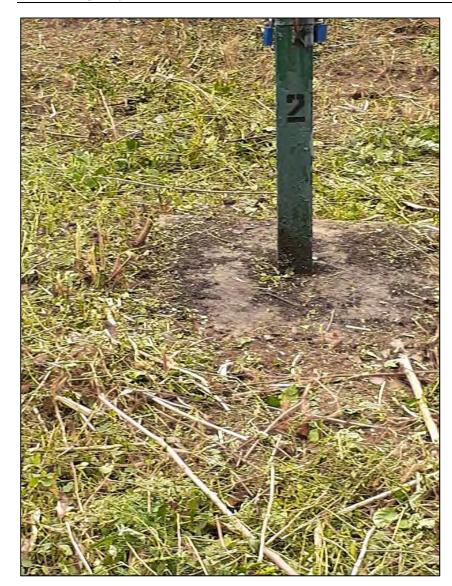
Photograph 1. SWMU 1 MW-02 with locked cap. (12/30/2019)

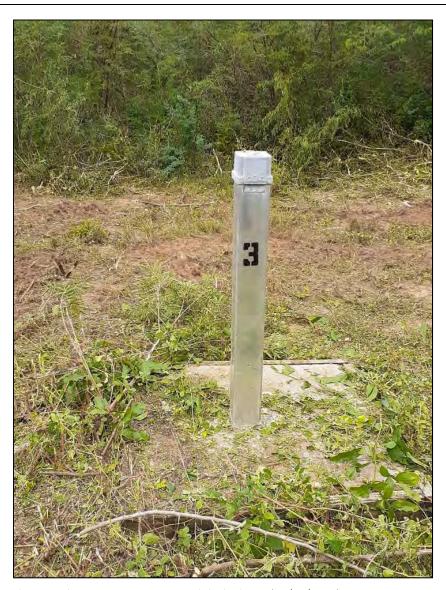
Photograph 2. SWMU 1 MW-03 with locked cap. (12/30/2019)

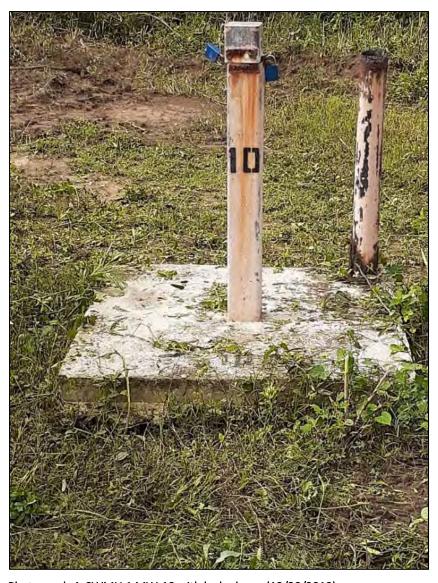
Photograph 4. SWMU 1 MW-10 with locked cap. (12/30/2019)

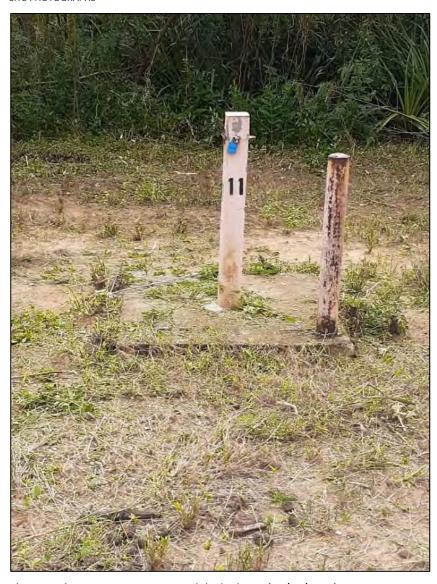
Photograph 5. SWMU 1 MW-11 with locked cap. (12/30/2019)

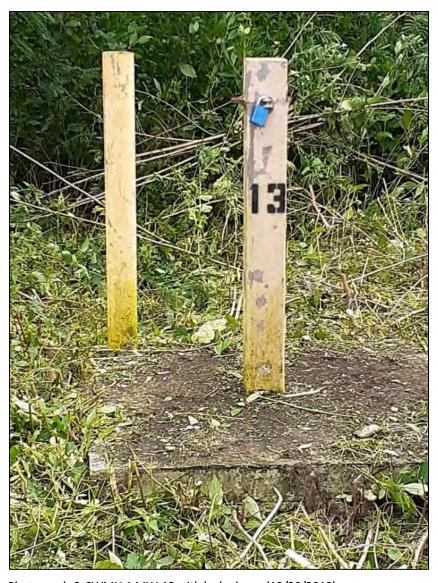
Photograph 6. SWMU 1 MW-13 with locked cap. (12/30/2019)

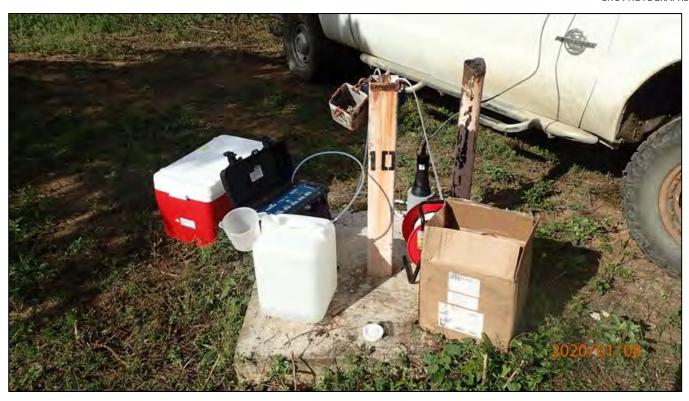
Photograph 7. Sampling equipment set up at SWMU 1 MW-10. (01/08/2020)

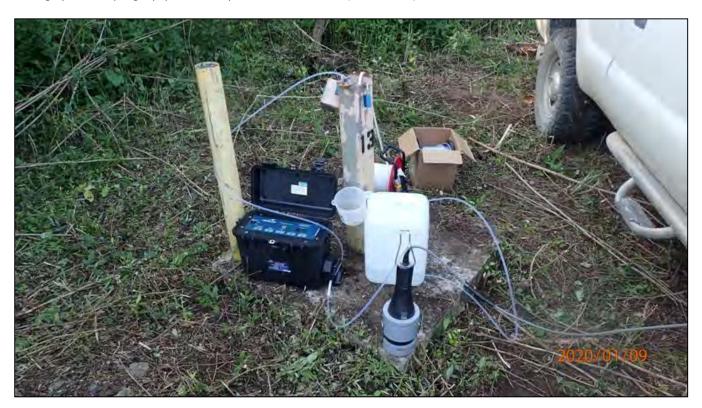
Photograph 8. Sampling equipment set up at SWMU 1 MW-13. (01/09/2020)

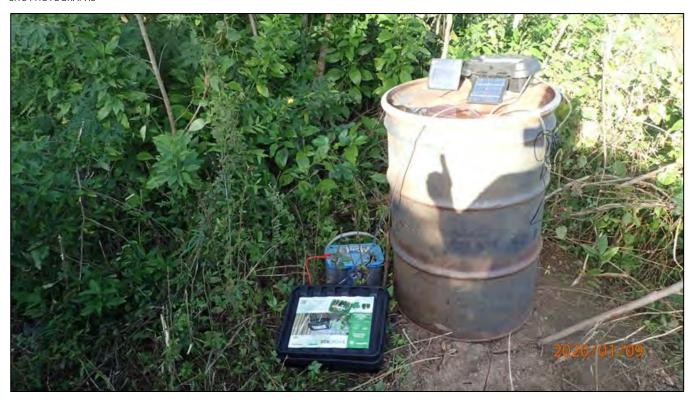
Photograph 9. Purge water 3 air pump system. (01/09/2020)

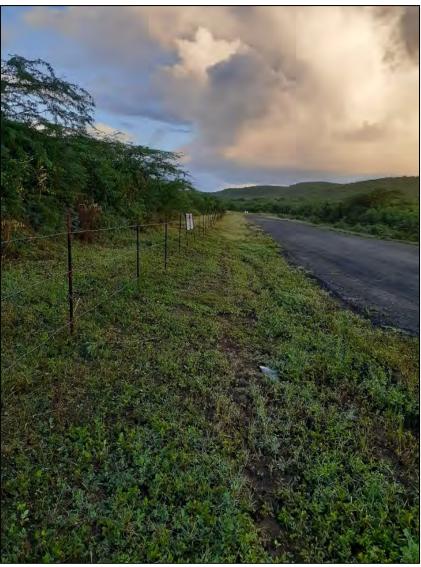
Photograph 15. SWMU 1 fence facing north. (12/30/2019)

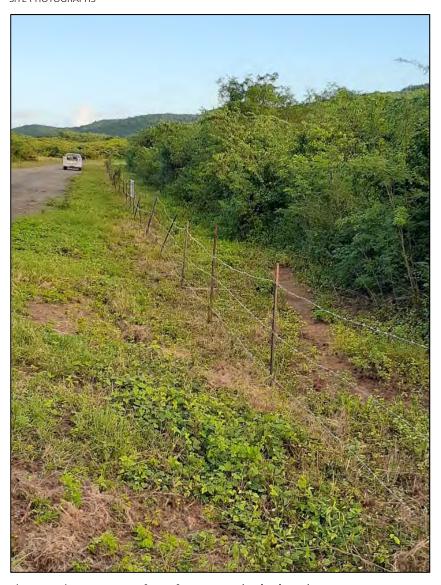
Photograph 16. SWMU 1 fence facing west. (12/30/2019)

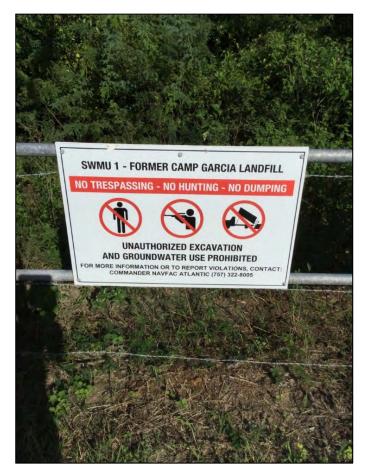
SWMU1-1a (English)

Photograph 1. SWMU 1 Sign 1a (12/6/2019)

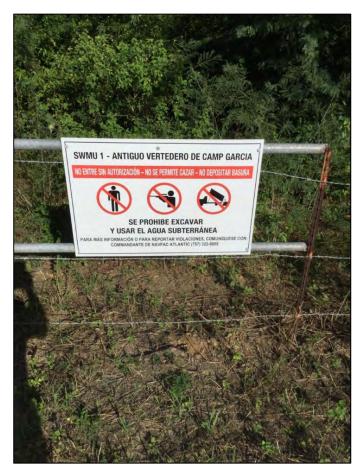
SWMU1-1b (Spanish)

Photograph 2. SWMU 1 Sign 1b (12/6/2019)

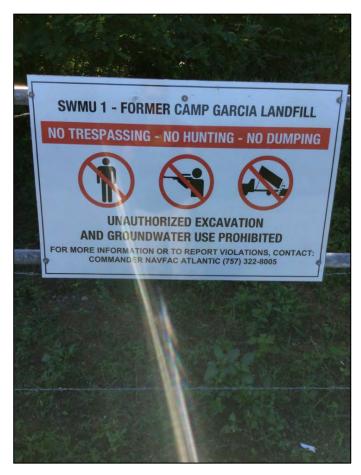
SWMU1-2a (English)

Photograph 3. SWMU 1 Sign 2a (12/6/2019)

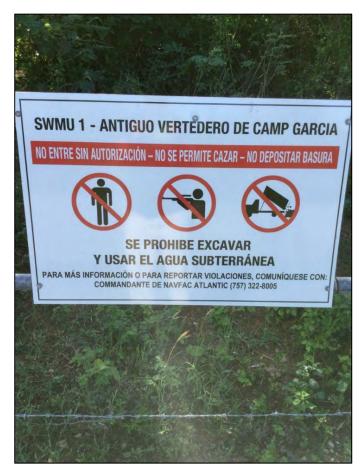
SWMU1-2b (Spanish)

Photograph 4. SWMU 1 Sign 2b (12/6/2019)

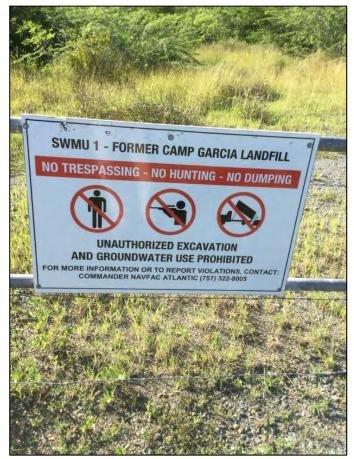
SWMU1-3a (English)

Photograph 5. SWMU 1 Sign 3a (12/6/2019)

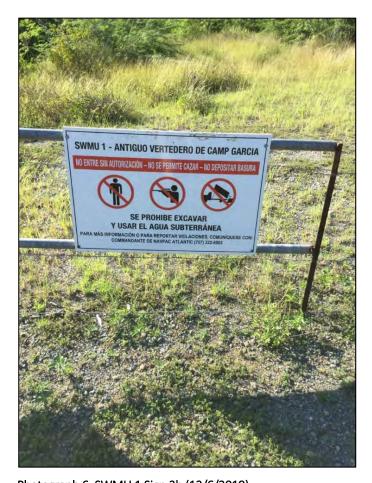
SWMU1-3b (Spanish)

Photograph 6. SWMU 1 Sign 3b (12/6/2019)

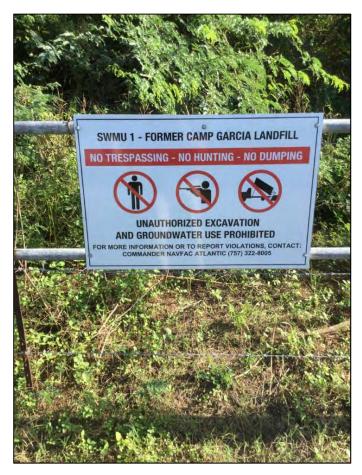
SWMU1-4a (English)

Photograph 7. SWMU 1 Sign 4a (12/6/2019)

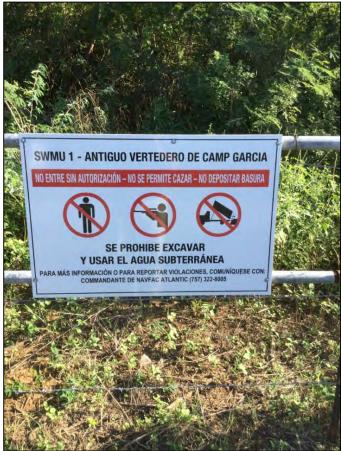
SWMU1-4b (Spanish)

Photograph 8. SWMU 1 Sign 4b (12/6/2019)

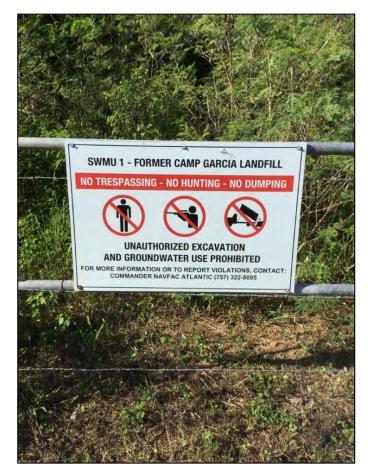
SWMU1-5a (English)

Photograph 9. SWMU 1 Sign 5a (12/6/2019)

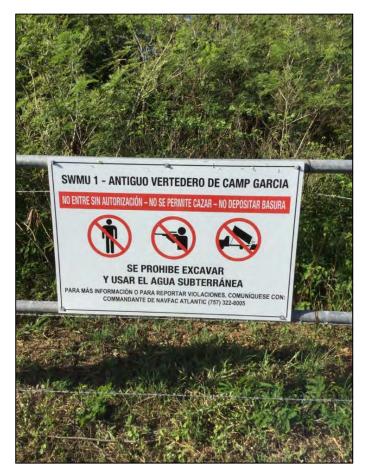
SWMU1-5b (Spanish)

Photograph 10. SWMU 1 Sign 5b (12/6/2019)

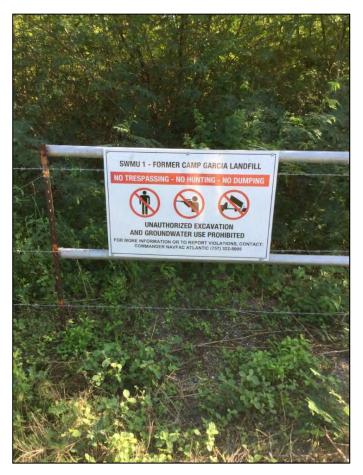
SWMU1-6a (English)

Photograph 11. SWMU 1 Sign 6a (12/6/2019)

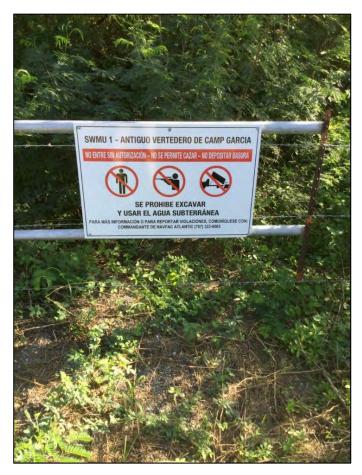
SWMU1-6b (Spanish)

Photograph 12. SWMU 1 Sign 6b (12/6/2019)

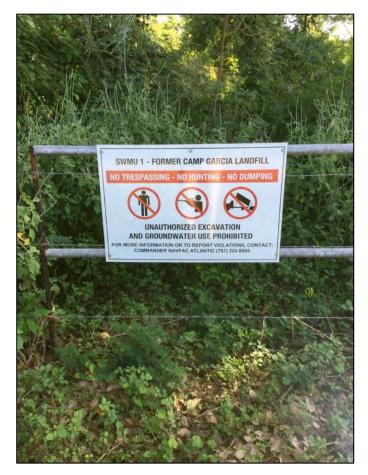
SWMU1-7a (English)

Photograph 13. SWMU 1 Sign 7a (12/6/2019)

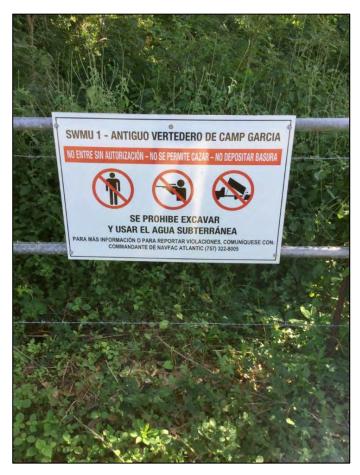
SWMU1-7b (Spanish)

Photograph 14. SWMU 1 Sign 7b (12/6/2019)

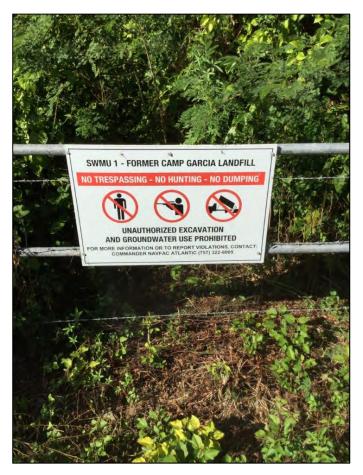
SWMU1-8a (English)

Photograph 15. SWMU 1 Sign 8a (12/6/2019)

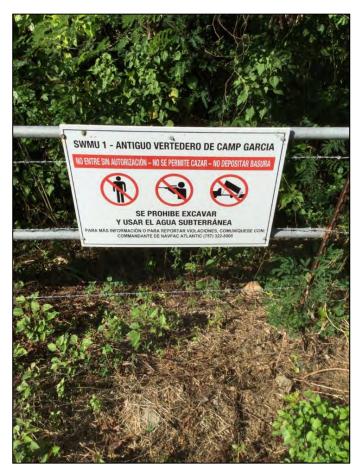
SWMU1-8b (Spanish)

Photograph 16. SWMU 1 Sign 8b (12/6/2019)

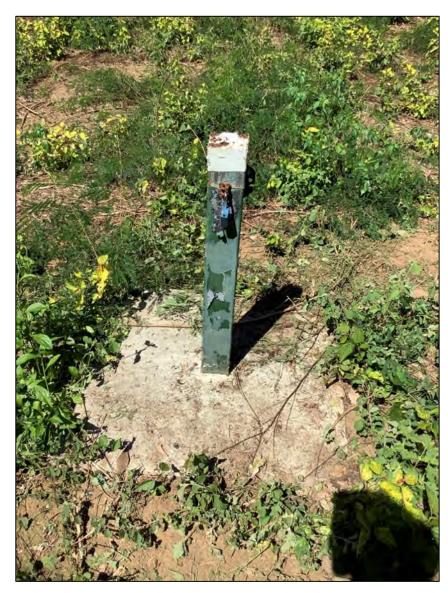
Photograph 1. MW-02 protective casing and concrete pad. Photograph taken on January 28, 2021.

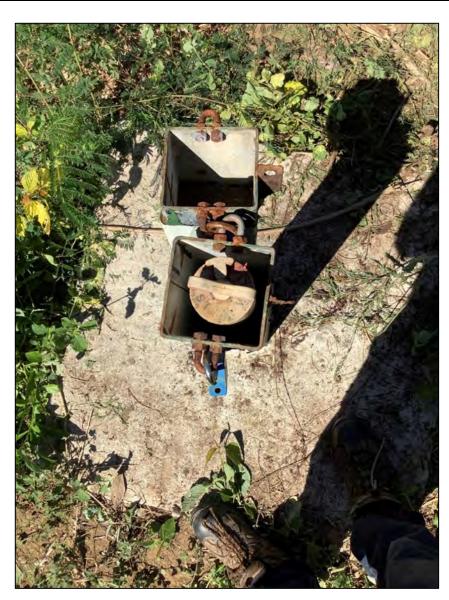
Photograph 2. MW-02 well and cap condition. Photograph taken on January 28, 2021.

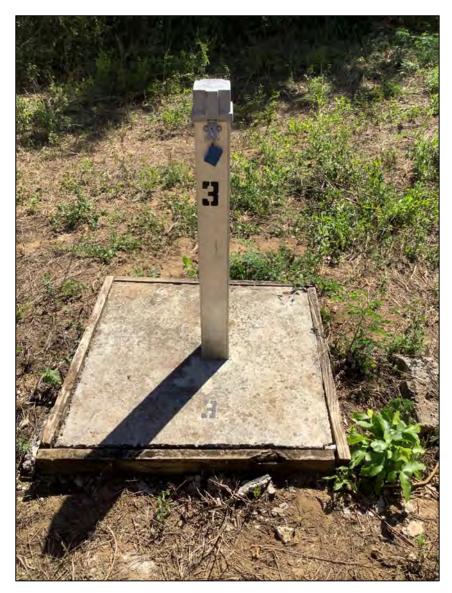
Photograph 3. MW-03 protective casing and well pad. Photograph taken on January 28, 2021.

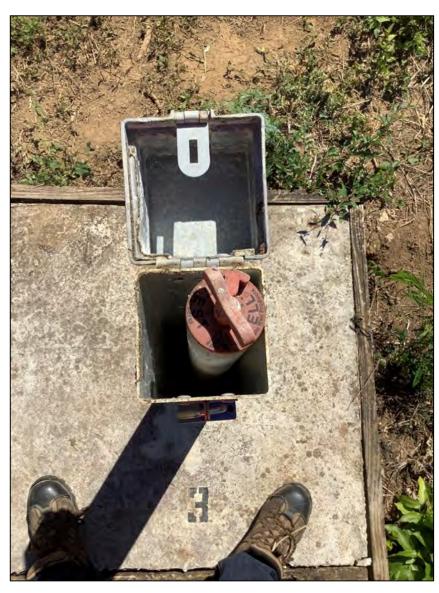
Photograph 4. MW-03 well and cap condition. Photograph taken on January 28, 2021.

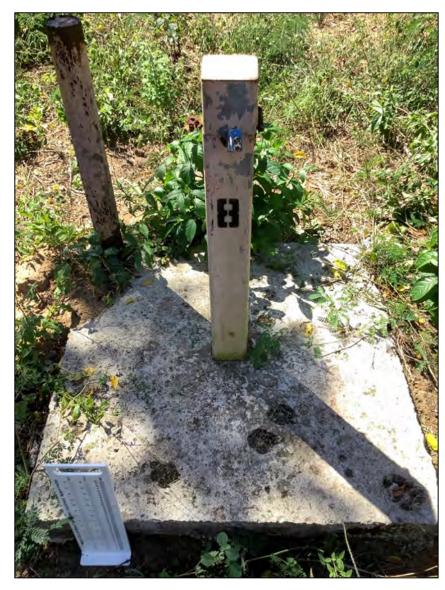
Photograph 5. MW-08 protective casing and well pad. Photograph taken on January 28, 2021.

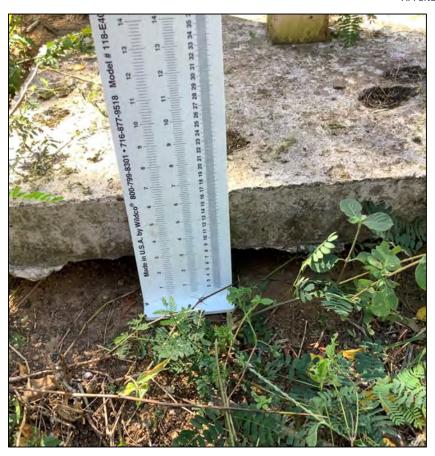
Erosion	Exposed debris; visible runoff patterns such as channels or gullies	NE facing side of MW-08 concrete pad has a 4-inch gap space from existing grade. Potential reptile den in space.	х		Add gravel or fill to block animal use of underside of MW-08 well pad.	5/27/2021
Other Observations		One black, rubber tire (no metal rim noted) approximately 65-inch outer diameter, observed lying flat on east side of cleared path leading to MW-08. Additionally, one empty metal container located in vegetation observed lying on the east side of cleared path leading to MW-08.	х		Remove debris along access path.	3/4/21 (metal container) and 3/5/2021 (rubber tire)

Photograph 7. MW-08 approximately 4-inch gap underneath concrete pad on northeast corner. Photograph taken on January 28, 2021.

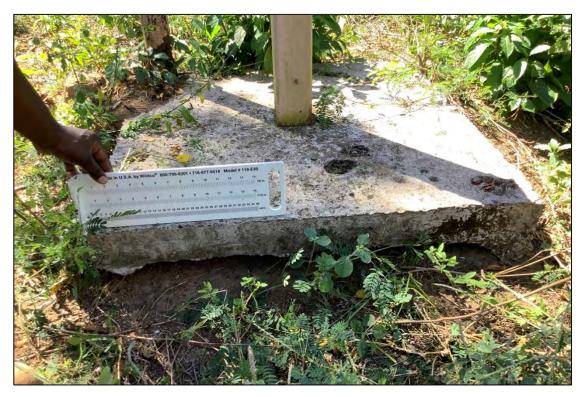
Photograph 8. MW-08 concrete pad showing potential animal burrow area below pad. Photograph taken on January 28, 2021.

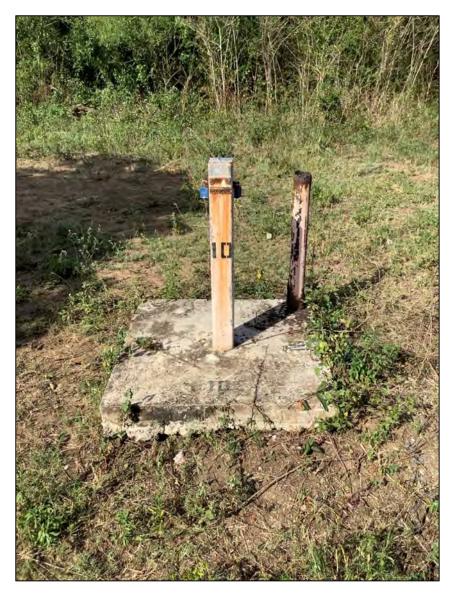
Photograph 10. MW-10 protective casing and well pad. Photograph taken on January 28, 2021.

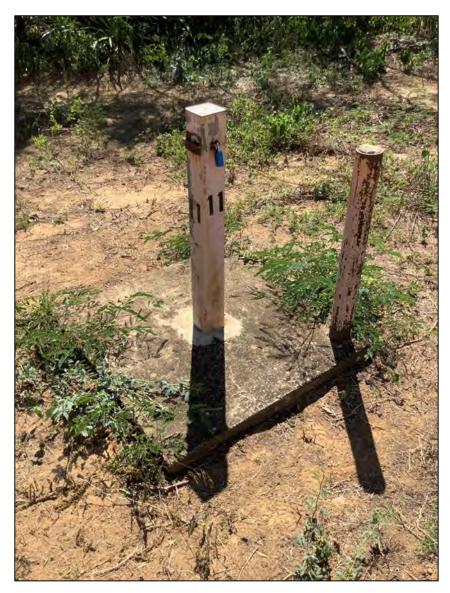
Photograph 12. MW-11 protective casing and well pad. Photograph taken on January 28, 2021.

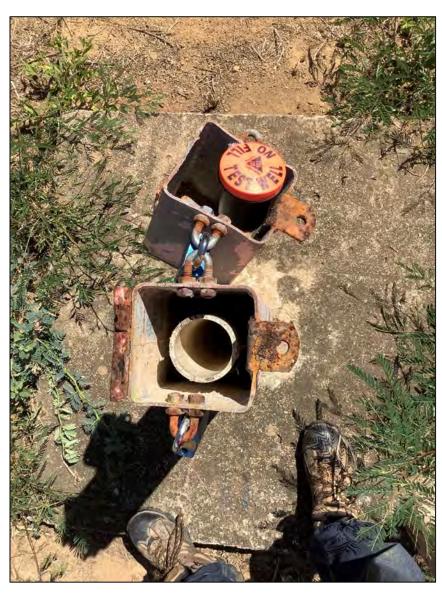
Photograph 13. MW-11 well and cap condition. Photograph taken on January 28, 2021.

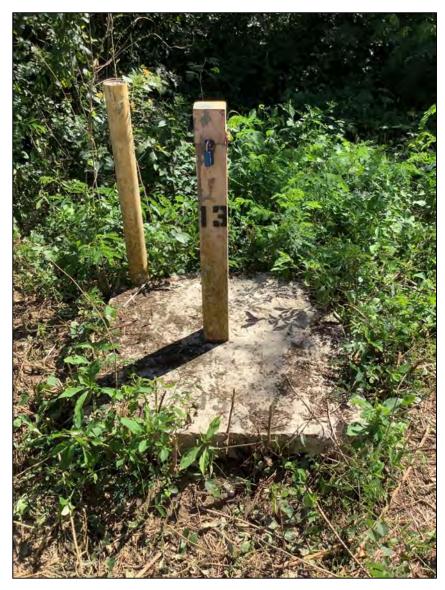
Photograph 14. MW-13 protective casing and well pad. Photograph taken on January 28, 2021.

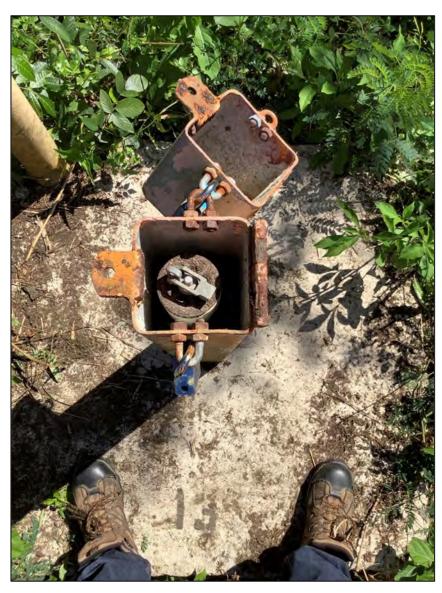
Photograph 15. MW-13 well and cap condition. Photograph taken on January 28, 2021.

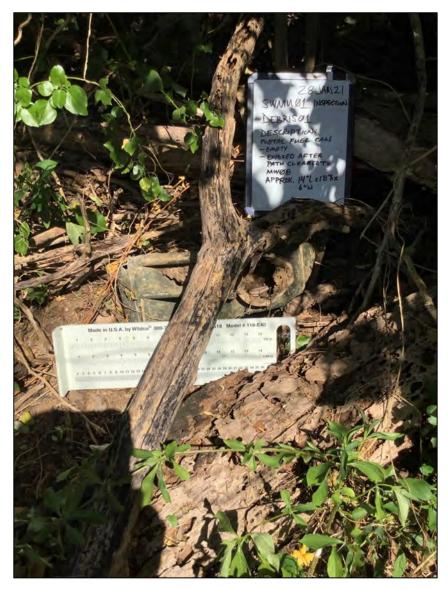
Photograph 16. Debris 1- metal container, facing north along path to MW-08. Photograph taken on January 28, 2021.

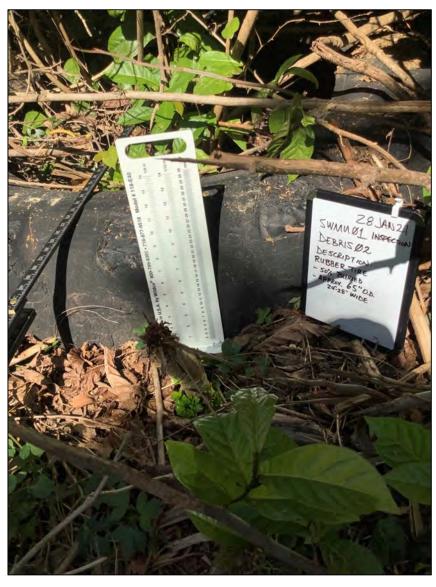
Photograph 17. Debris 2 – rubber tire, facing north along path to MW-08. Photograph taken on January 28, 2021.

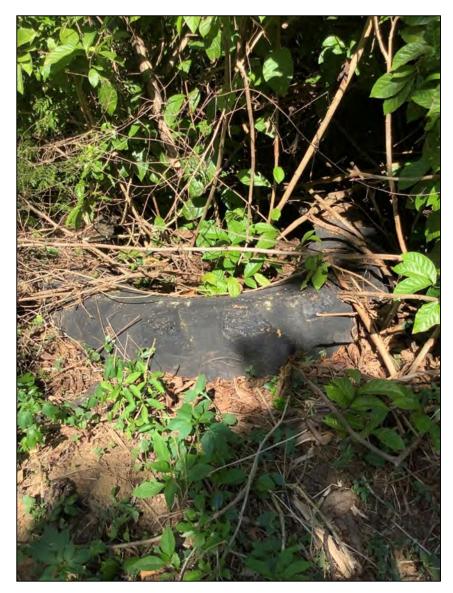
Photograph 18. Debris 2 – rubber tire, facing north along path to MW-08. Photograph taken on January 28, 2021.

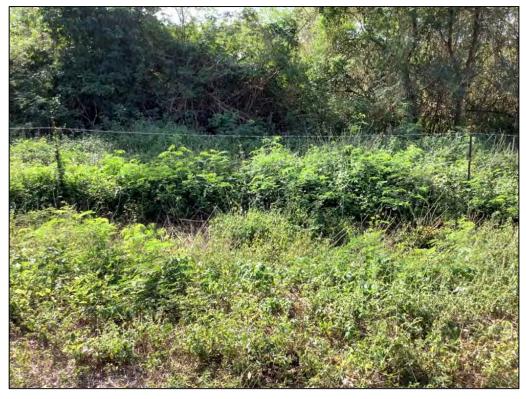
Photograph 24. SWMU 1 missing fence post #2. Photograph taken on January 28, 2021.

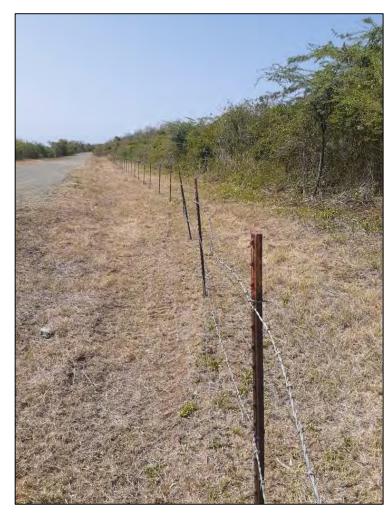
Photograph 28. Vegetation cleared around fences and fence posts repaired on May 24, 2021.

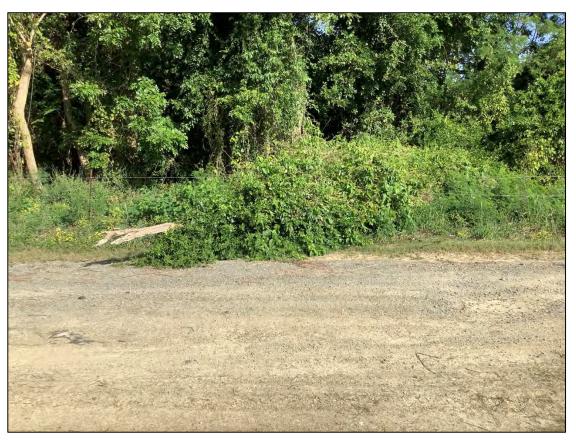
Photograph 30. Same small tree down along north side of access road with dense overgrowth, facing north.

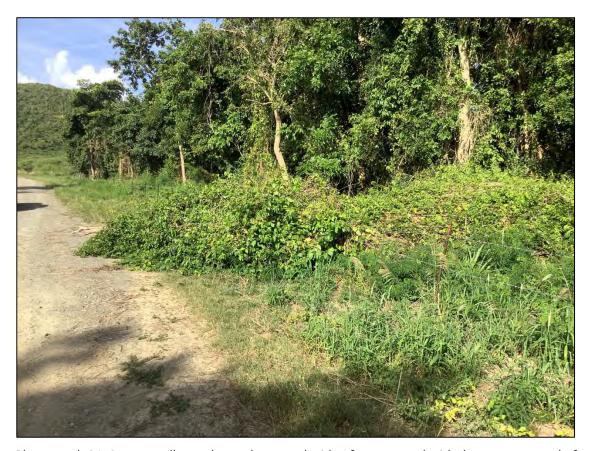
Photograph 31. Same small tree down along north side of access road with dense overgrowth, facing northwest.

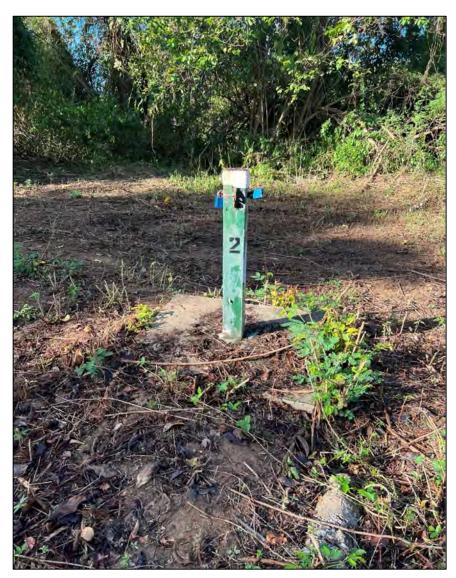
Photograph 1. MW-02 protective casing and concrete pad. Photograph taken on January 20, 2022.

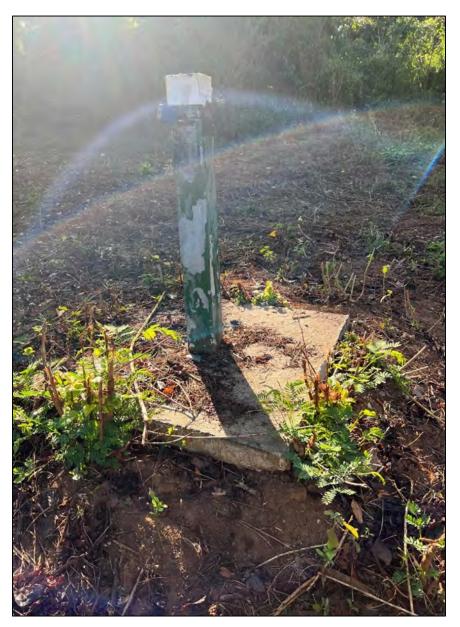
Photograph 3. MW-02 Protective casing and well pad. Photograph taken on January 20, 2022.

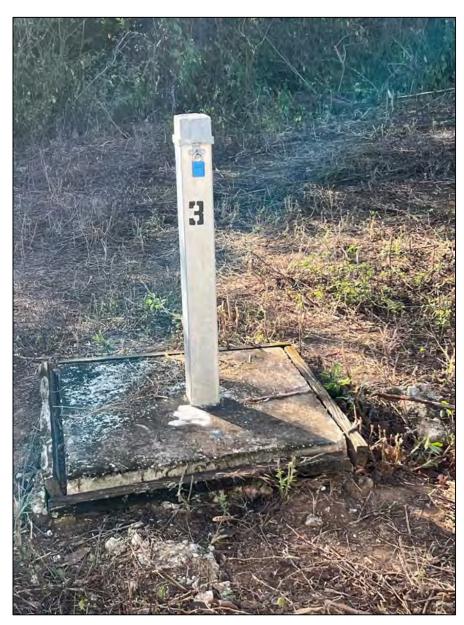
Photograph 4. MW-03 Protective casing and well pad. Photograph taken on January 20, 2022.

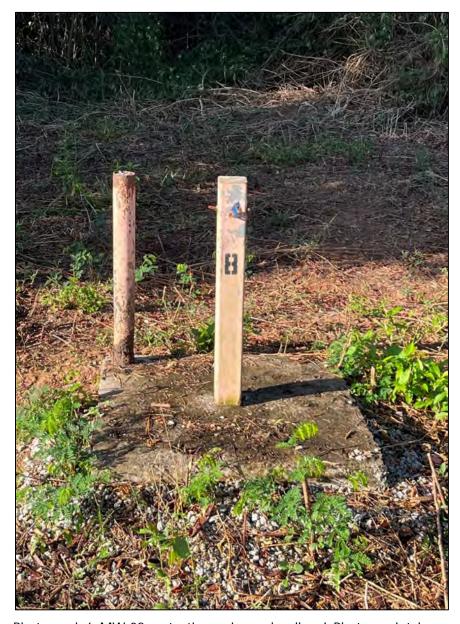
Photograph 6. MW-08 protective casing and well pad. Photograph taken on January 20, 2022.

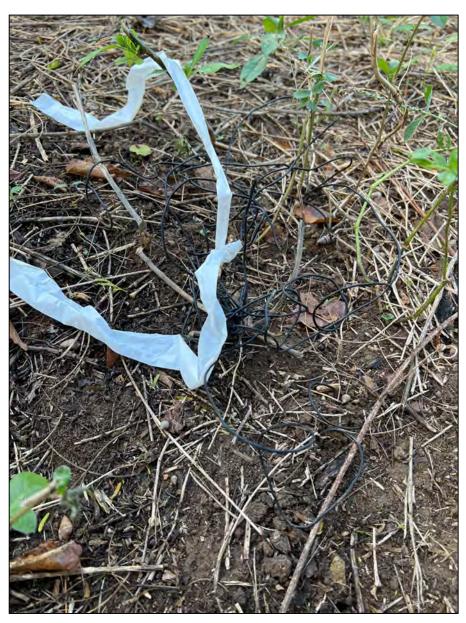
Photograph 7. Exposed com wire on the path to MW-08, approximately 50 feet from the edge of the road. Photograph taken on January 20, 2022.

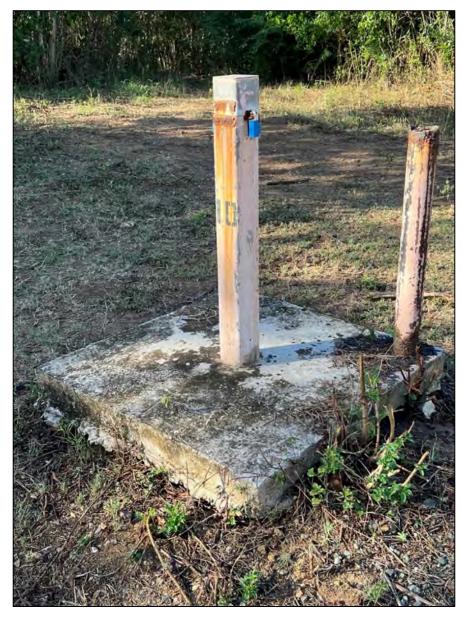
Photograph 8. MW-10 protective casing and well pad. Photograph taken on January 20, 2022.

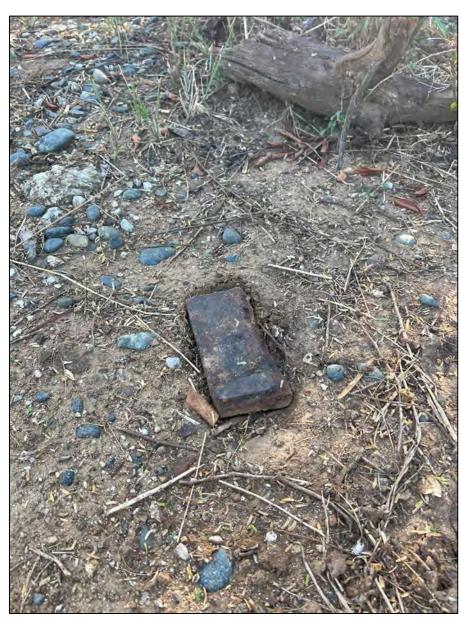
Photograph 9. Surface metal debris 30 feet northeast of MW-10. Photograph taken on January 20, 2022.

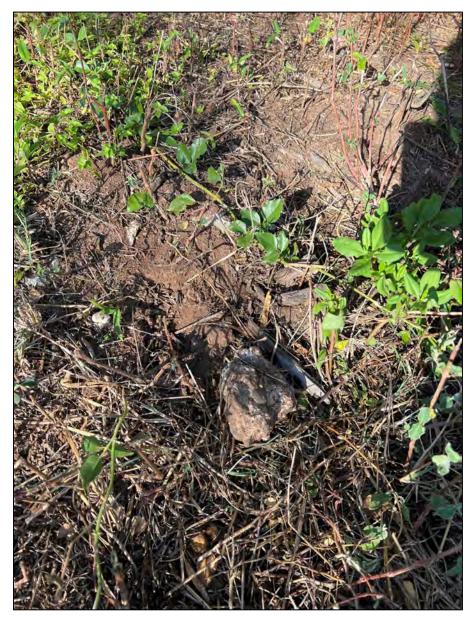
Photograph 10. Concrete debris 90 feet northeast of MW-10. Photograph taken on January 20, 2022.

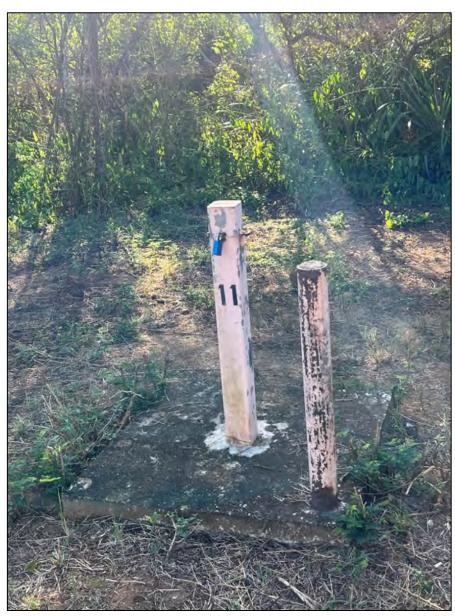
Photograph 11. MW-11 protective casing and well pad. Photograph taken on January 20, 2022.

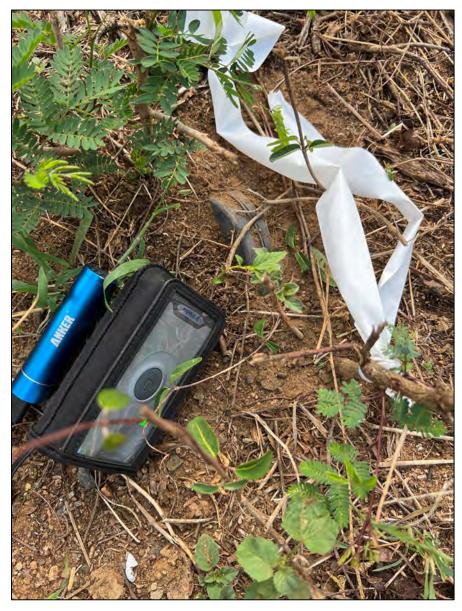
Photograph 12. Exposed plastic debris 50 feet north of MW-11. Photograph taken on January 20, 2022.

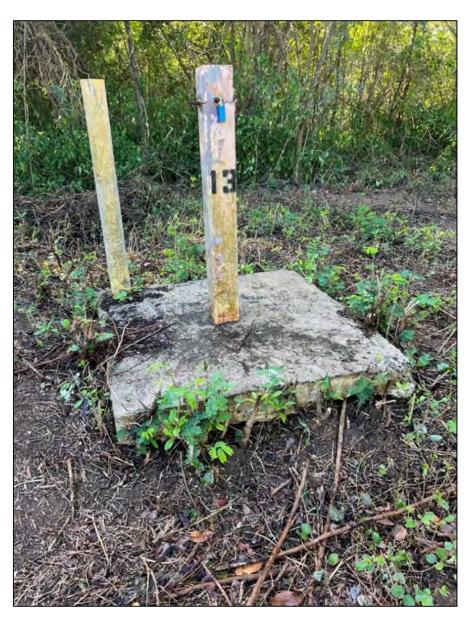
Photograph 13. MW-13 protective casing and well pad. Photograph taken on January 20, 2022.

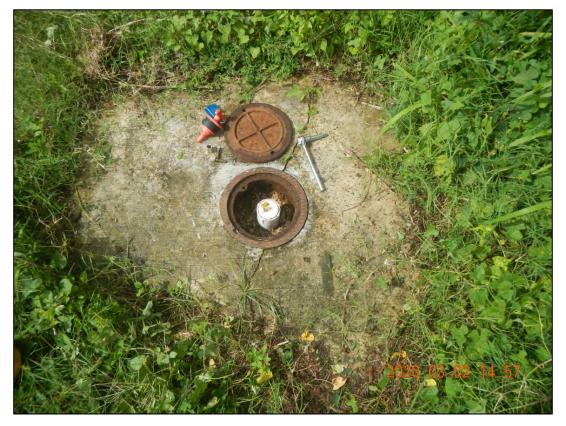
Figure 18. MW-01 capped following in situ chemical oxidation (ISCO) injections.

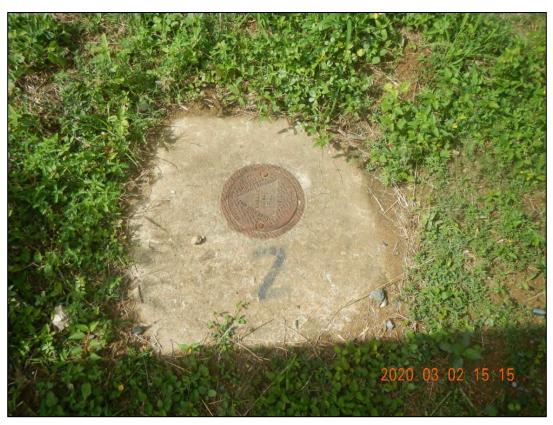
Figure 19. MW-02 pad and well cover condition.

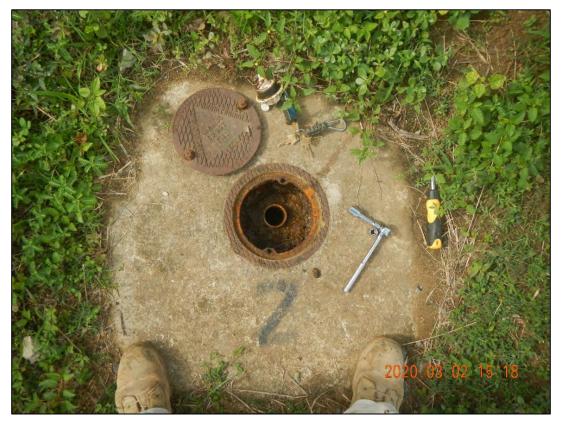
Figure 20. MW-02 well and cap condition.

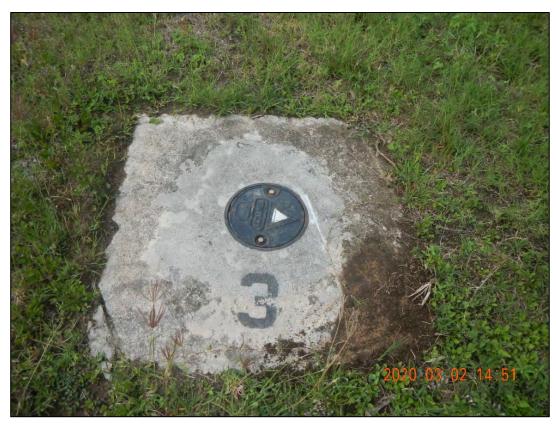
Figure 21. MW-03 pad and well cover condition.

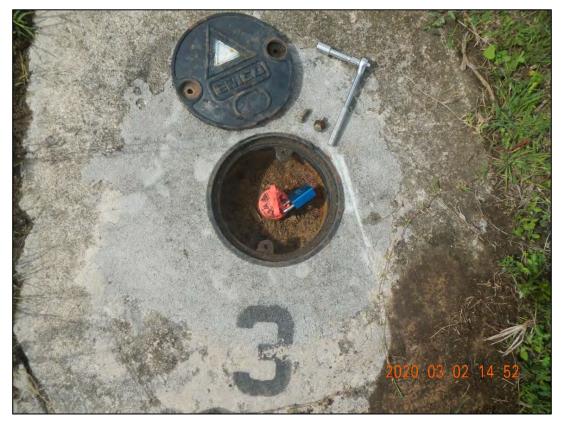
Figure 22. MW-03 well and cap condition.

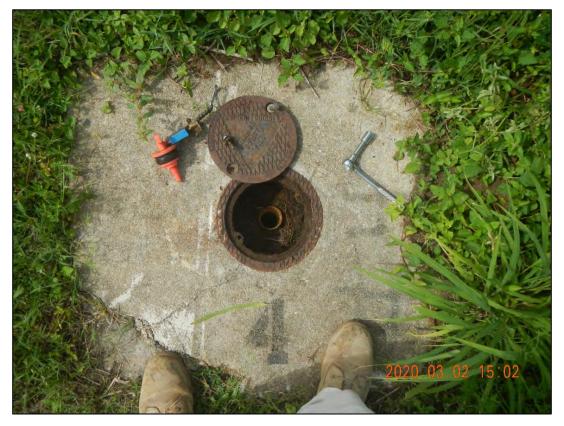
Figure 24. MW-04 well and cap condition.

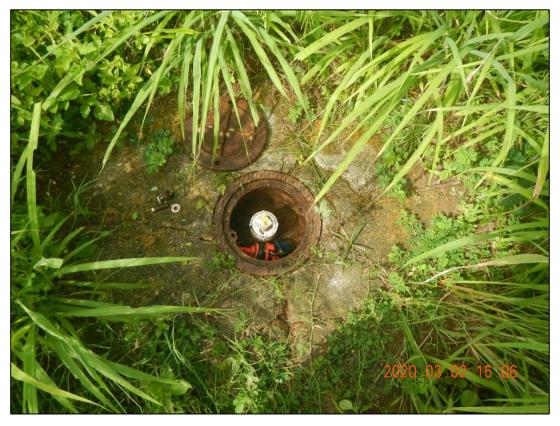
Figure 26. MW-05 capped following ISCO injections.

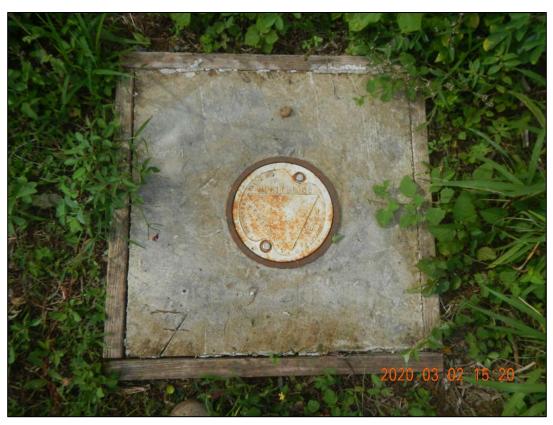
Figure 27. MW-07 pad and well cover condition.

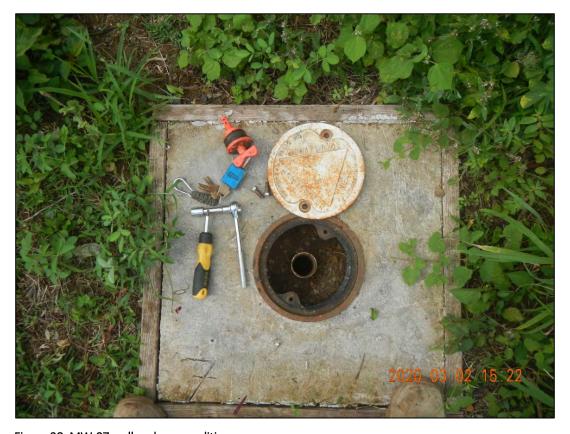
Figure 28. MW-07 well and cap condition.

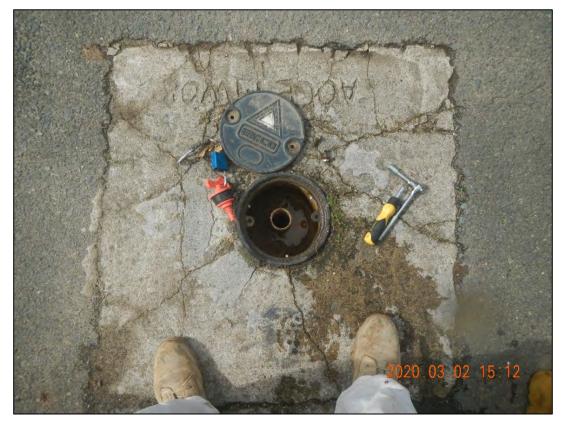
Figure 30. MW-08 well and cap condition.

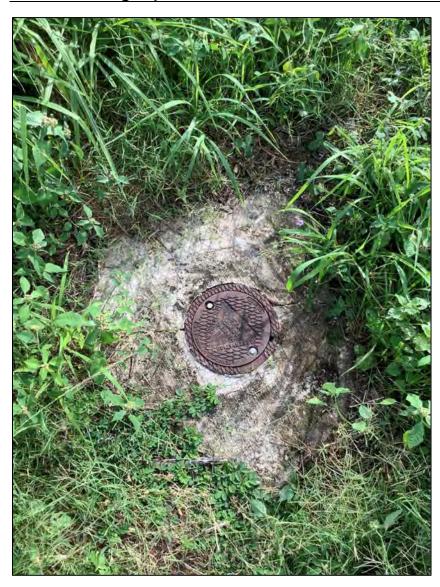
Photograph 1. MW-01 concrete pad and well cover condition on 2/1/2021.

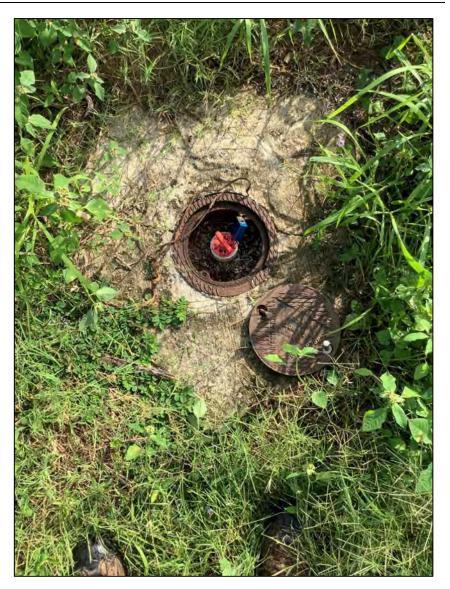
Photograph 2. MW-01 well and cap condition on 2/1/2021.

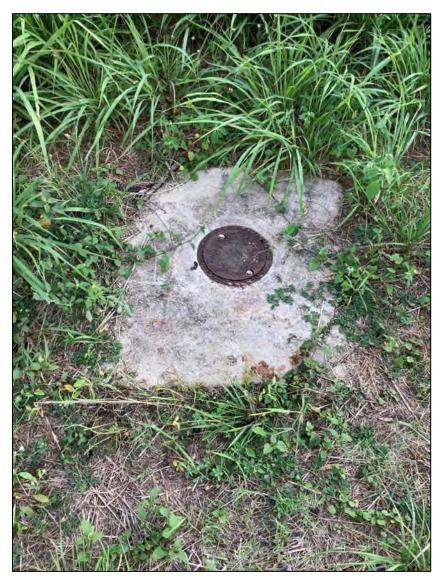
Photograph 3. MW-04 concrete pad and well cover condition on 2/1/2021.

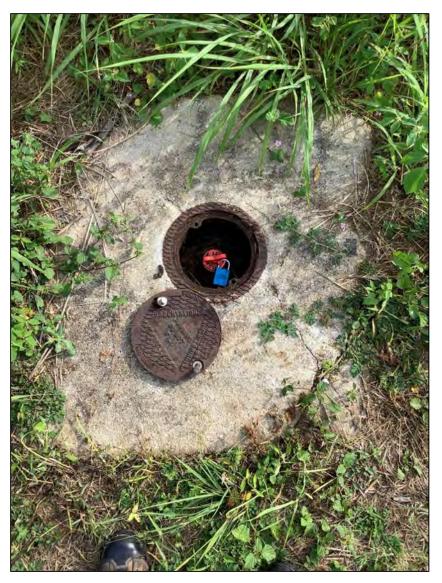
Photograph 4. MW-04 well and cap condition on 2/1/2021.
