Second Five-Year Review Report

Atlantic Fleet Weapons Training Area – Vieques Vieques, Puerto Rico

December 2023

Prepared for NAVFAC Atlantic by CH2M HILL, Inc. Virginia Beach, Virginia Contract N62470-21-D-0007 CTO N6247021F4140

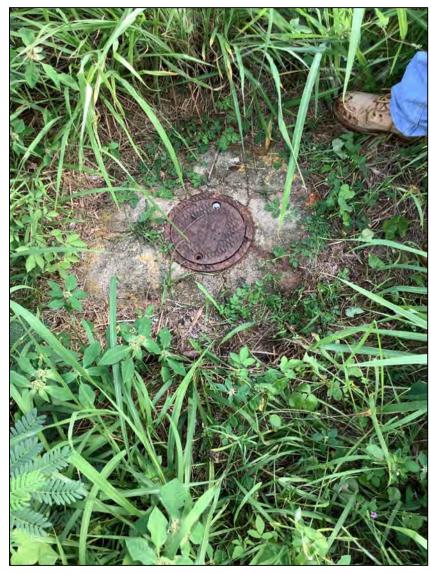
Photograph 5. MW-05 concrete pad and well cover condition on 2/1/2021.

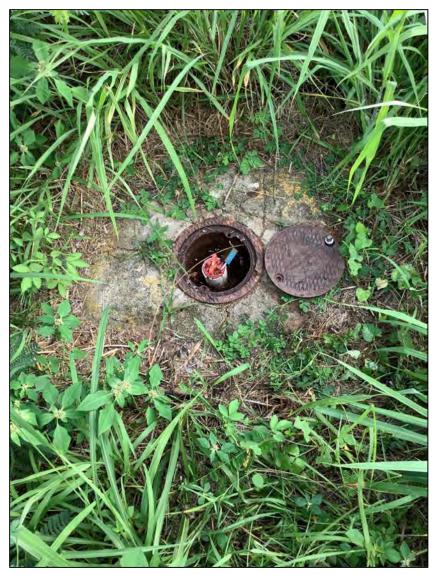
Photograph 6. MW-05 well and cap condition on 2/1/2021.

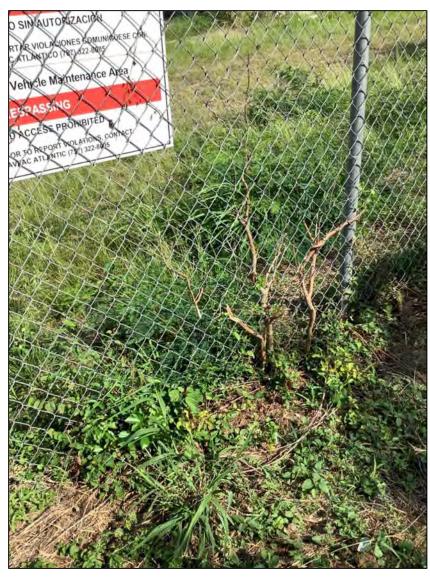
Photograph 8. Same small tree along west fence line facing east on 2/1/2021.

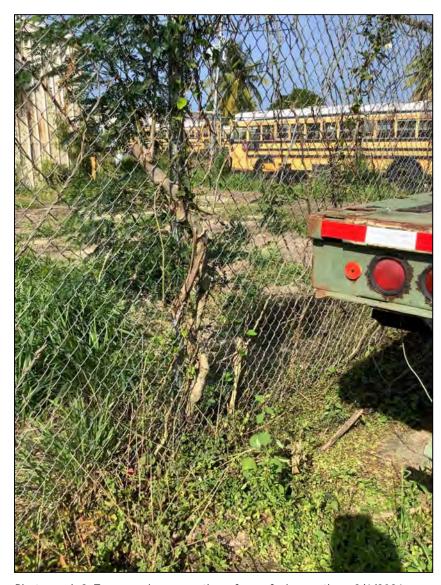
Photograph 9. Tree growing on southern fence, facing north on 2/1/2021.

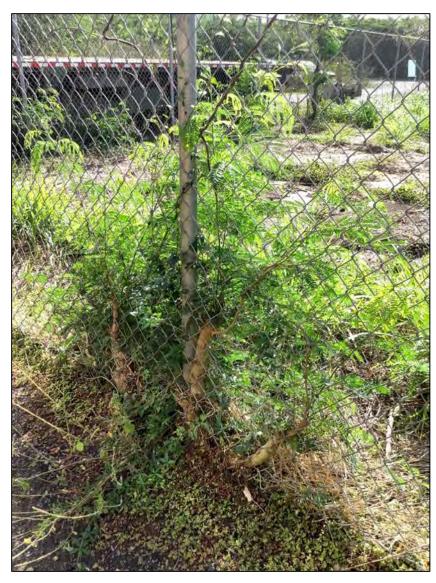
Photograph 10. Tree growing along eastern fence, facing southwest on 2/1/2021.

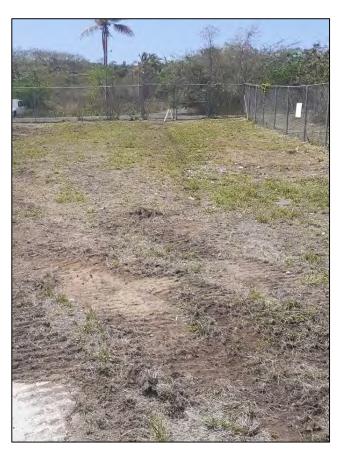
Photograph 11. Vegetation cleared on 5/25/2021. Facing south along western fence line.

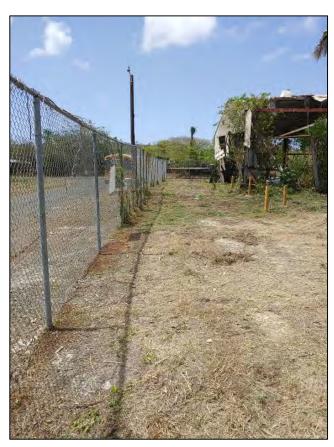
Photograph 12. Vegetation cleared on 5/25/2021. Facing south along eastern fence line. FES0513210908VBO

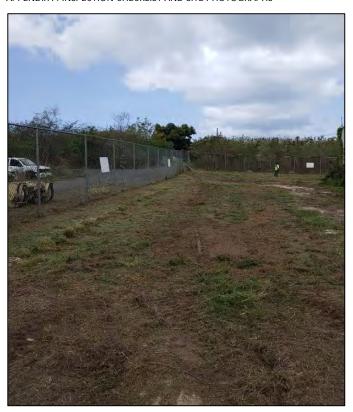
Photograph 13. Vegetation cleared on 5/25/2021. Facing west along southern fence line.

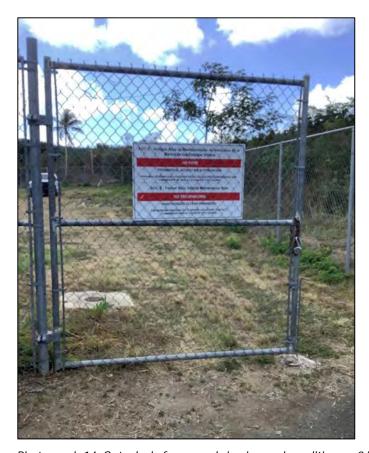
Photograph 14. Gate, lock, fence, and sign in good condition on 2/1/2021. Looking south at main gate in northwest corner of site.

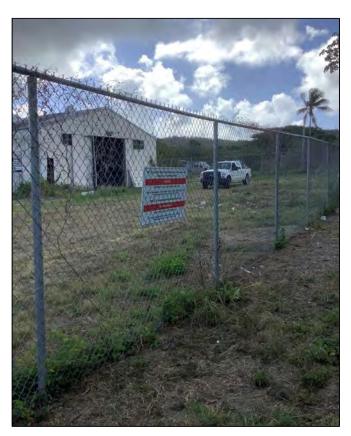
Photograph 15. Fence and sign in good condition on 2/1/2021. Looking south along western most fence.

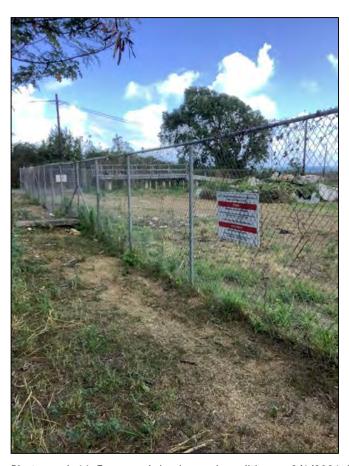
Photograph 16. Fence and sign in good condition on 2/1/2021. Looking north along western most fence.

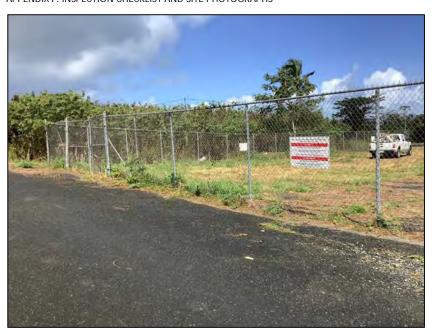
Photograph 17. Fence and sign in good condition on 2/1/2021. Looking northwest at southern fence line.

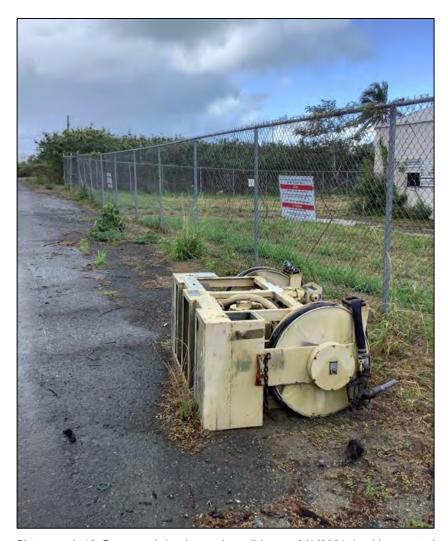
Photograph 18. Fence and sign in good condition on 2/1/2021. Looking west along south fence line.

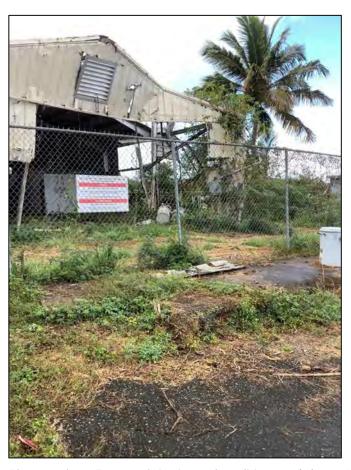
Photograph 19. Fence and sign in good condition on 2/1/2021. Looking northwest at eastern most fence.

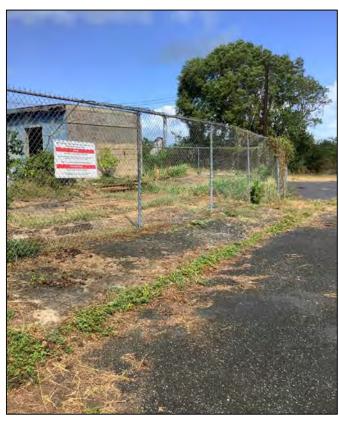
Photograph 20. Fence and sign in good condition on 2/1/2021. Looking north along eastern most fence. FES0513210908VBO

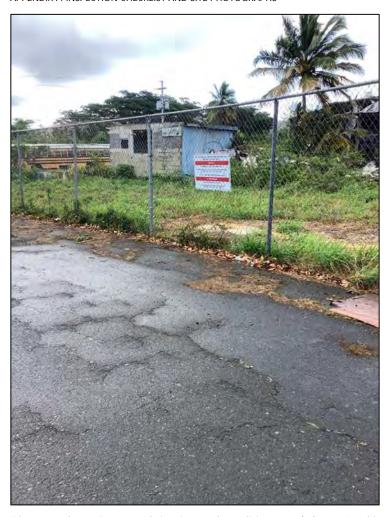
Photograph 21. Fence and sign in good condition on 2/1/2021. Looking southeast along northern most fence.

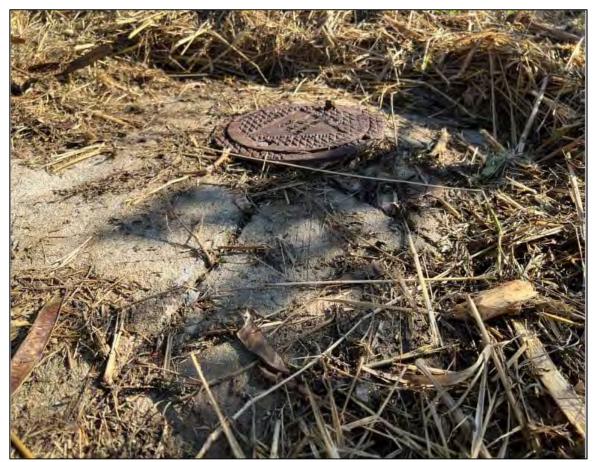
Photograph 2. MW-06 surface condition on 1/14/2022.

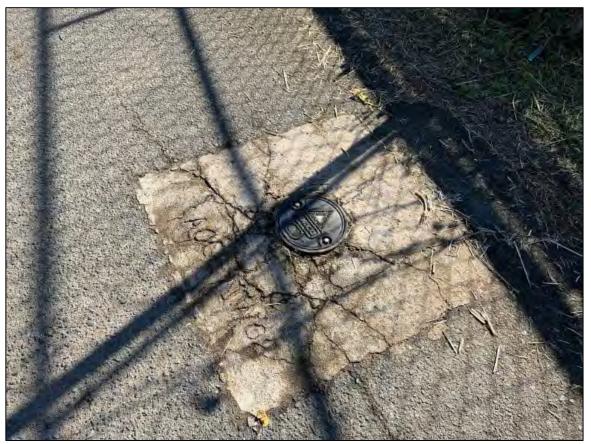
Photograph 3. MW-08 surface condition on 1/14/2022.

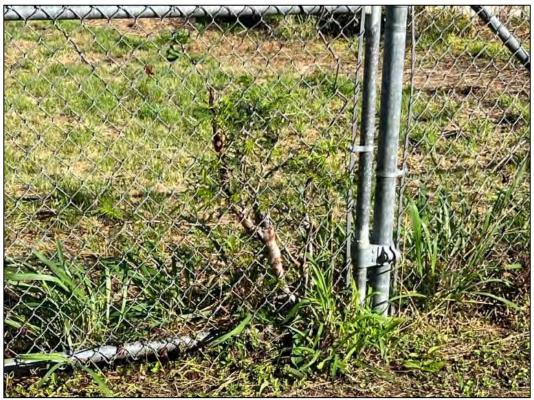
Photograph 5. Tree growing in southern fence line near gate entrance 1/14/2022.

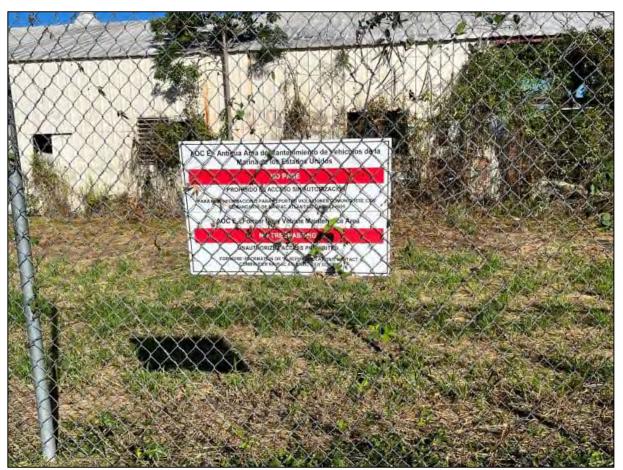
Photograph 6. Fence and sign in good condition on 1/14/2022. Looking west along south fence line.

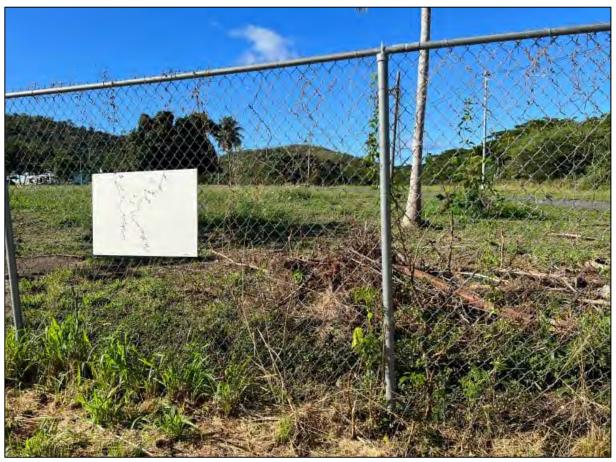
Photograph 7. Western fence and sign in good condition on 1/14/2022.

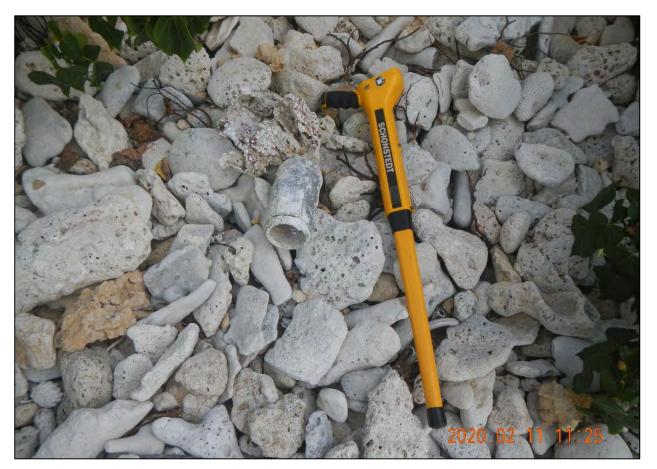
Expended parachute flare part encountered on southern ECA coastline. A Schonstedt is shown to the right of the item for scale.

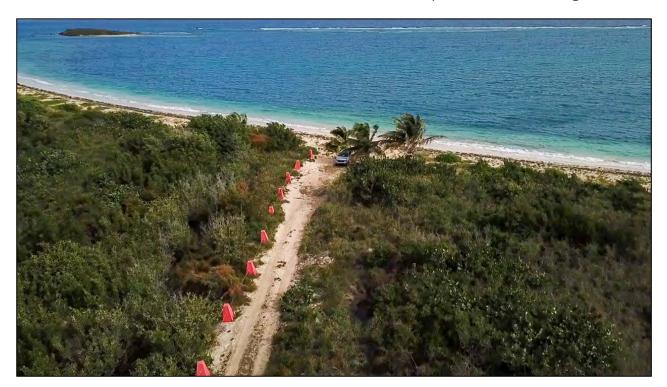
Physical demarcation boundary along the Live Impact Area/Surface Impact Area (LIA/SIA) boundary line. Photo shows the northern portion of the boundary near Playa Bahia Icacos/Beach 5 and no signs of vandalism.

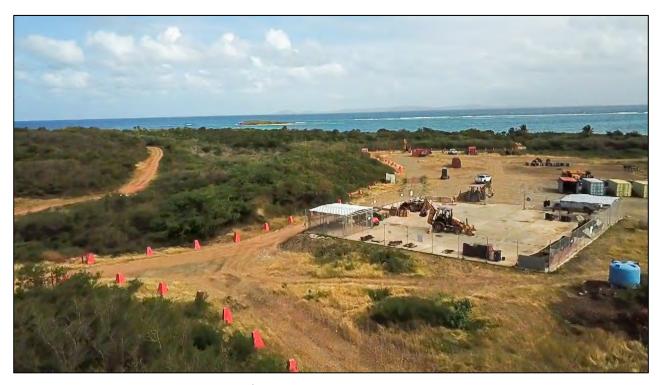
Physical demarcation boundary along the LIA/SIA boundary line. Photo shows the northern portion of the boundary and no signs of vandalism. Photo was taken south of the Central Processing Center (CPC) looking north toward Playa Bahia Icacos/Beach 5. The southern access gate can be seen on the left side of the photo.

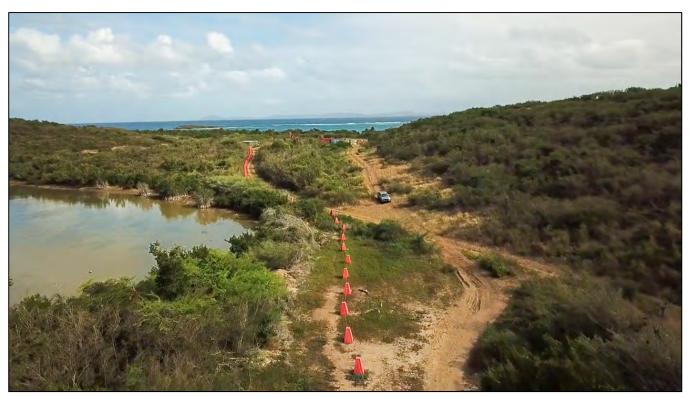
Physical demarcation boundary along the LIA/SIA boundary line. Photo was taken looking north toward Playa Bahia Icacos/ Beach 5 and shows Laguna Icacos to the left of the demarcation boundary and no signs of vandalism.

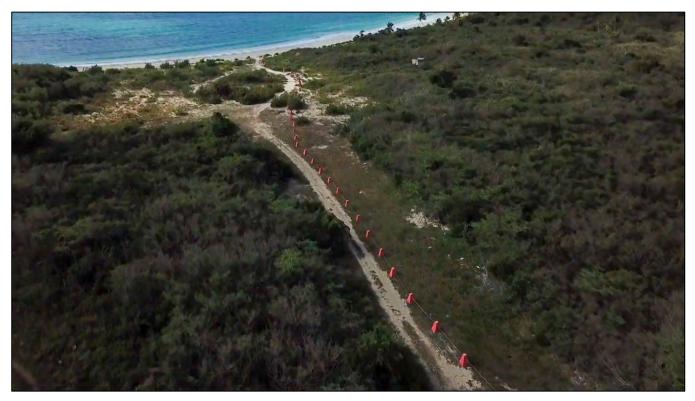
Physical demarcation boundary along the LIA/SIA boundary line. Photo was taken looking south toward Playa Bahia Salinas del Sur/Beach 2 and shows no signs of vandalism.

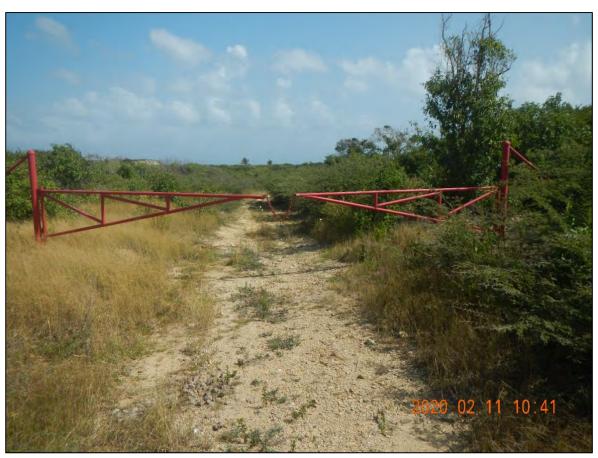
ECA access gate shown in the photo. Inspections of the gate concluded the gate and lock were operating as intended with no defects.

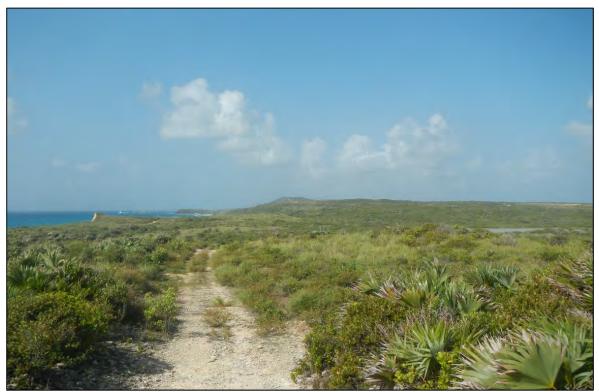
Annual inspection activities found no indications of trespassing. Photo taken on the ECA access road looking west with OP 1 in the distance.

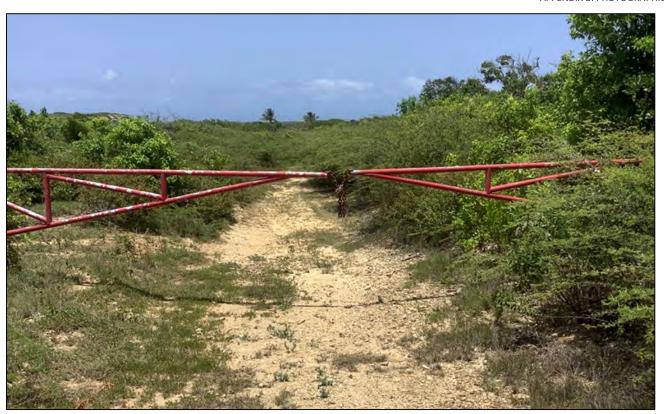
ECA access gate and lock. Inspection of the gate and lock concluded they were operating with no defects that would threaten their integrity.

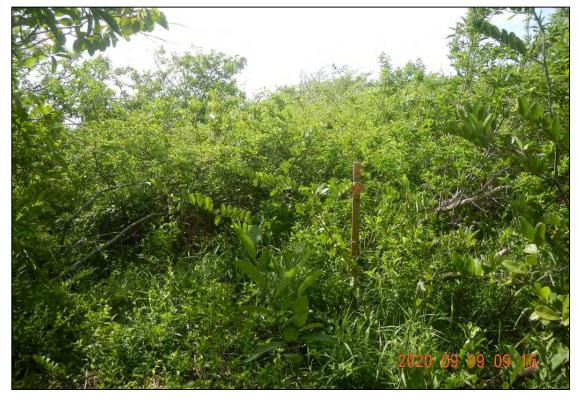
UXO 18 Cayo La Chiva trail with overgrowth of vegetation.

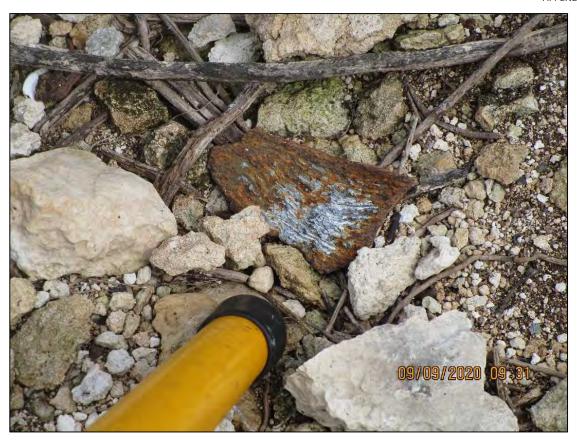
UXO 18 Cayo La Chiva small metal piece located near southern overlook/picnic area.

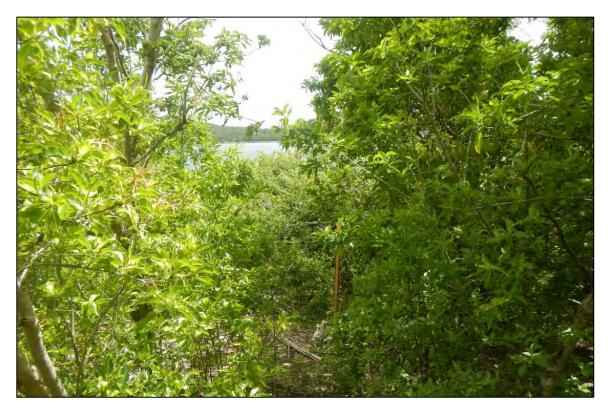
Photo showing general trail conditions while traversing the trail north from the southern picnic area. Trail marker visible on right side of trail. Vegetation growth was observed to be consistent along the trail, indicating no new trails had been established.

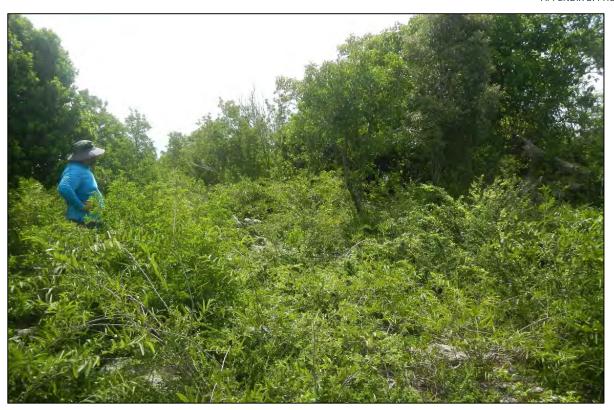
Photo shows southern overlook/picnic area general site conditions. UXO Technician shown standing in high vegetation growth of thick and typically thorny scrub.

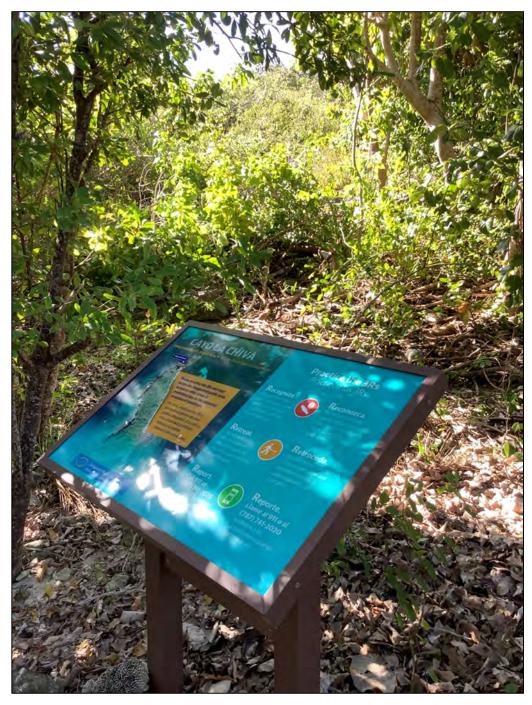
New sign installation with trail entrance shown in the background. Vegetation debris was placed across the trail entrance to naturally obscure it.

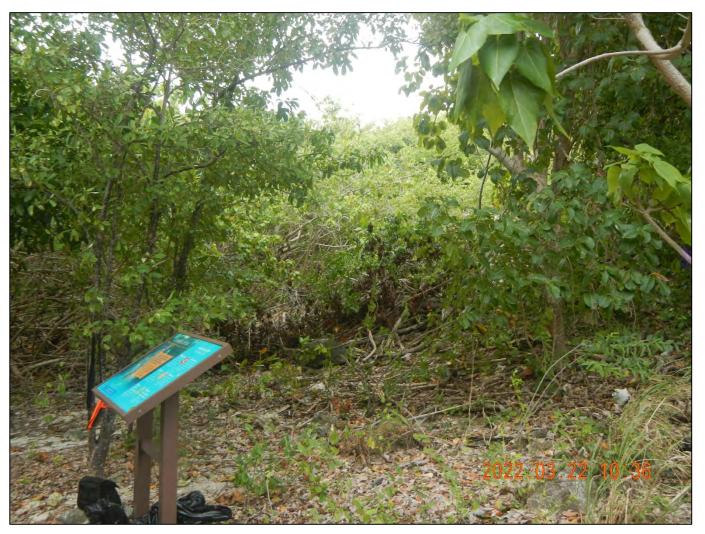
UXO 18 kiosk shown with vegetation debris obscuring trail access point. Inspection teams equipment/supplies shown at the base of the kiosk.

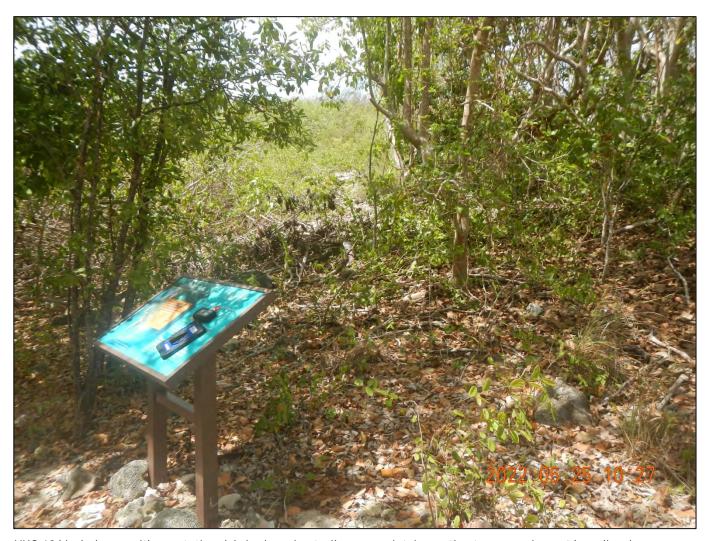
UXO 18 kiosk shown with vegetation debris obscuring trail access point. Inspection teams equipment/supplies shown on top of the kiosk.

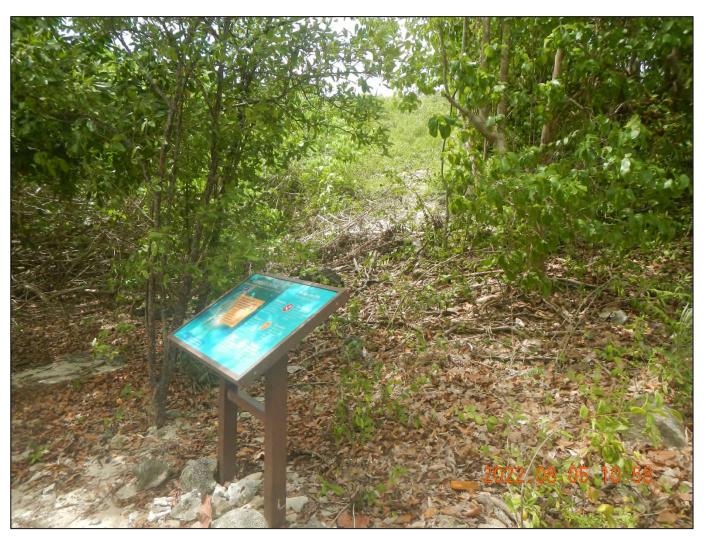
UXO 18 kiosk shown with vegetation debris obscuring trail access point.

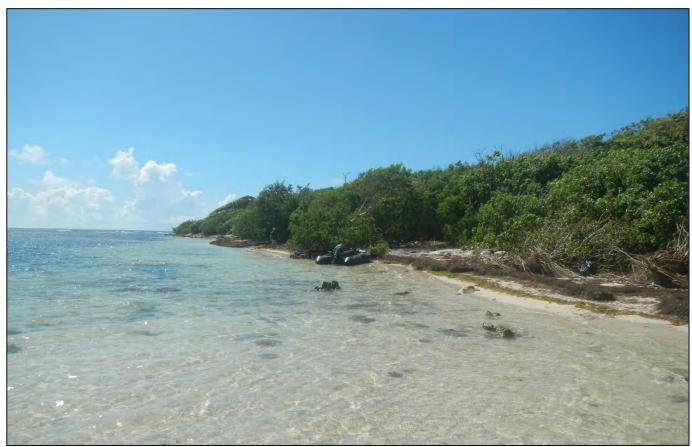
View from water of the Public Beach Area at Cayo La Chiva. UXO Technician shown conducting inspection to the left of the boat used to access the island.

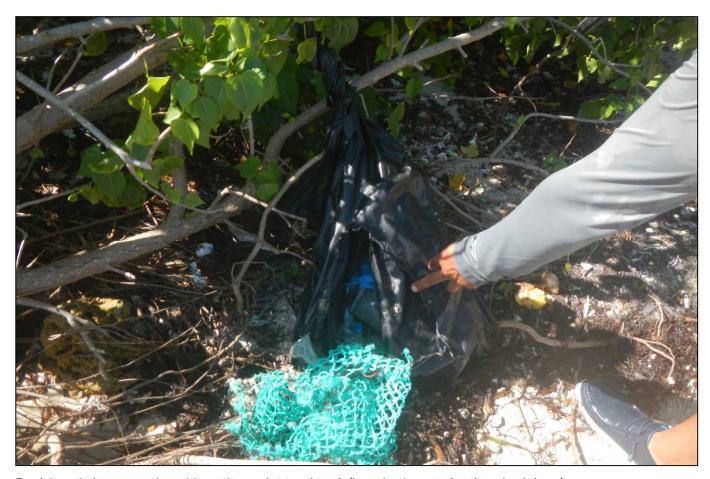
Trash bag tied to vegetation with netting and general trash (i.e., plastic water bottles, plastic bags).
