Final
Asbestos Inspection Report
for

Naval Activity Puerto Rico
Ceiba, Puerto Rico

Volume 4 of 7

Buildings 1706 through 1994

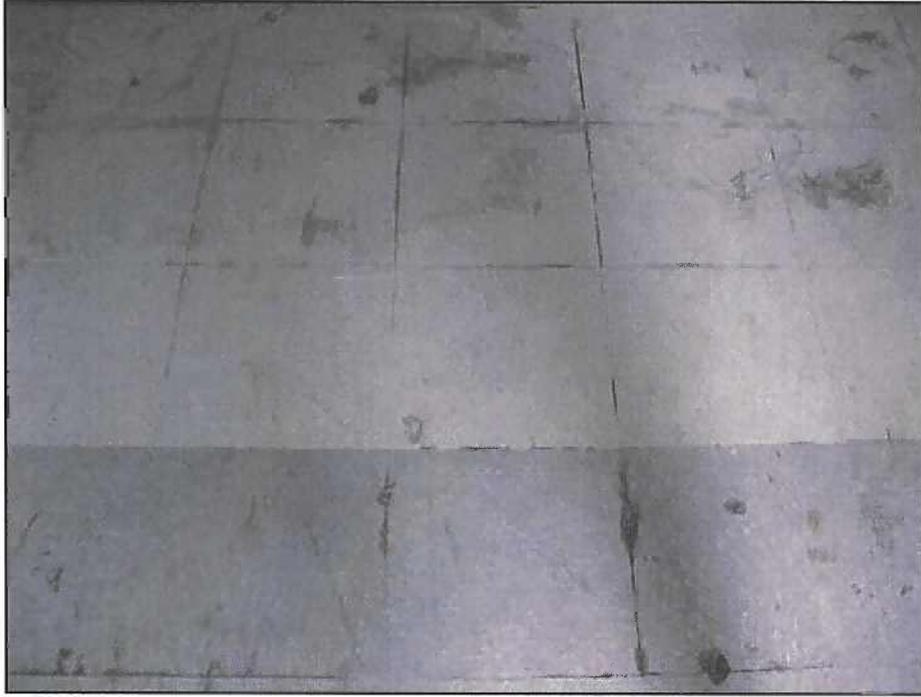
Building 1706 is identified as “TEMP CPO Hut/Pier 3 Pub” and is approximately 960 square feet in size. Five suspect homogeneous materials were identified and sampled. One material, floor adhesive (Material #002), was found to be an ACM. Note that “31” was accidentally included in the sample identifications instead of “1706”. No friable, damaged, and accessible ACM was identified.

MATERIAL NUMBER	MATERIAL TYPE (MATERIAL DESCRIPTION)	ASBESTOS CONTENT	MATERIAL LOCATION(S)	FRIABLE	CONDITION	QUANTITY	COMMENTS
002	FLOOR ADHESIVE (BLACK UNDER 1' X 1' GRAY AND CREAM VINYL FLOOR TILE)	Layer 1 ND Layer 2 2% CH	1	No	UNDAMAGED	960 SF

Vinyl floor tile (Material #001) over ACM floor adhesive (Material #002)

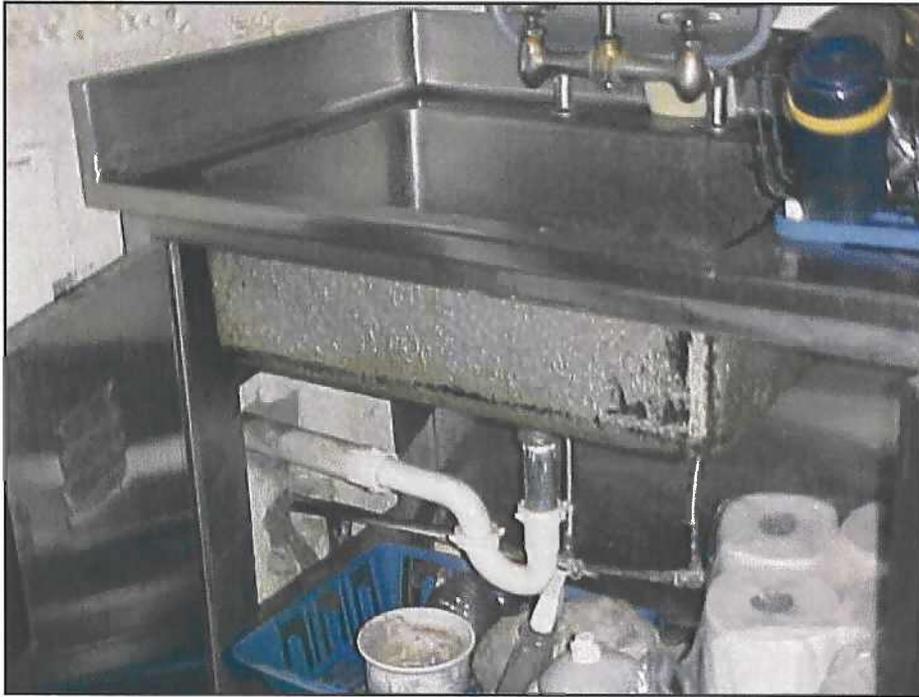
MATERIAL NUMBER	MATERIAL TYPE (MATERIAL DESCRIPTION)	ASBESTOS CONTENT	MATERIAL LOCATION(S)	FRIABLE	CONDITION	QUANTITY	COMMENTS
004	SINK COATING (GRAY, ROUGH)	10% CH	1	No	UNDAMAGED	1 EA

Sink coating (Material #004)

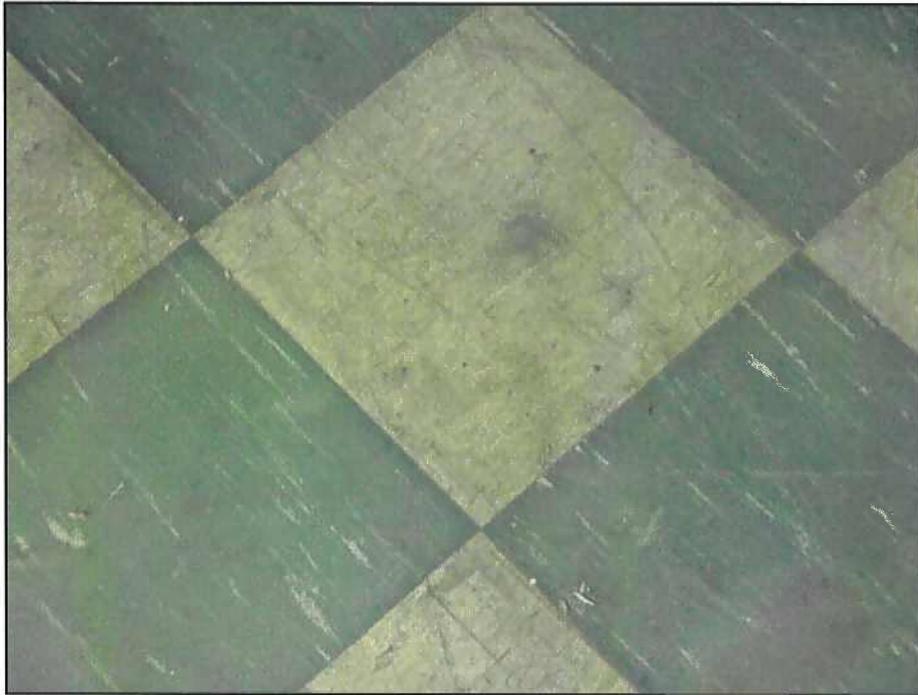
MATERIAL NUMBER	MATERIAL TYPE (MATERIAL DESCRIPTION)	ASBESTOS CONTENT	MATERIAL LOCATION(S)	FRIABLE	CONDITION	QUANTITY	COMMENTS
001	VINYL FLOOR TILE (1' X 1' GREEN)	5% CH	BAY	No	UNDAMAGED	75 SF	
004	FLOOR ADHESIVE (BLACK, UNDER 1'X1' BONE VINYL FLOOR TILE)	10% CH	BAY	No	UNDAMAGED	150 SF

1'x1' green vinyl floor tile (Material #001)

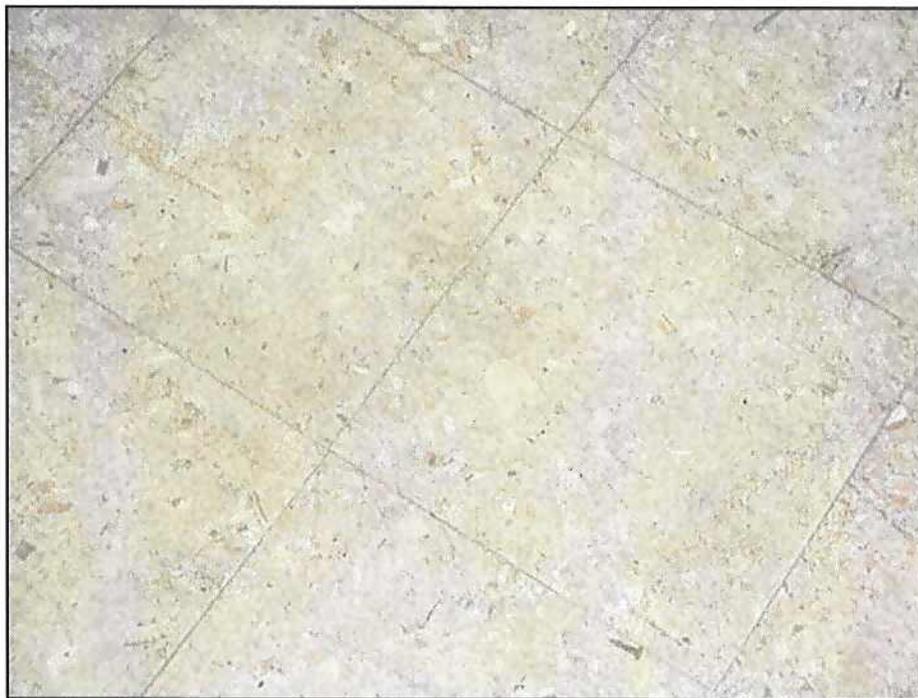
1'x1' bone vinyl floor tile over ACM floor adhesive (Material #004)

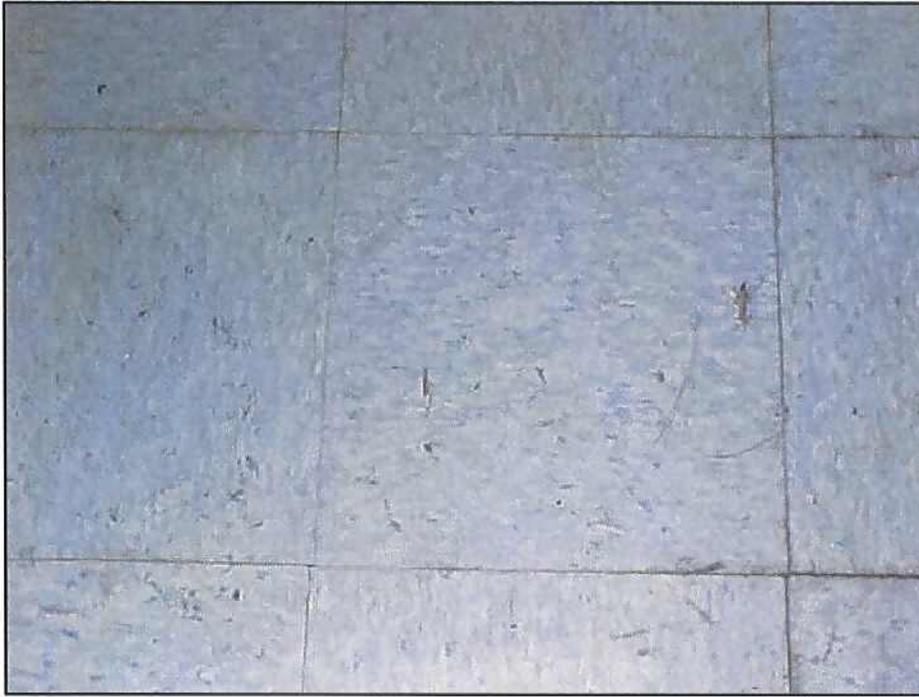
MATERIAL NUMBER	MATERIAL TYPE (MATERIAL DESCRIPTION)	ASBESTOS CONTENT	MATERIAL LOCATION(S)	FRIABLE	CONDITION	QUANTITY	COMMENTS
002	FLOOR ADHESIVE (YELLOW/BLACK, UNDER 1' X 1' GRAY VINYL FLOOR TILE)	5% CH	2	Yes	UNDAMAGED	400 SF

Vinyl floor tile (Material #001) over ACM adhesive (Material #002)

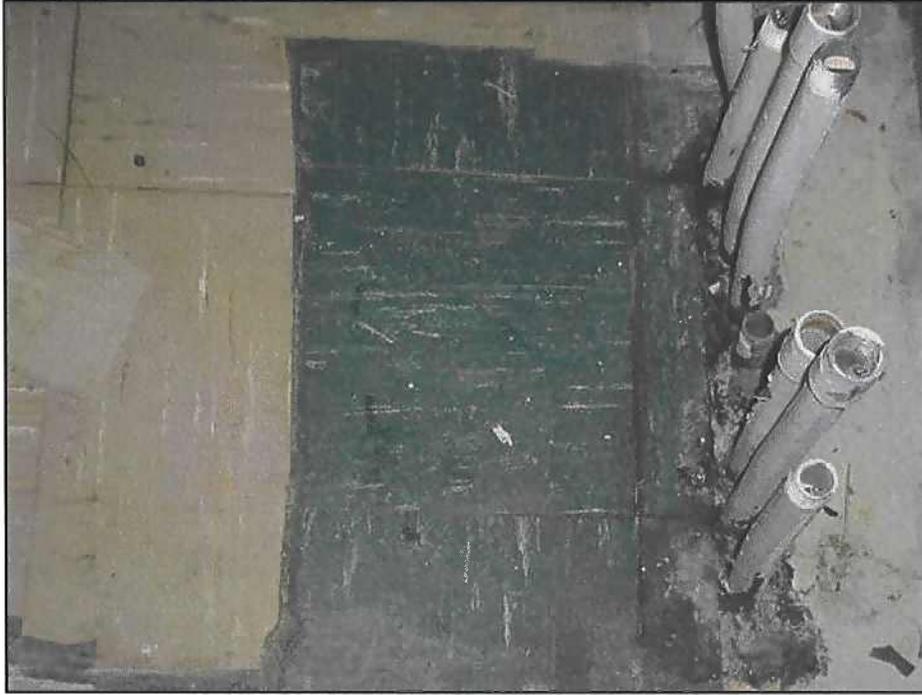
Vinyl floor tile (Material #008)

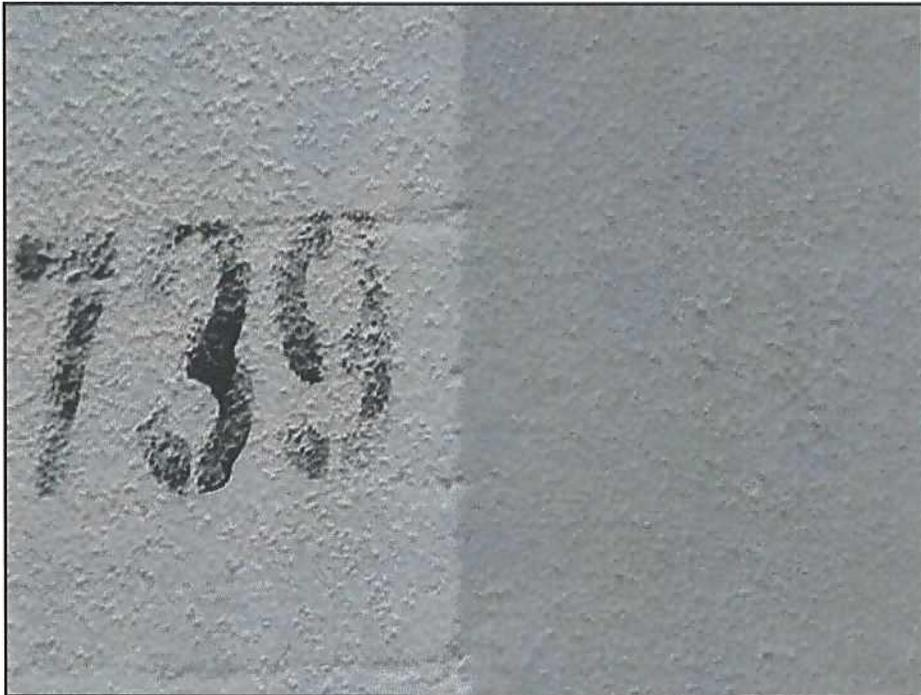
Exterior plaster (Material #010)

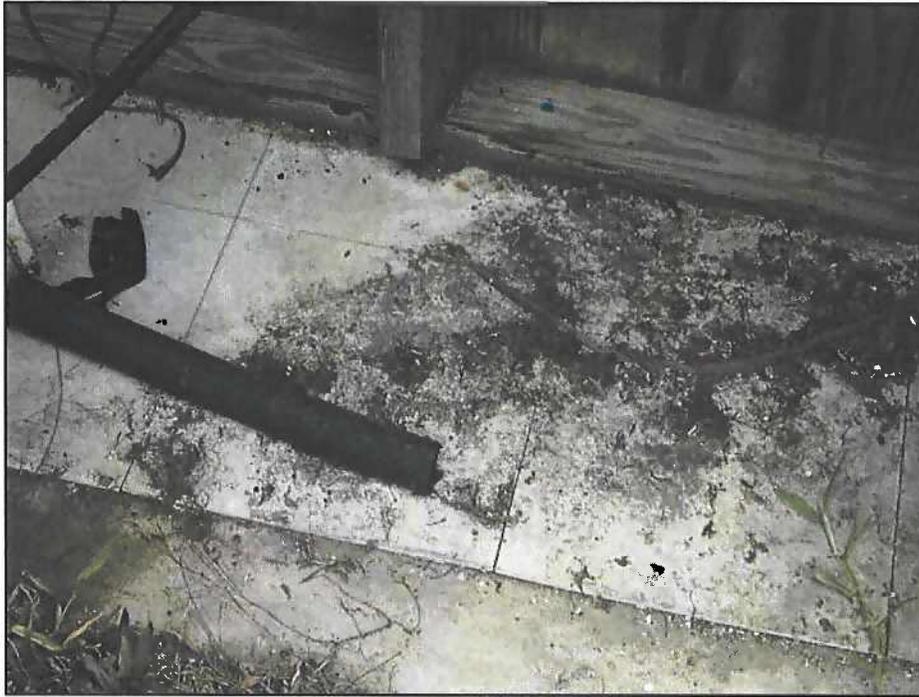
1'x1' cream with gray mottle vinyl floor tile over ACM adhesive (Material #002)

MATERIAL NUMBER	MATERIAL TYPE (MATERIAL DESCRIPTION)	ASBESTOS CONTENT	MATERIAL LOCATION(S)	FRIABLE	CONDITION	QUANTITY	COMMENTS
002	FLOOR ADHESIVE (BROWN/BLACK, UNDER 001)	3% CH	1	No	UNDAMAGED	200 SF

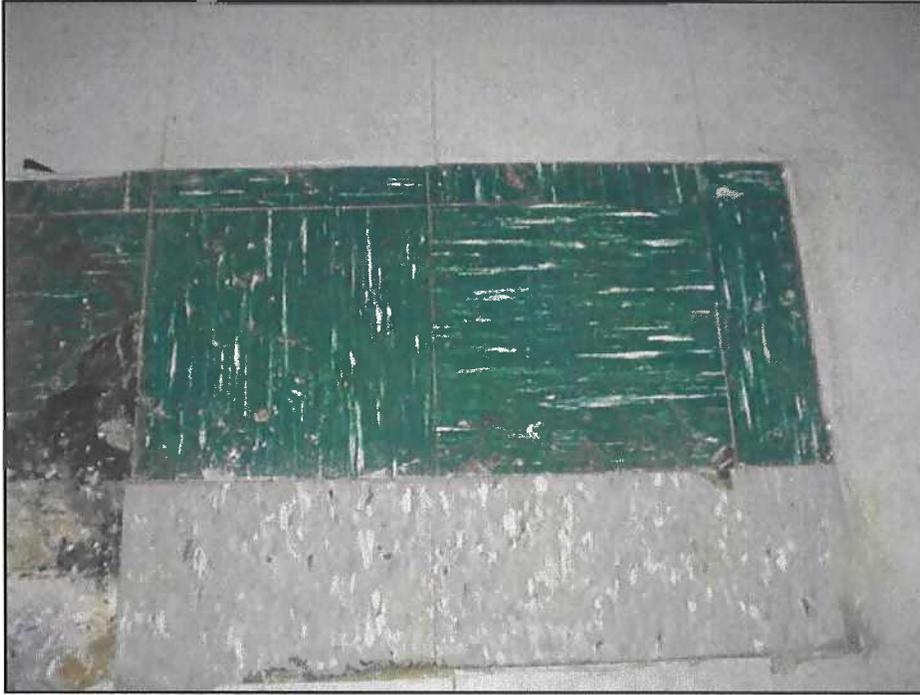
MATERIAL NUMBER	MATERIAL TYPE (MATERIAL DESCRIPTION)	ASBESTOS CONTENT	MATERIAL LOCATION(S)	FRIABLE	CONDITION	QUANTITY	COMMENTS
013	VINYL FLOOR TILE (1' X 1' GREEN WITH WHITE STREAKS)	2% CH	3 4	No	UNDAMAGED	190 SF	THE ADHESIVE FOR THIS MATERIAL IS MATERIAL #014.
014	FLOOR ADHESIVE (BLACK, UNDER 1' X 1' GREEN WITH WHITE STREAKS VINYL FLOOR TILE)	5% CH	3 4	No	UNDAMAGED	190 SF	THIS IS THE ADHESIVE FOR MATERIAL #013
018	VINYL FLOOR TILE (1' X 1' TAN WITH BROWN SPECKS)	5% CH	5	No	UNDAMAGED	48 SF	THE ADHESIVE FOR THIS MATERIAL IS MATERIAL #019
019	FLOOR ADHESIVE (BROWN, UNDER 1' X 1' TAN WITH BROWN SPECKS VINYL FLOOR TILE)	5% CH	5	No	UNDAMAGED	48 SF	THIS IS THE ADHESIVE FOR MATERIAL #018.

Vinyl floor tile (Material #013) and associated floor adhesive (Material #014)

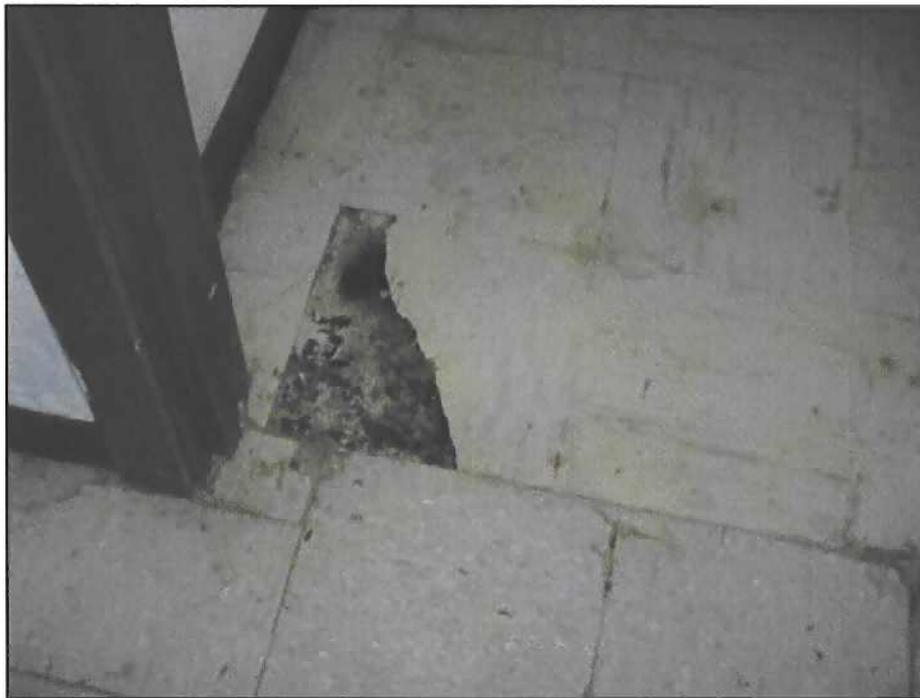
Vinyl floor tile (Material #018) and associated floor adhesive (Material #019)

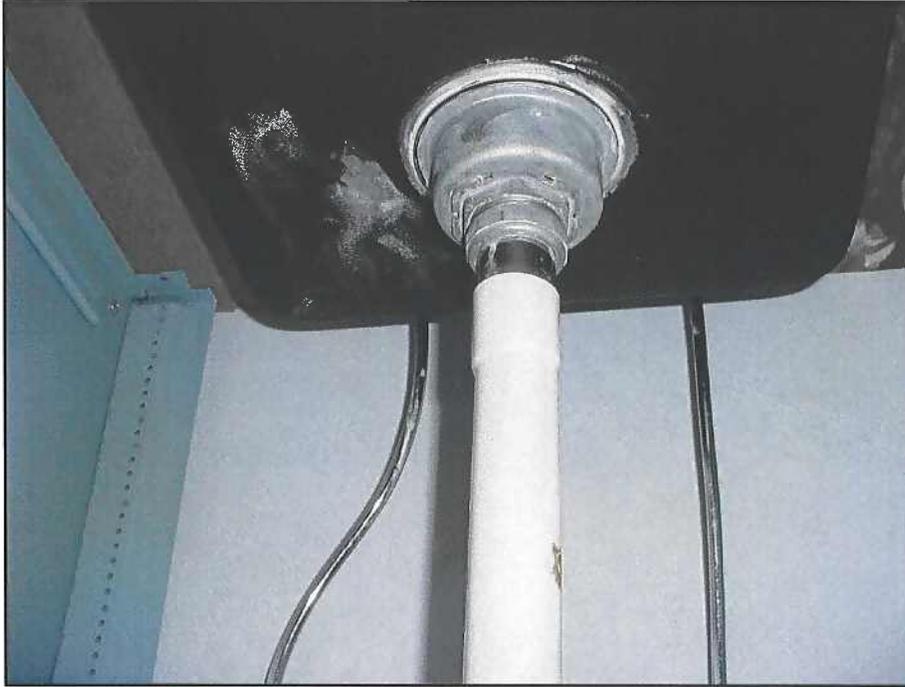
MATERIAL NUMBER	MATERIAL TYPE (MATERIAL DESCRIPTION)	ASBESTOS CONTENT	MATERIAL LOCATION(S)	FRIABLE	CONDITION	QUANTITY	COMMENTS
005	SINK COATING (BLACK)	ND None 3% CH	A106 A172 A234 B105 B113 B115 B130 B137 B149 B152 B156 B167 B214 C116 C117 C140 C144 C162 C210 C221 C243 D214 D227	No	UNDAMAGED	25 EA

Black sink coating (Material #005)

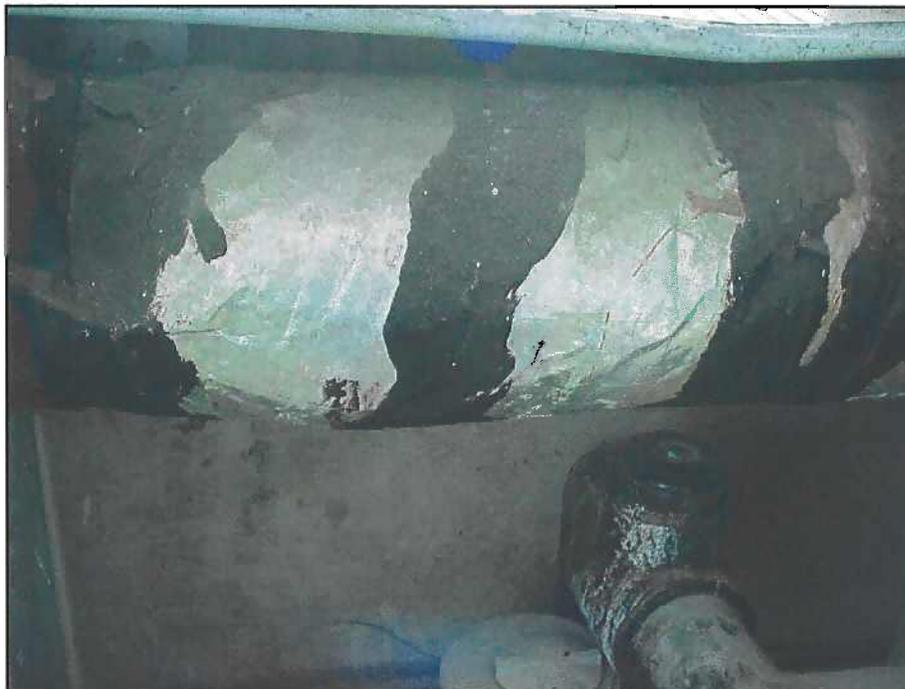
MATERIAL NUMBER	MATERIAL TYPE (MATERIAL DESCRIPTION)	ASBESTOS CONTENT	MATERIAL LOCATION(S)	FRIABLE	CONDITION	QUANTITY	COMMENTS
006	DUCT INSULATION (BLACK ASPHALTIC TAR ON SEAMS OF FIBERGLASS DUCT INSULATION)	6% CH	A010 A022 A024 A025 A034 A08 A126 A129 A130 A131 A136 A137 A141 A143 A147 A148 A157 A158 A162 A163 A167 A168 A174 A175 A208 A219 A220 A221 A230 A231 A241 A244 A255 A256 B012 B013 B104 B120	No	UNDAMAGED	203 SF

Black asphaltic duct insulation tar (Material #006)

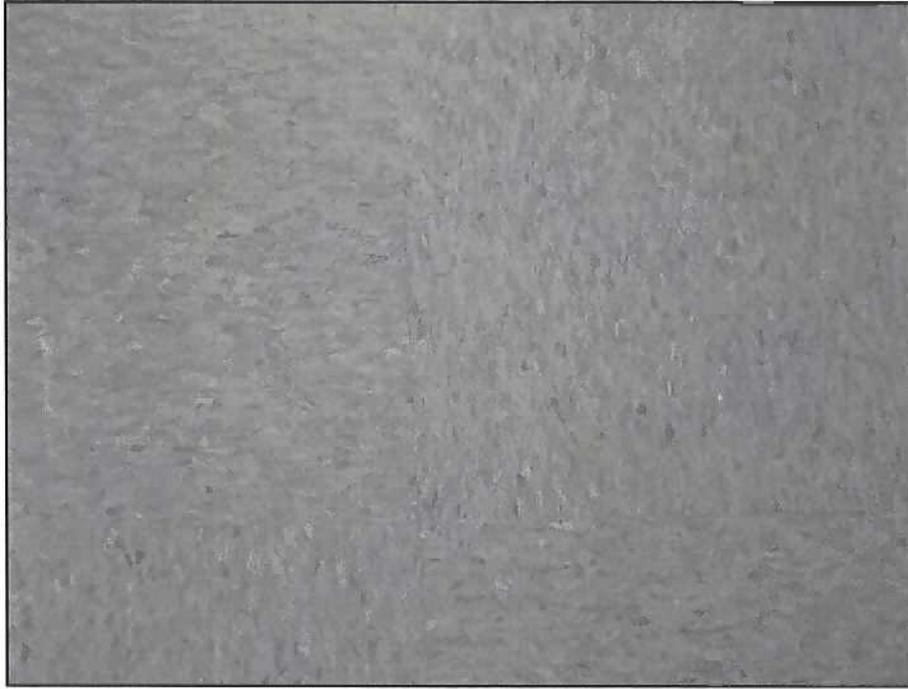
Vinyl floor tile (Material #011) over ACM yellow/ black floor adhesive (Material #014)

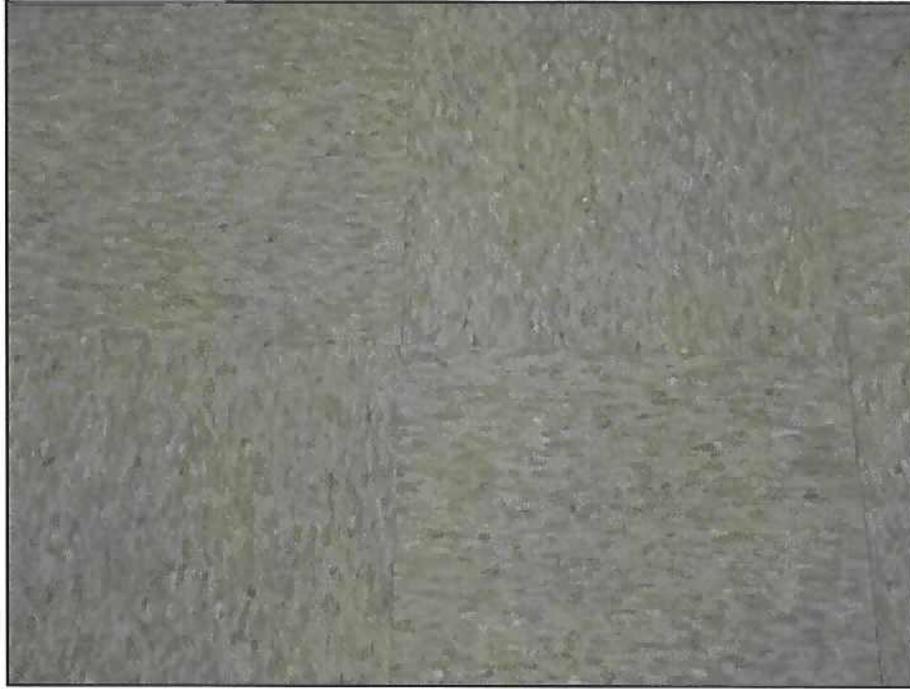
MATERIAL NUMBER	MATERIAL TYPE (MATERIAL DESCRIPTION)	ASBESTOS CONTENT	MATERIAL LOCATION(S)	FRIABLE	CONDITION	QUANTITY	COMMENTS
020	FLOOR ADHESIVE (BLACK, UNDER 018 AND 019)	7% CH	A03 A043 A043A B02H B02I B07 C018 C05 C06 C211 C223 C225 C227 C233 C235 C240 C243 D012 D025	No	UNDAMAGED	6,587 SF	THIS IS THE ADHESIVE FOR MATERIALS #018 AND 019.
022	FLOOR ADHESIVE (BLACK AND TAN, UNDER 021)	3% CH	C201 C223	No	UNDAMAGED	768 SF	THIS IS THE ADHESIVE FOR MATERIAL #021.
024	FLOOR ADHESIVE (BLACK, UNDER 023)	3% CH	C02 C02A	No	UNDAMAGED	127 SF	THIS IS THE ADHESIVE FOR MATERIAL #023.
039	FLOOR ADHESIVE (BLACK, UNDER 038)	5% CH	SB4	No	UNDAMAGED	225 SF	THIS IS THE ADHESIVE FOR MATERIAL #038.
044	FLOOR ADHESIVE (BLACK, UNDER 043)	6% CH	B03 B05 C02 C02A C04	No	UNDAMAGED	993 SF	THIS IS THE ADHESIVE FOR MATERIAL #043.

Vinyl floor tile (Material #018) over ACM black floor adhesive (Material #020)

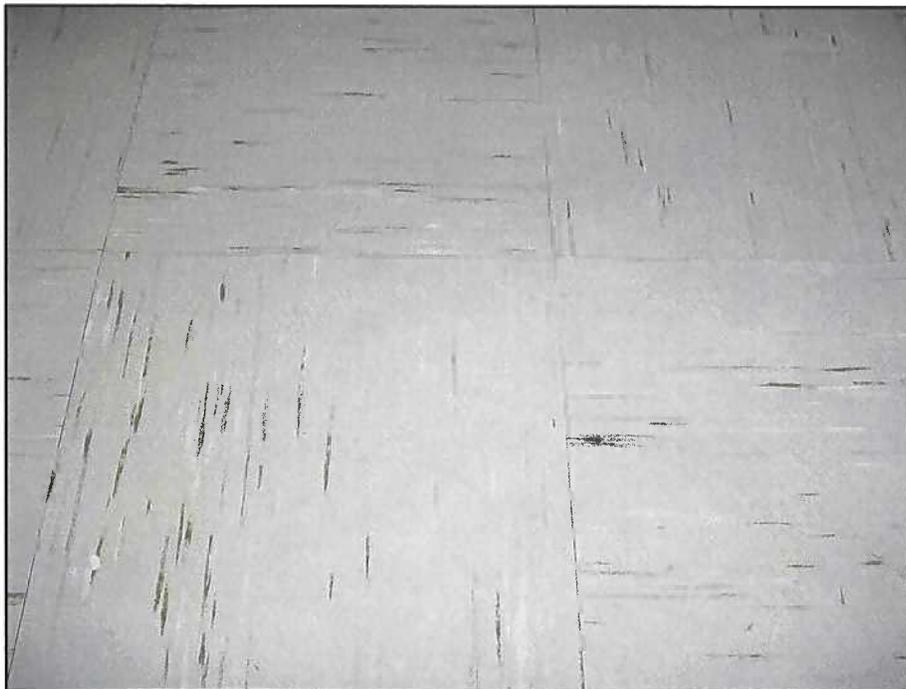
Vinyl floor tile (Material #021) over ACM black floor adhesive (Material #022)

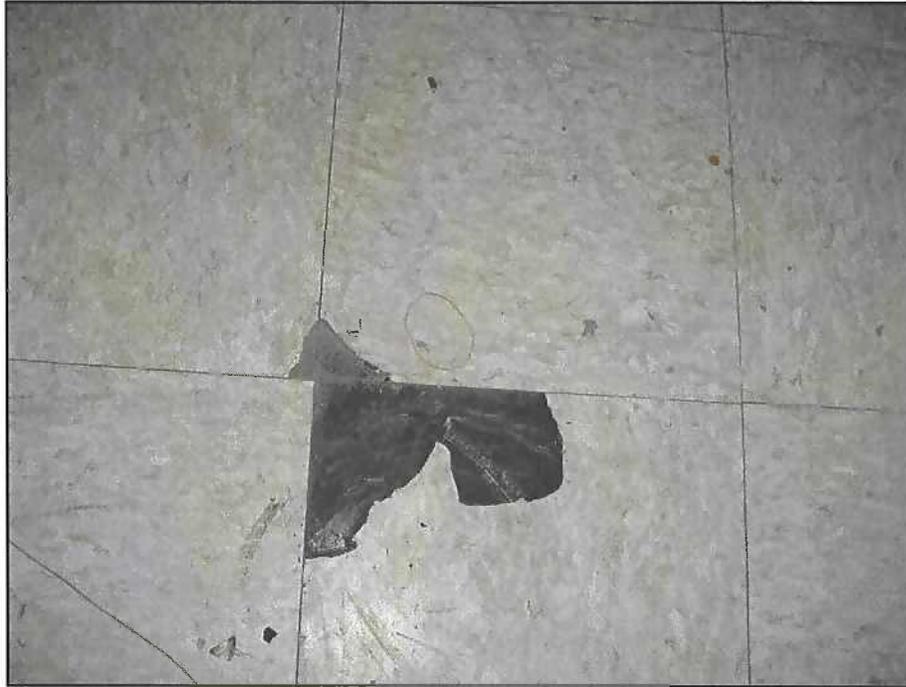
Vinyl floor tile (Material #038) over ACM black floor adhesive (Material #039)

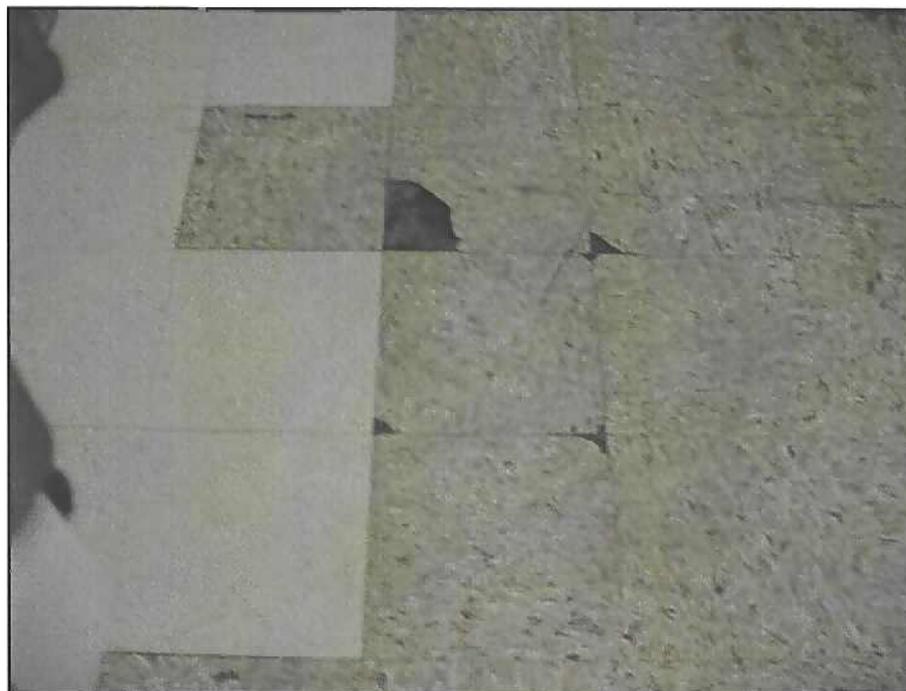
Vinyl floor tile (Material #043) over ACM black floor adhesive (Material #043)

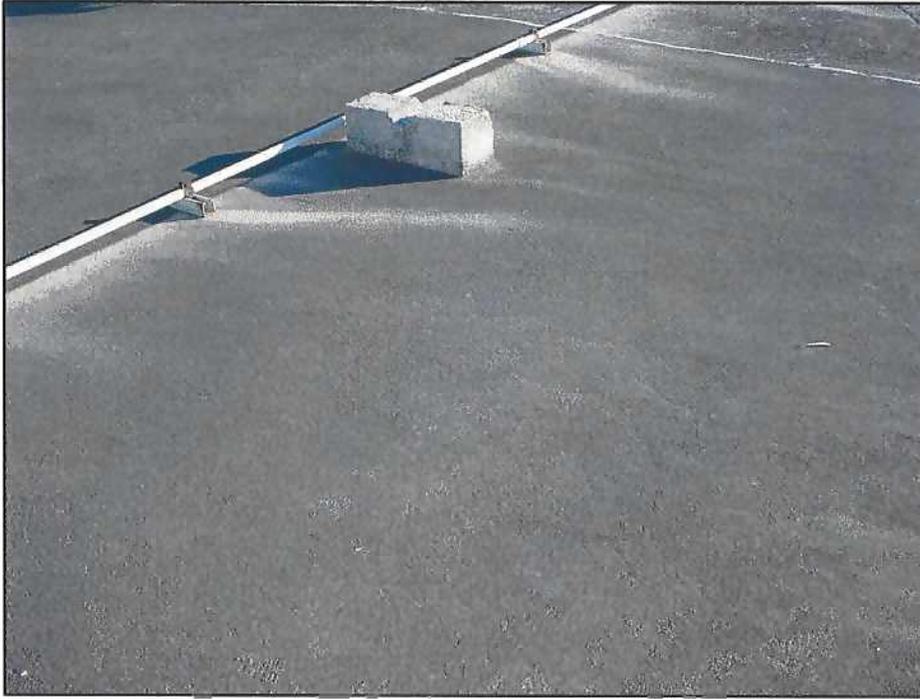
MATERIAL NUMBER	MATERIAL TYPE (MATERIAL DESCRIPTION)	ASBESTOS CONTENT	MATERIAL LOCATION(S)	FRIABLE	CONDITION	QUANTITY	COMMENTS
010	ASPHALTIC ROOFING MATERIALS (BLACK, USED TO SEAL ROOF PENETRATIONS)	10% CH	ROOF	No	UNDAMAGED	6 SF	
011	SHEET GASKET (BLACK, 14" SHEET GASKET ON BLUE WATER TANK)	45% CH	MECHANICAL ROOM	No	UNDAMAGED	1 EA

Asphaltic roofing material (Material # 010)

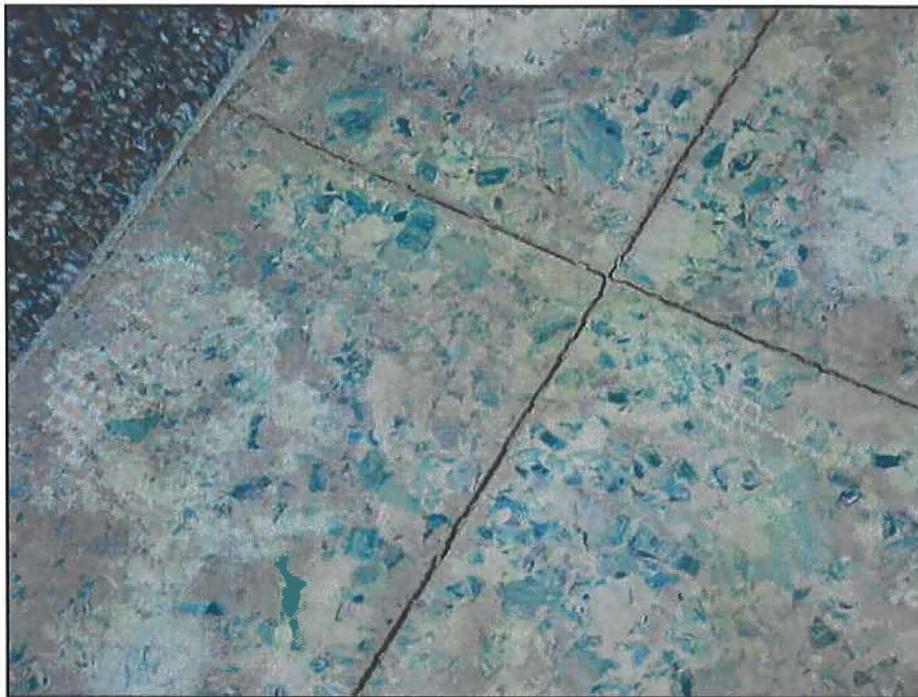
MATERIAL NUMBER	MATERIAL TYPE (MATERIAL DESCRIPTION)	ASBESTOS CONTENT	MATERIAL LOCATION(S)	FRIABLE	CONDITION	QUANTITY	COMMENTS
003	FLOOR ADHESIVE (BLACK, UNDER 1' X 1' GREEN AND WHITE MOTTLED VINYL FLOOR TILE)	10% CH	1 2 7	No	UNDAMAGED	399 SF	THIS IS THE ADHESIVE FOR MATERIAL #002.
006	FLOOR ADHESIVE (BROWN, UNDER 1' X 1' GREEN VINYL FLOOR TILE)	8% CH	3 4	No	UNDAMAGED	112 SF	THIS IS THE ADHESIVE FOR MATERIAL #005.
010	FLOOR ADHESIVE (BLACK, UNDER 1' X 1' WHITE WITH BROWN STREAKS VINYL FLOOR TILE)	5% CH	5 6	No	UNDAMAGED	615 SF	THIS IS THE ADHESIVE FOR MATERIAL #009.
013	FLOOR ADHESIVE (BLACK AND YELLOW, UNDER 1' X 1' TAN MOTTLED AND 1' X 1' GRAY MOTTLED VINYL FLOOR TILE)	8% CH	5 6	No	UNDAMAGED	41 SF	THIS IS THE ADHESIVE FOR MATERIAL #011 AND #012.
014	VINYL FLOOR TILE (1' X 1' GRAY WITH BLUE STREAKS)	4% CH	7	No	UNDAMAGED	15 SF	THE ADHESIVE FOR THIS MATERIAL IS MATERIAL #015.
015	FLOOR ADHESIVE (BLACK, UNDER 1' X 1' GRAY WITH BLUE STREAKS VINYL FLOOR TILE)	10% CH	7	No	UNDAMAGED	15 SF	THIS IS THE ADHESIVE FOR MATERIAL #014.

Floor adhesive (Material #003) for Material #002 (shown above)

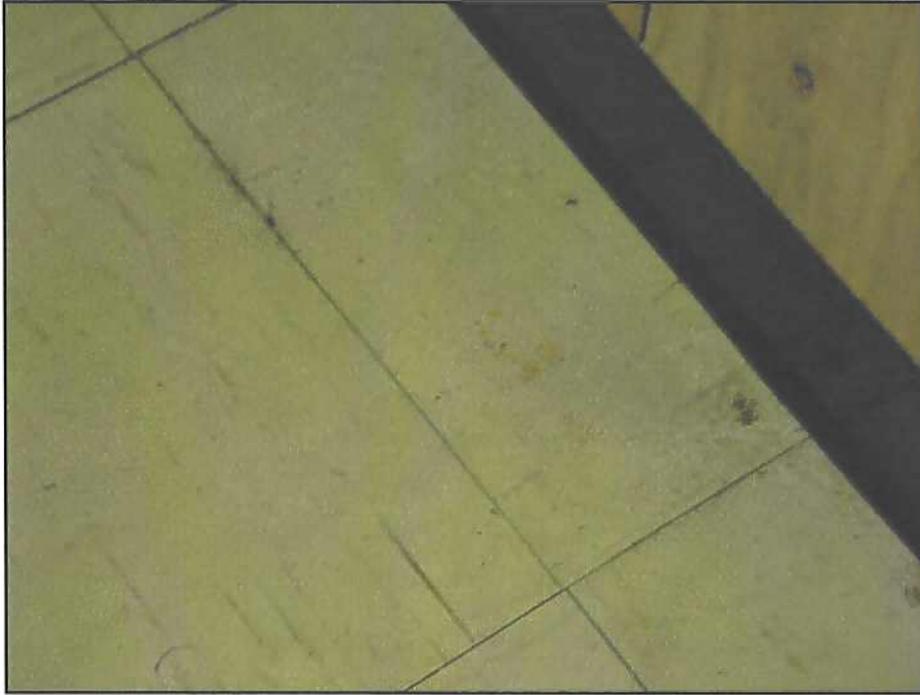
Floor adhesive (Material #010) for Material #009 (shown above)

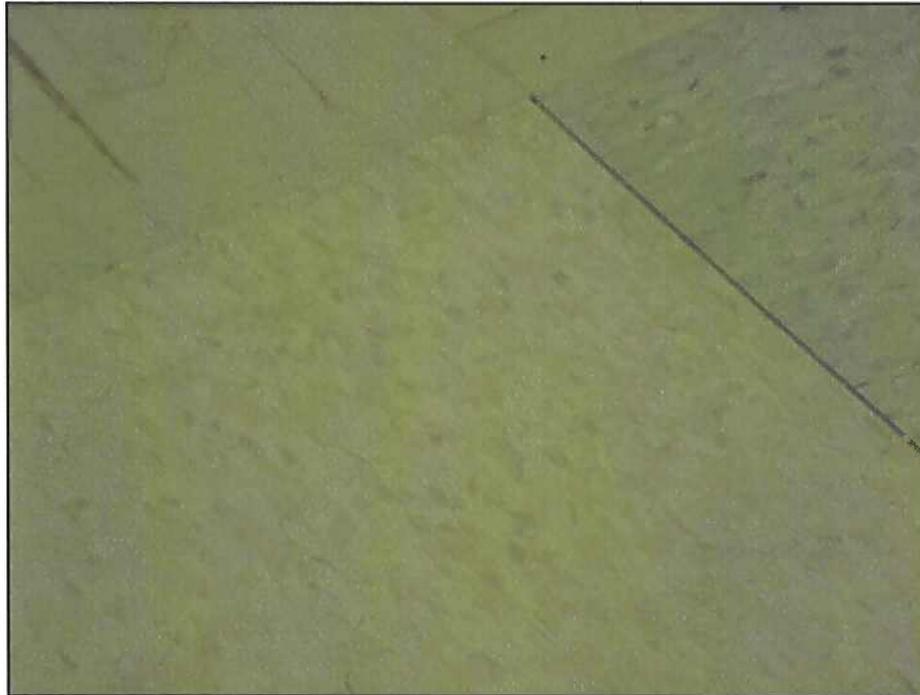
Floor adhesive (Material #013) for Material #012 (shown above)

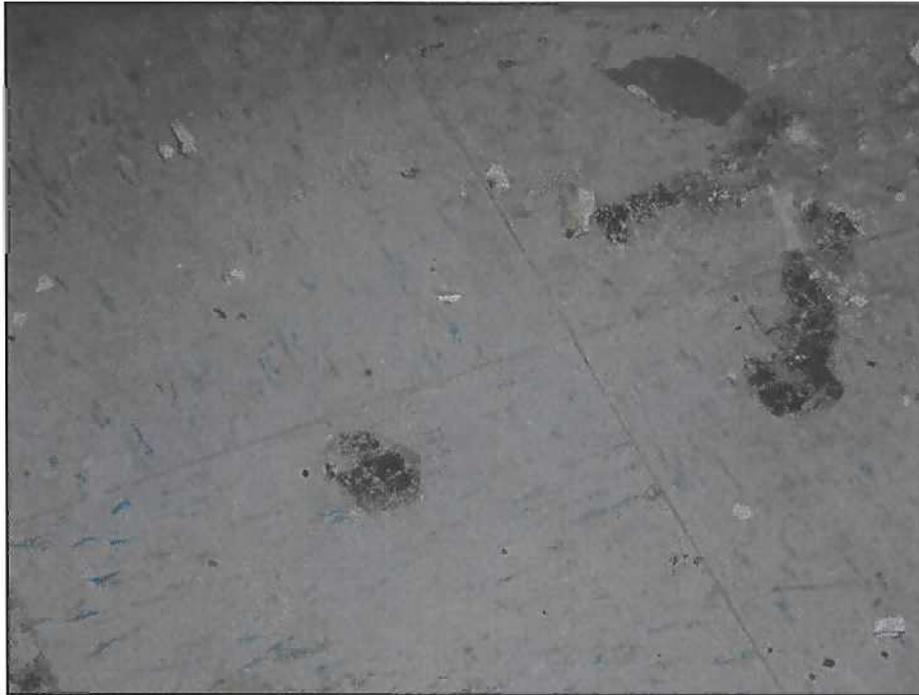
Vinyl floor tile (Material #014) and its adhesive (Material #015)

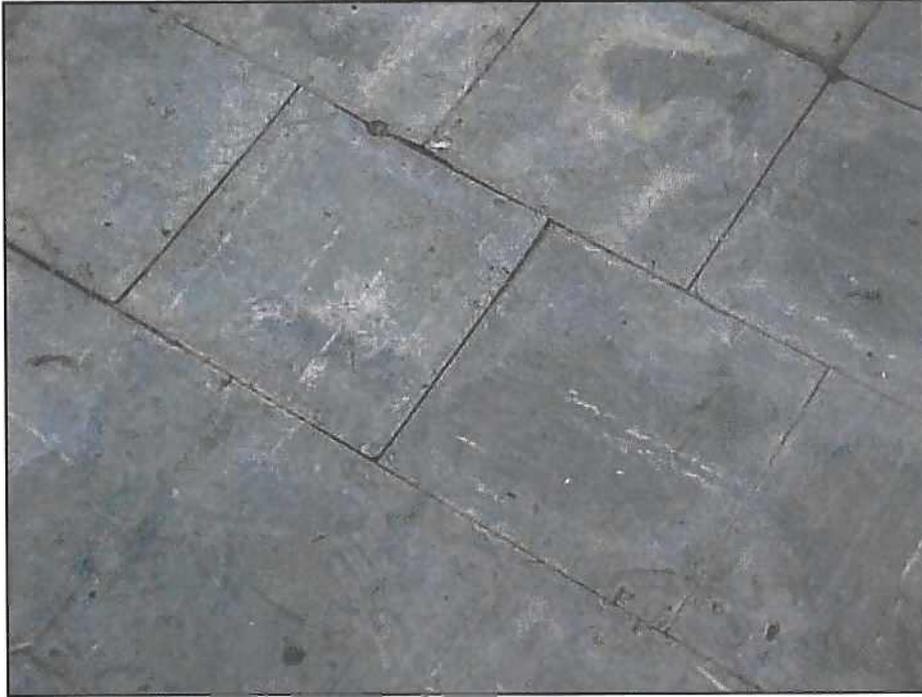
MATERIAL NUMBER	MATERIAL TYPE (MATERIAL DESCRIPTION)	ASBESTOS CONTENT	MATERIAL LOCATION(S)	FRIABLE	CONDITION	QUANTITY	COMMENTS
002	VINYL FLOOR TILE (9" X 9" GREEN)	2% CH	1 2 3 4	No	UNDAMAGED	1,600 SF	
003	FLOOR ADHESIVE (BLACK, UNDER 1' X 1' GREEN VINYL FLOOR TILE)	10% CH	1 2 3 4	No	UNDAMAGED	1,600 SF

9" x 9" green vinyl floor tile (Material #002) over black floor adhesive (Material #003)

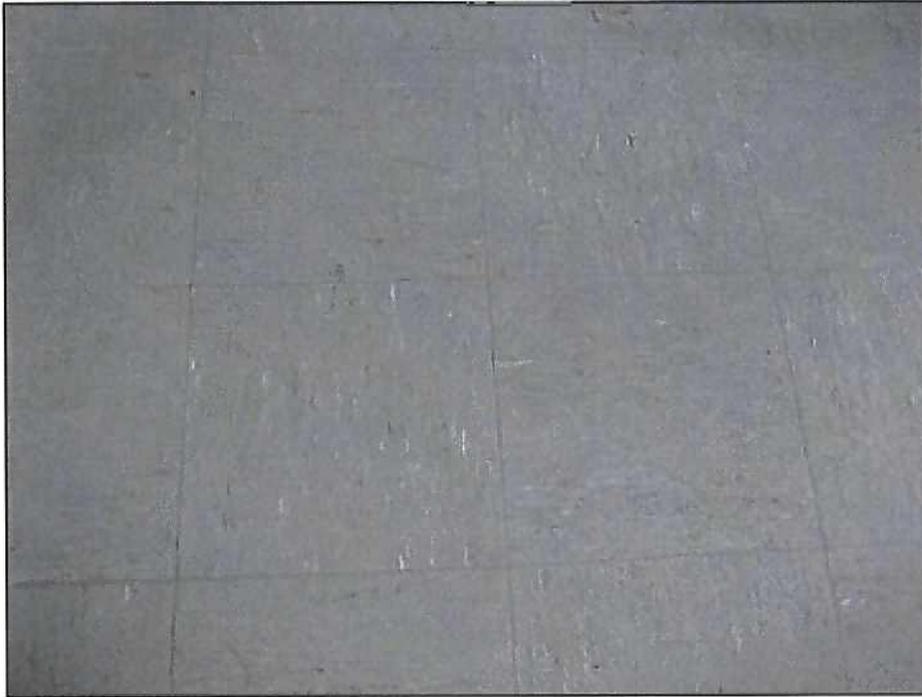
MATERIAL NUMBER	MATERIAL TYPE (MATERIAL DESCRIPTION)	ASBESTOS CONTENT	MATERIAL LOCATION(S)	FRIABLE	CONDITION	QUANTITY	COMMENTS
001	VINYL FLOOR TILE (1' X 1' TAN)	2% CH	1 10 11 12 13 15 17 2 21 3 30 4 5 6 8 9	No	UNDAMAGED	3,529 SF

1'x1' tan vinyl floor tile (Material #001)

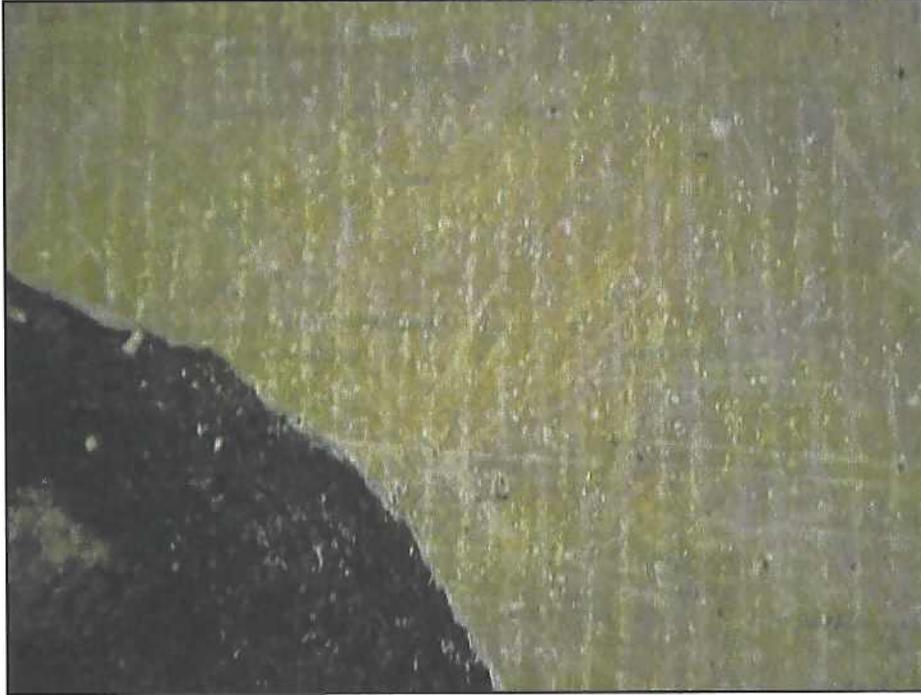
MATERIAL NUMBER	MATERIAL TYPE (MATERIAL DESCRIPTION)	ASBESTOS CONTENT	MATERIAL LOCATION(S)	FRIABLE	CONDITION	QUANTITY	COMMENTS
001	VINYL FLOOR TILE (1' X 1' WHITE)	3% CH	7	No	UNDAMAGED	120 SF	
002	FLOOR ADHESIVE (BLACK, UNDER 1' X 1' WHITE VINYL FLOOR TILE)	8% CH	7	No	UNDAMAGED	120 SF	
008	ASPHALTIC ROOFING MATERIALS (BLACK)	5% CH	ROOF	No	UNDAMAGED	14,430 SF	
011	SHEET GASKET (4" DIAMETER, GRAY)	70% CH	15	No	UNDAMAGED	1 EA

Vinyl floor tile (Material #001) over floor adhesive (Material #002)

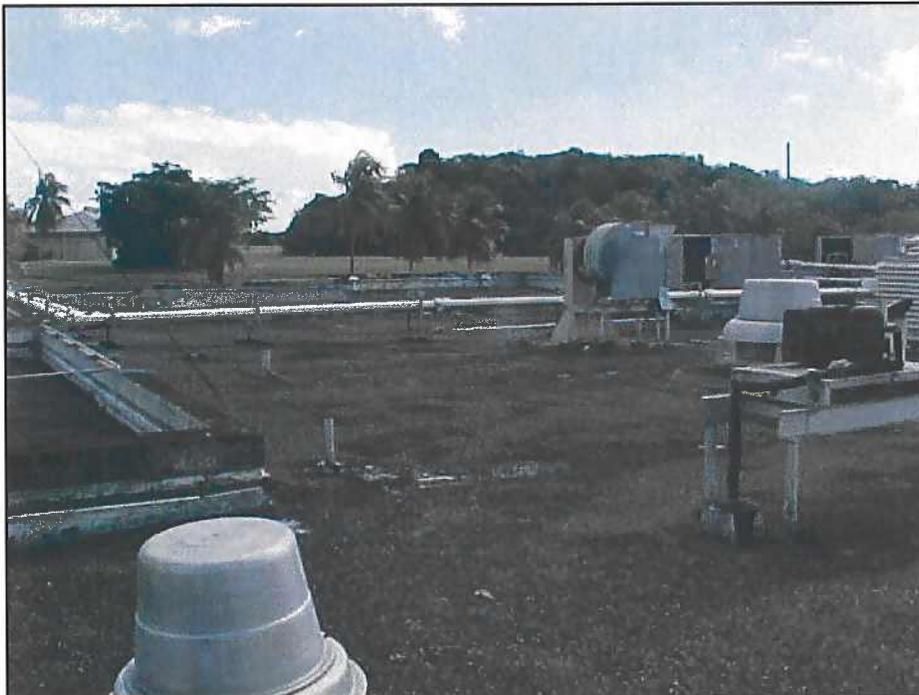
Asphaltic roofing material (Material #008)

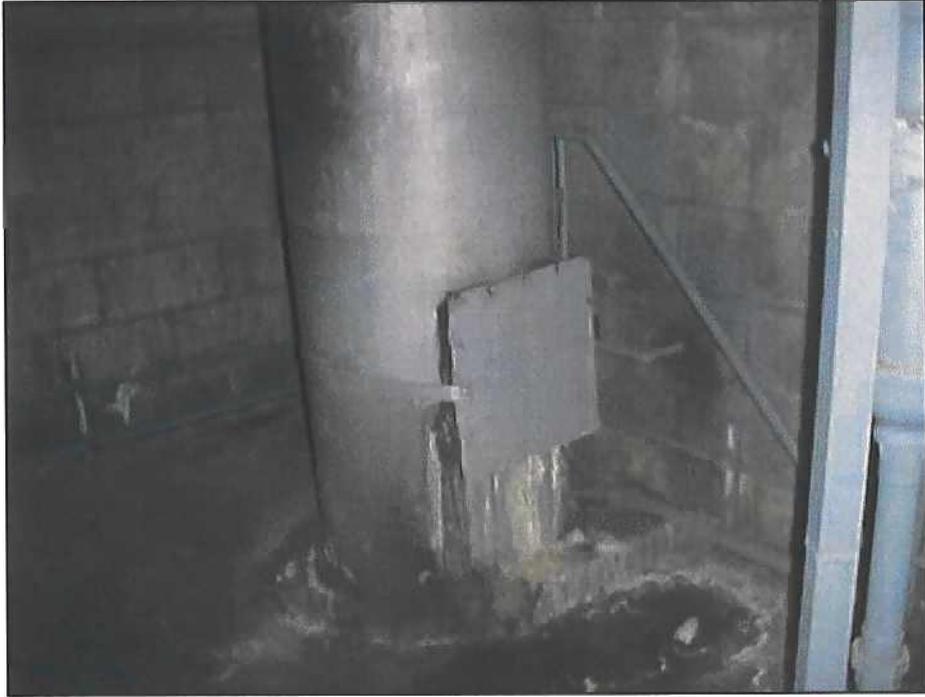
Sheet Gasket (Material #011)

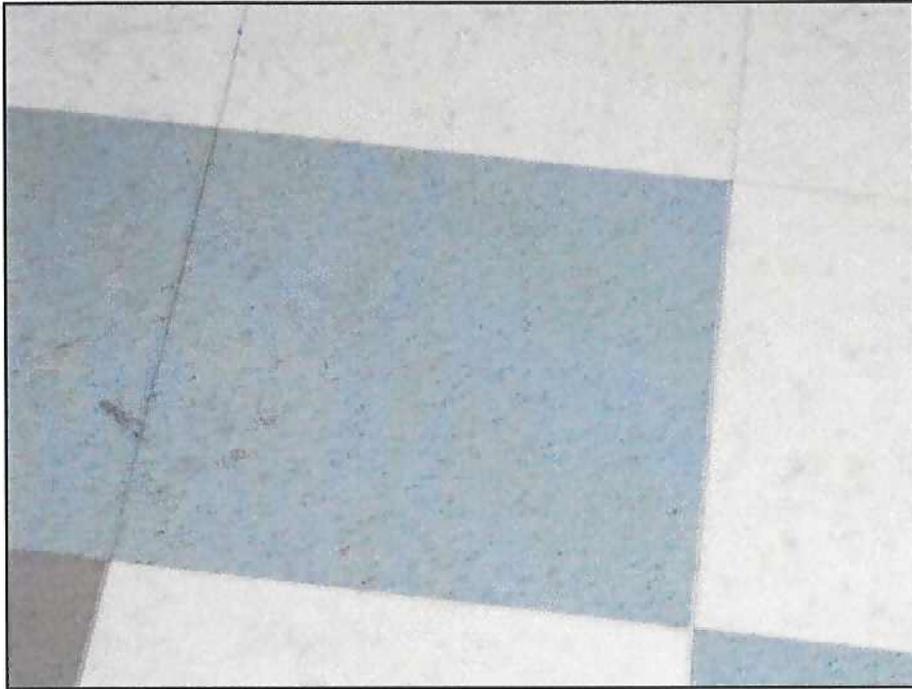
MATERIAL NUMBER	MATERIAL TYPE (MATERIAL DESCRIPTION)	ASBESTOS CONTENT	MATERIAL LOCATION(S)	FRIABLE	CONDITION	QUANTITY	COMMENTS
002	FLOOR ADHESIVE (TAN/BLACK, UNDER 001, 003, AND 005)	2% CH	1 4 5 6 7	No	UNDAMAGED	4,232 SF	
010	FLOOR ADHESIVE (BLACK, UNDER PINK, WHITE AND BLUE STONE TILES)	6% CH	ENTRY HALL	No	UNDAMAGED	325 SF

1'x1' white, blue and pink vinyl floor tiles over ACM floor adhesive (Material #002)

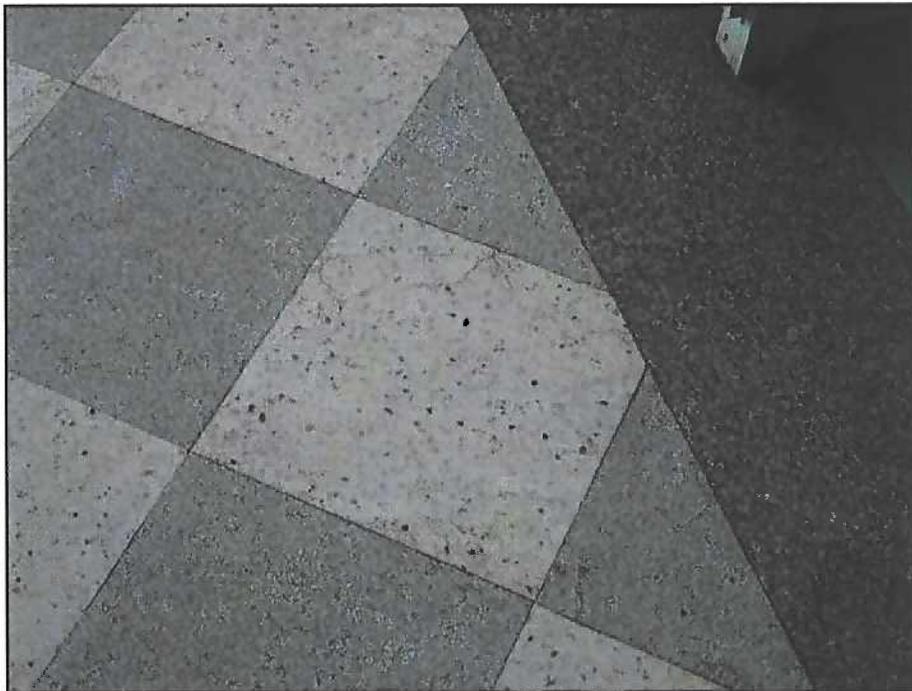
1'x1' stone floor tiles over ACM floor adhesive (Material #010)

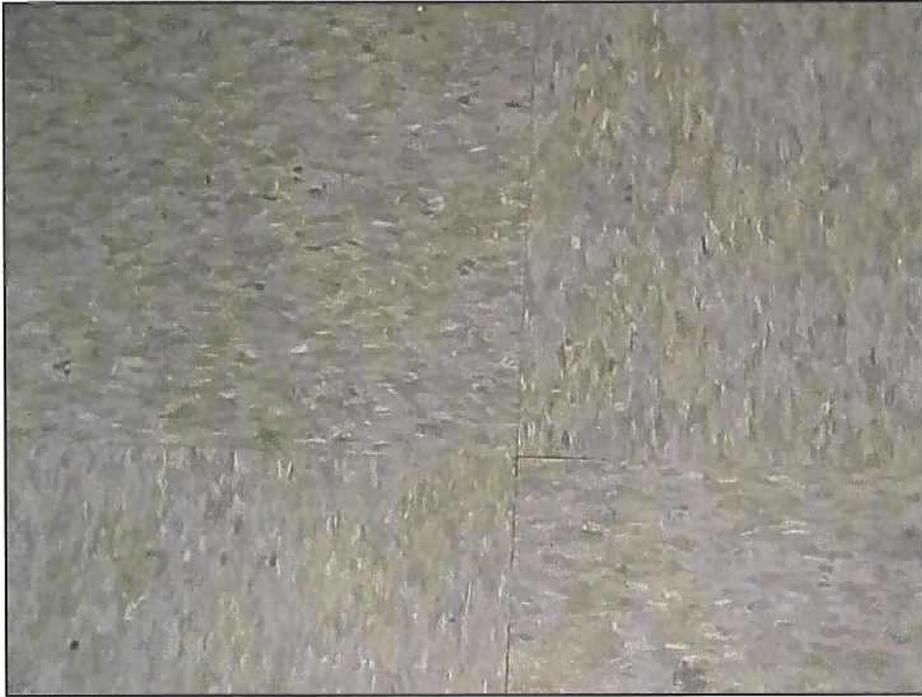
Vinyl floor tile (Material #010) over ACM adhesive (Material #011)

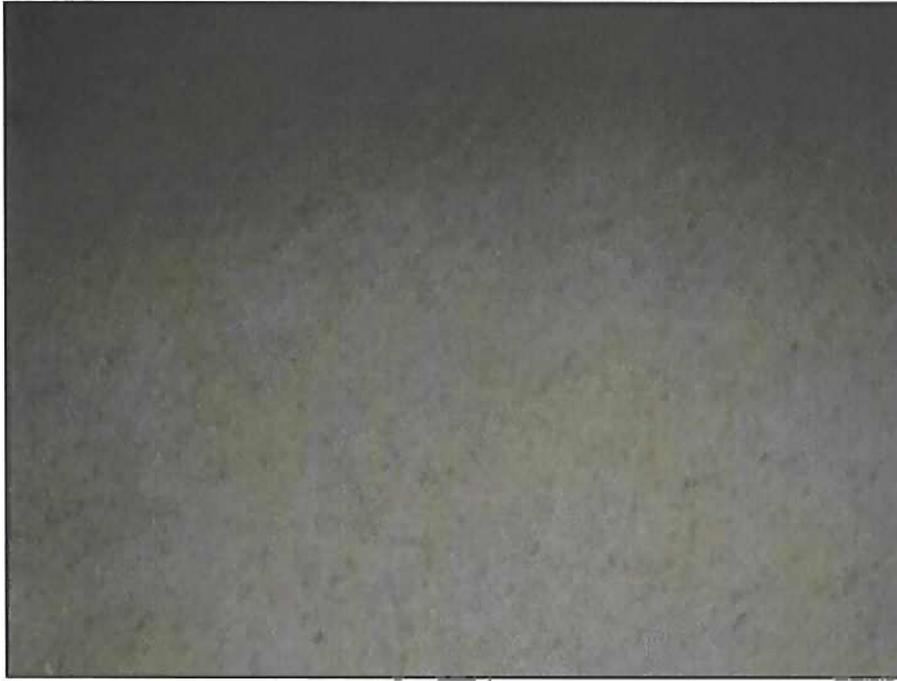
1'x1' white with tan swirls vinyl floor tile (Material #001) over floor adhesive (Material #002)

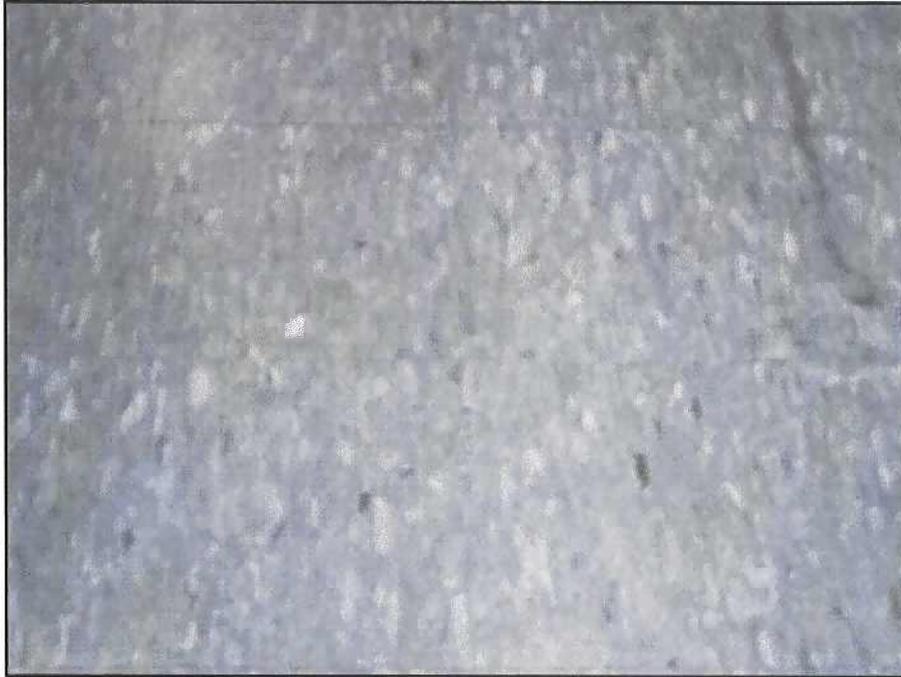
1'x1' gray with brown and white swirls vinyl floor tile (Material #007) over ACM floor adhesive (Material #008)
