Final
Asbestos Inspection Report
for

Naval Activity Puerto Rico
Ceiba, Puerto Rico

Volume 4 of 7

Buildings 1706 through 1994

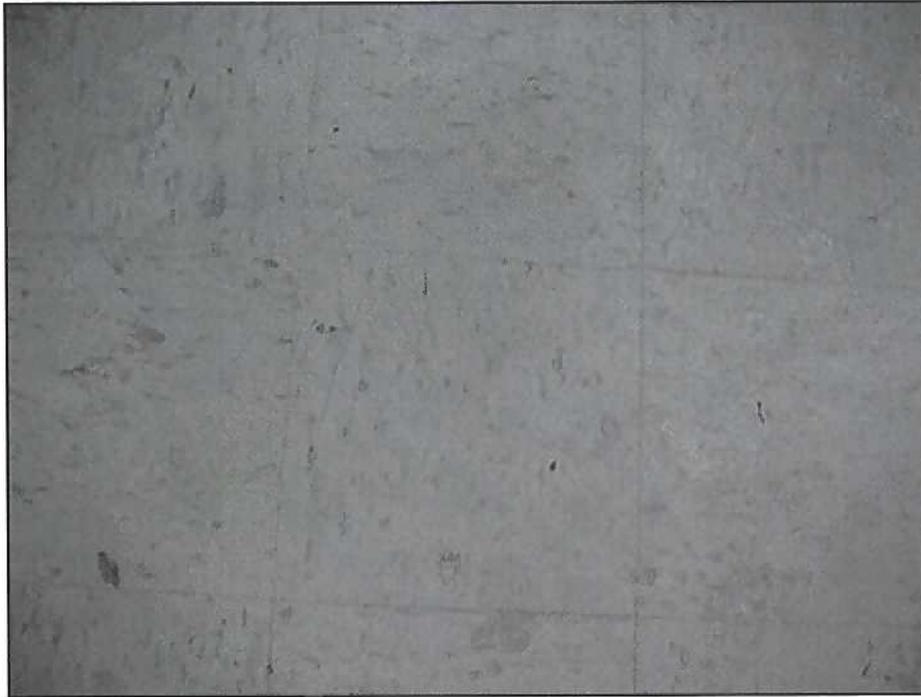
MATERIAL NUMBER	MATERIAL TYPE (MATERIAL DESCRIPTION)	ASBESTOS CONTENT	MATERIAL LOCATION(S)	FRIABLE	CONDITION	QUANTITY	COMMENTS
001	VINYL FLOOR TILE (9" X 9" LIGHT GREEN WITH GREEN STREAKS)	3% CH	SHOP	No	UNDAMAGED	960 SF	THE ADHESIVE FOR THIS TILE IS MATERIAL #002
002	FLOOR ADHESIVE (BLACK, UNDER 9" X 9" LIGHT GREEN WITH GREEN STREAKS VINYL FLOOR TILE)	7% CH	SHOP	No	UNDAMAGED	960 SF	THIS IS THE ADHESIVE FOR MATERIAL #001.

9" x 9" light green with green streaks vinyl floor tile (Material #001)
over black floor adhesive (Material #002)

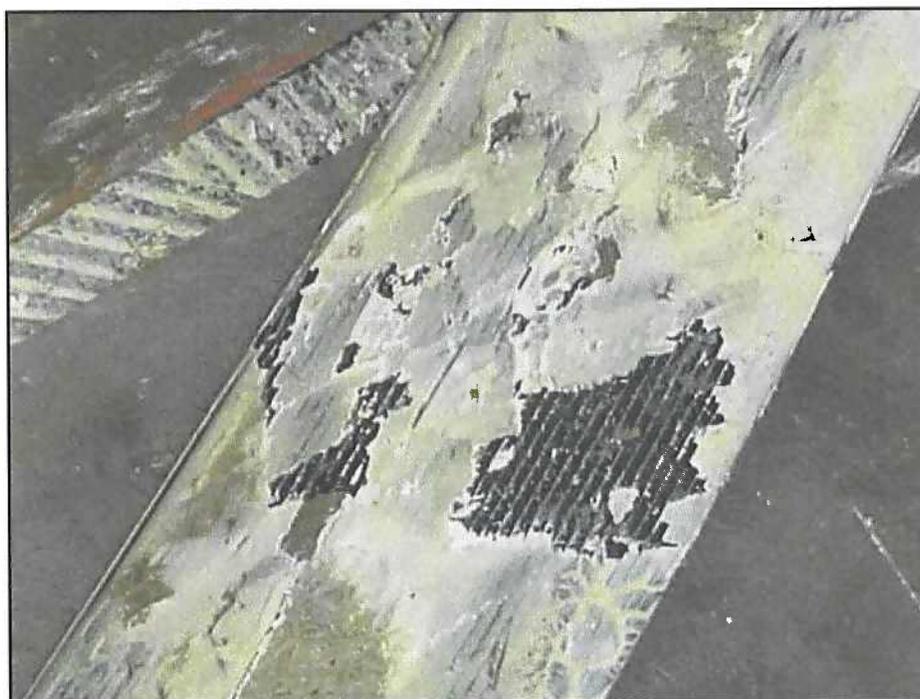
Cove base adhesive (Material #007)

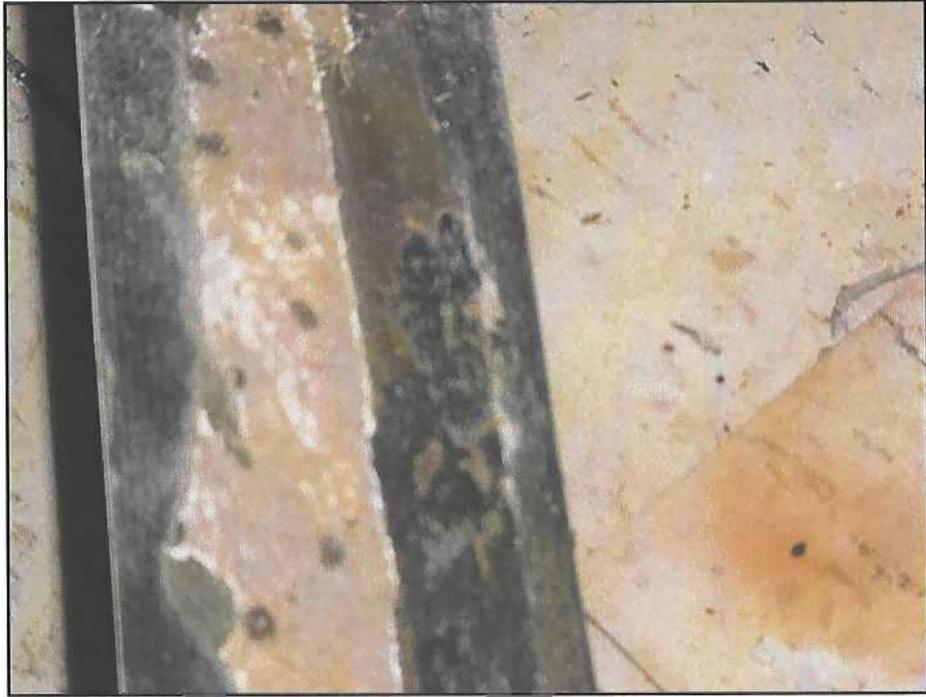
Cove base adhesive (Material #008)

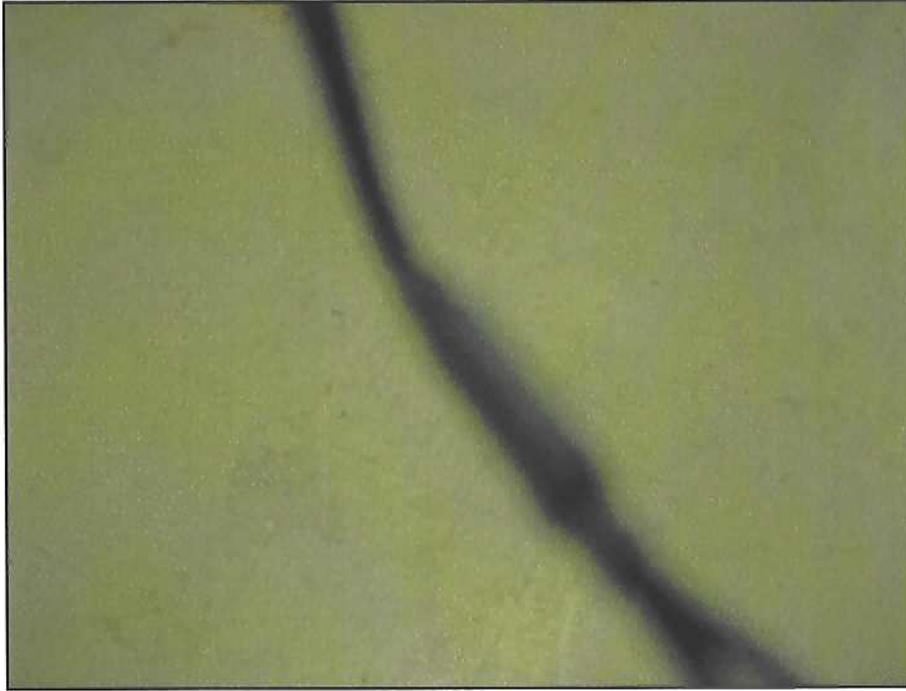
MATERIAL NUMBER	MATERIAL TYPE (MATERIAL DESCRIPTION)	ASBESTOS CONTENT	MATERIAL LOCATION(S)	FRIABLE	CONDITION	QUANTITY	COMMENTS
013	FLOOR ADHESIVE (BLACK, UNDER 012)	6% CH	009 010 011 T3 T4	No	UNDAMAGED	590 SF	THIS IS THE ADHESIVE FOR MATERIAL # 012
014	ASPHALTIC ROOFING MATERIALS (ASPHALTIC BUILT UP ROOF, BLACK)	5% CH	ROOF	No	UNDAMAGED	47,400 SF

1' x 1' gray vinyl floor tile with white streaks (Material # 012) over ACM floor adhesive (Material #013)

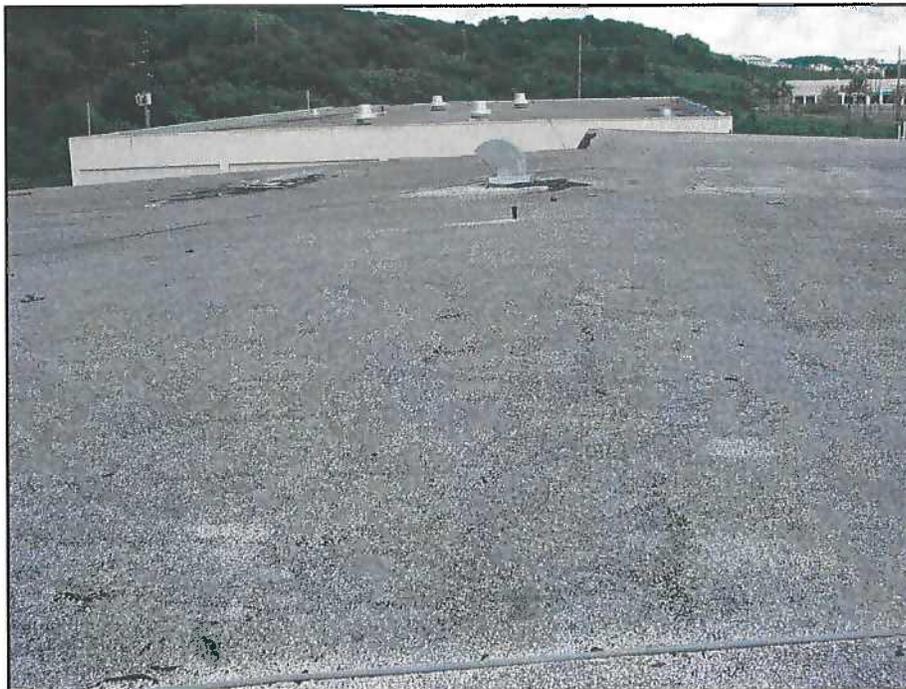
Black asphaltic roofing material (Material #014)

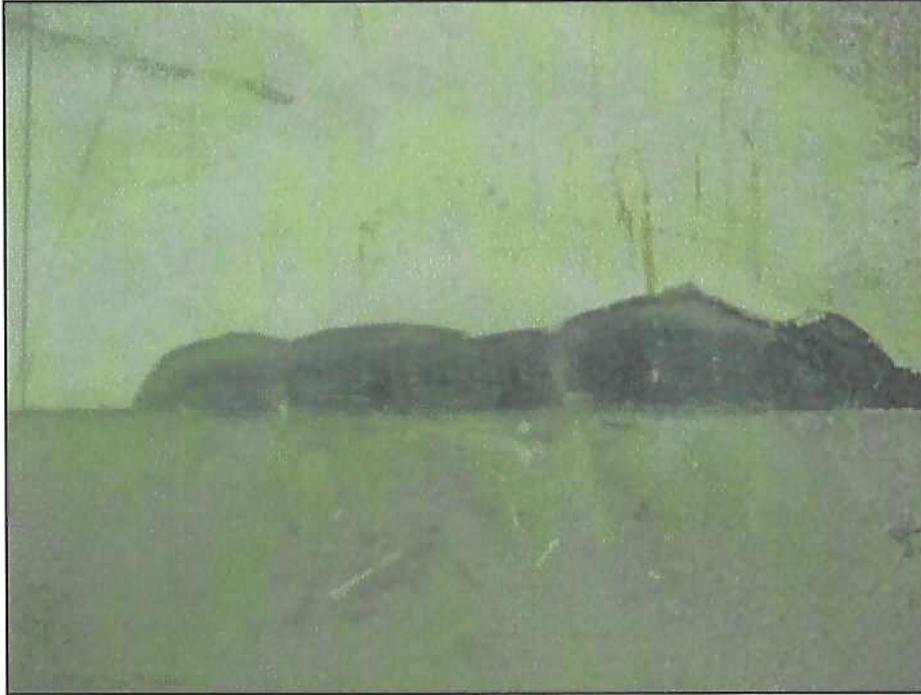
MATERIAL NUMBER	MATERIAL TYPE (MATERIAL DESCRIPTION)	ASBESTOS CONTENT	MATERIAL LOCATION(S)	FRIABLE	CONDITION	QUANTITY	COMMENTS
003	VINYL FLOOR TILE (1' X 1' TAN WITH BROWN STREAKS)	3% CH	T1	No	DAMAGED	42 SF	THE ADHESIVE FOR THIS MATERIAL IS MATERIAL #004.

1' x 1' tan with brown streaks vinyl floor tile (Material # 003)

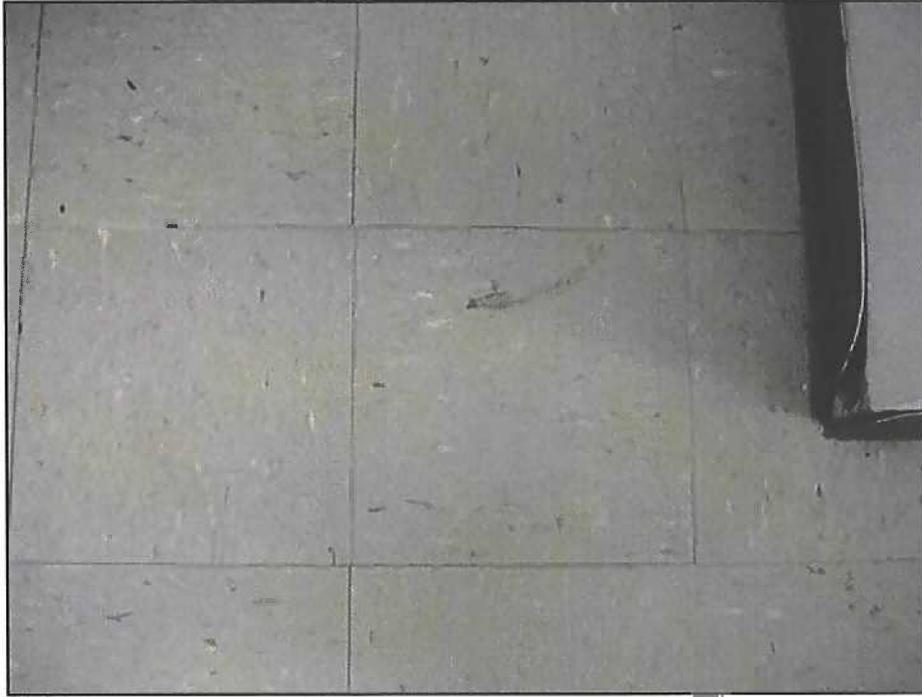
MATERIAL NUMBER	MATERIAL TYPE (MATERIAL DESCRIPTION)	ASBESTOS CONTENT	MATERIAL LOCATION(S)	FRIABLE	CONDITION	QUANTITY	COMMENTS
004	VINYL FLOOR TILE (1' X 1' BONE WITH BROWN AND WHITE STREAKS)	4% CH	002 003 005 HALLWAY	No	UNDAMAGED	2,572 SF	THE ADHESIVE FOR THIS MATERIAL IS MATERIAL #002.

1' x 1' bone colored vinyl floor tile with brown and white streaks (Material # 004)

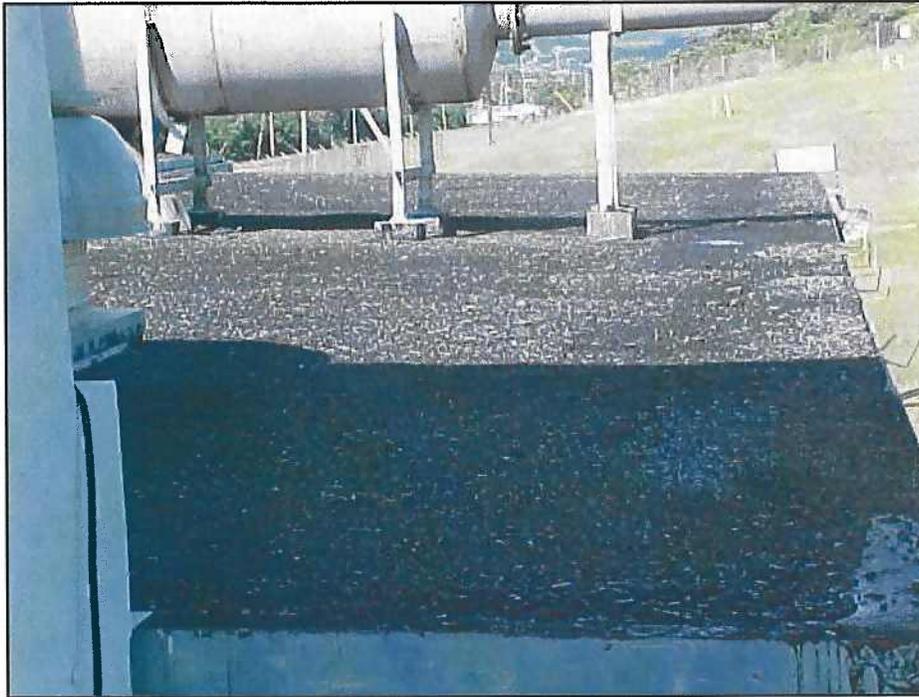
MATERIAL NUMBER	MATERIAL TYPE (MATERIAL DESCRIPTION)	ASBESTOS CONTENT	MATERIAL LOCATION(S)	FRIABLE	CONDITION	QUANTITY	COMMENTS
001	ASPHALTIC ROOFING MATERIALS (BLACK)	15% CH	ROOF	No	UNDAMAGED	5,494 SF	
002	SHEET GASKET (8" - 12" DIAMETER, BLACK)	65% CH	4	No	UNDAMAGED	120 EA

Asphaltic roofing material (Material #001)

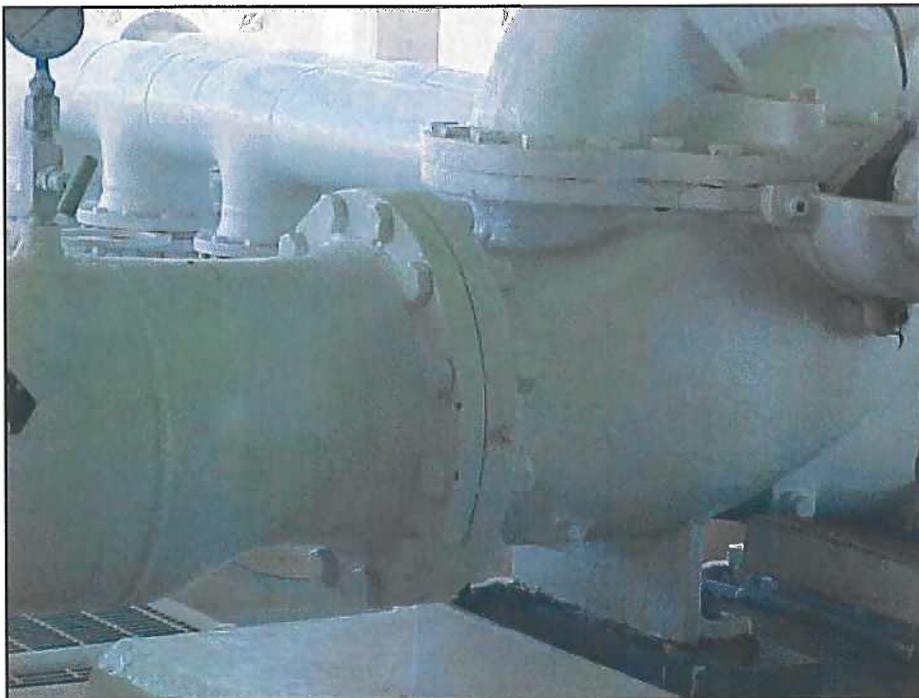
Sheet gasket (Material #002)
