REMEDIAL INVESTIGATION PHOTOGRAPH ALBUM

**OPERABLE UNIT NO. 8 (SITE 16)
OPERABLE UNIT NO. 11 (SITES 7 AND 80)
OPERABLE UNIT NO. 12 (SITE 3)**

**MARINE CORPS BASE, CAMP LEJEUNE
NORTH CAROLINA**

MARCH 27, 1995

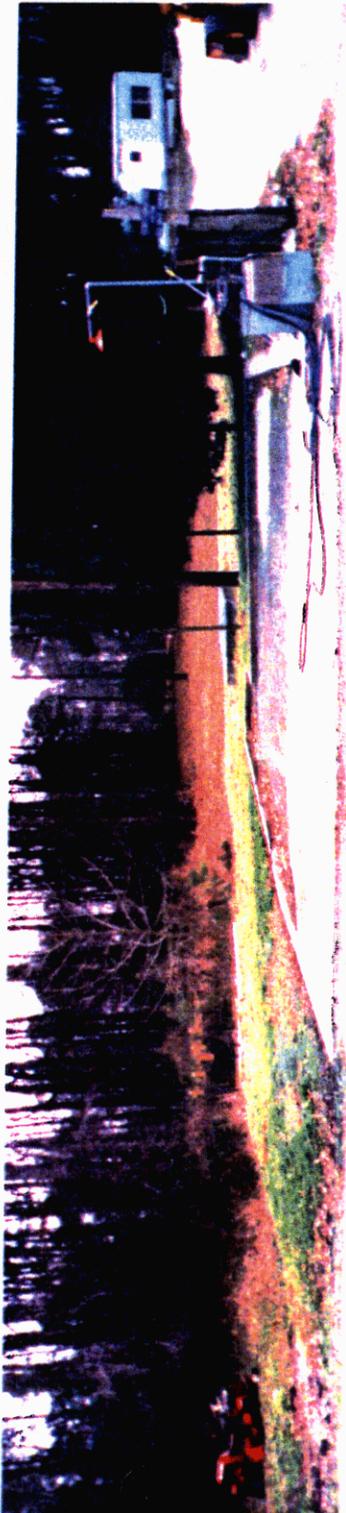
OU11-Site80:

View of concrete pad wash area
with monitoring well 80-MW03 to
the left.

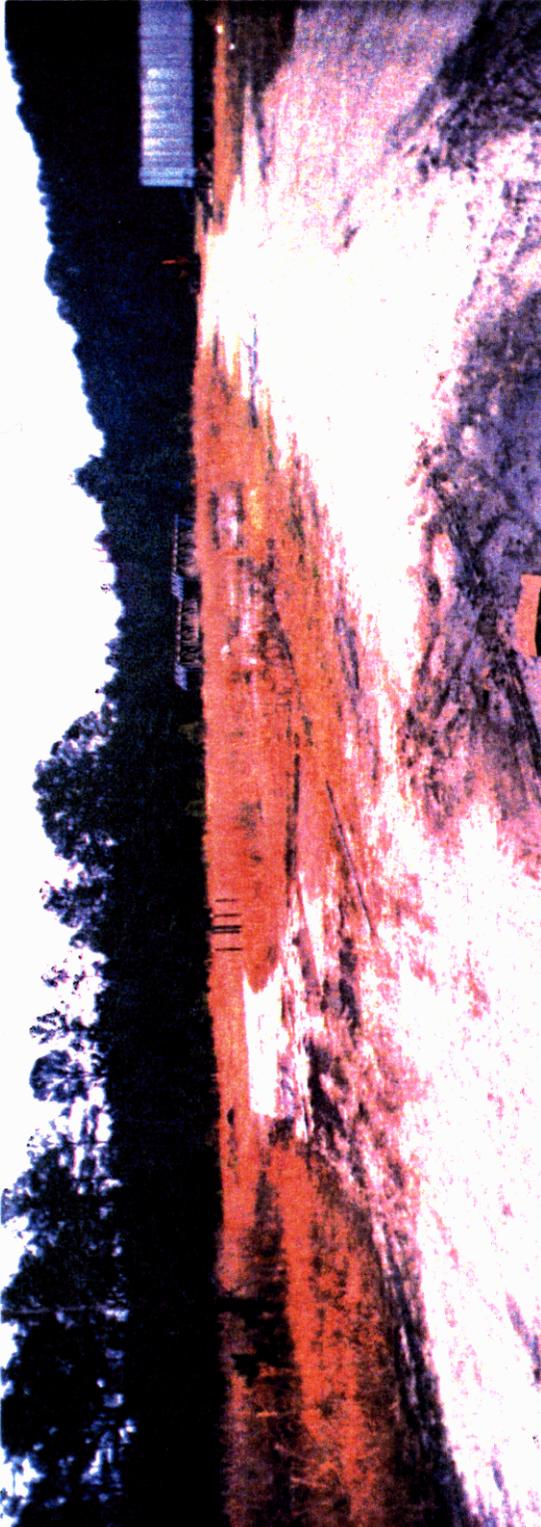
OU12-Site3:

Photograph of south area (treatment area). Monitoring well 3-MW02 is visible at the right center of the photograph.

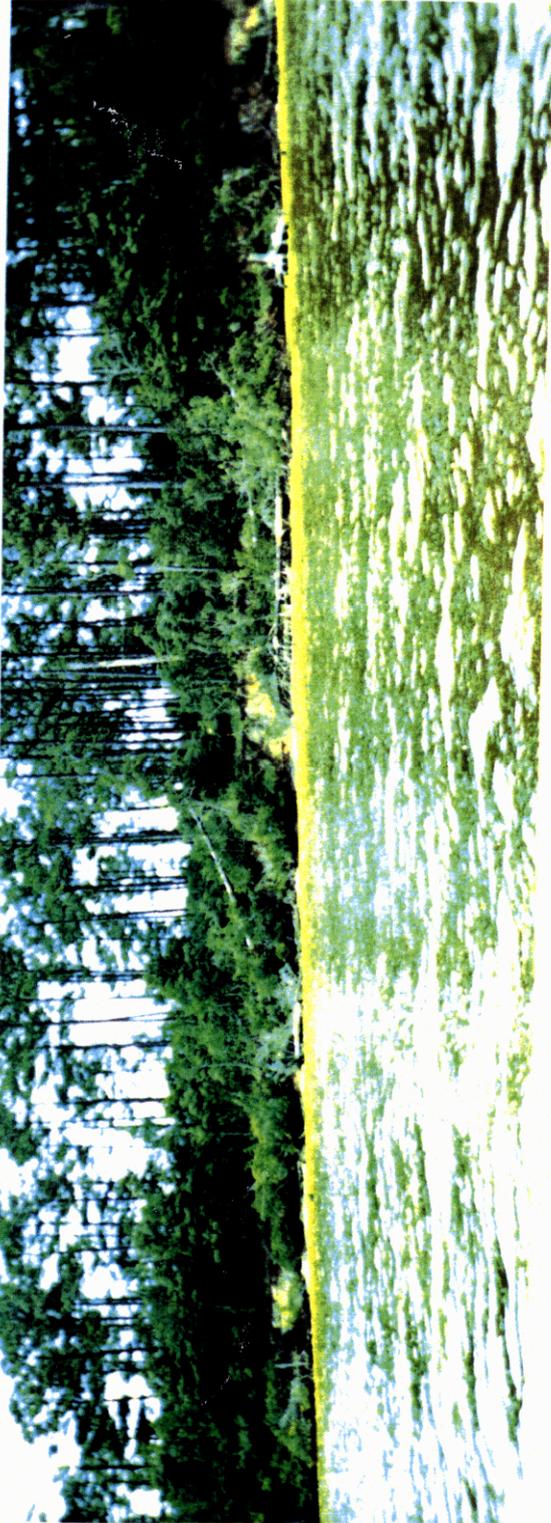
SWSEDINVEST:

Photograph taken from Northeast Creek (middle of creek) looking at sampling station 16-SW/SD03 located in the middle of the photograph.

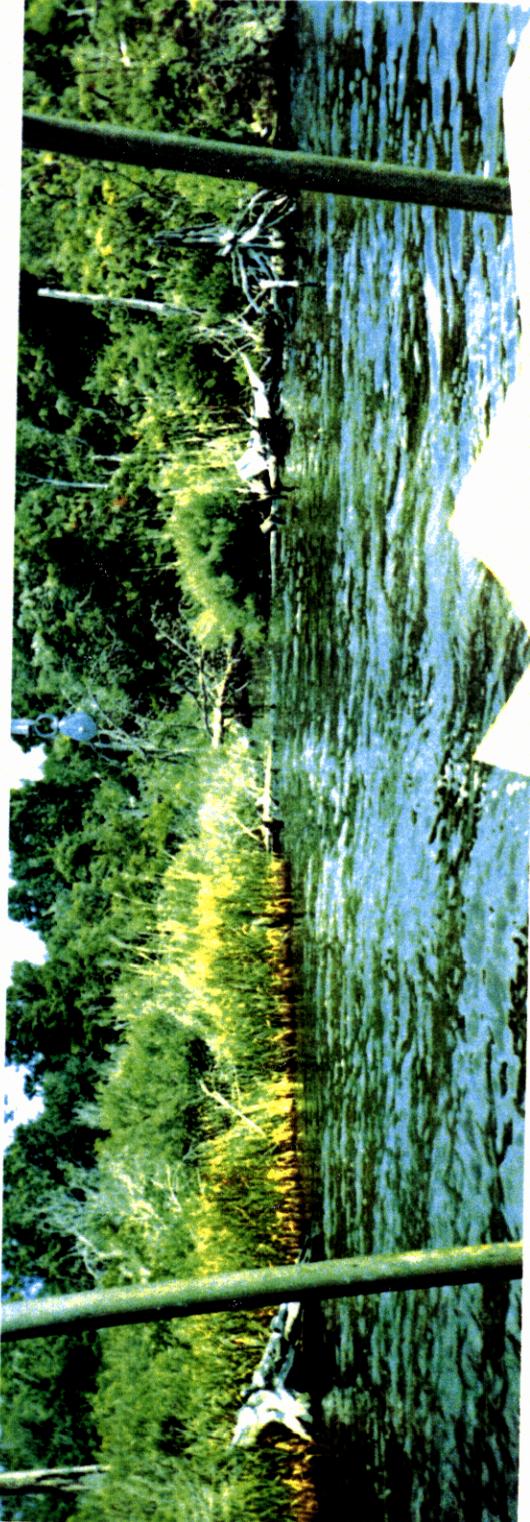
SWSEDINVEST:

Photograph of sampling station 7-NC-SW/SD03 along Northeast Creek. This is confluence of Eastern Tributary with Northeast Creek.

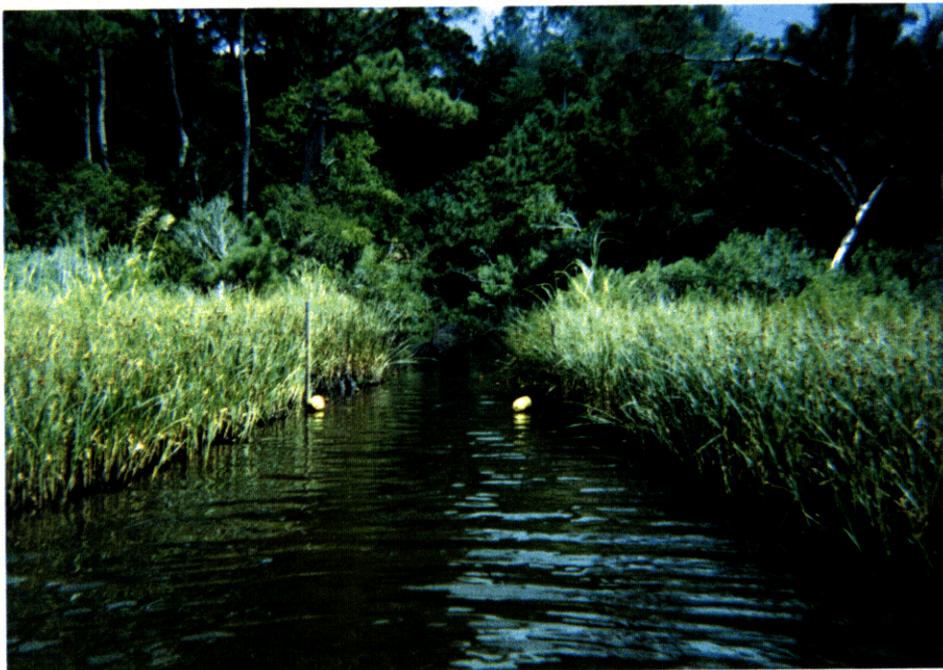
AQUATICECOL: Photograph taken from station 7-WT-SW/SD03 looking north.

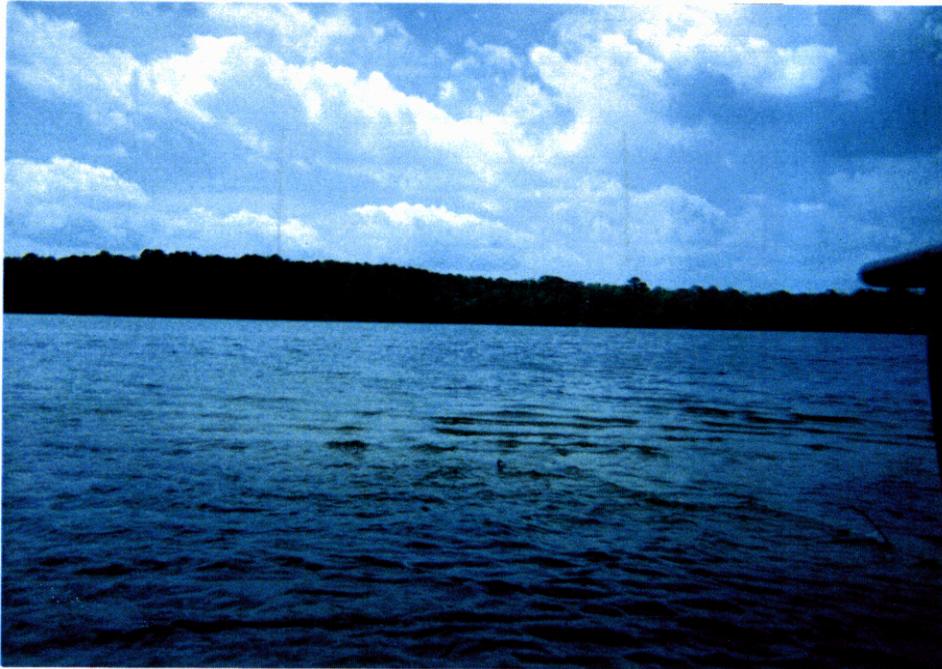
AQUATICECOL: Photograph taken from station 7-WT-SW/SD03 facing away from the station looking out into the Northeast Creek.

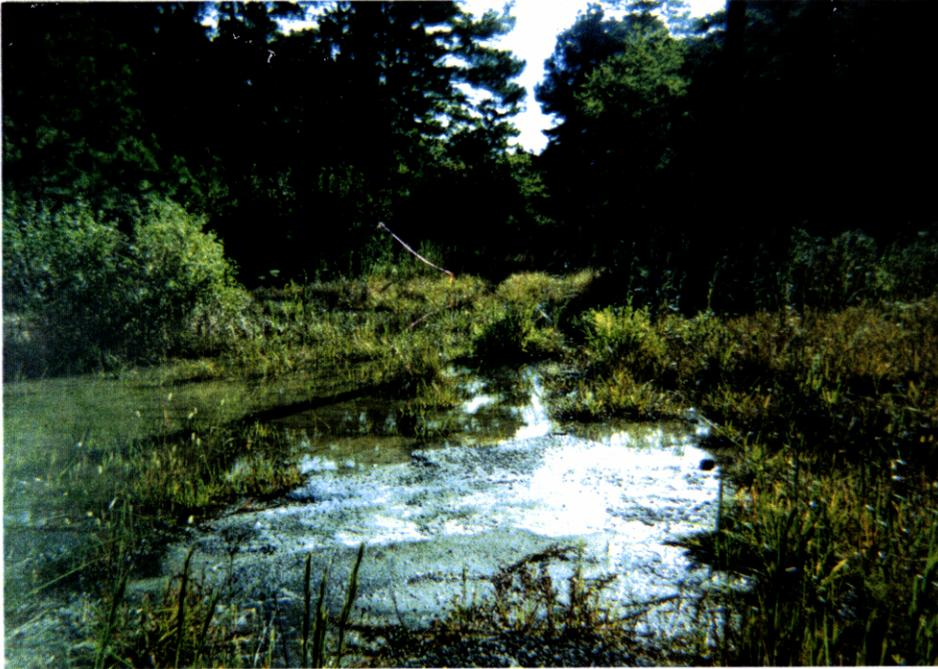
AQUATICECOL: Photograph of ponded water east of the Community Center parking lot near sampling location 7-EA-SB05.
