**FRIABLE AND DAMAGED FRIABLE ASBESTOS-CONTAINING  
MATERIALS SURVEY AT THE  
CHARLESTON NAVAL SHIPYARD  
CHARLESTON, SOUTH CAROLINA**

**CONTRACT NUMBER N62467-00-D-0345**

**SEPTEMBER 2000**

**Friable and Damaged Friable Asbestos-Containing Materials Survey for  
Buildings 81, 86, 141, 180, 199, 220, 658, 1079, 1509, 1777, 1884, 1886,  
1892, NS67, and NS675 at Charleston Naval Shipyard  
Charleston, South Carolina**

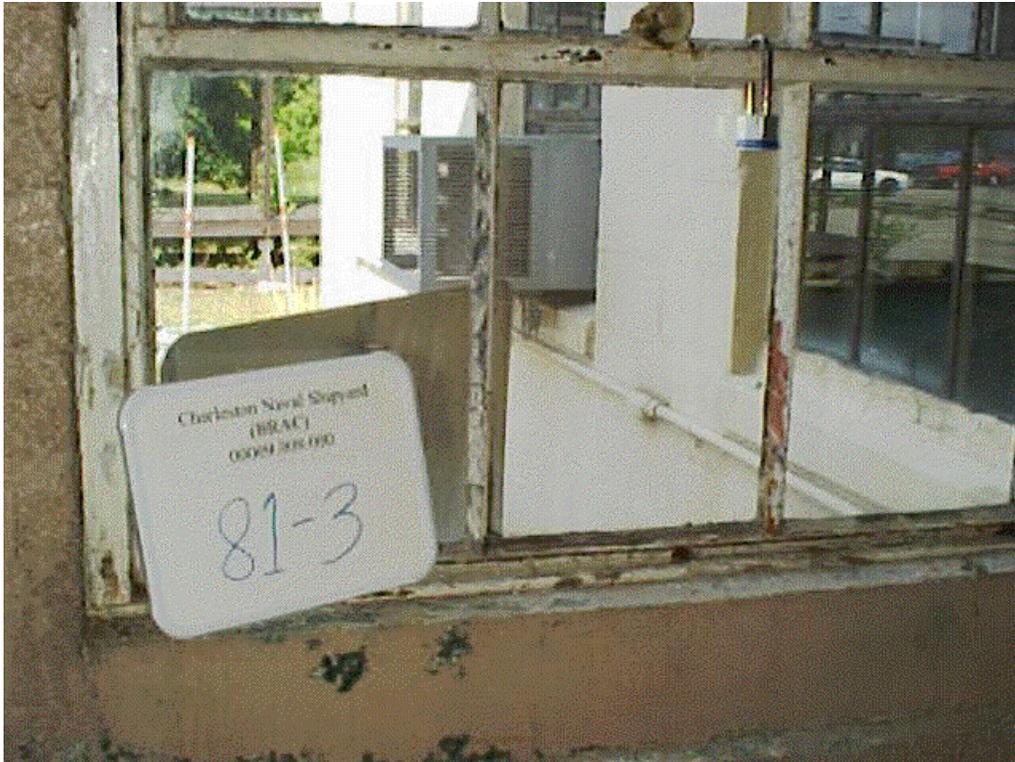
HA #	Material Description	Material Location	ACM (YES/NO)
3	Damaged window putty	Interior windows	YES

<b>HA#</b>	<b>Material Description</b>	<b>Damage Location</b>	<b>Damage Quantity</b>	<b>Abatement Response Action</b>
1	9"x9" floor tile and mastic, green	101	230 SF	Remove/replace
3	Window putty	Interior windows	650 LF	Remove/replace

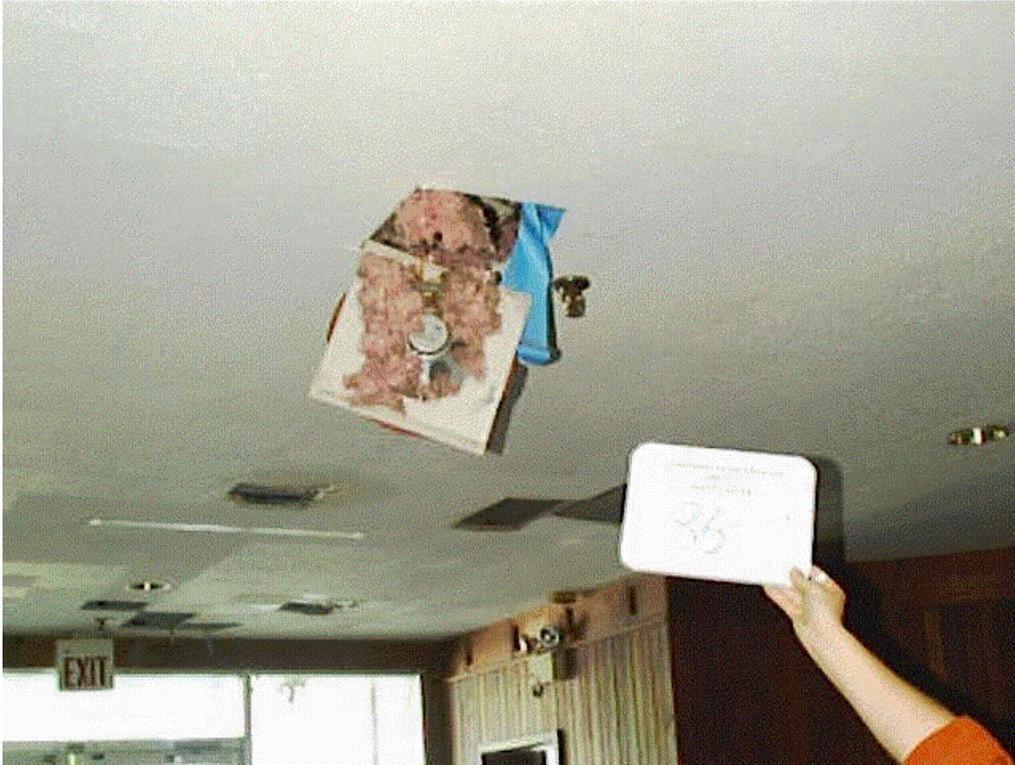
HA #	Material Description	Material Location	ACM (YES/NO)
10	1'x1' ceiling tile, grooved	C1, C2, C4, 115-117, 101	NO

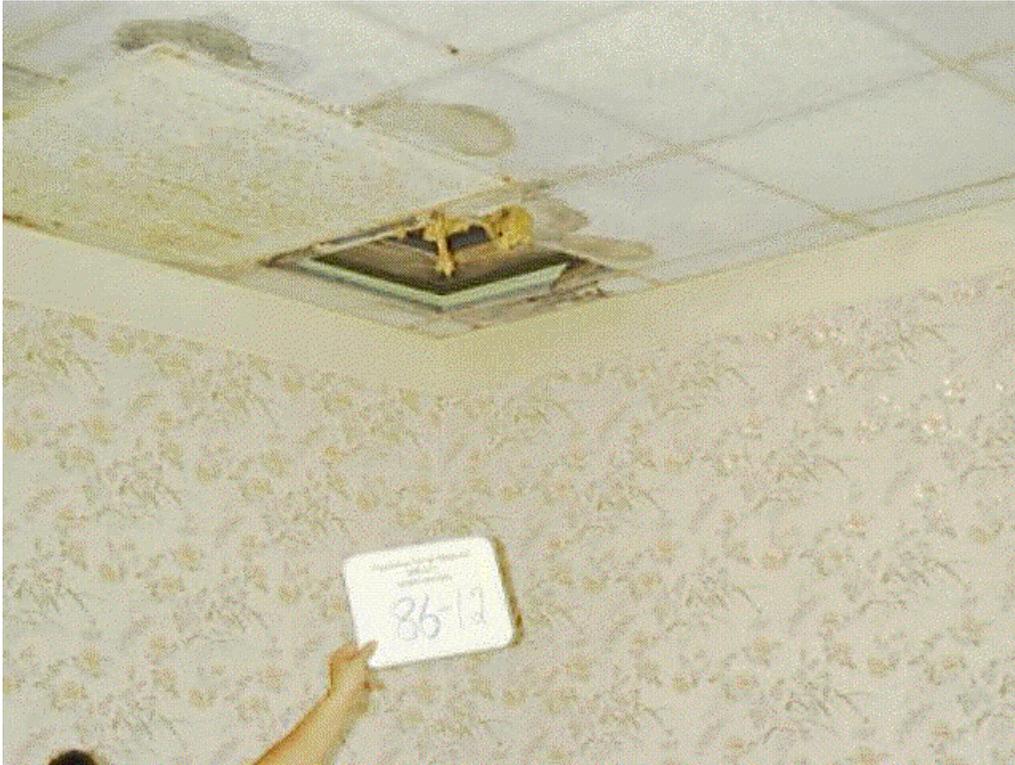
HA #	Material Description	Material Location	ACM (YES/NO)
12	2'x2' ceiling tile, recessed-rough	101	NO

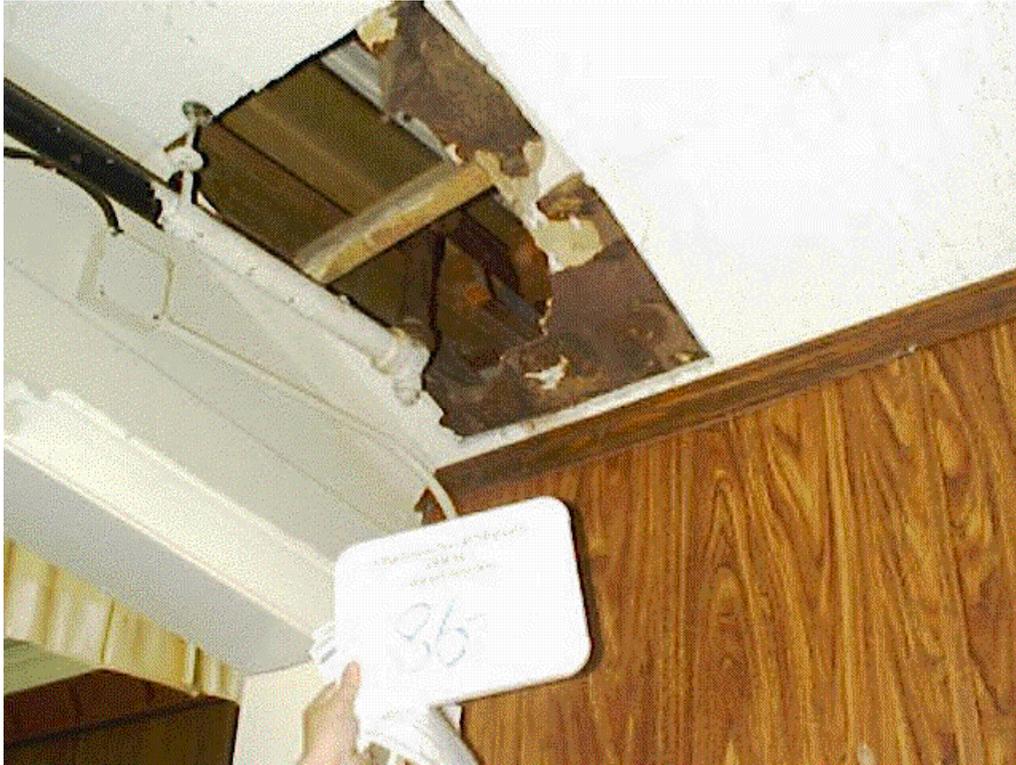
HA #	Material Description	Material Location	ACM (YES/NO)
13	2'x2' ceiling tile, recessed-grooved-pinhole	102	NO

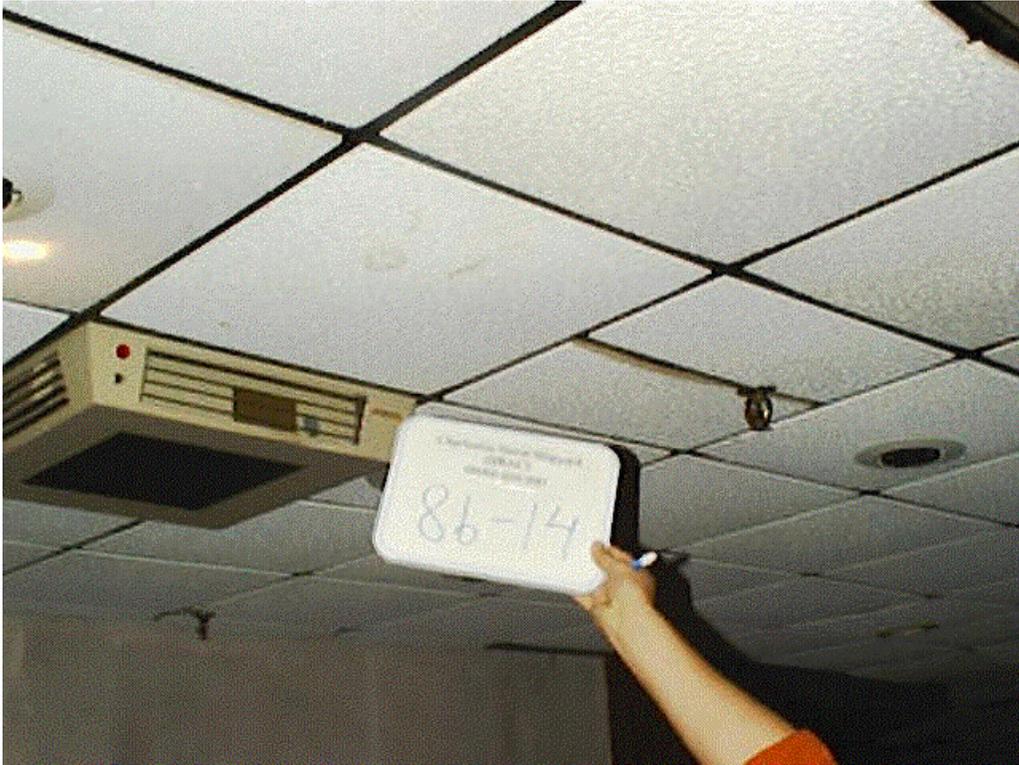
HA #	Material Description	Material Location	ACM (YES/NO)
14	2'x2' ceiling tile, recessed-pitted-pinhole	121	NO

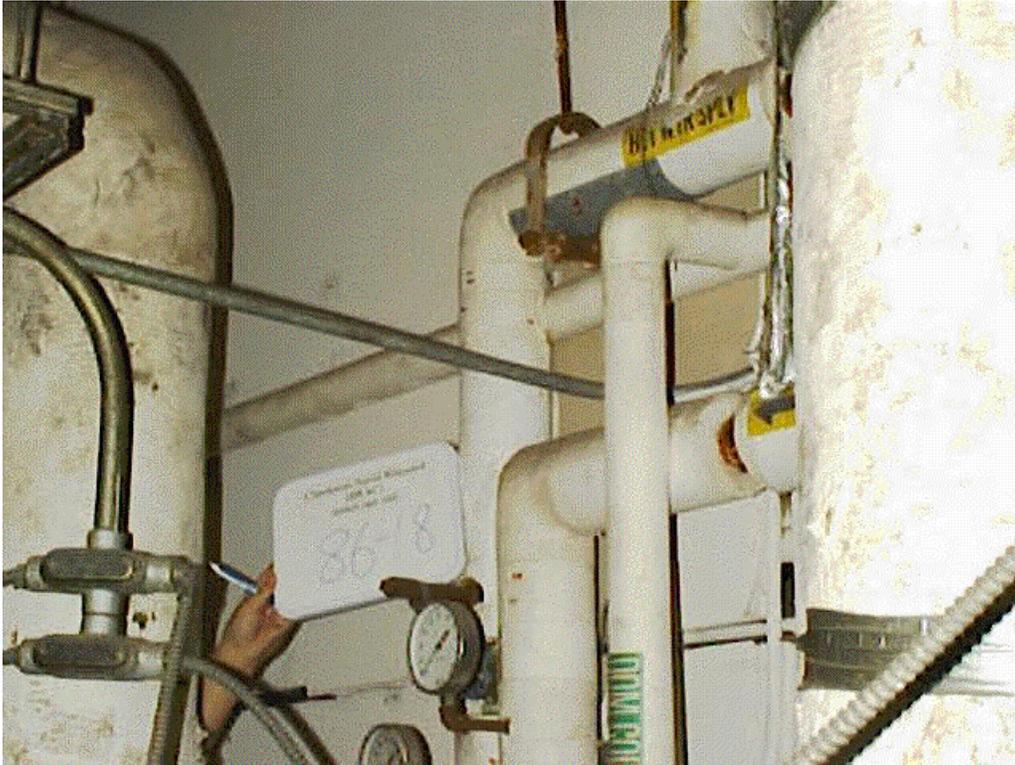
HA #	Material Description	Material Location	ACM (YES/NO)
18	Pipe fitting insulation on domestic lines	M1	NO

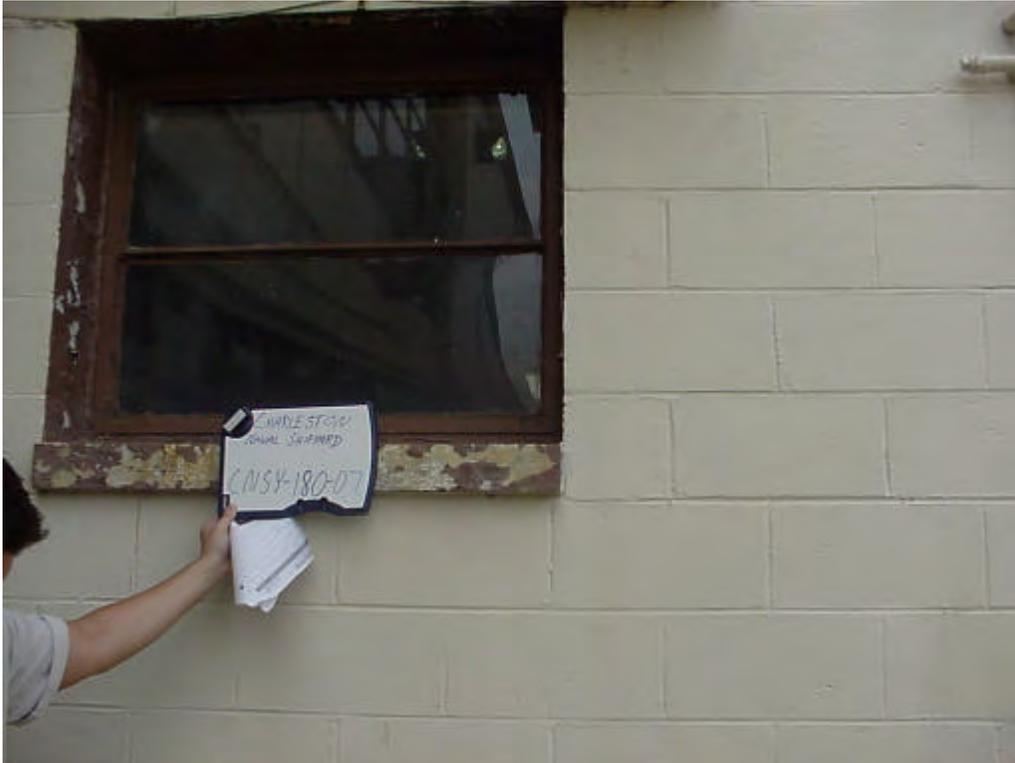
HA #	Material Description	Material Location	ACM (YES/NO)
7	Damaged window putty	Exterior windows	No

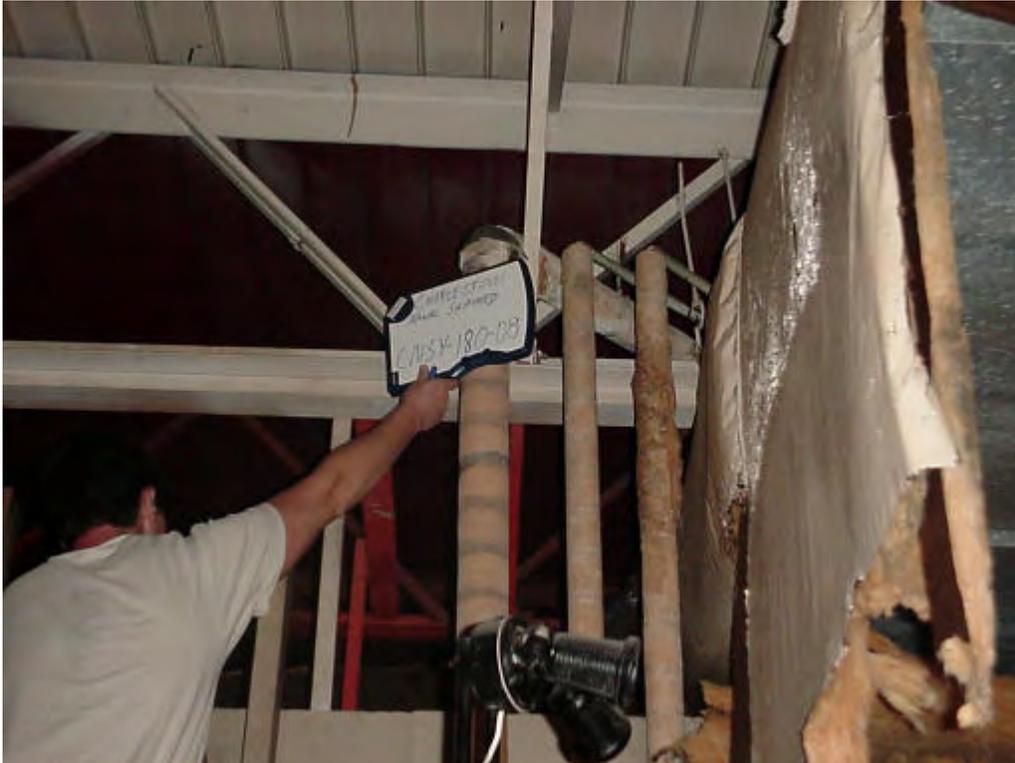
HA #	Material Description	Material Location	ACM (YES/NO)
8	Pipe fitting insulation on domestic water line	Storage 2, Gymnasium	No

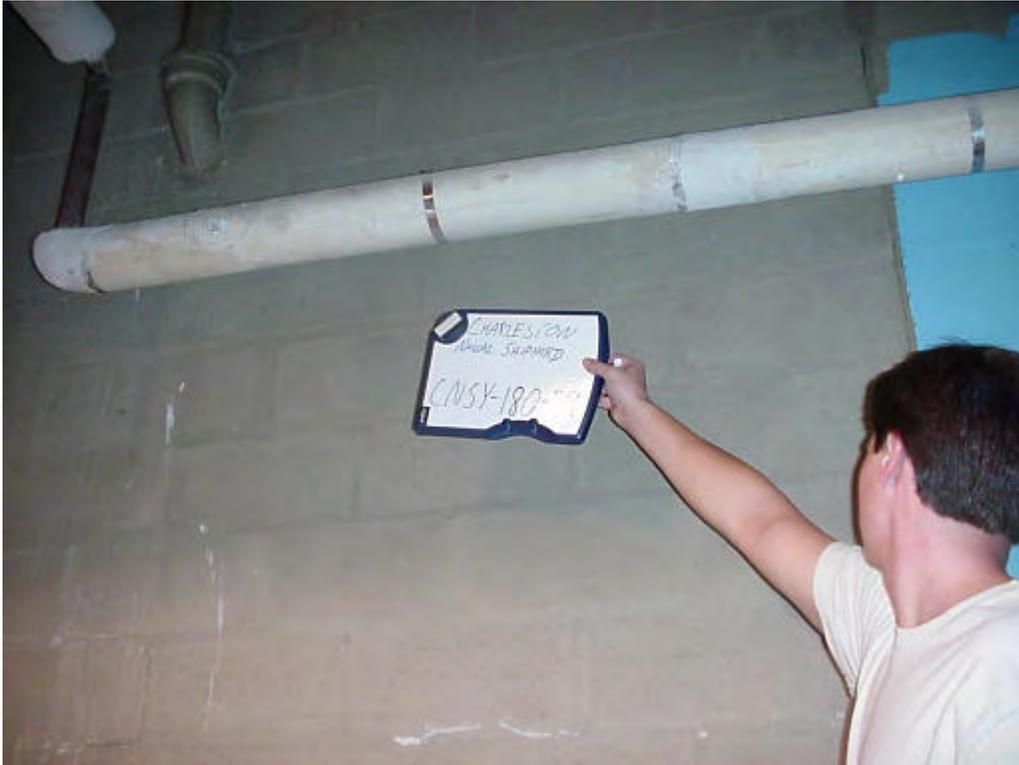
HA #	Material Description	Material Location	ACM (YES/NO)
9	Pipe insulation on steam lines	Auditorium, Storage 5, Storage 2, Lobby, Men's Room	No

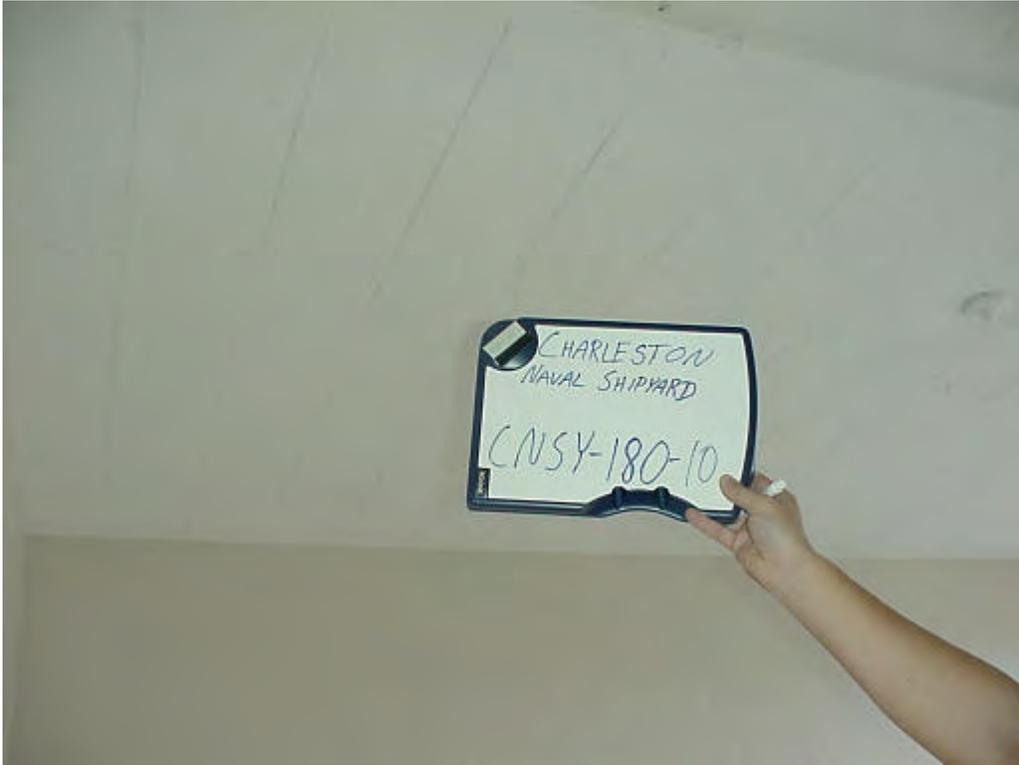
HA #	Material Description	Material Location	ACM (YES/NO)
10	1' x 1' ceiling tile	Office 25, Office 26	No

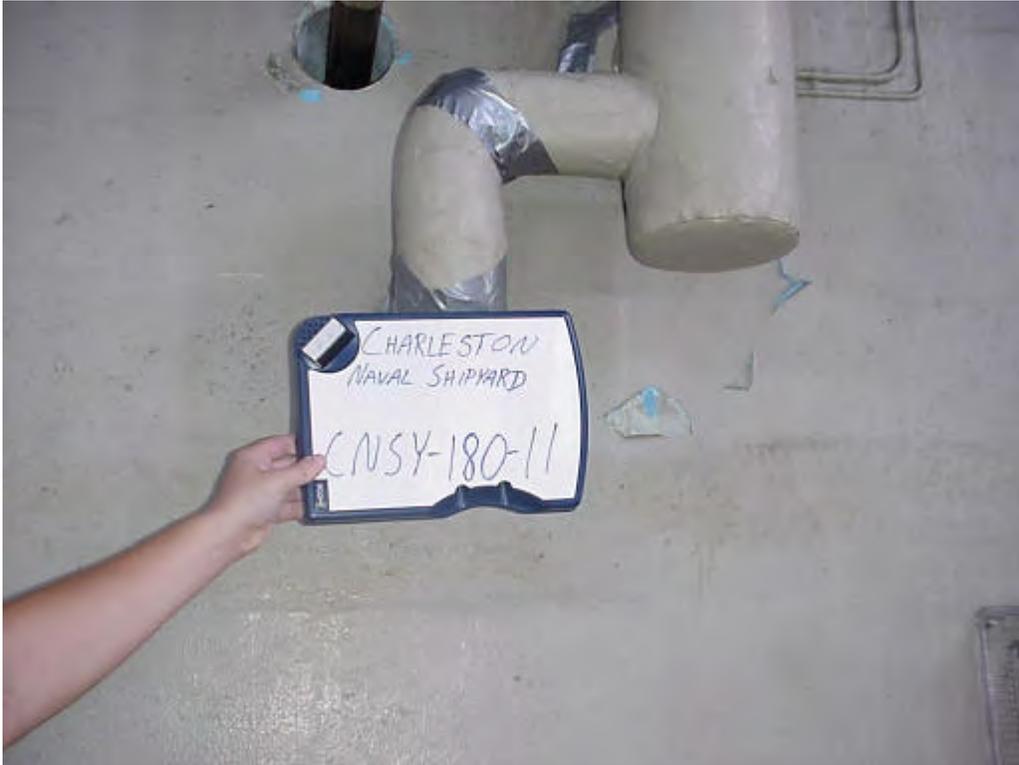
HA #	Material Description	Material Location	ACM (YES/NO)
11	Pipe fitting insulation on steam lines	Gymnasium	No

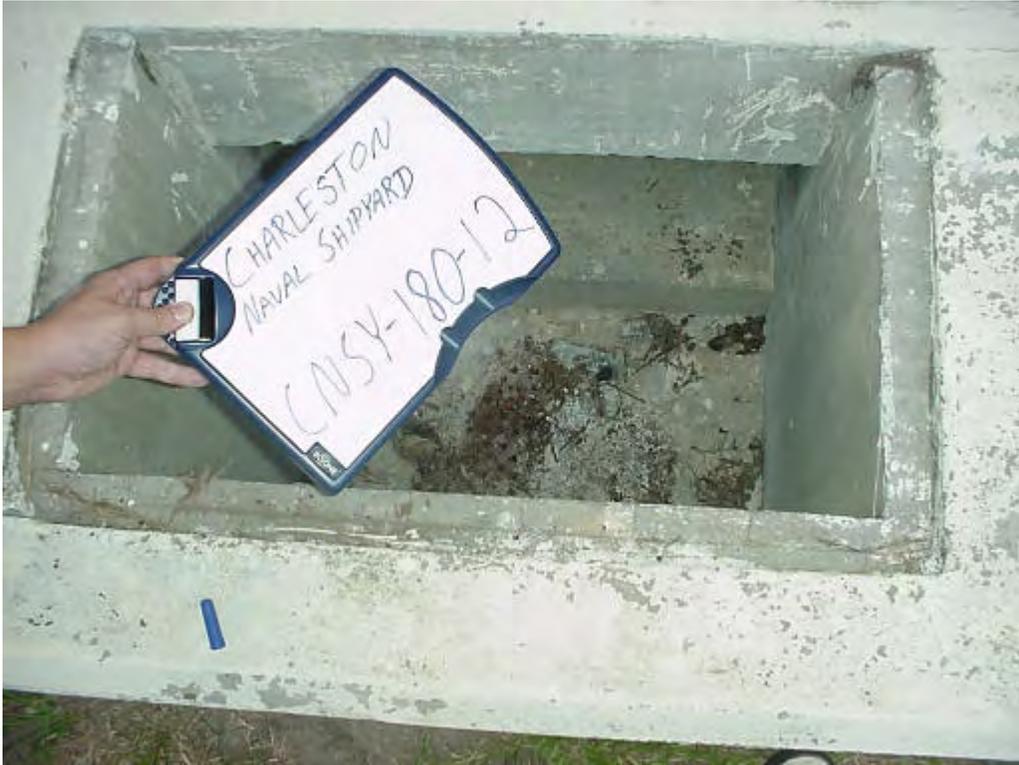
HA #	Material Description	Material Location	ACM (YES/NO)
12	Thermal system insulation debris	Exterior (N.W. side)	No

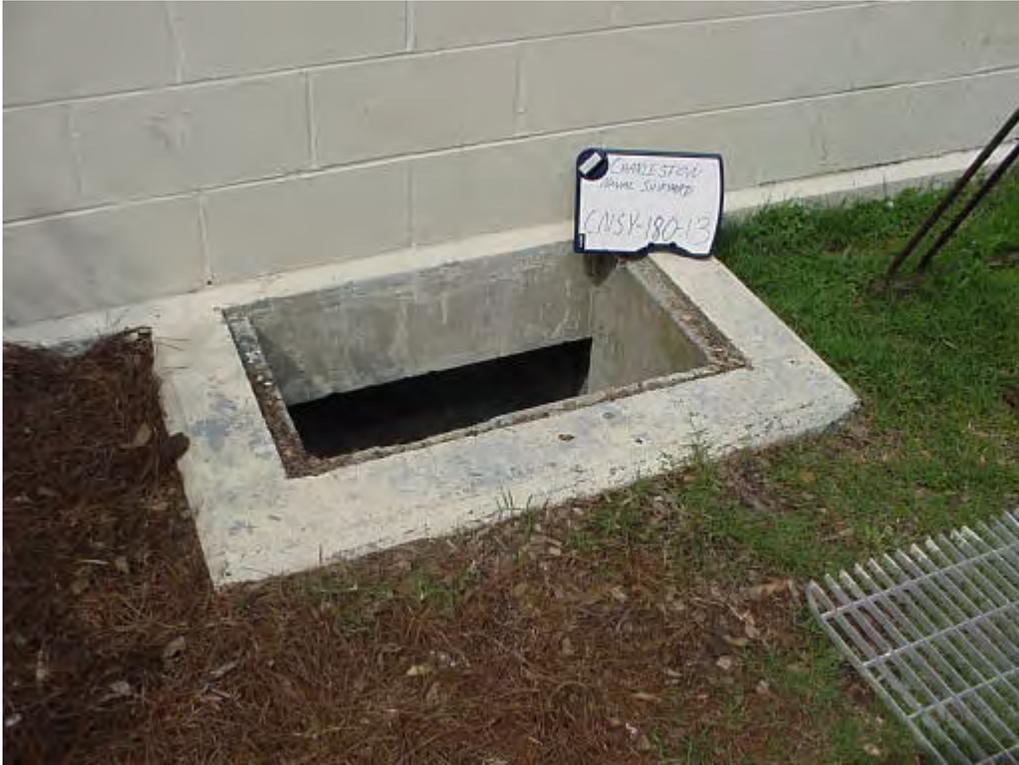
HA #	Material Description	Material Location	ACM (YES/NO)
13	Contaminated soil	Crawlspace	Yes

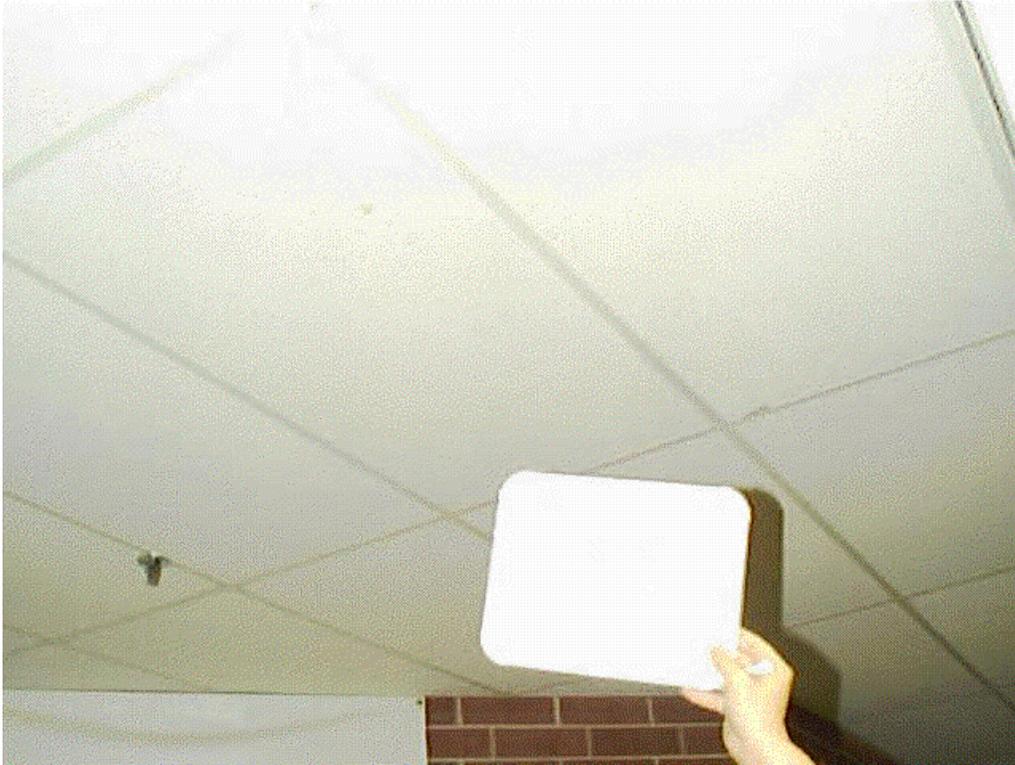
HA #	Material Description	Material Location	ACM (YES/NO)
2	2'x4' ceiling tile, pitted-pinhole	South wing (1 <sup>st</sup> and 2 <sup>nd</sup> floors)	NO

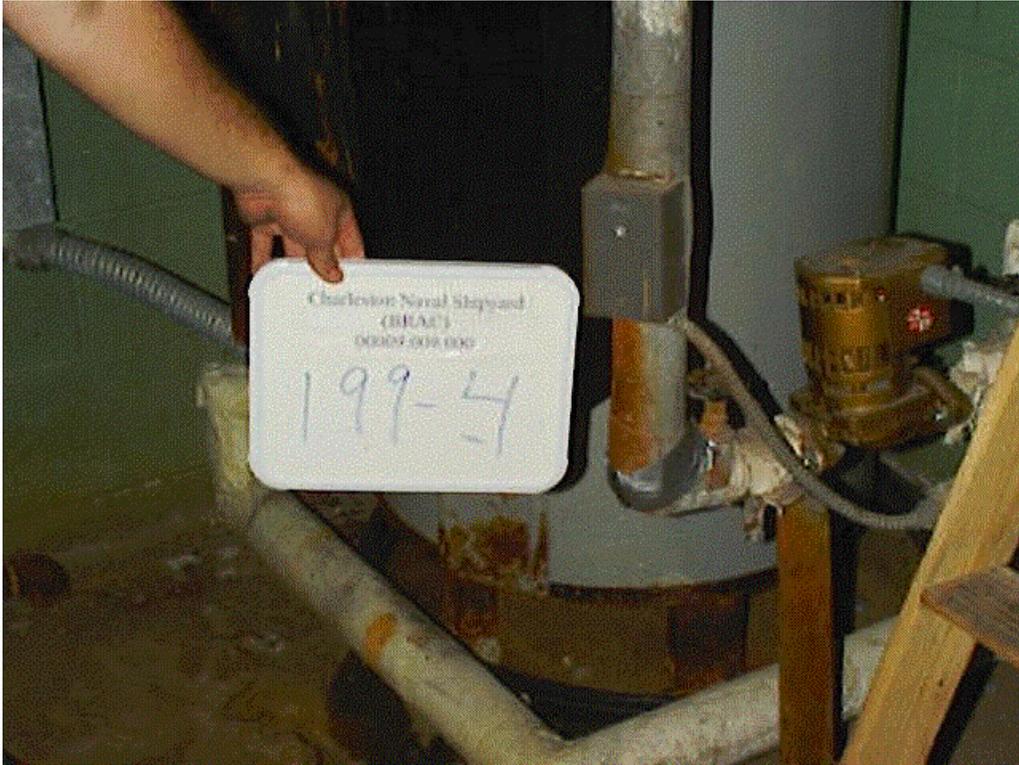
HA #	Material Description	Material Location	ACM (YES/NO)
4	Pipe fitting insulation on water lines	Mech. room	YES

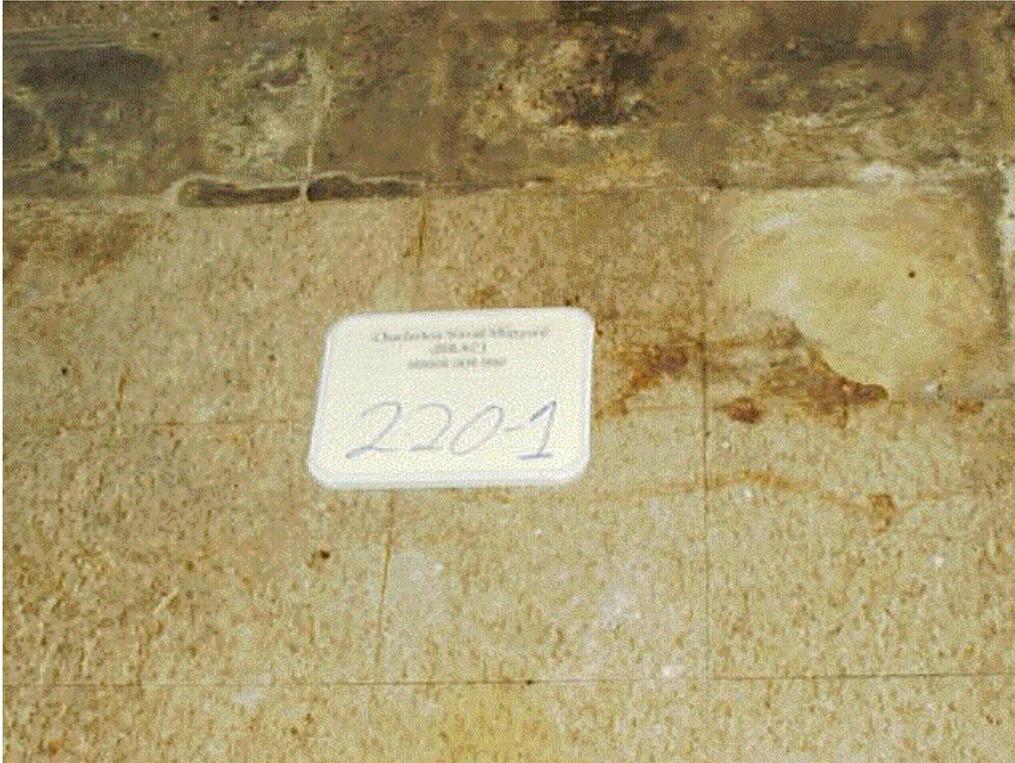
HA #	Material Description	Material Location	ACM (YES/NO)
1	Damaged 12"x12" floor tile and mastic, tan	110	YES

HA#	Material Description	Damage Location	Damage Quantity	Abatement Response Action
1	12"x12" non-asbestos containing floor tile with asbestos-containing mastic, tan	110	25 SF	Remove/replace
2	Joint compound associated with gypsum wallboard	110	20 SF	Repair
3	Transite-type wall panels	112	60 SF	Remove
8	Textured ceiling material	112	10 SF	Remove/replace

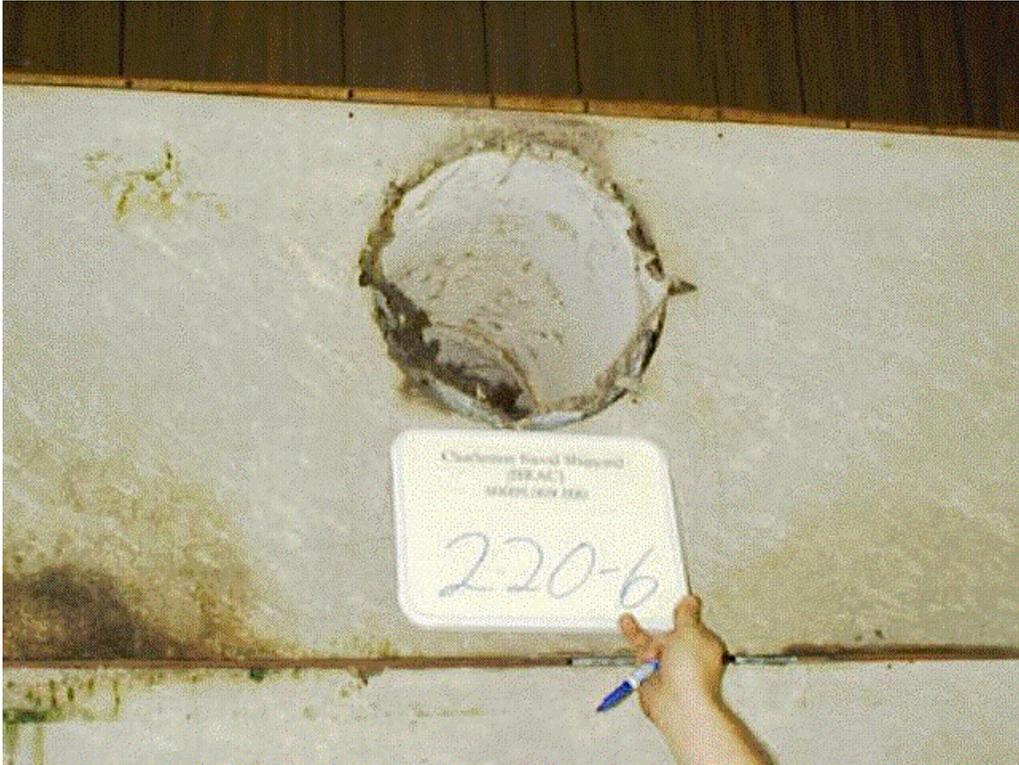
HA #	Material Description	Material Location	ACM (YES/NO)
6	Exhaust duct insulation	112	NO

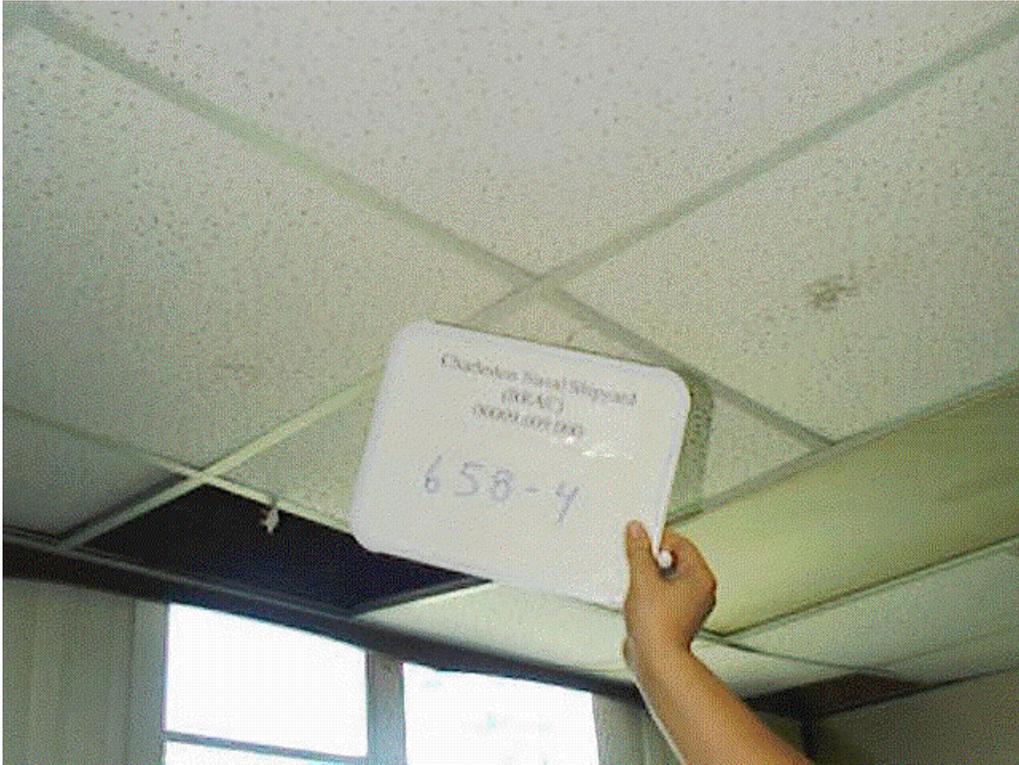
HA #	Material Description	Material Location	ACM (YES/NO)
4	2'x2' ceiling tile, star pattern	121, 122	NO

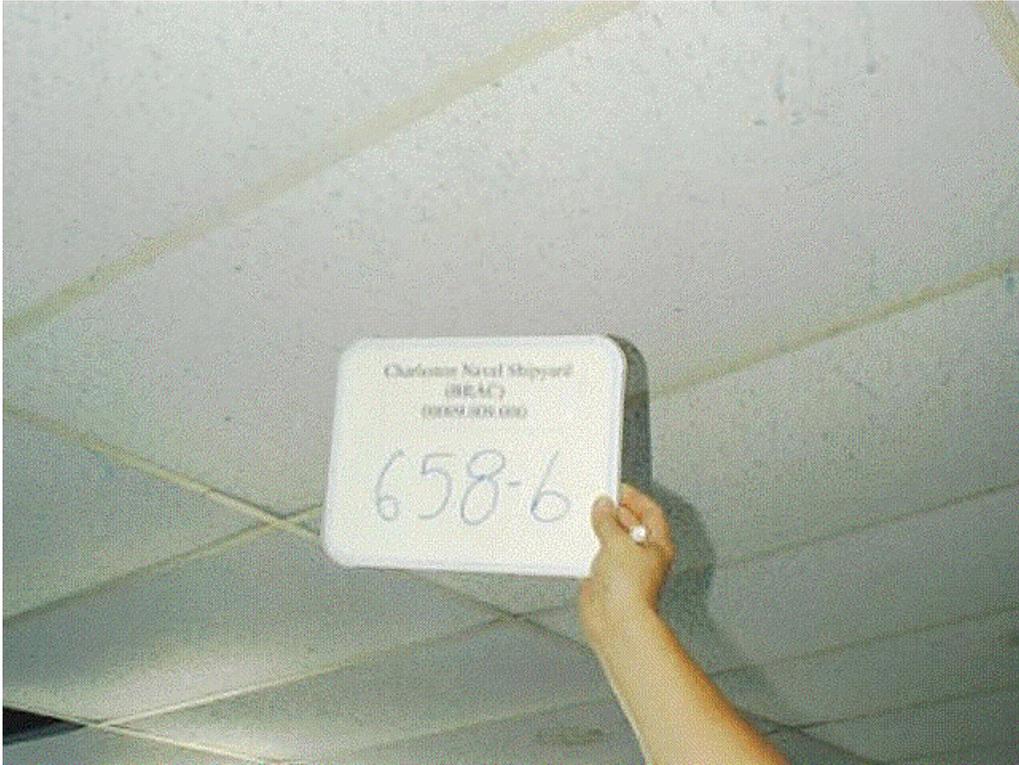
HA #	Material Description	Material Location	ACM (YES/NO)
6	2'x4' ceiling tile, pinhole grooved	225, 326	NO

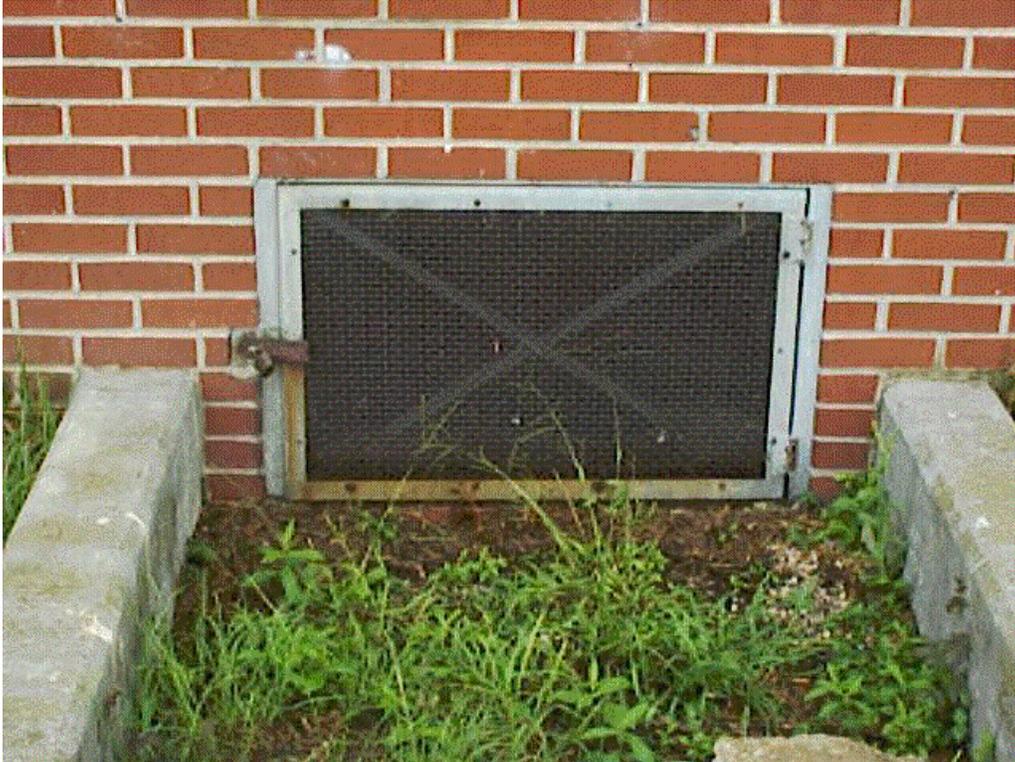
HA #	Material Description	Material Location	ACM (YES/NO)
9	Soil	Crawlspace	NO

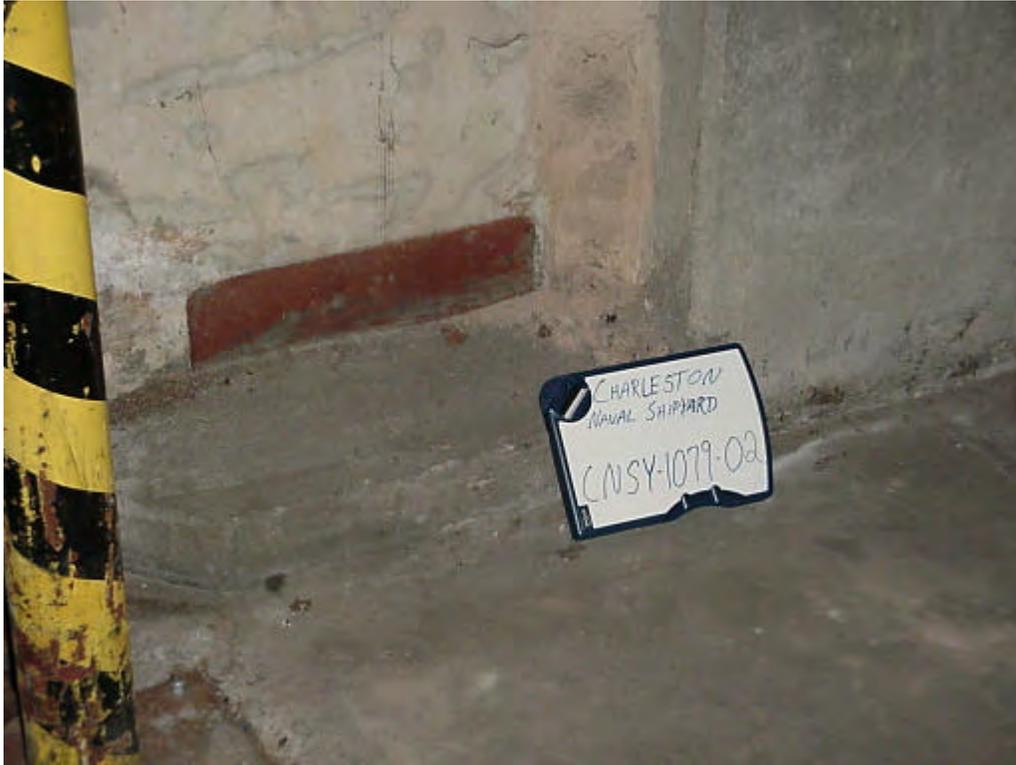
HA #	Material Description	Material Location	ACM (YES/NO)
2	Spray-applied fire proofing material	Throughout building	No

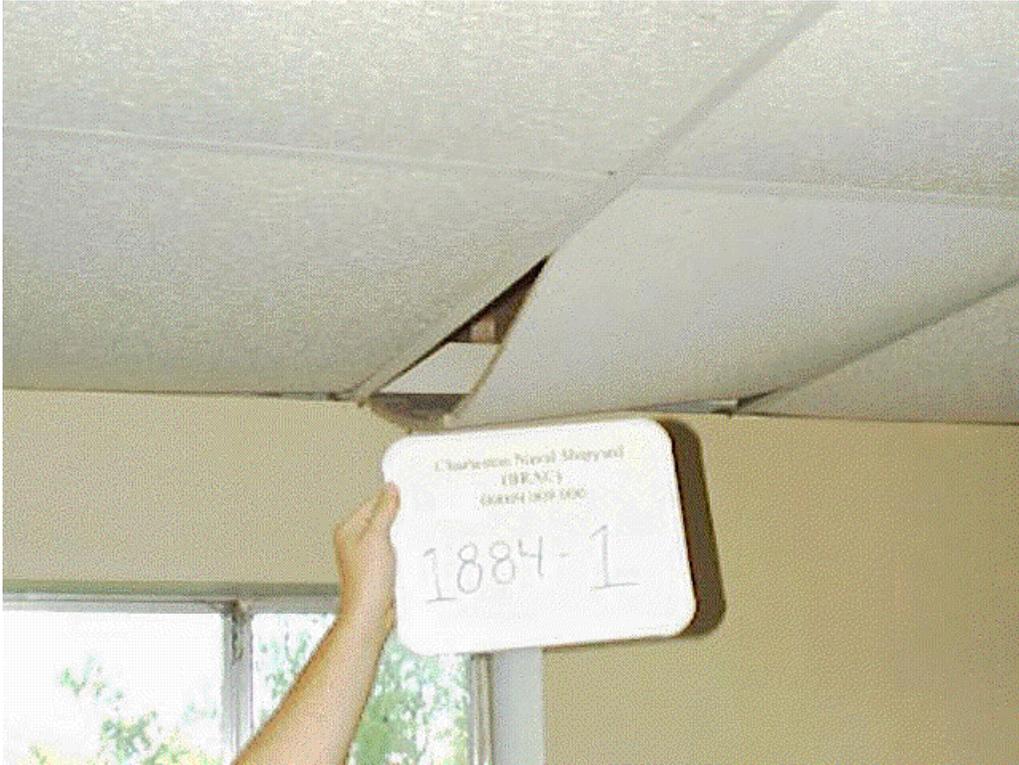
HA #	Material Description	Material Location	ACM (YES/NO)
1	2'x4' ceiling tile, pinhole-fissured	102	NO

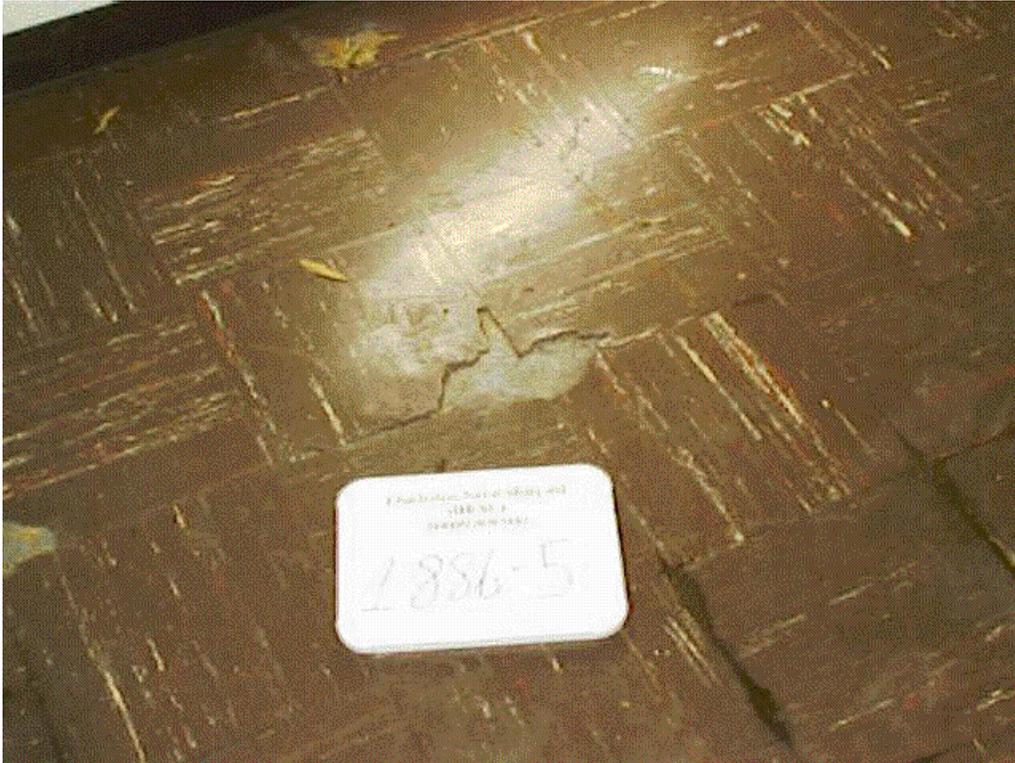
HA #	Material Description	Material Location	ACM (YES/NO)
5	Damaged 12"x12" floor tile and mastic, brown	103	NO

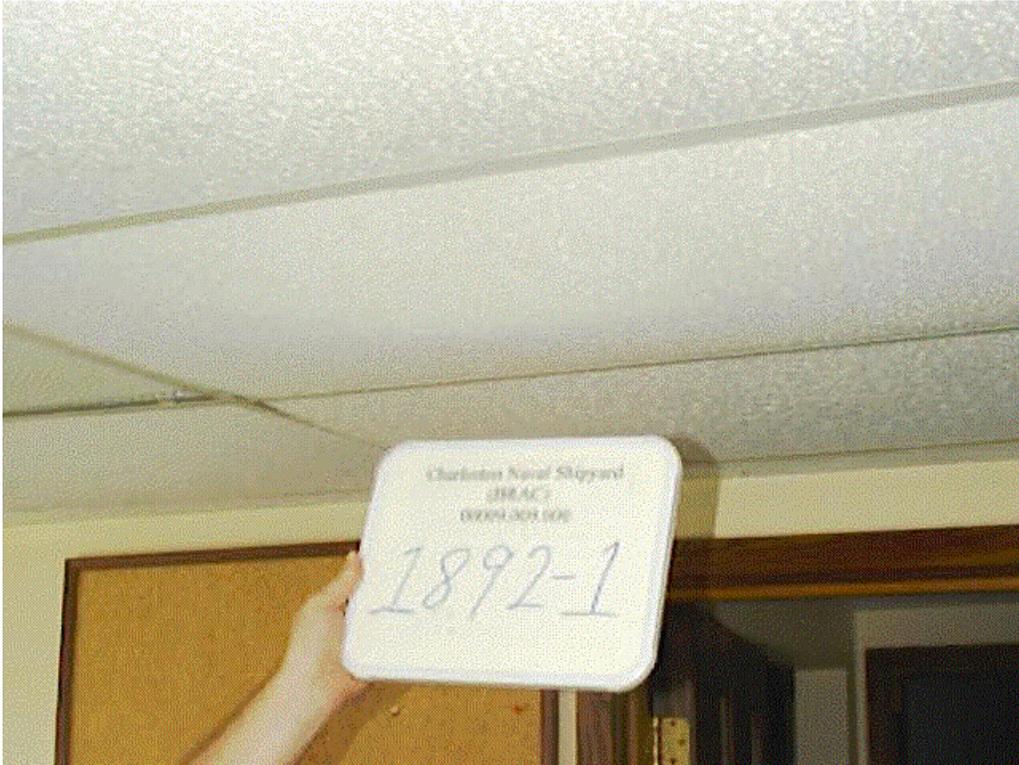
HA #	Material Description	Material Location	ACM (YES/NO)
1	2'x4' ceiling tile, pinhole-fissured	100, 101, 104, C1, 105	NO

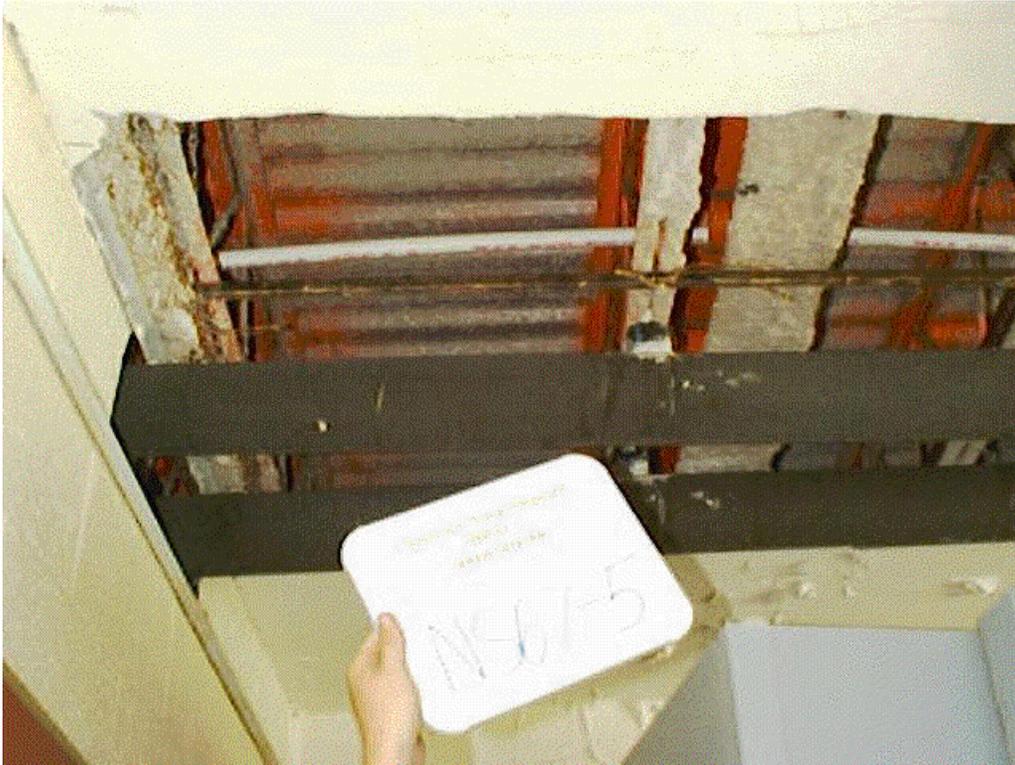
HA #	Material Description	Material Location	ACM (YES/NO)
5	Spray-applied fireproofing	Throughout	NO

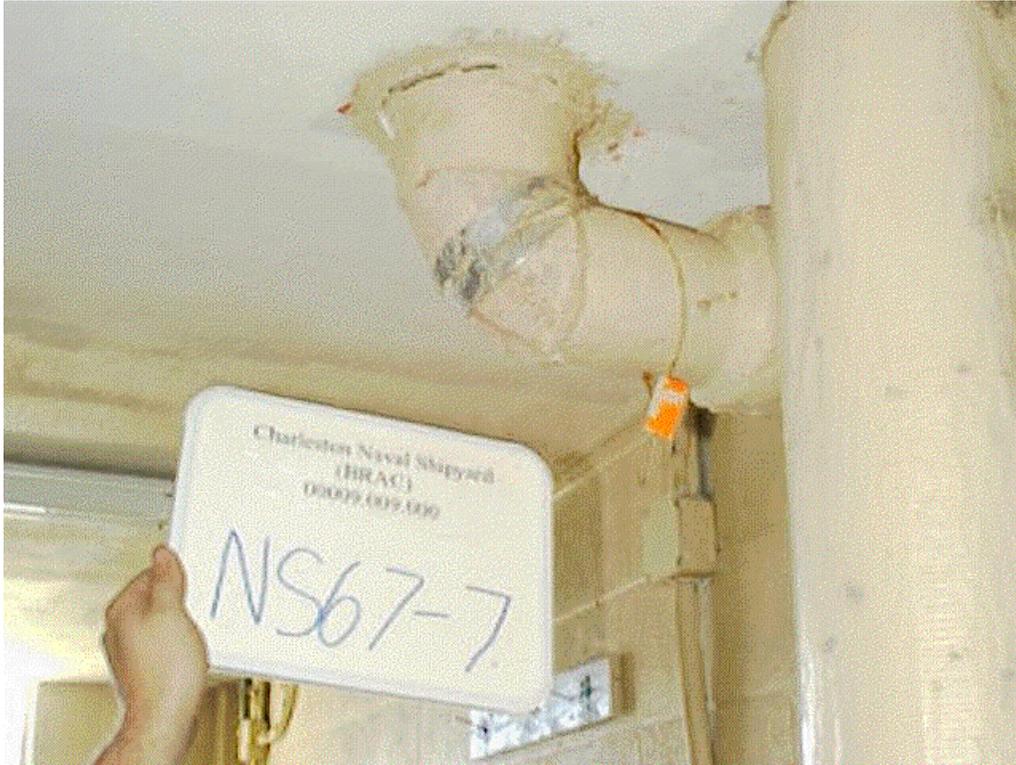
HA #	Material Description	Material Location	ACM (YES/NO)
7	Pipe fitting insulation on hot water lines	226, Corr. 2	NO

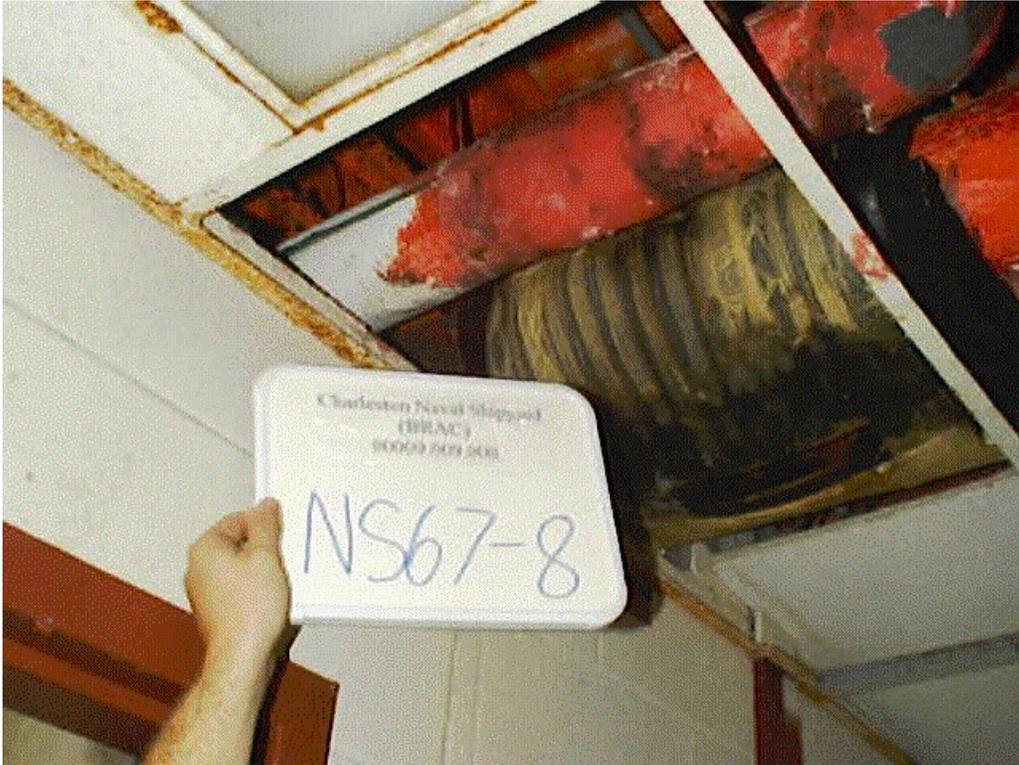
HA #	Material Description	Material Location	ACM (YES/NO)
8	Pipe insulation on hot water lines	Corr. 2	NO

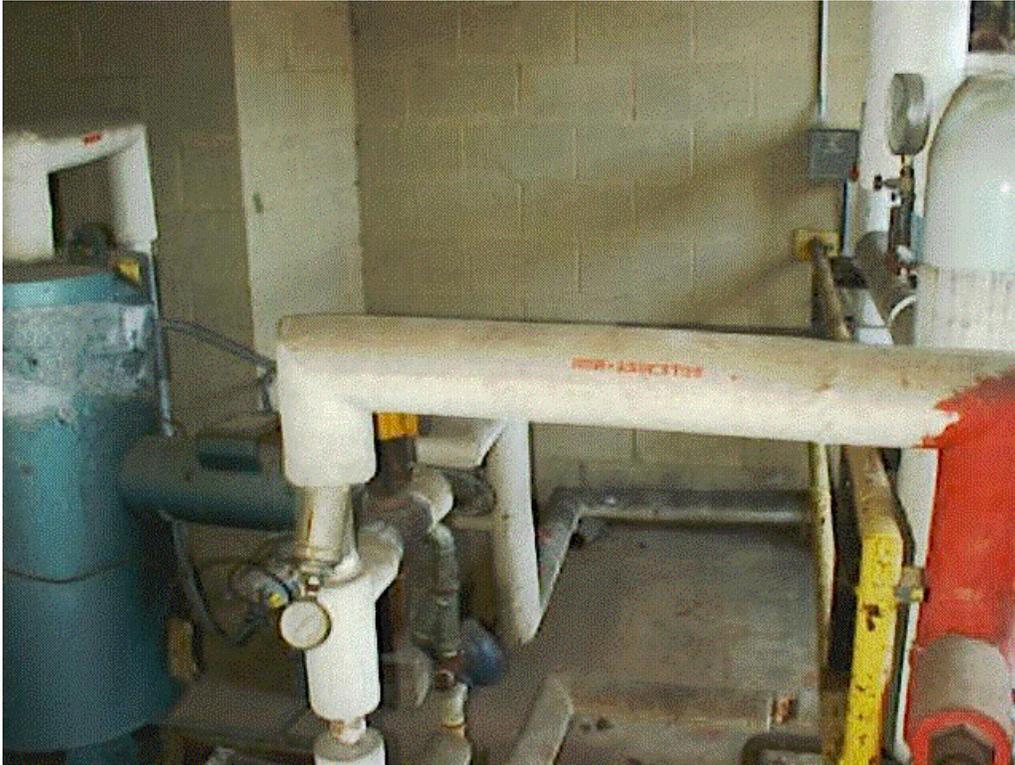
HA #	Material Description	Material Location	ACM (YES/NO)
11	Canvas wrap on hot water lines	Mech. room	NO
