**FRIABLE AND DAMAGED FRIABLE ASBESTOS-CONTAINING  
MATERIALS SURVEY AT THE  
CHARLESTON NAVAL SHIPYARD  
CHARLESTON, SOUTH CAROLINA**

**CONTRACT NUMBER N62467-00-D-0345**

**SEPTEMBER 2000**

**Friable and Damaged Friable Asbestos-Containing Materials Survey for  
Buildings 81, 86, 141, 180, 199, 220, 658, 1079, 1509, 1777, 1884, 1886,  
1892, NS67, and NS675 at Charleston Naval Shipyard  
Charleston, South Carolina**

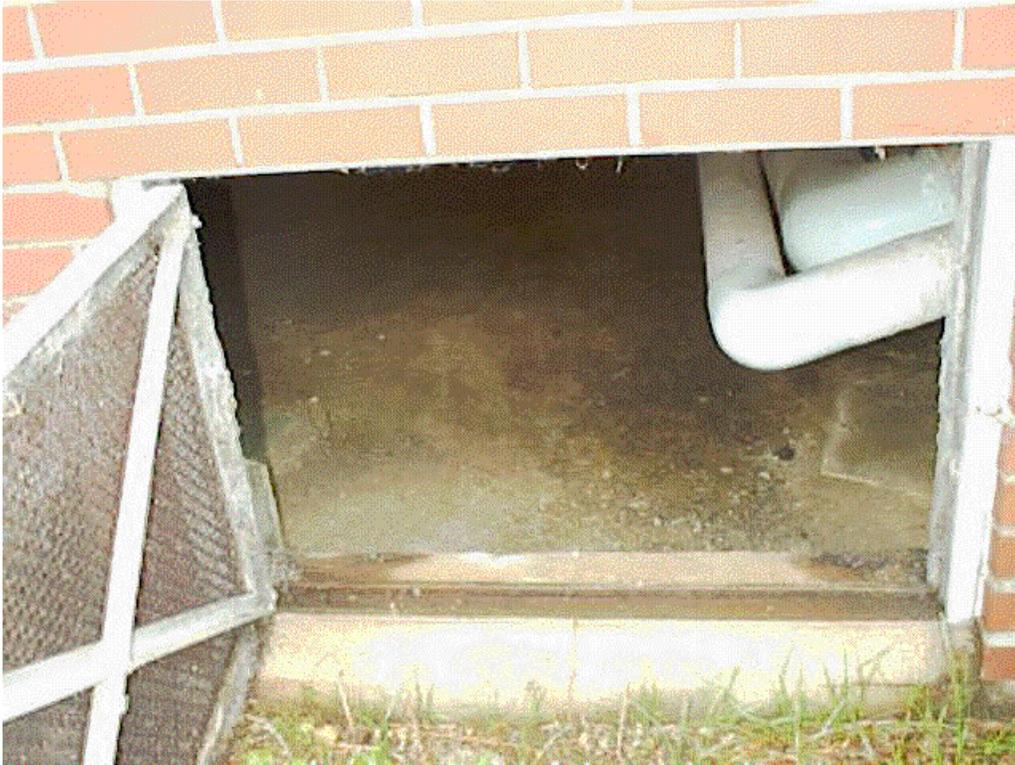
HA#	Material Description	Location of Friable Material	Material Type	Quantity of Friable Material	Damage Assessment
10	Pipe fitting insulation on steam lines	Exterior (east side of building)	TSI	5 EA	Damaged
12	Contaminated soil	Crawlspace	Misc	10,000 SF	Damaged

HA #	Material Description	Material Location	ACM (YES/NO)
12	Contaminated soil	Crawlspace	YES

HA#	Material Description	Damage Location	Damage Quantity	Abatement Response Action
10	Pipe fitting insulation on steam lines	Exterior (east side of building)	5 EA	Repair/Encapsulate
12	Contaminated soil	Crawlspace	10,000 SF	Isolate/remove
