FINAL 2013 WELL INSPECTION AND MAINTENANCE RECORD MILLINGTON SUPPACT TN
(PUBLIC DOCUMENT)
3/14/2014
RESOLUTION CONSULTANTS

2013 WELL INSPECTION AND MAINTENANCE RECORD

NAVAL SUPPORT ACTIVITY MID-SOUTH
MILLINGTON, TENNESSEE

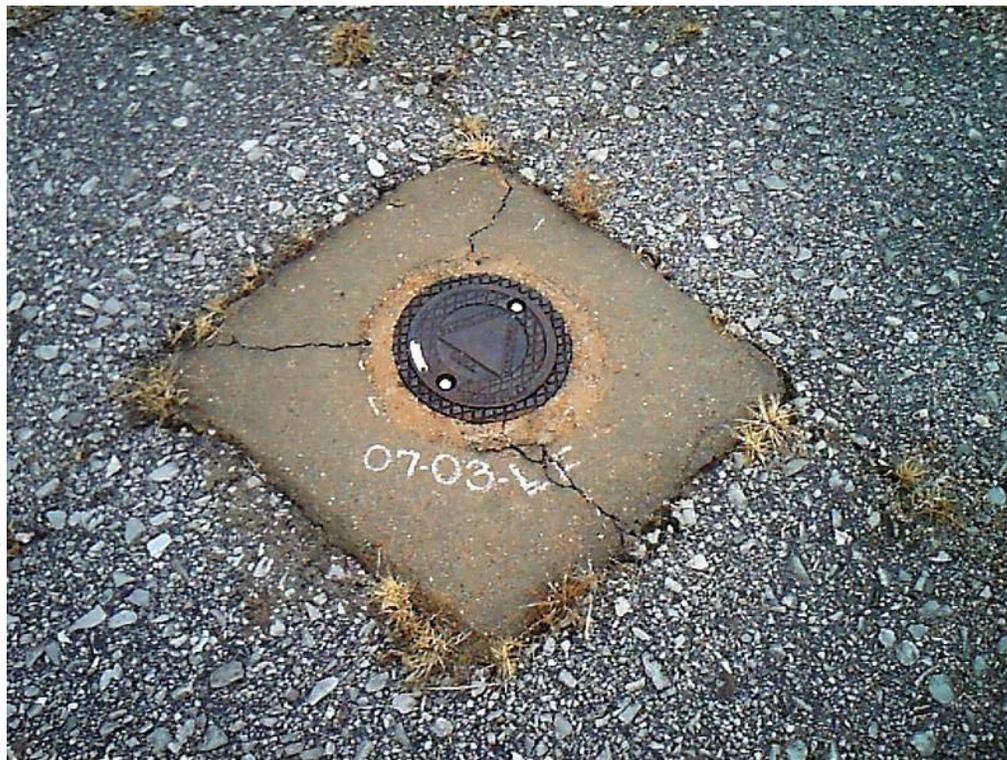
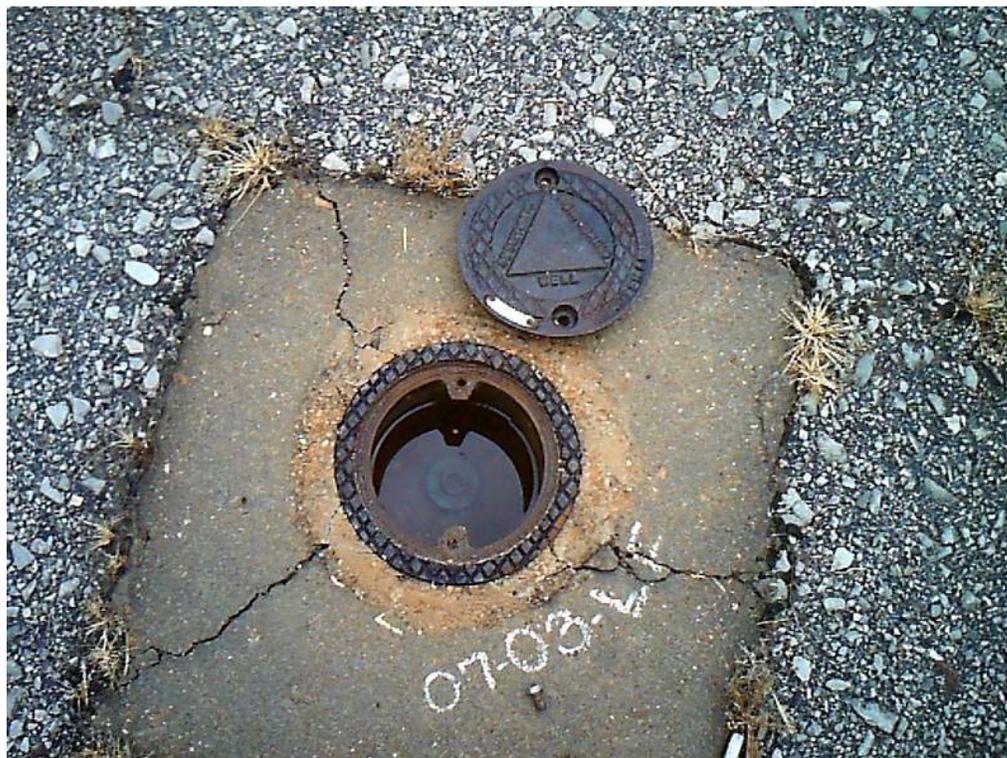
Water in well vault. One bolt is stripped but was left in the manhole cover.
 Replaced well cap; old well cap would not tighten due to middle portion being broken.

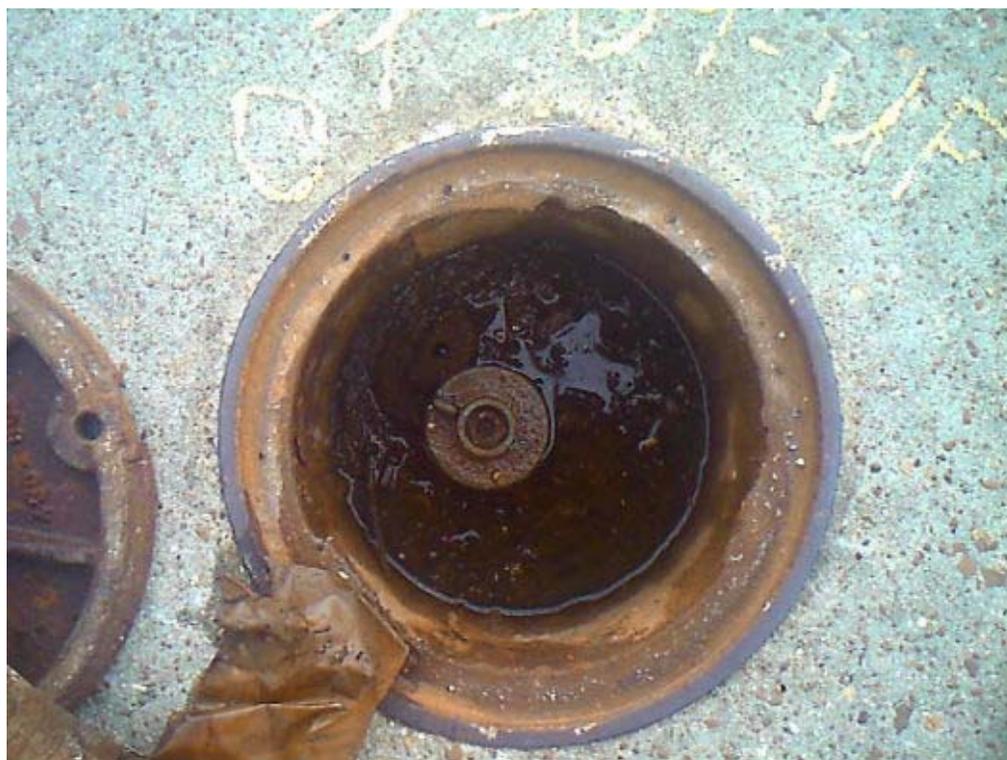
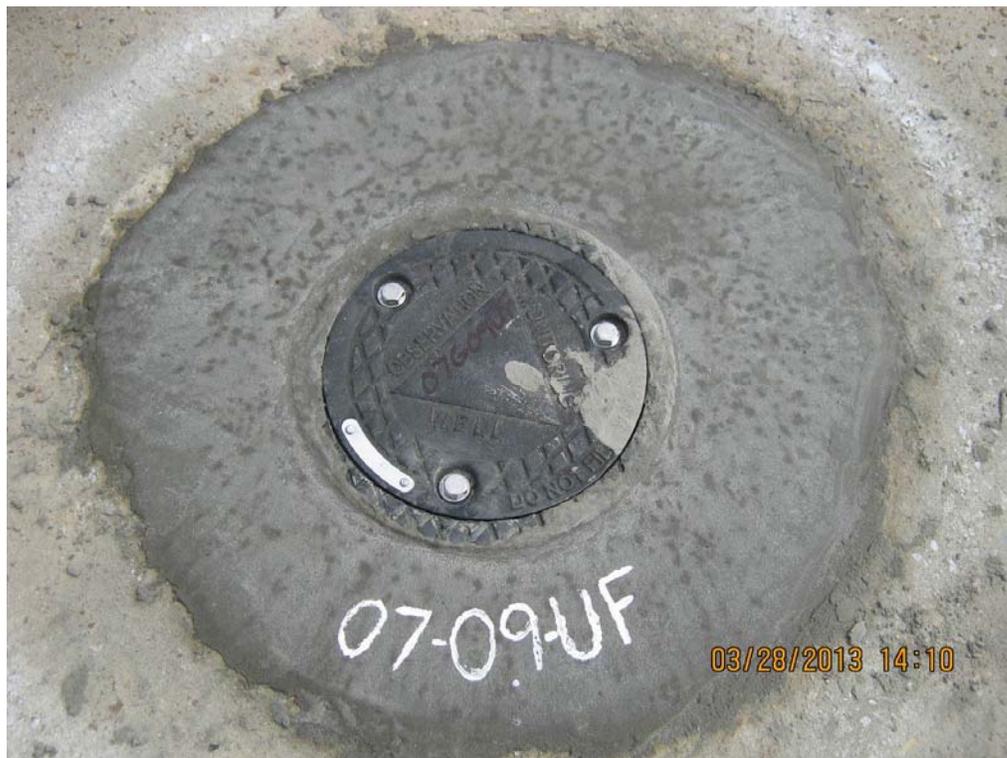
NSA Mid-South - AOC A - SWMU 7 - 007G09UF

Does well have a surface seal or well pad?	Yes
Does the well have a cap or lockable expansion cap?	Yes
Is the well cap protecting against entry of possible surface water in manhole?	No
Does the manhole have a least one locking bolt?	No
Does the protective casing or well box have an external ID tab or label?	Yes
Is the manhole gasket in good condition?	No

Pad badly broken. ID barely visible.

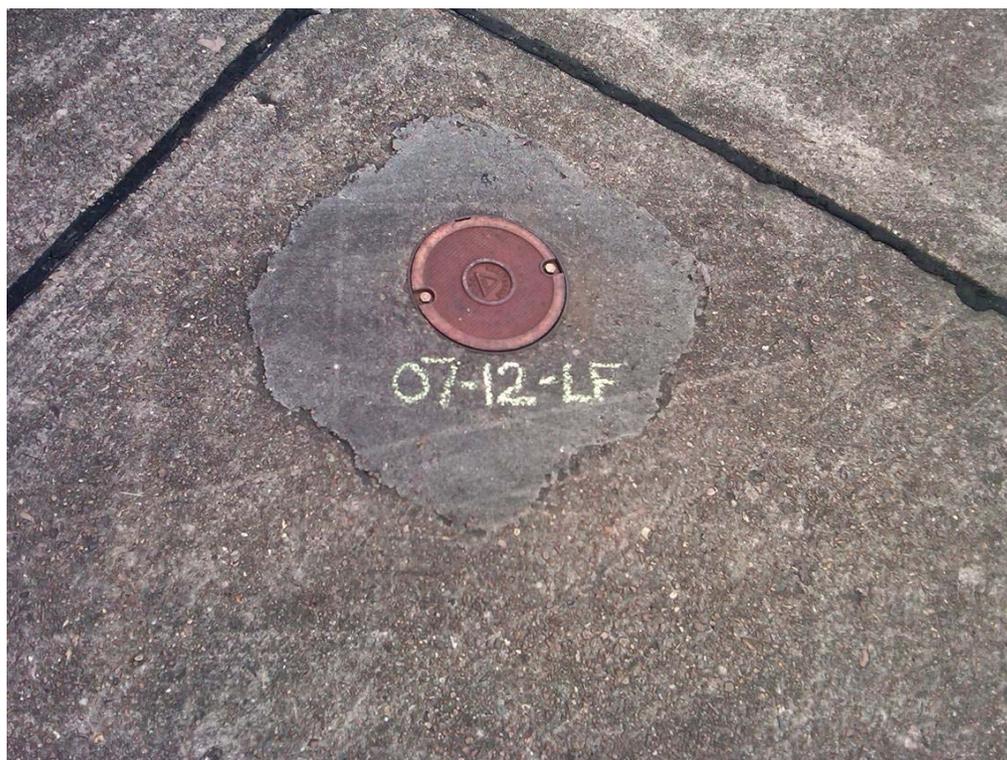
NSA Mid-South - AOC A - SWMU 7 - 007G12LF

Does well have a surface seal or well pad?	Yes
Does the well have a cap or lockable expansion cap?	Yes
Is the well cap protecting against entry of possible surface water in manhole?	No
Does the manhole have a least one locking bolt?	No
Does the protective casing or well box have an external ID tab or label?	Yes
Is the manhole gasket in good condition?	No

One bolt loose

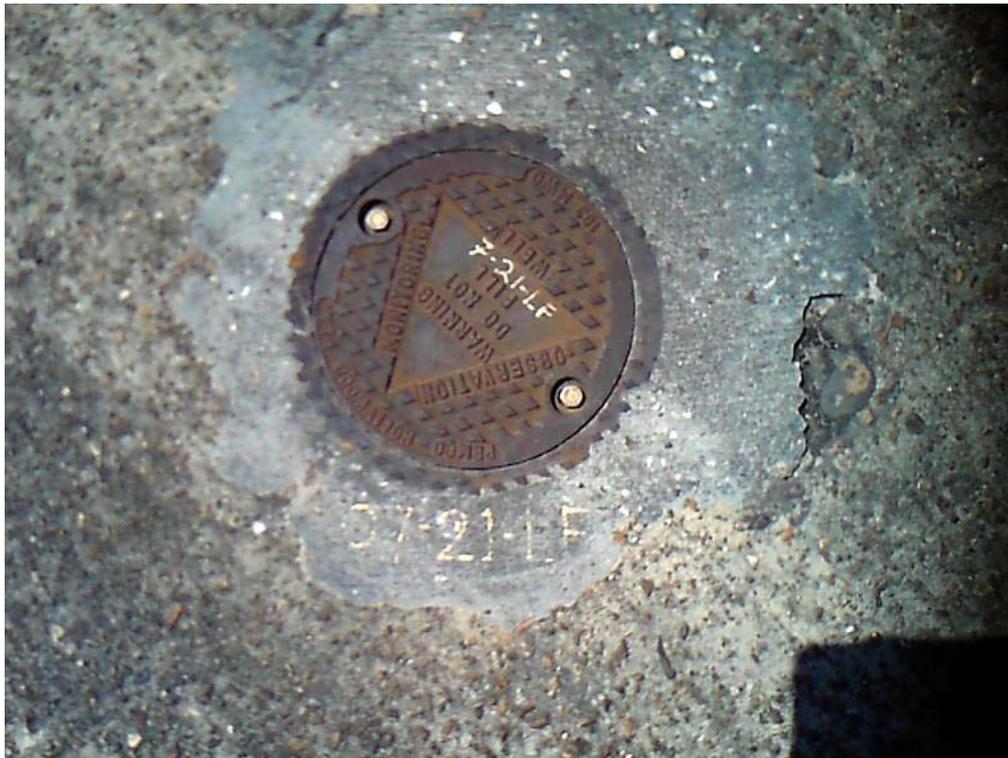
NSA Mid-South - AOC A - SWMU 7 - 007G21LF

Does well have a surface seal or well pad?	Yes
Does the well have a cap or lockable expansion cap?	Yes
Is the well cap protecting against entry of possible surface water in manhole?	No
Does the manhole have a least one locking bolt?	No
Does the protective casing or well box have an external ID tab or label?	Yes
Is the manhole gasket in good condition?	No

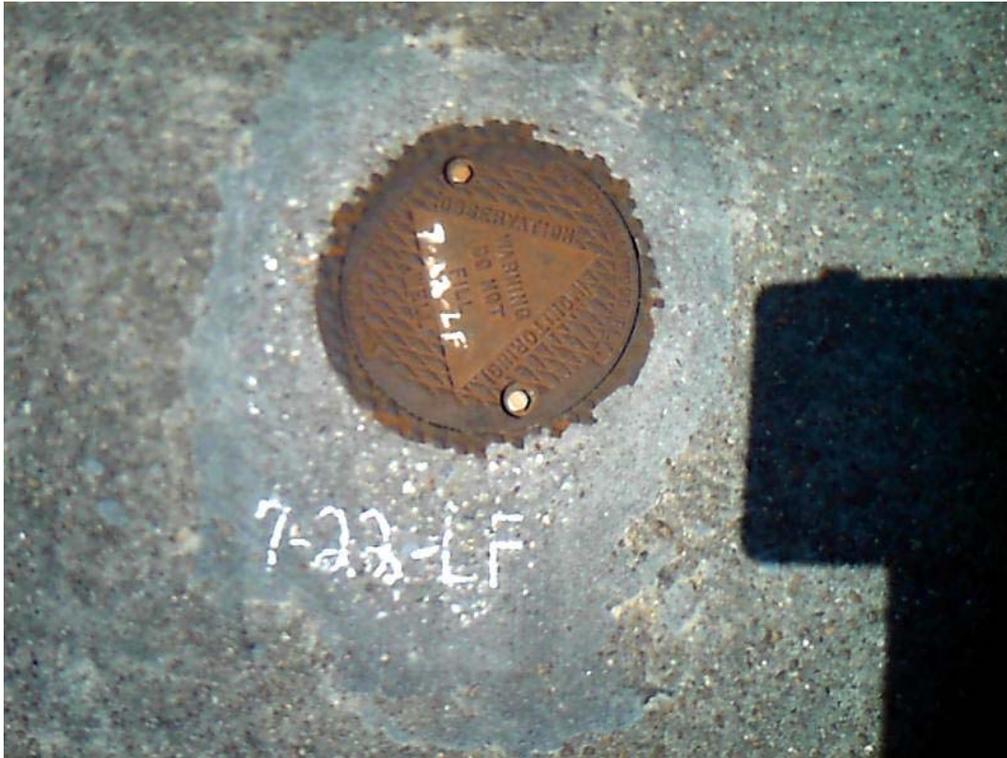
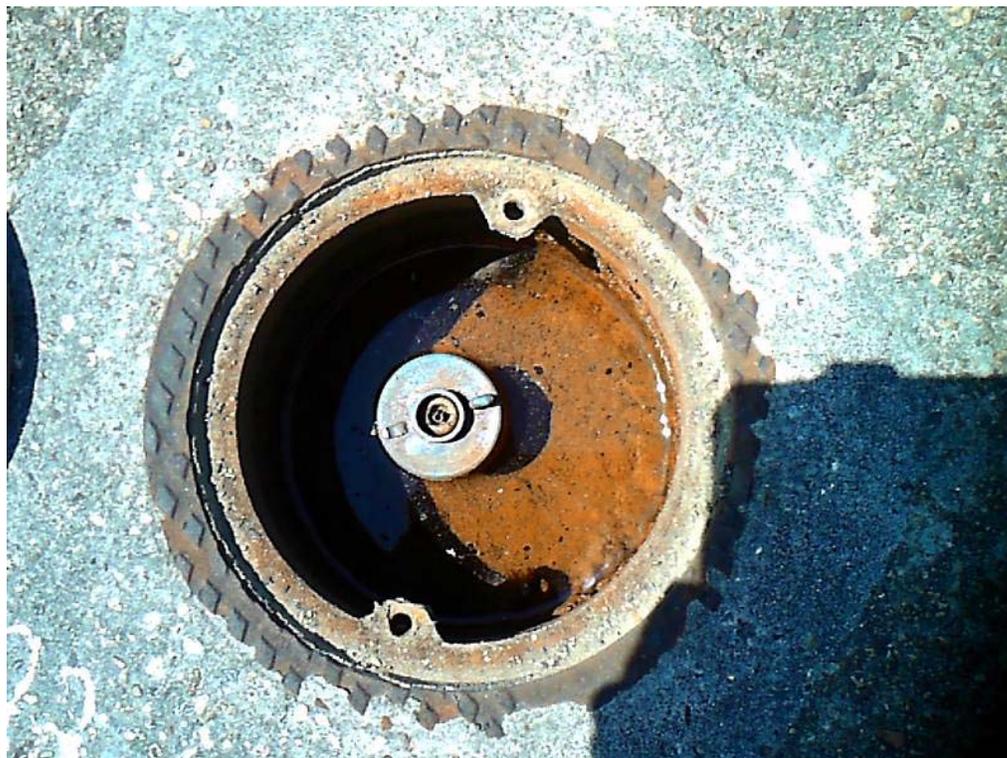
NSA Mid-South - AOC A - SWMU 7 - 007G22LF

Does well have a surface seal or well pad?	Yes
Does the well have a cap or lockable expansion cap?	Yes
Is the well cap protecting against entry of possible surface water in manhole?	No
Does the manhole have a least one locking bolt?	No
Does the protective casing or well box have an external ID tab or label?	Yes
Is the manhole gasket in good condition?	No

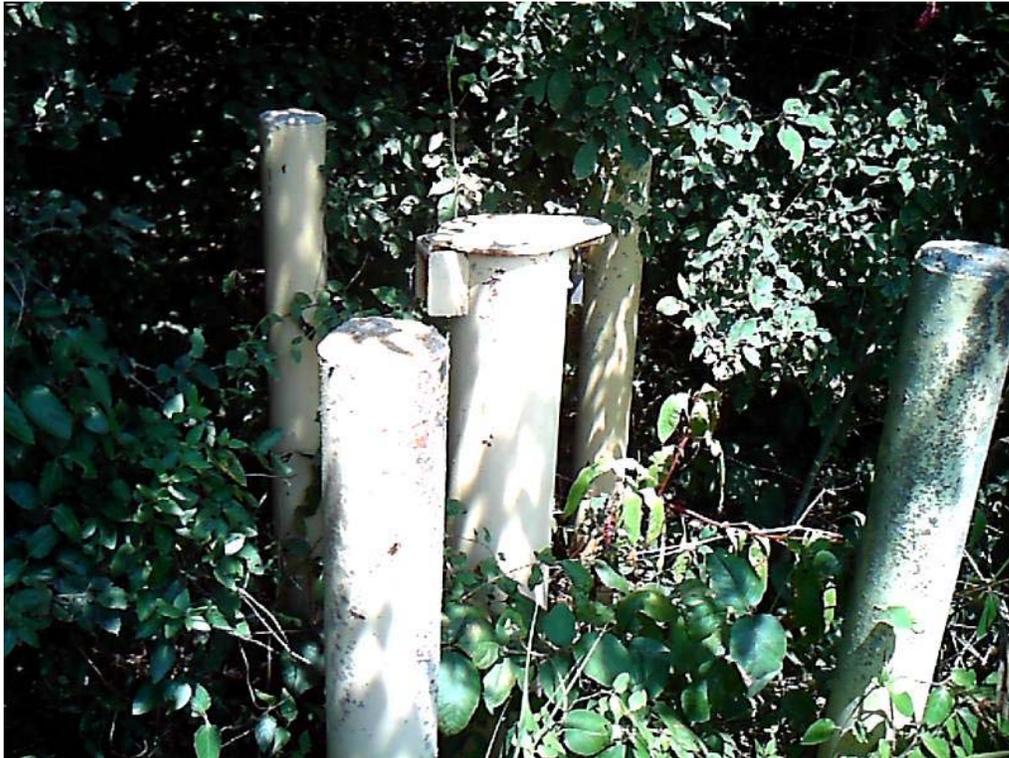
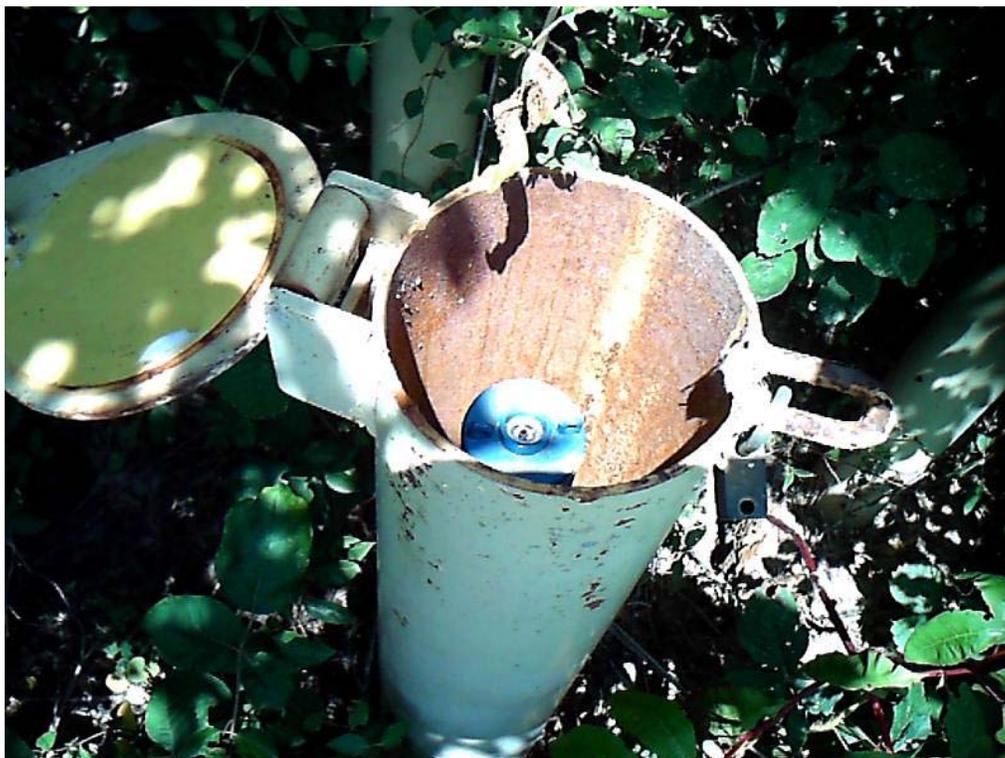
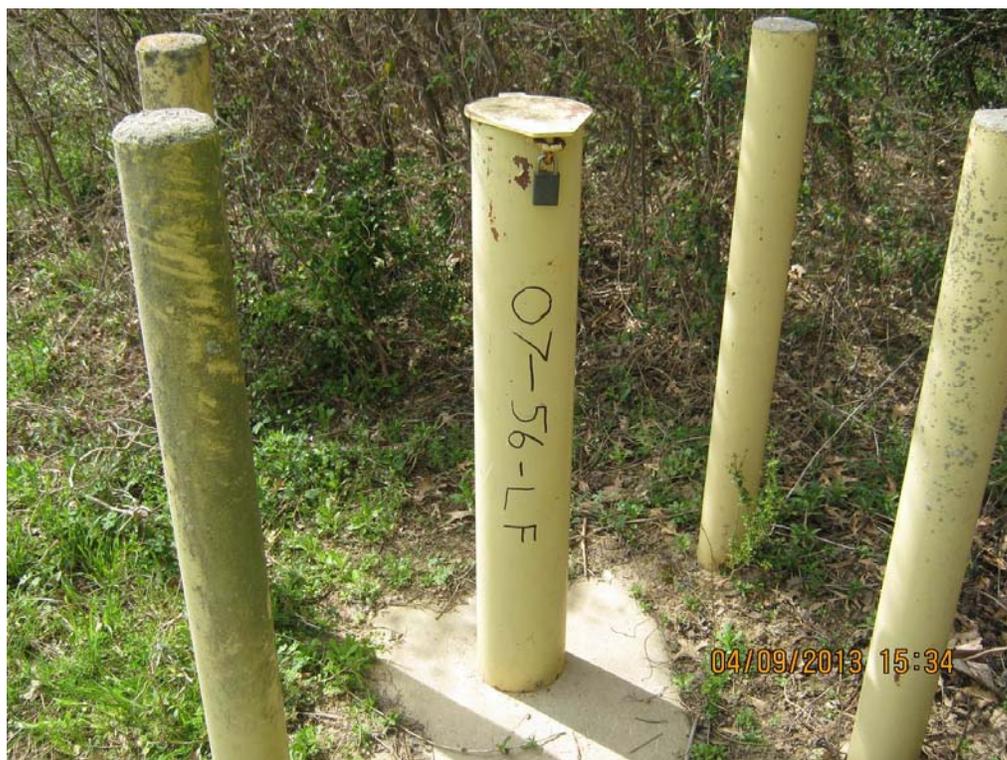
Two bolts are missing and a third bolt was broken during August 2013 sampling event.

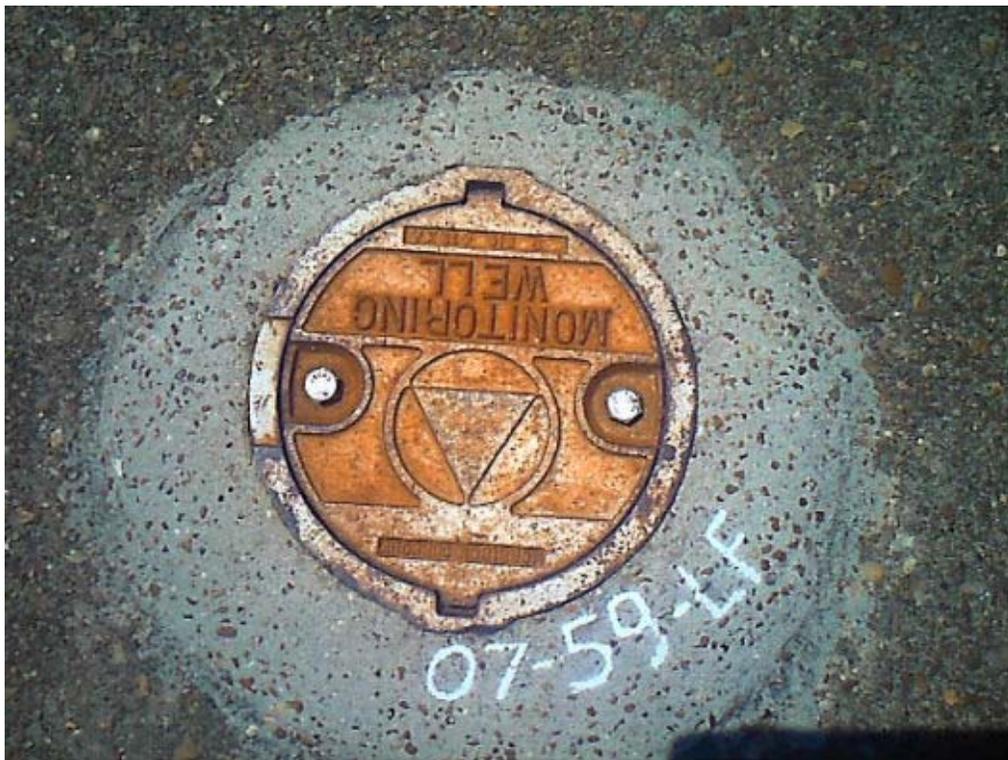
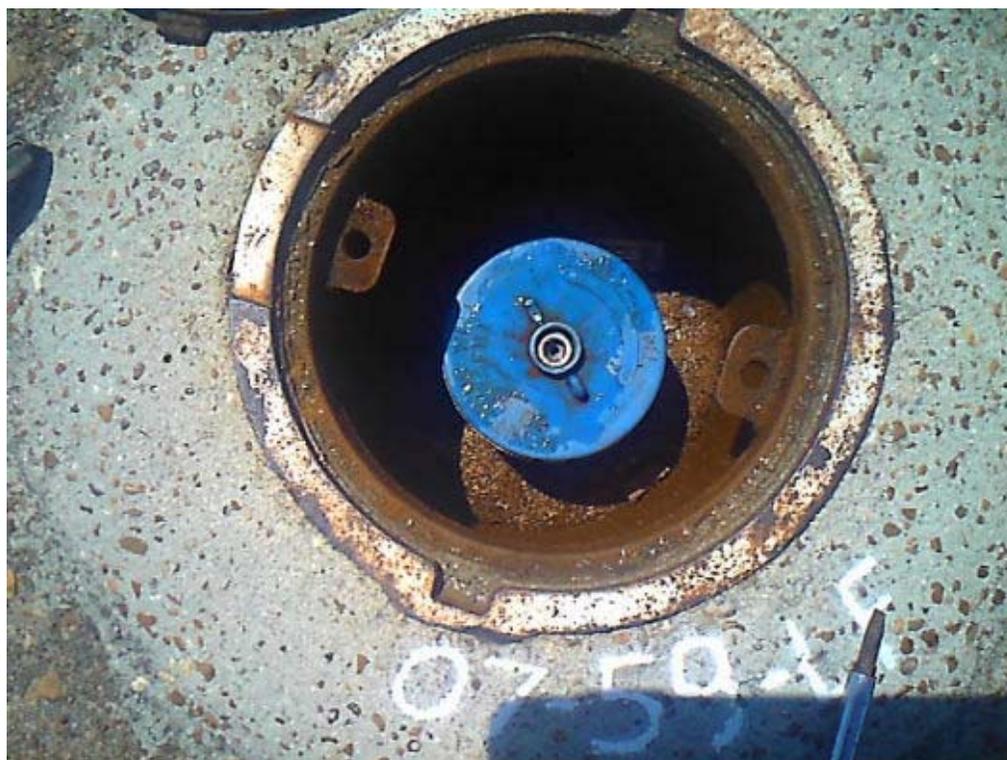
Bolt missing.

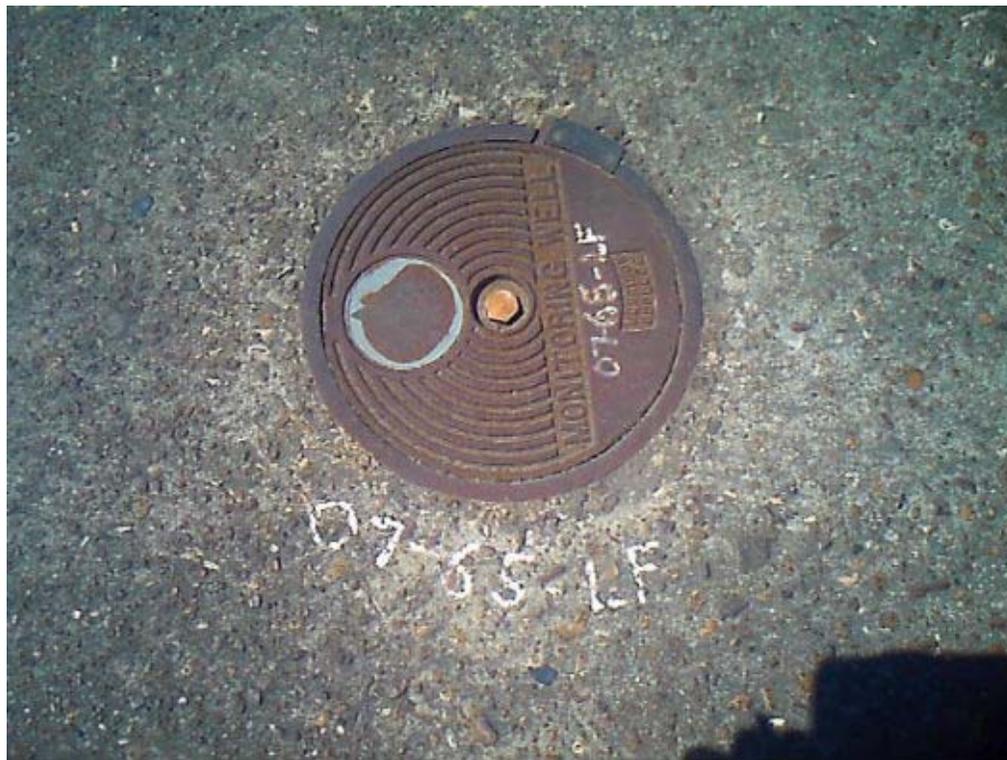
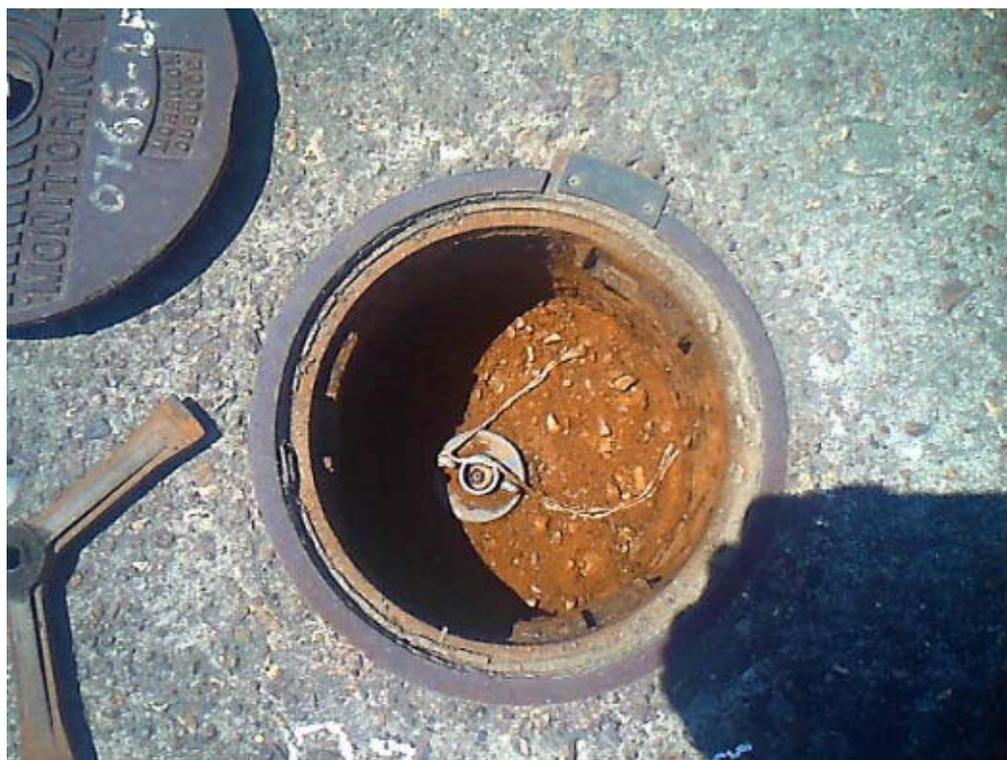
Bolt on surface seal needs to be replaced because it's bent and will not tighten.

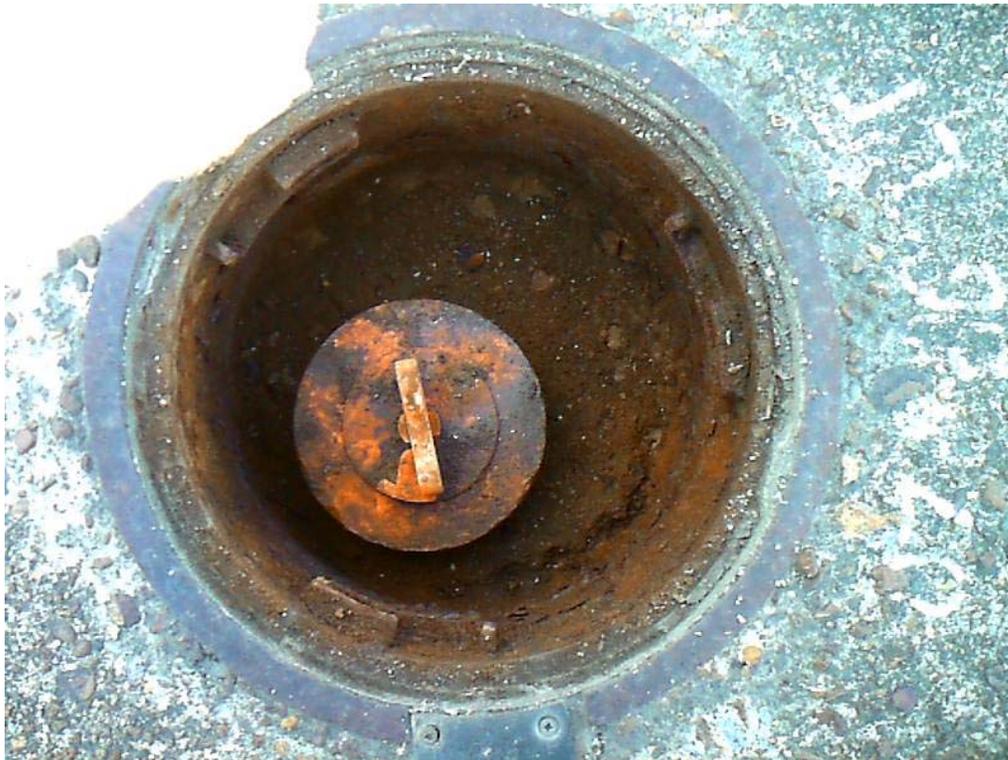
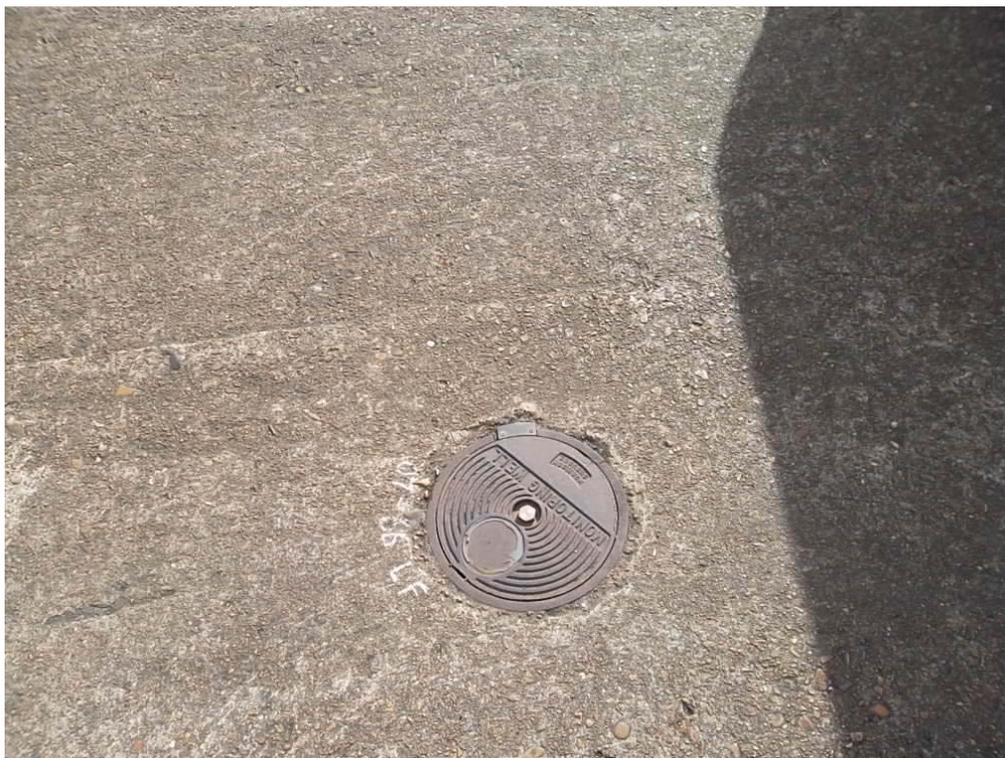
Water in vault; covering cap. Pad is damaged.
 Could not measure total depth due to 1" well.

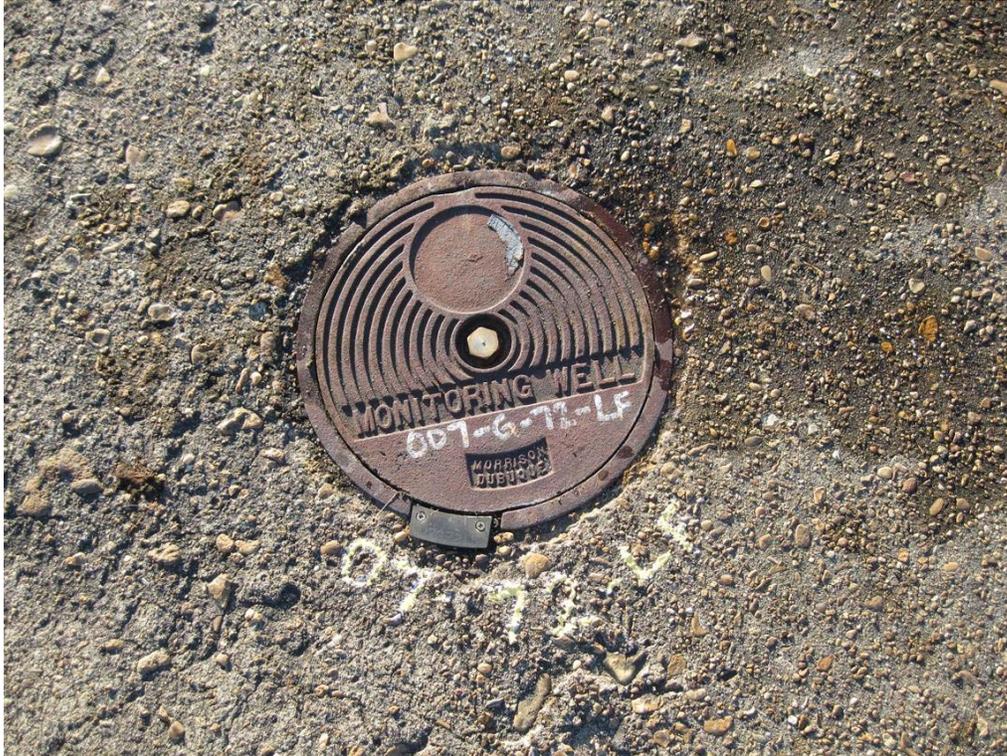
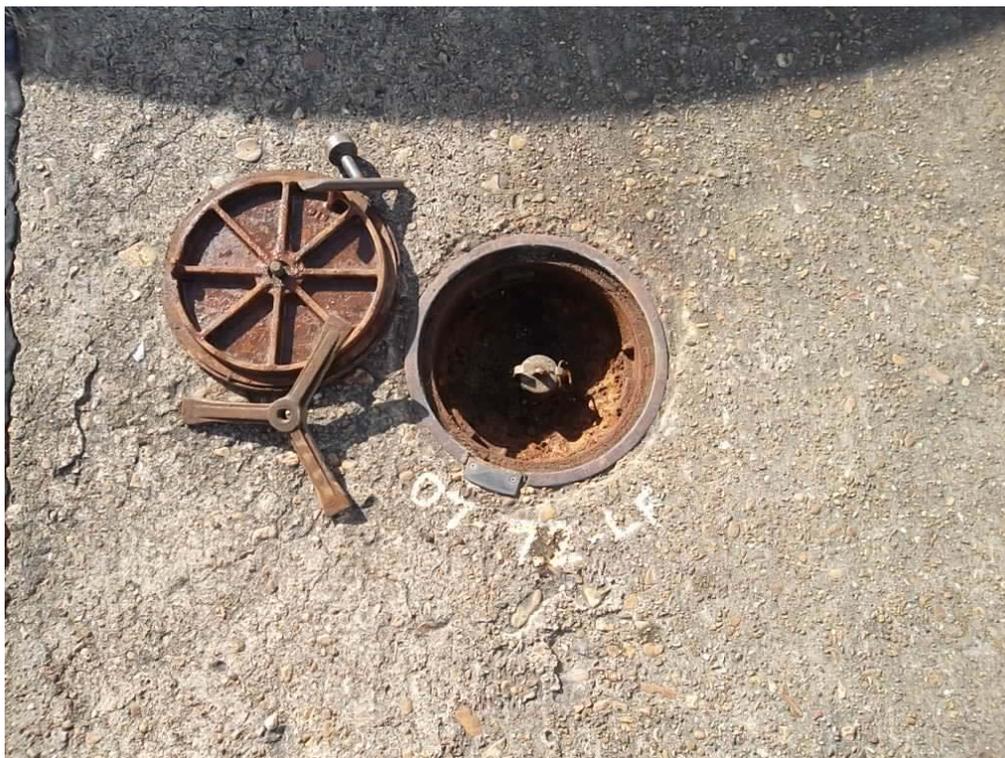
Well cap was cemented in when well manhole was replaced on March 28, 2013. Unable to open well cap due to this (see photos).

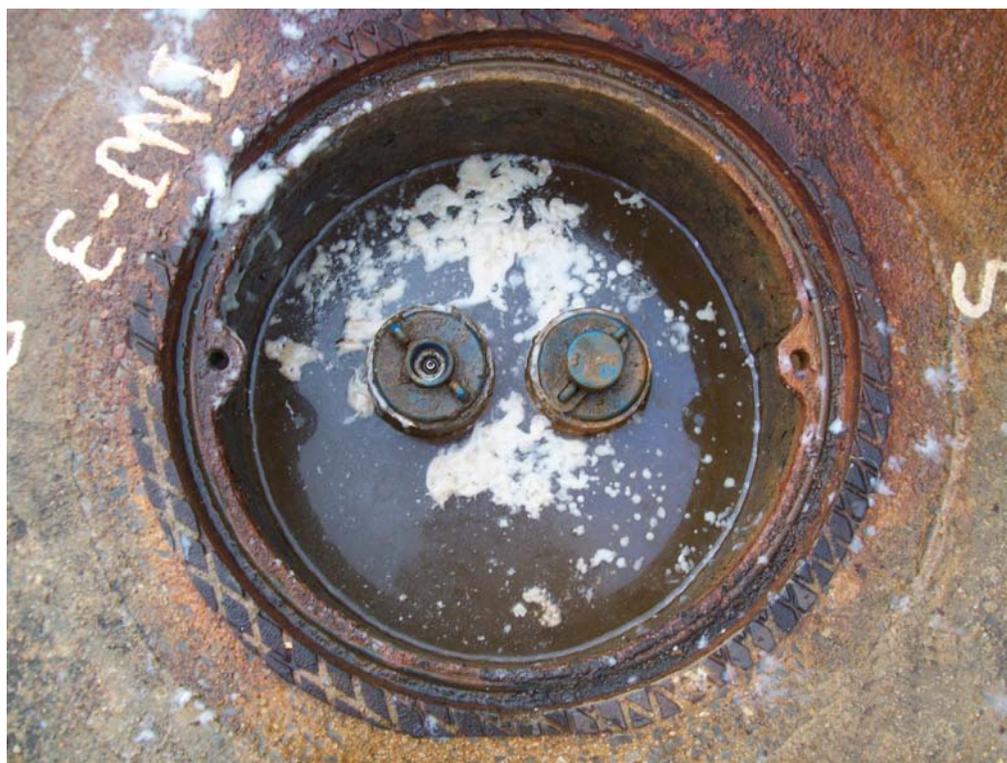
PESINJ3S_1

One bolt will not properly tighten. Check/Replace well cap

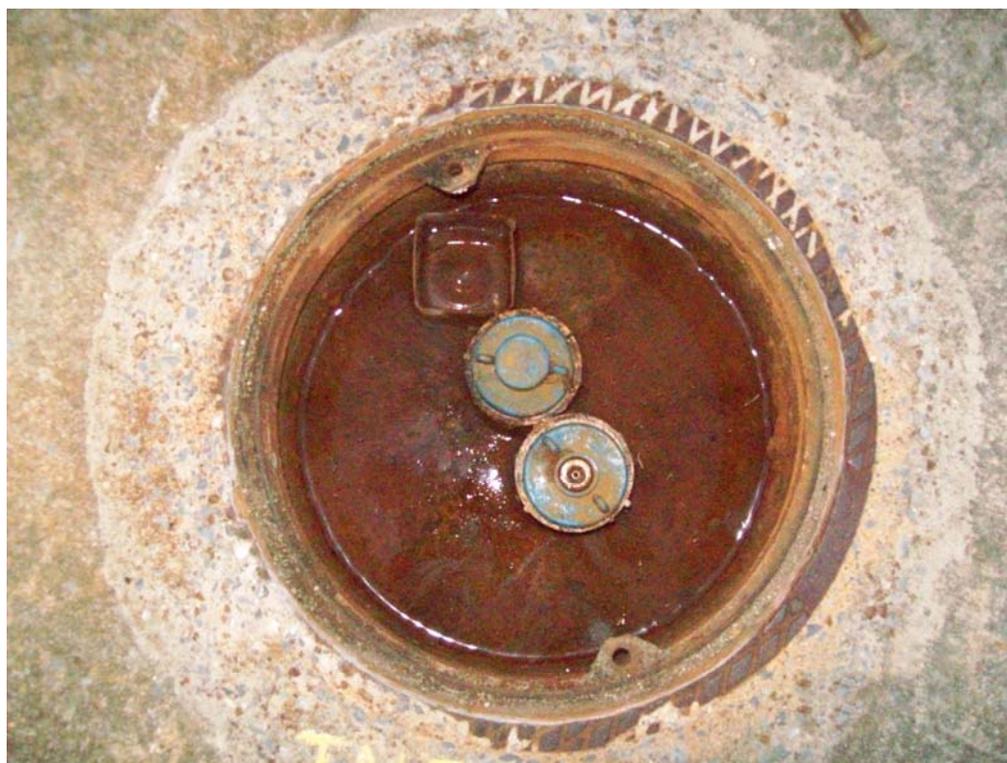
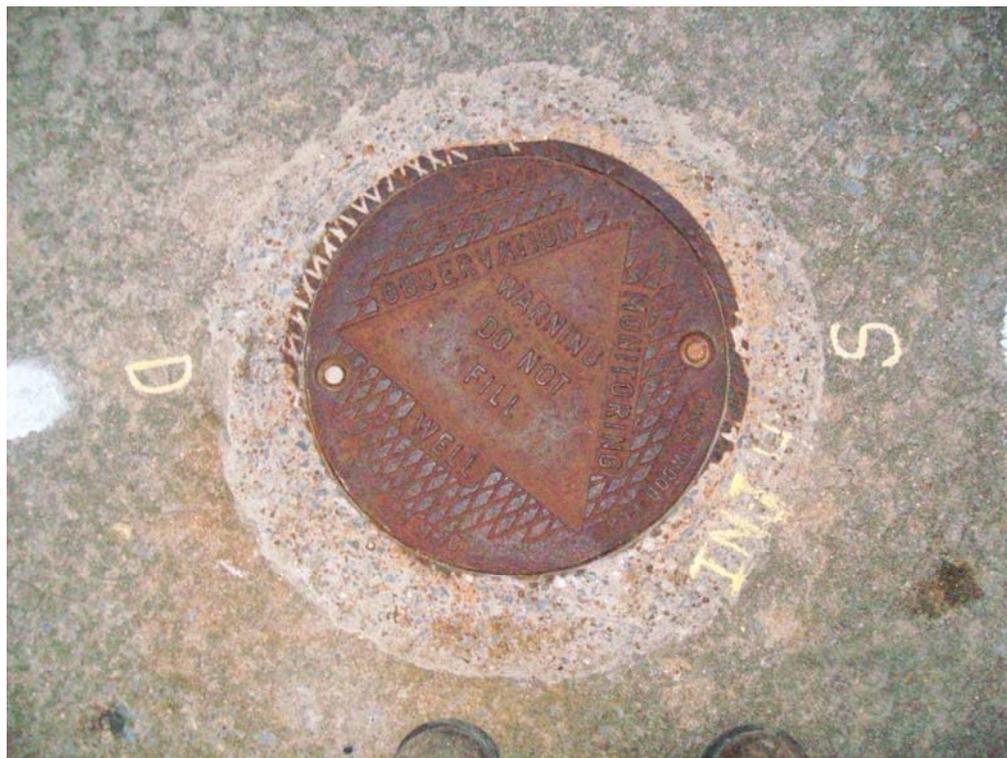
PESINJ4D_1

One bolt will not properly tighten. Check/Replace well cap

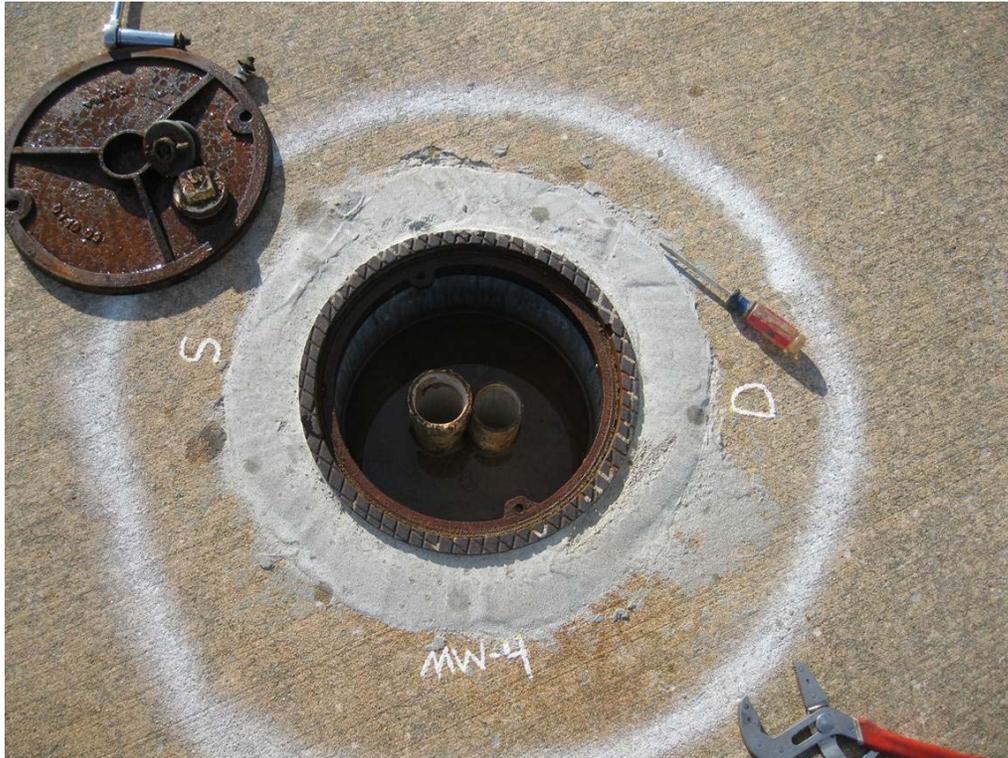
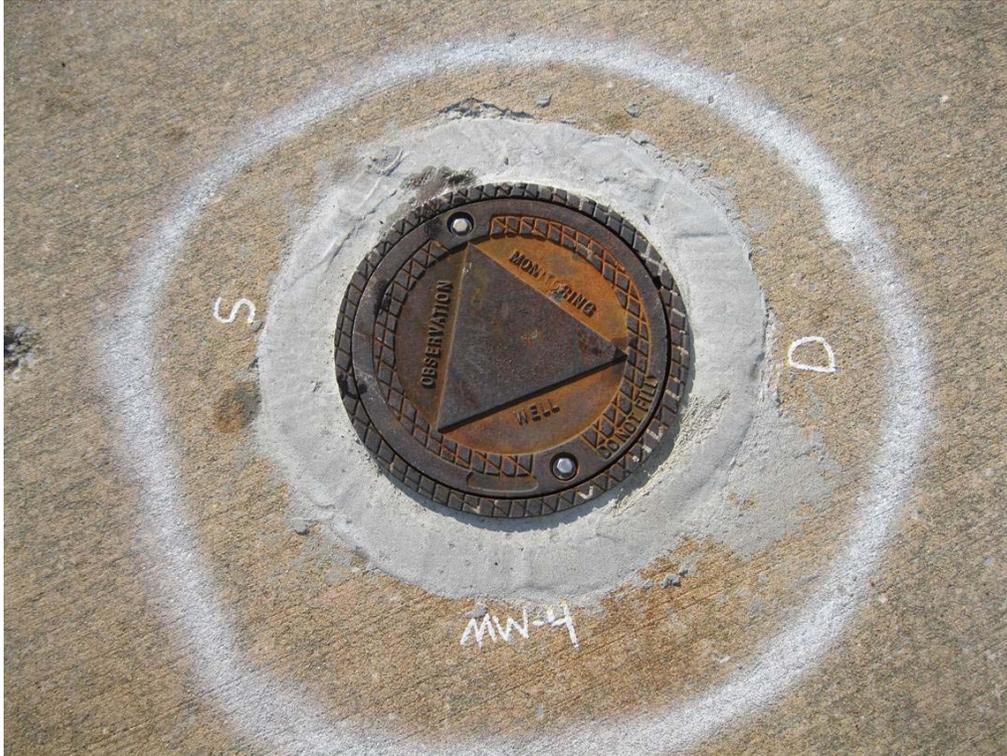
PESMW4S_01

Found well lid cracked when completing additional well inspections on 12/10/2013.

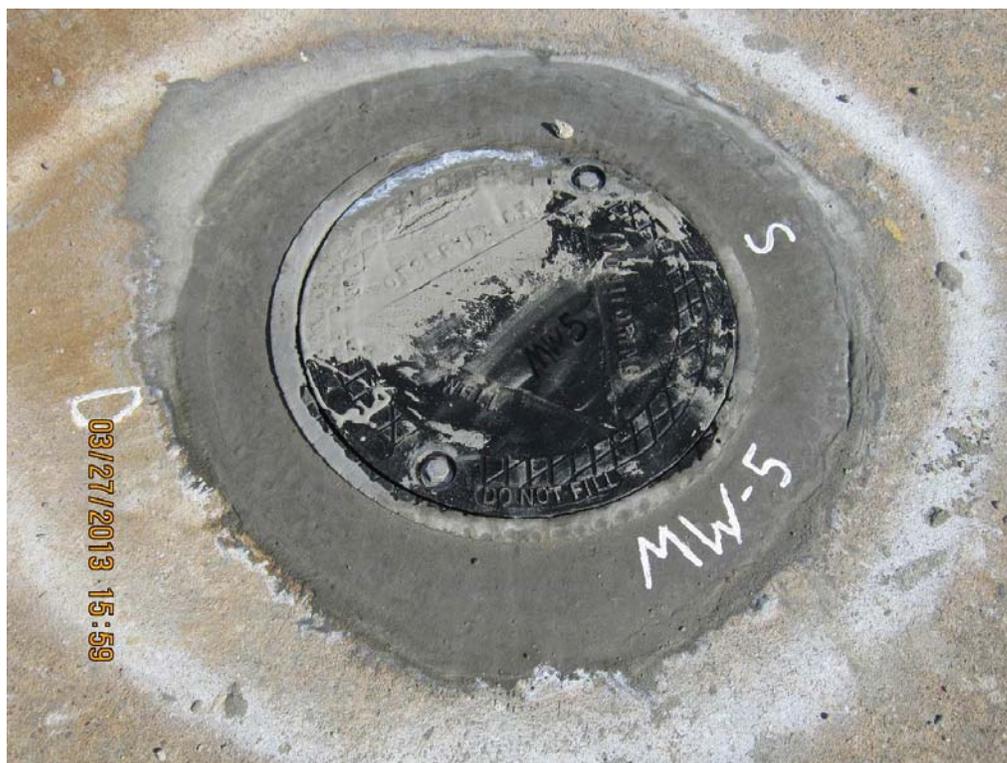
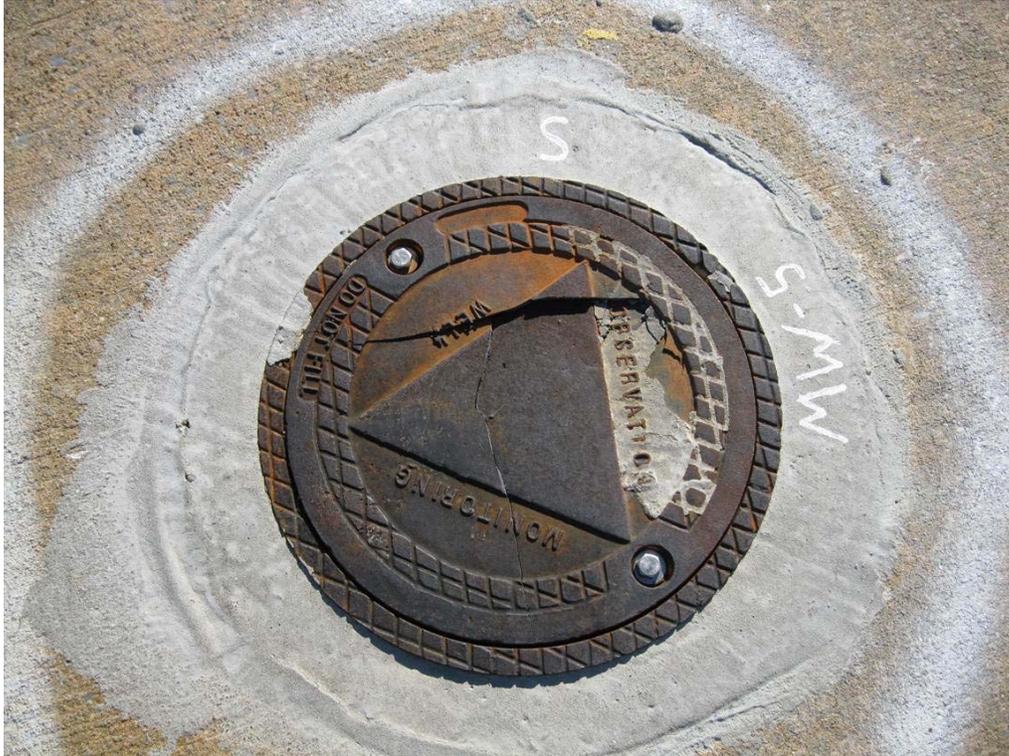
PESMW5DR

Well lid was found cracked when completing additional well inspections on 12/10/2013.

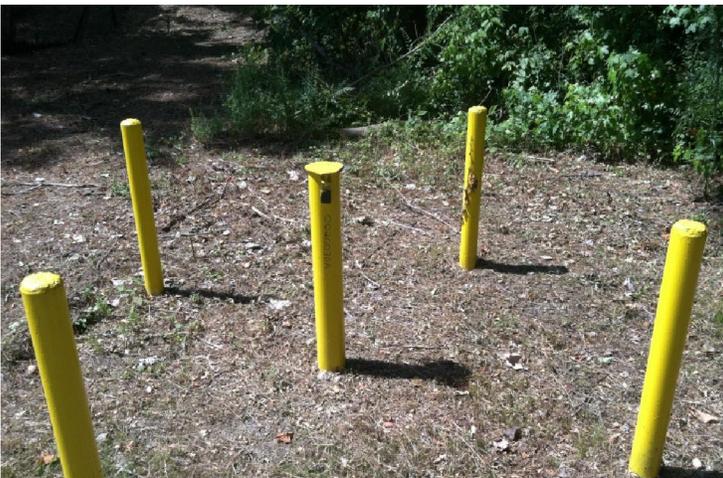
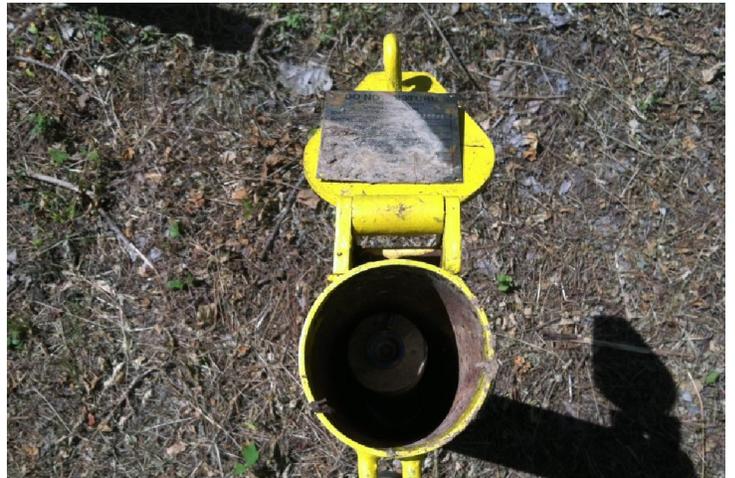
Observations: The monitoring well is in good shape and operational.

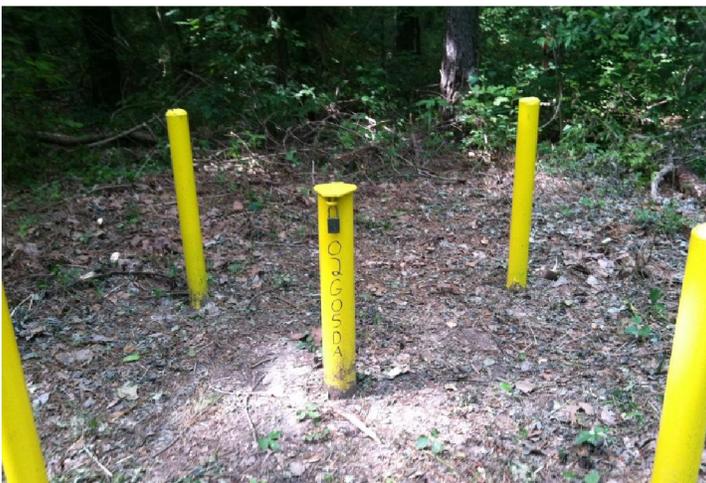
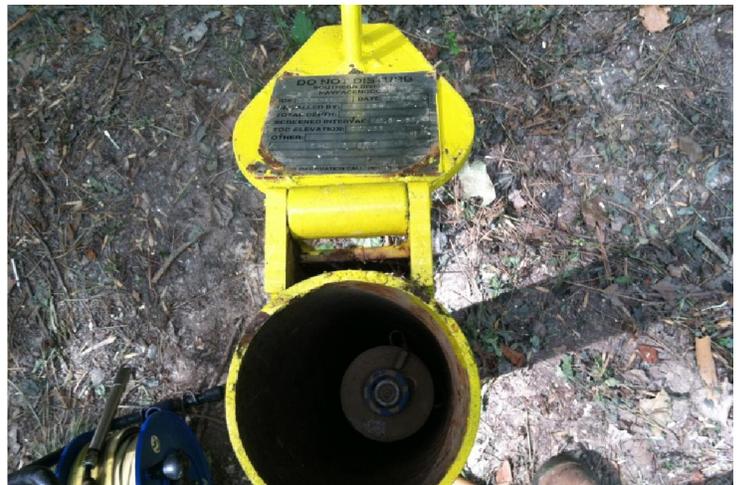
Observations: The monitoring well is in good shape and operational.

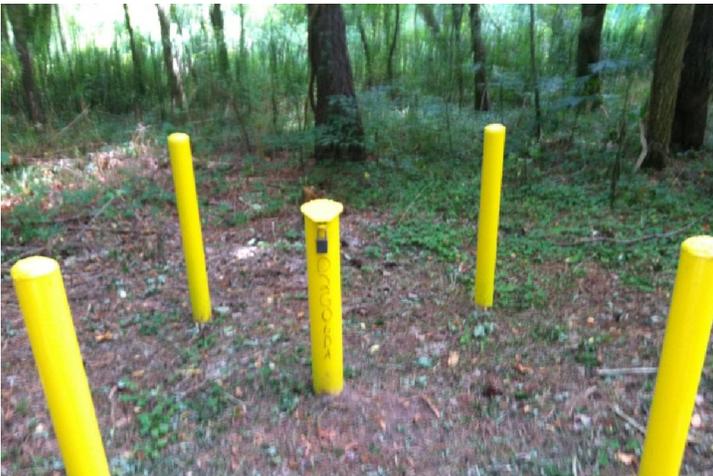
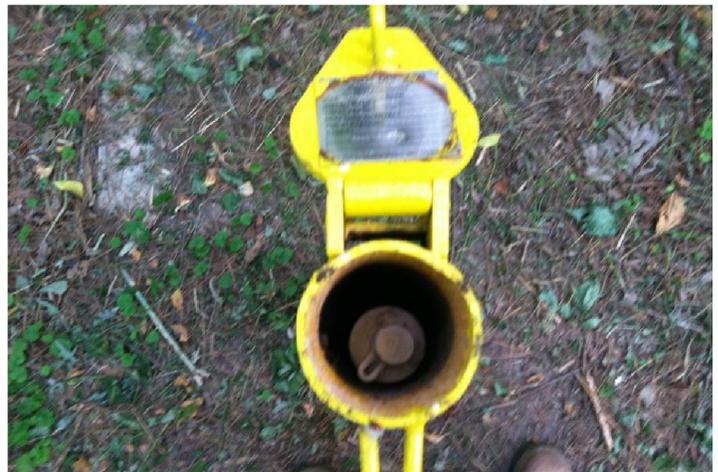
Observations: The monitoring well is in good shape and operational.
