FINAL 2013 WELL INSPECTION AND MAINTENANCE RECORD MILLINGTON SUPPACT TN
(PUBLIC DOCUMENT)
3/14/2014
RESOLUTION CONSULTANTS

2013 WELL INSPECTION AND MAINTENANCE RECORD

NAVAL SUPPORT ACTIVITY MID-SOUTH
MILLINGTON, TENNESSEE

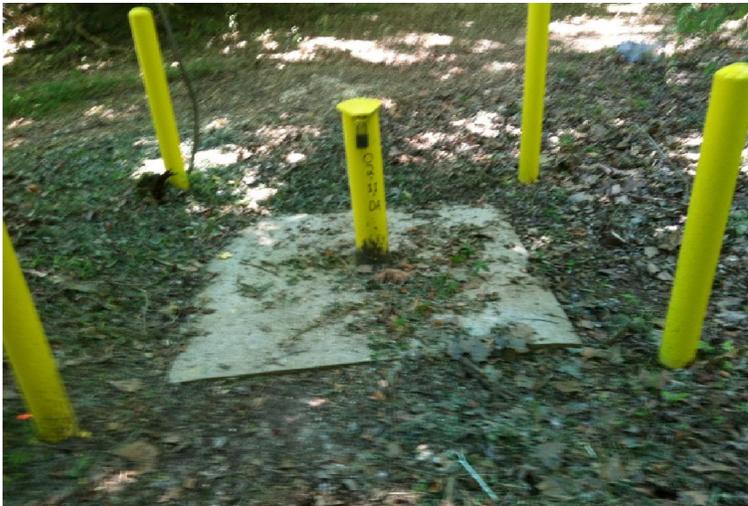
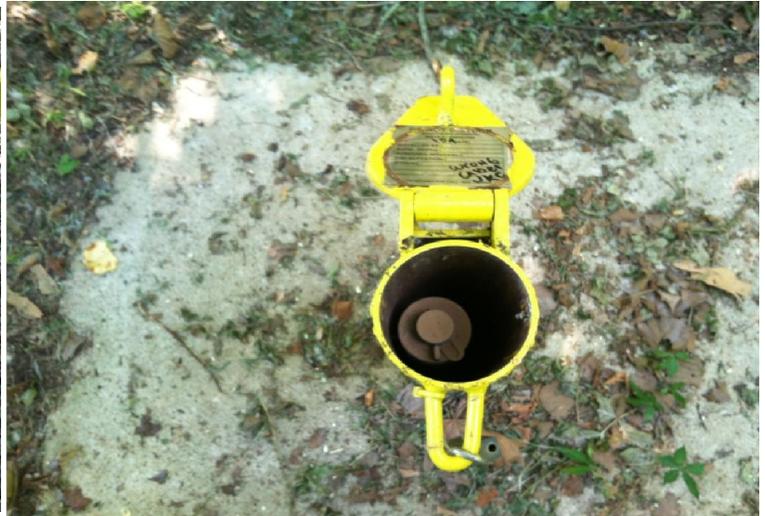
Observations: The monitoring well is in good shape and operational.

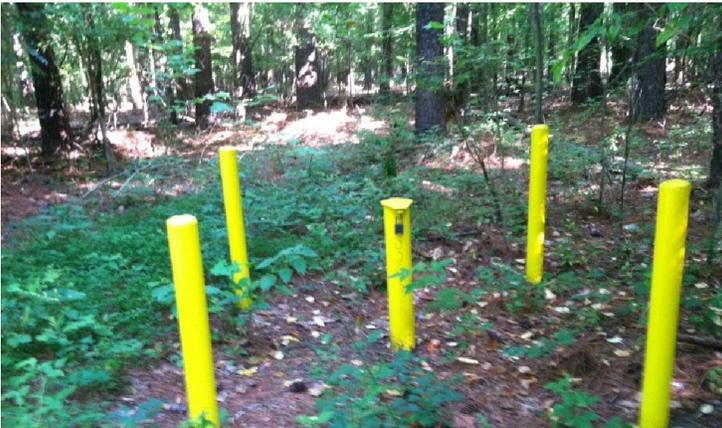
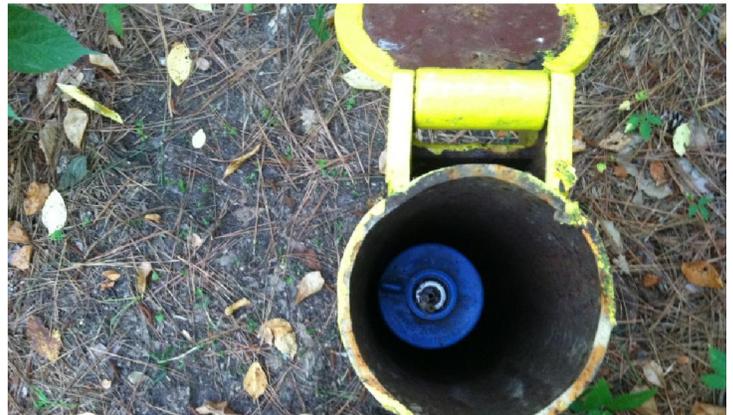
Observations: The monitoring well is in good shape and operational.

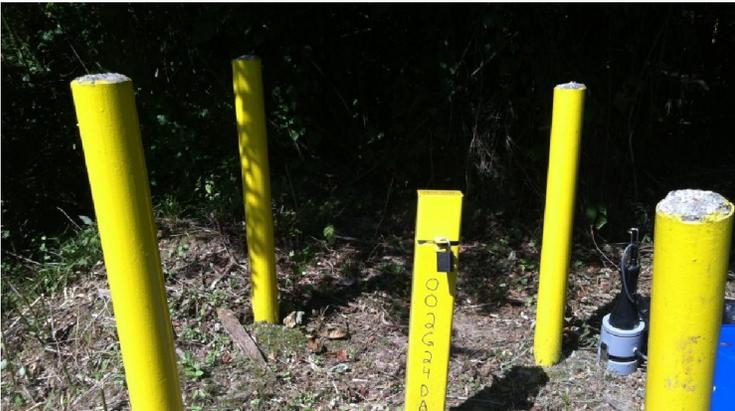
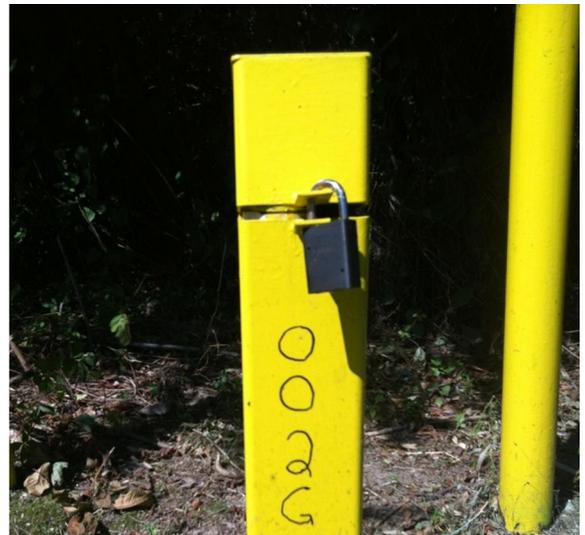
Observations: The monitoring well is in good shape and operational.

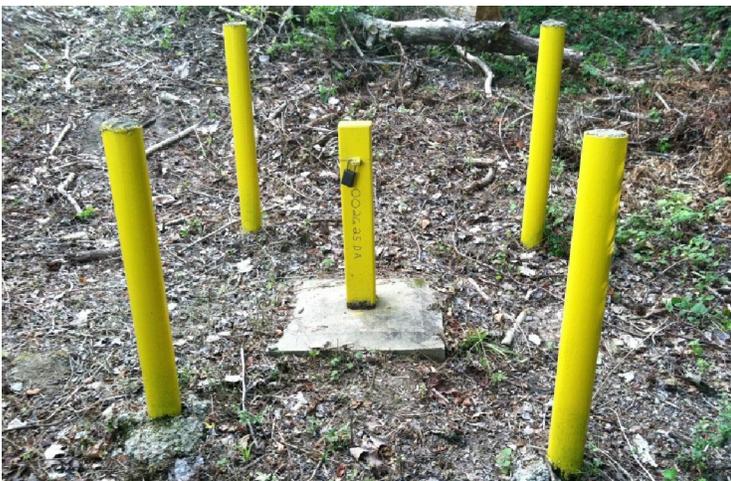
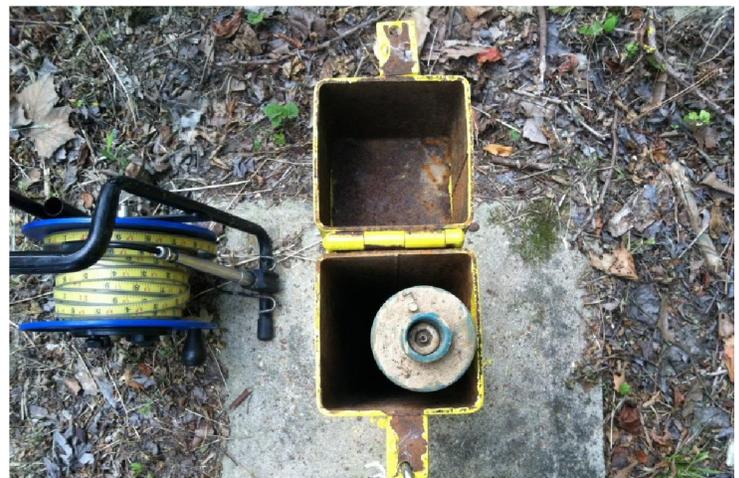
Observations: The monitoring well is in good shape and operational.

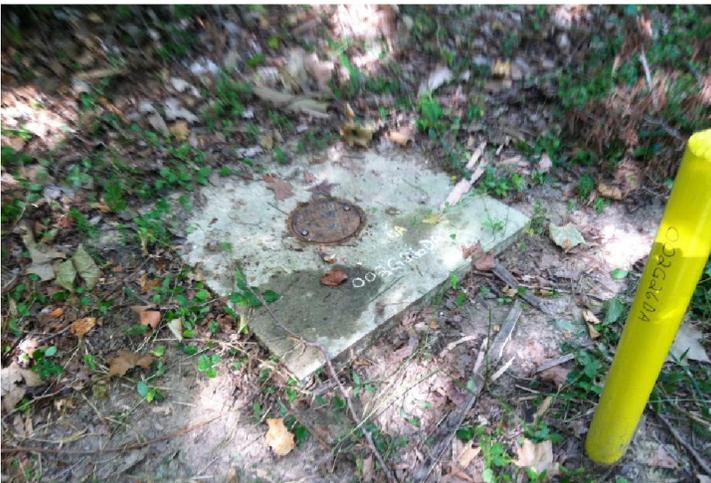
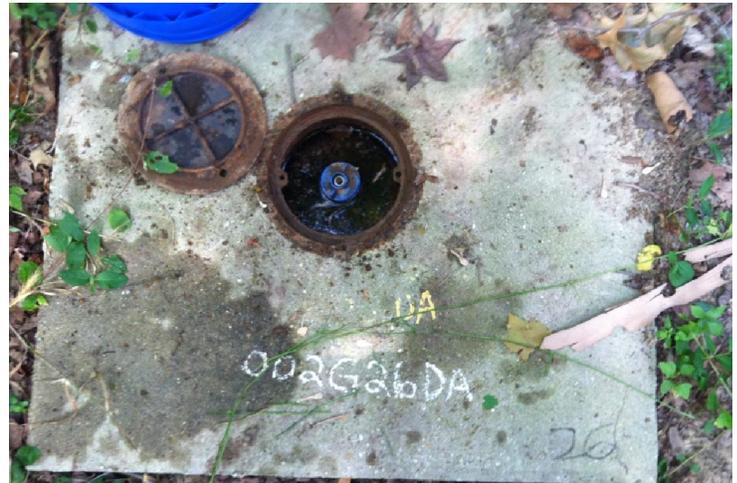
Observations: The monitoring well is in good shape and operational.

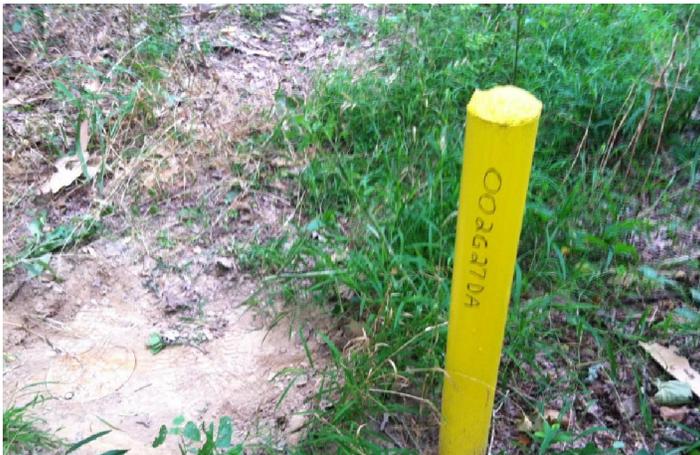
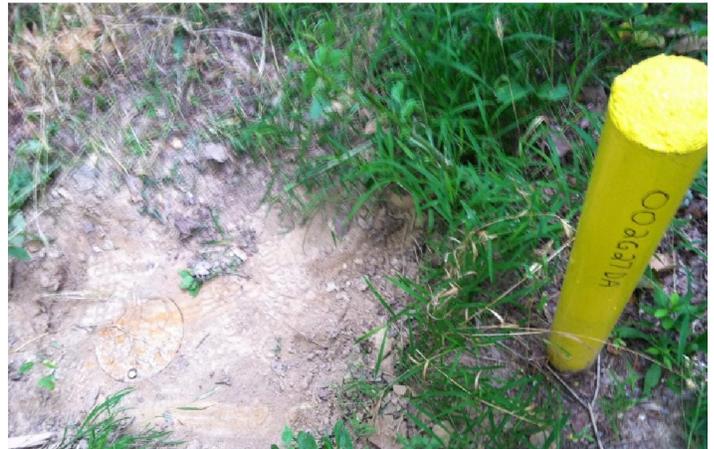
Observations: The monitoring well is in good shape and operational.

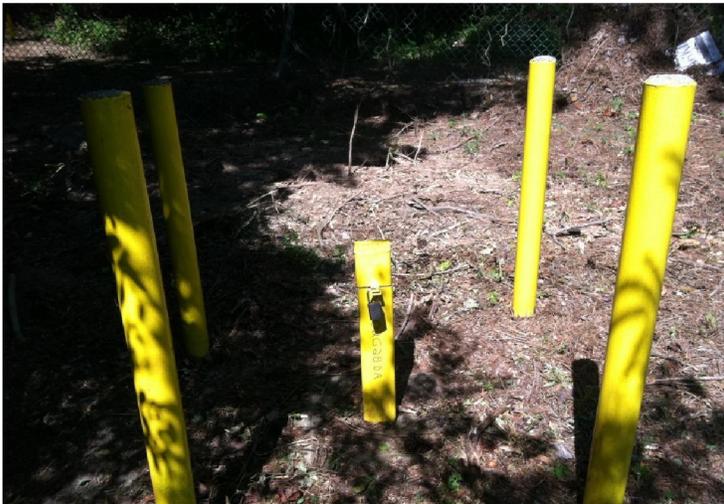
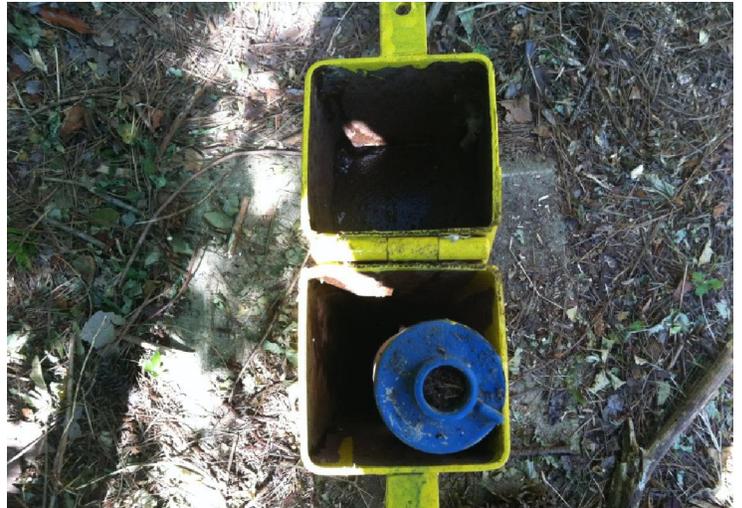
Observations: The monitoring well is in good shape and operational.

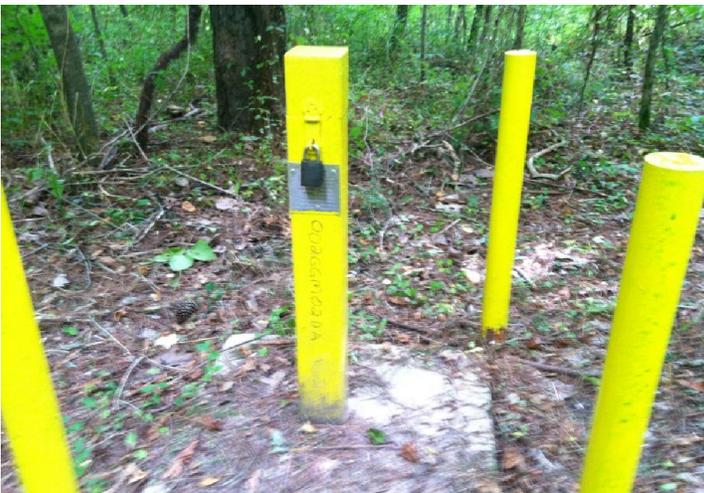
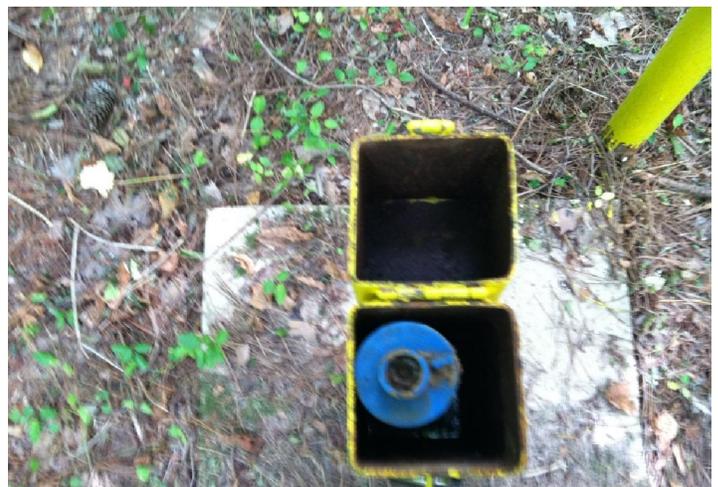
Observations: The monitoring well is in good shape and operational.

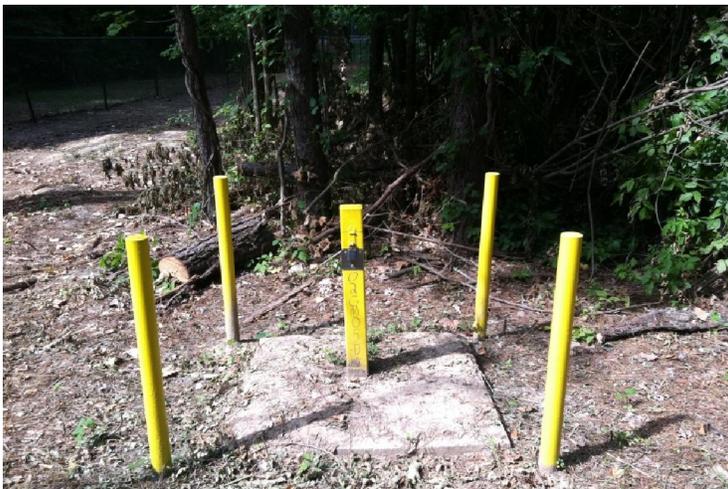
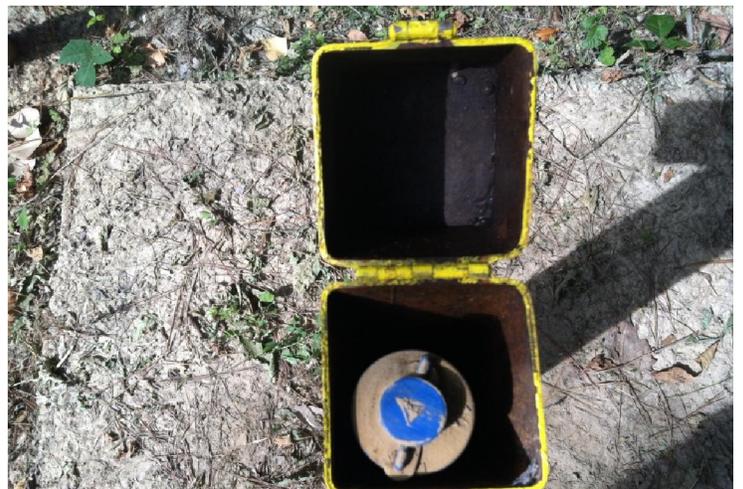
Observations: The monitoring well is in good shape and operational.

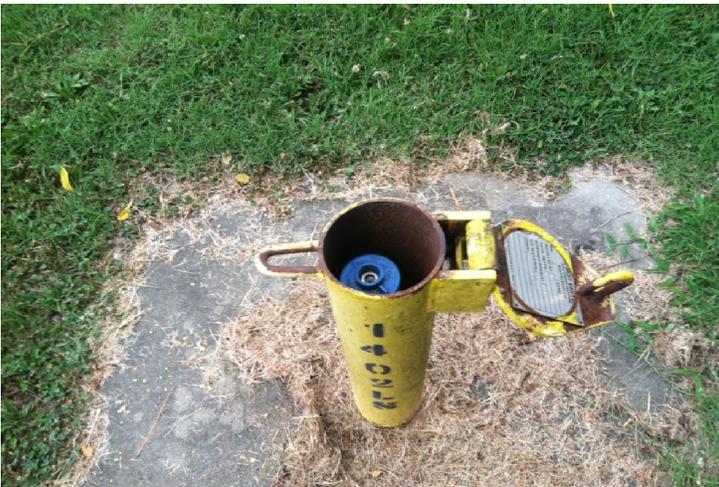
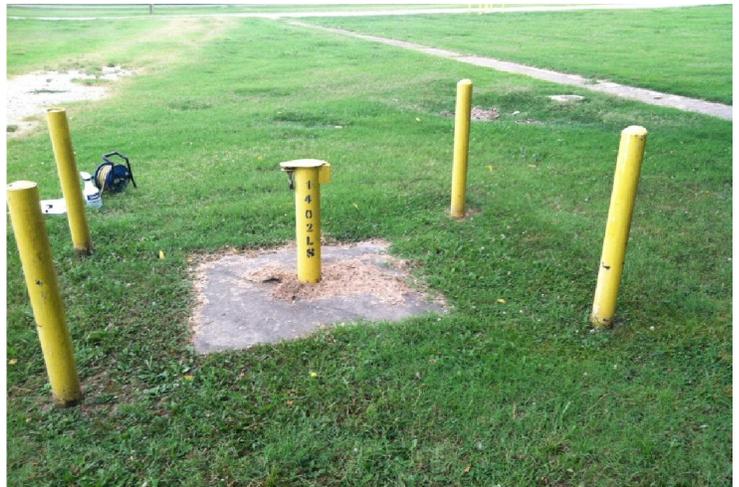
Observations: The monitoring well is in good shape and operational.

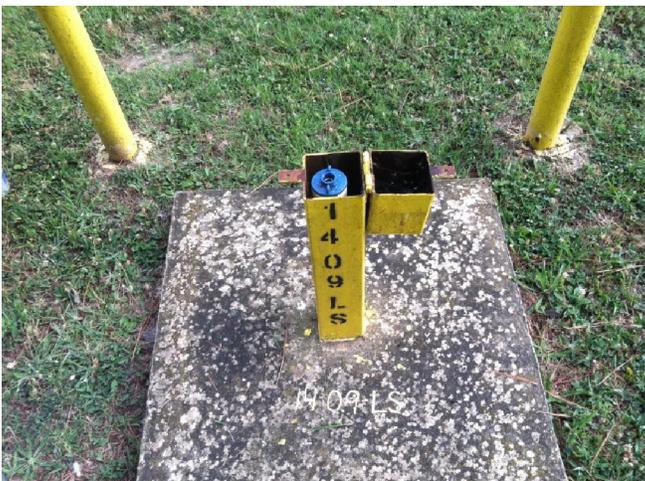
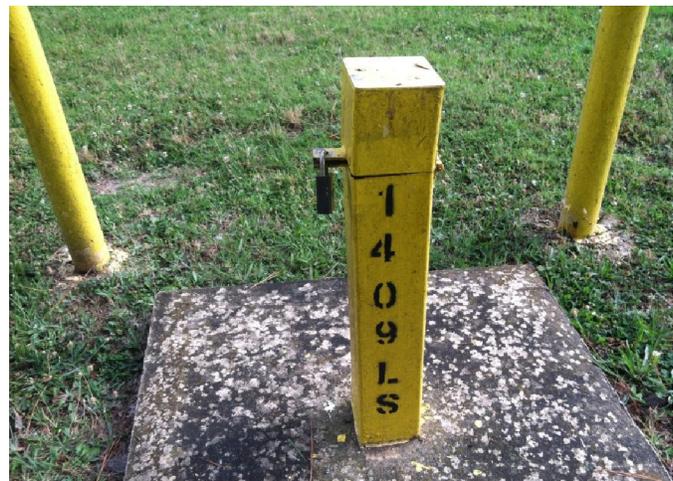
Date: 7/15/2013
 Well ID: 014G09LS Picture No.: _____ Location: SWMU 14/46
 Completion: _____ Above-ground: Yes

Observations: The monitoring well is in good shape and operational.

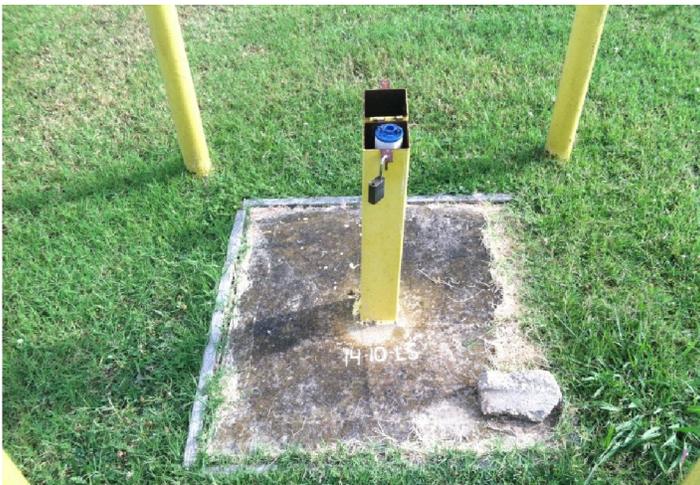
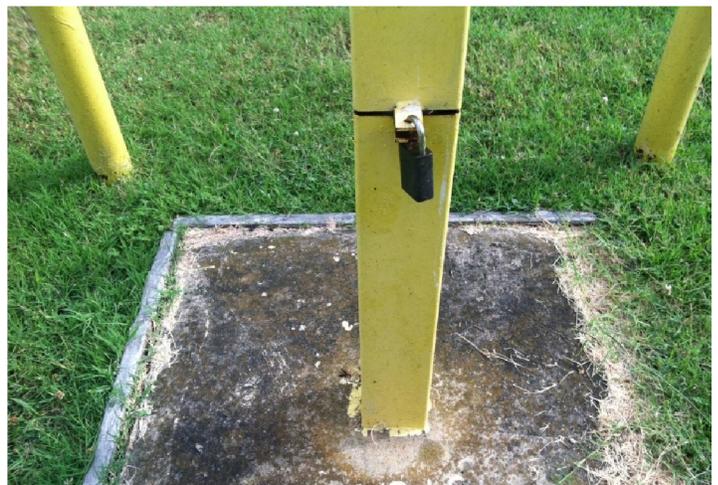
Date: 7/15/2013
 Well ID: 014G10LS Picture No.: _____ Location: SWMU 14/46
 Completion: _____ Above-ground: Yes

Observations: The monitoring well is in good shape and operational.

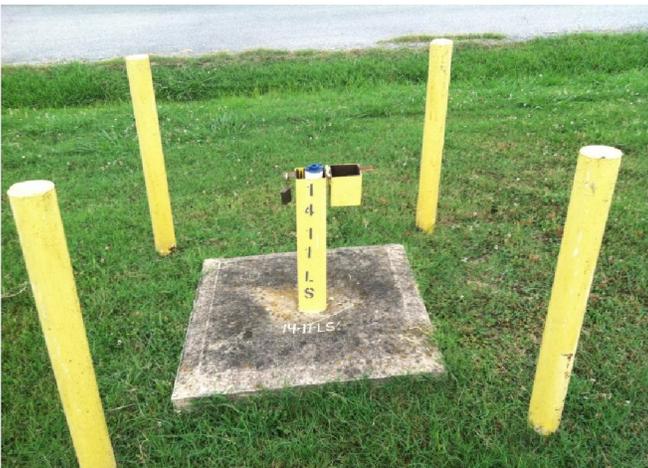
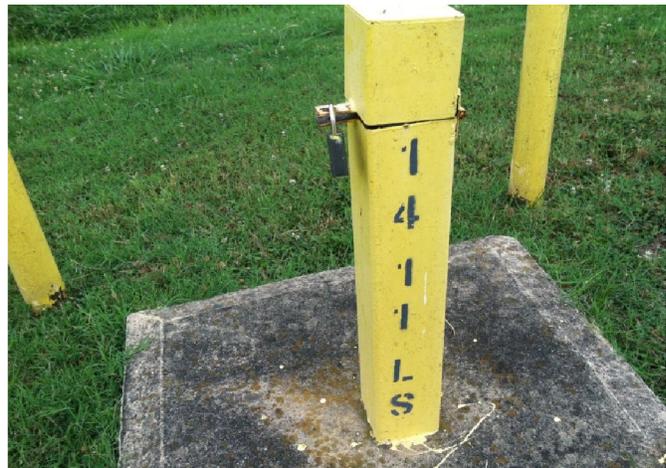
Date: 7/15/2013
 Well ID: 014G11LS Picture No.: _____ Location: SWMU 14/46
 Completion: _____ Above-ground: Yes

Observations: The monitoring well is in good shape and operational.

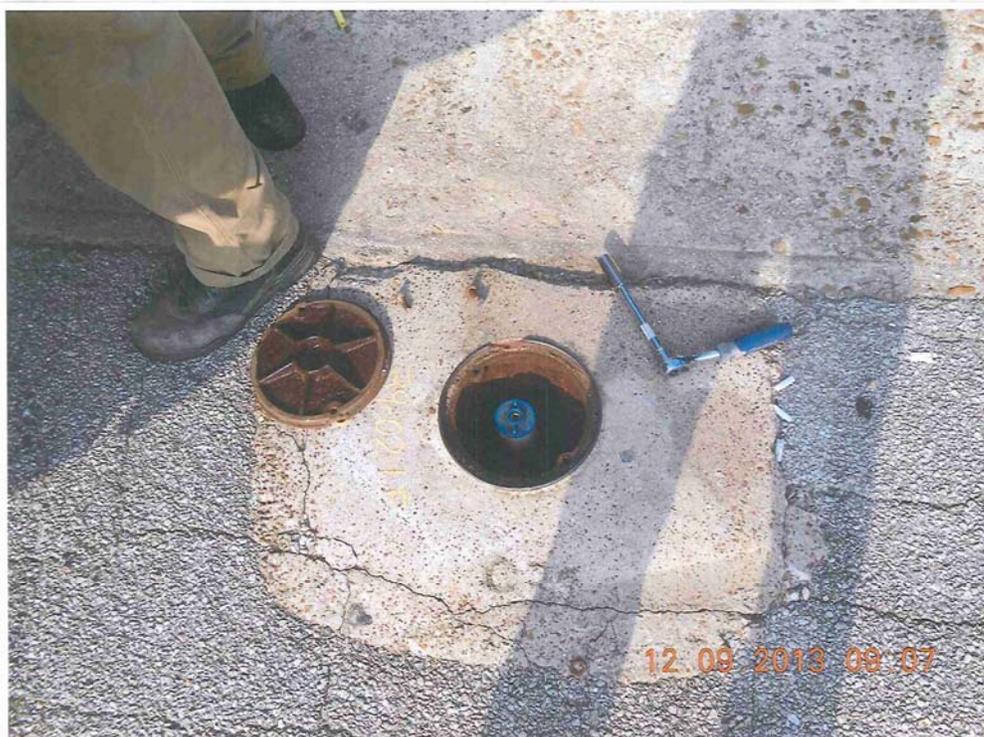
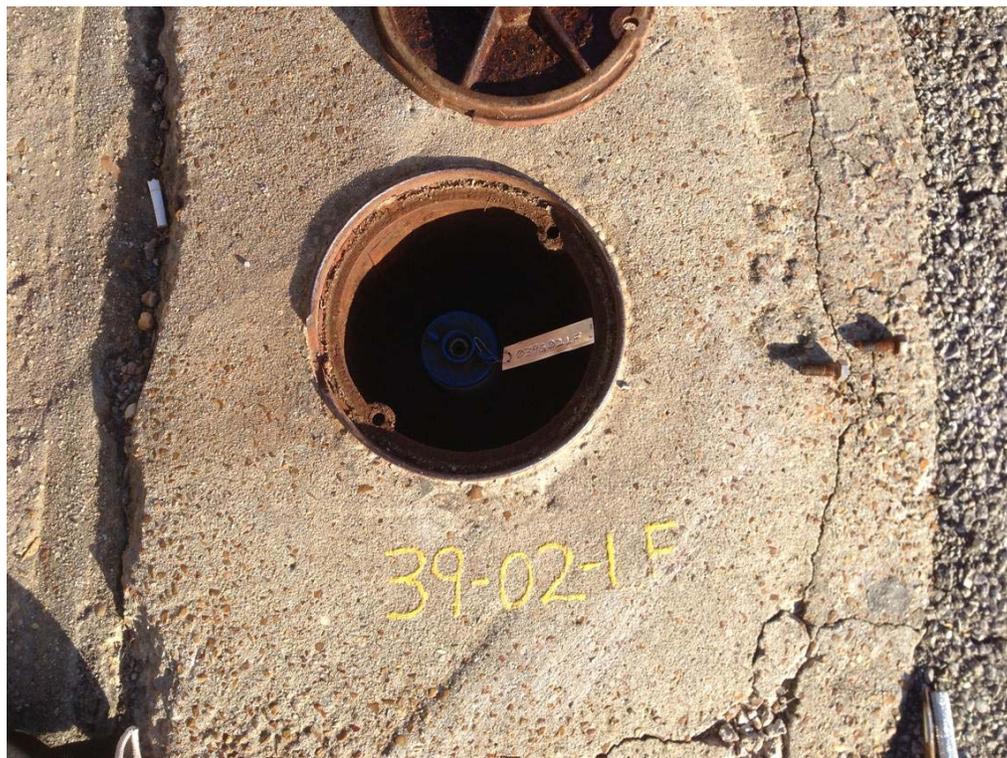
039G02LF

Does well have a surface seal or well pad?	Yes
Does the well have a cap or lockable expansion cap?	Yes
Is the well cap protecting against entry of possible surface water in manhole?	Yes
Does the manhole have a least one locking bolt?	No
Does the protective casing or well box have an external ID tab or label?	Yes
Is the manhole gasket in good condition?	No

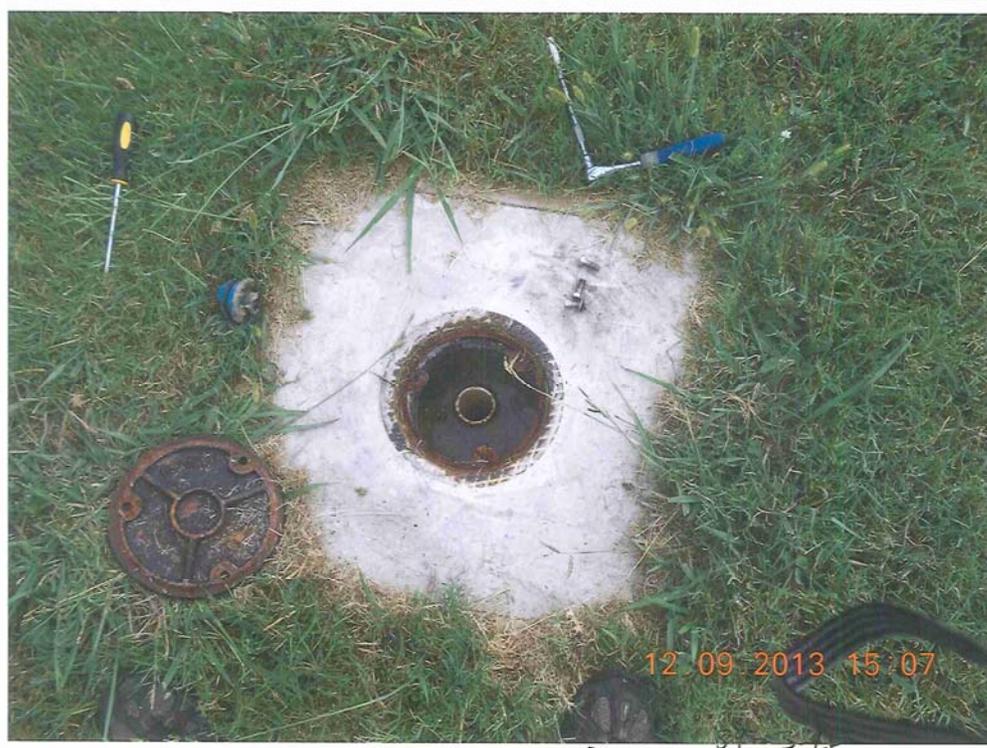
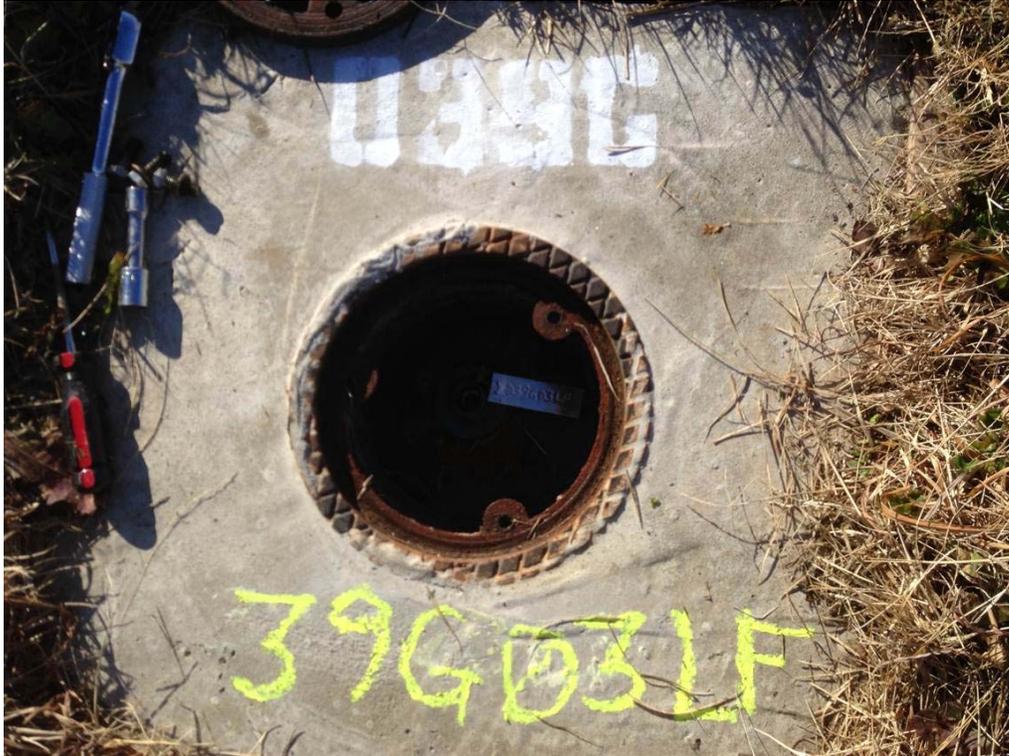
039G03LF

Does well have a surface seal or well pad?	Yes
Does the well have a cap or lockable expansion cap?	Yes
Is the well cap protecting against entry of possible surface water in manhole?	Yes
Does the manhole have a least one locking bolt?	No
Does the protective casing or well box have an external ID tab or label?	Yes
Is the manhole gasket in good condition?	No
