Final
Asbestos Inspection Report
for

Naval Activity Puerto Rico
Ceiba, Puerto Rico

Volume 2 of 7

Buildings DN2-3 through 598

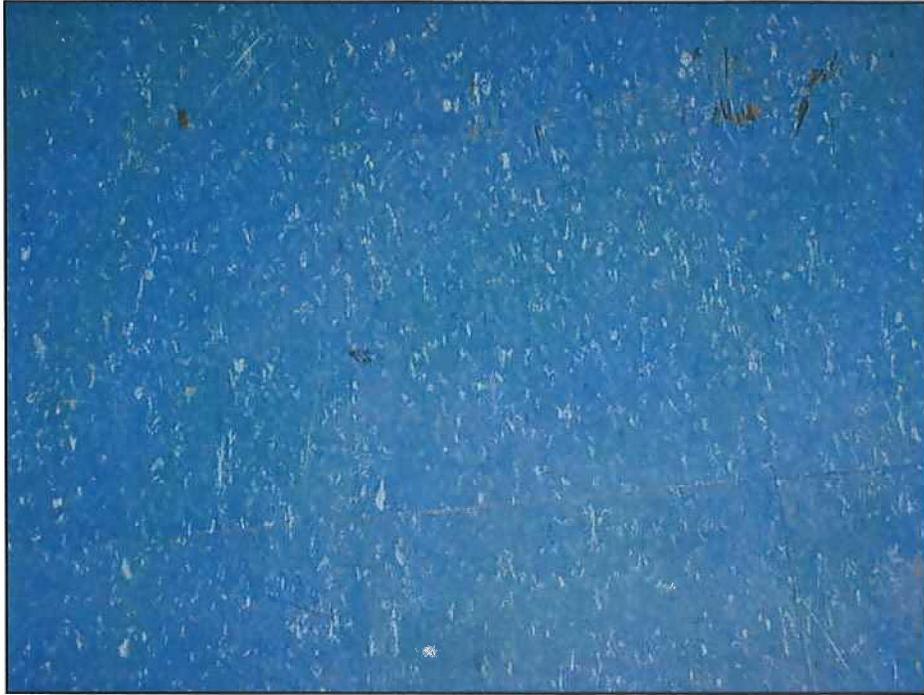
1' x1' vinyl floor tile (Material #010) over ACM adhesive (Material #011)

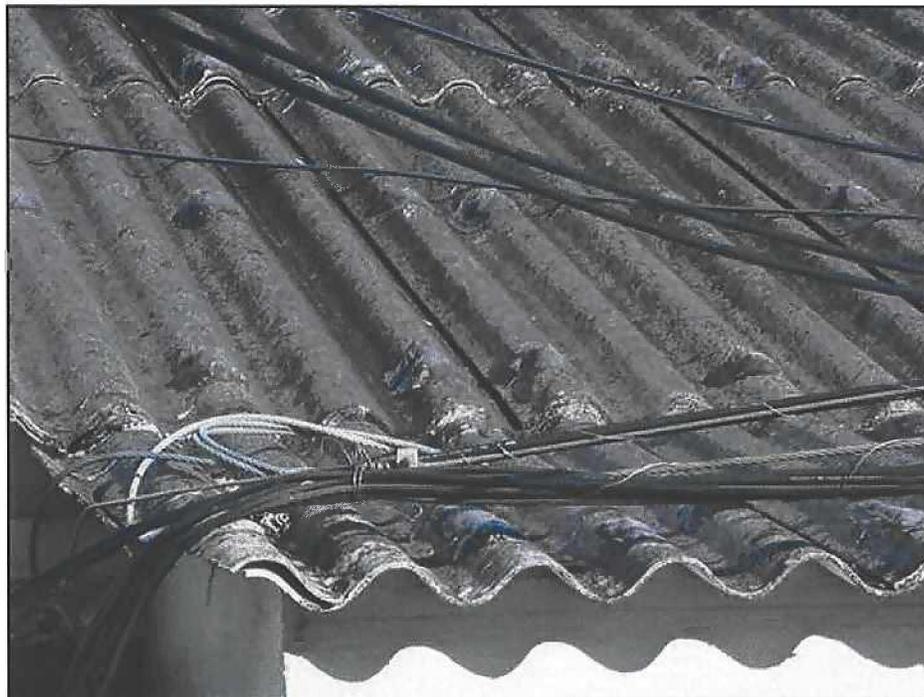
Corrugated cement roofing (Material #014)

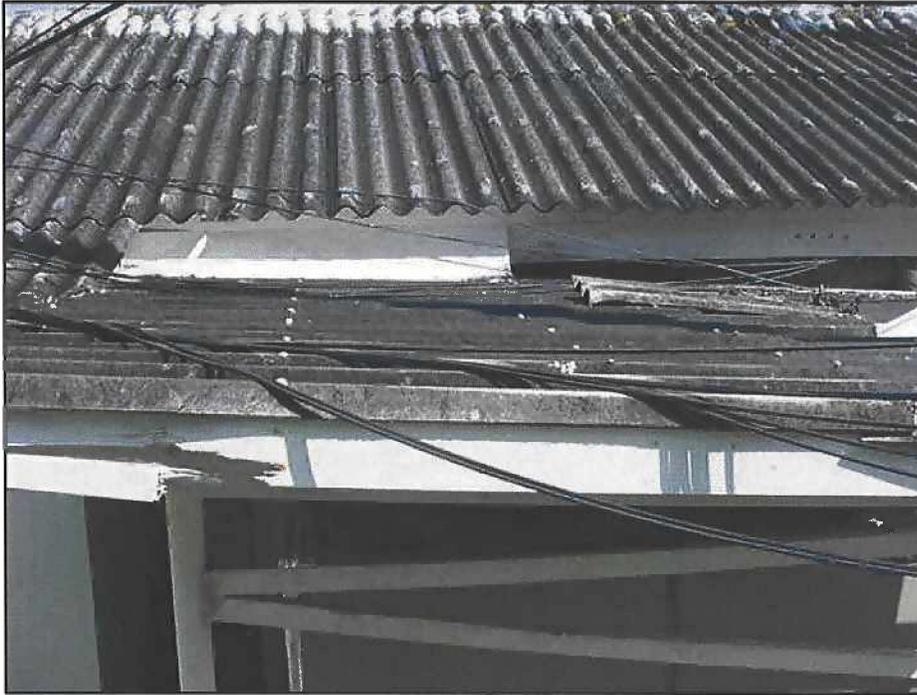
Building DN2-3A is identified as “AC Shelter at DN2-3” and is approximately 100 square feet in size. One suspect homogeneous material was identified and sampled. This material, corrugated cement roofing (Material #001), was found to be ACM. No friable, damaged, and accessible ACM was identified.

Corrugated cement roofing panels (Material #001)

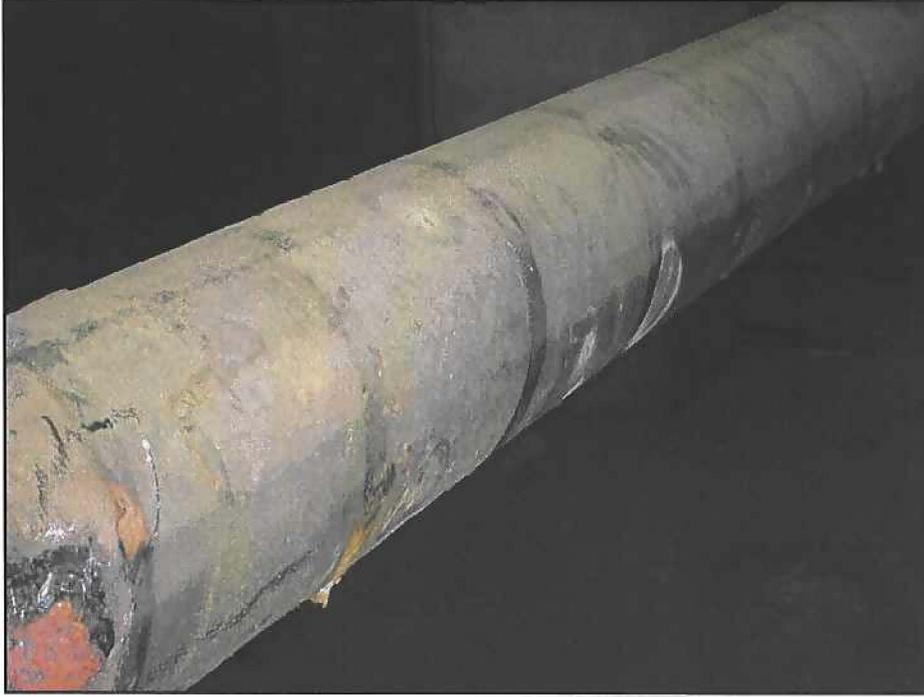
Building 30 is identified as “EOD OPNS Building” and is approximately 13,086 square feet in size. Ten suspect homogeneous materials were identified and sampled. One material, thermal pipe insulation (Material #010), was found to be an ACM. No friable, damaged, and accessible ACM was identified.

Thermal pipe insulation (Material # 010)

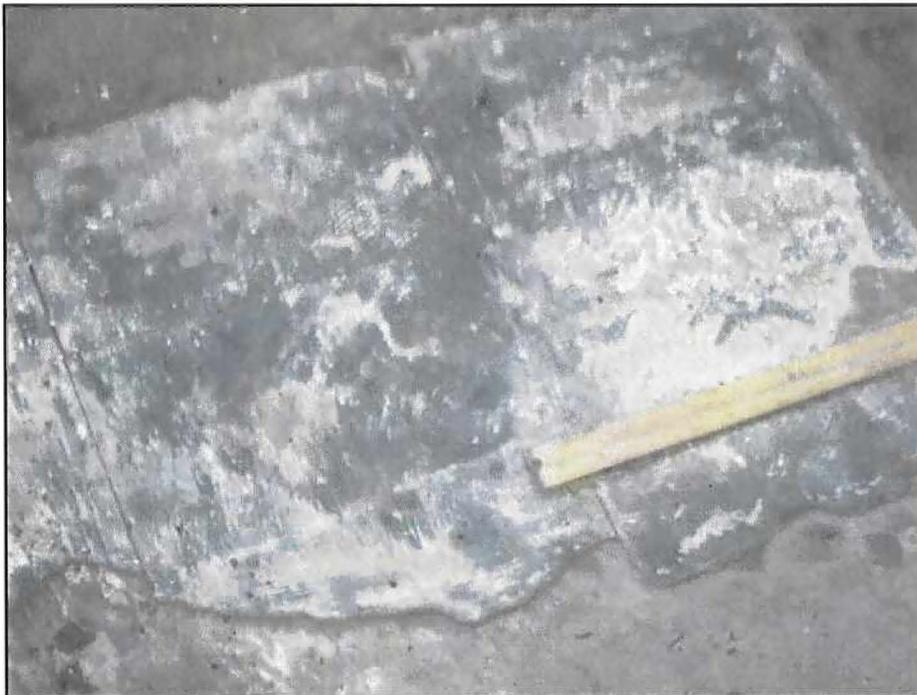
1'x1' green vinyl floor tile (material #016) over ACM floor adhesive (Material #018)

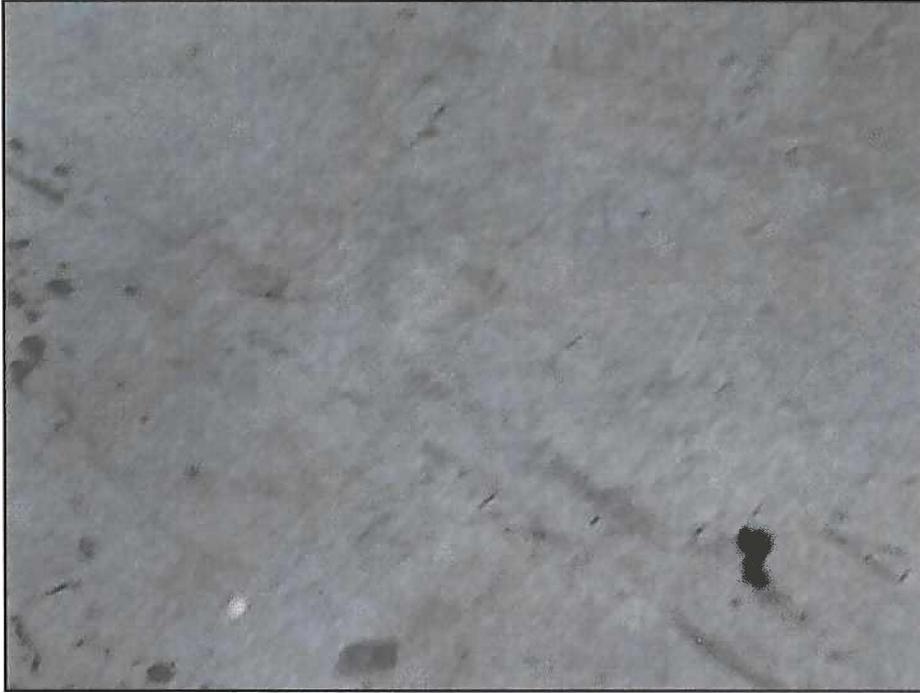
Blue / gray swirled vinyl sheet flooring (Material #020) over ACM floor adhesive (Material #021)

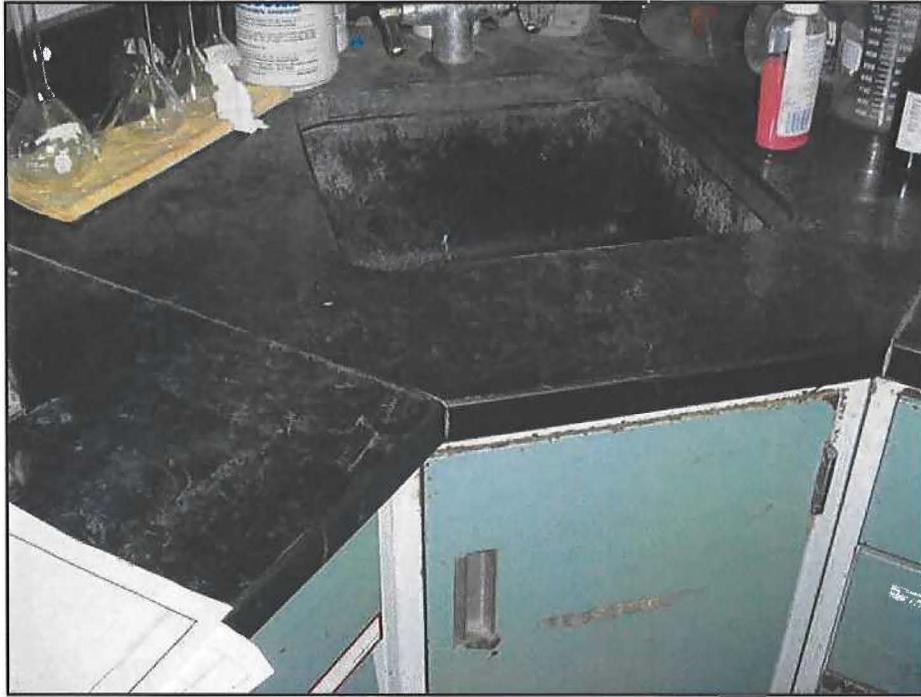
Laboratory tabletops (Material #005)

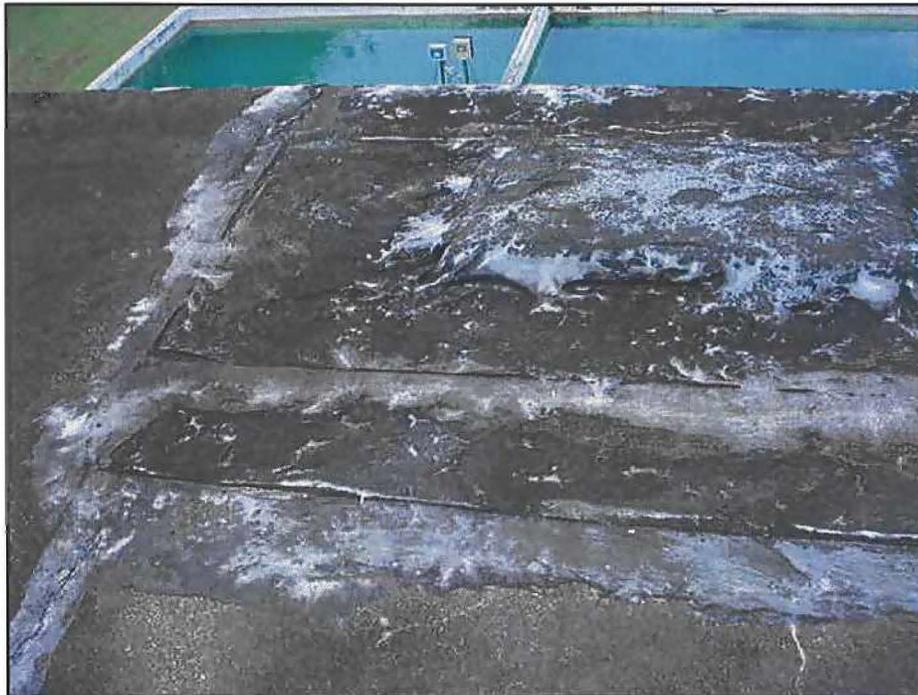
Roof tar (Material #006)

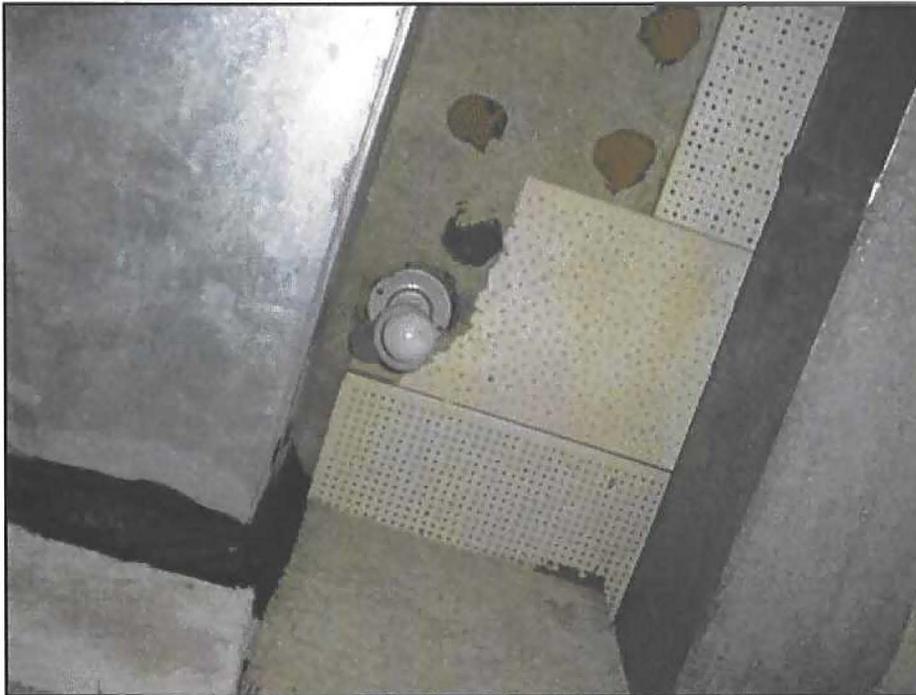
Adhesive for 1'x1' ceiling tiles (Material #011)

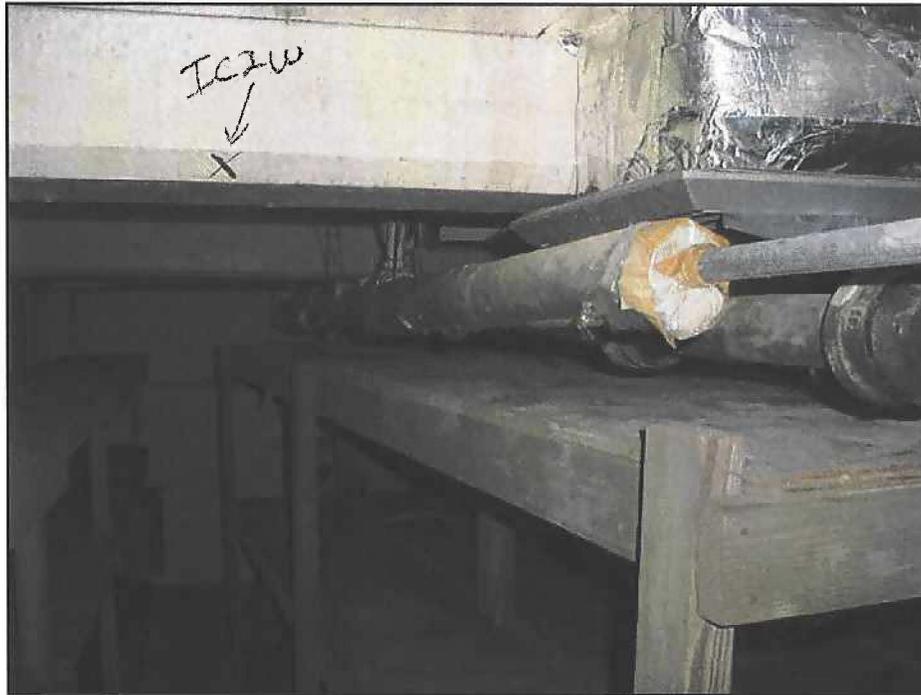
HOMOGENEOUS MATERIAL	BUILDING NUMBER	QUANTITY
THERMAL PIPE INSULATION (Material Number 013)	296	20 LF

Pipe insulation (Material #013)

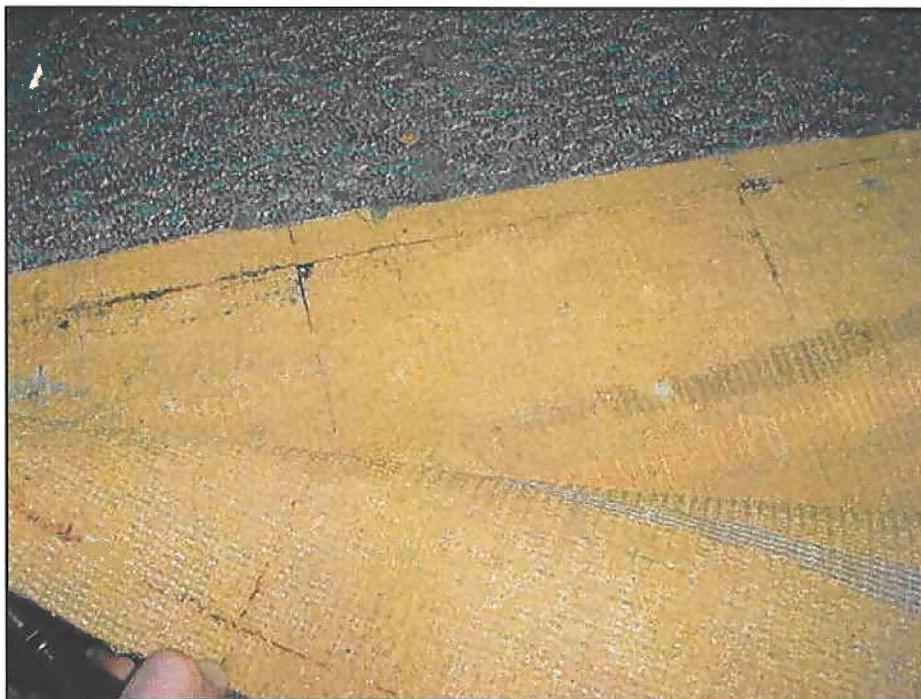
9" x 9" white vinyl floor tile (Material #016)

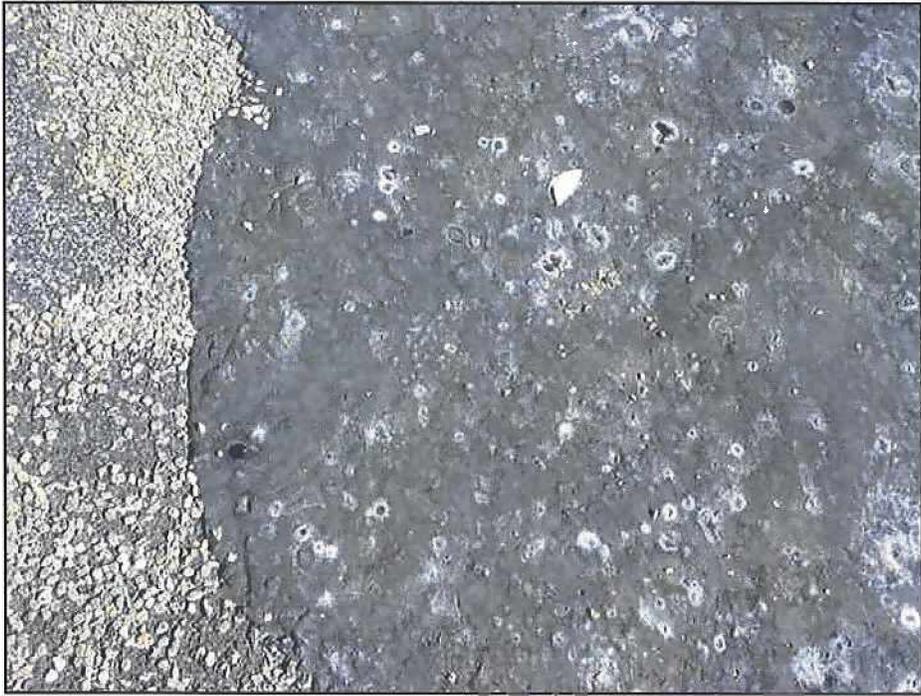
Roofing tar (Material #020)

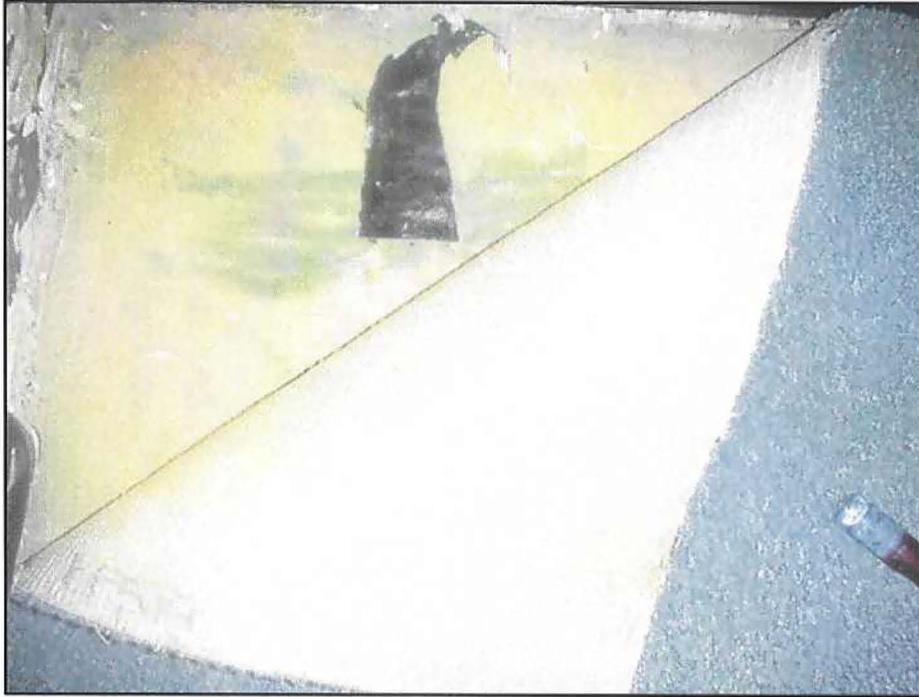
9" x 9" green vinyl floor tile (Material # 006)

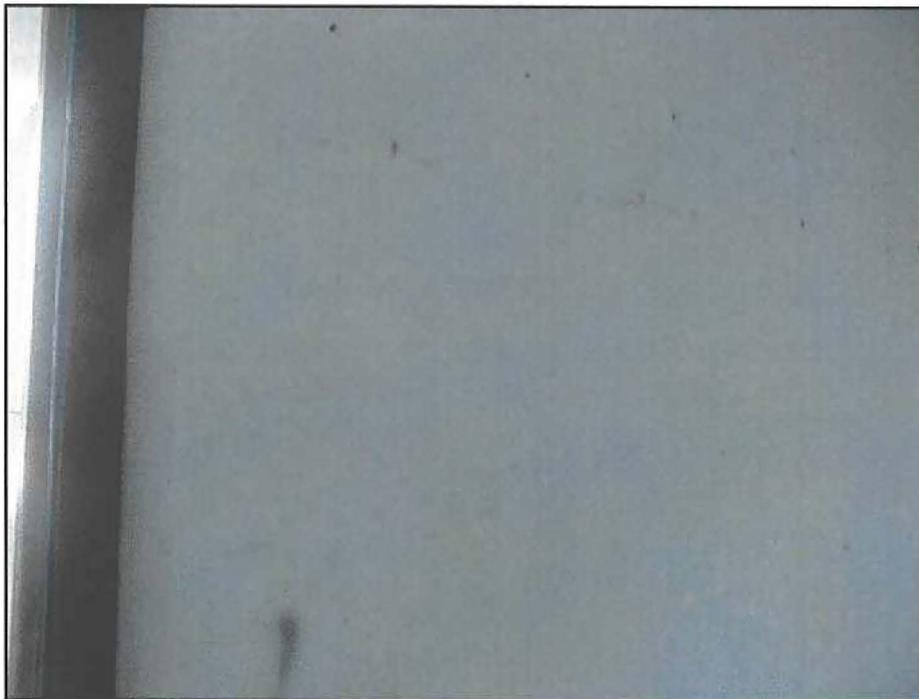
Wallboard (Material #008)

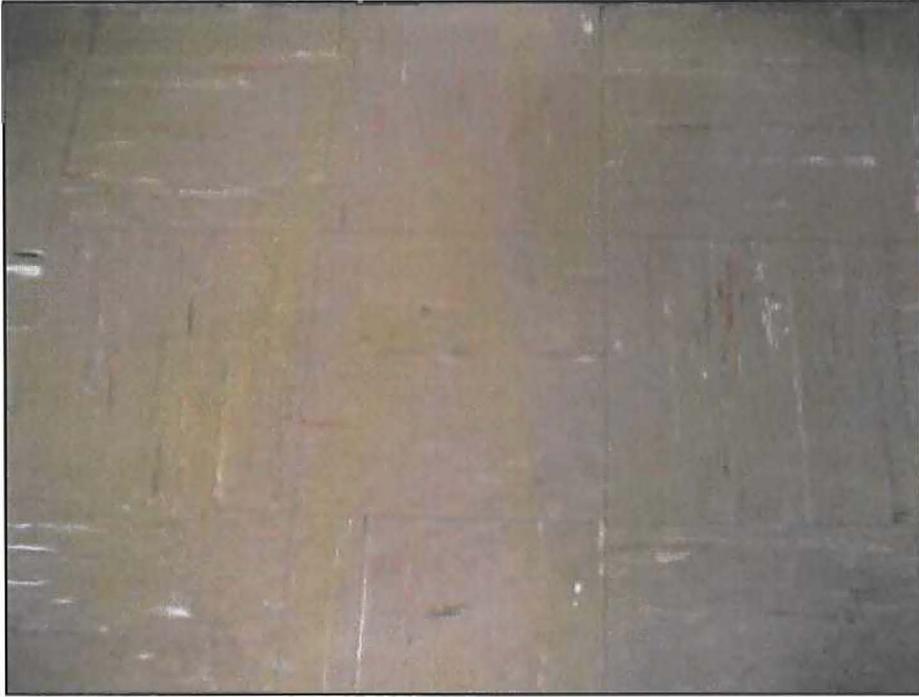
Vinyl floor tile (Material #003) over ACM floor adhesive (Material #004)

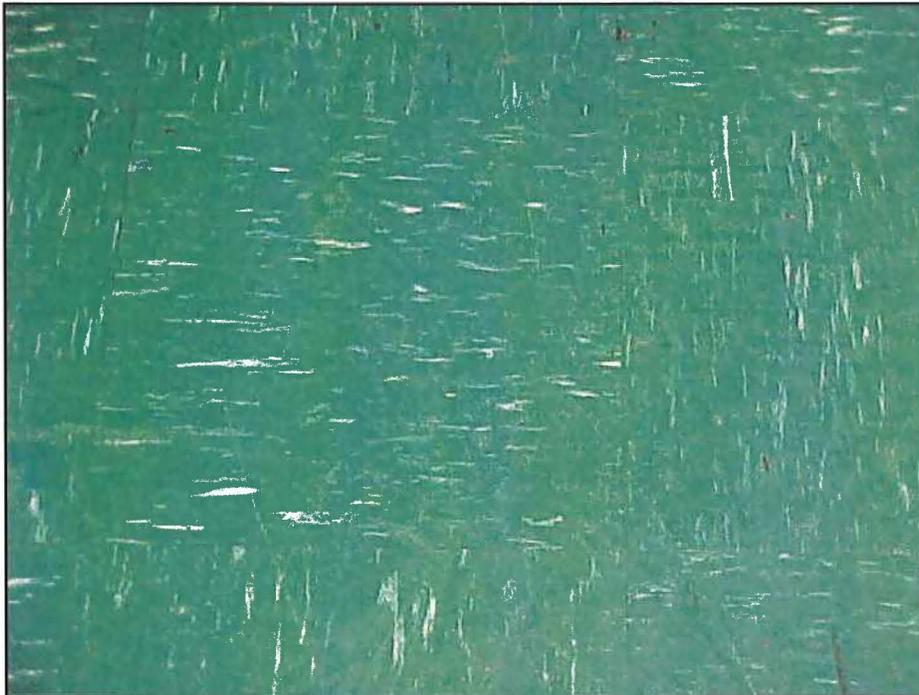
Vinyl floor tile (Material #005)

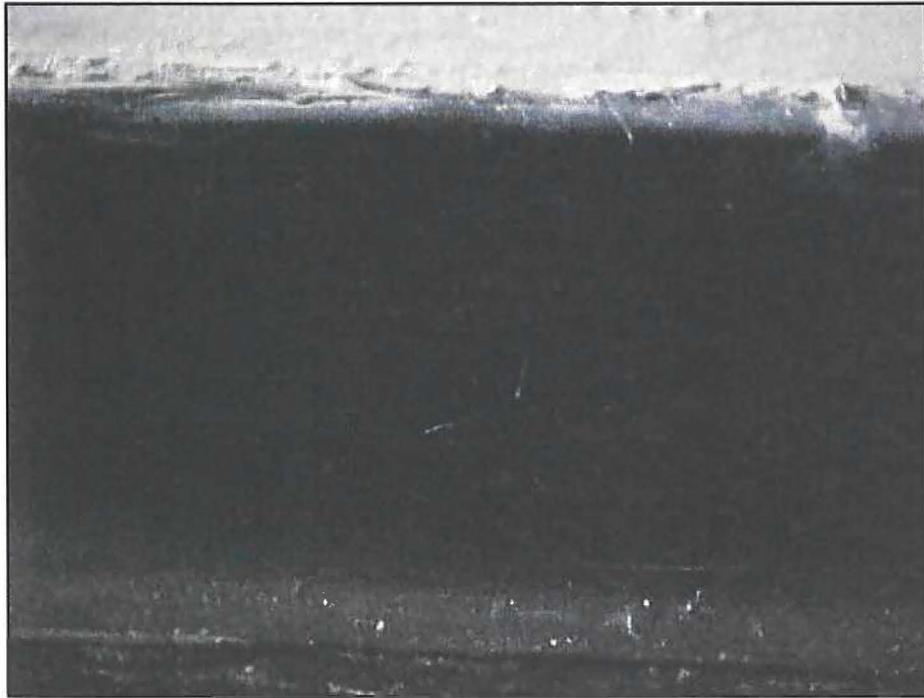
Vinyl floor tile (Material #010)

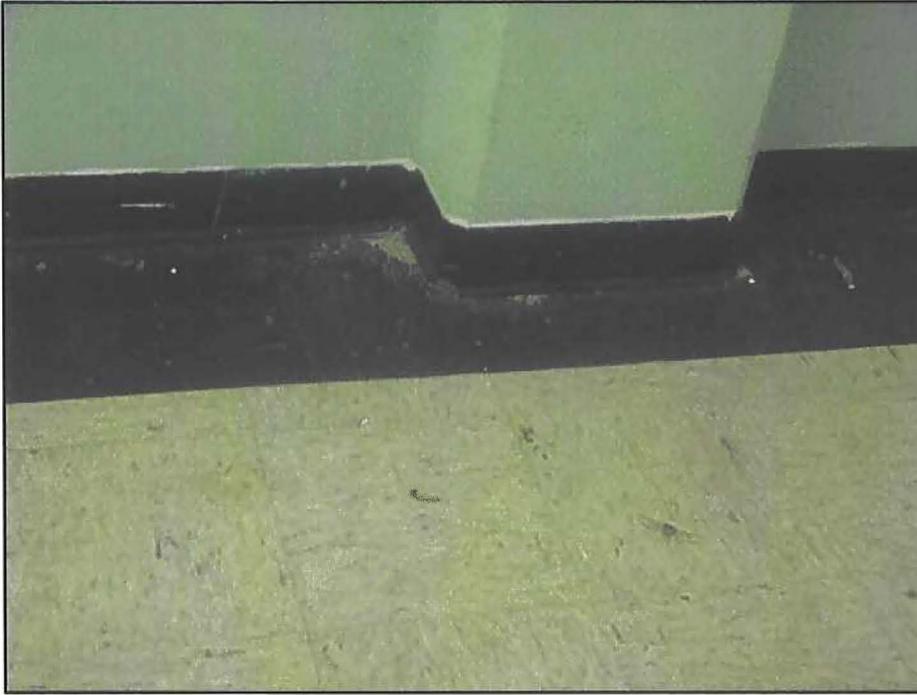
1'x1' black vinyl floor tile (Material #003)

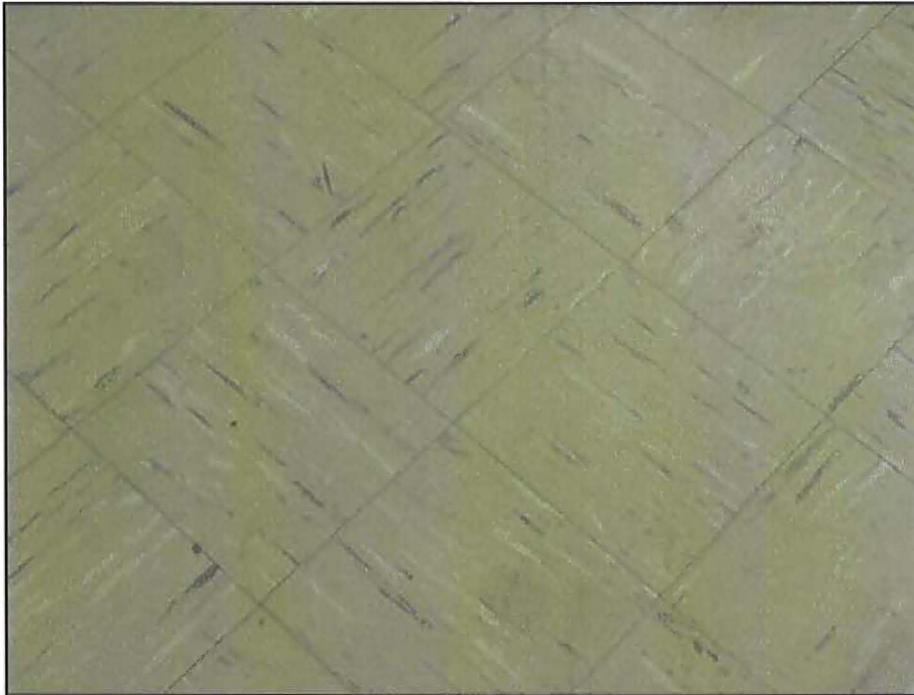
9"x9" tan with red and white streaks vinyl floor tile (Material #006) over black floor adhesive (Material #007)

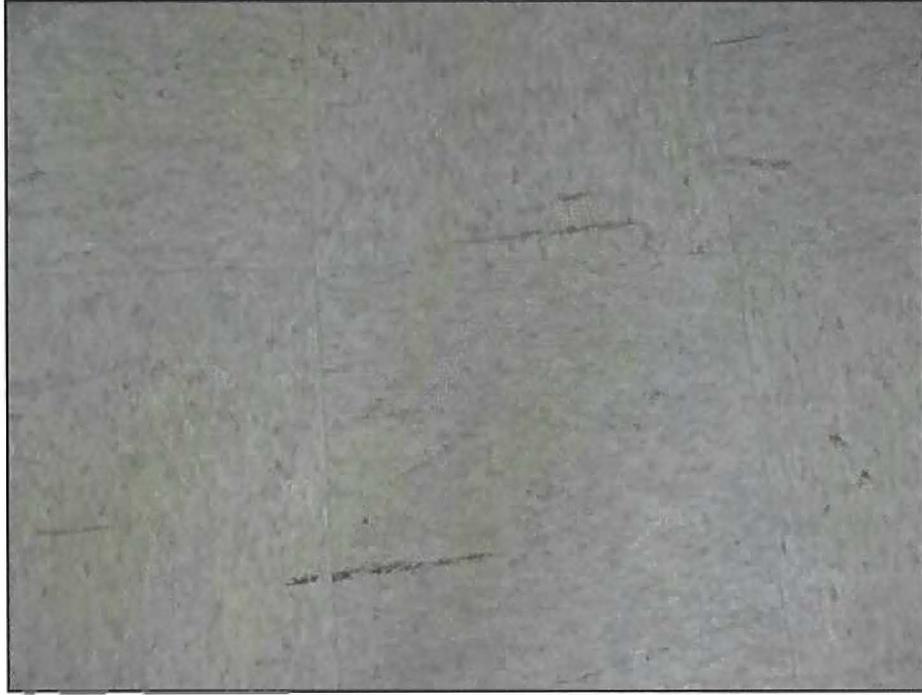
9"x9" gray vinyl floor tile (Material #013) over black floor adhesive (Material #007)

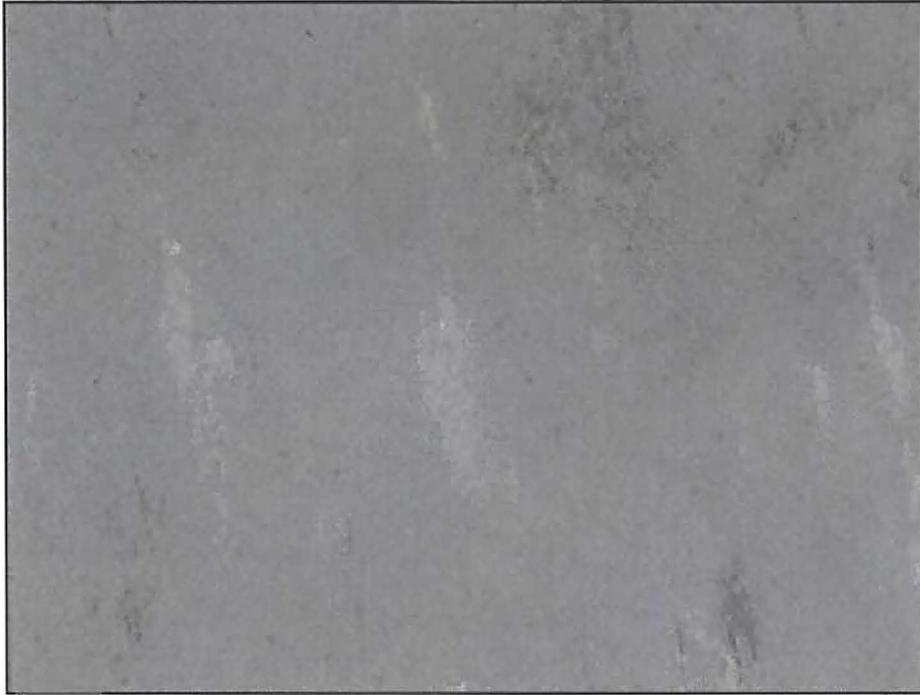
1' x 1' pale green with white streaks vinyl floor tile (Material #008)

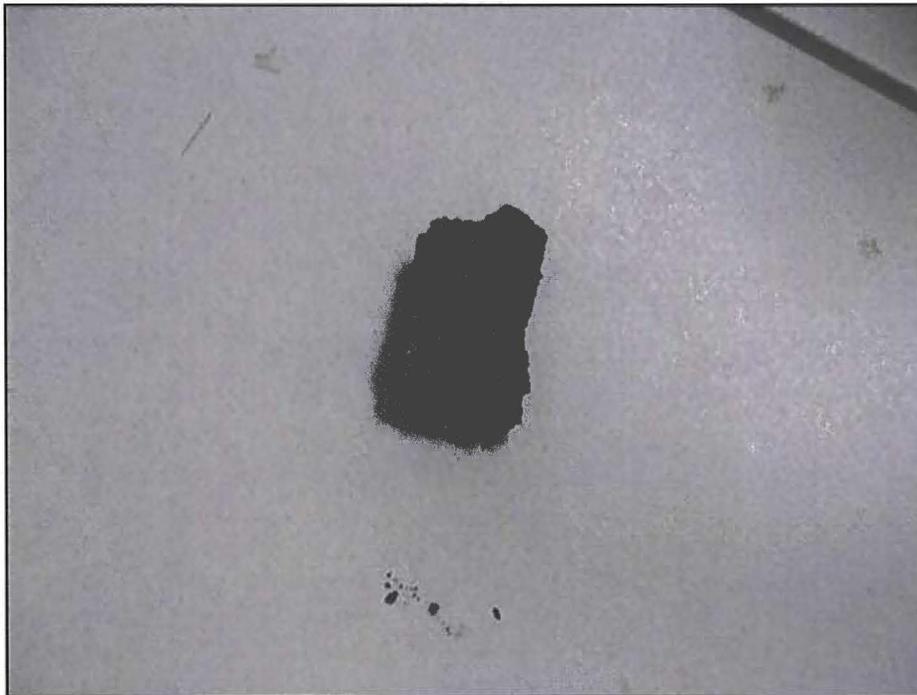
Black asphaltic expansion material between concrete floor sections (Material #019)

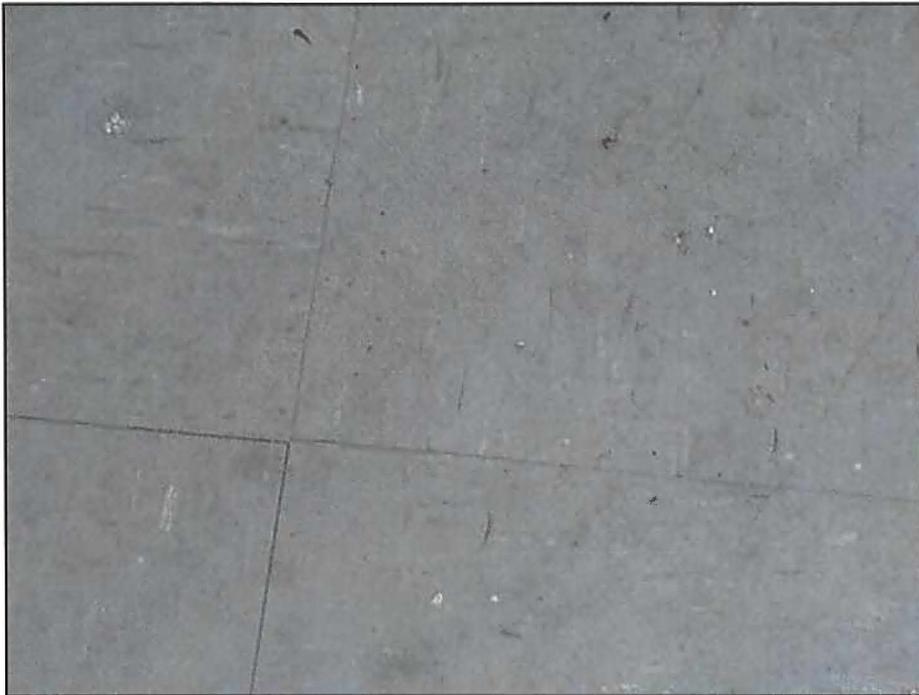
1' x 1' gray vinyl floor tile (Material #001)

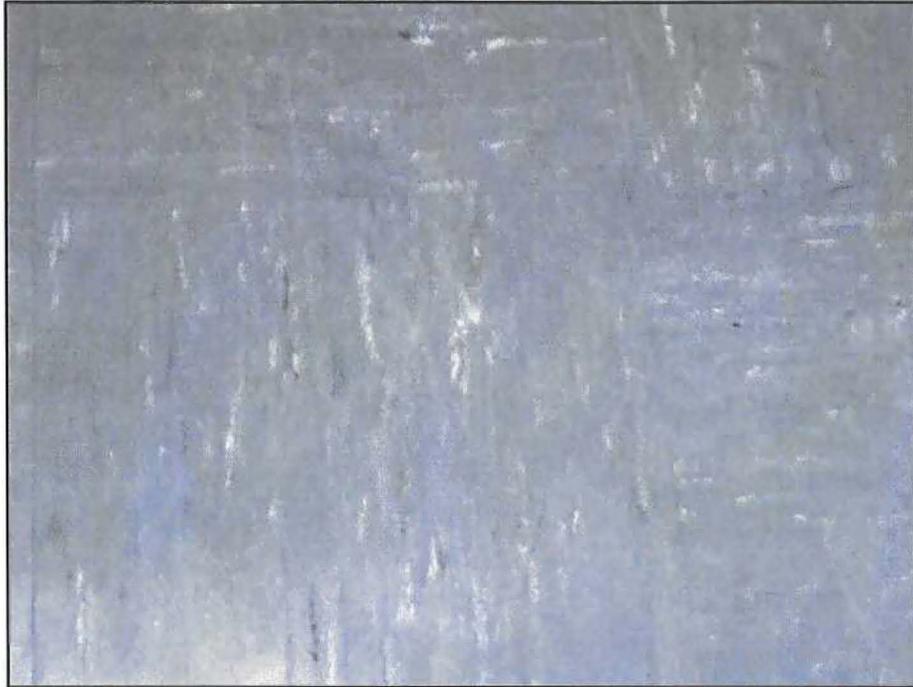
1'x1' gray with white and black streaks vinyl floor tile (Material #008) over ACM floor adhesive (Material #009)

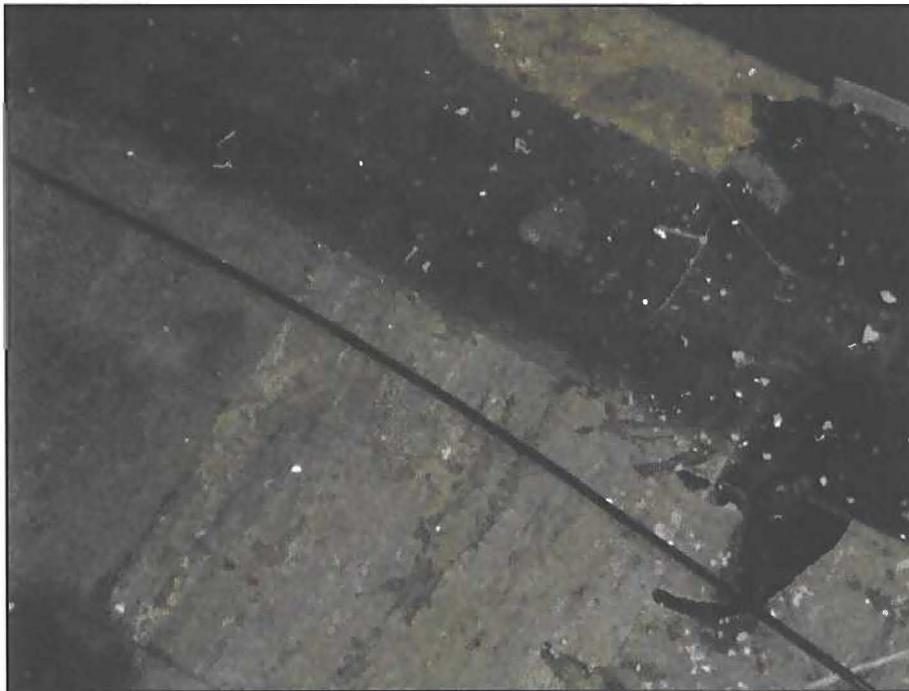
9"x9" tan vinyl floor tile (Material #010) over floor adhesive (Material #011)

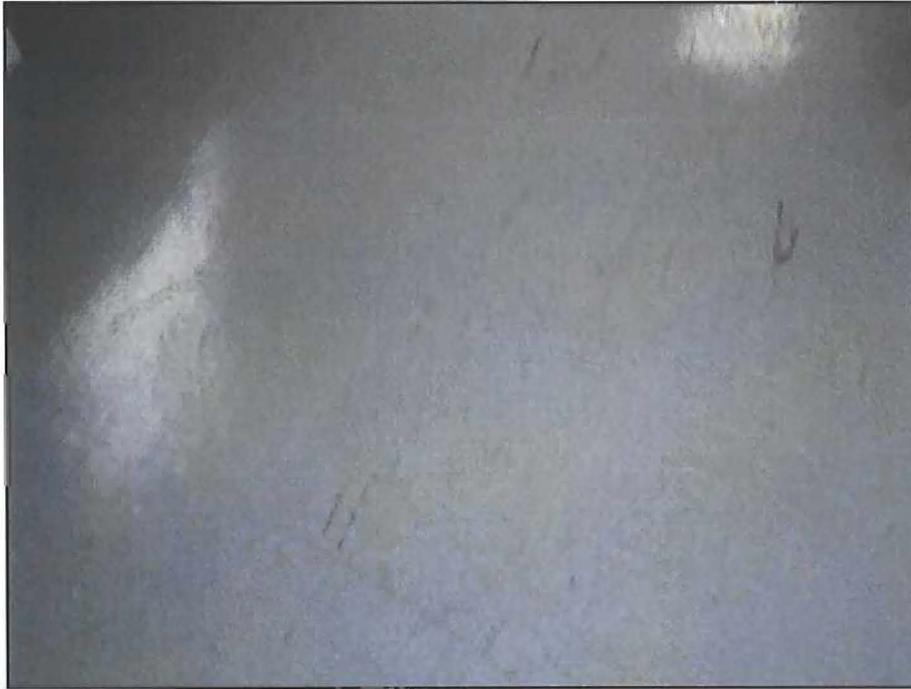
Blue-gray vinyl floor sheeting (Material #015) over ACM floor adhesive (Material #016)

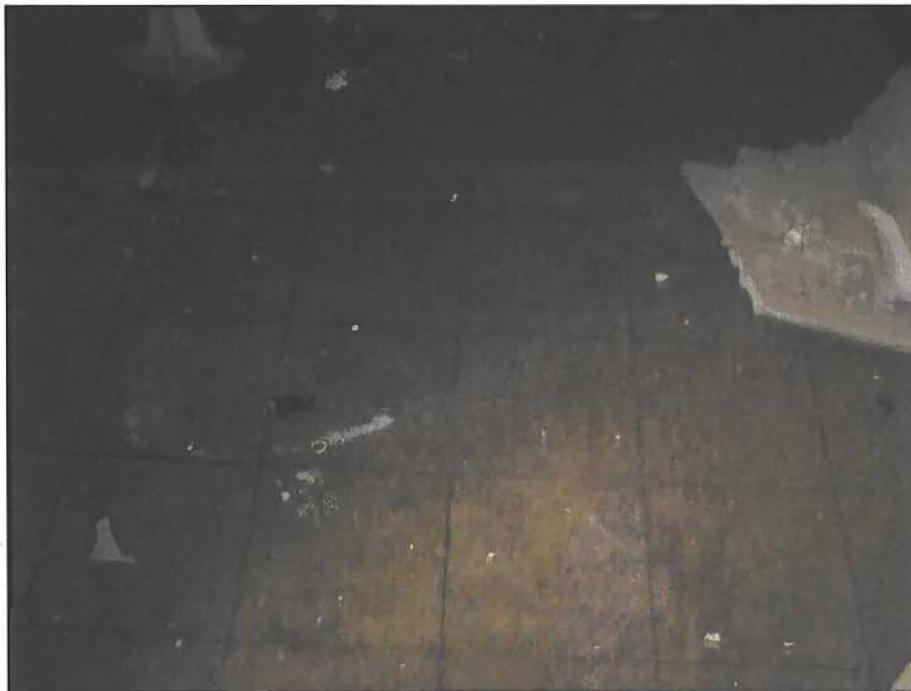
9"x9" Brown with tan speckles vinyl floor tile (Material #022) over floor adhesive (Material #023)

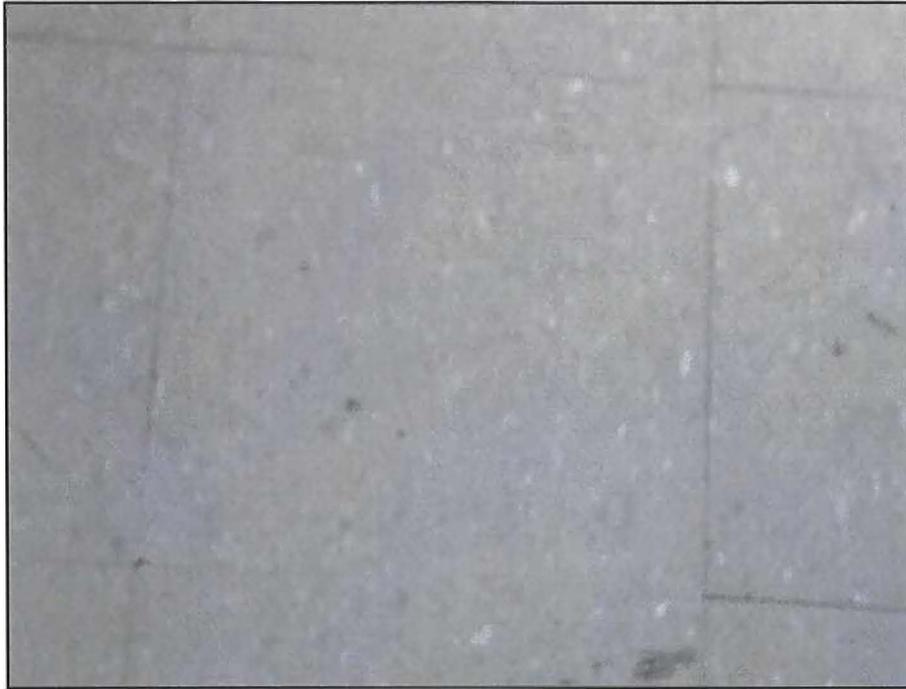
1'x1' tan with white and dark spots vinyl floor tile (Material #027) over ACM floor adhesive (Material #028)

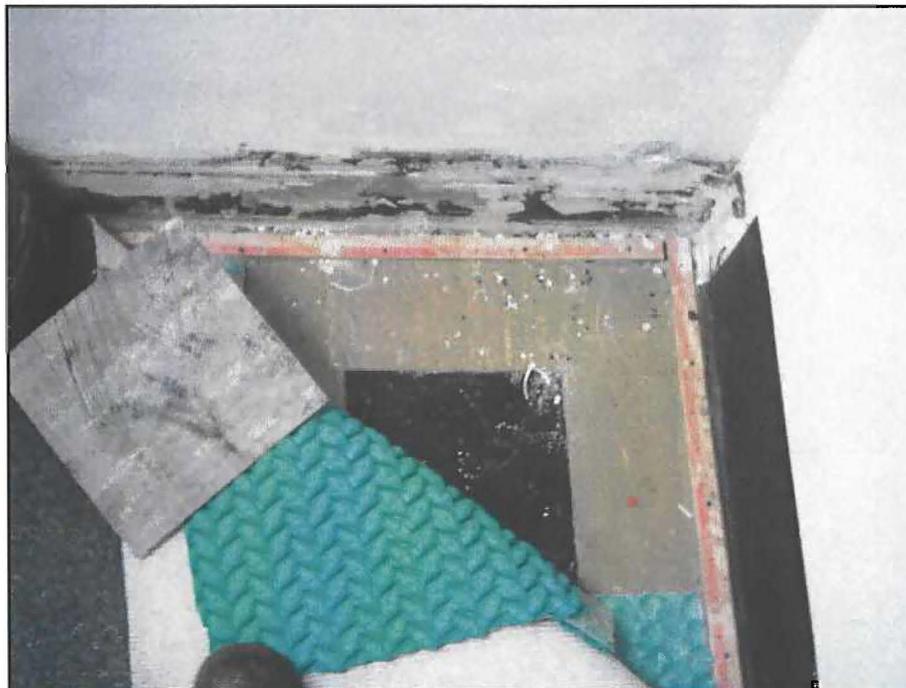
9"x9" brown with white streaks vinyl floor tile (Material #031) over floor adhesive (Material #032)

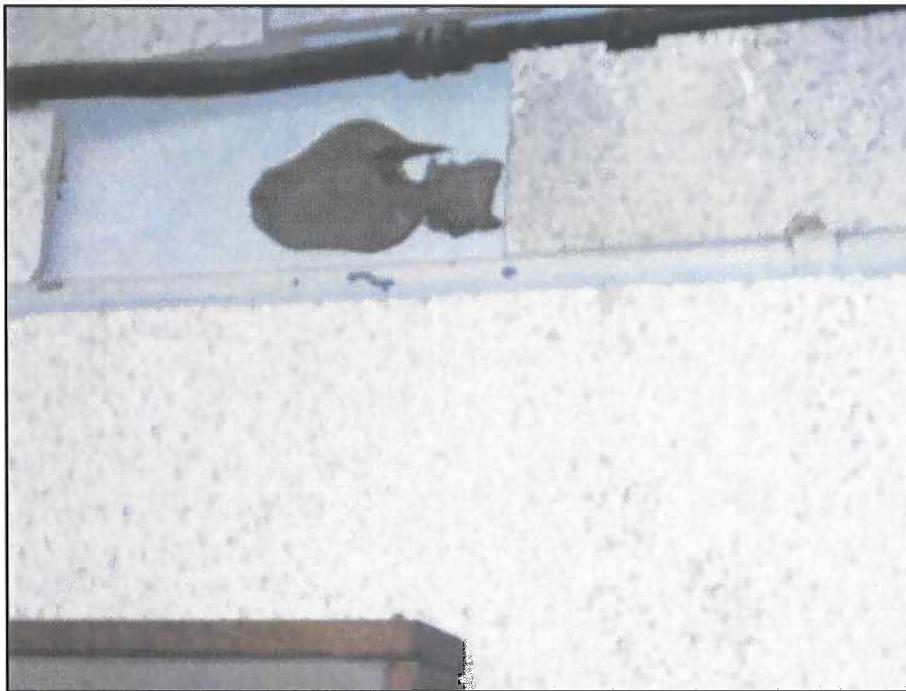
ACM wall tile adhesive (Material #036) behind 1'x1' gouge and pinhole wall and ceiling tile (Material #035)

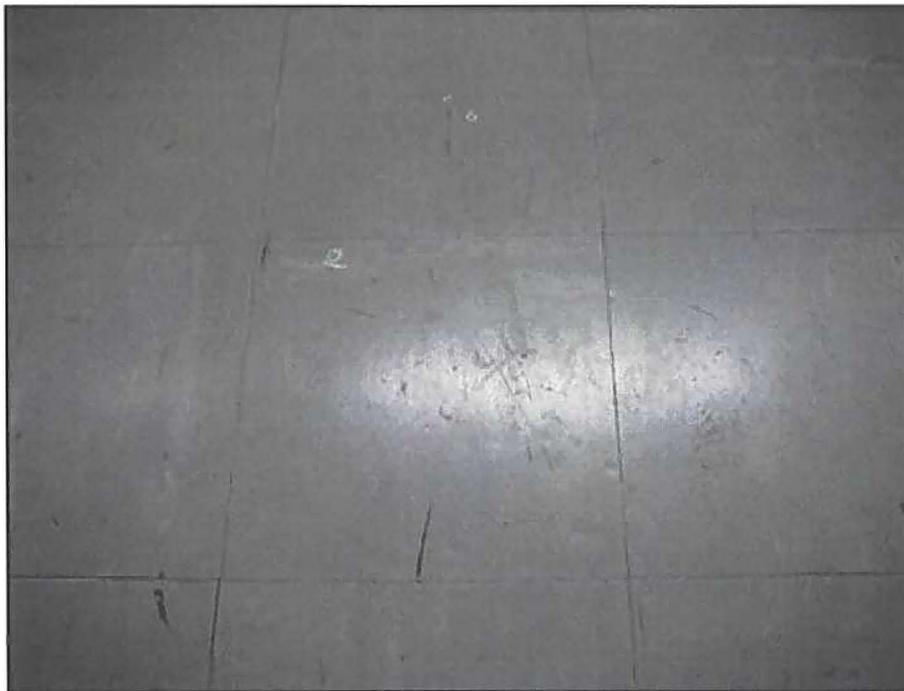
9"x9" gray with pink vinyl floor tile (Material #011)

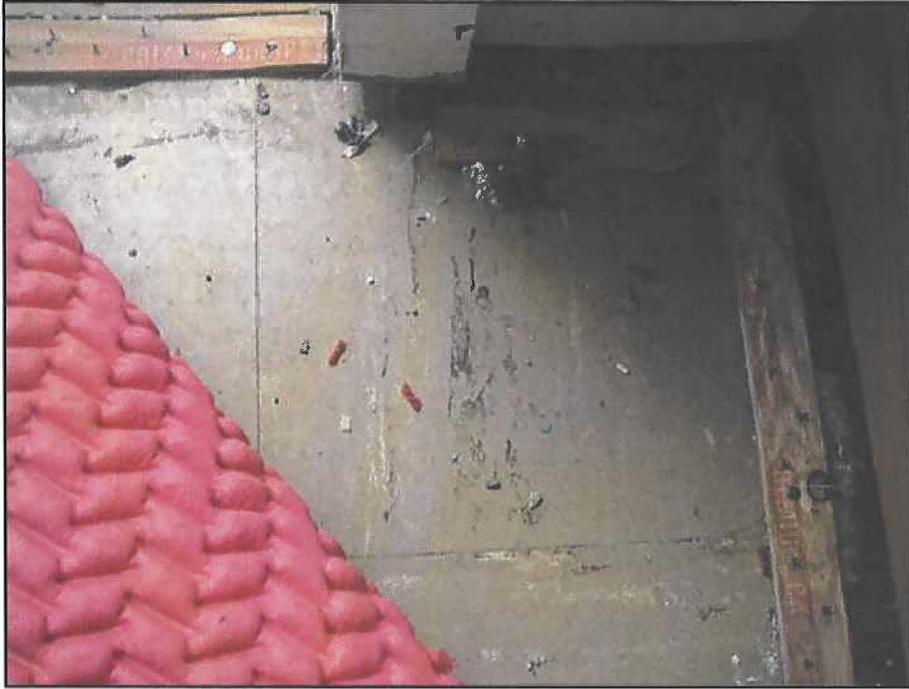
9"x 9" brown with dark brown, white, and pink vinyl floor tile (Material #012)

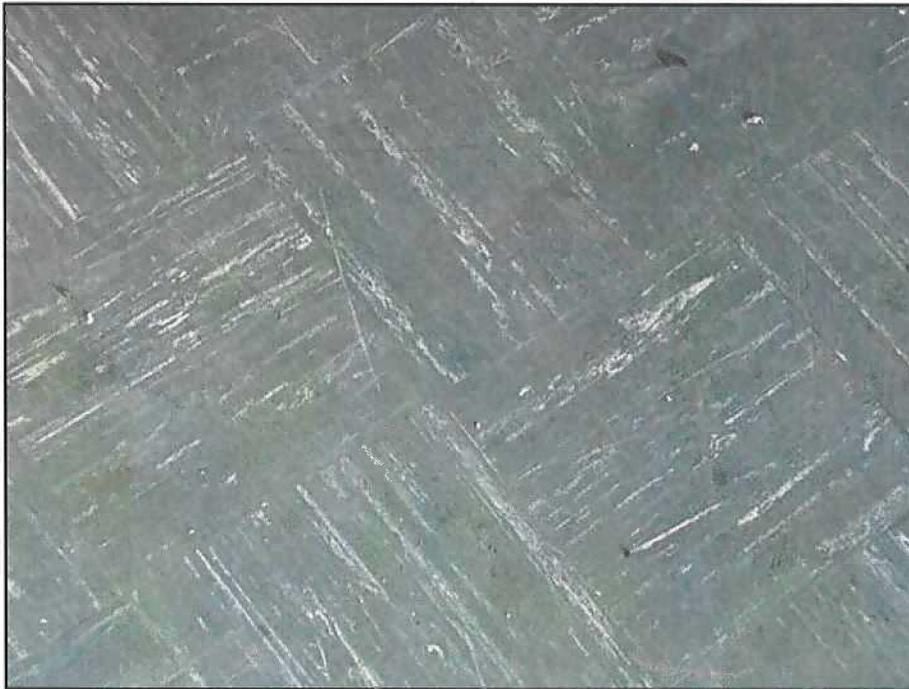
9"x 9" green with white streaks vinyl floor tile (Material #018)

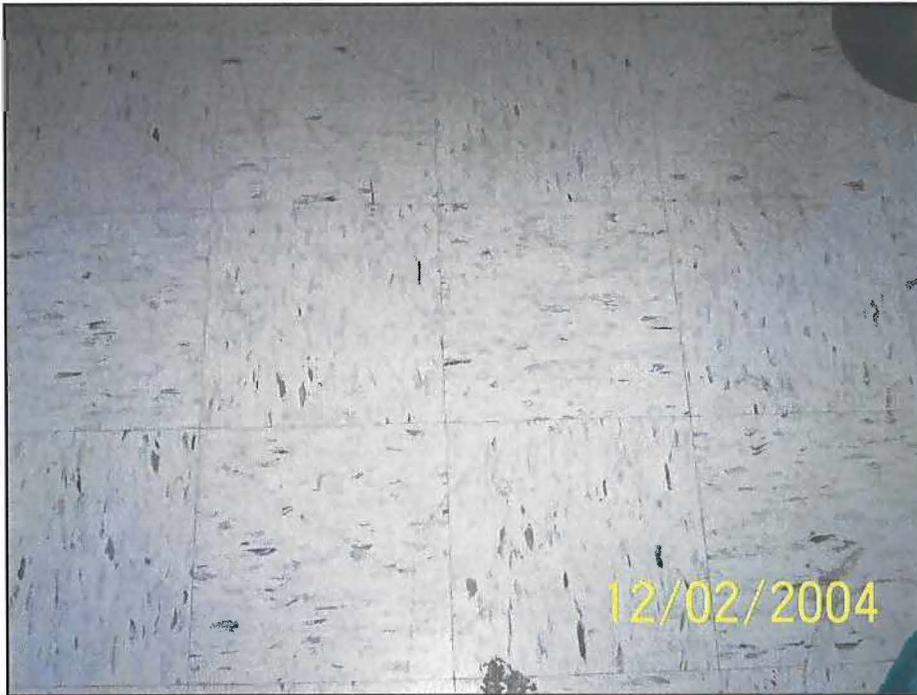
1' x 1' white with streaks vinyl floor tile (Material #002)

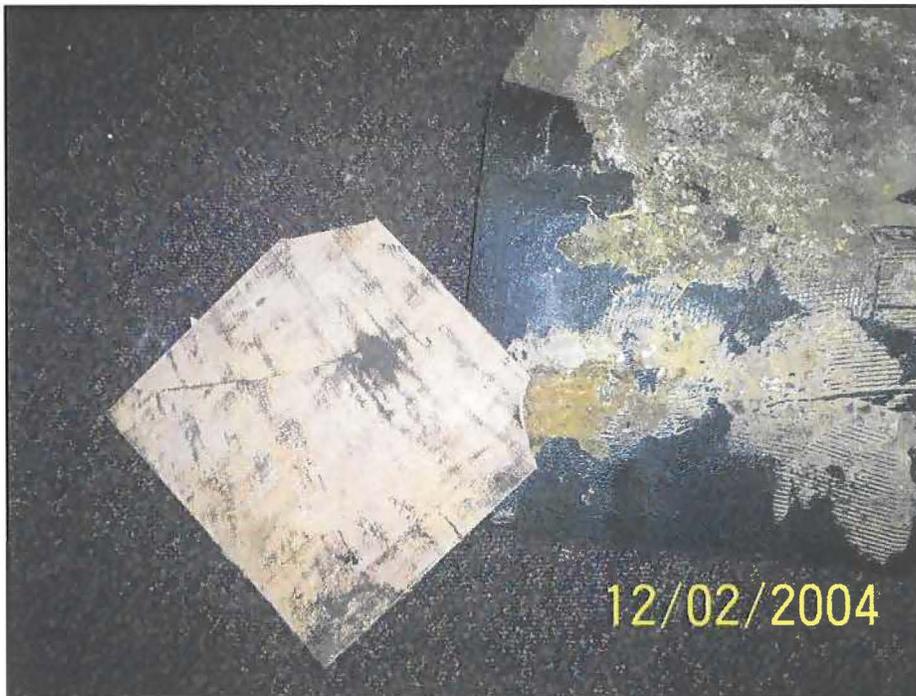
9'' x 9'' tan vinyl floor tile and associated black mastic (Material #009)
