Final
Asbestos Inspection Report
for

Naval Activity Puerto Rico
Ceiba, Puerto Rico

Volume 2 of 7

Buildings DN2-3 through 598

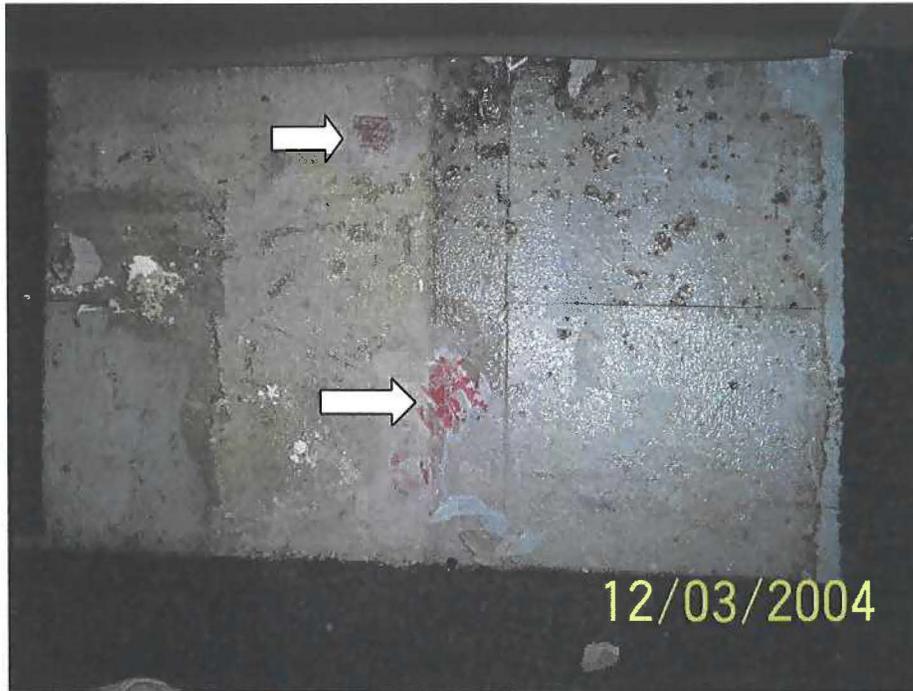
9" x 9" red vinyl floor tile with black mastic (Material #008)

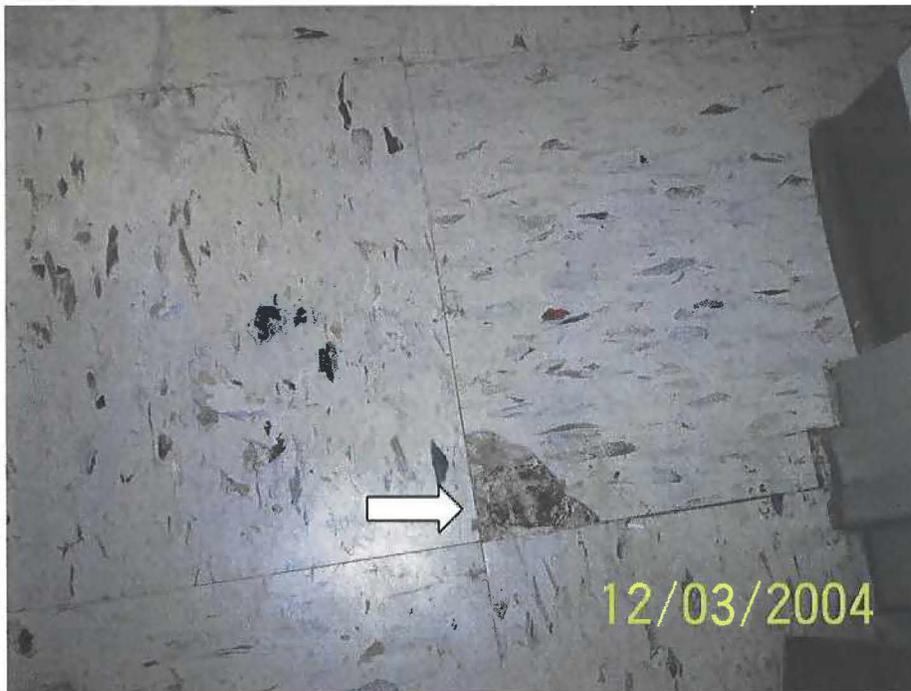
Leveling compound (Material #009)

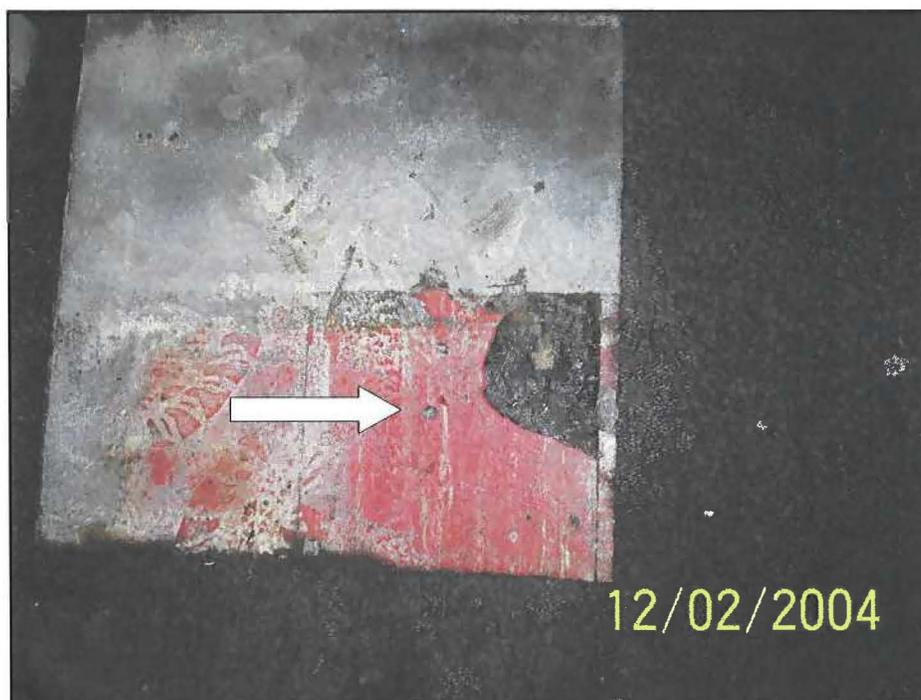
9" x 9" red vinyl floor tile and associated black mastic (Material #007)

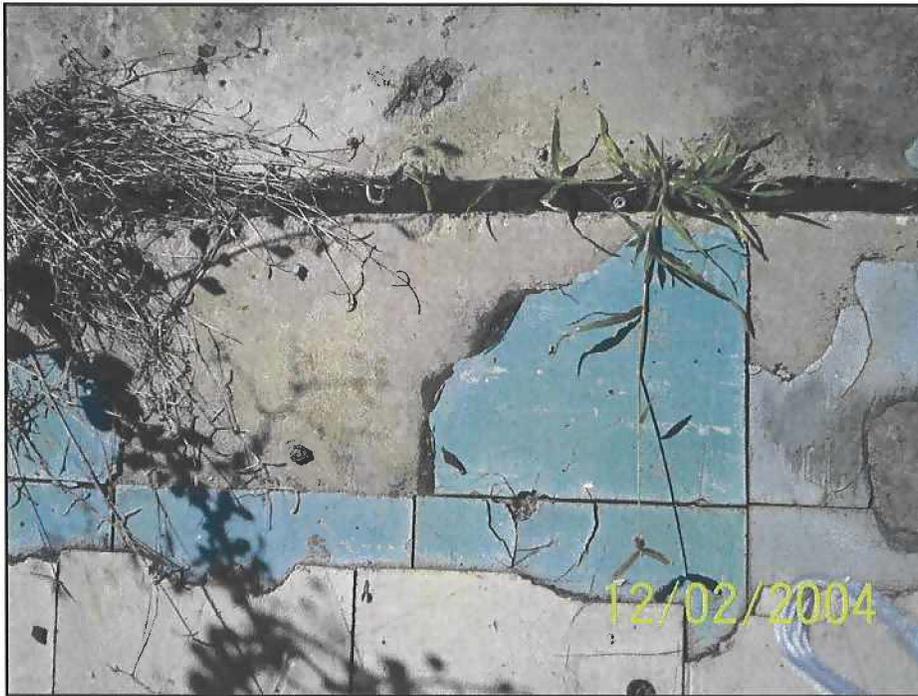
9" x 9" green vinyl floor tile with mastic (Material #001)

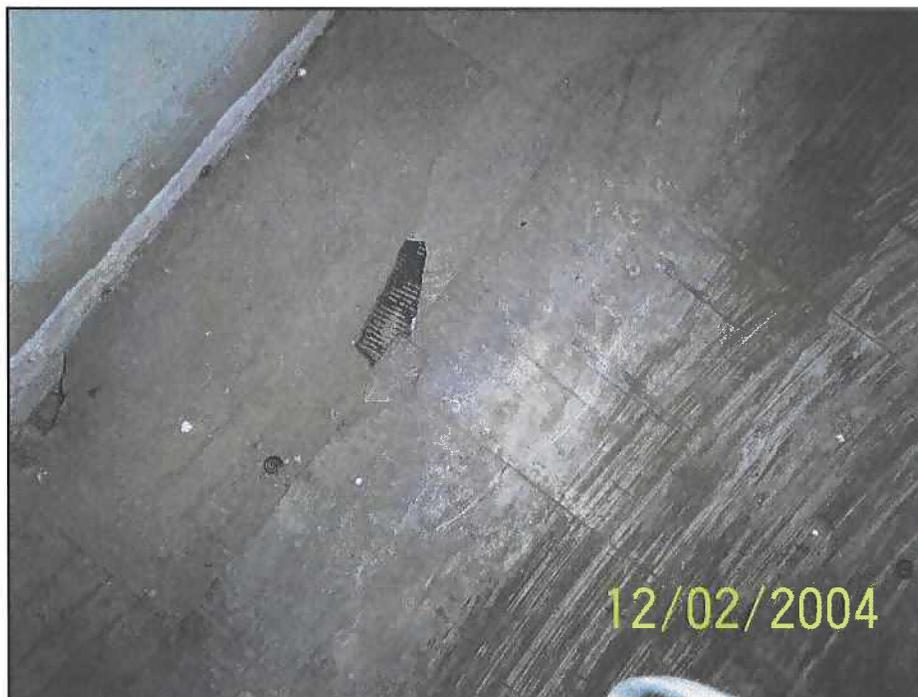
9" x 9" gray vinyl floor tile with mastic (Material #002)

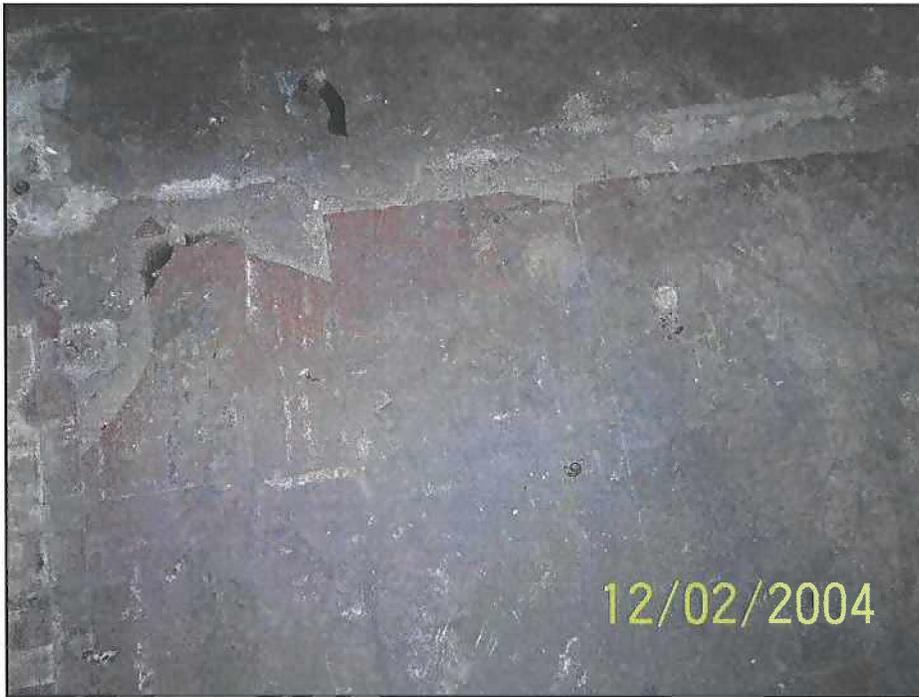
9" x 9" red vinyl floor tile (Material #003)

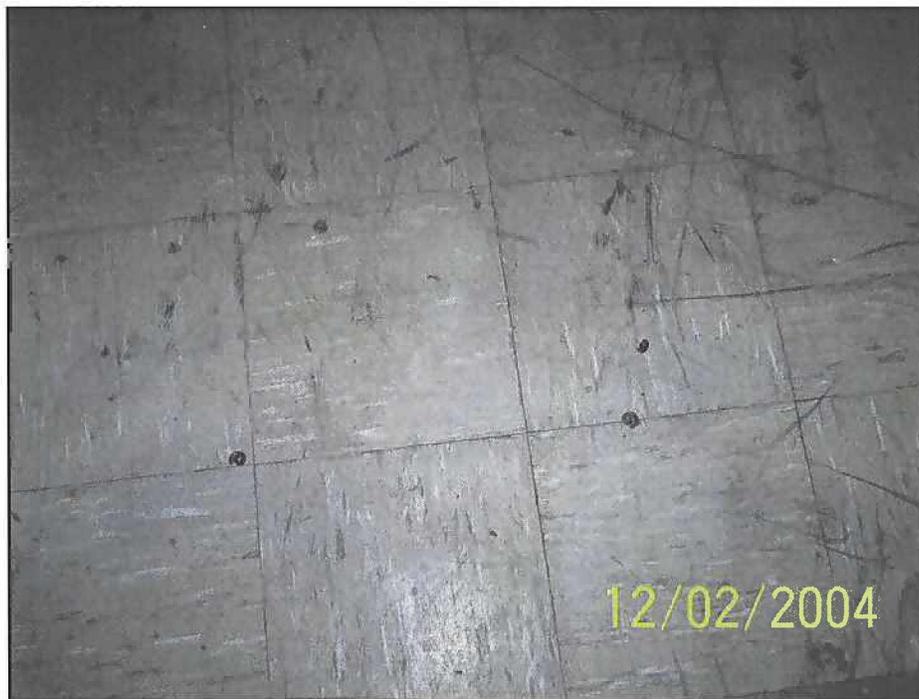
9" x 9" streaked cream vinyl floor tile with mastic (Material #004)

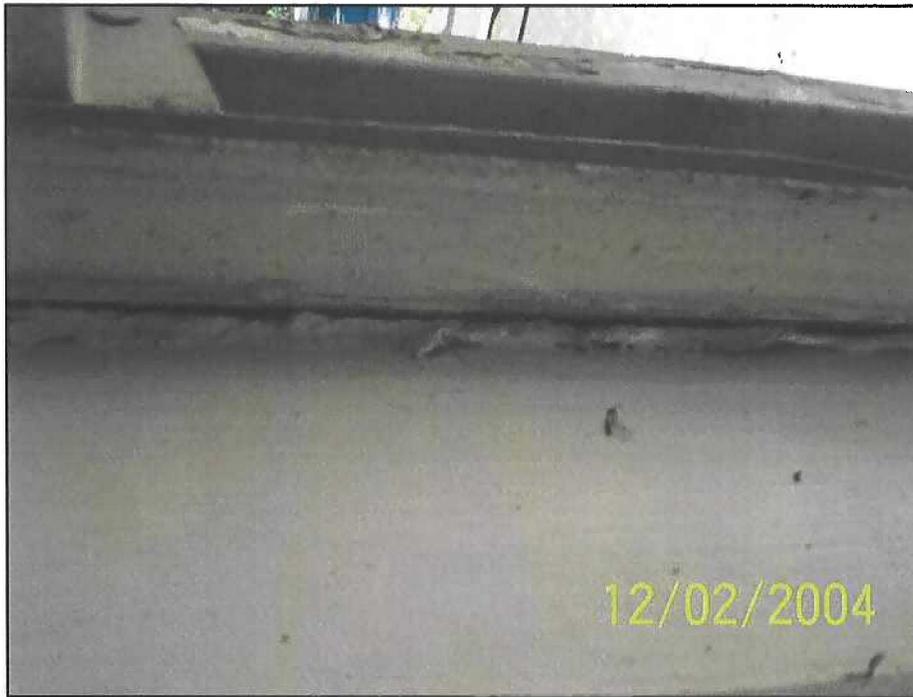
Interior window caulking (Material #005)

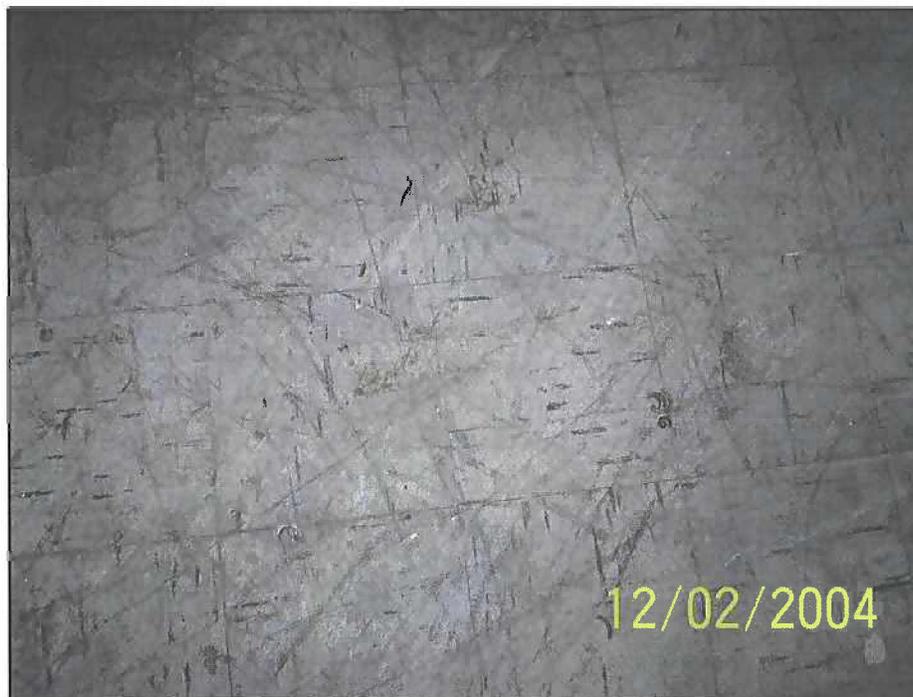
9" x 9" white with black streaks vinyl floor tile with mastic (Material #008)

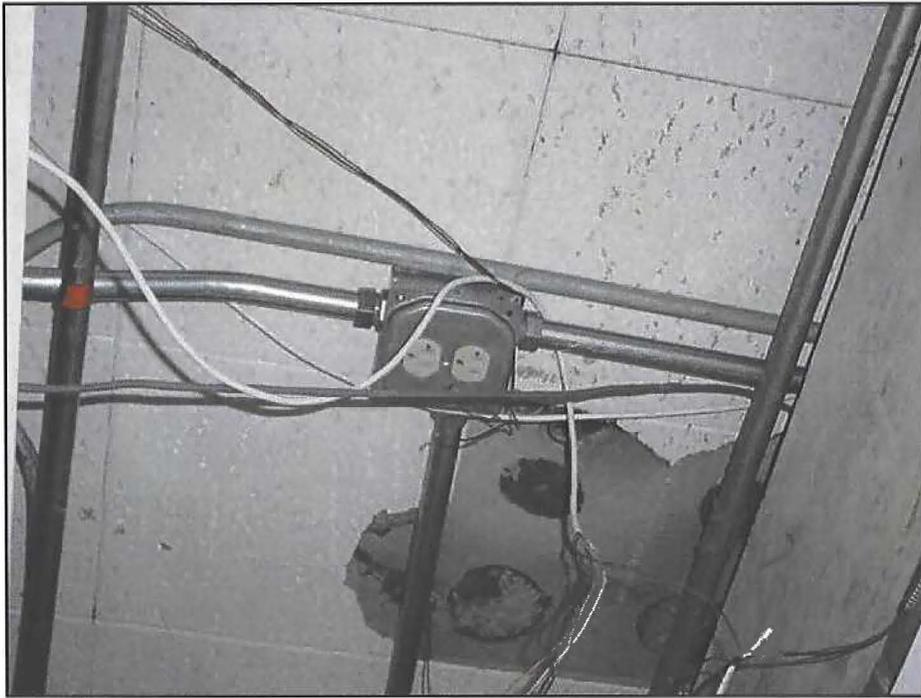
Ceiling tile adhesive (Material #012)

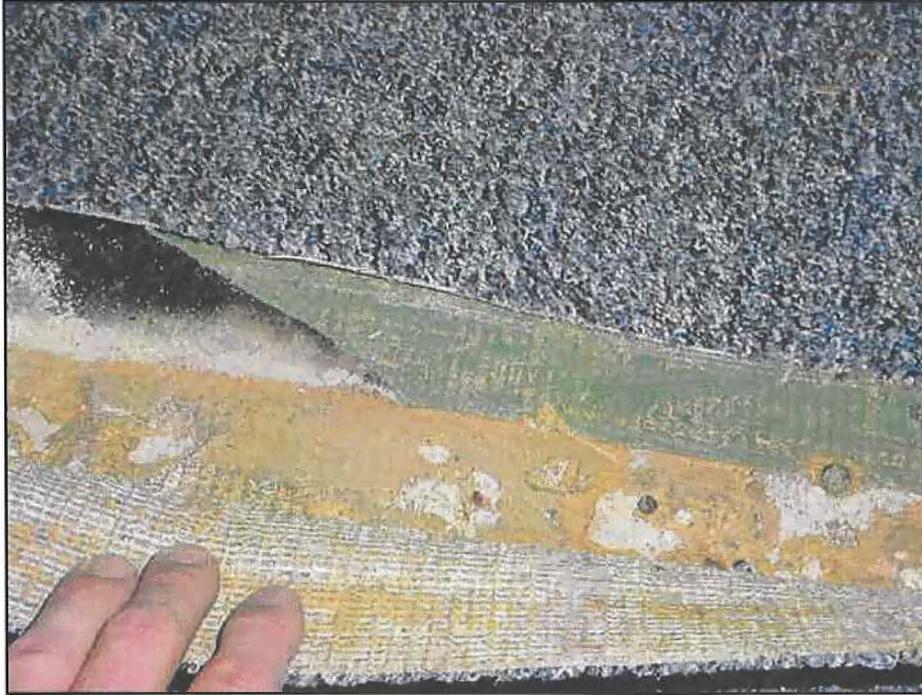
9"x9" green vinyl floor tile (Material #014) over floor adhesive (Material #016)

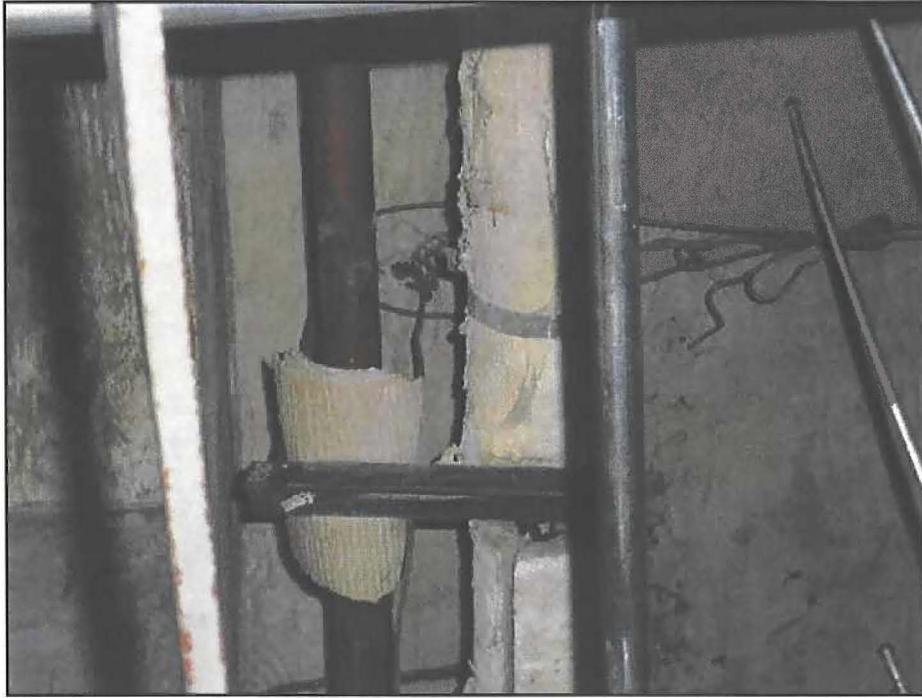
HOMOGENEOUS MATERIAL	BUILDING NUMBER	QUANTITY
THERMAL PIPE INSULATION (Material Number 023)	598	5 LF
THERMAL PIPE INSULATION (Material Number 024)	598	1 LF

Pipe insulation materials (Material #023 – right, and Material #024 – left)

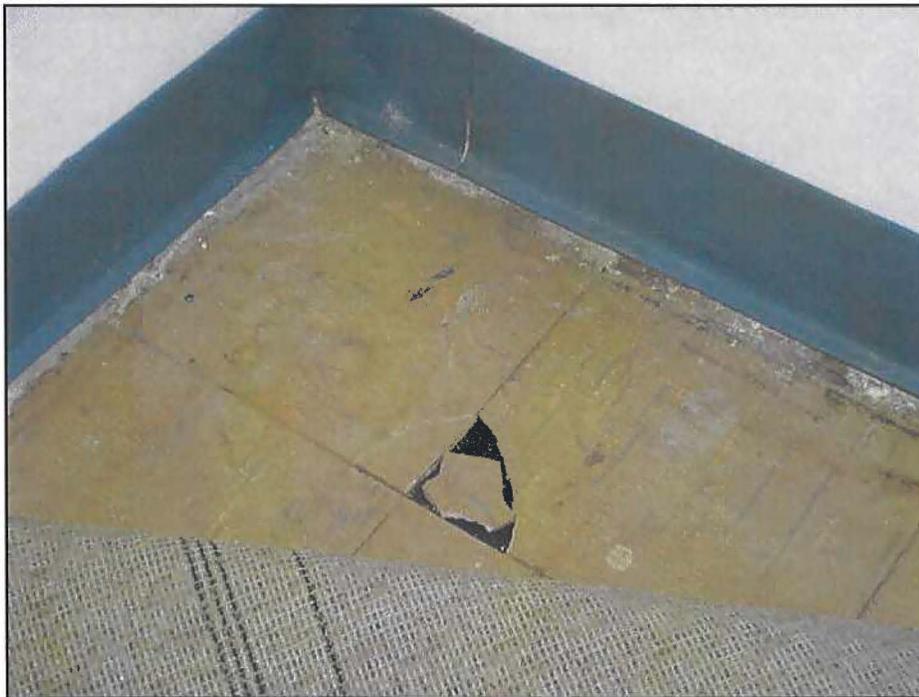
9"x9" gray vinyl floor tile (Material #026)
