Final  
**Asbestos Inspection Report**  
for  
Military Family Housing  
Naval Activity Puerto Rico  
Ceiba, Puerto Rico

Contract N62472-01-D-1440 • Project Number 15 • June 2005

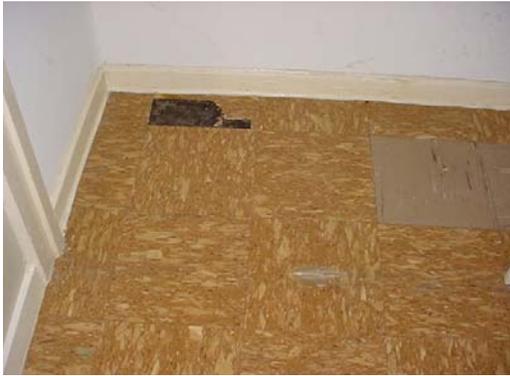
Material Numbers 001 and 002  
1' x 1' Vinyl Floor Tile and Adhesive

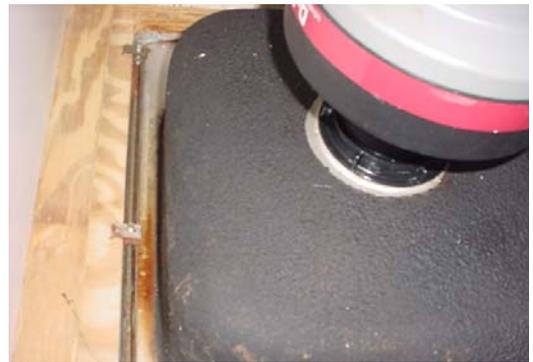
Material Number 004  
Sink Coating

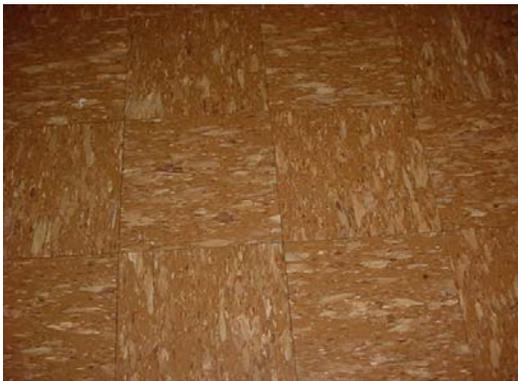
Material Number 007  
1' x 1' Vinyl Floor Tile

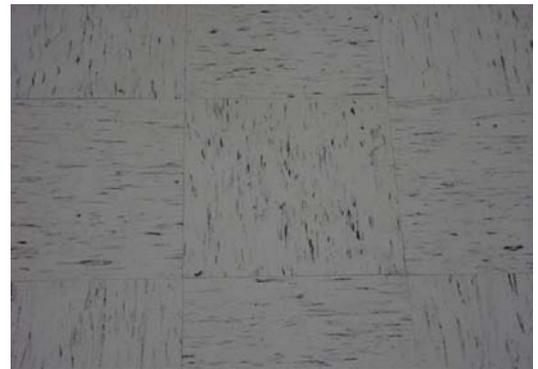
Material Number 010  
1' x 1' Vinyl Floor Tile

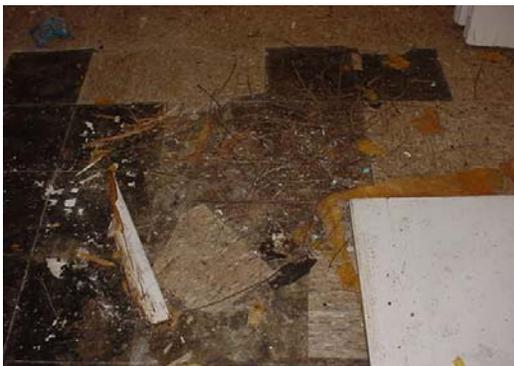
Material Numbers 011 and 012  
1' x 1' Vinyl Floor Tile and Adhesive

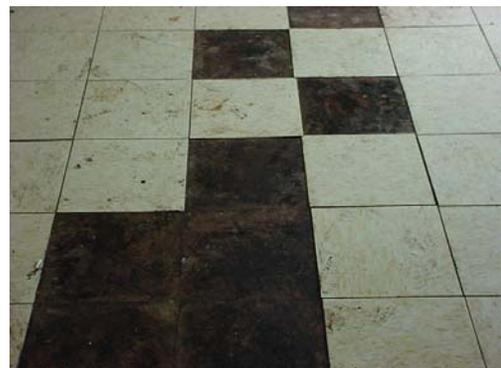
Material Number 013  
1' x 1' Vinyl Floor Tile
