FINAL LEAD-BASED PAINT RISK ASSESSMENT REPORT MILITARY FAMILY HOUSING

***For* NAVAL ACTIVITY PUERTO RICO
CEIBA, PUERTO RICO**

Michael Baker Jr., Inc.
Moon Township, PA

December 21, 2011

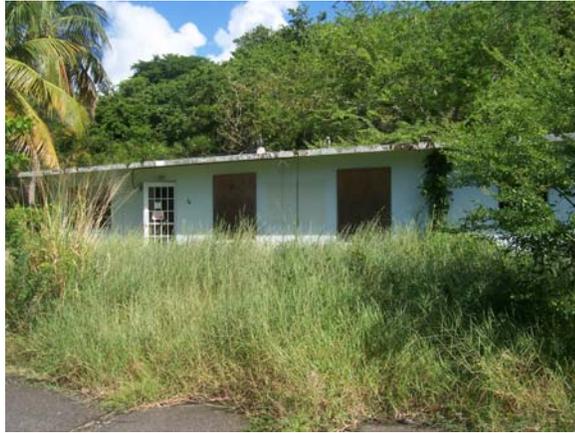
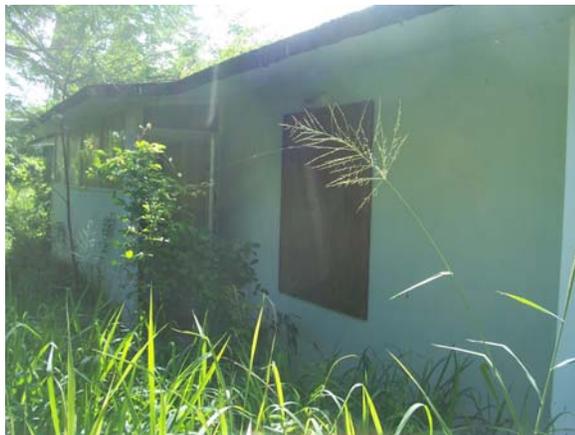
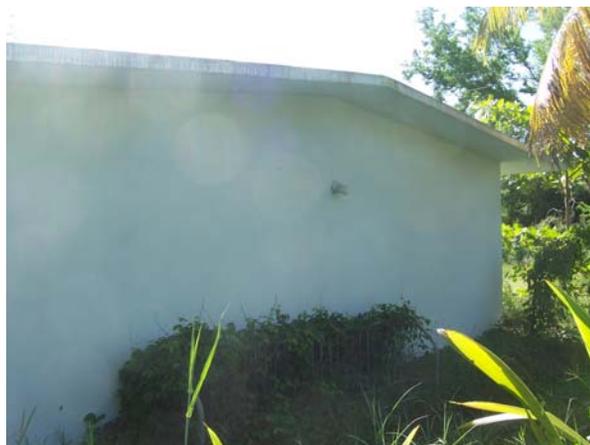
**Front, rear, and side of typical Coast Guard 2, 3, and 4 bedroom units.
Unit shown is 1676 Intrepid Street.**

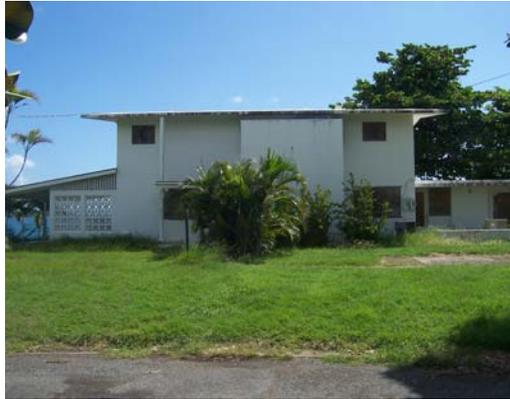
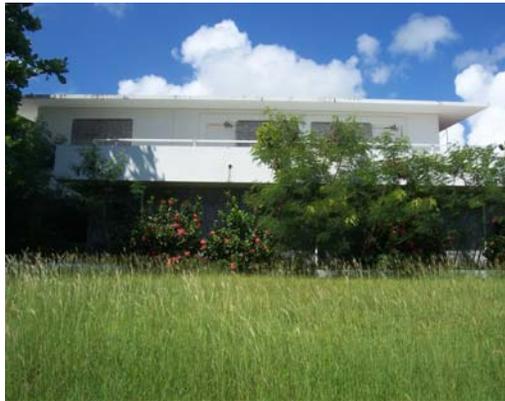
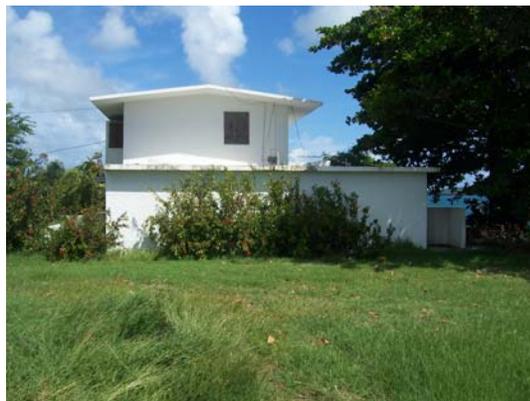
**Front, rear, and side of typical FDR Drive 3 bedroom houses.
Unit shown is 1 FDR Drive.**

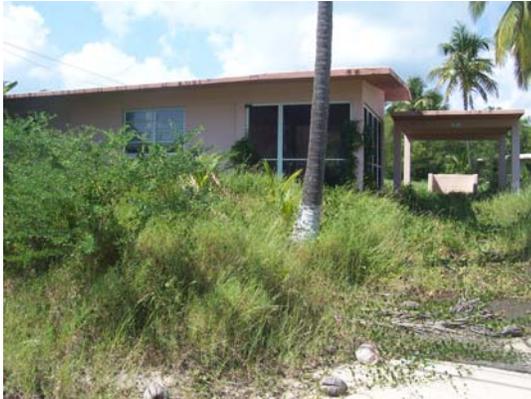
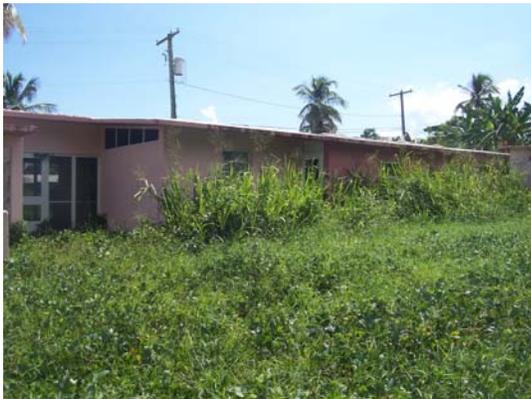
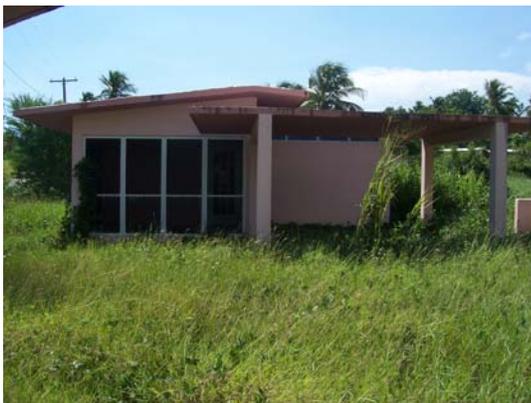
**Front, rear, and side of typical Manatee Bay 2, 3, and 4 bedroom units.
Unit shown is 4 Coral Sea Drive.**

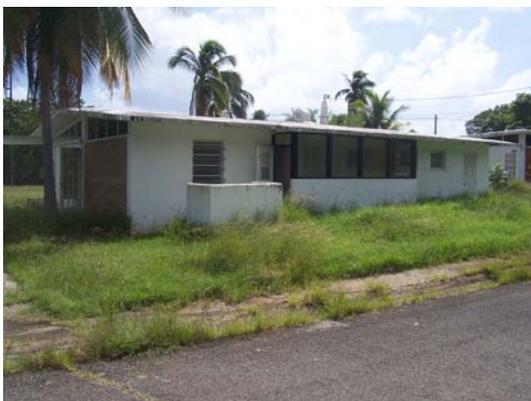
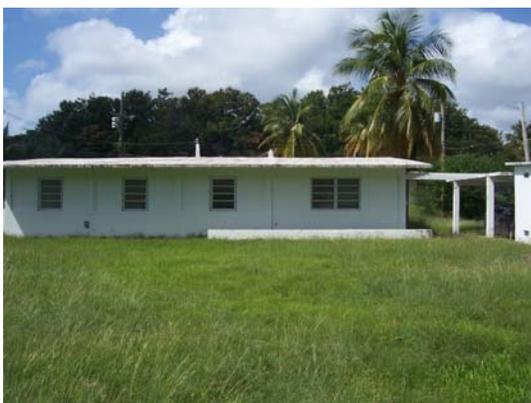
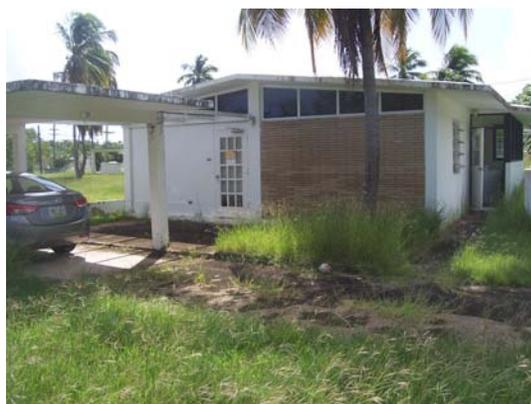
**Front, rear, and side of typical Mangrove Manor 2, 3, and 4 bedroom units.
Unit shown is 29 Lexington Drive.**

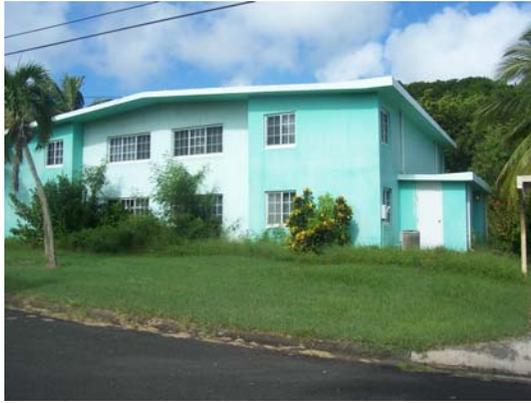
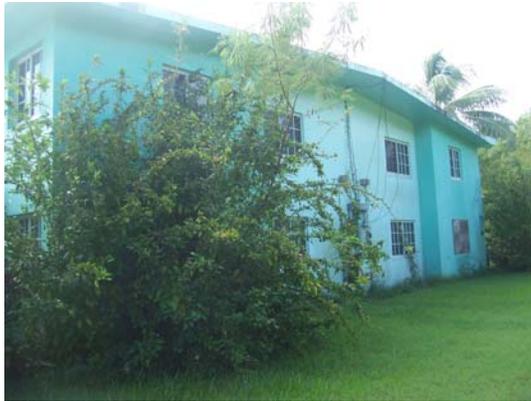
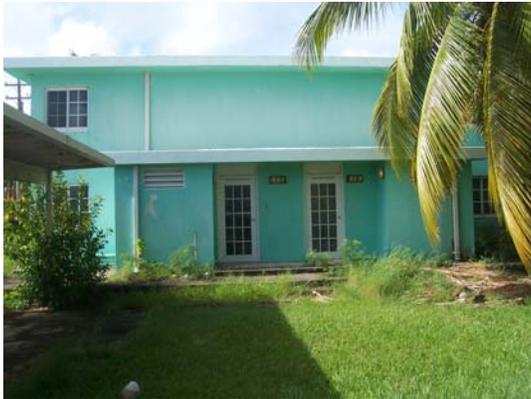
**Front, rear, and side of typical Rainbow Hill 2 bedroom unit.
Unit shown is 23 C-D Nimitz Drive.**

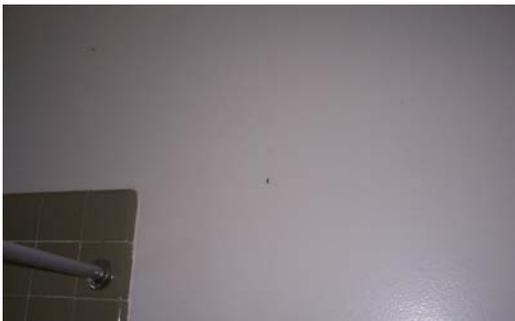
**Concrete Wall
1678 Intrepid – Bath 1**

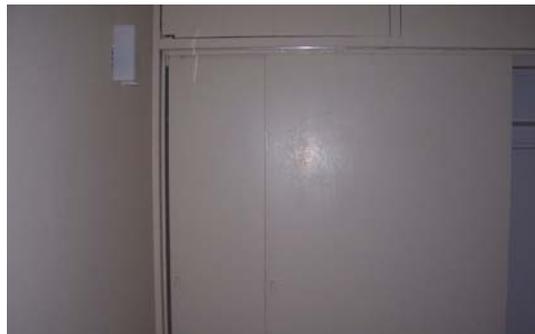
**Sliding Door and Sliding Door Casing
1678 Intrepid – BR 1**

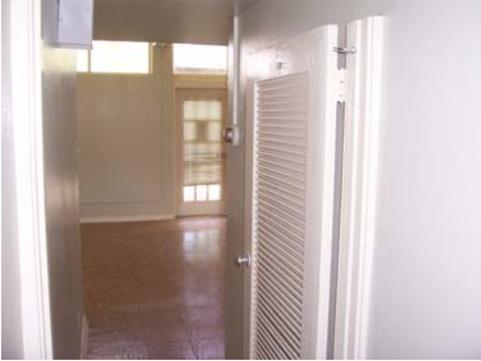
Door Casing/Jamb/ Stop (Wood)
11 Essex Drive - Hall

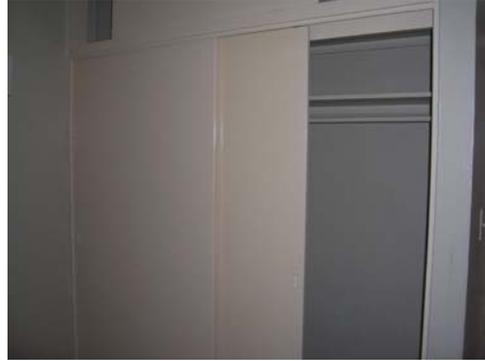
Sliding Door
18 Enterprise Drive – BR2

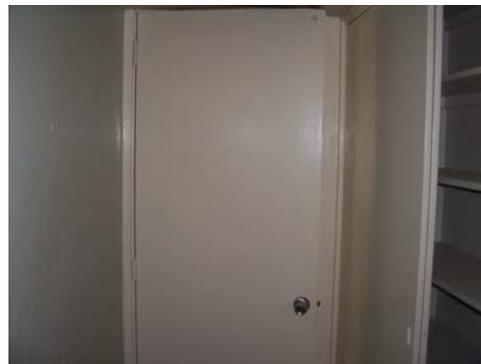
Door (Wood)
11 Essex Drive – BR1

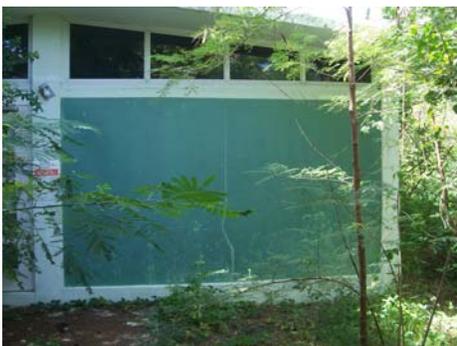
Exterior Wall (Ceramic)
6 Ticonderoga - Exterior
